Project FORTH REPLACEMENT CROSSING

VIBRATION MONITORING REPORT APRIL 2016

Made by Michael Richardson	Checked By: Steven Westwater		
Initials: MRN	Initials: SWR		
Document number			
REP-00277	00

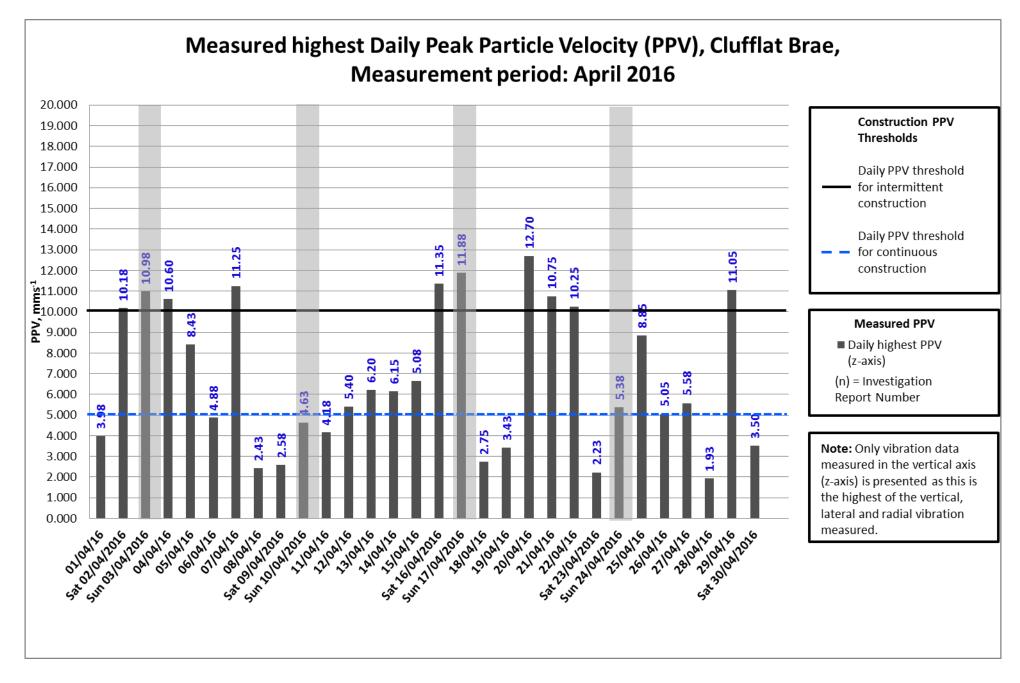
Exceedances on the 2nd, 3rd, 4th, 5th, 7th, 12th, 13th, 14th, 16th, 20th, 22nd, 25th, and 29th of April have been investigated and found to be caused by individual isolated events that are unlikely to have been construction related activities (graph above from the 07/04/2016).

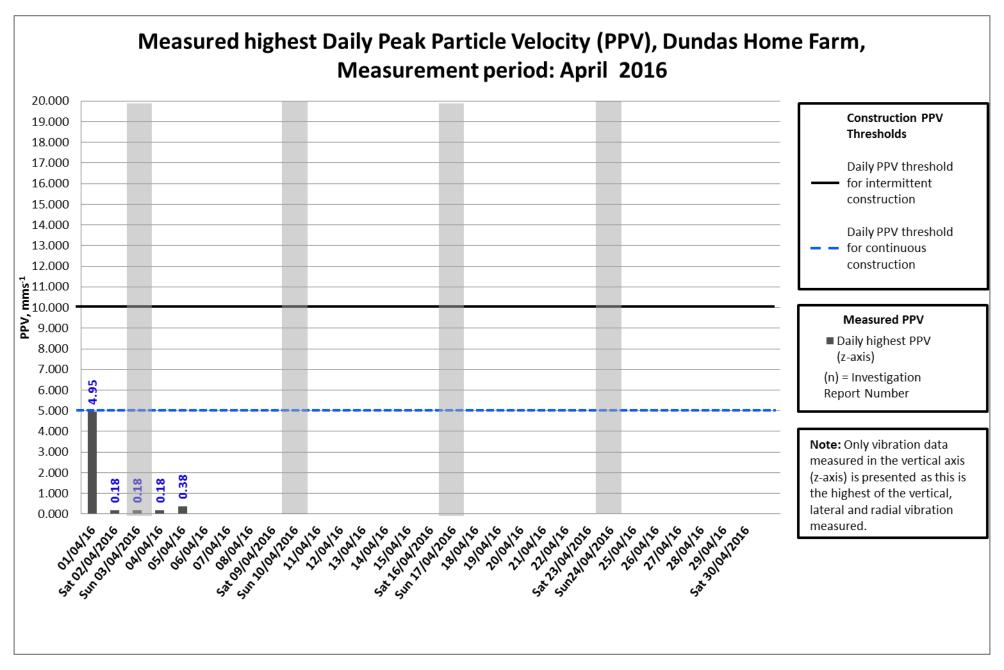
Data missing from the 6th to the 30th of April was caused by power issue at the monitor location. This has since been resolved on the 11th of May.

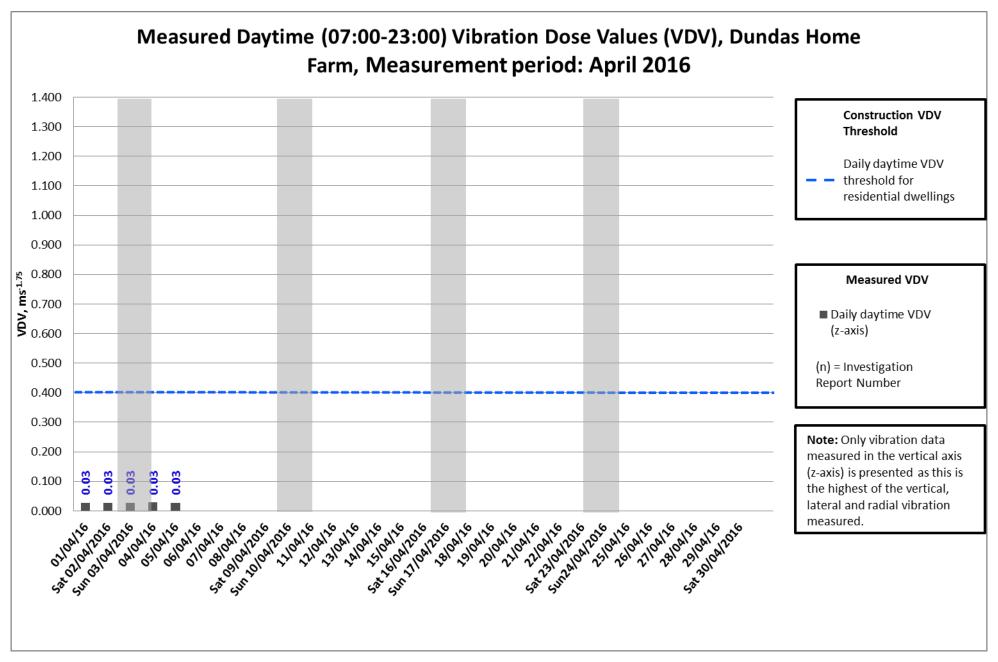
Data missing from the 6th to the 30th of April was caused by power issue at the monitor location. This has since been resolved on the 11th of May.

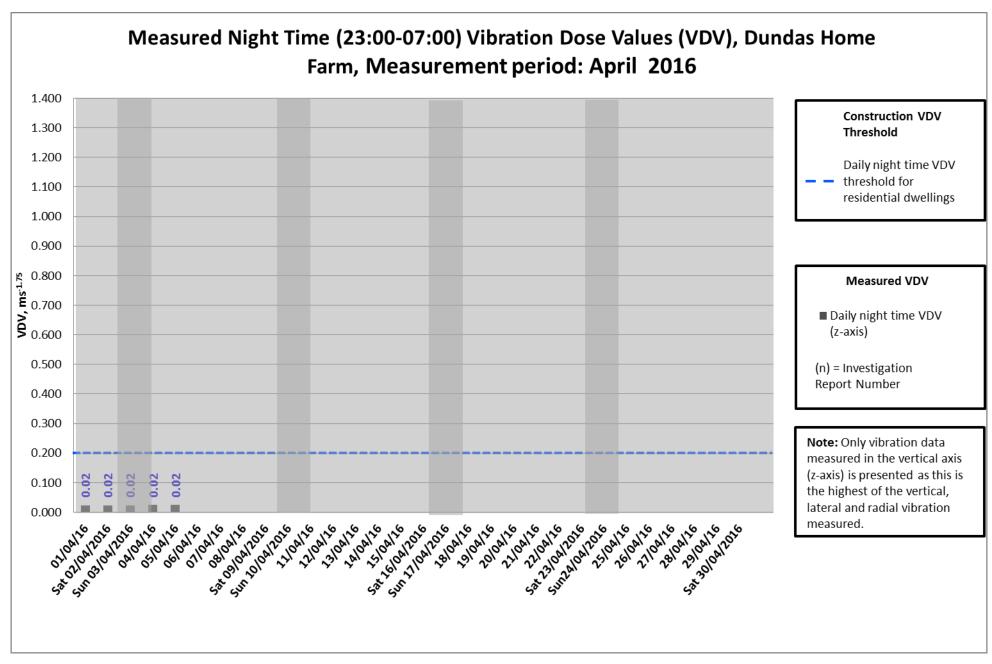
Data missing from the 6th to the 30th of April was caused by power issue at the monitor location. This has since been resolved on the 11th of May.

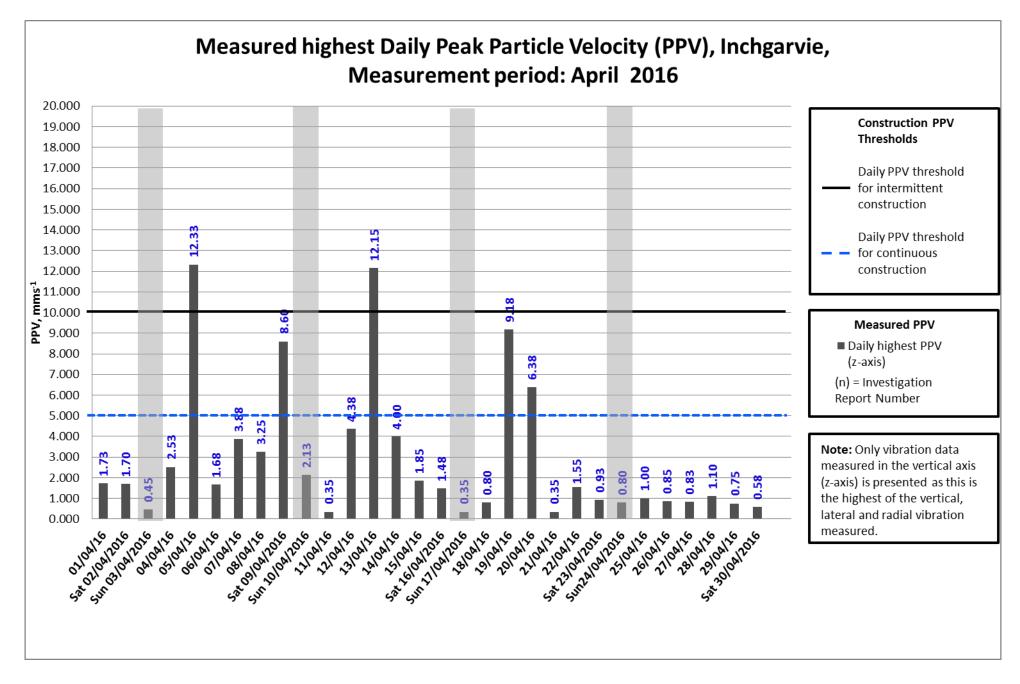
Exceedances on the 5th and 19th of April have been investigated and found to be caused by individual isolated events that are unlikely to have been construction related activities (graph above from the 05/04/2016).

Exceedances on the 9th, 13th and 20th of April have been investigated and found to be caused out with construction working hours and therefore it is unlikely that construction related activity was the cause of these (graph above from the 09/04/2016).

During this period the resident at the property, where the monitor is situated, has ongoing private construction works. It is likely that exceedances within the graph above were caused by the works on the property rather than the construction of the new crossing and supporting infrastructure.

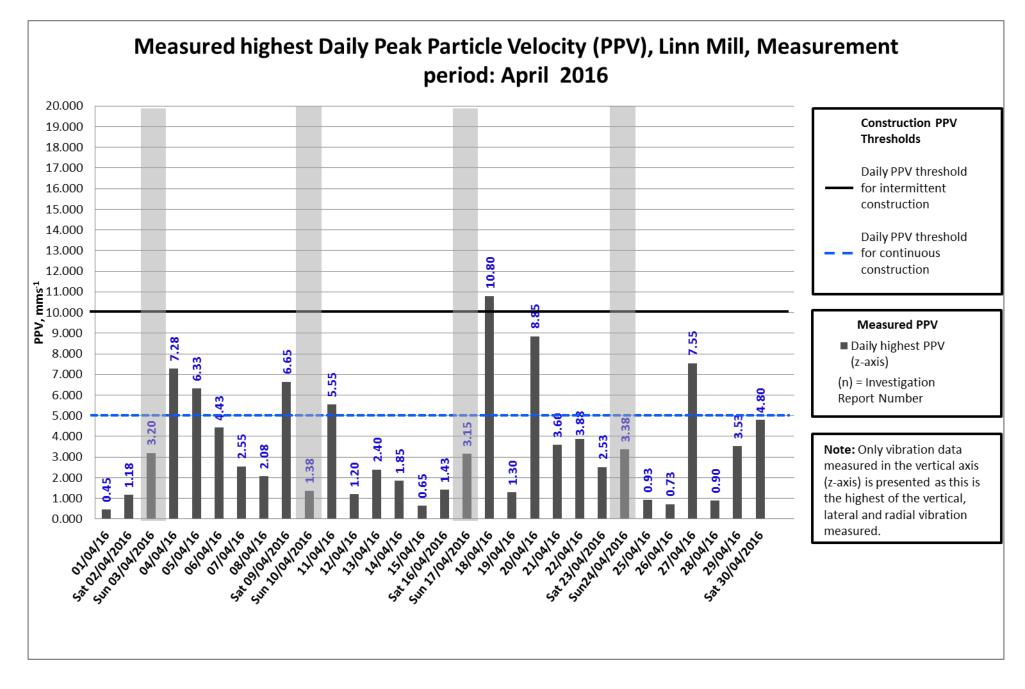
Exceedances on the 4th, 5th, 9th, 11th, 20th, and 27th of April have been investigated and found to be caused by individual isolated events that are unlikely to have been caused by construction related activities (graph above from the 09/04/2016). During this period there was minimal plant in the vicinity of this location.

Exceedance on the 18th of April have been investigated and found to have occured outwith construction working hours and therefore it is unlikely that construction related activity was the cause of these (graph above from the 18/04/2016).

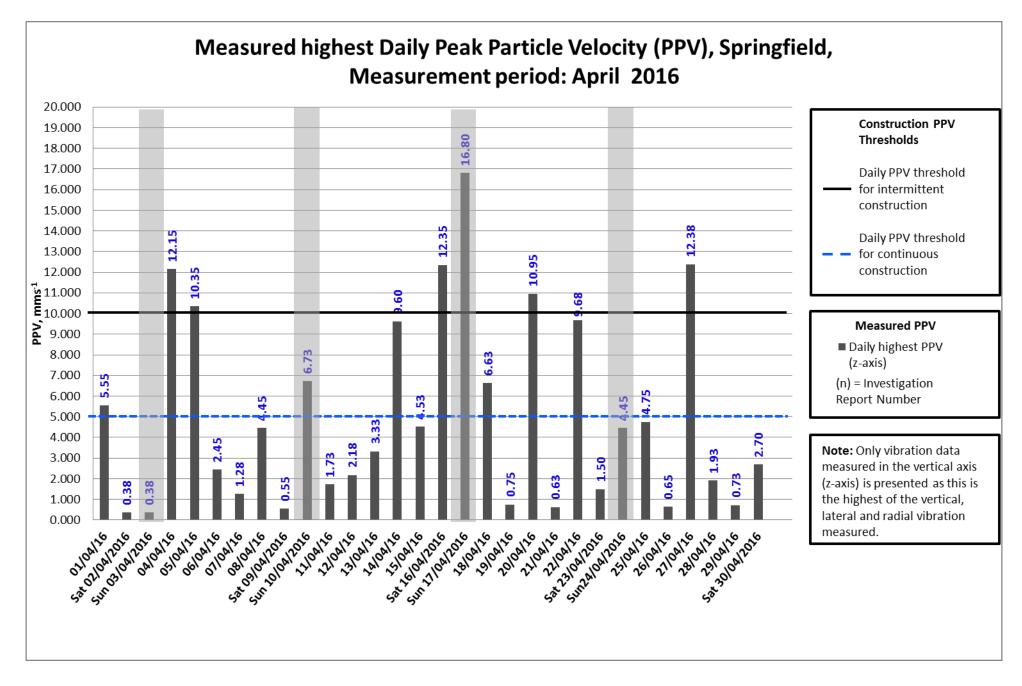
Exceedances on the 1st, 4th, 5th, 14th, 16th, 18th, 20th, 22nd and 27th of April have been investigated and found to be individual isolated events that are unlikely to have been caused by construction related activities (graph above from the 04/04/2016). During this period there was an increase of activity from the resident in his garden in which the monitor is situated. Due to this there is a likelihood that this activity is what has been picked up on the monitor (closest works to the monitor was approximately 290m away with no vibratory plant in use with the exception of a concrete poker on AVS).

Exceedances on the 10th and 17th of April have been investigated and found to have occured outwith construction working hours and therefore it is unlikely that construction relate activity was the cause.

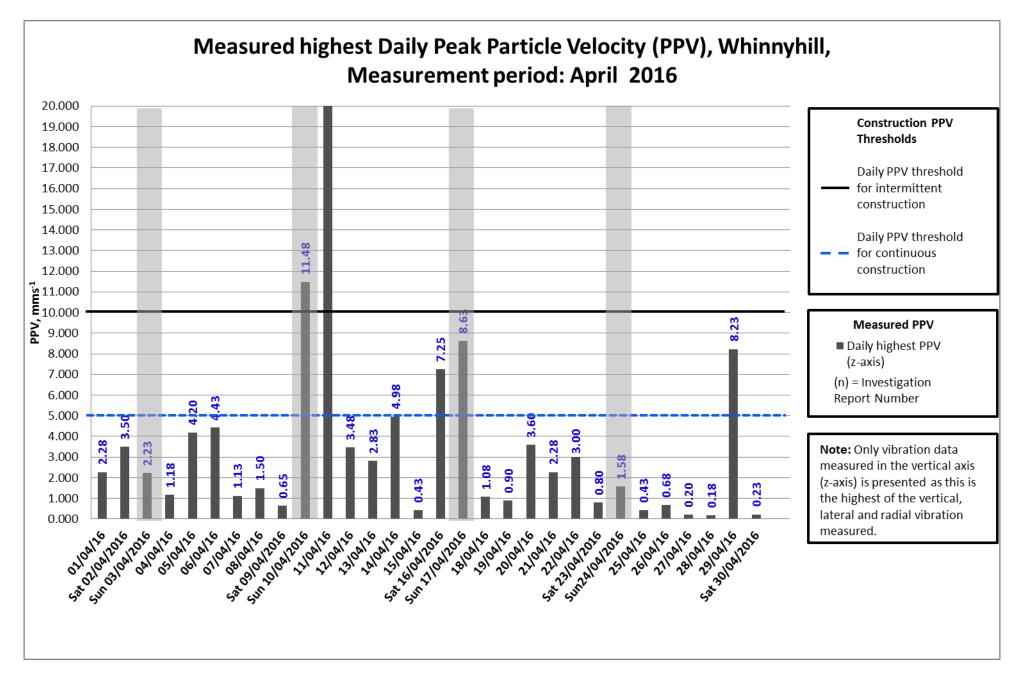
Exceedances on the 10th, 16th and 17th of April have been investigated and found to have occured outwith construction working hours and therefore it is unlikely that construction related activities was the cause. (graph above from the 16/04/2016).

Exceedance on the 11th of April has been investigated and found to be caused by AQM carrying out maintenance and calibration to the Air quality monitors. Due to the close proximity of the air quality monitor and the vibration monitor, movement by the calibration engineer was picked up on the vibration monitor.

Exceedance on the 29th of April has been investigated and found to be caused by individual isolated events that are unlikely to have been caused by construction related activities (graph above from the 29/04/2016).
