FORTH REPLACEMENT CROSSING

VIBRATION MONITORING REPORT DECEMBER 2016

Made by David Clark Checked By: Steven Westwater	
Initials: DCK	Initials: SWR
Document number	
REP-00305	00

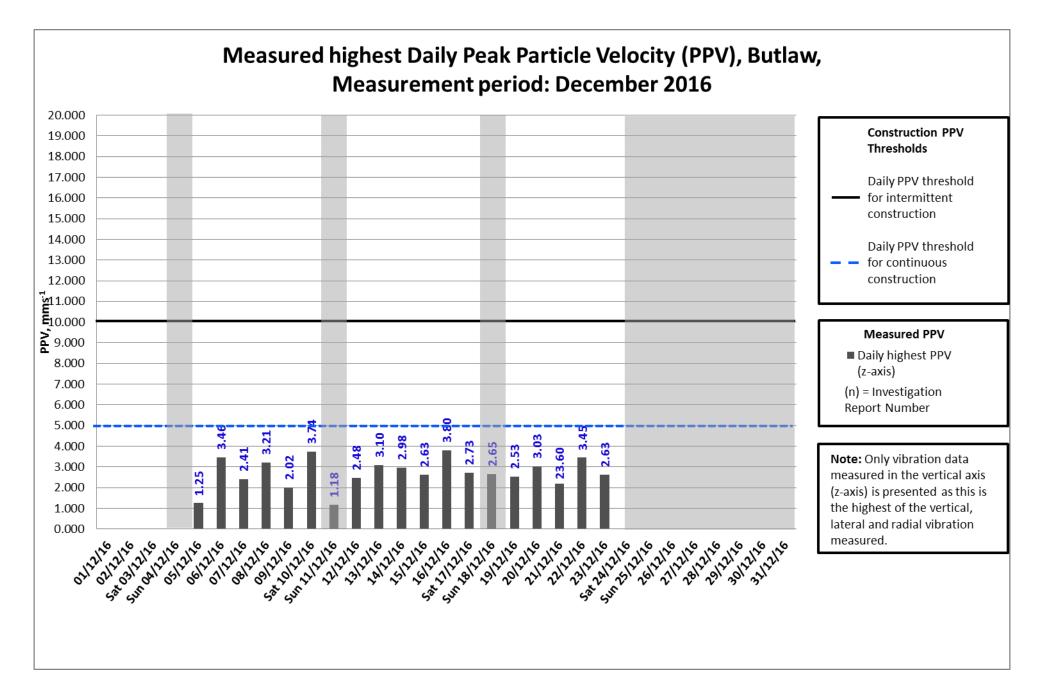
Data missing on the $1^{st} - 4^{th}$ December was caused by electrical issue with monitor.

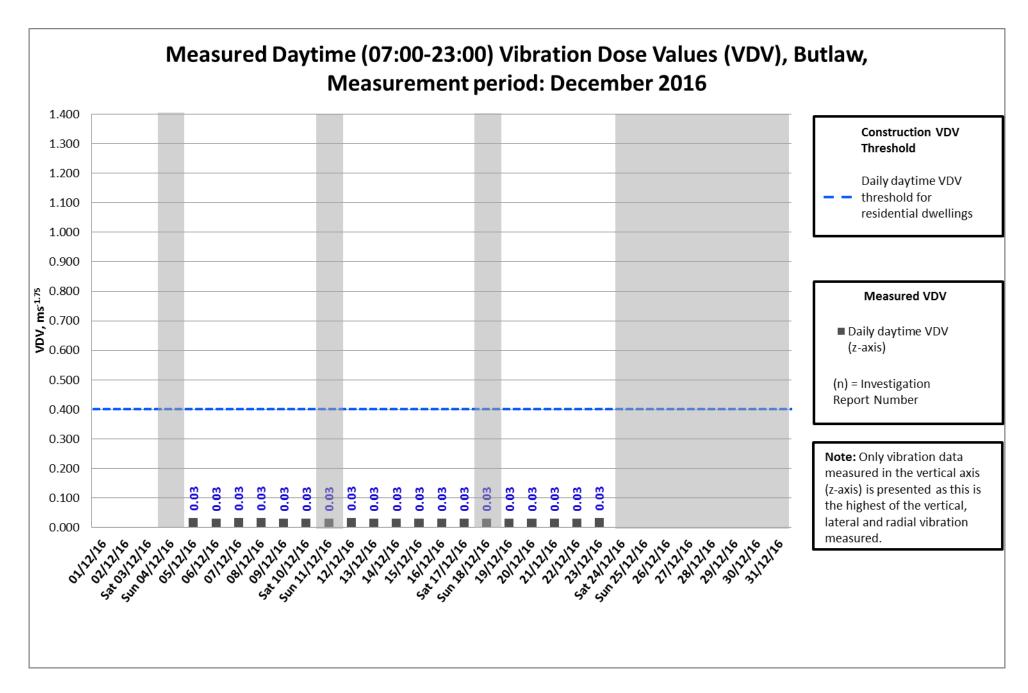
Data missing on the $1^{st} - 4^{th}$ December was caused by electrical issue with monitor.

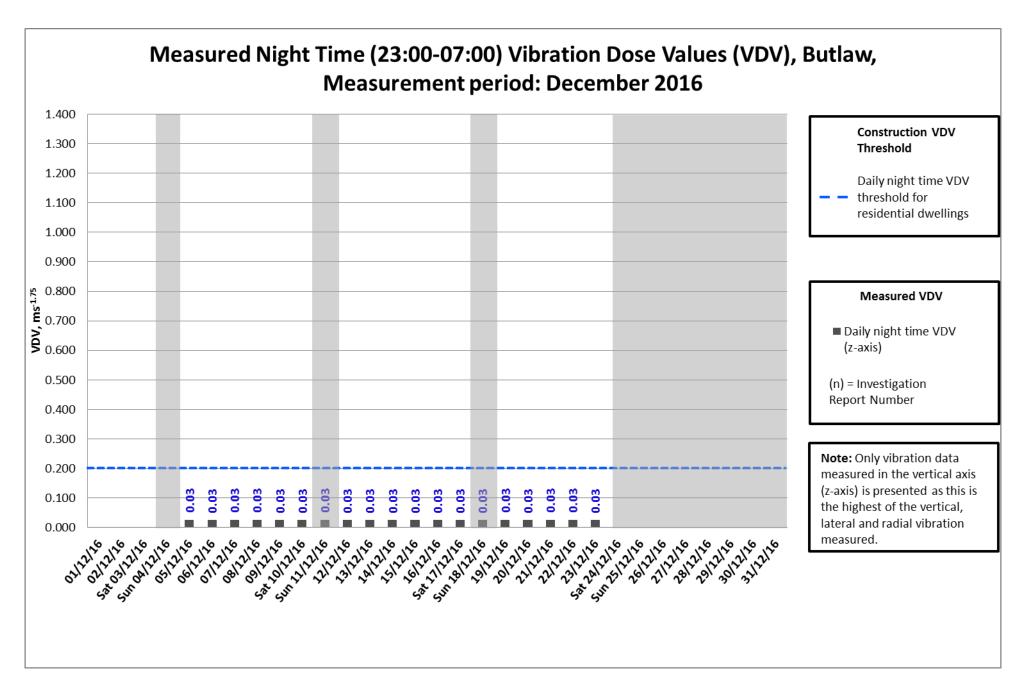
Data missing on the $1^{st} - 4^{th}$ December was caused by electrical issue with monitor.

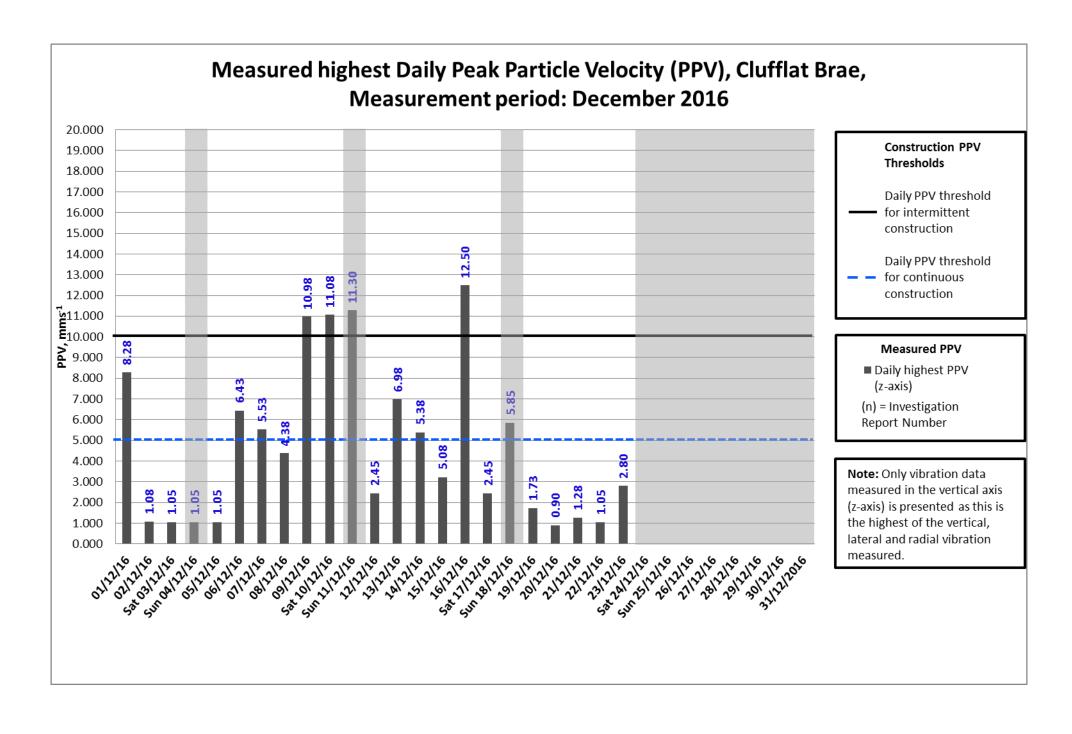
Exceedances on the 10th, 13th and 18th of December have been investigated and found to be caused by individual isolated events (graph above from the 18/12/2016). With this monitor being located in a public amenity area there is a likelihood that the exceedances seen above might have been caused by pedestrians using the area.

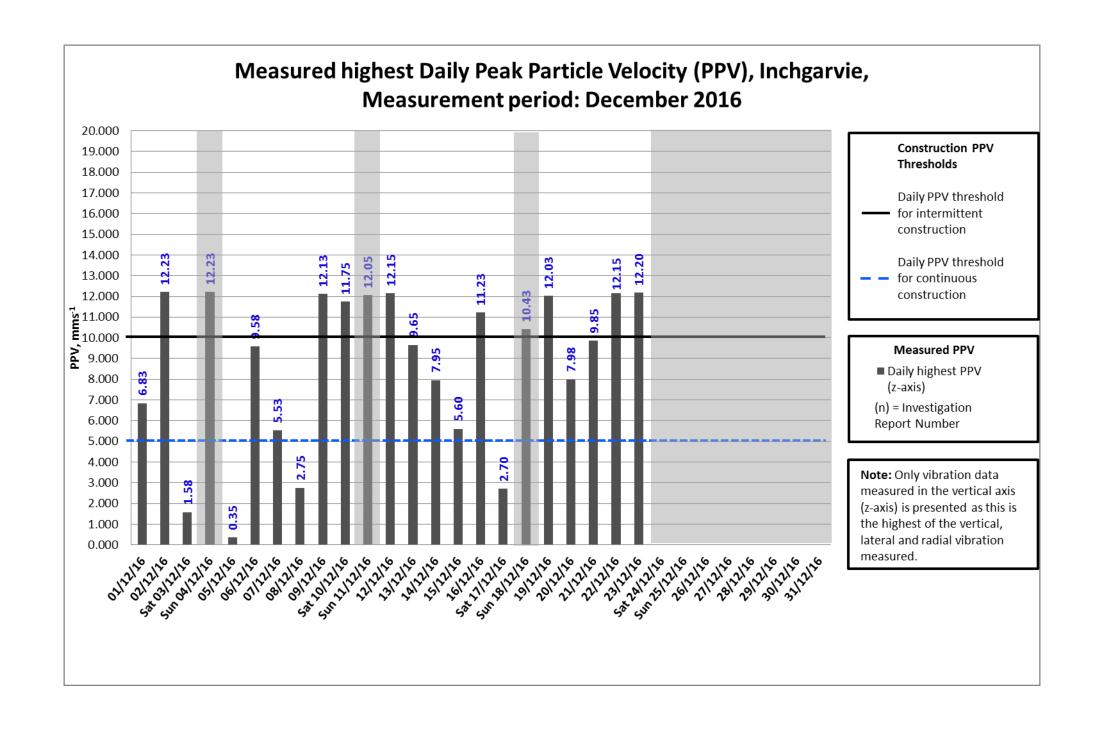
Exceedances on the 1st, 2nd, 4th, 6th, 9th, 10th, 11th, 12th, 13th, 15th, 18th, 20th, 22nd, 23rd and 28th of December have been investigated and found to be caused by individual isolated events that are unlikely to have been construction related avtivities (graph above from the 11/12/2016). The vibration monitor is located in the residents back garden, therefore resident's activity may have caused these exceedances.

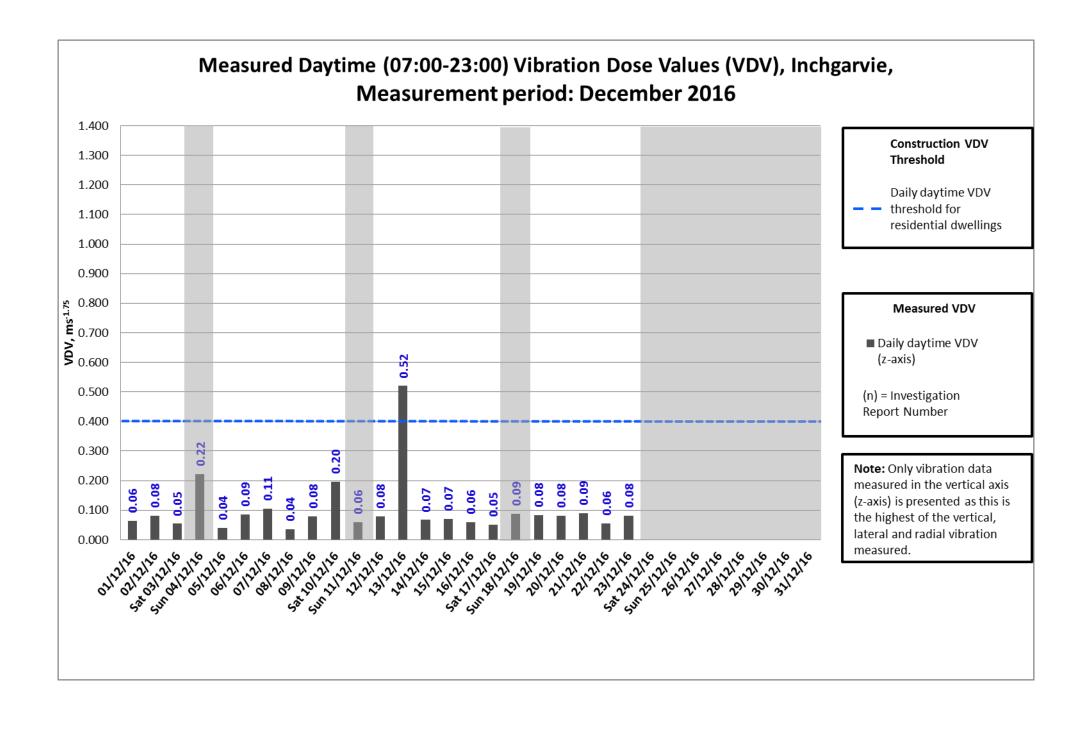
Exceedance on the 13th of December has been investigated and found to be caused out with construction working hours and therefore it is unlikely that a construction related activity (graph above from the 13/12/2016).

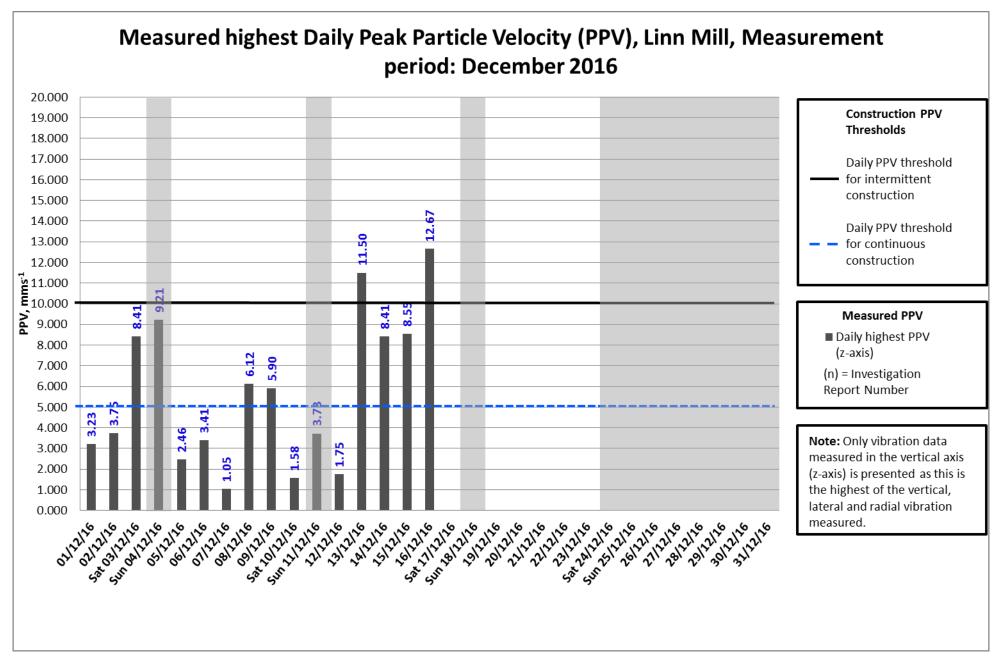
Data missing on the $17^{th} - 23^{rd}$ December was caused by electrical issue with monitor.

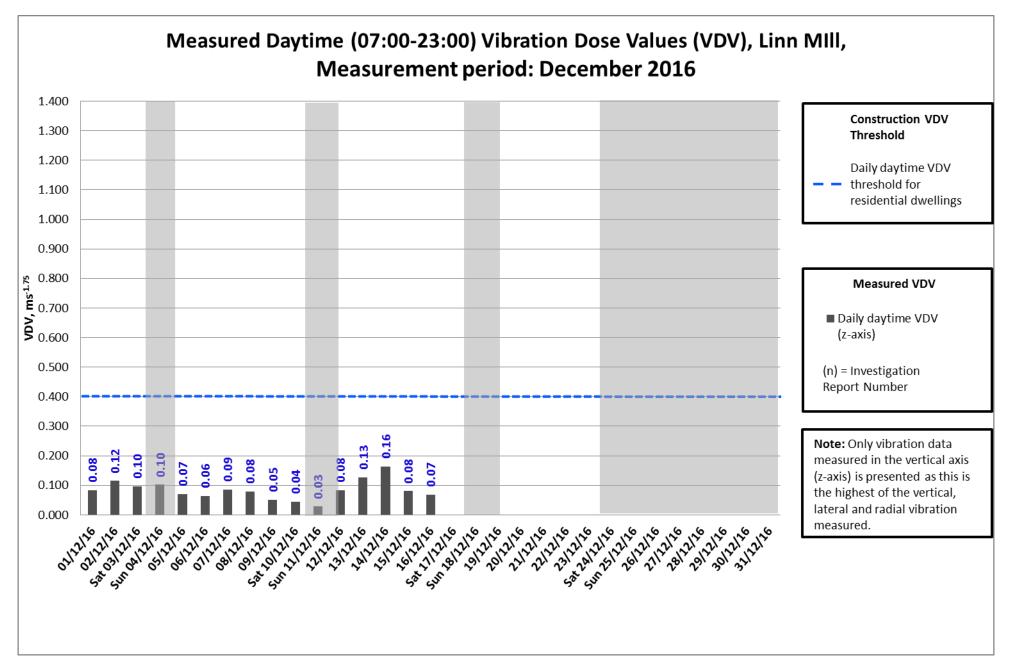
Data missing on the $17^{th} - 23^{rd}$ December was caused by electrical issue with monitor.

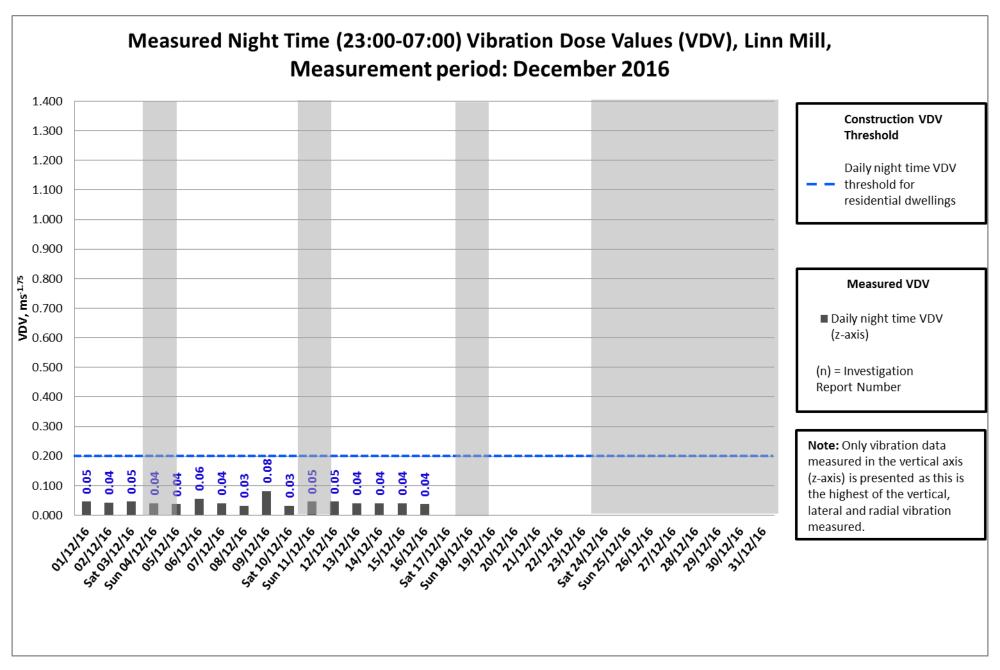
Data missing on the $17^{th} - 23^{rd}$ December was caused by electrical issue with monitor.

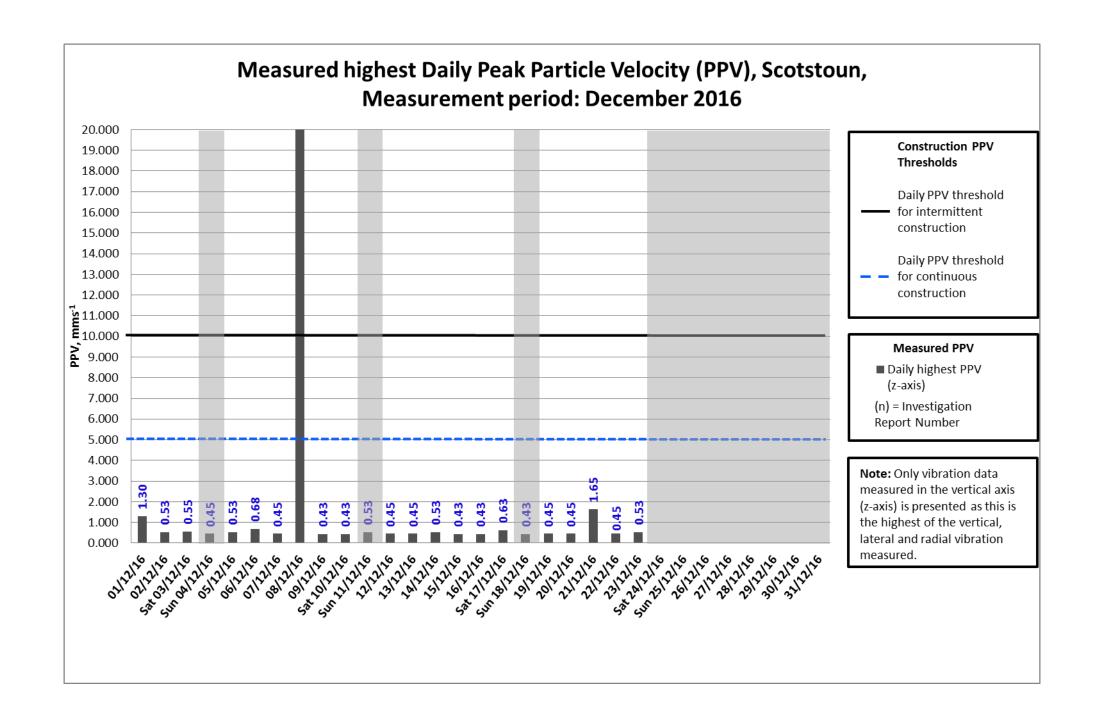
Exceedance on the 8th of December has been investigated and found to have been caused by an isolated event that is unlikely to have been due to a construction related activity (graph above from the 08/12/2016).

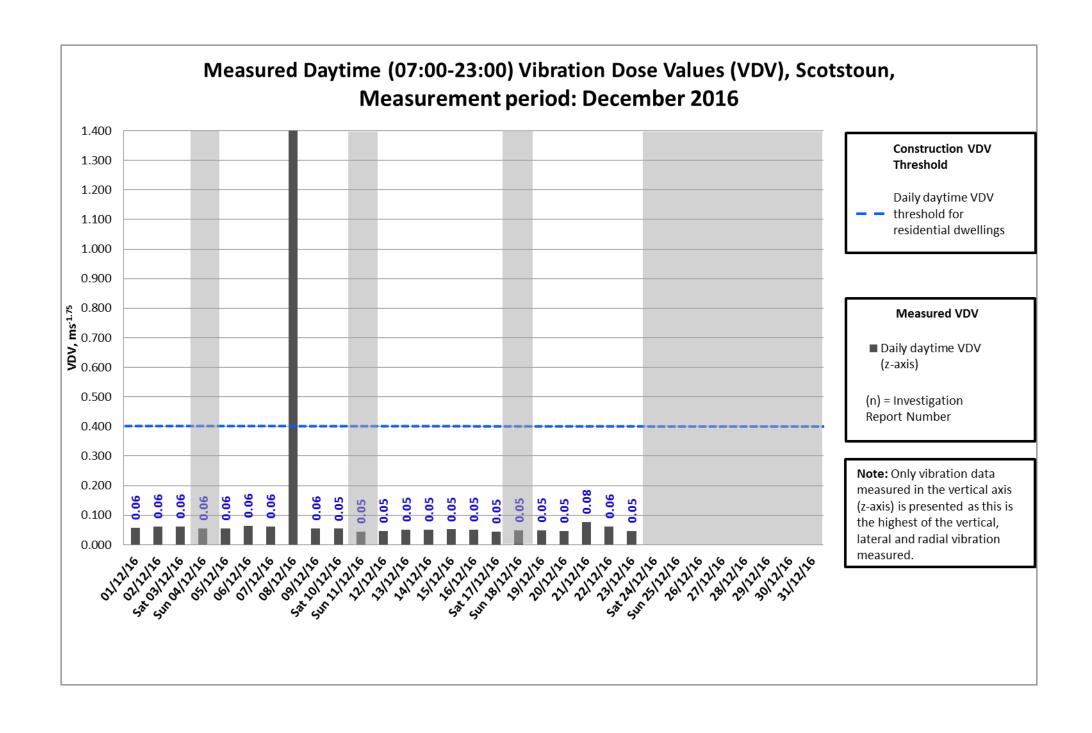
Exceedance on the 8th of December has been investigated and found to have been caused by an isolated event that is unlikely to have been due to a construction related activity (graph above from the 08/12/2016).

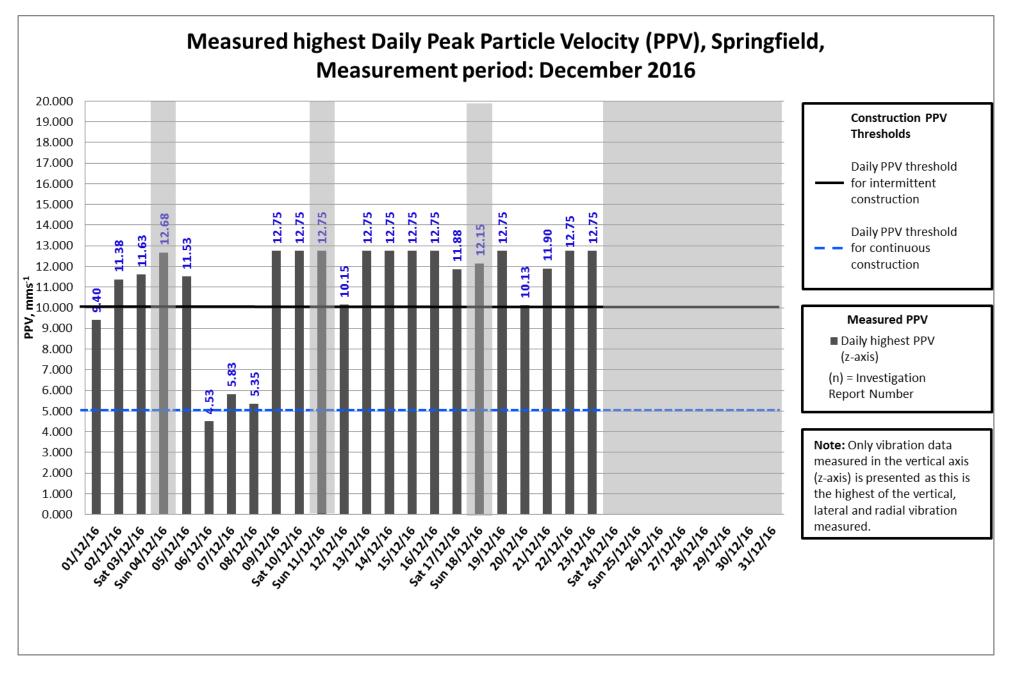
Exceedances throughout December have been investigated and found to be caused by individual isolated events that are unlikely to have been construction related activities (graph above from the 14/12/2016). The vibration monitor is located in the residents back garden, therefore resident's activity may have caused these exceedances.

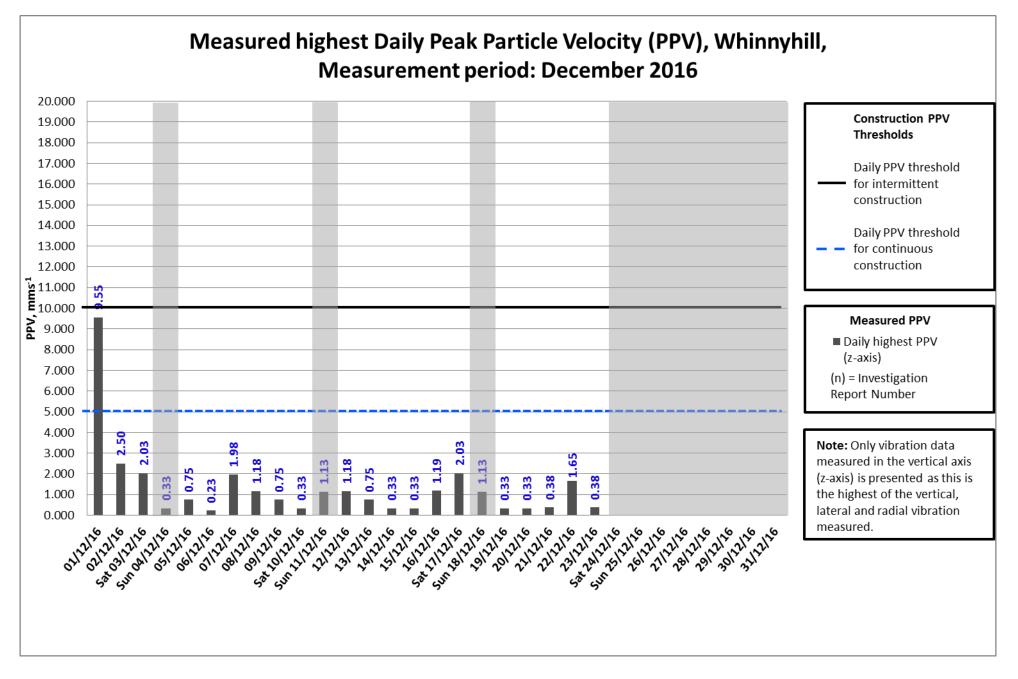
Exceedance on the 1st of December has been investigated and found to have been caused by an isolated event that is unlikely to have been due to a construction related activity (graph above from the 01/12/2016).
