Project FORTH REPLACEMENT CROSSING

VIBRATION MONITORING REPORT FEBRUARY 2016

Made by Michael Richardson	Checked By: Steven Westwater		
Initials: MRN	Initials: SWR		
Document number			
REP-00272		00

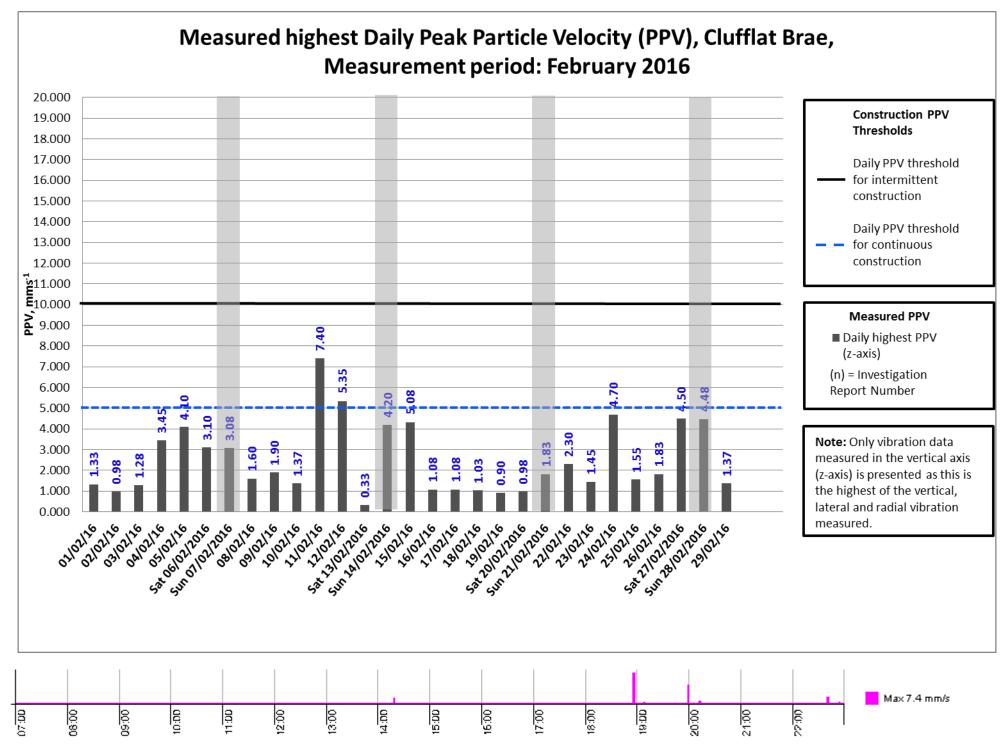
Exceedances on the 11th and 12th of February have been investigated and found to be caused by a one off isolated events that is unlikely to have been caused by construction related activities (graph above from the 11/02/2016).

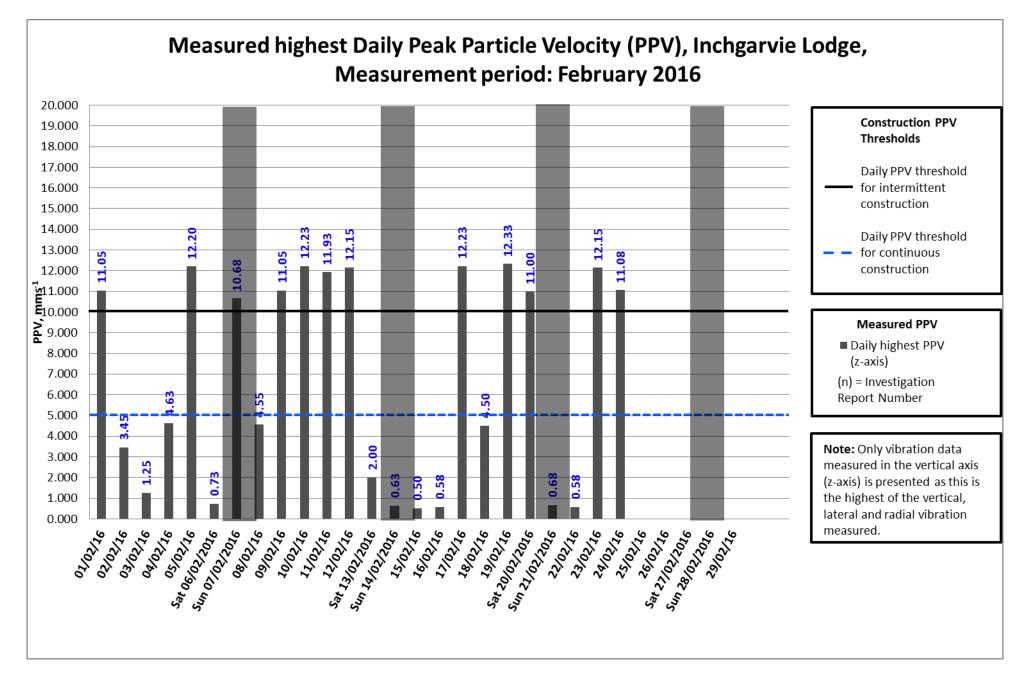
Exceedances on the 5th, 9th, 11th, 17th, 19th, 20th and 24th of February have been investigated and found to be caused by one off isolated events. During this period the closest works to the vibration monitor was approximately 160m away with minimal vibration emitting equipment used (rebar and concrete works). The vibration monitor is situated at a residents house in which there was ongoing private construction works on the property which are likely to have been the cause of the vibration levels. On this basis it is highly unlikely that the vibration levels seen above have been caused by construction related activities (graph above from the 01/02/2016).

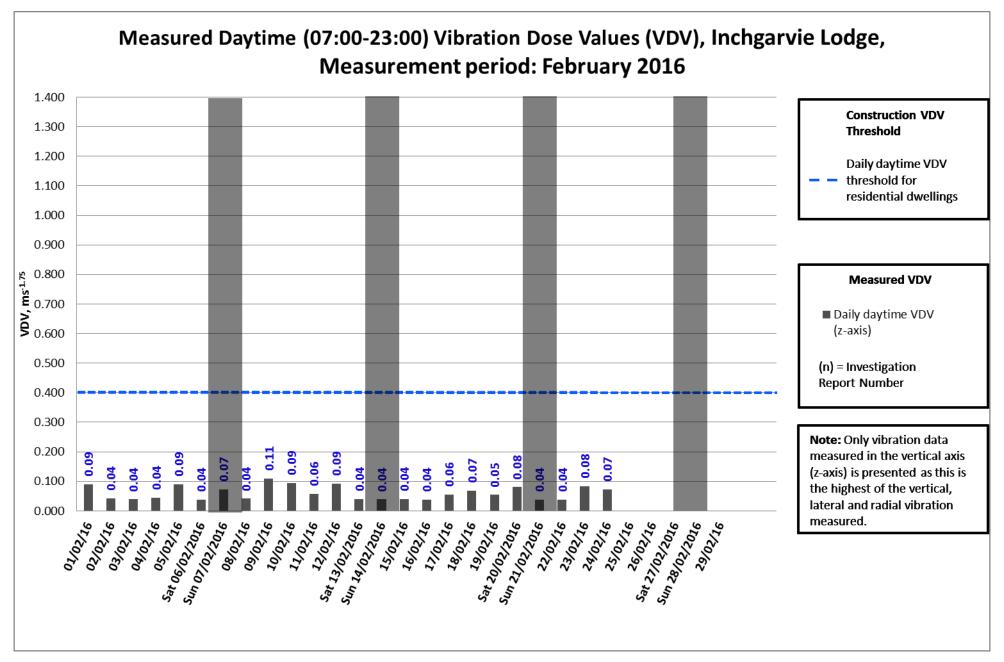
Data missing from the 25th to the 29th February was due to a fault with the monitor. This issue was resolved on the 1st March and will continue to log vibration data from this date.

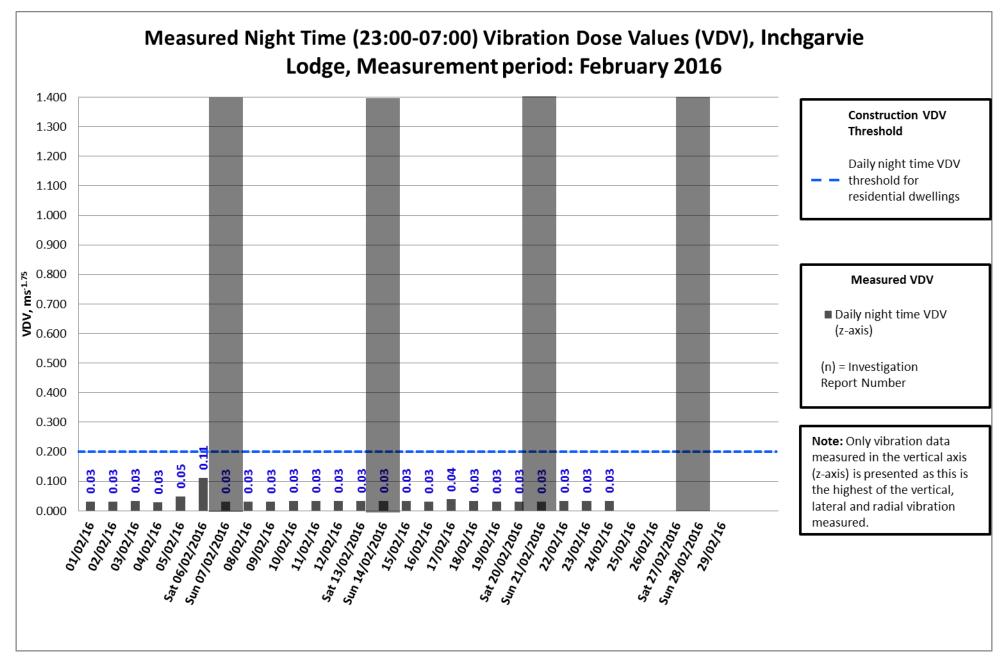
Data missing from the 25th to the 29th February was due to a fault with the monitor. This issue was resolved on the 1st March and will continue to log vibration data from this date.

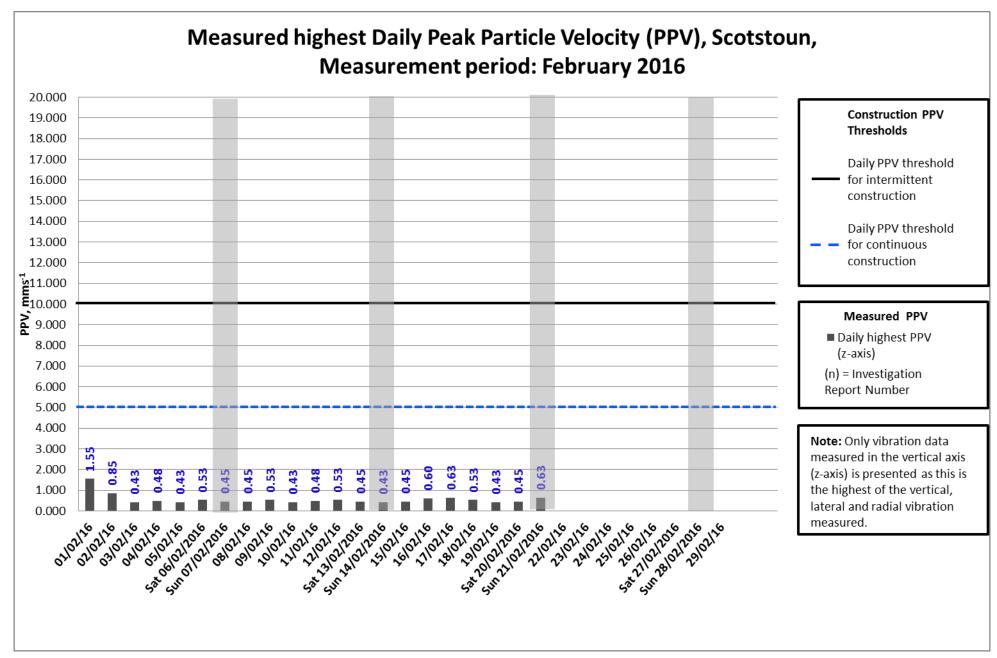
Data missing from the 22nd to the 29th of February was due to a localised power issue. The issue was followed up and resolved on the 1st of March and will continue to log vibration data form this date.

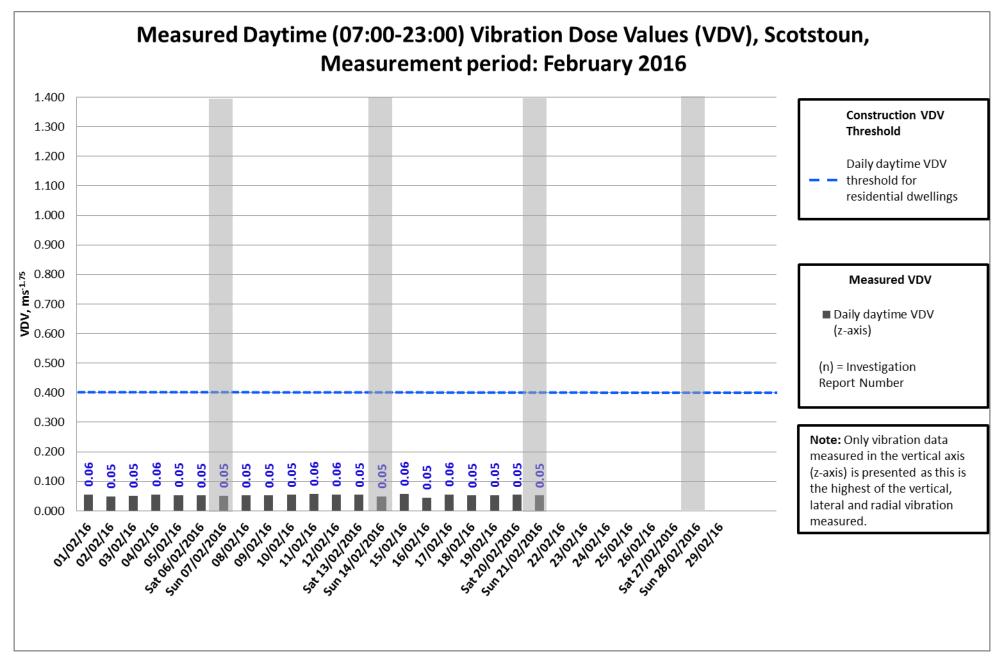
Data missing from the 22nd to the 29th of February was due to a localised power issue. The issue was followed up and resolved on the 1st of March and will continue to log vibration data form this date.

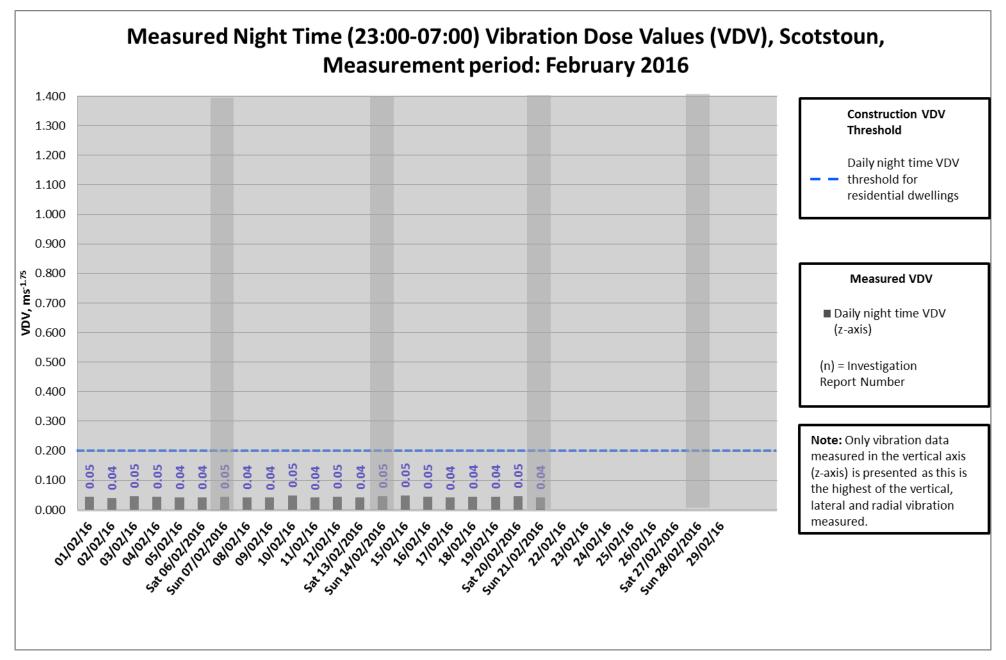
Data missing from the 22nd to the 29th of February was due to a localised power issue. The issue was followed up and resolved on the 1st of March and will continue to log vibration data form this date.

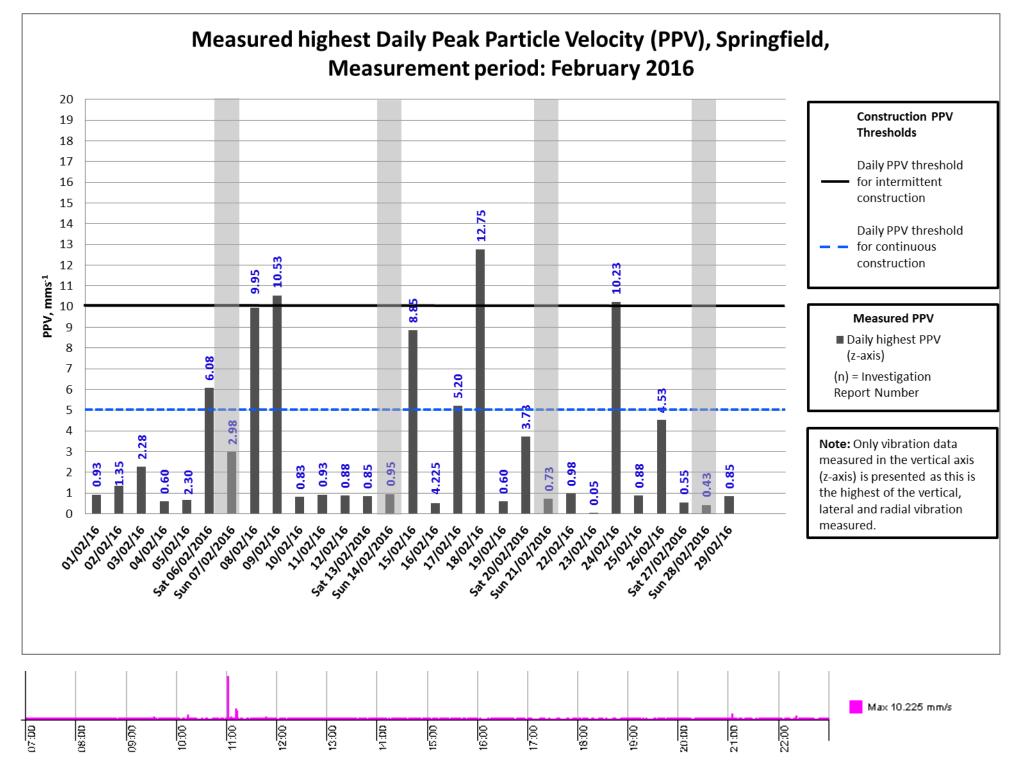
Exceedances on the 17th and 24th of February have been investigated and found to be one off isolated events that are highly unlikely to have been caused by construction related activities (graph above from the 24/02/2016). During this period the nearest construction works to the vibration monitor was approximately 200m away with minimal vibration emitting equipment used (site clearance at area 1).

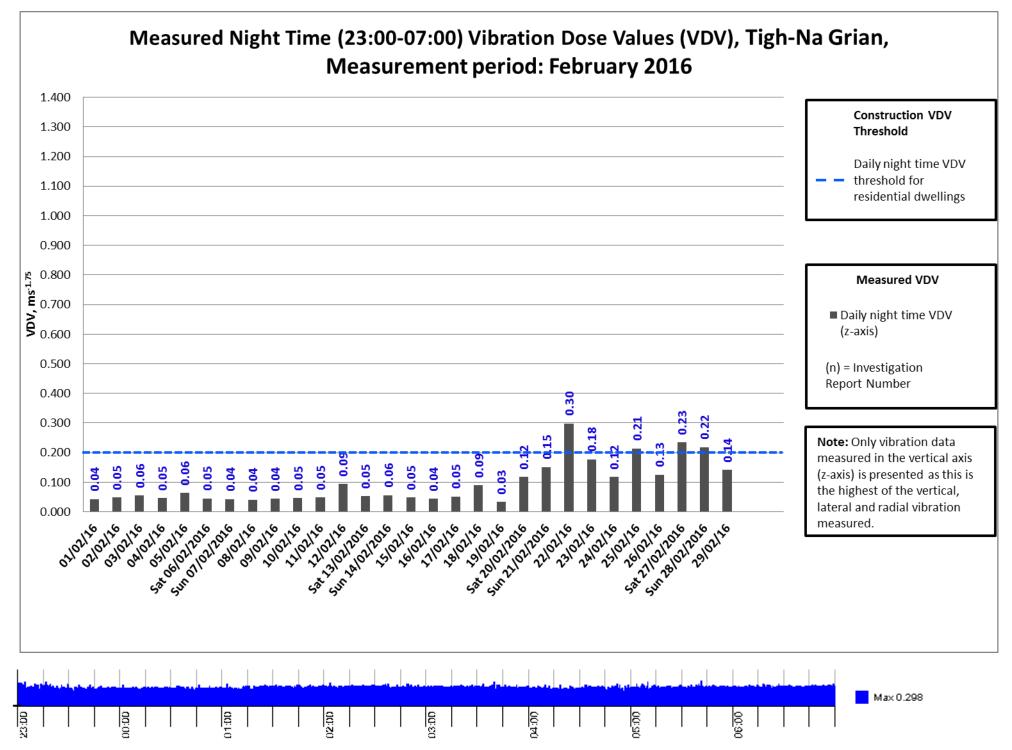
Exceedances on the 22nd, 25th, 27th and 28th of February have been investigated and found unlikely to be caused by construction related activities. During this time period the only activities that are ongoing are welding and cleaning up activities on north tower (approximately 250m away). The only other activities ongoing in this area is the launch of the approaching viaducts north deck level however this is only ongoing during the day (graph above form the 22/02/2016).

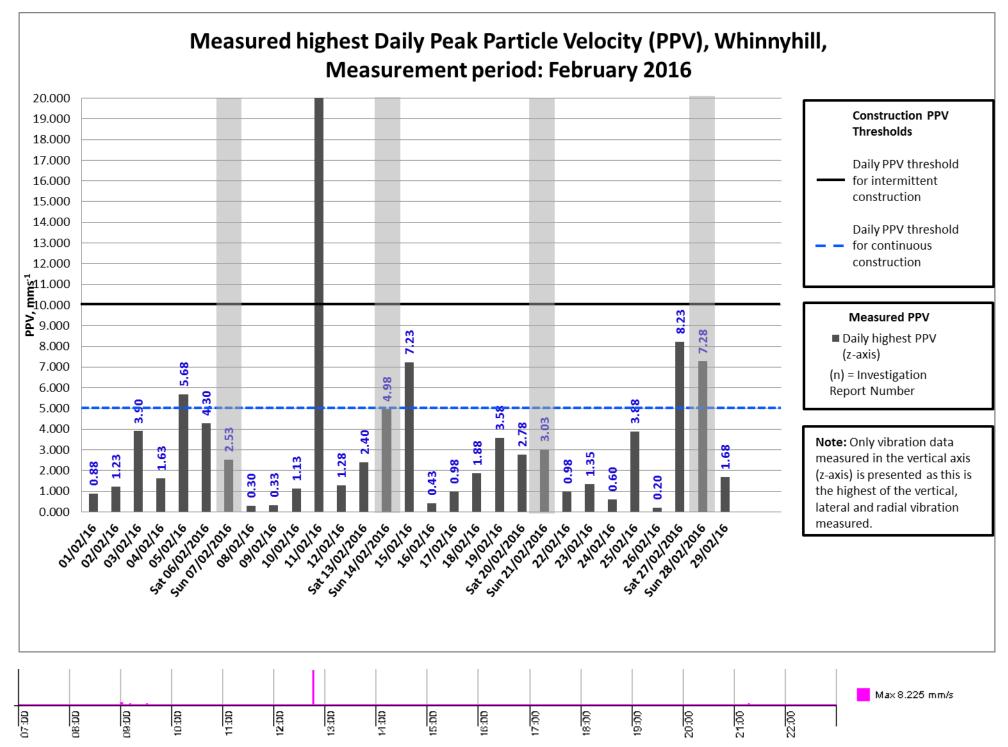
Exceedances on the 5th and 27th of February have been investigated and found to be one off isolated events that are highly unlikely to have been caused by construction related activities (graph above from the 27/02/2016). During this period the nearest construction works to the vibration monitor was approximately 100m away with a vibratory roller used throughout however if the exceedances seen above were caused by this it would be expected to be more consistent over the monthly period.
