Project FORTH REPLACEMENT CROSSING

VIBRATION MONITORING REPORT JANUARY 2016

Made by Michael Richardson Checked By: Steven Westwater		
Initials: MRN	Initials: SWR	
Document number		
REP-00269		00

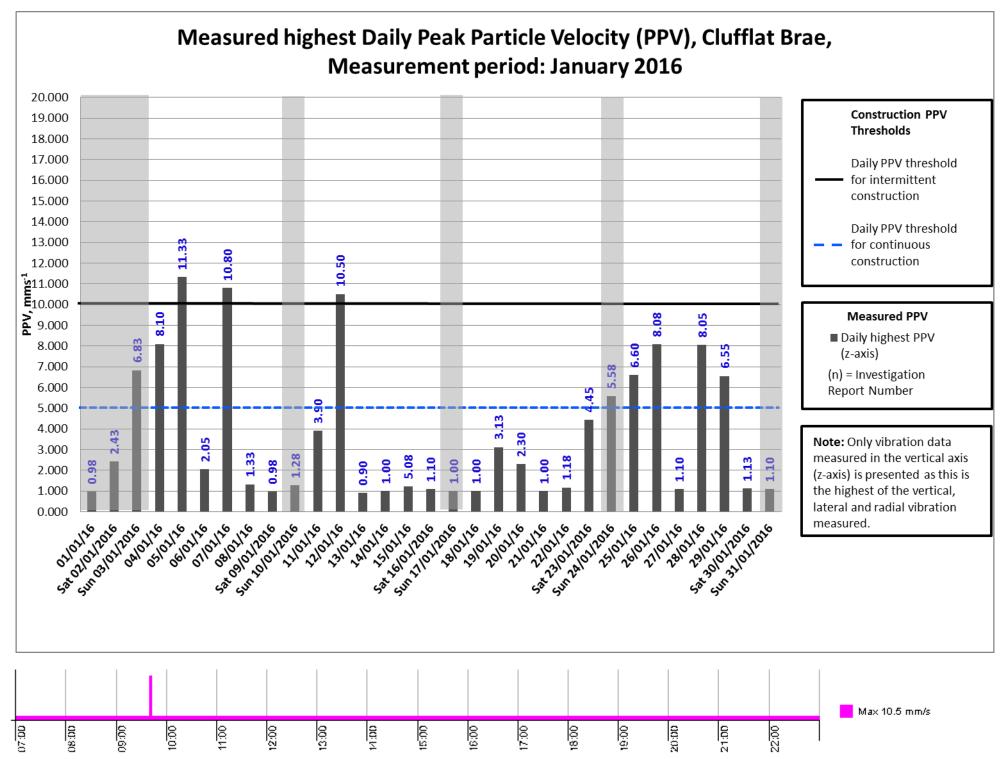
Exceedances on the 4th, 5th, 7th, 12th, 25th, 26th, 26th, 28th and 29th of January were found to be caused by isolated events that are unlikely to have been caused by construction related activities (graph above from the 12/01/2016).

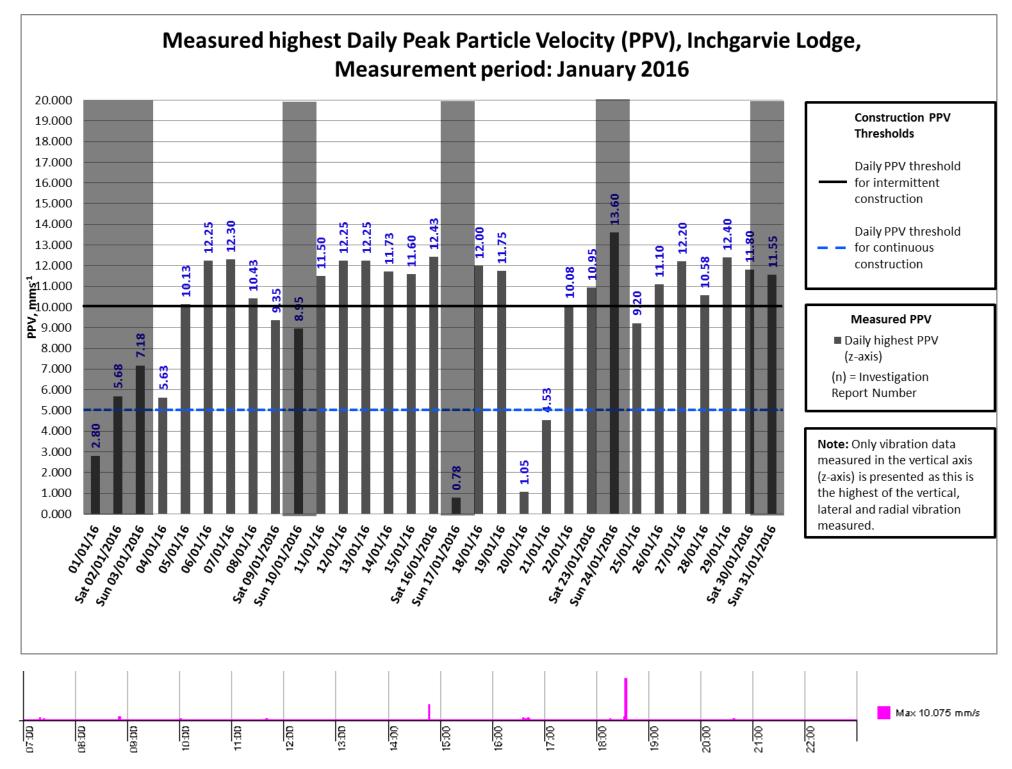
Exceedances on the 4th, 5th, 7th, 9th, 10th, 11th, 12th, 13th, 14th, 15th, 22nd, 24th, 25th, 26th, 27th, 28th, 29th and 30th have been investigated and found to be intermittent and are unlikely to be caused by construction related activities (closest works to the monitor is approximately 185m). During this period there have been ongoing private construction works on the property which are likely to have been the cause of the high vibration levels. Vibration levels in this location will continue to be closely monitored to identify the source of the vibration levels (graph above taken from data acquired on 22/01/2016).

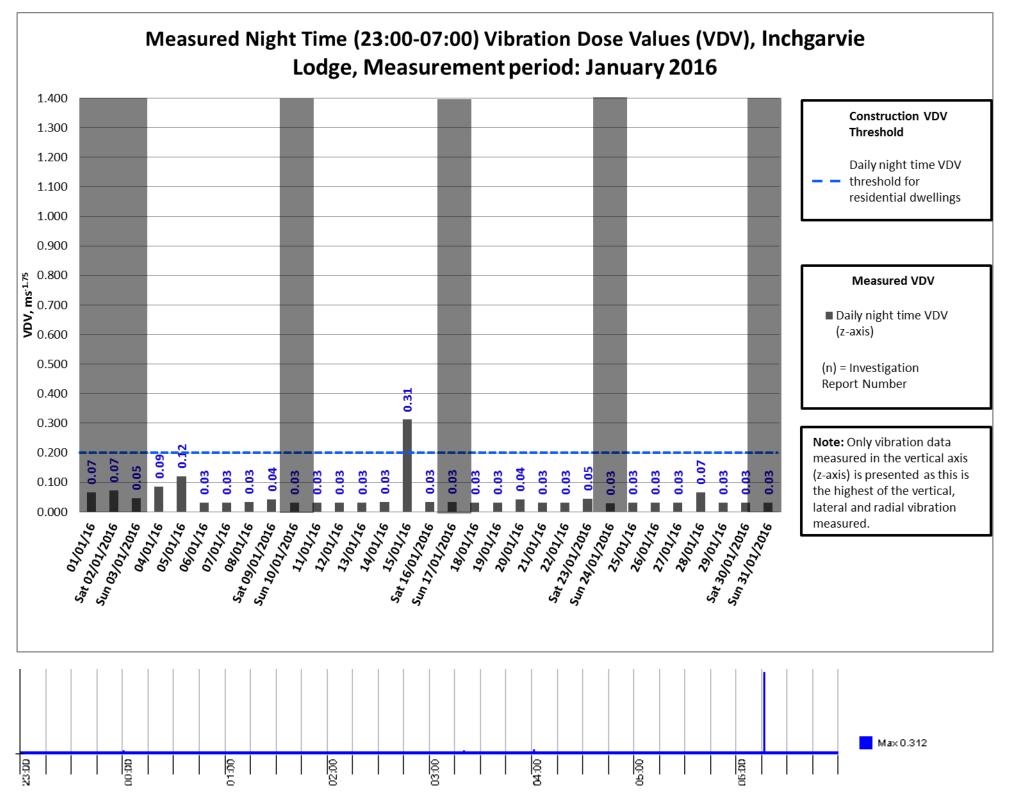
Exceedance on the 15th of January has been investigated and found to be out with working hours in the proximity of the monitor, with the closest known works being approximately 500m away. It is therefore highly unlikely that the exceedance was caused by construction related activities.

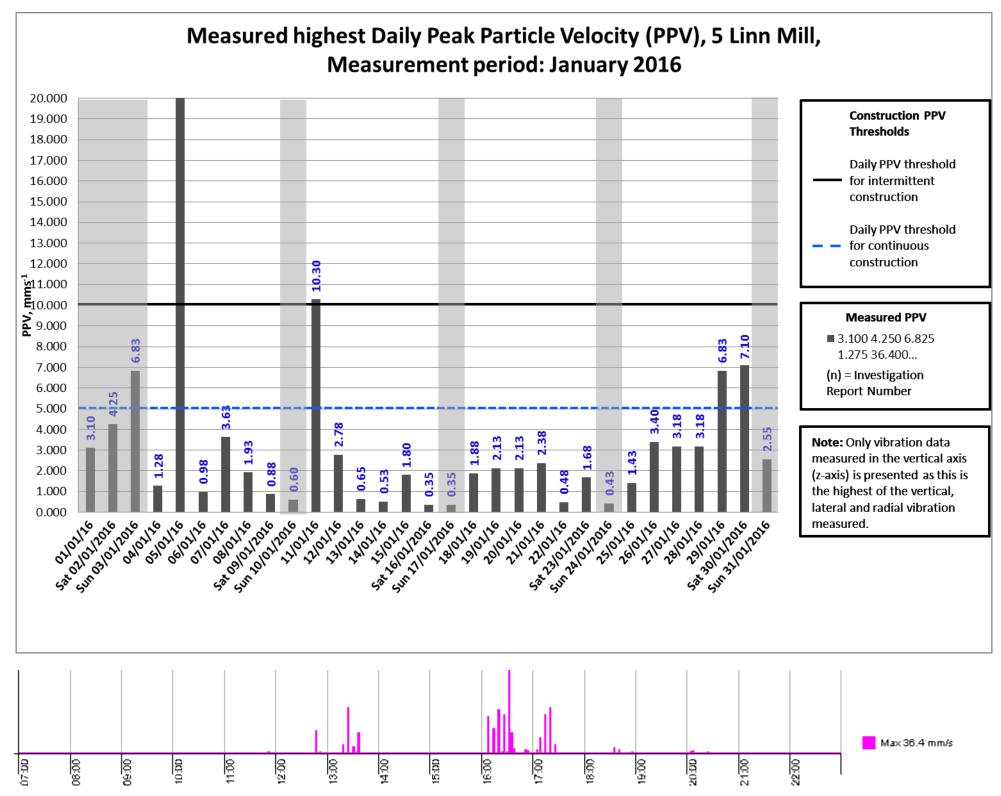
Exceedance on the 5th of January was caused by monitor maintenance by the Environmental department.

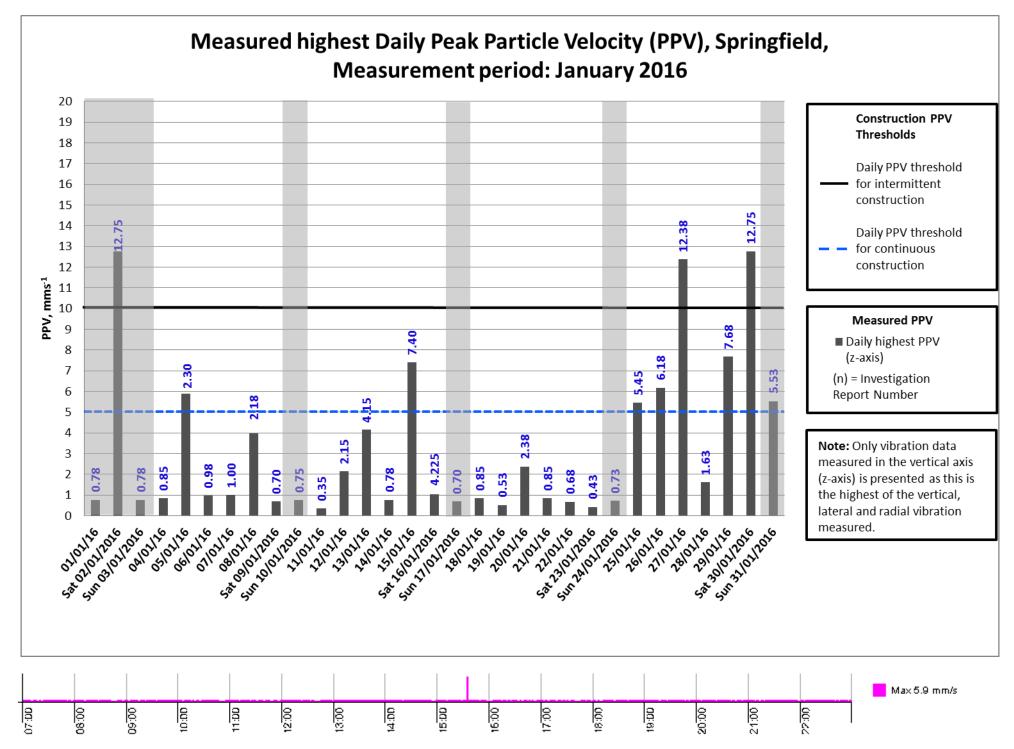
Exceedance on the 5th of January was caused by monitor maintenance by the environmental department.

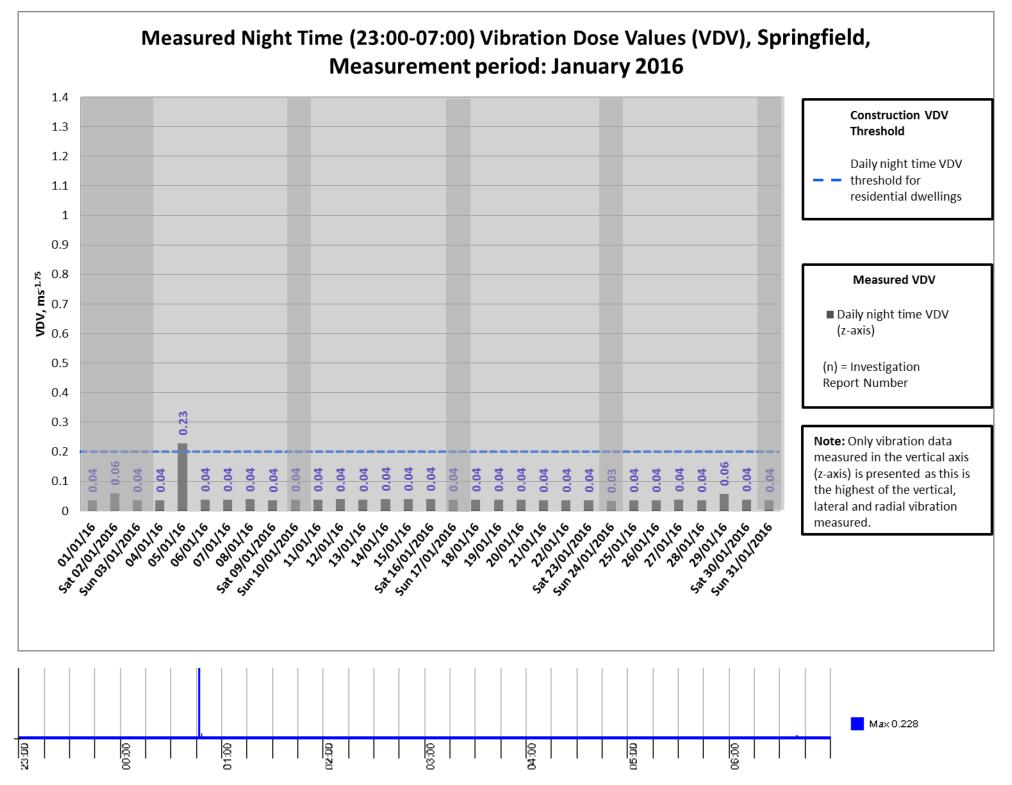
Exceedance on the 5th of January was caused out with normal working hours for construction related works on road networks. Due to this it is highly unlikely that the source of the vibration levels was from construction works, but more likely to have been caused by localised activity close to the monitor.

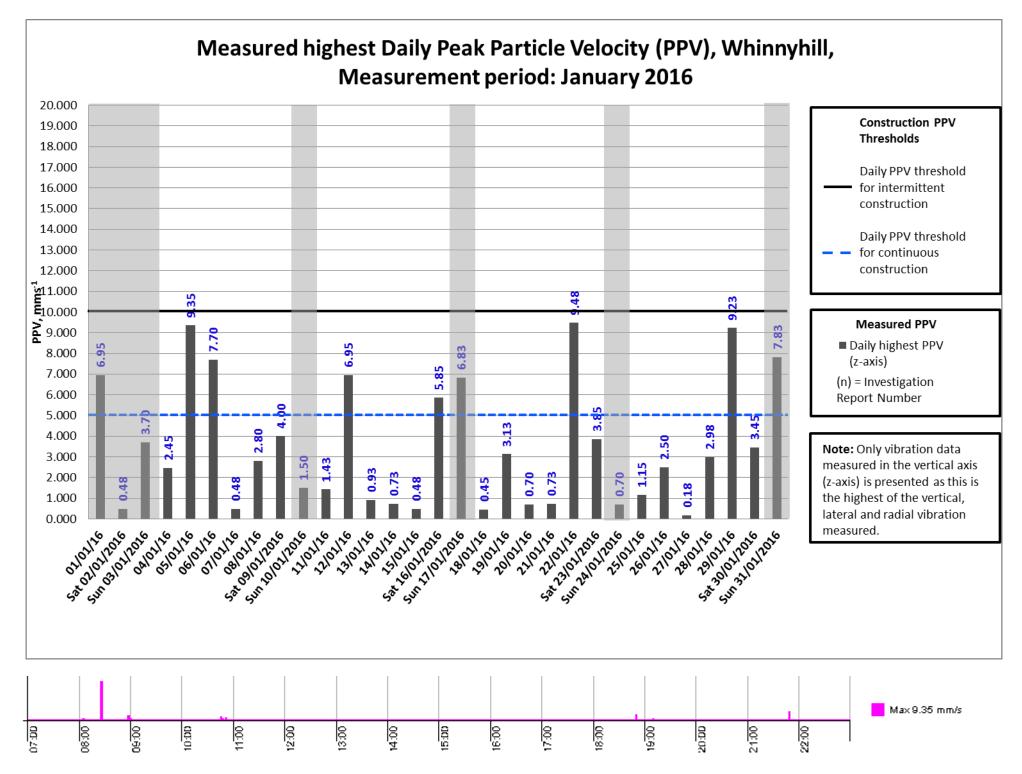
Exceedance on the 5th of January was caused by monitor maintenance by the environmental department.
