Project FORTH REPLACEMENT CROSSING

VIBRATION MONITORING REPORT MARCH 2016

Made by Michael Richardson Checked By: Steven Westwater	
Initials: MRN	Initials: SWR
Document number	
REP-00273	00

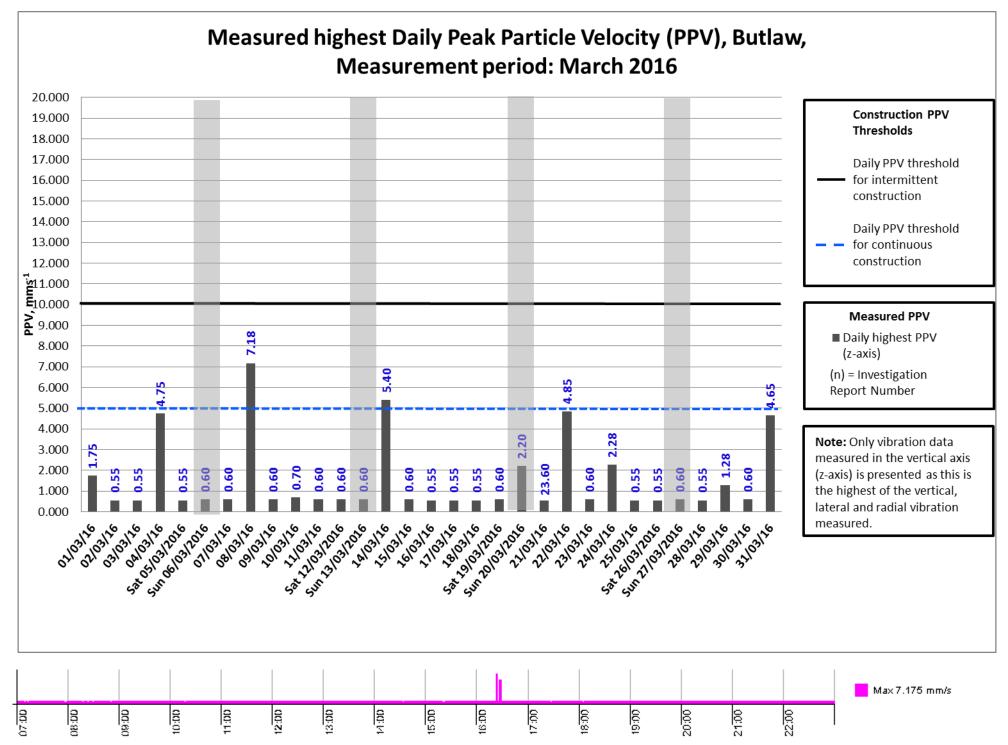
Exceedances on the 8th and 14th of March have been investigated and found to be caused by the environmental department carrying out maintenance to monitoring equipment in this location.

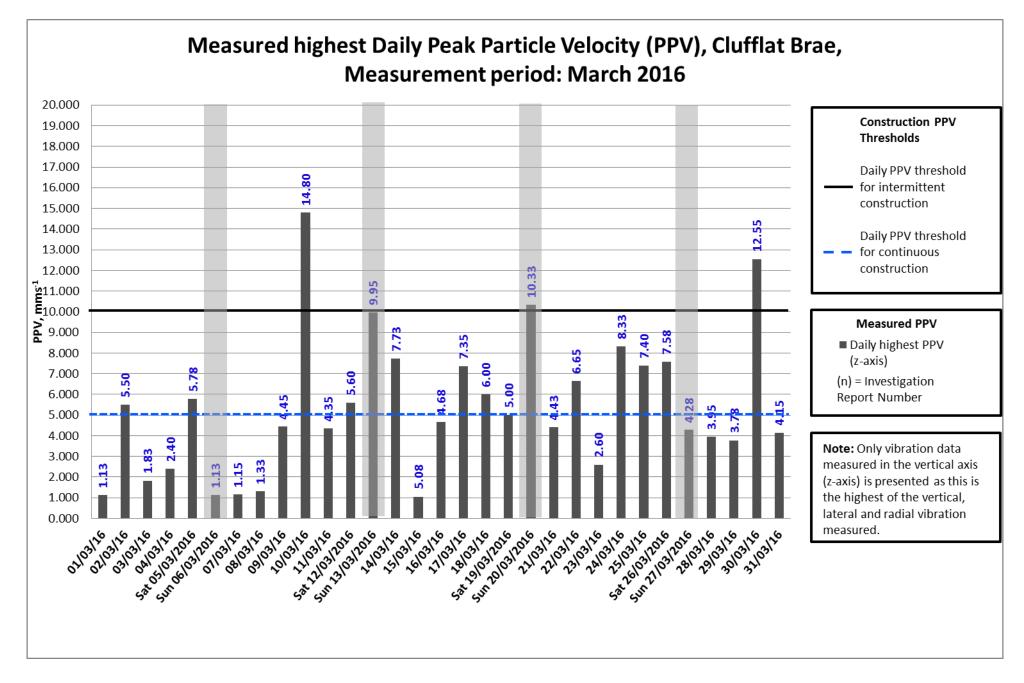
Exceedances on the 2nd, 5th, 10th, 12th, 14th, 17th, 18th, 22nd, 24th, 25th, and 26th of March have been investigated and found to be caused by individual isolated events that are unlikely to have been caused by construction related activities (graph above from the 05/03/2016).

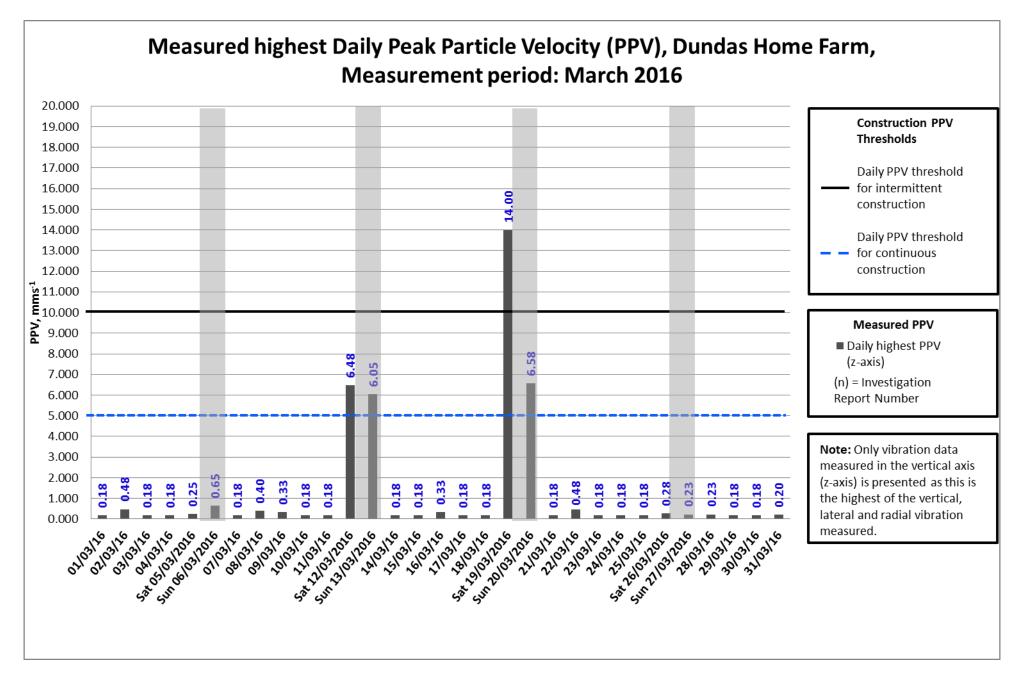
Exceedances on the 12th, 13th and 20th of March have been investigated with the source of the vibration to be unknown. During inspection of the monitor location there was large quantities of wood left nearby the monitor location which when being place in this location may have resulted in the continuous vibration levels seen above (Figure 1 from 12/03/2016, figure 2 from 13/03/2016). During these periods of sustained vibration levels exceedances on the 13th of March (as seen above) was during a Sunday which is out of normal working hours which supports the following conclusion that there vibration levels may have been caused by localised movement rather than construction related activities.

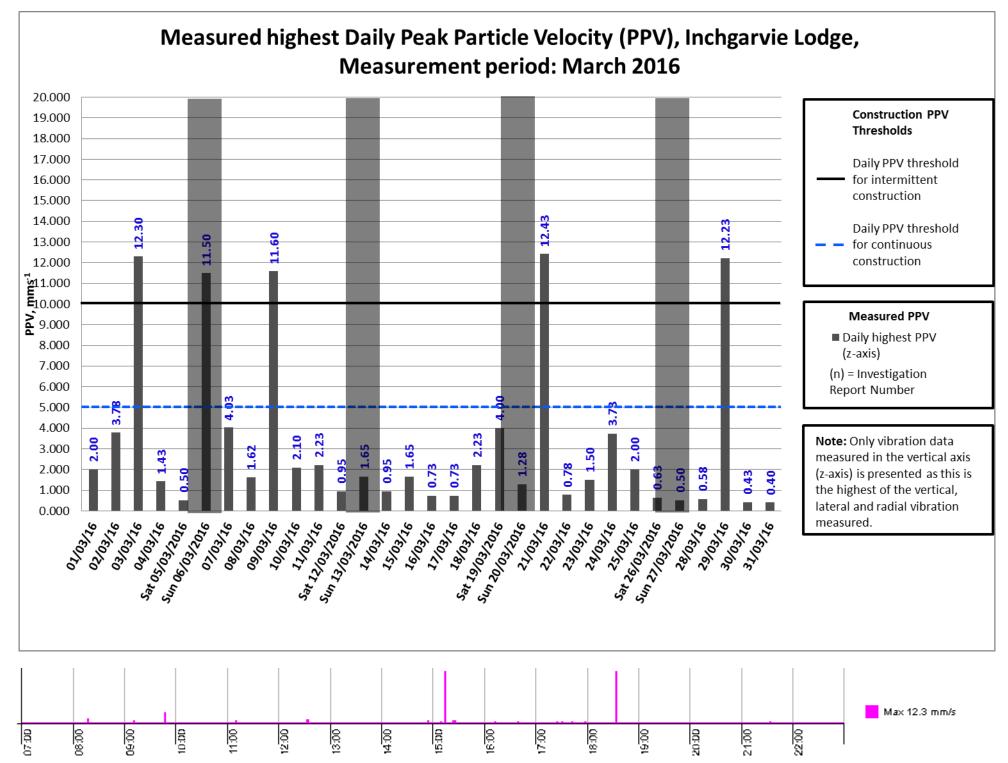
Exceedances on the 3rd,6th, 9th, 21st and 29th have been investigated and found to be one off isolated events. During this period the closest works to the vibration monitor was approximately 160m away with minimal vibration emitting equipment used (rebar and concrete works). The vibration monitor is situated at a resident's house in which there was ongoing private construction works on the property which are likely to have been the cause of the vibration levels. On this basis it is highly unlikely that the vibration levels seen above have been caused by construction related activities (graph above from the 12/03/2016).

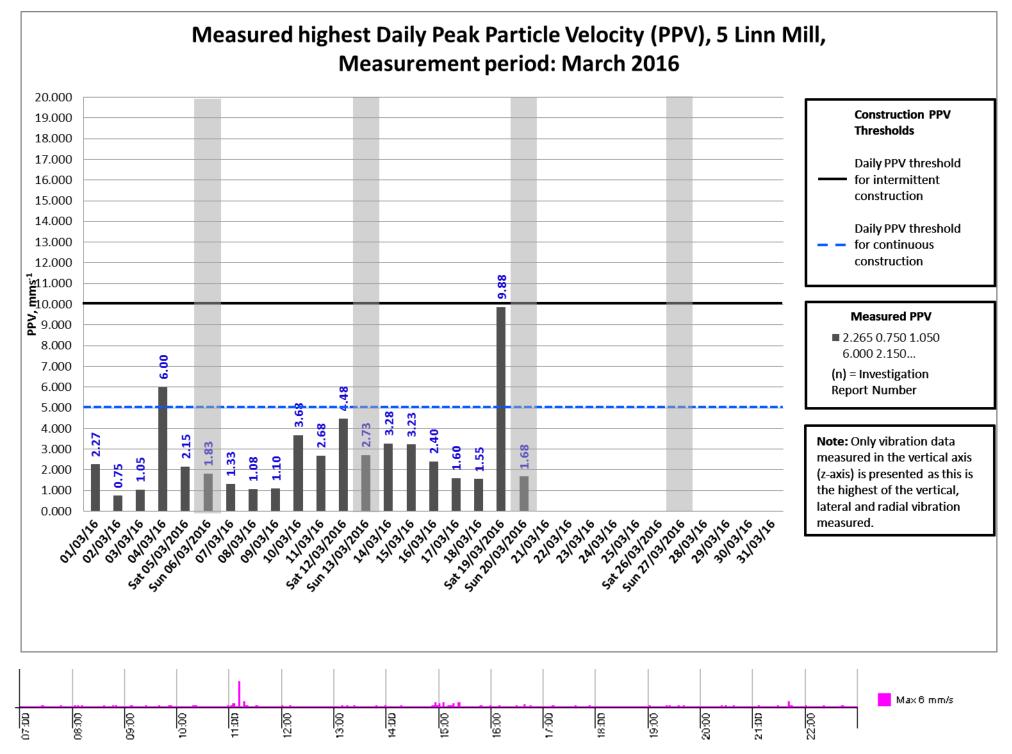
Exceedances on the 4th and 19th of March have been investigated and found to be individual isolated events. It is highly unlikely that these events were caused by construction related activities (graph above from the 04/03/2016). The monitor is situated in close proximity to the residents outdoor log store situated in the back garden. It is envisaged that these high readings were in fact due to the residents fetching logs from this store area.

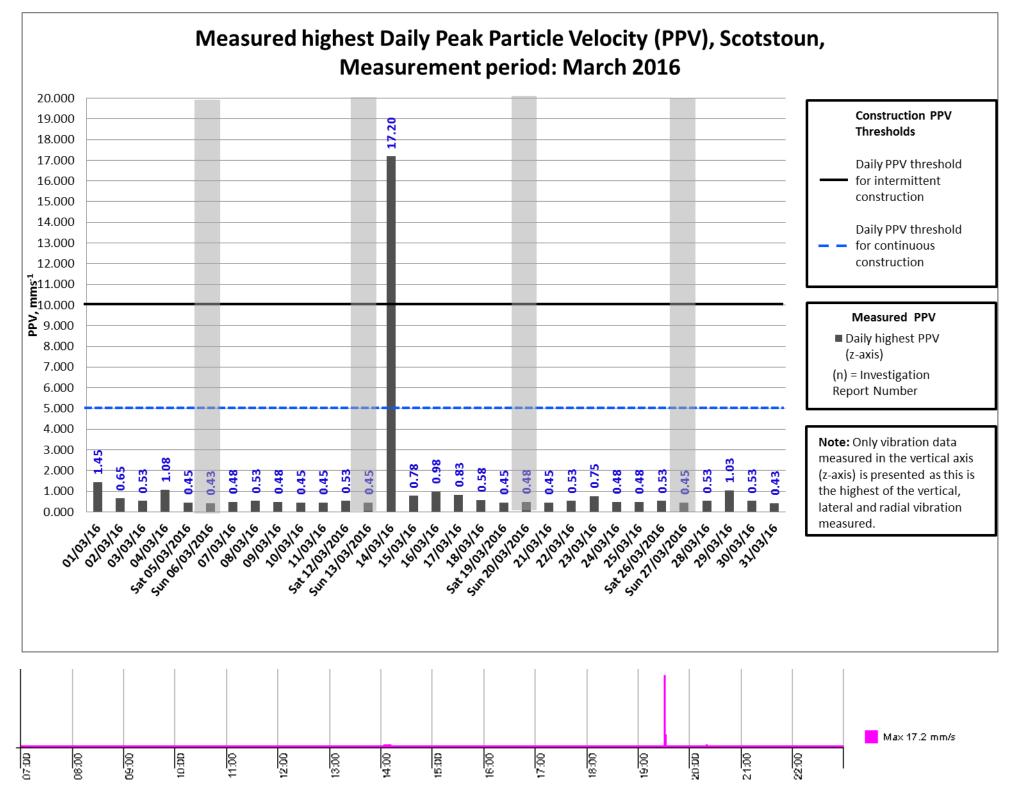
Exceedance on the 14th of March has been investigated and found to be out with normal working hours and is unlikely to have been caused by construction related activities (graph above from the 14/03/2016).

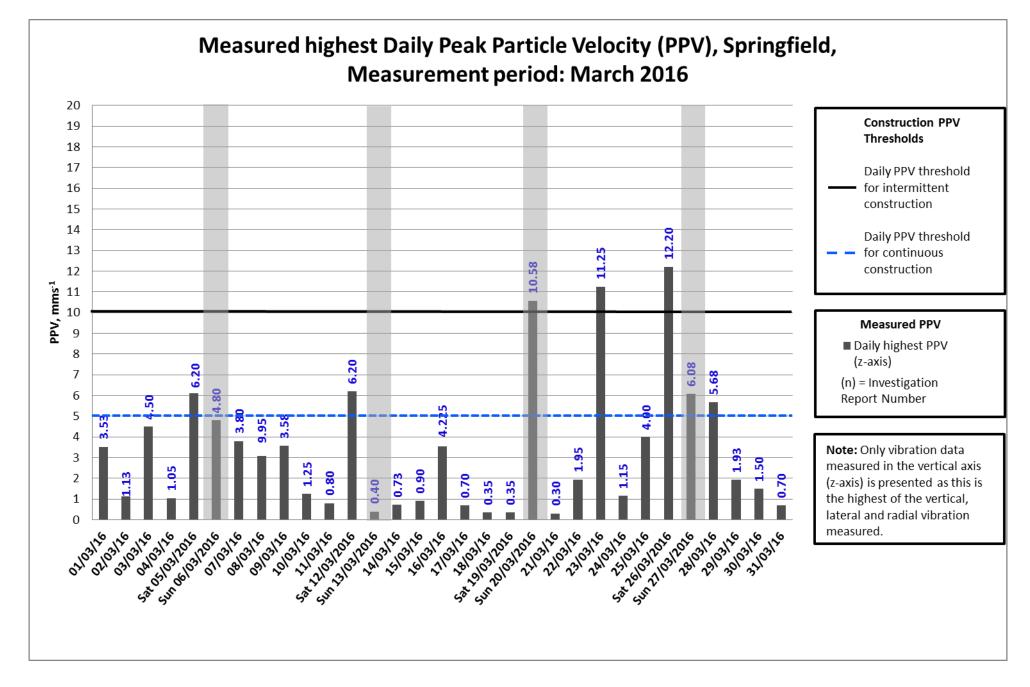
Exceedances on the 5th, 12th, 26th and 28th of March have been investigated and found to be isolated events that are unlikely to have been caused by construction related activities (graph above from the 26/03/2016)

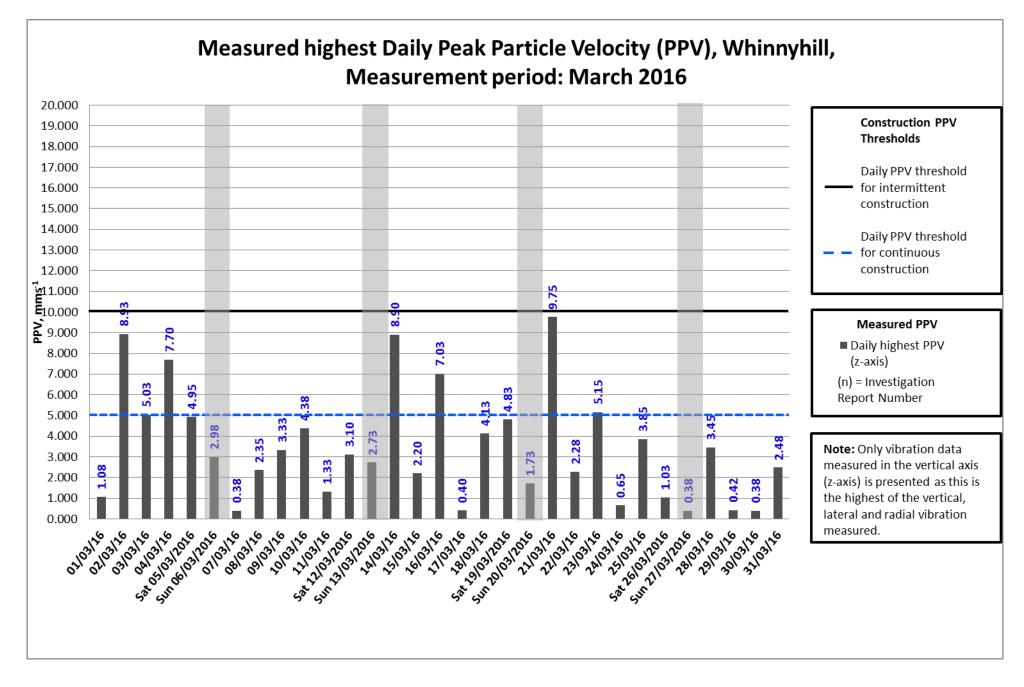
Exceedances on the 2nd, 4th, 15th and 23rd of March have been investigated and found to be caused by isolated events that are unlikely to have been caused by construction related activities (graph above from the 4/03/2016).
