# FORTH REPLACEMENT CROSSING

# VIBRATION MONITORING REPORT SEPTEMBER 2016

Made by Steven Westwater Checked By: Lindsay McIntyre		
Initials: SWR	Initials: LME	
Document number	Rev	
REP-00294	00

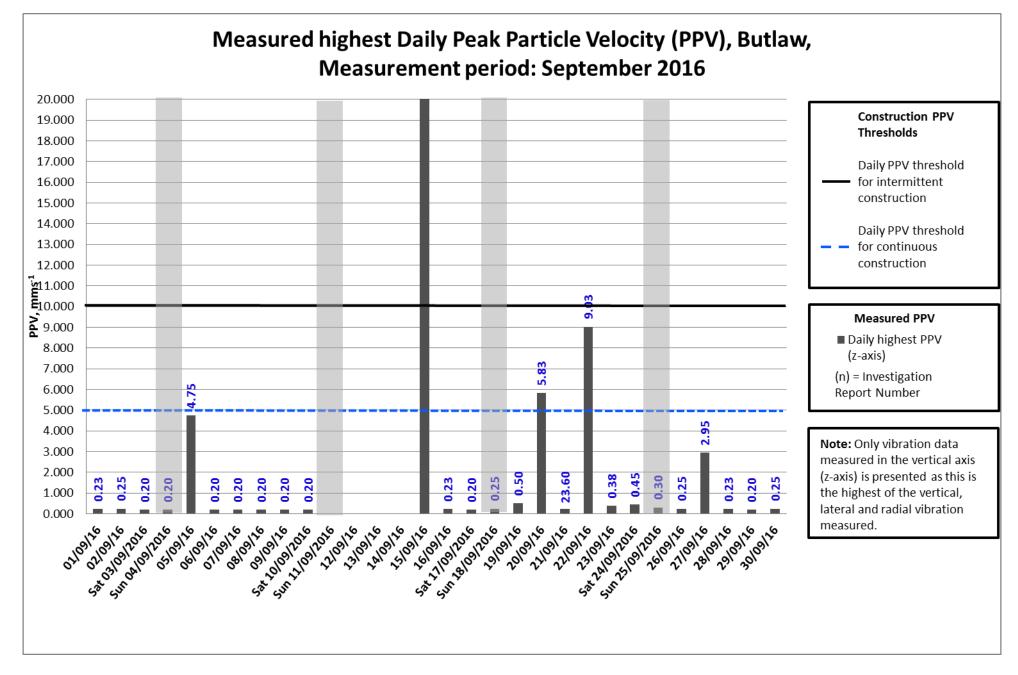
Exceedance on the 15<sup>th</sup> September has been investigated and found to be caused by the environmental department carrying out maintenance on the vibration monitor.

Exceedance on the 20<sup>th</sup> September has been investigated and found to be caused by the resident cutting the grass where the vibration is situated at approximately 11:15.

Exceedance on the 22<sup>nd</sup> September has been investigated and could not be determined.

Data missing on the 11<sup>th</sup>-14<sup>th</sup> September was caused by electrical issue with monitor.

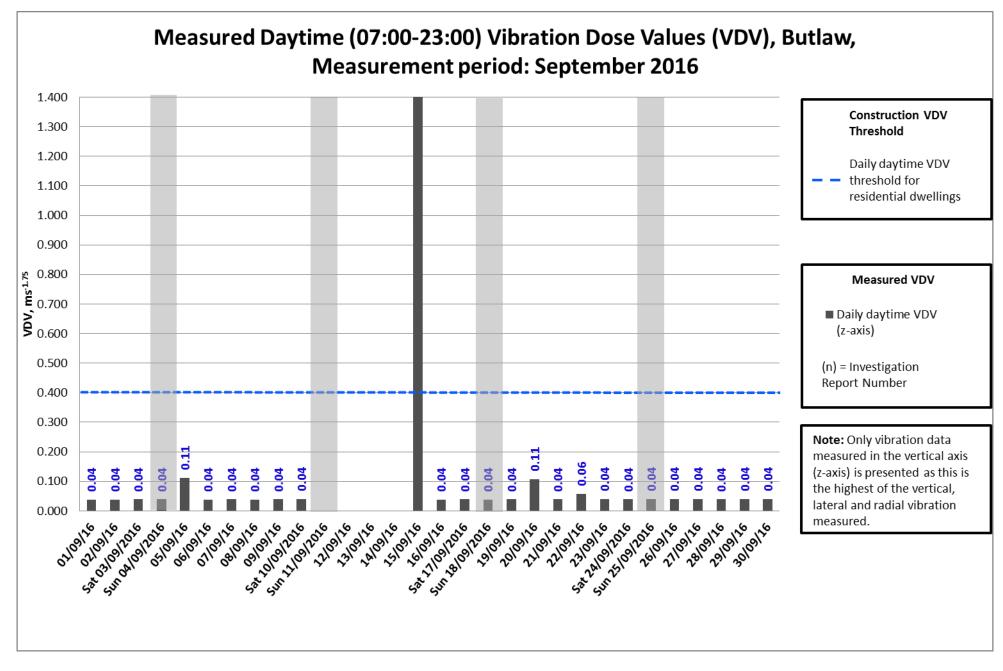
Exceedance on the 15<sup>th</sup> September has been investigated and found to be caused by the environmental department carrying out maintenance on the vibration monitor.

Data missing on the 11<sup>th</sup>-14<sup>th</sup> September was caused by electrical issue with monitor.

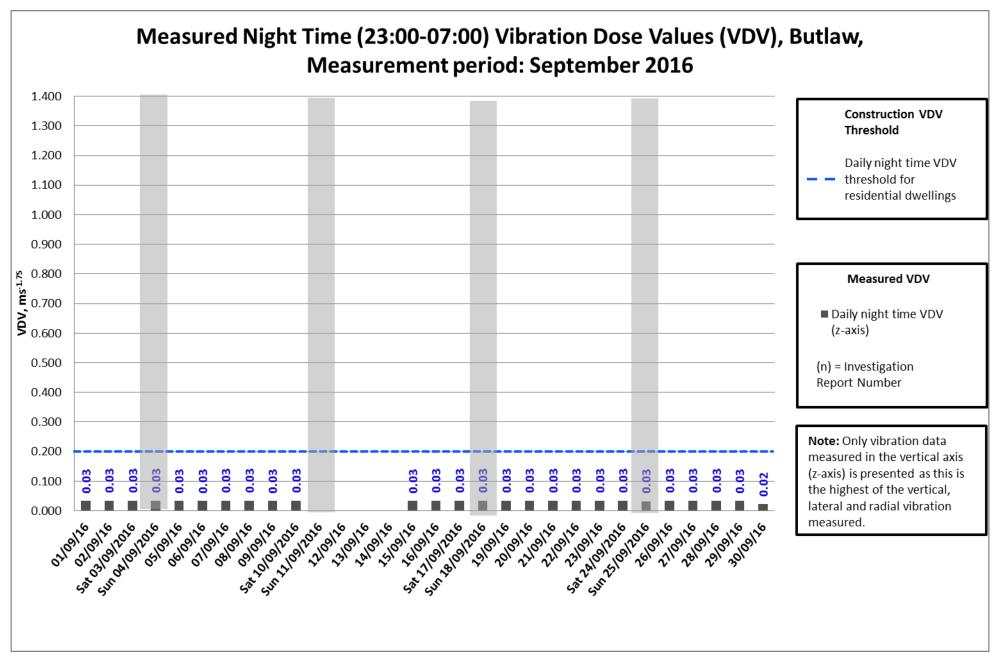
Data missing on the 11<sup>th</sup>-14<sup>th</sup> September was caused by electrical issue with monitor.

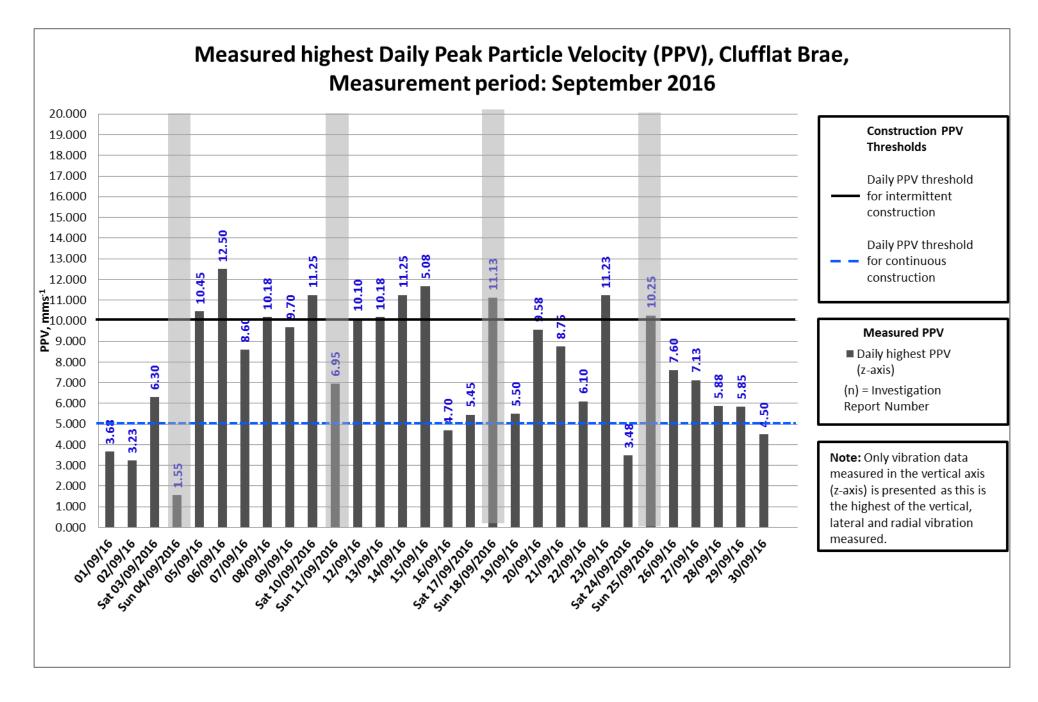
Exceedances on the 3<sup>rd</sup>, 5<sup>th</sup>, 6<sup>th</sup>, 7<sup>th</sup>, 8<sup>th</sup>, 10<sup>th</sup>, 12<sup>th</sup>, 13<sup>th</sup>, 15<sup>th</sup>, 17<sup>th</sup>, 23<sup>rd</sup>, 25<sup>th</sup>, 28<sup>th</sup> and 29<sup>th</sup> of September have been investigated and found to be caused by individual isolated events (graph above from the 12/09/2016). With the monitor being located in a public amenity area there is a likelihood that the exceedances seen above might have been caused by pedestrians using this area. However it is worth noting that during this period, there have been excavation works ongoing at the Suds pond east of the south abutment, approximately 30m away. Due to this and the fact that there isn't any supporting evidence to state otherwise, these exceedances might also have been caused by the Suds works.

Exceedances on the 9<sup>th</sup>, 11<sup>th</sup>, 14<sup>th</sup>, 18<sup>th</sup>, 19<sup>th</sup>, 20<sup>th</sup>, 21<sup>st</sup>, 22<sup>nd</sup>, 26<sup>th</sup> and 27<sup>th</sup> of September have been investigated and found to be caused out with construction working hours and therefore it is unlikely that construction related activity was the cause of these events (graph above from the 11/09/2016).

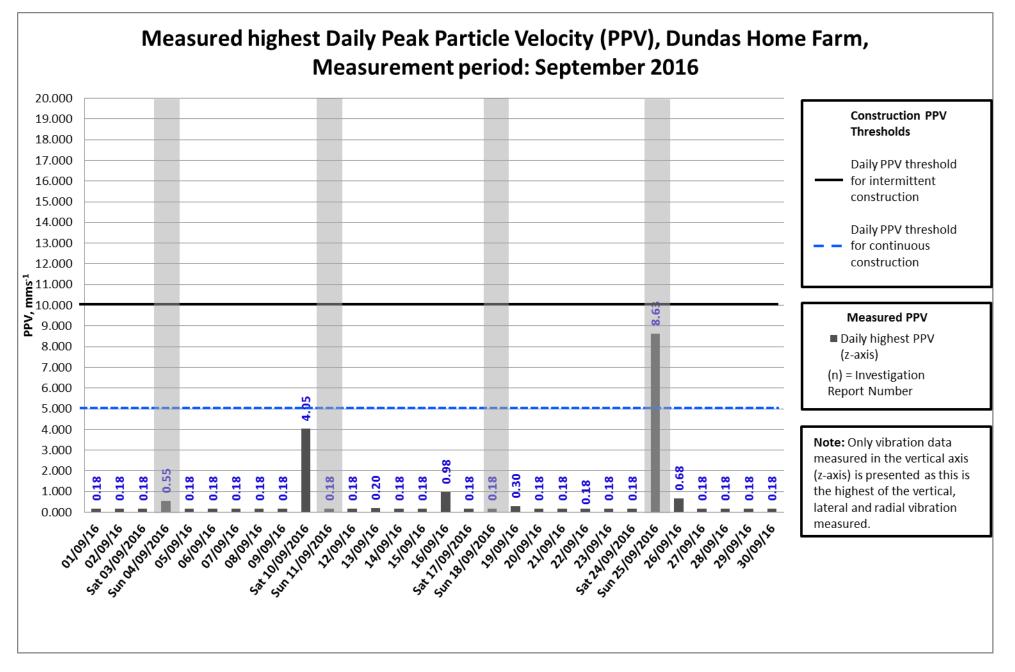
Exceedance on the 25<sup>th</sup> September has been investigated and found to be caused by an isolated event that is unlikely to have been a construction related activity.

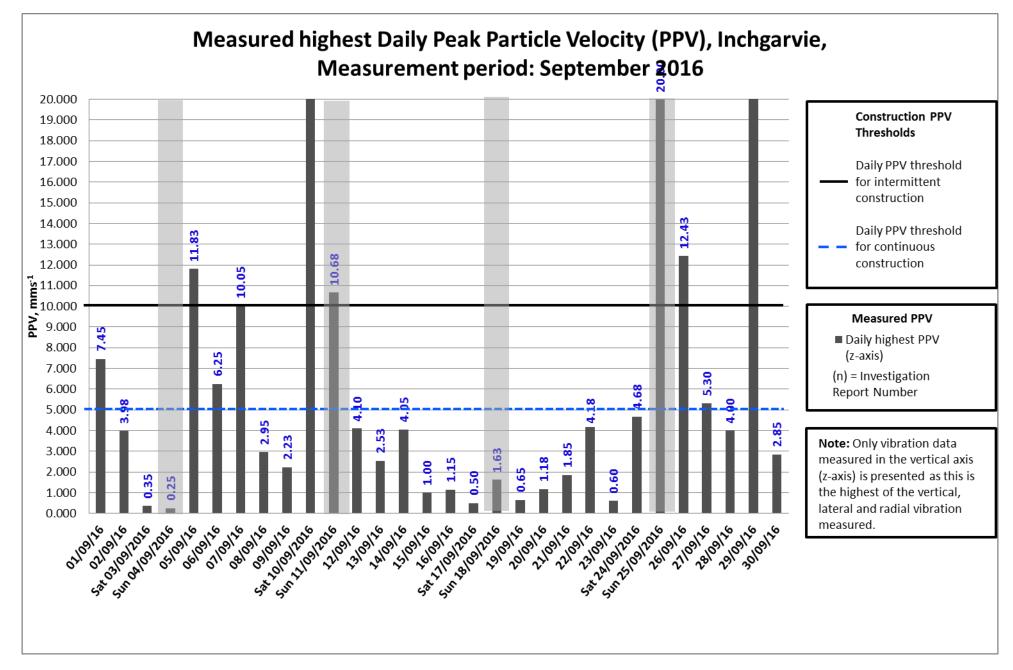
Exceedances on the 11<sup>th</sup> and 26<sup>th</sup> September have been investigated and found to be caused by individual isolated events that are unlikely to have been construction related activities (graph above from the 11/09/2016). During this period, the resident at the property where the monitor is situated, had ongoing private construction works. It is likely that the exceedances shown in the graph above were caused by the private works at the property, rather than construction activities connected with the new bridge crossing and supporting infrastructure. However, it is worth noting during this period that there has been excavation works ongoing at the SUDS pond east of the south abutment, approximately 40m away. Due to the proximity of the excavation works, and the fact there isn't any supporting evidence to state otherwise, these exceedances might also have been caused by the Suds works.

Exceedances on the 1<sup>st</sup>, 5<sup>th</sup>, 6<sup>th</sup> and 7<sup>th</sup> September have been investigated and found to have been caused out with construction working hours and therefore it is unlikely that construction related activates were the cause of these events (graph above from the 05/09/2016).

Exceedances on the 10<sup>th</sup>, 25<sup>th</sup> and 29<sup>th</sup> September have been investigated and found to have been caused by the resident having private building work done on their property (graph above from 25/09/2016).

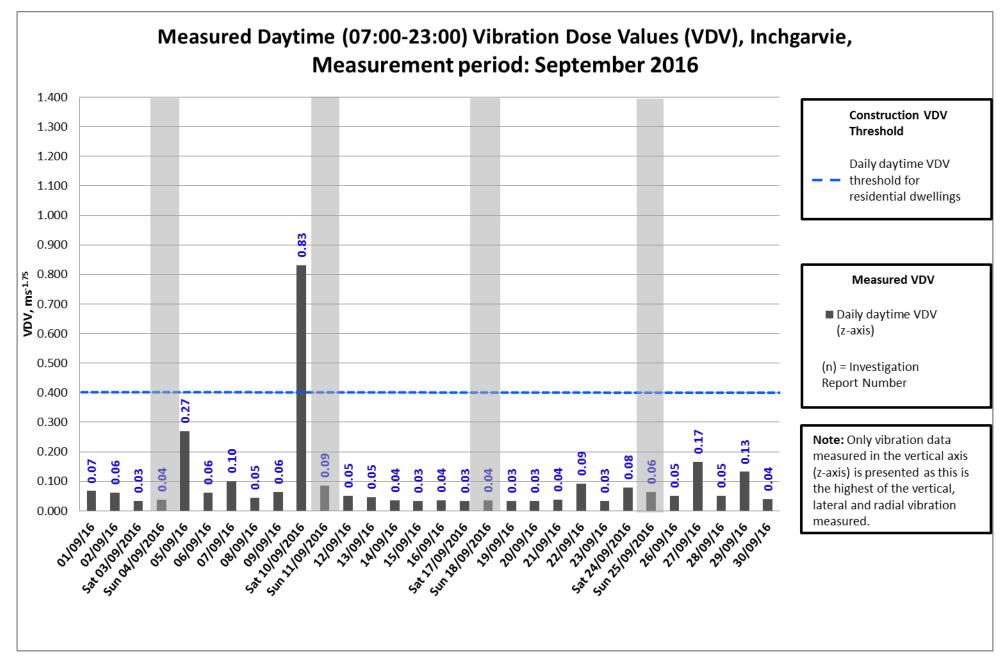
Exceedance on the 10<sup>th</sup> of September has been investigated and found to have been caused by the resident having private building work done on their property.

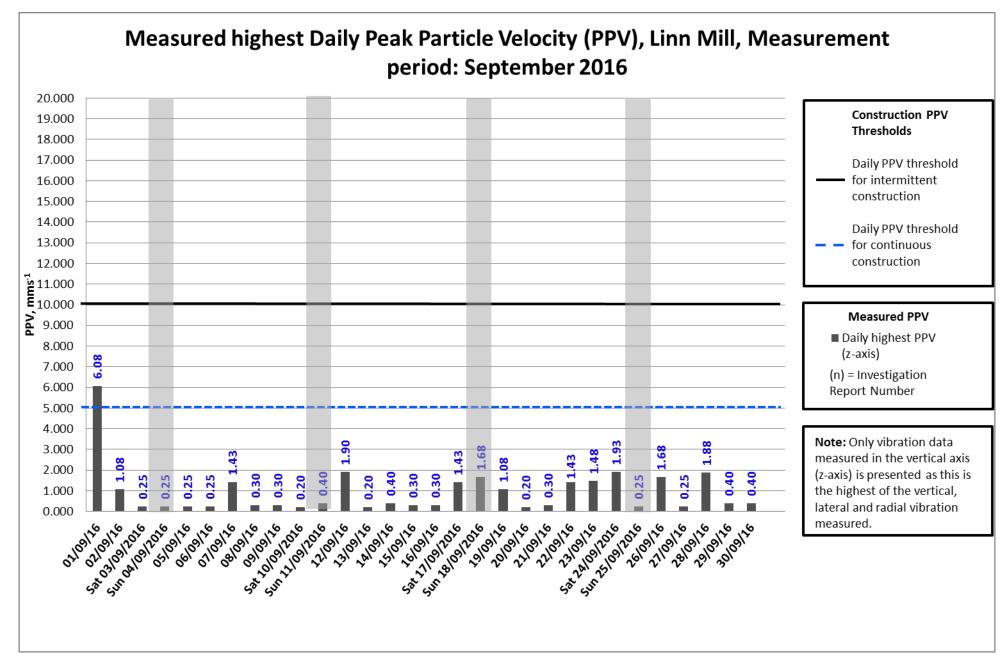
Exceedance on the 1<sup>st</sup> September has been investigated and found to have been caused by an individual isolated event that is unlikely to have been due to construction related activity.

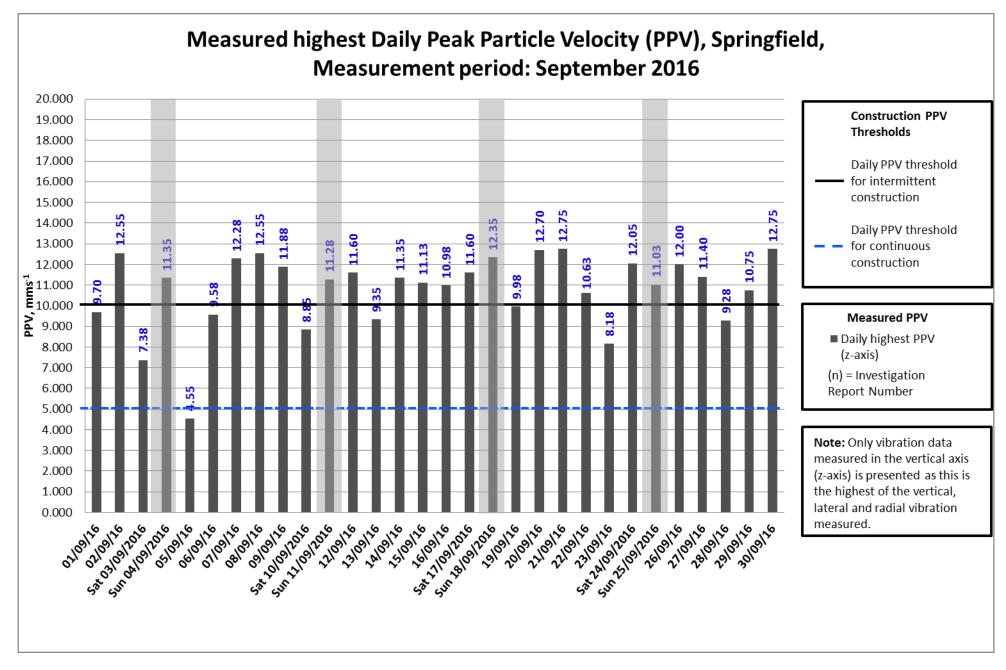
Exceedances on the 4<sup>th</sup>, 7<sup>th</sup>, 8<sup>th</sup>, 9<sup>th</sup>, 10<sup>th</sup>, 12<sup>th</sup>, 13<sup>th</sup>, 17<sup>th</sup>, 18<sup>th</sup>, 19<sup>th</sup>, 22<sup>nd</sup>, 24<sup>th</sup>, 25<sup>th</sup>, 26<sup>th</sup>, 27<sup>th</sup>, 28<sup>th</sup>, 29<sup>th</sup> and 30<sup>th</sup> of September have been investigated and found to have been caused by individual isolated events that are unlikely to have been construction related activities (graph above from the 10/09/16). The vibration monitor is located in the residents back garden, so resident's activity may have caused these exceedances. The closest works were located approximately 260m away which consists mainly of road surfacing. Due to the distance to the nearest works it is unlikely the exceedances stated above were caused by the Forth Crossing works.

Exceedances on the 1<sup>st</sup>, 2<sup>nd</sup>, 3<sup>rd</sup>, 6<sup>th</sup>, 11<sup>th</sup>, 14<sup>th</sup>, 15<sup>th</sup>, 16<sup>th</sup>, 20<sup>th</sup>, 21<sup>st</sup> and 23<sup>rd</sup> of September have been investigated and found to be caused out with construction working hours and therefore it is unlikely that construction related activities were the cause for these exceedances (graph above from the 14/09/2016).

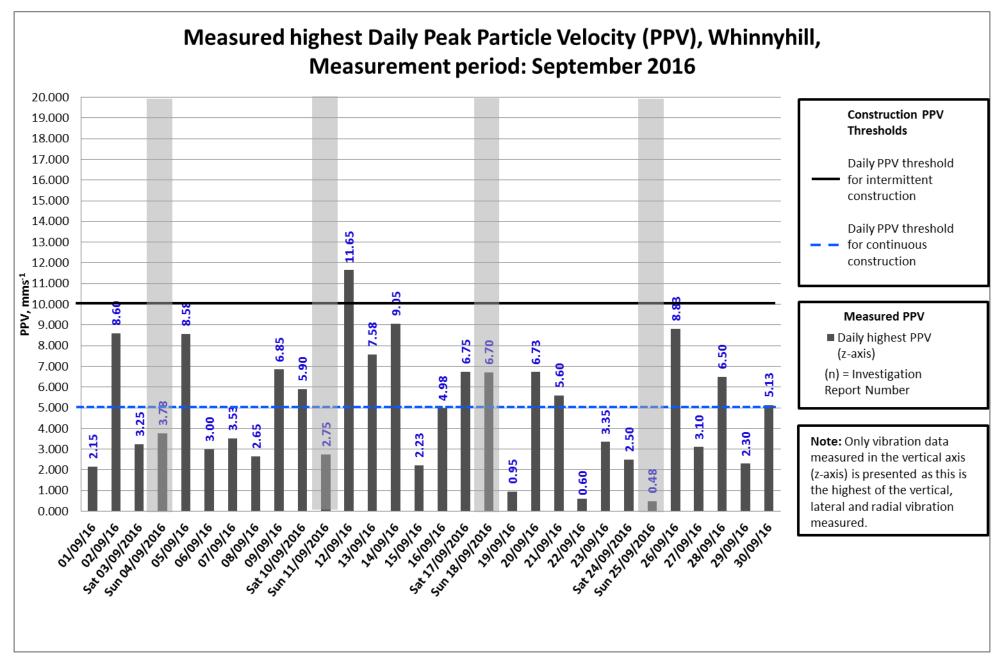
Exceedances on the 2<sup>nd</sup>, 9<sup>th</sup>, 10<sup>th</sup>, 12<sup>th</sup>, 13<sup>th</sup>, 14<sup>th</sup>, 16<sup>th</sup>, 17<sup>th</sup>, 19<sup>th</sup>, 20<sup>th</sup>, 21<sup>st</sup> 26<sup>th</sup> and 28<sup>th</sup> of September have been investigated and found to have been caused by individual isolated events that are unlikely to have been construction related activities (graph above from the 12/09/16).

Exceedances on the 5<sup>th</sup> and 30<sup>th</sup> of September have been investigated and found to have been caused out with construction working hours and therefore it is unlikely that construction related activities were the cause for these exceedances (graph above from the 05/09/2016).
