**Employer's Delivery Team Construction Noise Monitoring Report**

Principal Contract and M9J1a Contract (November to December 2011)

February 2012

#### FORTH REPLACEMENT CROSSING

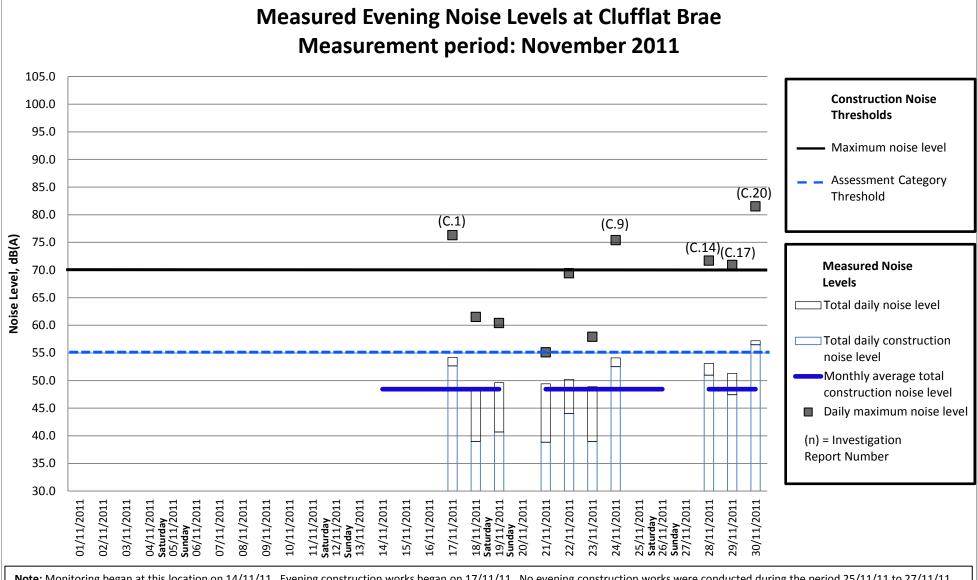
**Note:** Monitoring began at this location on 14/11/11. Evening construction works began on 17/11/11. No evening construction works were conducted during the period 25/11/11 to 27/11/11. Suday noise data has not been included as no construction works have been conducted during these hours.

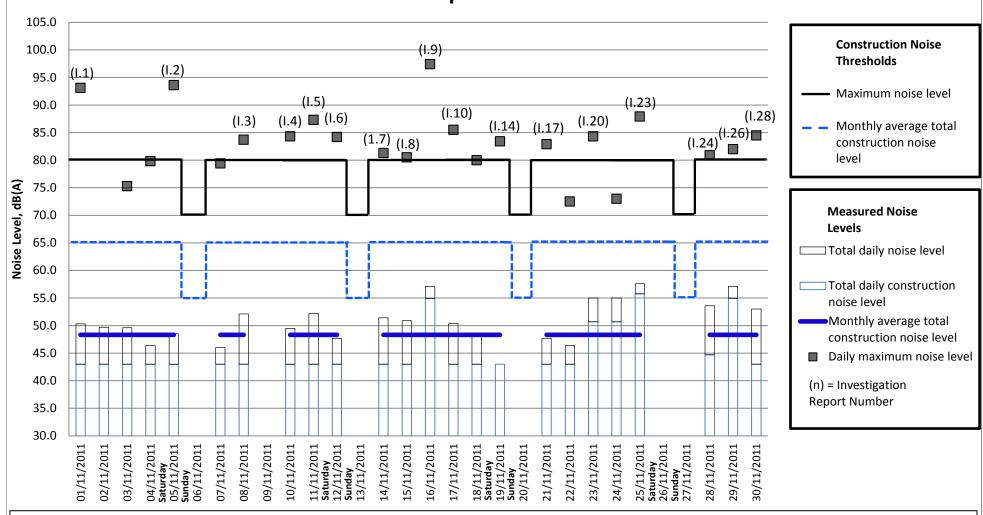
**Note**: Sunday noise data has not been included as no construction works have been conducted during these hours. Daytime noise data is missing for 09/11/11 and 26/11/11 due to device error. Daily maximum noise level is missing for 02/11/11 due to device error.

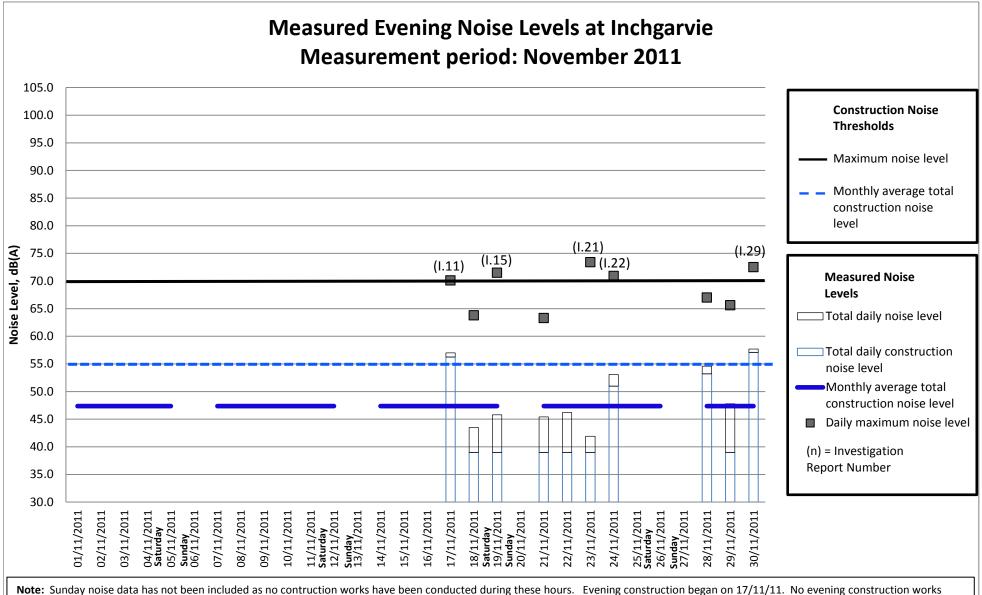
**Note:** Sunday noise data has not been included as no contruction works have been conducted during these hours. Evening construction began on 17/11/11. No evening construction works were conducted during the period 25/11/11 to 17/11/11. Evening maximum noise level data is missing for 22/11/11 due to device error.

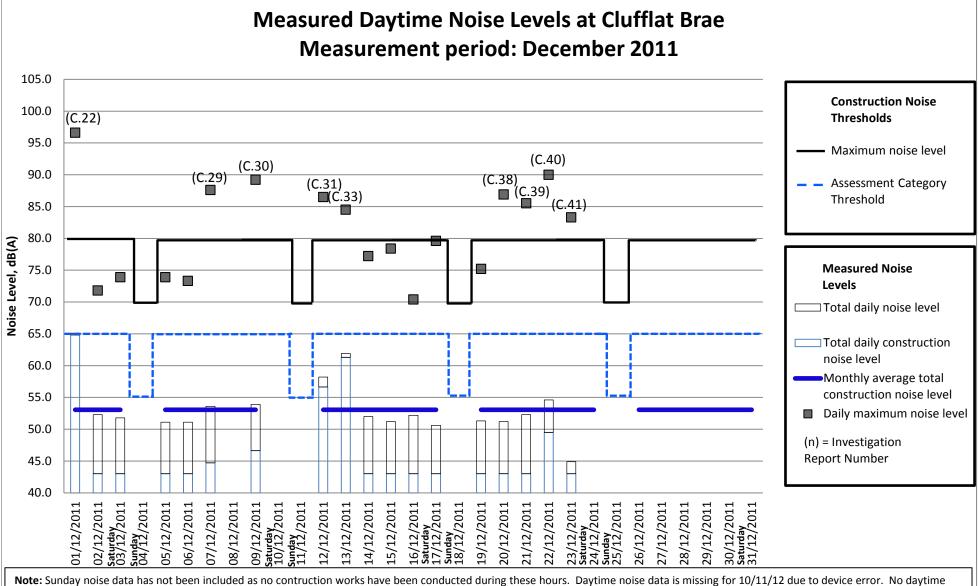
**Note:** Sunday noise data has not been included as no contruction works have been conducted during these hours. Daytime noise data is missing for 10/11/12 due to device error. No daytime construction works were conducted on 08/12/2011 due to adverse weather conditions. No daytime construction works were conducted over the Christmas period (beginning 24/12/11 to 09/01/12).

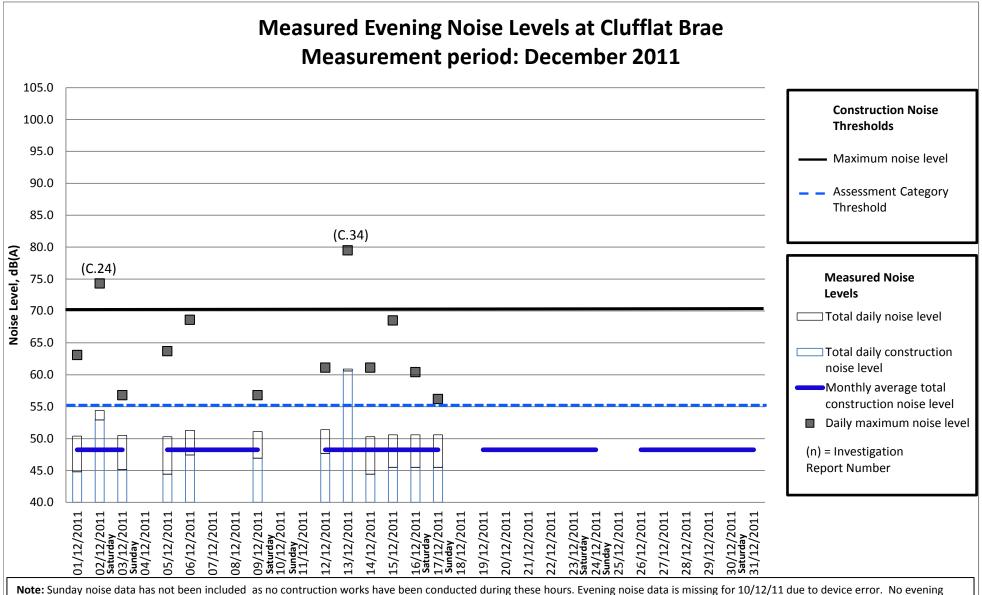
**Note:** Sunday noise data has not been included as no contruction works have been conducted during these hours. Evening noise data is missing for 10/12/11 due to device error. No evening construction works were conducted on 07/12/11 and 08/12/11 due to adverse weather conditions. No evening construction works were conducted over the Christmas period (beginning 19/12/11 to 09/01/12).

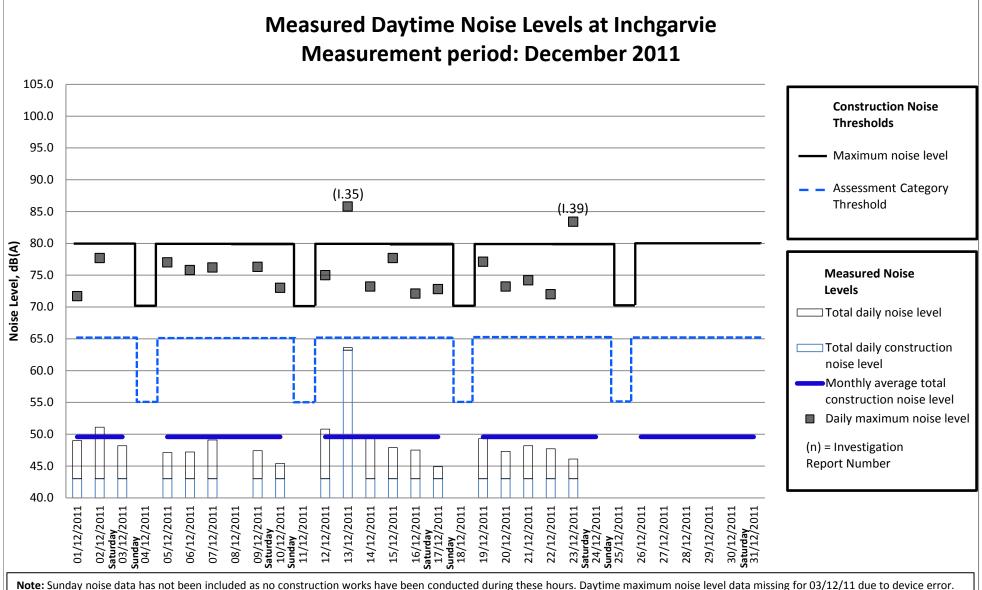
Note: Sunday noise data has not been included as no construction works have been conducted during these hours. Daytime maximum noise level data missing for 03/12/11 due to device error. No daytime construction works were conducted on 08/12/11 due to adverse weather conditions No daytime construction works were conducted over the Christmas period (beginning 24/12/11 to 09/01/12).

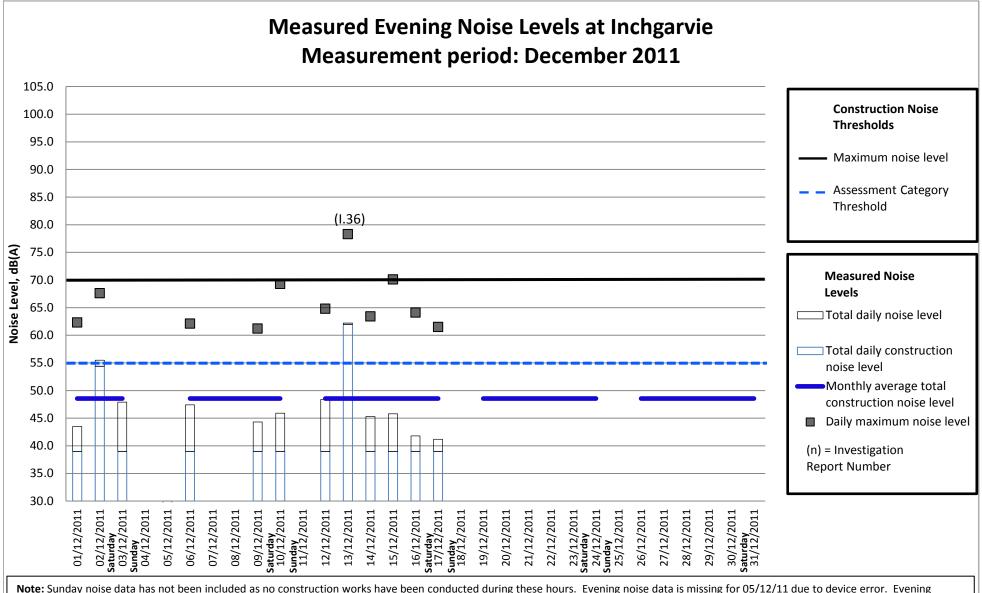
**Note:** Sunday noise data has not been included as no construction works have been conducted during these hours. Evening noise data is missing for 05/12/11 due to device error. Evening maximum noise data is missing for 03/12/11 due to device error. No evening construction works were conducted on 07/12/11 and 08/12/11 due to adverse weather condictions. No evening construction works were conducted over the Christmas period (beginning 19/12/11 to 09/01/12).

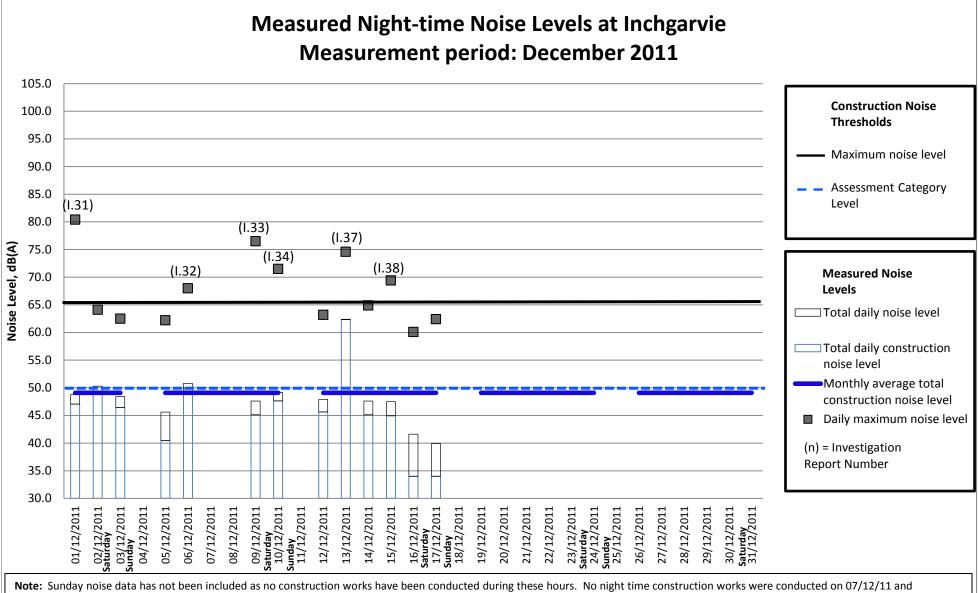
Note: Sunday noise data has not been included as no construction works have been conducted during these hours. No night time construction works were conducted on 07/12/11 and 08/12/11 due to adverse weather conditions. No night time construction works were conducted over the Christmas period (beginning 19/12/11 to 09/01/12).

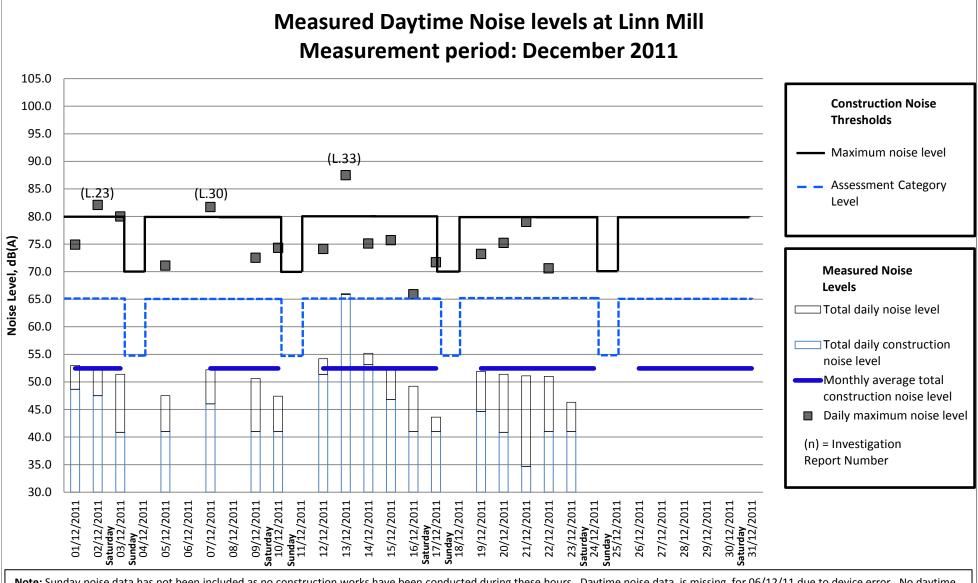
**Note:** Sunday noise data has not been included as no construction works have been conducted during these hours. Daytime noise data is missing for 06/12/11 due to device error. No daytime construction works were conducted on 08/12/11 due to adverse weather conditions. No daytime construction works were conducted over the Christmas period (beginning 24/12/11 to 09/01/12).

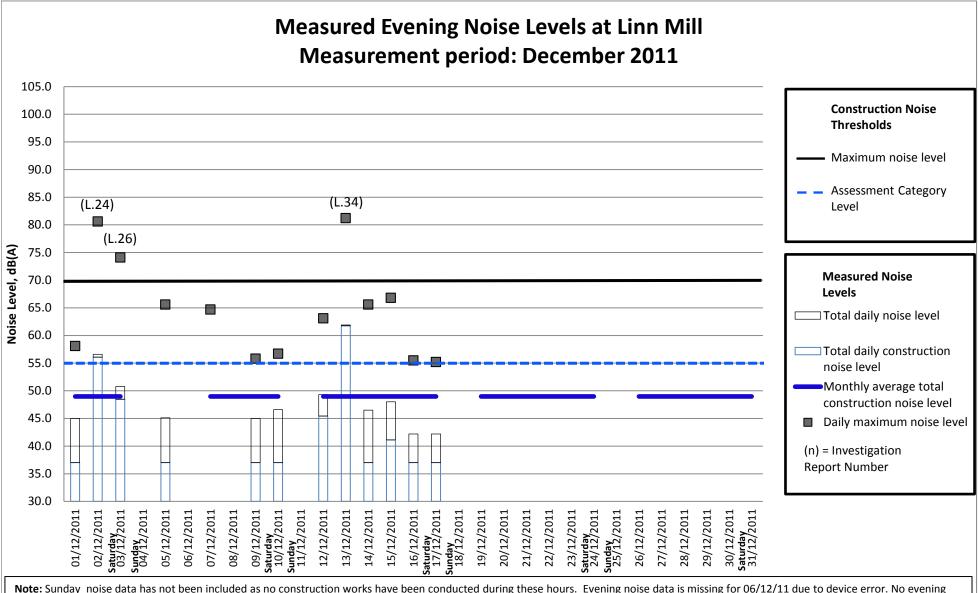
**Note:** Sunday noise data has not been included as no construction works have been conducted during these hours. Evening noise data is missing for 06/12/11 due to device error. No evening construction works were conducted on 07/12/11 and 08/12/11 due to adverse weather conditions. No evening construction works were conducted over the Christmas period (beginning 19/12/11 to 09/01/12).

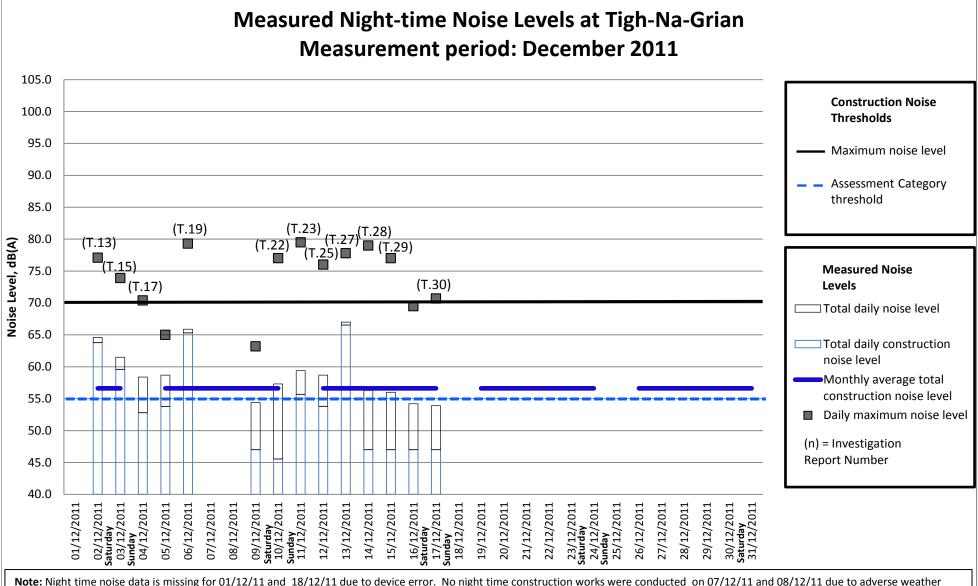
**Note:** Night time noise data is missing for 01/12/11 and 18/12/11 due to device error. No night time construction works were conducted on 07/12/11 and 08/12/11 due to adverse weather conditions. No night time construction works were conducted over the Christmas period (beginning 19/12/11 to 09/01/12).

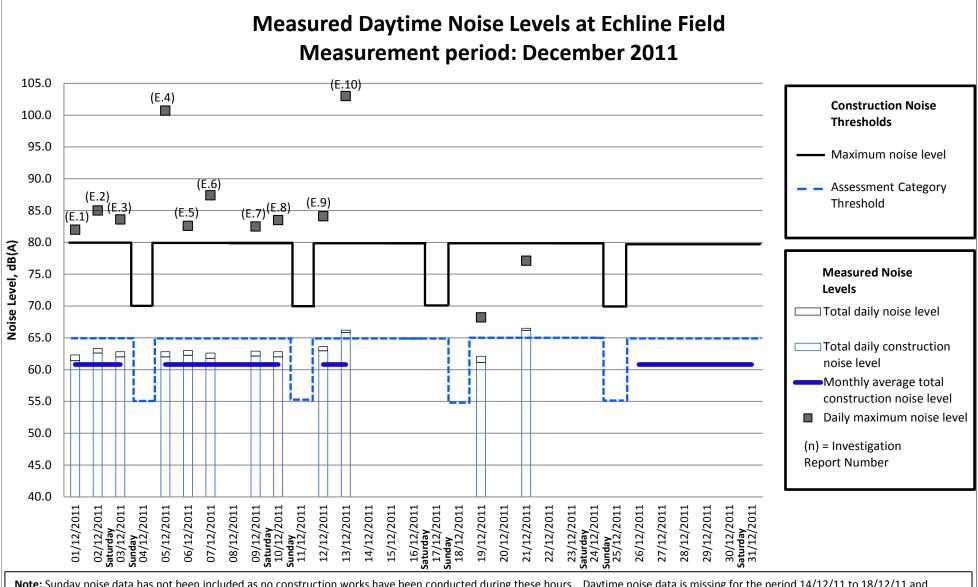
**Note:** Sunday noise data has not been included as no construction works have been conducted during these hours. Daytime noise data is missing for the period 14/12/11 to 18/12/11 and 20/12/11 due to device error. No daytime construction works were conducted on 08/12/11 due to adverse weather conditions. No daytime construction works were conducted over the Christmas period (beginning 24/12/11 to 09/01/12).

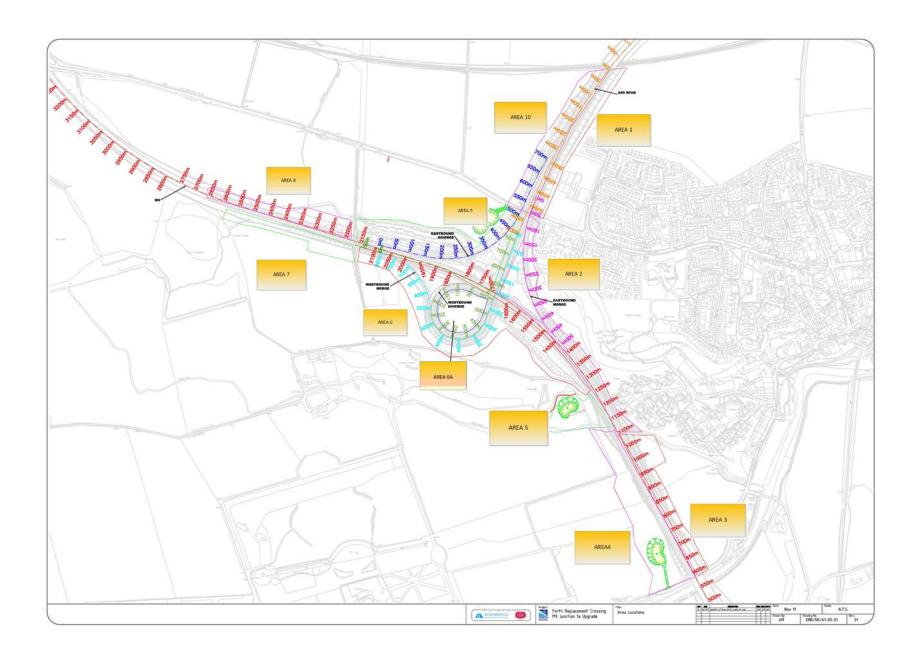
Works did not take place in Area 2 and 3 within 300m of the sensitive receptor within the month of November. Works took place in Areas 4 and 5 during this period within 300m of the sensitive receptor, however these were at their closest, 90m away from the receptor and were spread throughout Areas 4 and 5 i.e. not intensive at the closest point to the receptor.

(See drawing attached):

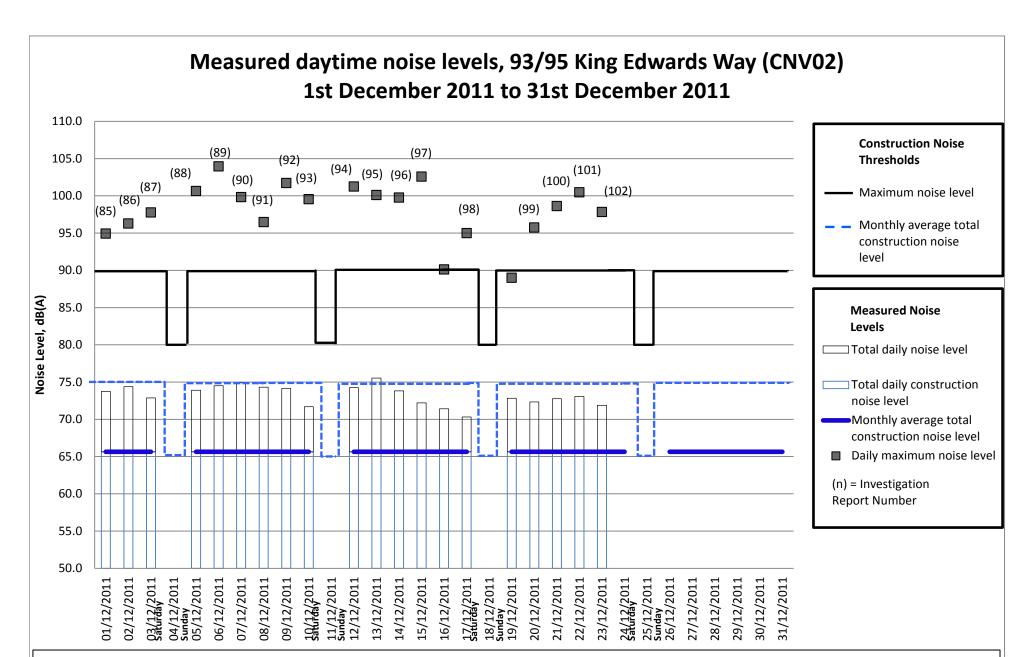
Sunday data have not been included as no construction works have been conducted during these hours.
