Project FORTH REPLACEMENT CROSSING

AIR QUALITY MONITORING REPORT MAY 2012

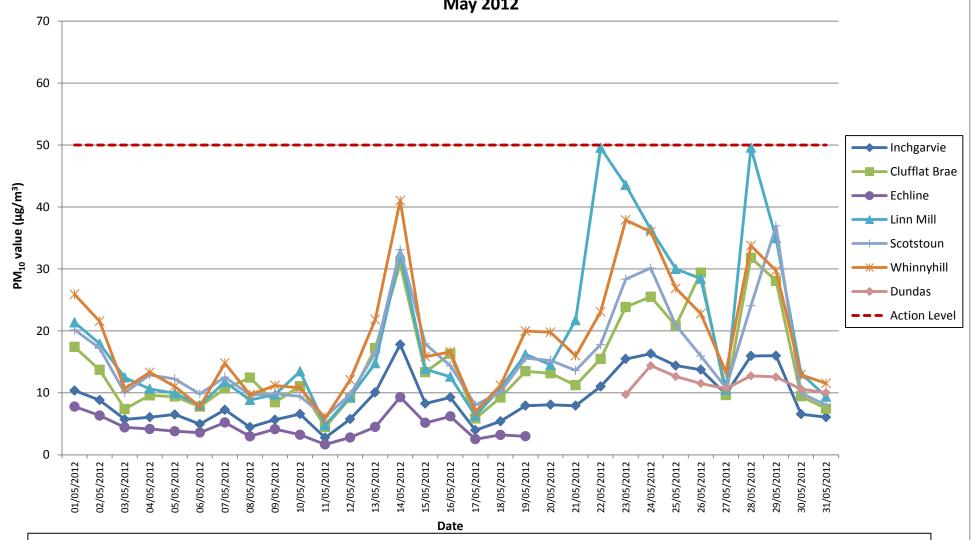
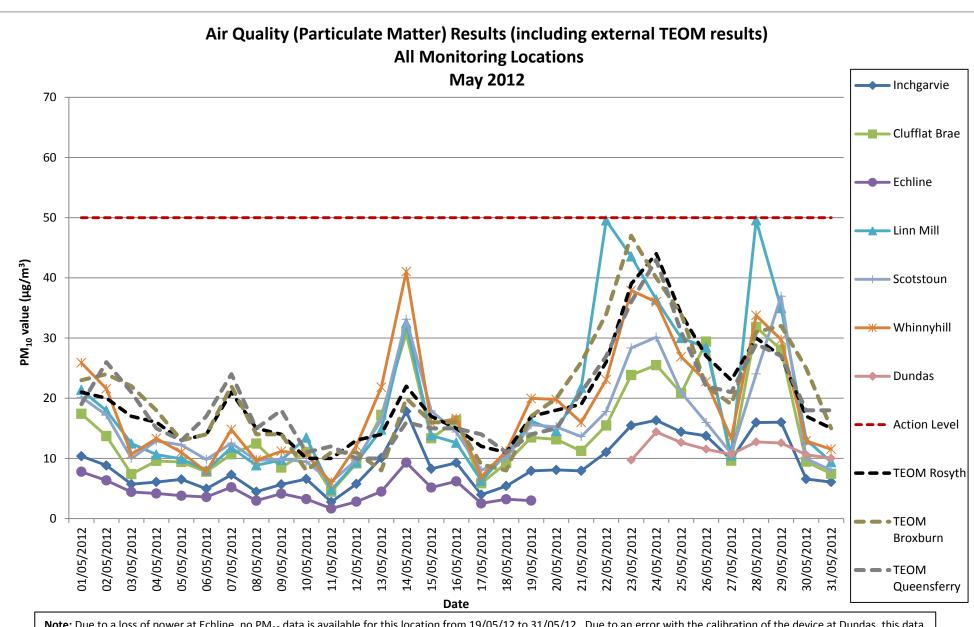
APPENDIX A: LIGHT SCATTER METER RESULTS

- 3.1.1. Light scatter results for May 2012 have been presented in a monthly chart; this can be found in Appendix A. Results show that there were no exceedances of the PM₁₀ threshold during May, and that results were generally low throughout the period. The results have been compared to the daily mean results obtained from the TEOM air quality monitoring stations located in Rosyth, Broxburn and Queensferry Road, Edinburgh. This demonstrates that the results acquired using the light scatter meters on site generally follow the same pattern at a similar level to those results collected by the TEOMs; this indicates that the pattern observed throughout May was largely due to regional changes in air quality, rather than due to construction works.

- 3.1.3. Due to low readings at Dundas during previous months, in comparison to the other meters on site, the meter at this location was remotely recalibrated by the manufacturer on 23 May. Results from the date of recalibration forward are shown in the monthly chart; due to uncertainties concerning the accuracy of the May results prior to this date, data has not been shown for the period from 1 May to 23 May. Additionally, due to a loss of the power supply at Echline, the data from this meter is missing from 19 May onwards. FCBC are currently working to restore the power supply to this device.

Note: Due to a loss of power at Echline, no PM_{10} data is available for this location from 19/05/12 to 31/05/12. Due to an error with the calibration of the device at Dundas, this data has been excluded for 01/05/12 to 22/05/12; the device was recalibrated on 23/05/12.

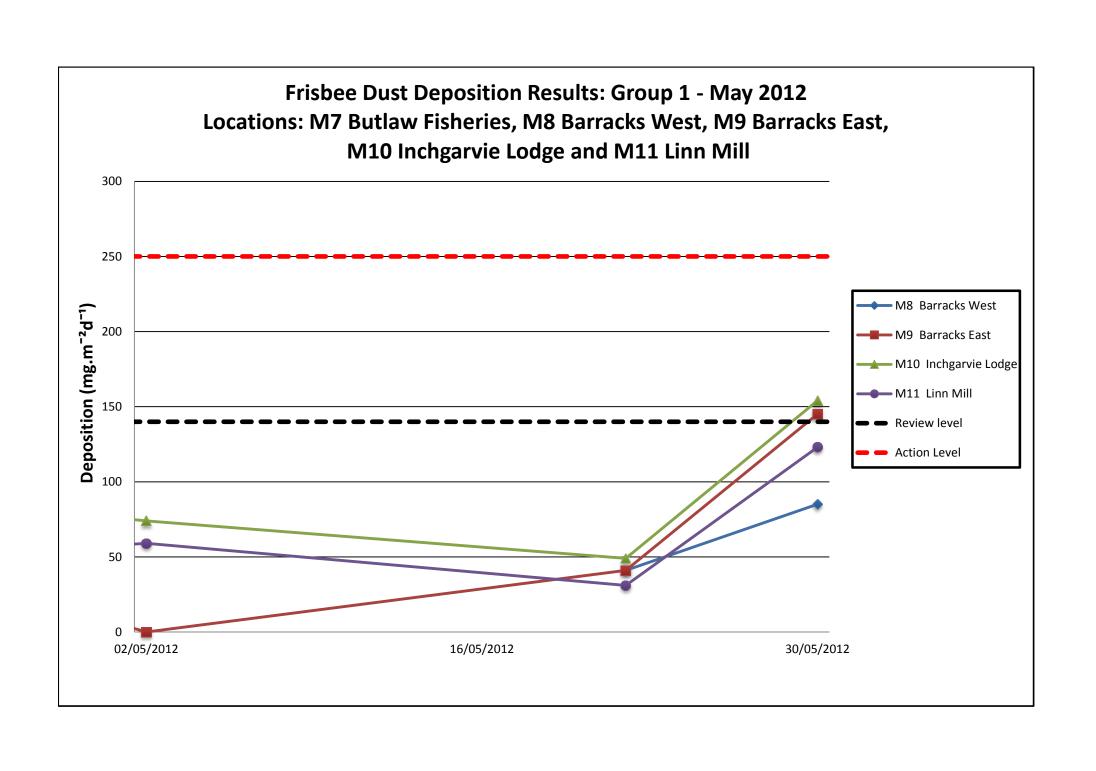
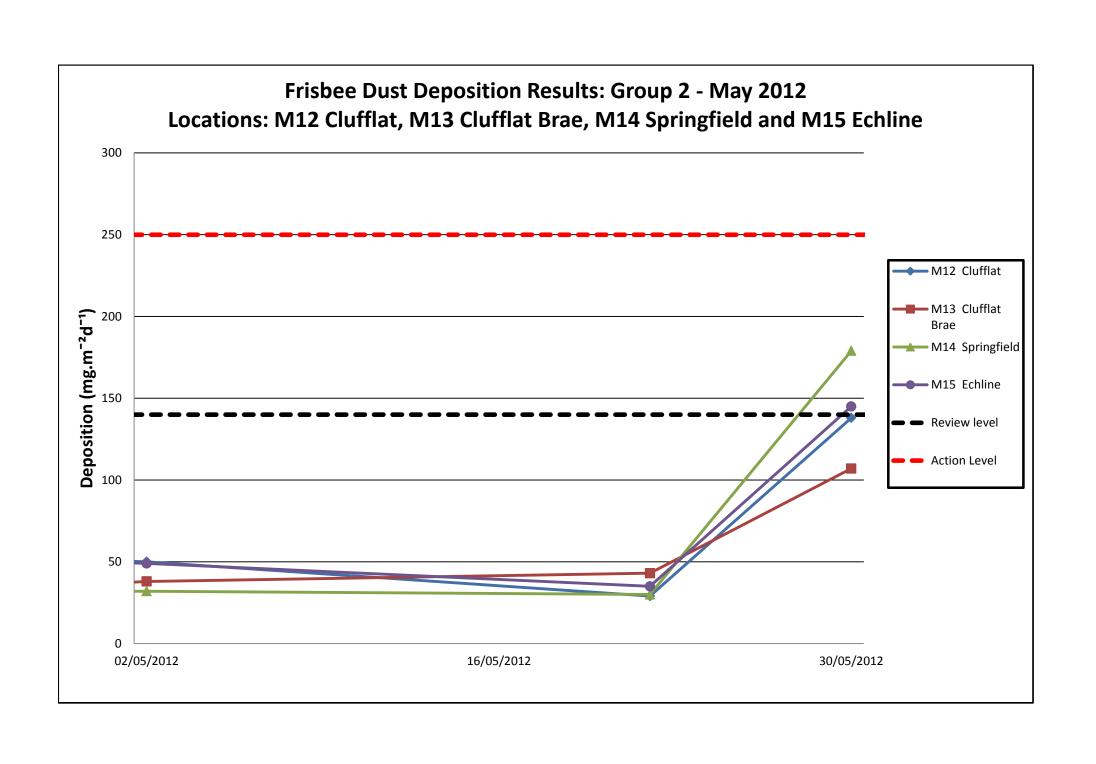
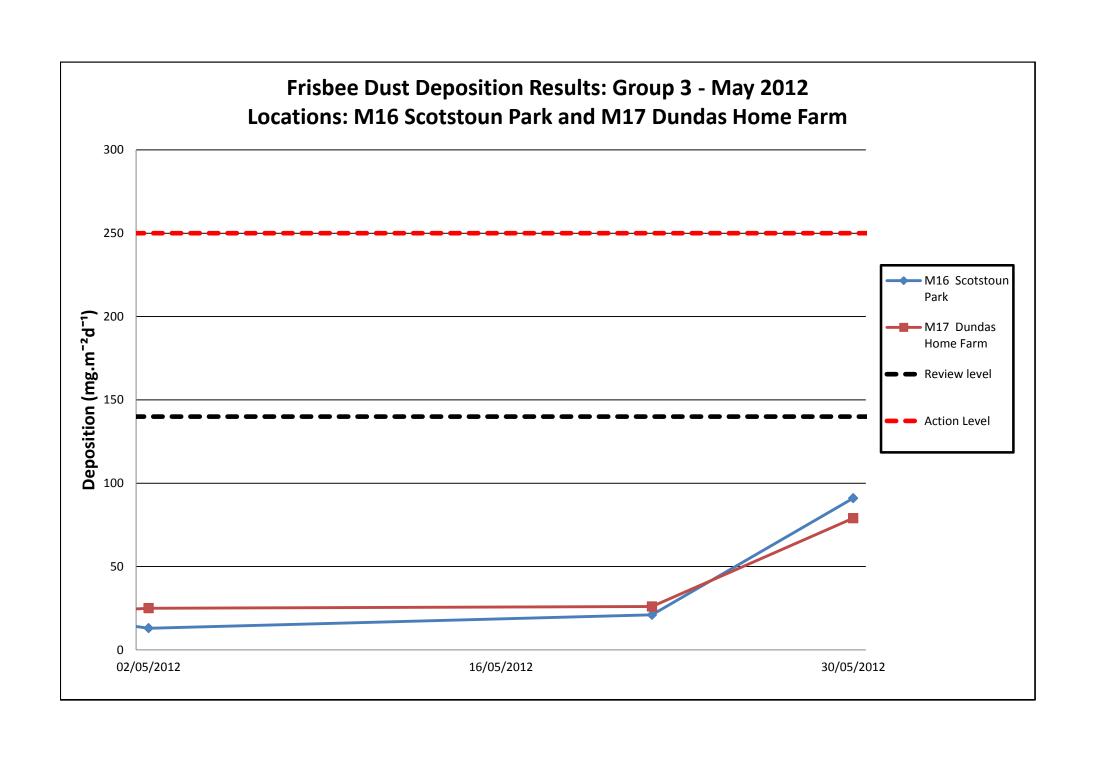
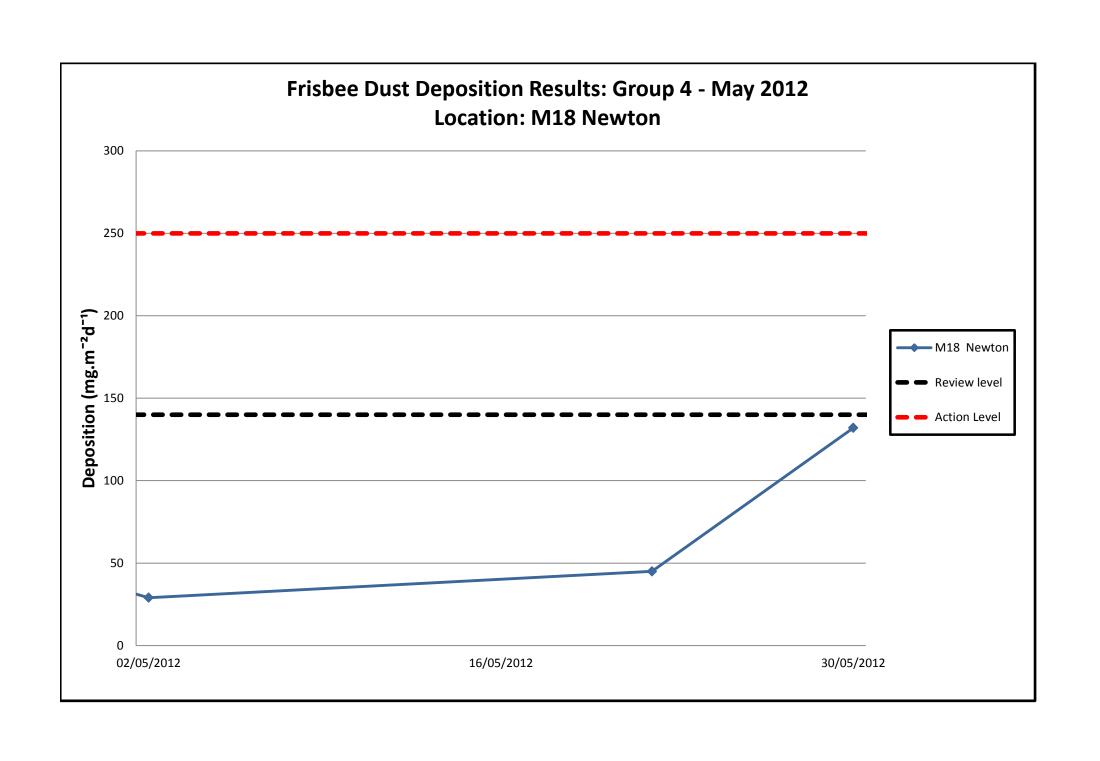
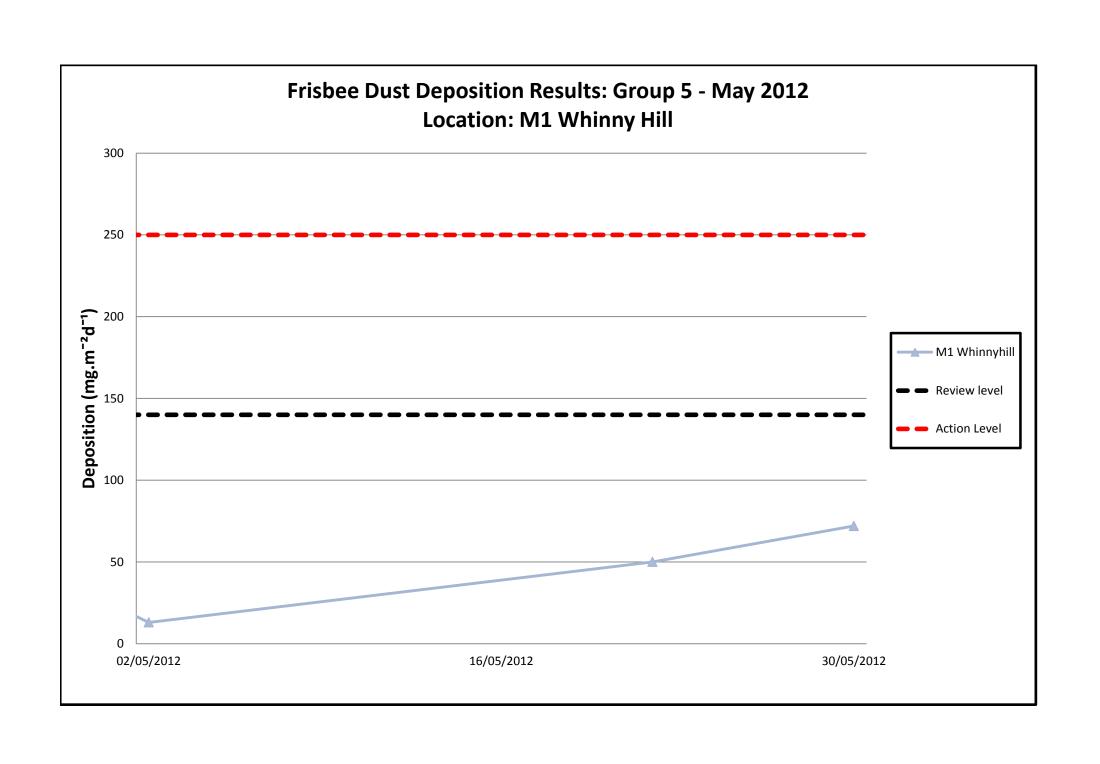
APPENDIX B: FRISBEE GAUGE RESULTS

- **3.2.3.** The site action level for the dust deposition rate has been set at 250 mg/m²/day and a site review level set at 140 mg/m²/day to ensure a site wide investigation and review into dust deposition levels and the appropriateness and effectiveness of the mitigation measures response currently in use. Dust deposition rates were largely low throughout May and were found to be below the action level throughout May. The results for the period ending on 30 May showed that the review level

had been exceeded at two locations in both Groups 1 and 2 (Group 1: Inchgarvie Lodge and Barracks East; Group 2: Springfield and Echline).

3.2.4. During the period for which dust levels were found to exceed the site review level, the weather conditions were dry. As a result, dust levels on site were closely monitored (aided by the real time particulate matter monitoring - see 3.1.2, daily dust inspections – 3.3.1 and environmental inspections – 3.3.2) and appropriate mitigation measures were implemented on site. A bowser was present on site throughout the period of dry weather to dampen down the track as required to prevent the spread of dust from the areas in which earthworks were on-going. Due to the exceedance a review of the current mitigation measures was undertaken, and further mitigation measures were not considered necessary on site at present.
