**Forth Crossing** Bridge Constructors

Project **FORTH REPLACEMENT CROSSING**

**AIR QUALITY MONITORING REPORT**  
**JUNE 2012**

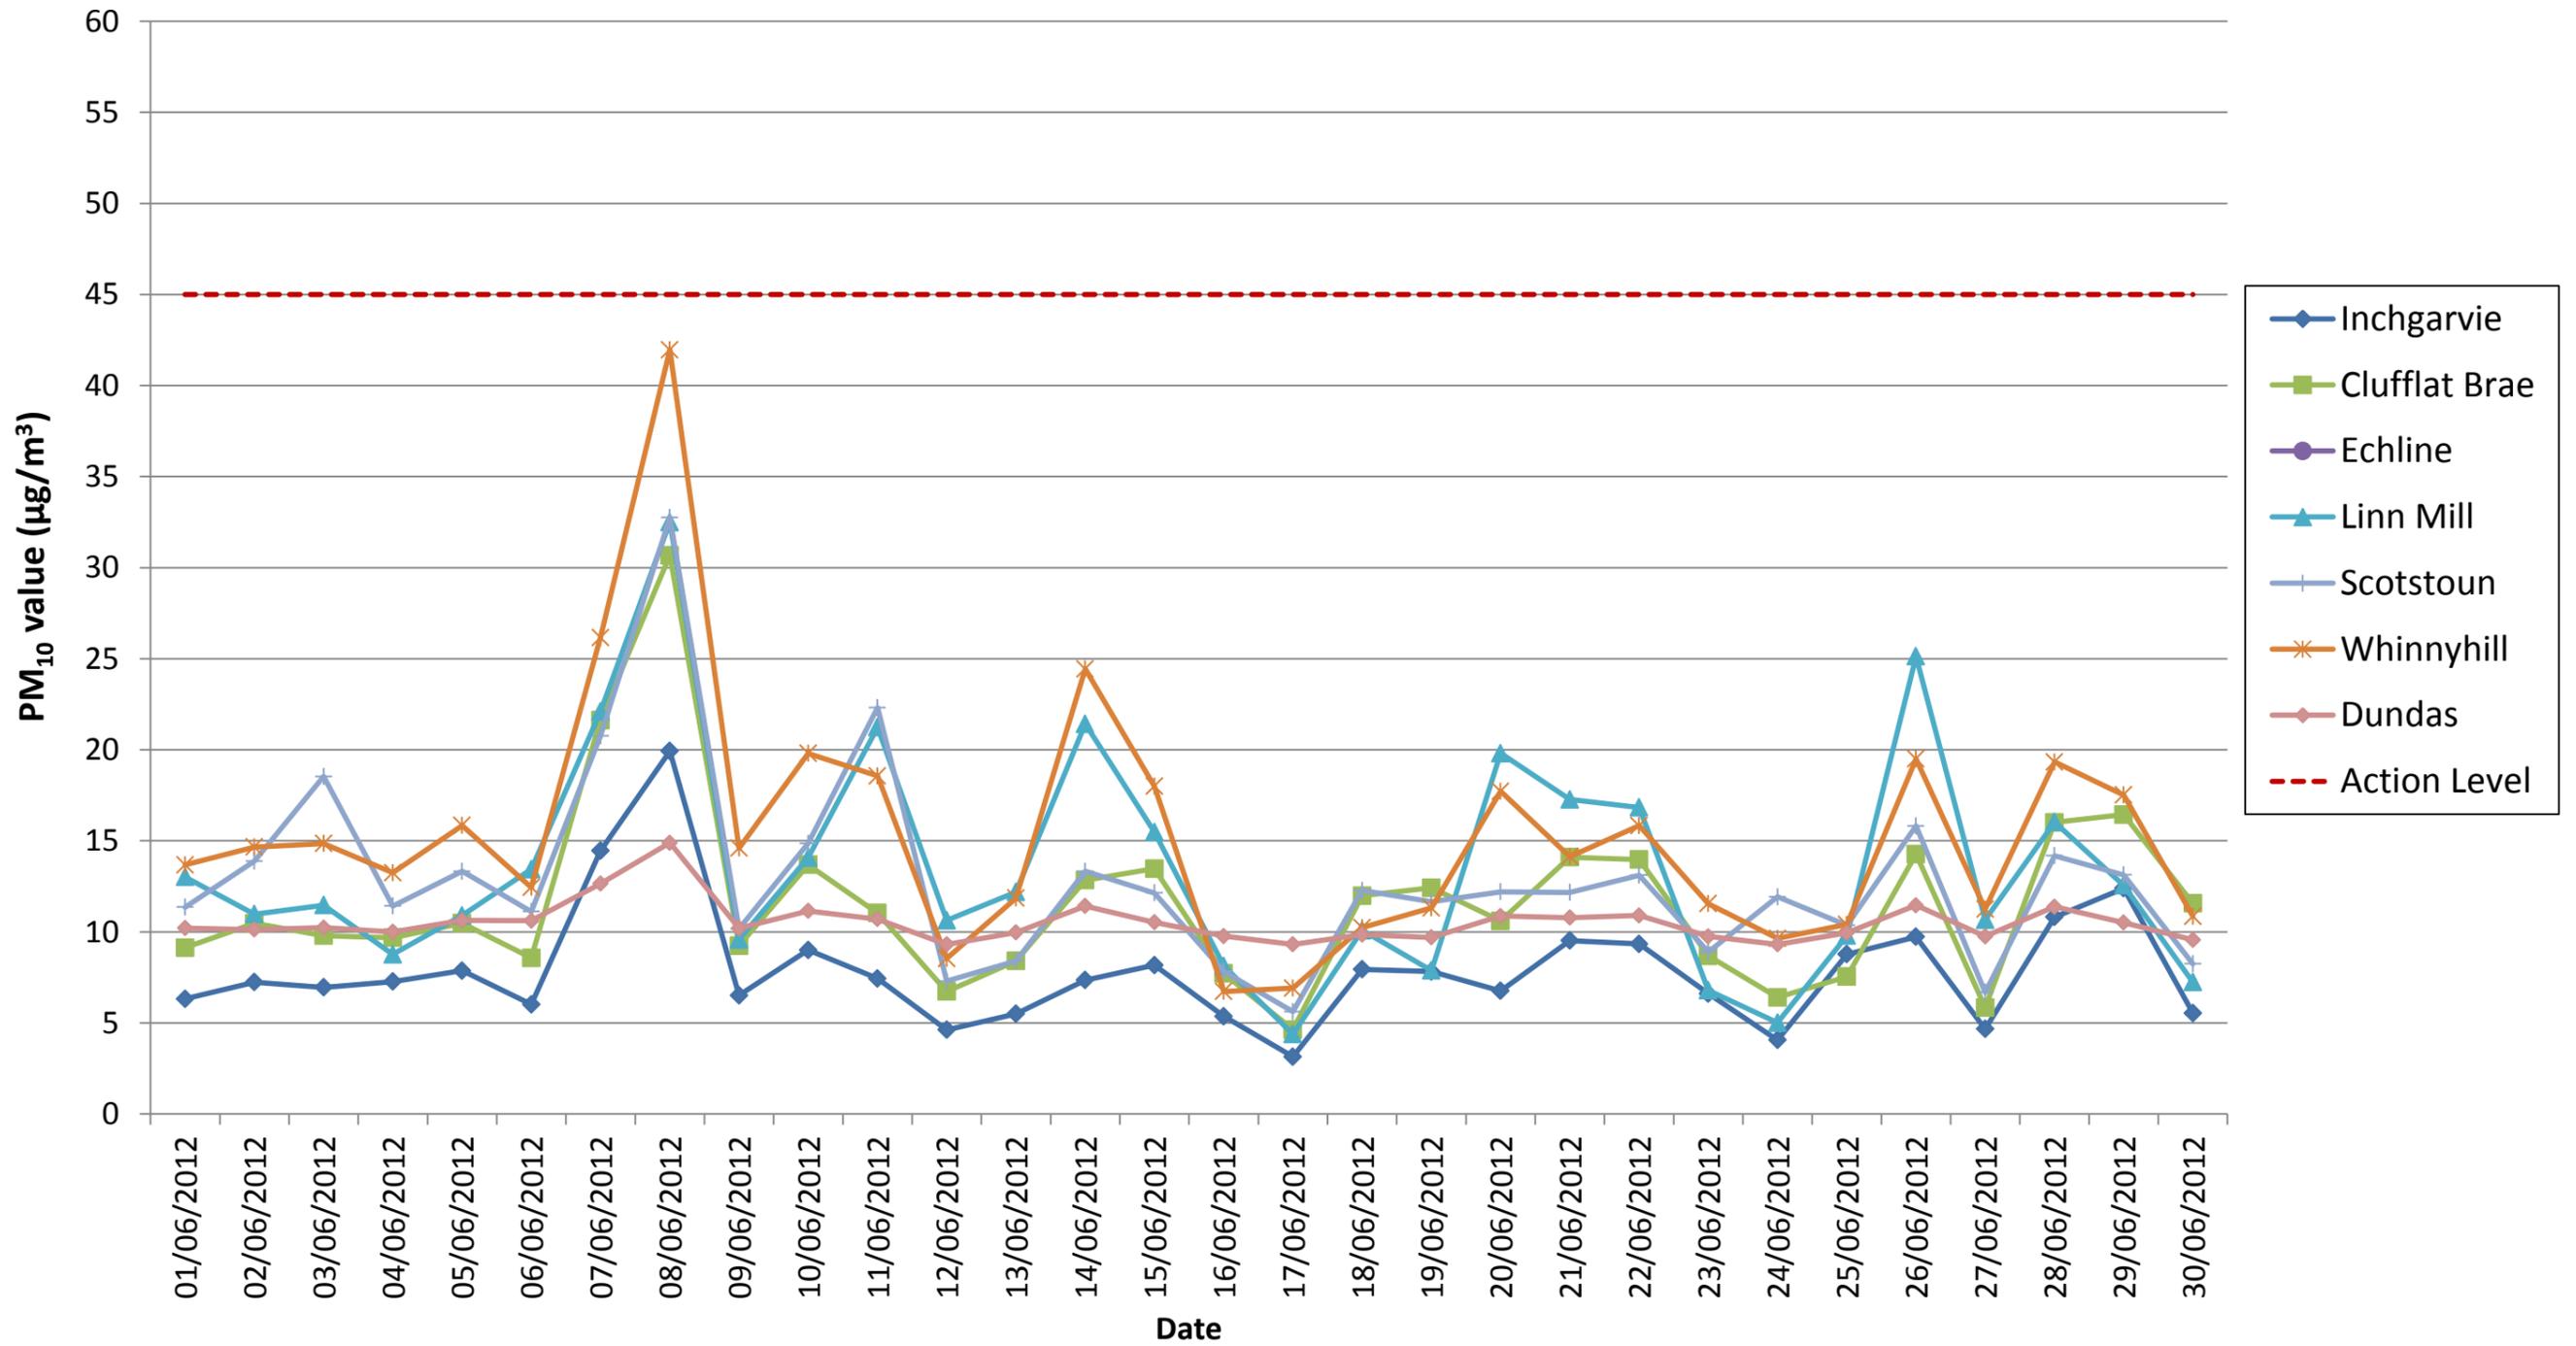
# PM10 Results

**3.1.1.** Light scatter results for June 2012 have been presented in a monthly chart; this can be found in Appendix A. Results show that there were no exceedances of the PM<sub>10</sub> threshold during June, and that results were generally low throughout the period. From June, the PM<sub>10</sub> action threshold has been lowered to 45µg/m<sup>3</sup>, in line with the levels set in the updated Environmental Management Plan.

**Note:** Due to a power failure at Echline, no PM<sub>10</sub> data is available for this location

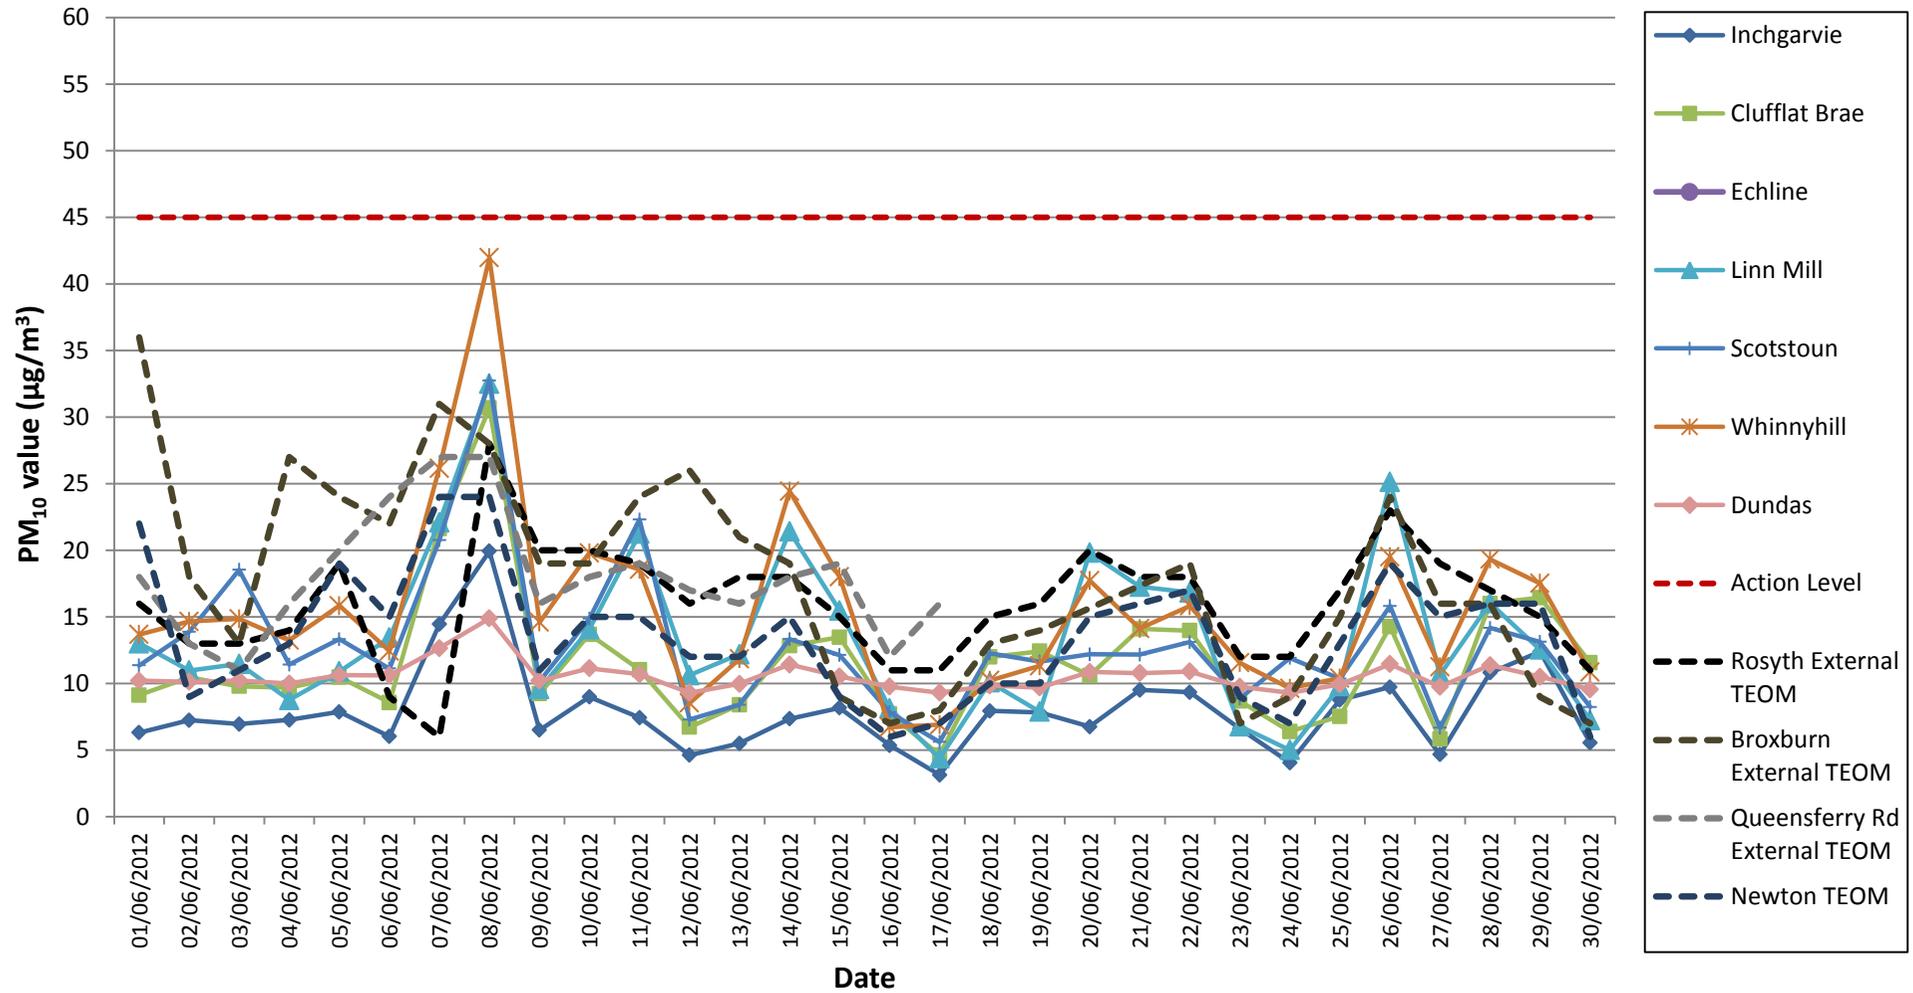
# PM10 Results (including TEOM Results)

**3.1.2.** The results have been compared to the daily mean results obtained from the TEOM air quality monitoring stations located in Newton, Rosyth, Broxburn and Queensferry Road, Edinburgh. The TEOM at Newton was installed by West Lothian Council, facilitated by FCBC, during May. The results from this station have therefore been included from the start of June. The comparison between the light scatter and TEOM results demonstrates that both sets of results generally follow the same pattern at similar levels, indicating that the pattern observed throughout June was largely due to regional changes in air quality, rather than due to construction works.

**Note:** Due to a power failure at Echline, no PM<sub>10</sub> data is available for this location

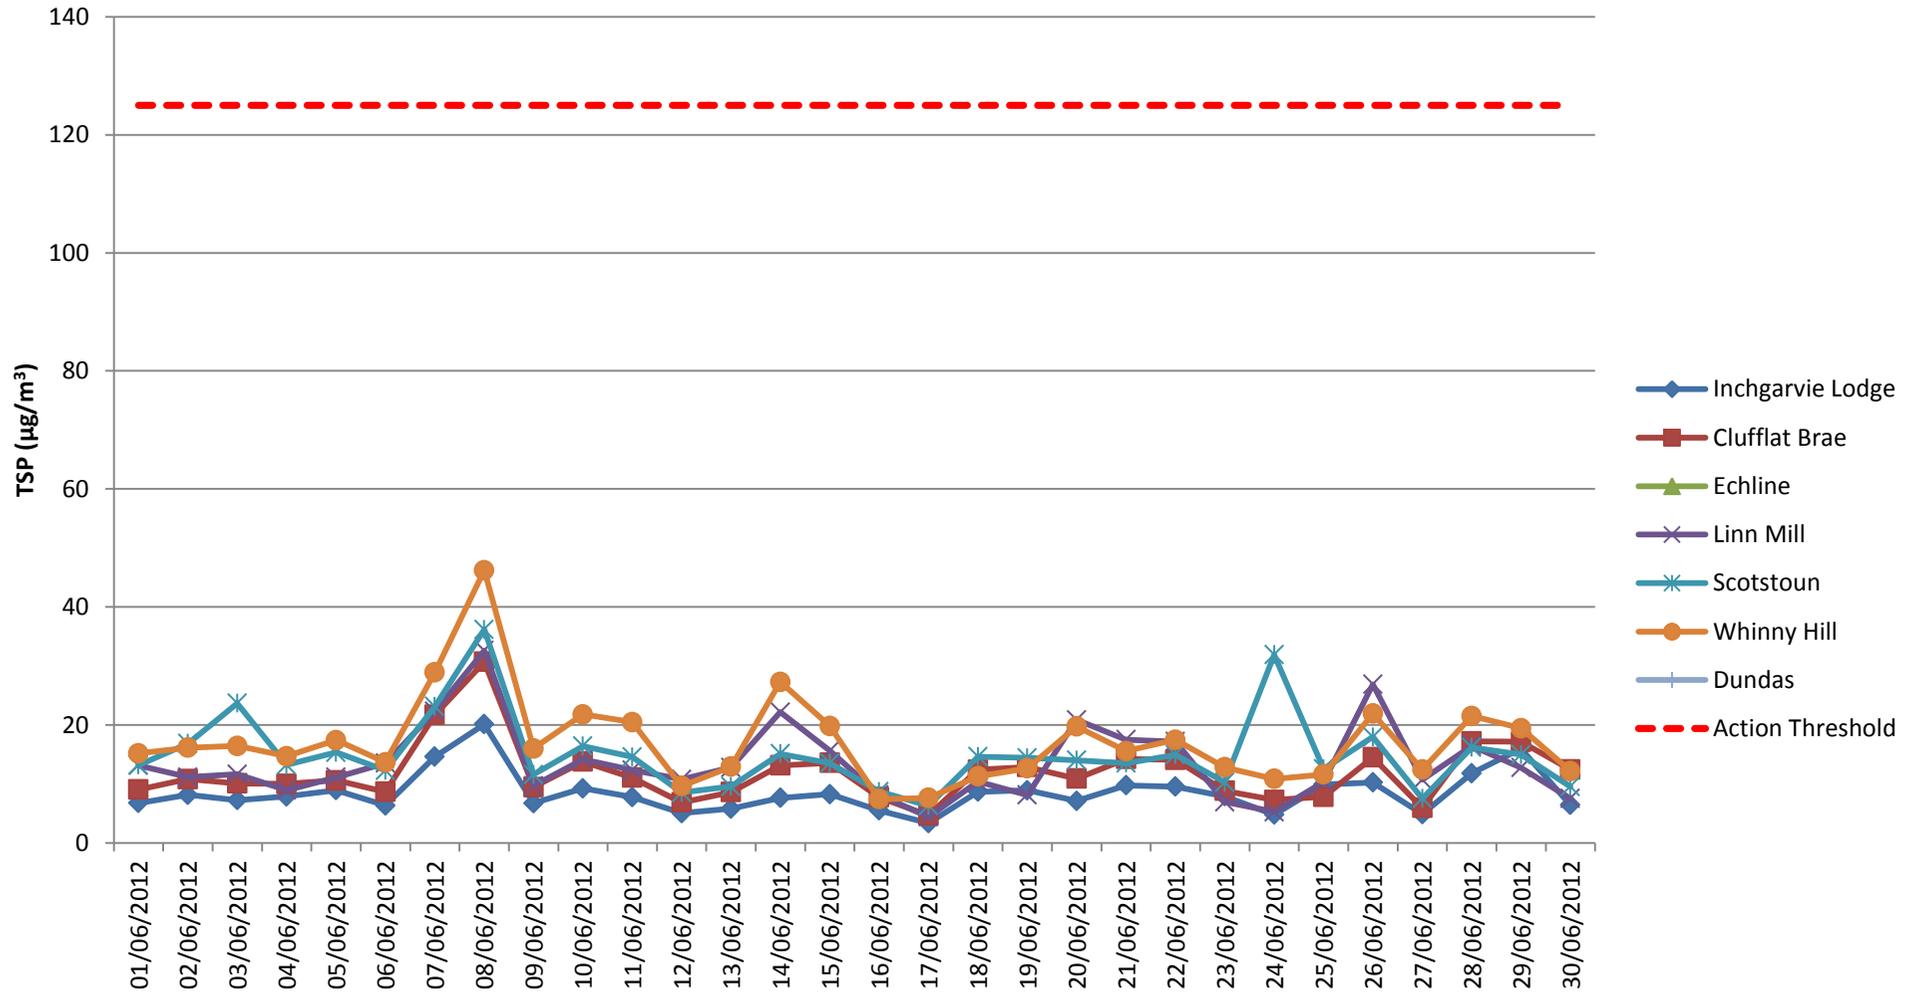
## Total Suspended Particles (TSP) Results June 2012

**3.2.1.** The TSP results for June 2012 have been presented in a monthly chart; this can be found in Appendix B. TSP levels at all monitoring locations throughout June were low and generally found to follow a similar pattern across the site, demonstrating that the levels are influenced by regional changes in TSP levels, rather than construction works.

**3.2.2.** Due to a device error associated with the measurement of TSP at Dundas, the results for this location have been excluded from the graph. This device error resulted in the measurements of TSP being unrealistically low. However, it should be noted that, following consultation with the supplier, this was a device error that affected the measurement of TSP only.

**Note:** Due to a loss of power at Echline, no TSP results are available for this location throughout June. Due to errors associated with the TSP results for Dundas, these results have been excluded.

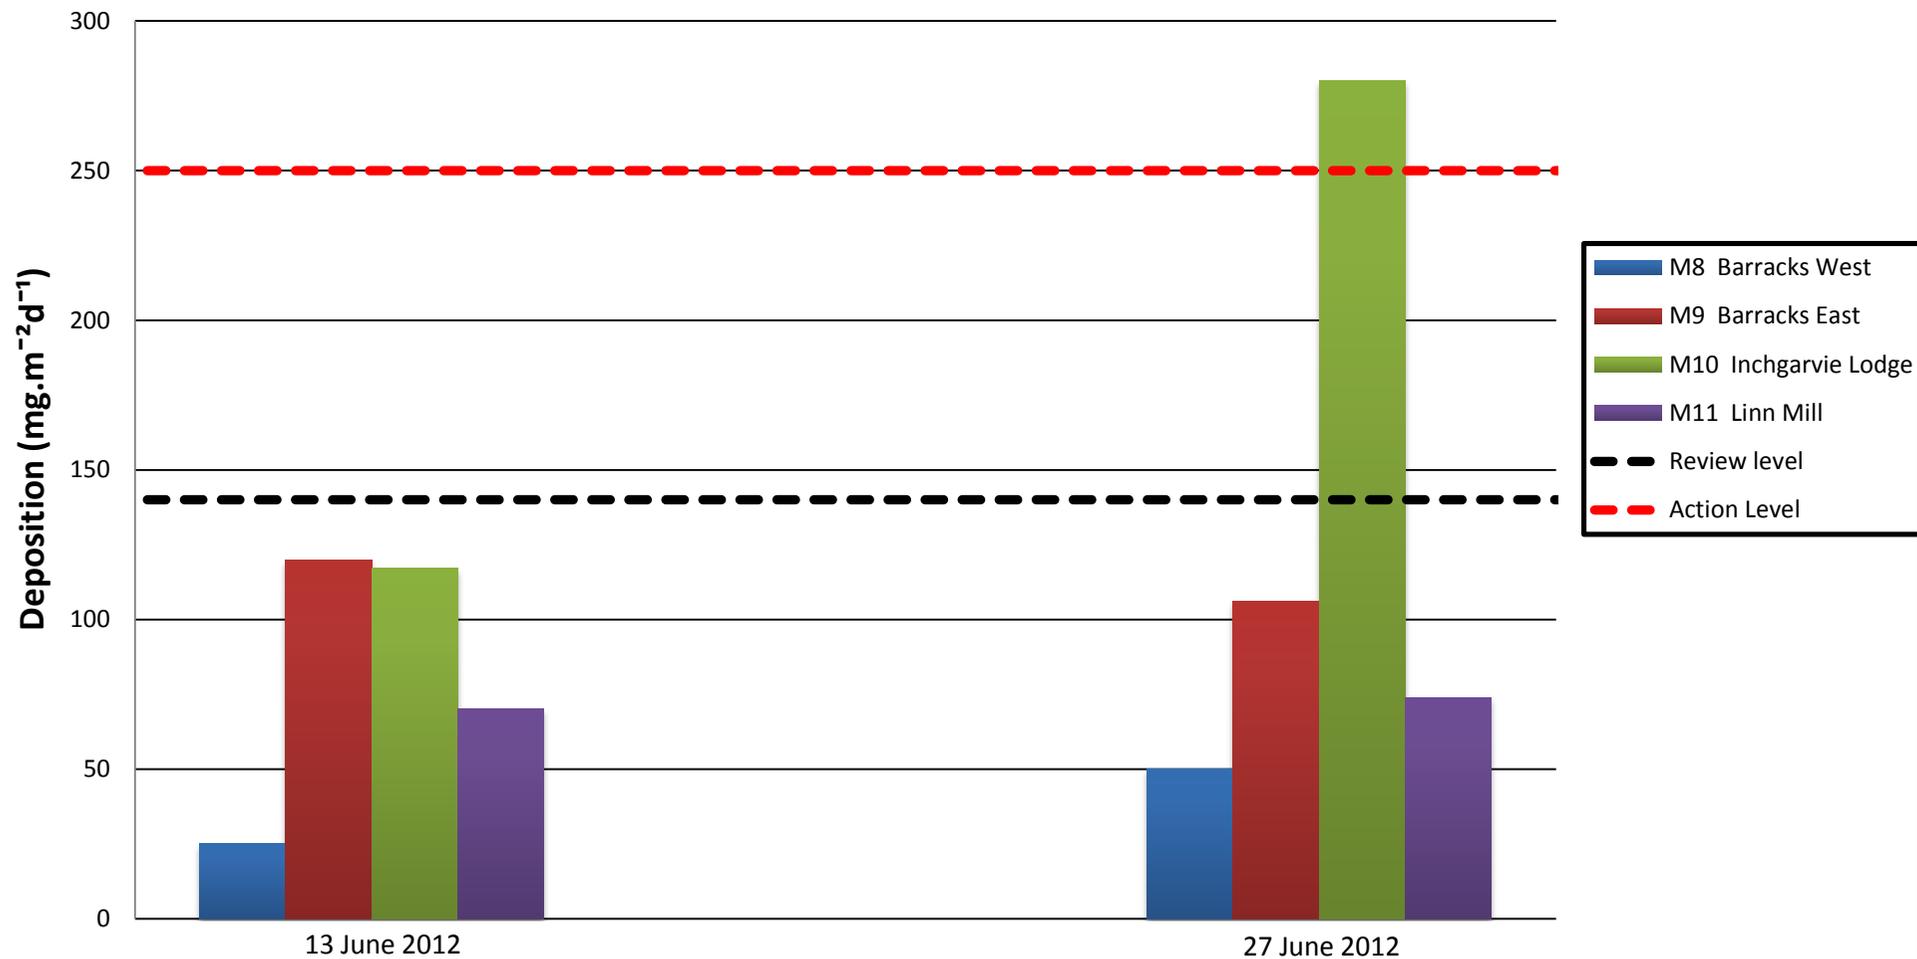
# Frisbee Dust Deposition Results: Group 1

**3.3.4.** Throughout June the dust deposition rates for Groups 3, 4 and 5 were within the threshold levels. For Group 1, results for all locations were within the threshold dust deposition levels for the fortnight ending on 13 June, however there was an exceedance of the site action level at Inchgarvie Lodge for the period ending on the 27 June. The results for Group 2 show that all locations were within the threshold levels, with the exception of Springfield. For both periods within June, the site action level was exceeded at this location.

**3.3.5.** Due to the exceedances of the site action level on three occasions during June, at two different locations, FCBC conducted a review into site wide dust levels and the construction works being undertaken at these locations. Investigations into the cause of the dusts, however, indicated that the construction works were unlikely to have resulted in the exceedances. South side daily dust inspections (see section 3.4) in the vicinity of the monitoring locations at which the exceedances were recorded did not highlight any instances of high dust levels on site. Wet weather was also frequently recorded and, where dry conditions were noted, the bowser was present on site to dampen down where required. Also, as the prevailing wind direction (as recorded by the onsite weather stations) was north-easterly throughout June, this would have generally carried any dust arising on site away from the monitoring locations at which exceedances were recorded.

**3.3.6.** Additionally, it was recognised that the Frisbees at the affected locations were both situated near to, or under, trees or hedges. Due to their positioning, small particles of vegetation have been observed in the Frisbees at the time of collection. As a result of this finding, and in recognition of the exceedances of the action level, FCBC have slightly altered the location of the Frisbees at these properties in order to

**Note:** Please see paragraphs 3.3.5 and 3.3.6 of the monitoring report for details regarding the exceedance at Inchgarvie Lodge.

reduce any impact that the surrounding vegetation may have been having on the dust deposition results. Furthermore, it should be noted that the PM<sub>10</sub> and TSP results indicate that the high dust deposition results were not related to construction works; if the dust deposition results were due to a pollution incident then it is likely that the results for the corresponding periods for both PM<sub>10</sub> and TSP would also have been high. As reported in sections 3.1 and 3.2 the PM<sub>10</sub> and TSP results were low throughout June.

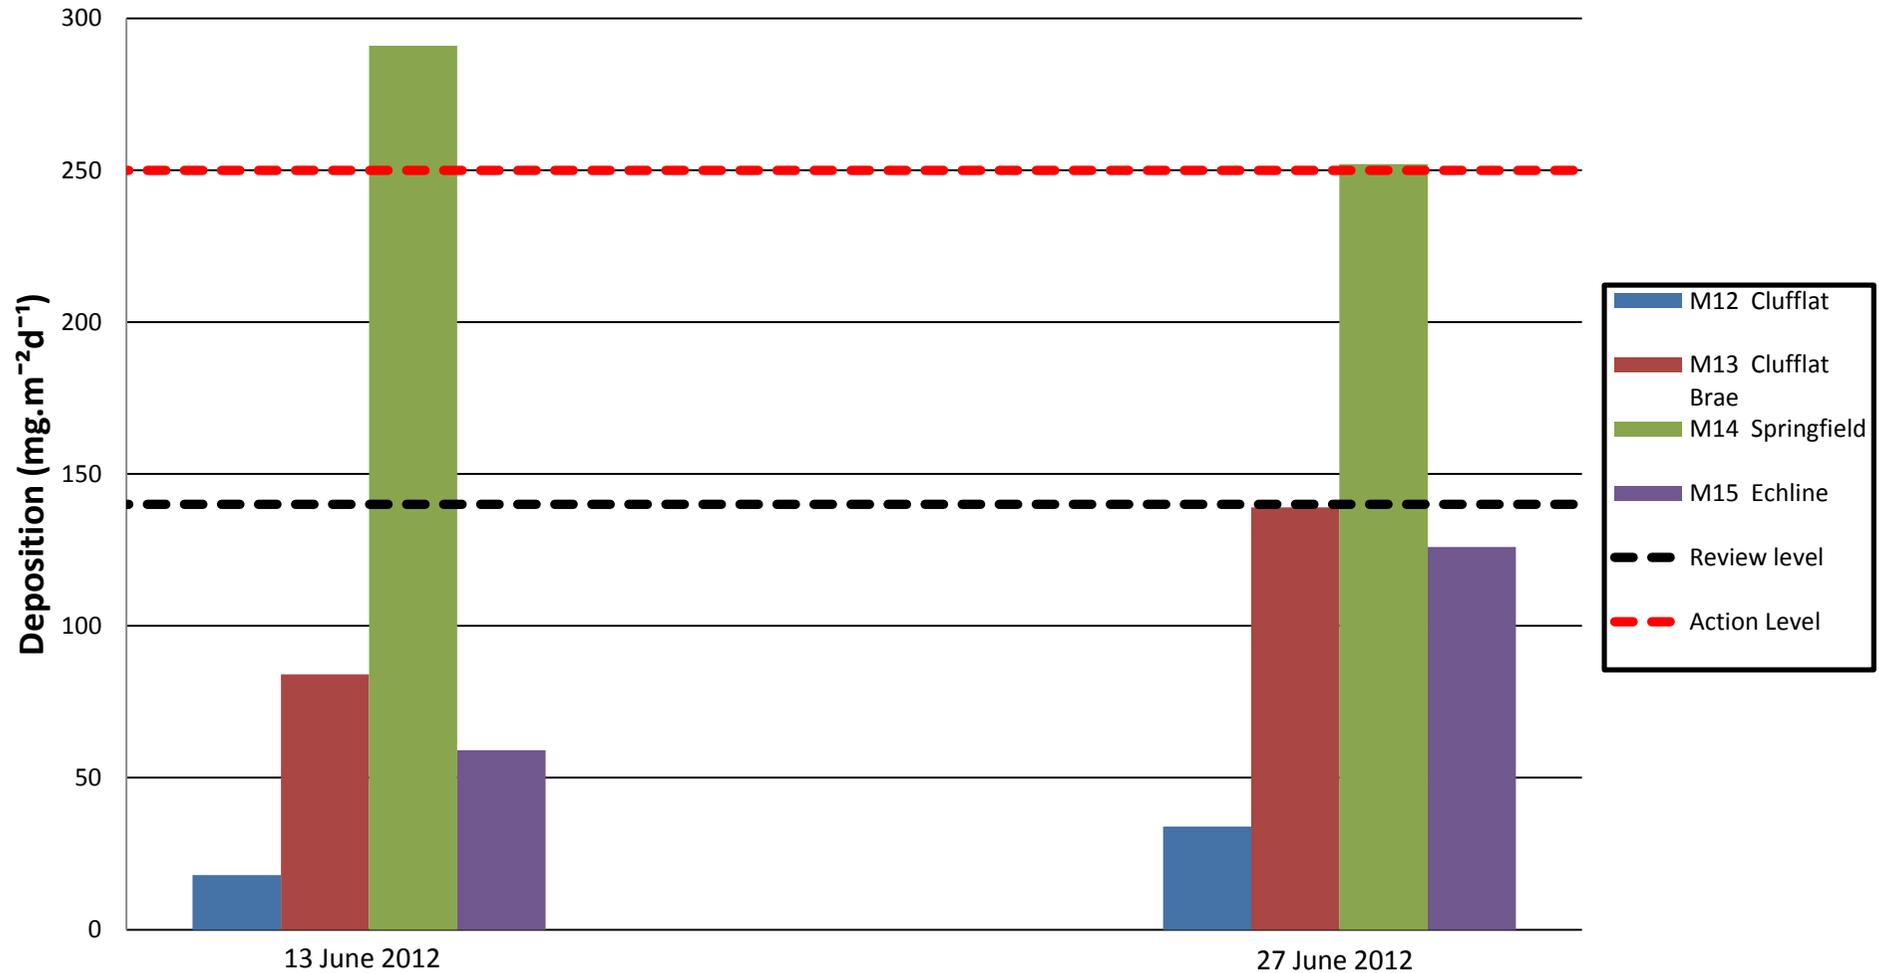
## Frisbee Dust Deposition Results: Group 2

**Note:** Please see paragraphs 3.3.5 and 3.3.6 of the monitoring report for details regarding the exceedances at Springfield.
