Queensferry  
Crossing

Project FORTH REPLACEMENT CROSSING

VIBRATION MONITORING REPORT  
MARCH 2017

Document number	Rev
<b>REP-00318</b>	<b>00</b>

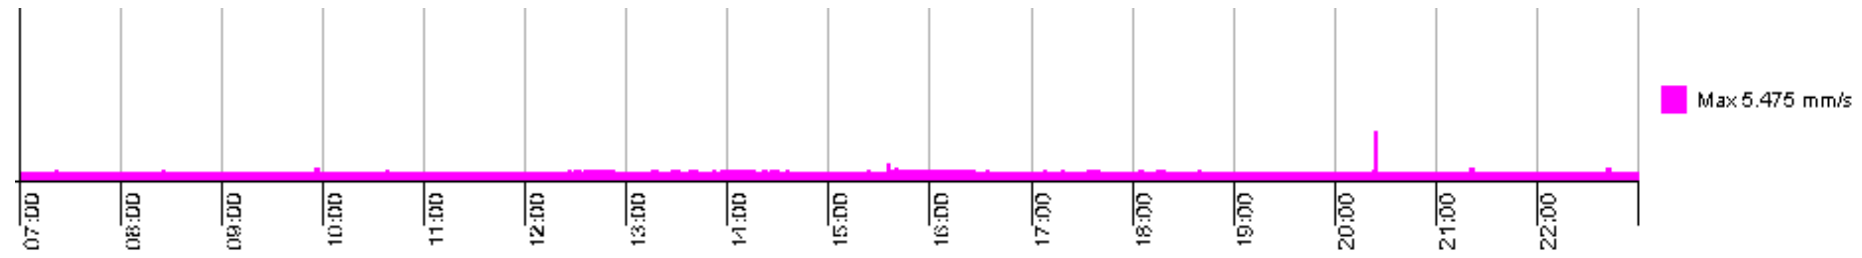
Exceedance on the 20<sup>th</sup> of February has been investigated and found to be caused out with construction working hours therefore it is unlikely that a construction related activity was the cause of this event (graph above from the 20/03/2017).

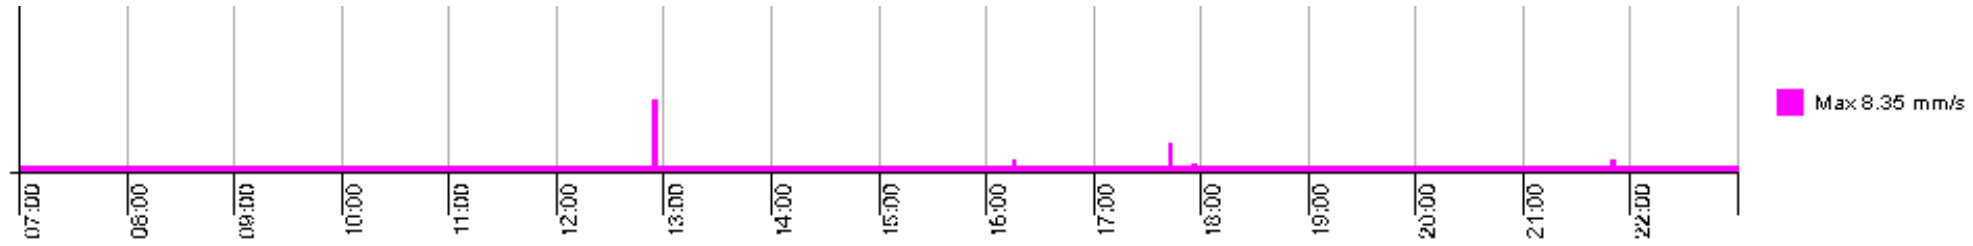
Exceedances on the 4<sup>th</sup>, 8<sup>th</sup>, 10<sup>th</sup>, 11<sup>th</sup>, 12<sup>th</sup>, 13<sup>th</sup>, 14<sup>th</sup>, 15<sup>th</sup>, 21<sup>st</sup>, 24<sup>th</sup>, 26<sup>th</sup>, 28<sup>th</sup>, 30<sup>th</sup> and 31<sup>st</sup> of March have been investigated and found to be caused by individual isolated events that are unlikely to have been construction related activities (graph above from the 24/03/2017). With this monitor being located in a public amenity area there is a likelihood that the exceedances seen above might have been caused by pedestrians using the area.

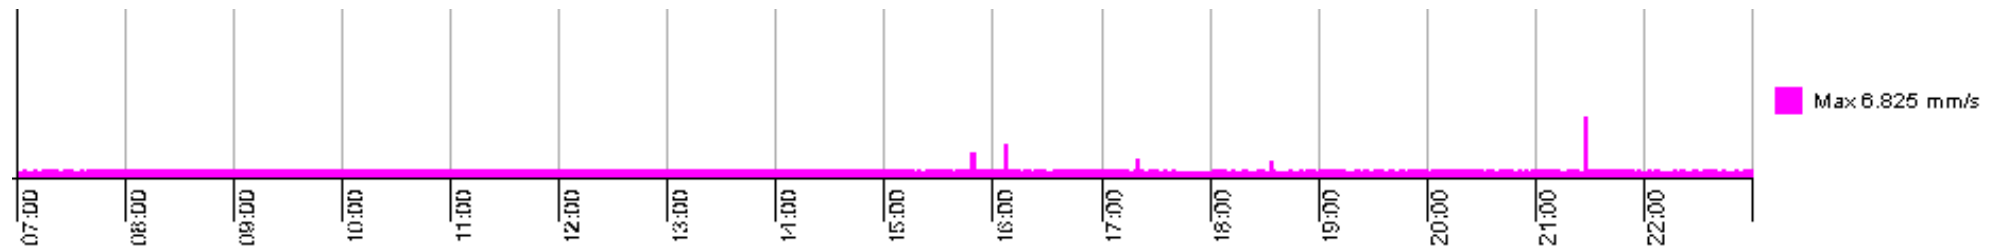
Exceedances on the 23<sup>rd</sup> and 25<sup>th</sup> of March have been investigated and found to be caused out with construction working hours and therefore it is unlikely that a construction related activity was the cause of these events (graph above from the 23/03/2017).

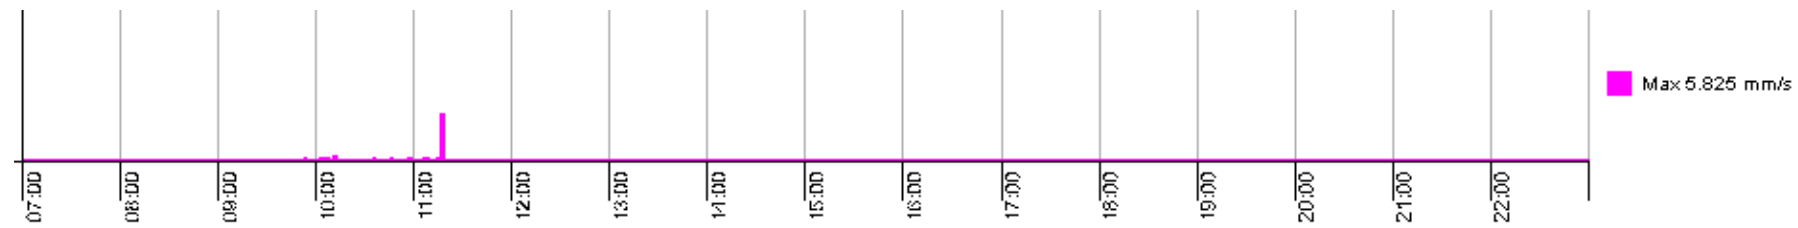
Exceedance on the 6<sup>th</sup> of March has been investigated and found to be caused by an individual isolated event that is unlikely to have been a construction related activity (graph above from the 06/03/2017). The vibration monitor is located in the residents back garden, therefore resident's activity may have caused this exceedance.

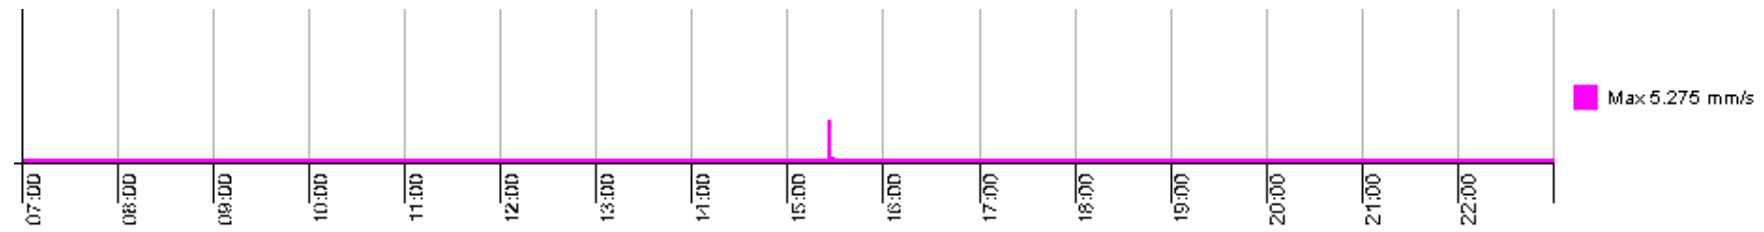
Exceedance on the 8<sup>th</sup> of March has been investigated and found to be caused by the environmental department collecting air quality data (graph above from the 08/03/2017).

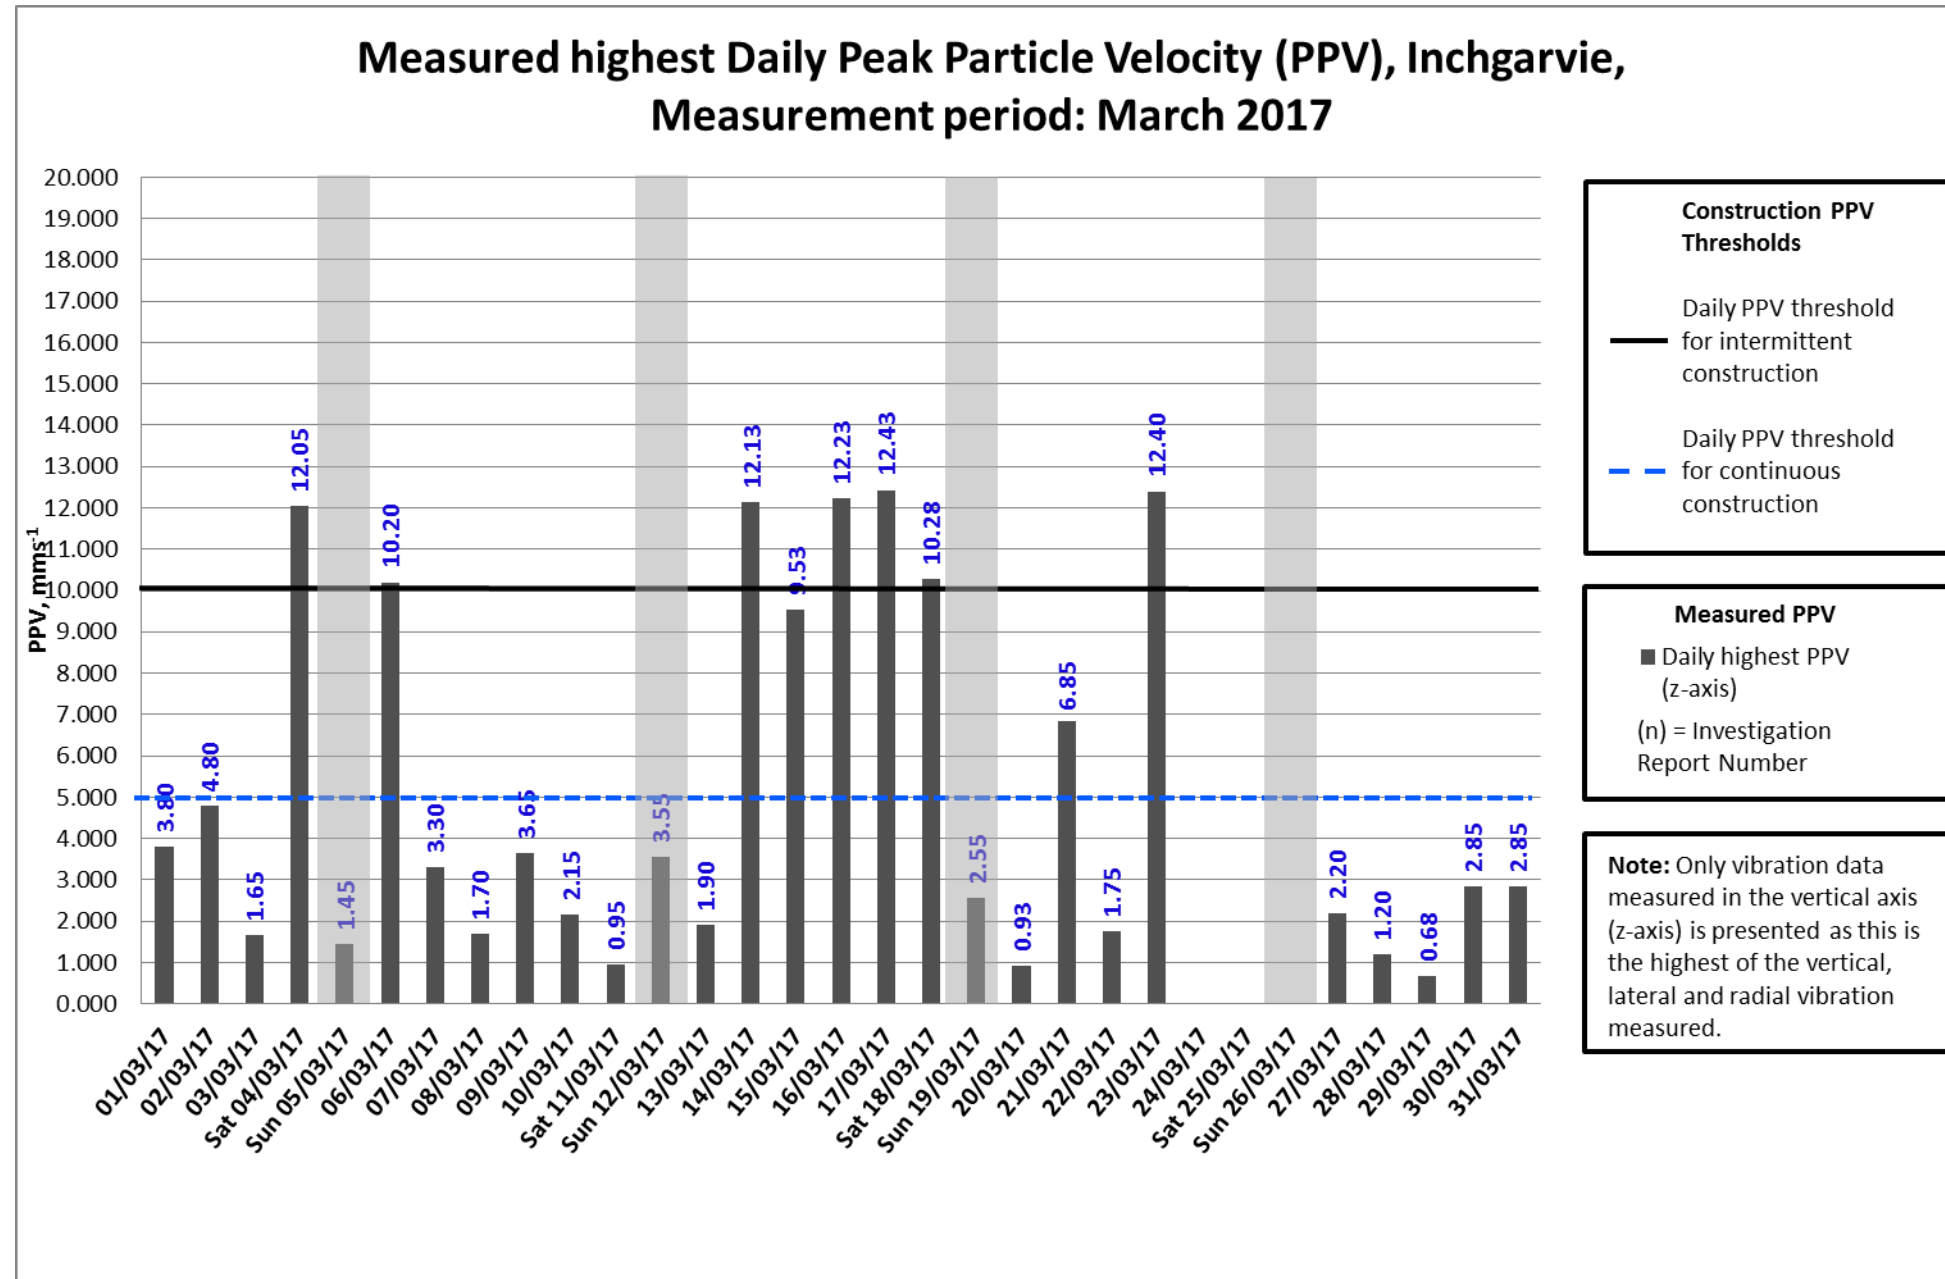
Data missing on the 24<sup>th</sup> – 26<sup>th</sup> March was caused by electrical issue with monitor.

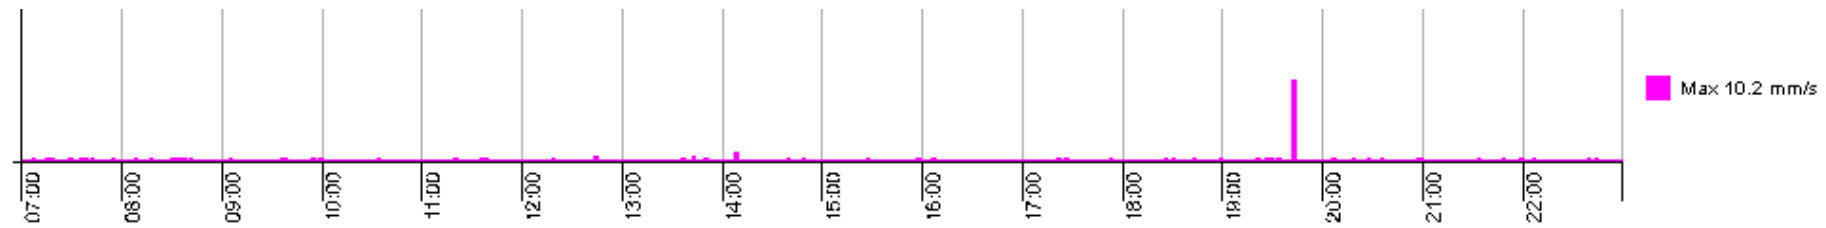
Exceedances on the 4<sup>th</sup>, 6<sup>th</sup>, 14<sup>th</sup>, 15<sup>th</sup>, 16<sup>th</sup>, 17<sup>th</sup> and 23<sup>rd</sup> of March have been investigated and found to be caused by individual isolated events that are unlikely to have been construction related activities (graph above from the 06/03/2017). The vibration monitor is located in the residents back garden, therefore resident's activity may have caused these exceedances.

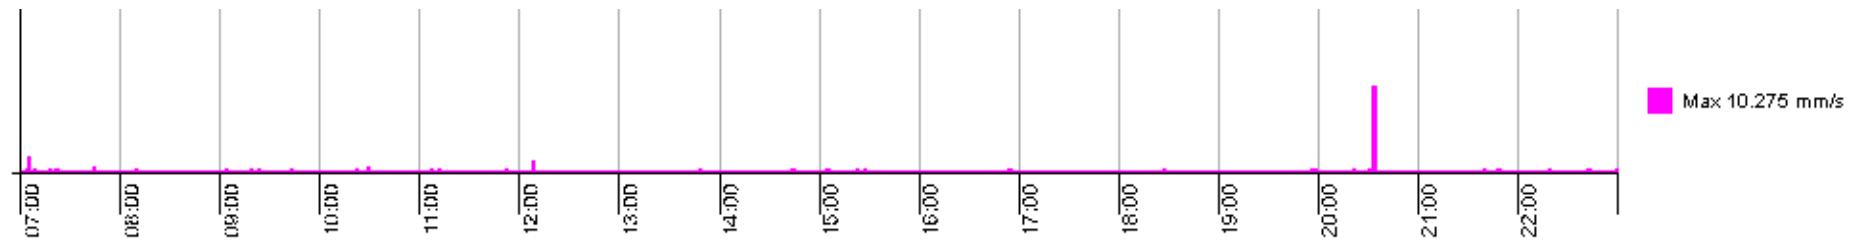
Exceedances on the 18<sup>th</sup> and 21<sup>st</sup> of March have been investigated and found to be caused out with construction working hours and therefore it is unlikely that a construction related activity was the cause of these events (graph above from the 18/03/2017).

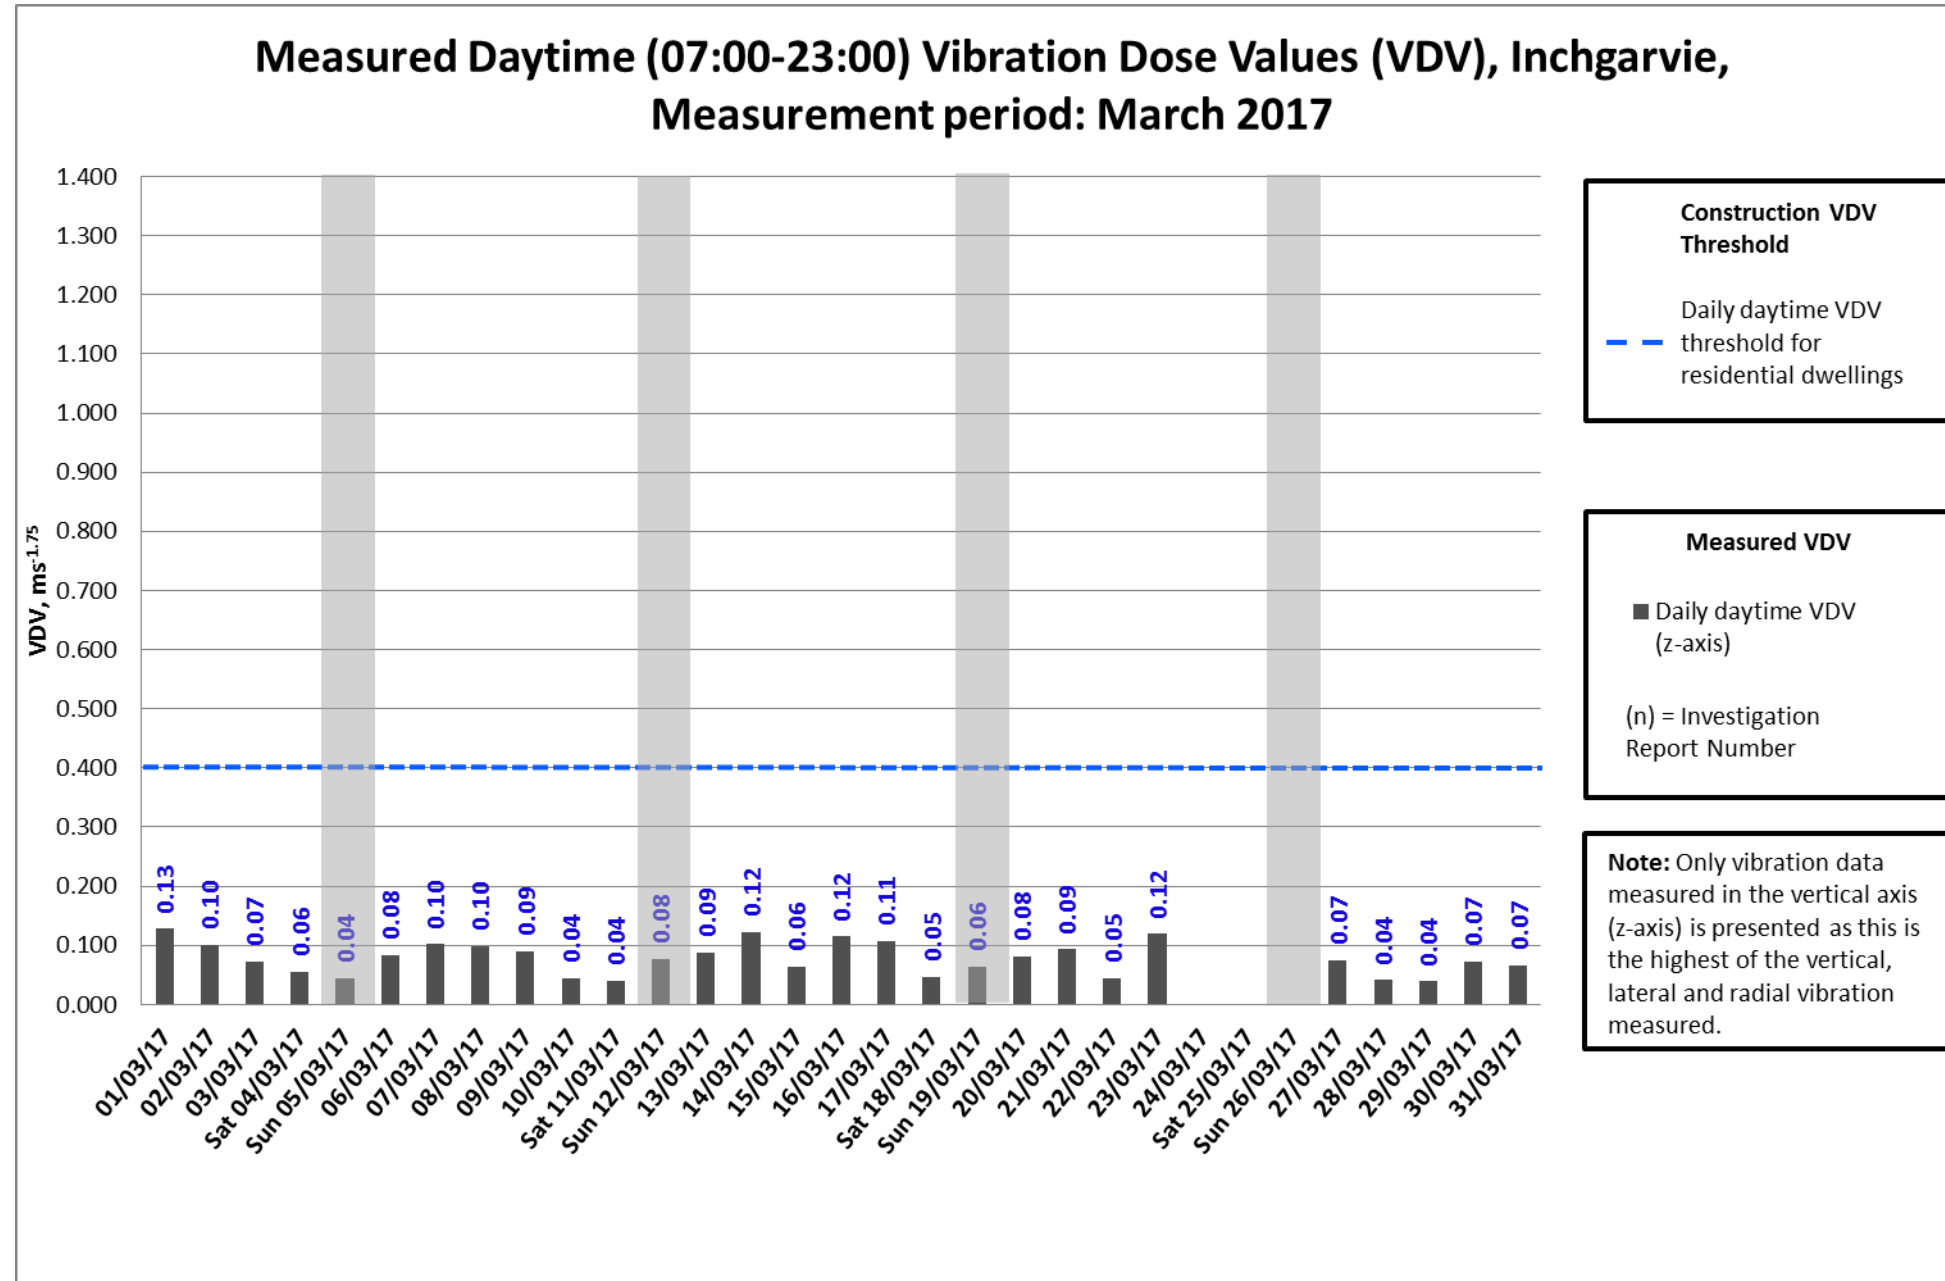
Data missing on the 24<sup>th</sup> – 26<sup>th</sup> March was caused by electrical issue with monitor.

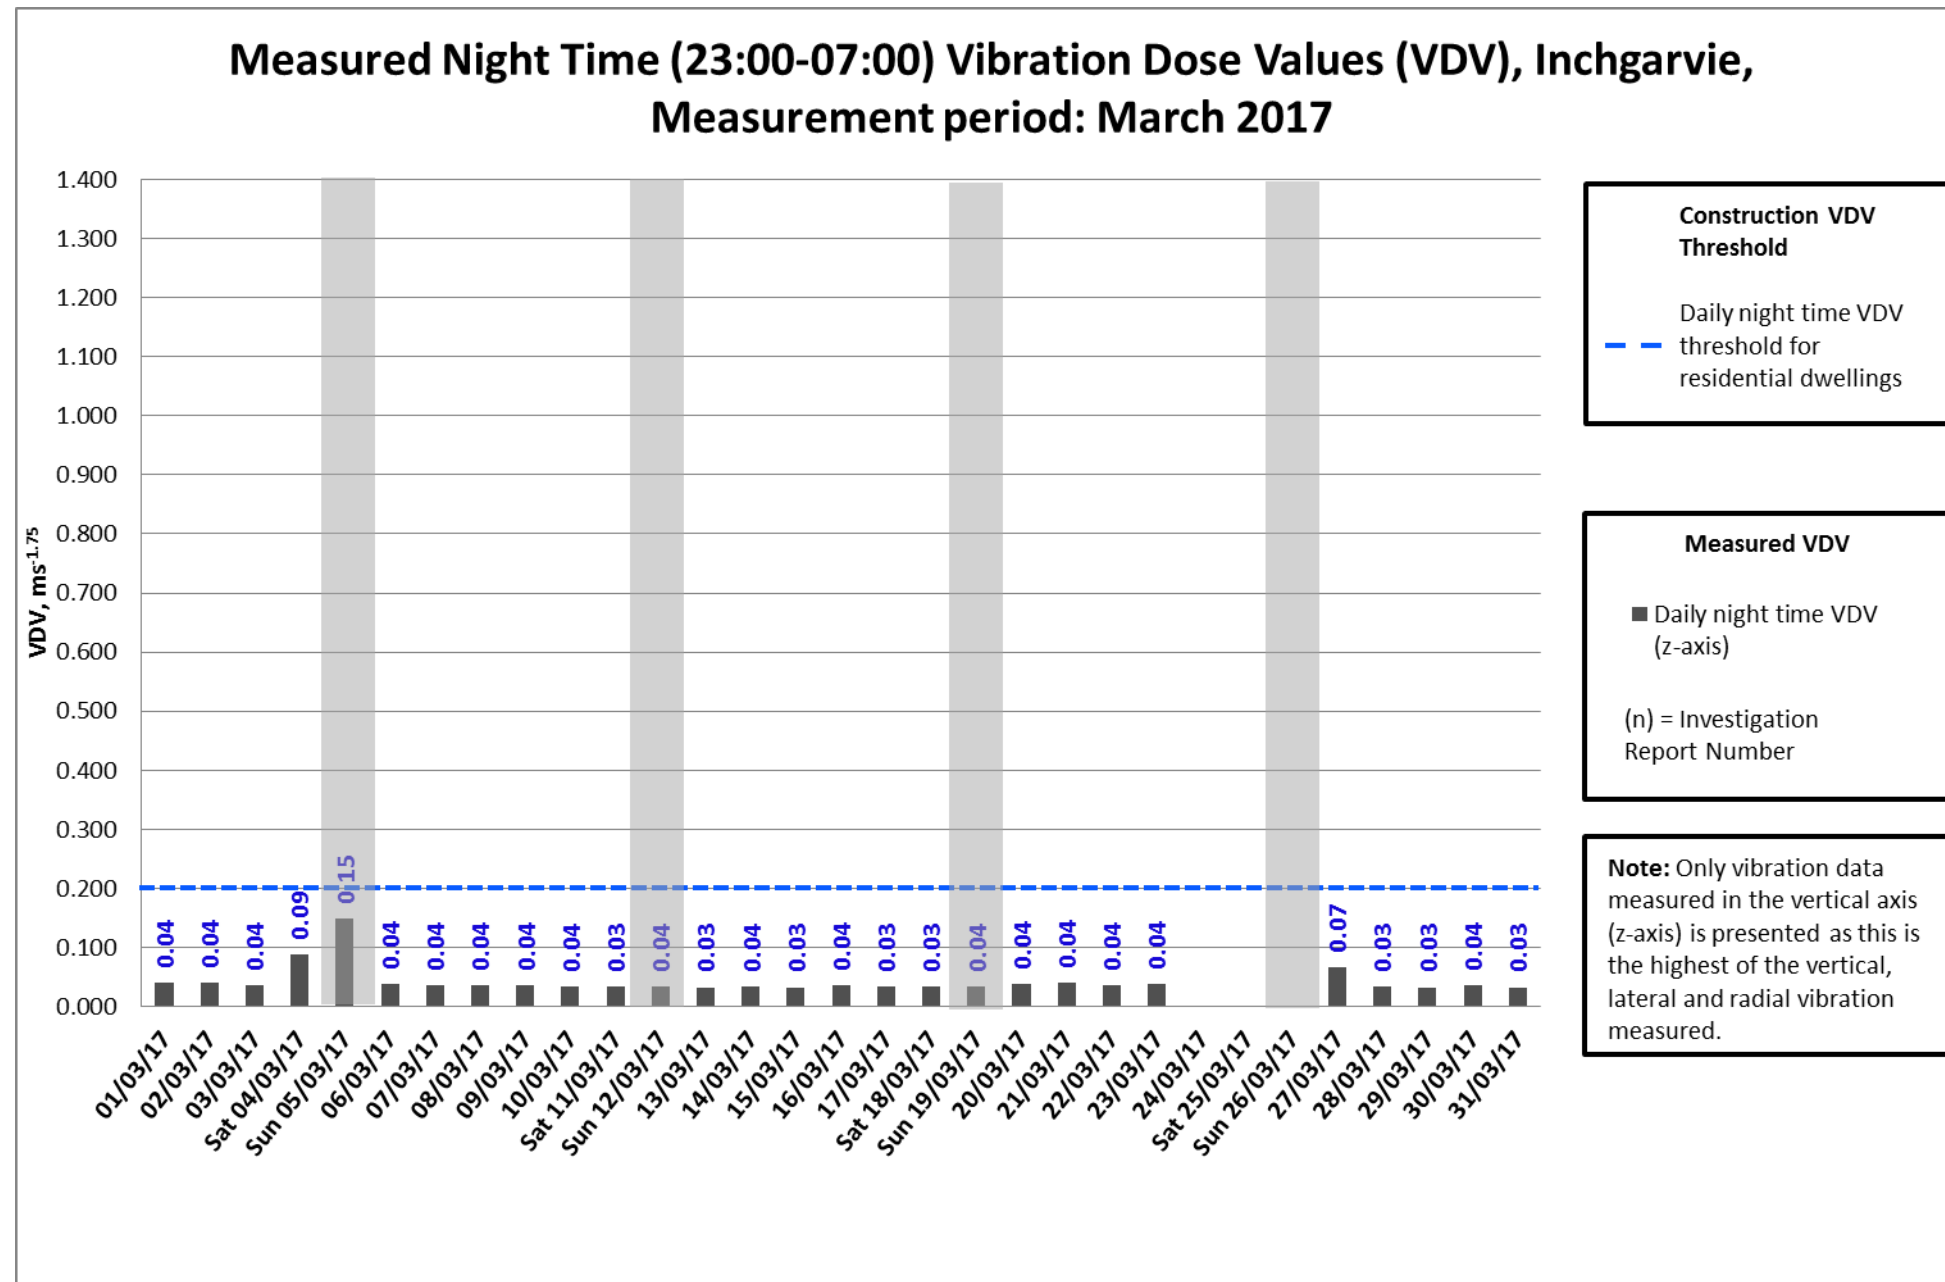
Data missing on the 24<sup>th</sup> – 26<sup>th</sup> March was caused by electrical issue with monitor.

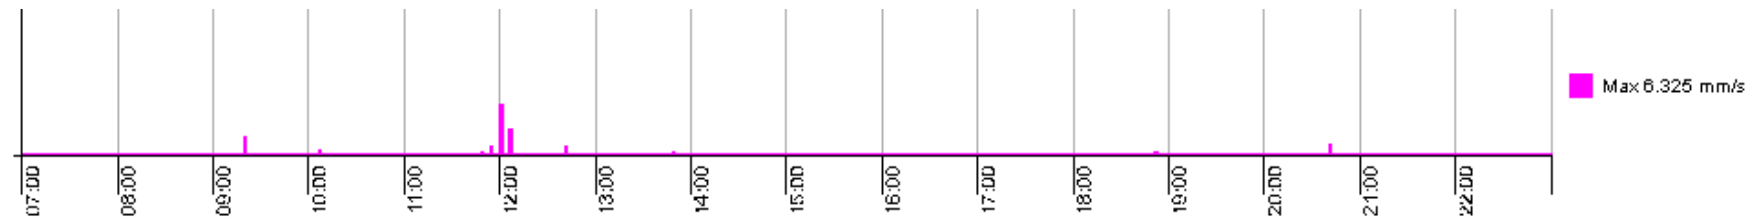
Exceedances on the 13<sup>th</sup>, 14<sup>th</sup> and 30<sup>th</sup> of March have been investigated and found to be caused by individual isolated events that are unlikely to have been construction related activities (graph above from the 30/03/2017). The monitor is situated in close proximity to the residents outdoor log store situated in the back garden. It is possible that these high readings were due to the residents fetching logs from this store area.

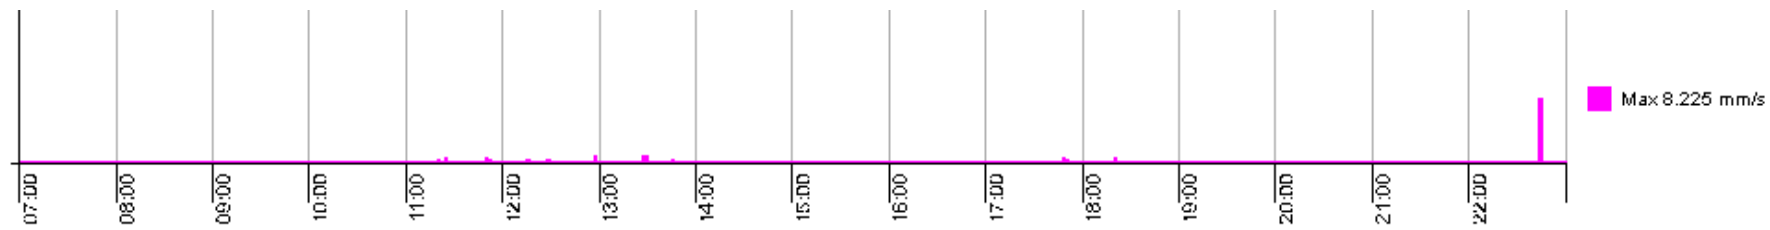
Exceedance on the 3<sup>rd</sup> of March has been investigated and found to be caused out with construction working hours and therefore it is unlikely that a construction related activity was the cause of this event (graph above from the 03/03/2017).

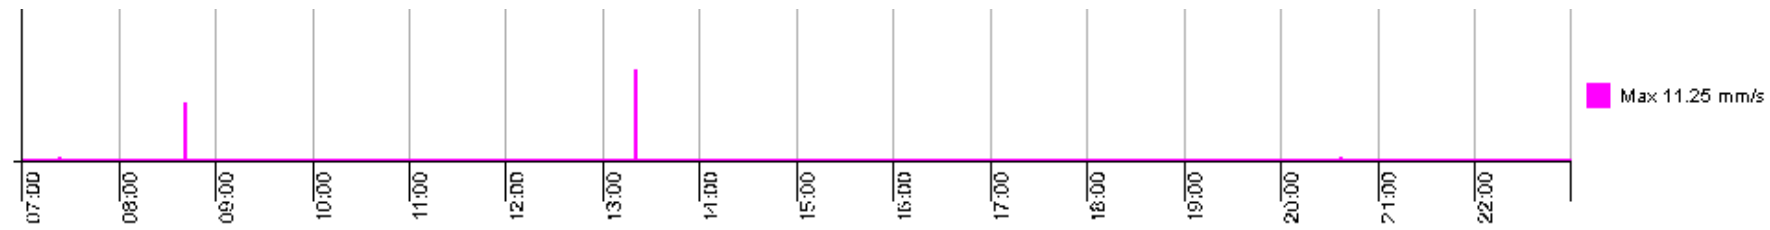
Exceedances throughout March have been investigated and found to be caused by individual isolated events that are unlikely to have been construction related activities (graph above from the 23/03/2017). The vibration monitor is located in the residents back garden, therefore resident's activity may have caused these exceedances.

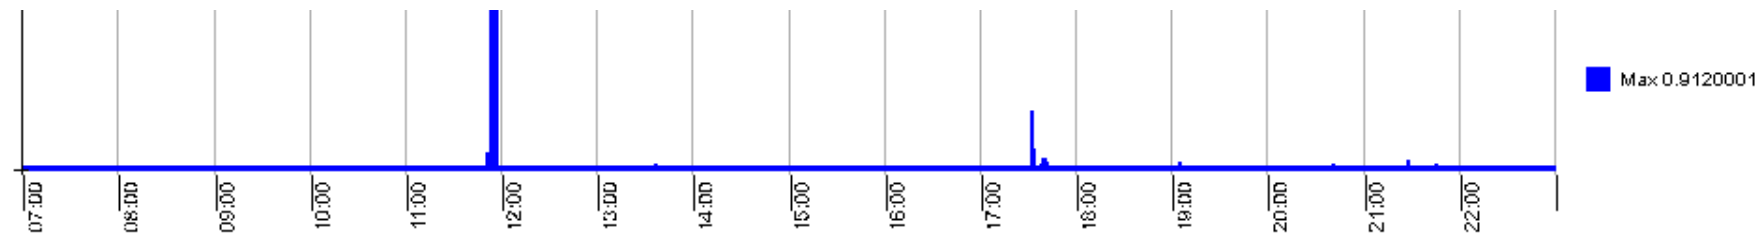
Exceedance on the 13<sup>th</sup> of March has been investigated and found to be caused by the environmental department carrying out maintenance on noise monitor (graph above from the 13/03/2017).

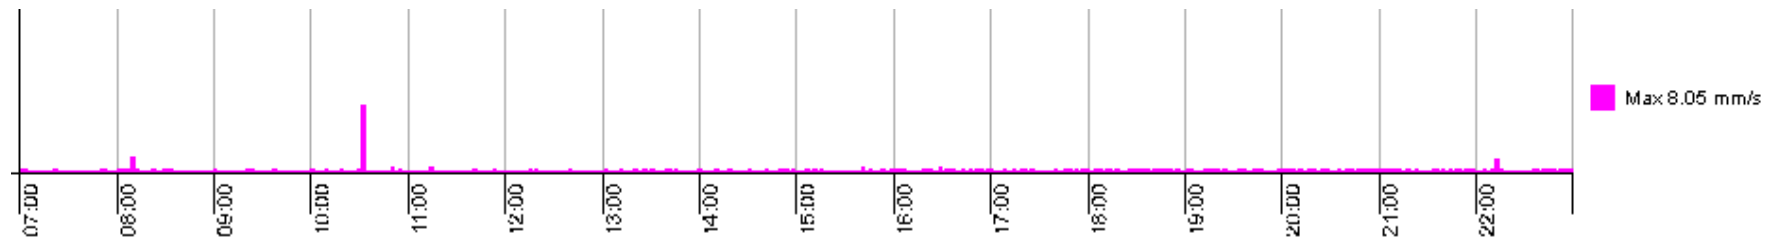
Exceedances throughout March have been investigated and found to be caused by individual isolated events that are unlikely to have been construction related activities (graph above from the 16/03/2017).

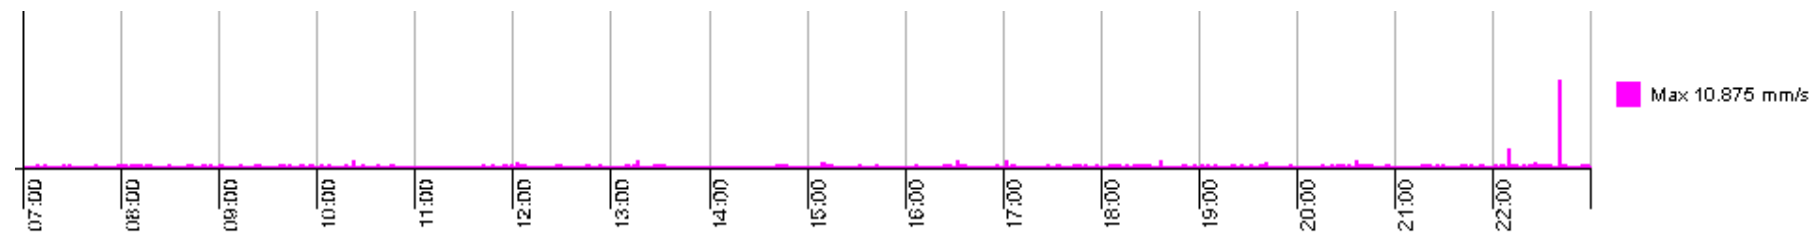
Exceedances on the 19<sup>th</sup> and 20<sup>th</sup> of March have been investigated and found to be caused out with construction working hours and therefore it is unlikely that a construction related activity was the cause of the events (graph above from the 19/03/2017).
