Project **FORTH REPLACEMENT CROSSING**

VIBRATION MONITORING REPORT
APRIL 2017

Made by: David Clark	Checked By: Steven Westwater
Initials: DCK	Initials: SWR
Document number REP-00321	Rev 00

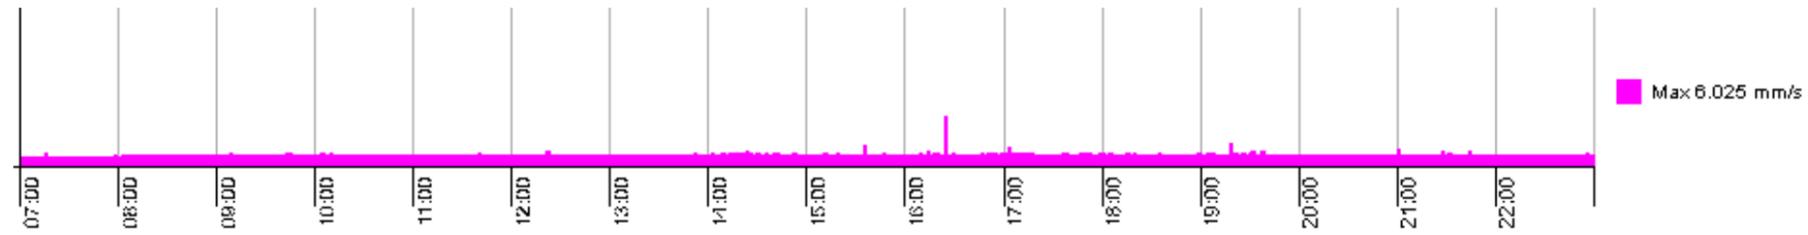
Exceedances on the 12th, 15th, 16th and 20th of April have been investigated and found to be caused by individual isolated events that are unlikely to have been construction related activities (graph above from the 20/04/2017). The vibration monitor is located in the residents back garden; therefore resident's activity may have caused these exceedances.

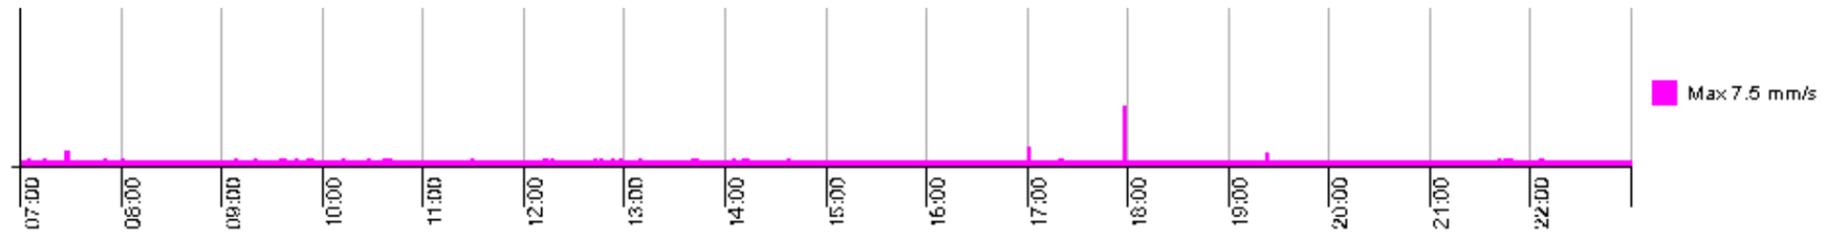
Exceedances on the 1st, 2nd, 5th, 6th, 8th, 9th, 10th, 12th, 13th, 16th, 17th, 21st, 22nd, 28th and 29th of April have been investigated and found to be caused by individual isolated events that are unlikely to have been construction related activities (graph above from the 28/04/2017). With this monitor being located in a public amenity area there is a likelihood that the exceedances seen above might have been caused by pedestrians using the area.

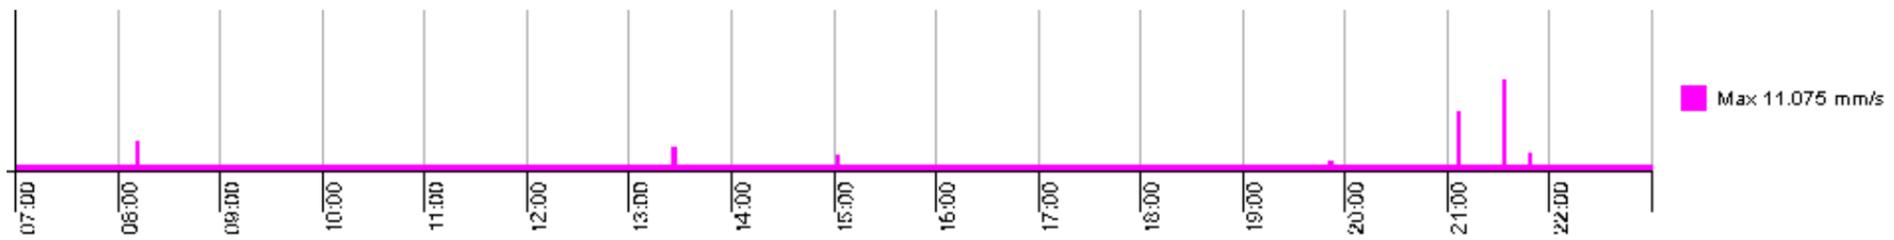
Exceedances on the 4th, 11th and 18th of April have been investigated and found to be caused out with construction working hours therefore it is unlikely that a construction related activity was the cause of these events (graph above from the 11/04/2017).

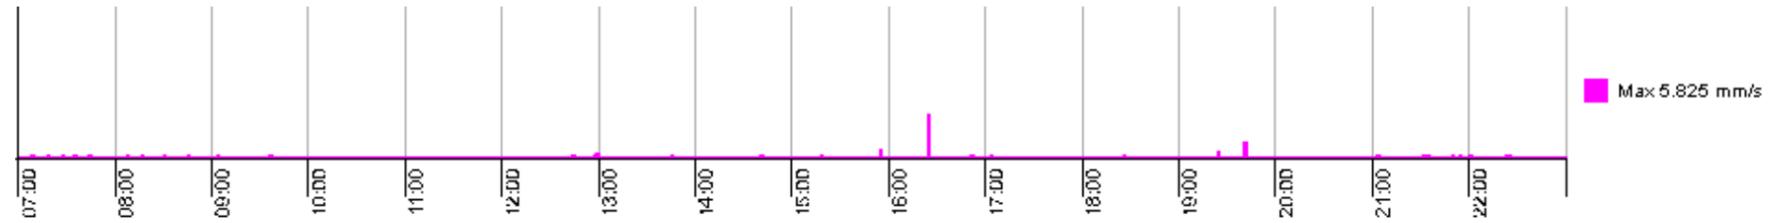
Exceedances on the 1st, 10th, 18th and 19th of April have been investigated and found to be caused by individual isolated events that are unlikely to have been construction related activities (graph above from the 10/04/2017). The vibration monitor is located in the residents back garden, therefore resident's activity may have caused these exceedances.

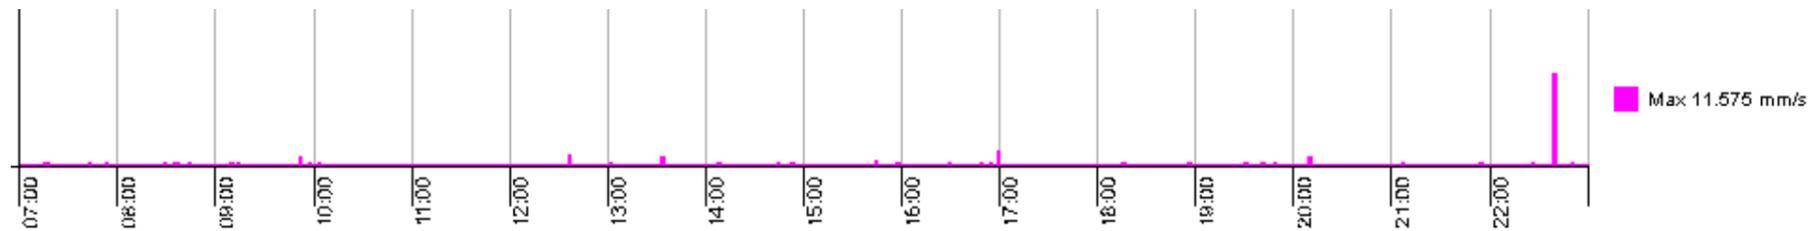
Exceedances on the 11th and 26th of April have been investigated and found to be caused out with construction working hours and therefore it is unlikely that a construction related activity was the cause of these events (graph above from the 11/042017).

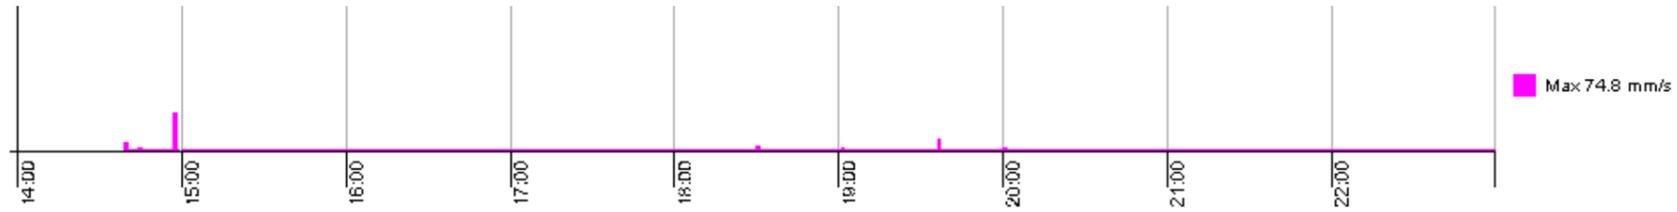
Exceedance on the 6th of April was investigated and found to be caused by the environmental department inspecting the vibration monitor (graph above from the 06/04/2017).

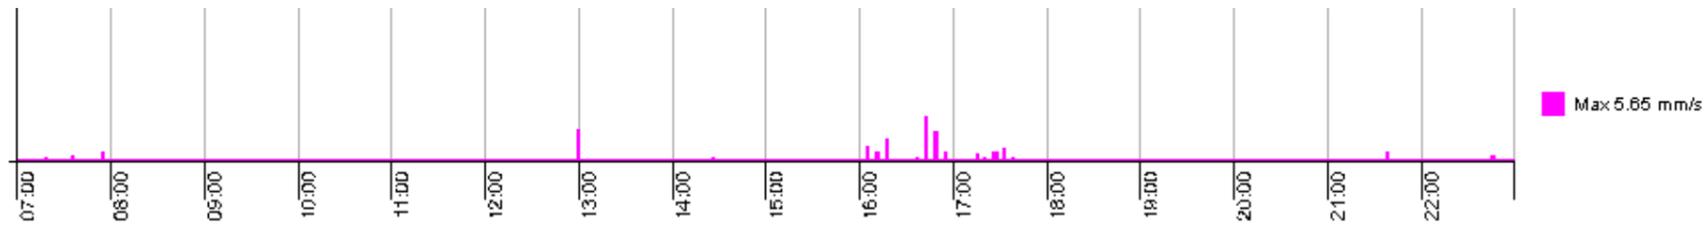
Exceedances on the 5th and 26th of April have been investigated and found to be caused by individual isolated events that are unlikely to have been construction related activities (graph above from the 05/04/2017). The vibration monitor is located in the residents back garden, therefore resident's activity may have caused these exceedances.

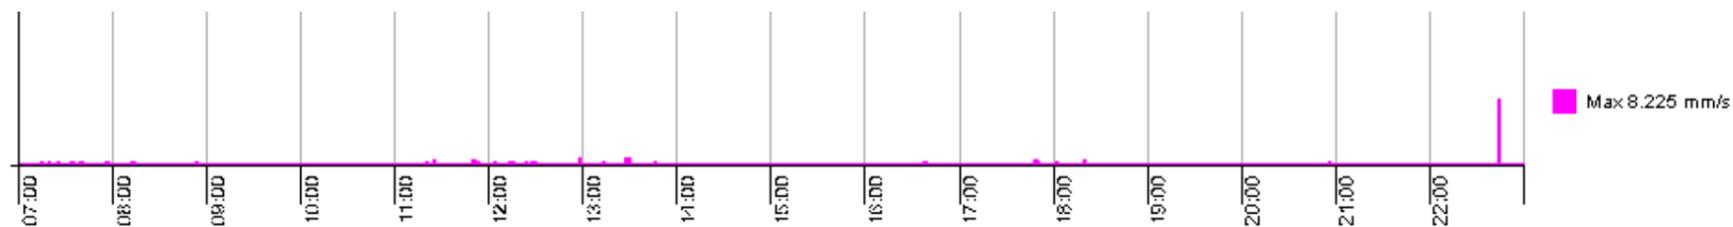
Exceedance on the 3rd of April has been investigated and found to be caused out with construction working hours and therefore it is unlikely that a construction related activity was the cause of this event (graph above from the 03/04/2017).

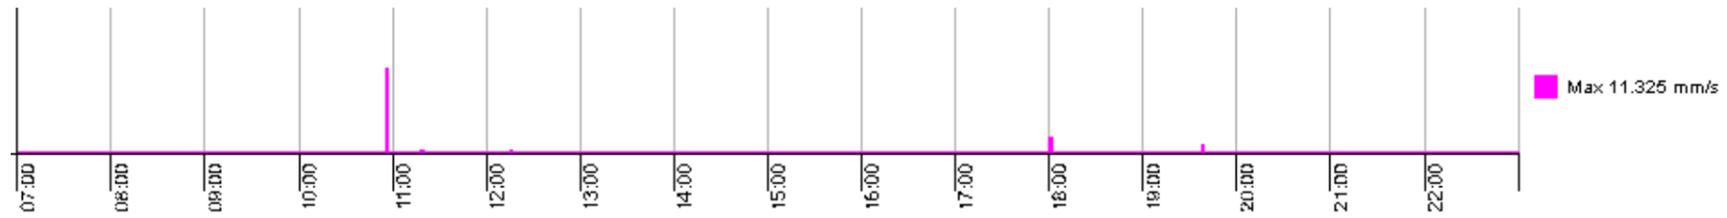
Exceedances throughout April have been investigated and found to be caused by individual isolated events that are unlikely to have been construction related activities (graph above from the 12/04/2017). The vibration monitor is located in the residents back garden, therefore resident's activity may have caused these exceedances.

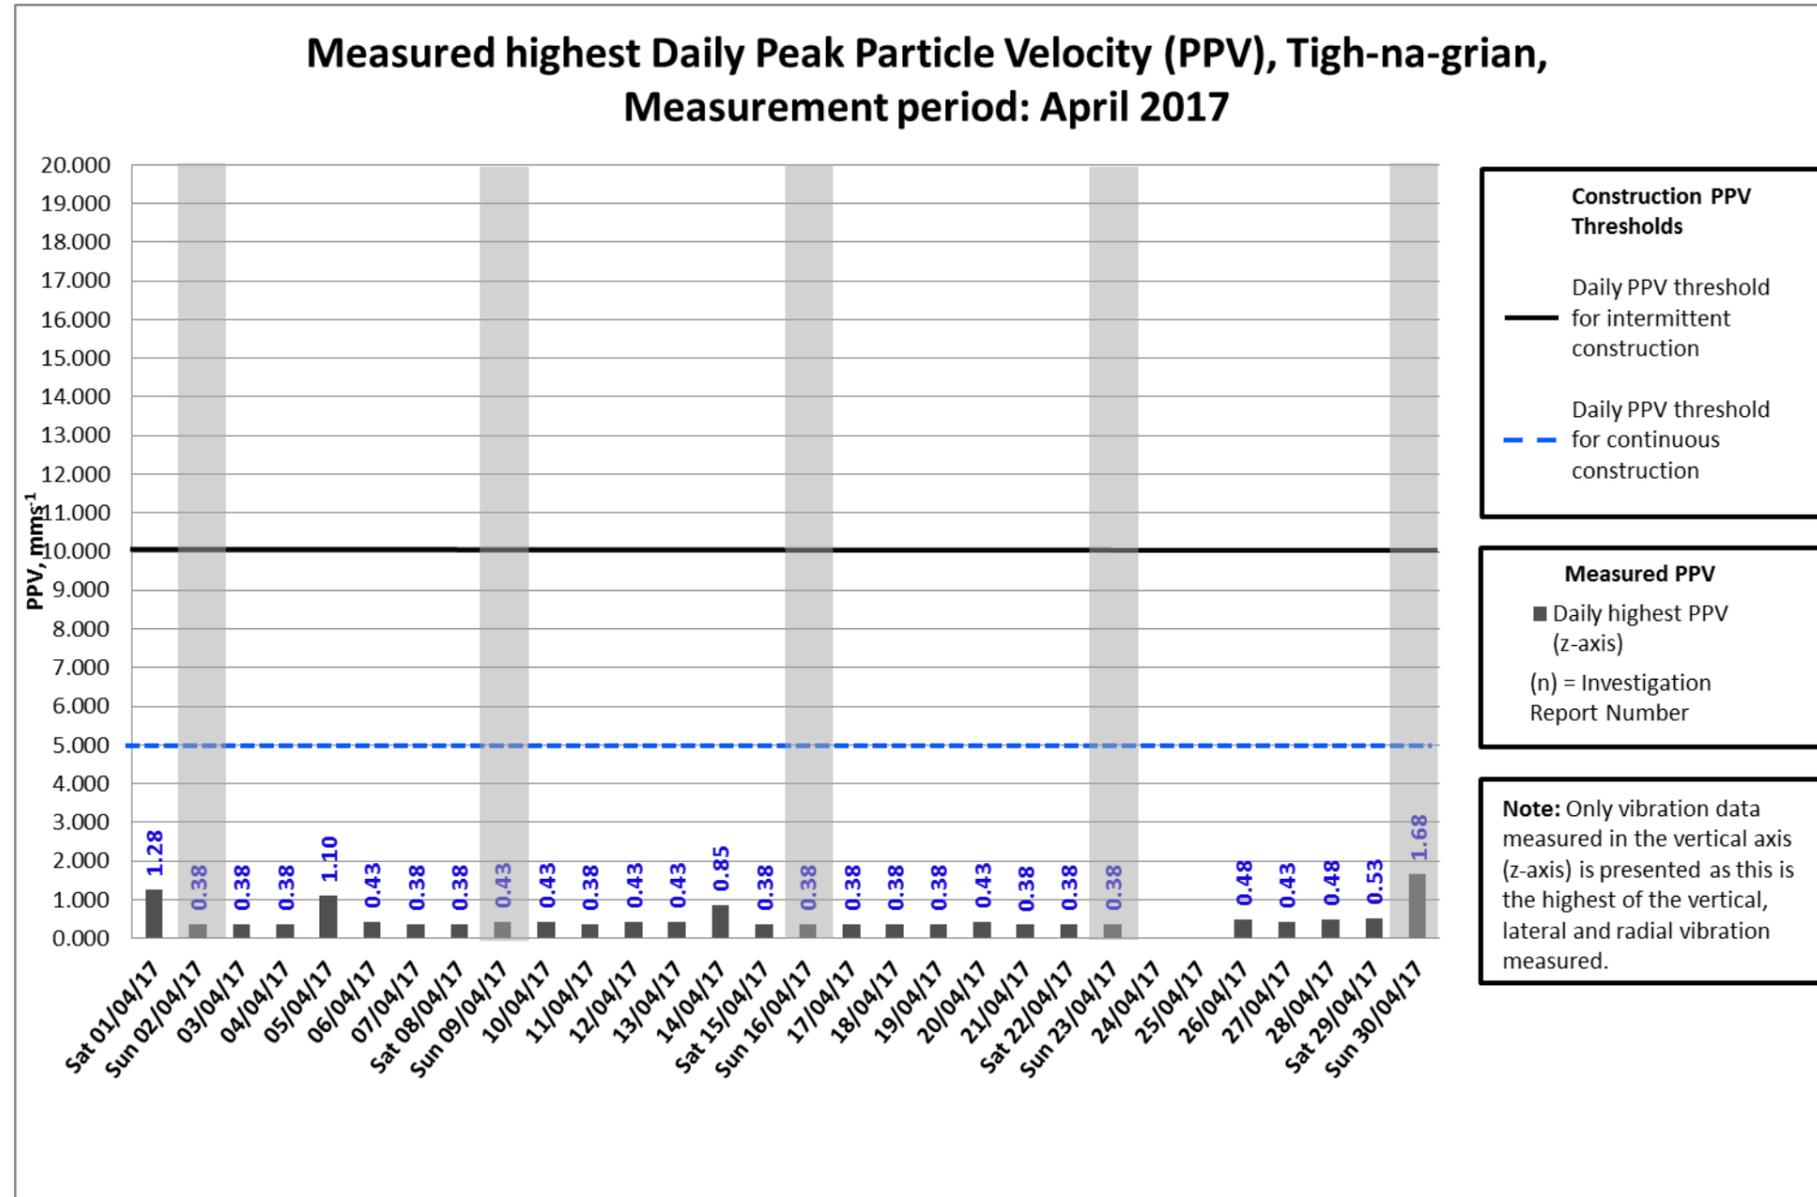
Data missing on the 24th – 25th was caused by electrical issue with monitor.

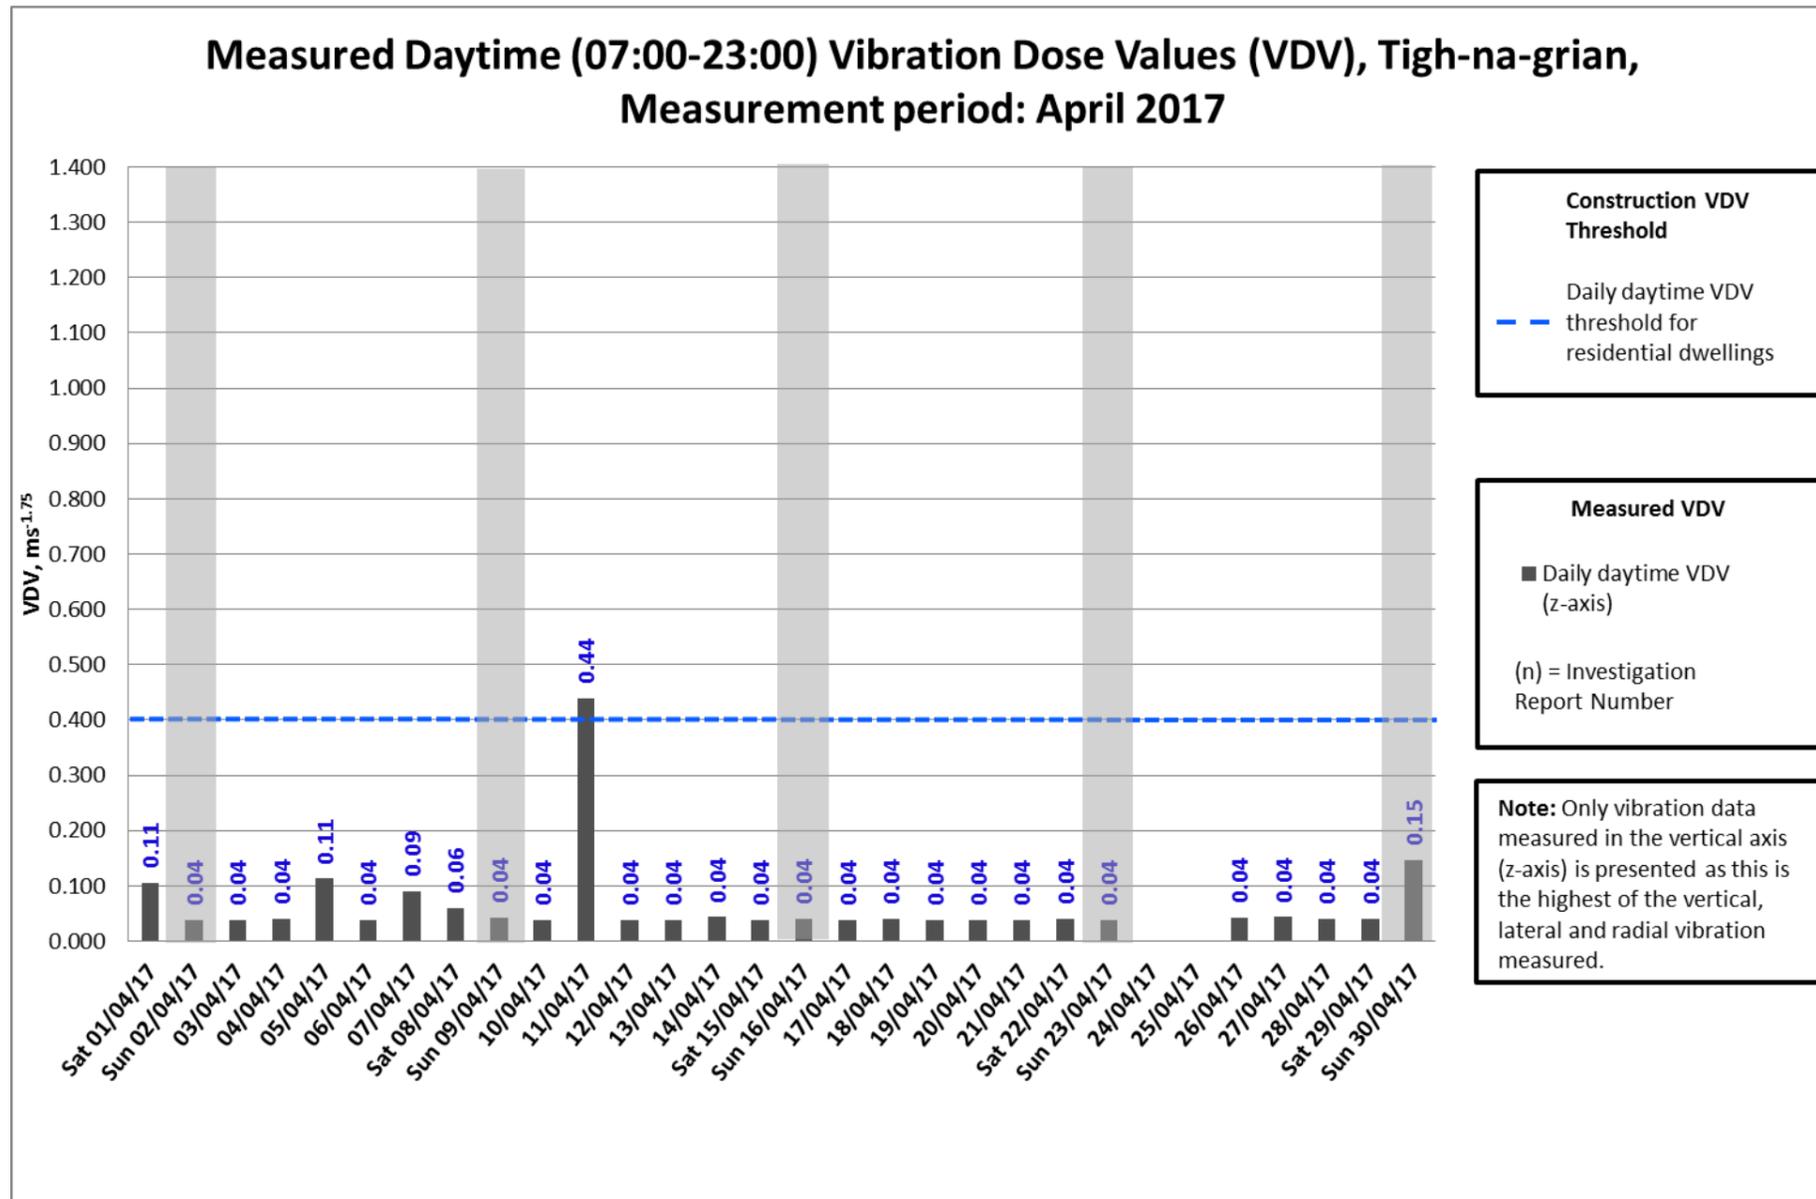
Data missing on the 24th – 25th was caused by electrical issue with monitor.

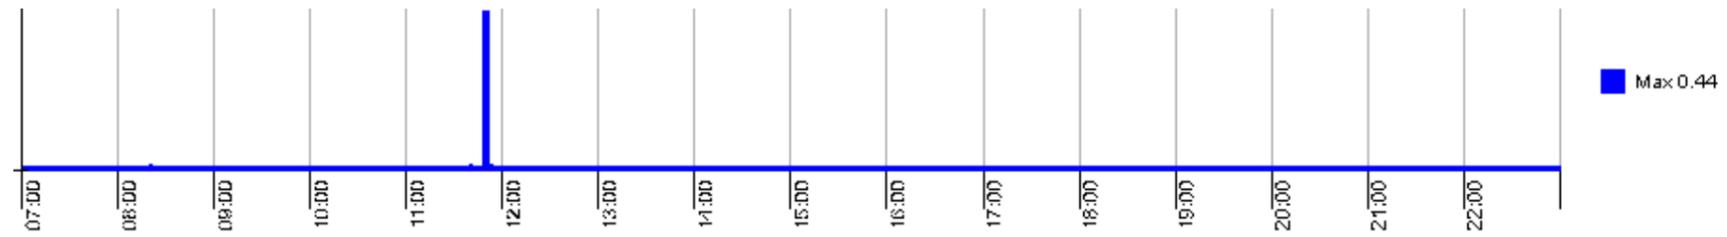
Exceedance on the 11th of April has been investigated and found to be caused by an individual isolated event that is unlikely to have been a construction related activity (graph above from the 11/04/2017). The vibration monitor is located in the residents back garden, therefore resident's activity may have caused this exceedance.

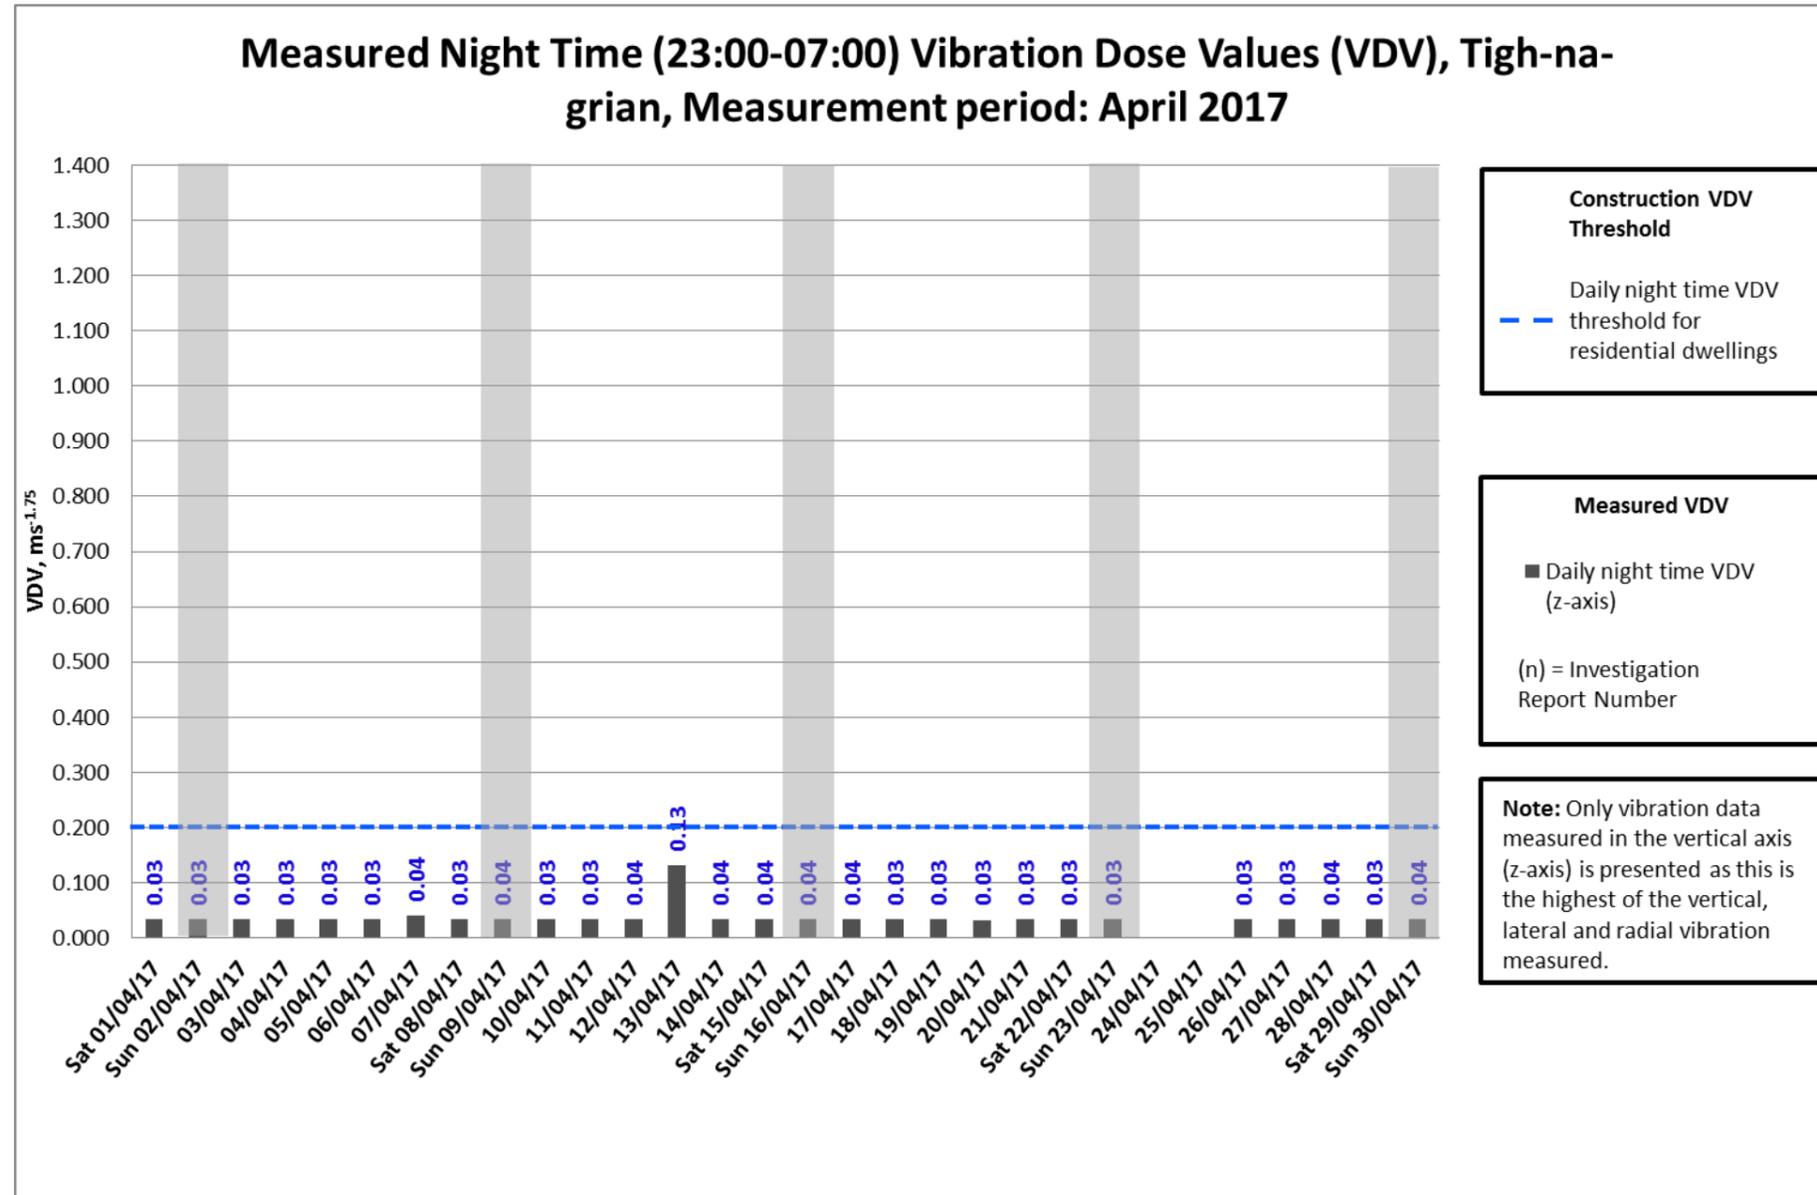
Data missing on the 24th – 25th was caused by electrical issue with monitor.

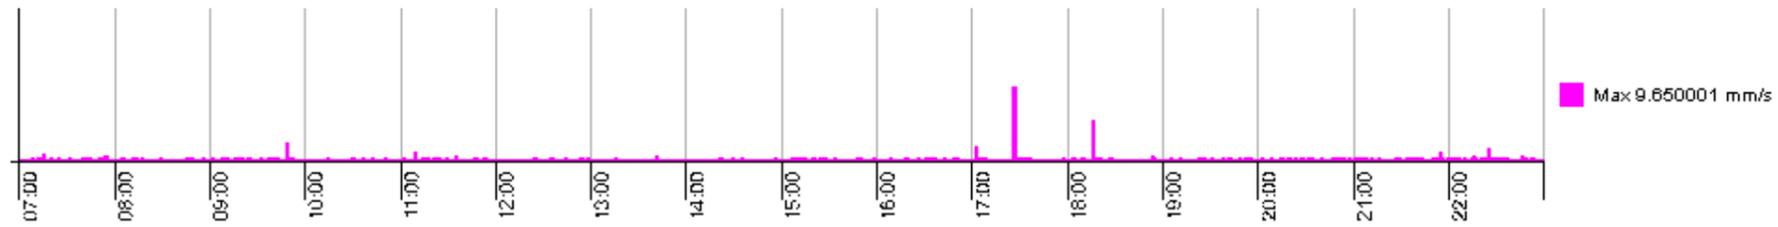
Exceedances throughout April have been investigated and found to be caused by individual isolated events that are unlikely to have been construction related activities (graph above from the 14/04/2017).

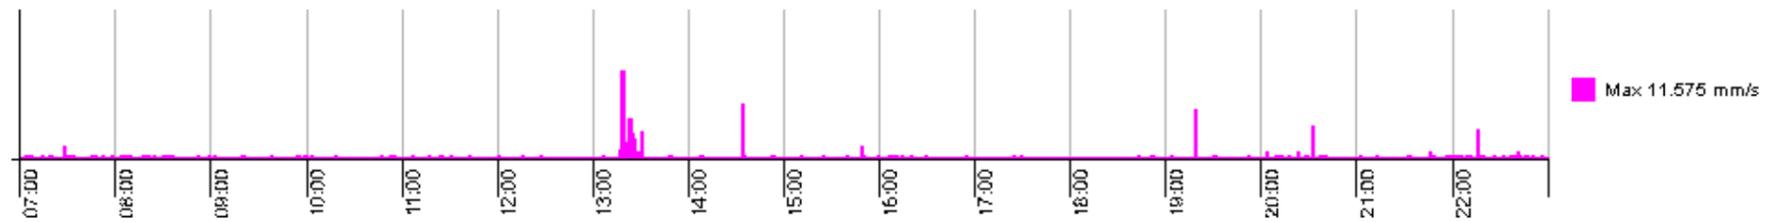
Exceedance on the 5th of April has been investigated and found to be caused by the environmental department collecting air quality data and carrying out maintenance on noise monitor (graph above from the 05/04/2017).
