FCBC
Queensferry
Crossing

Project **FORTH REPLACEMENT CROSSING**

VIBRATION MONITORING REPORT
MAY 2017

Made by: David Clark	Checked By: Steven Westwater
Initials: DCK	Initials: SWR
Document number REP-00325	Rev 00

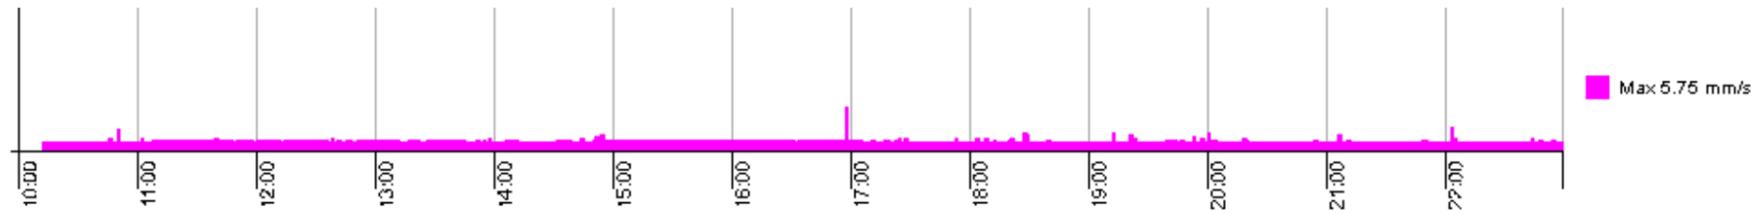
Exceedances on the 1st, 2nd, 14th and 26th of May have been investigated and found to be caused by individual isolated events that are unlikely to have been construction related activities (graph above from the 01/05/2017). The vibration monitor is located in the residents back garden, therefore resident's activity may have caused these exceedances.

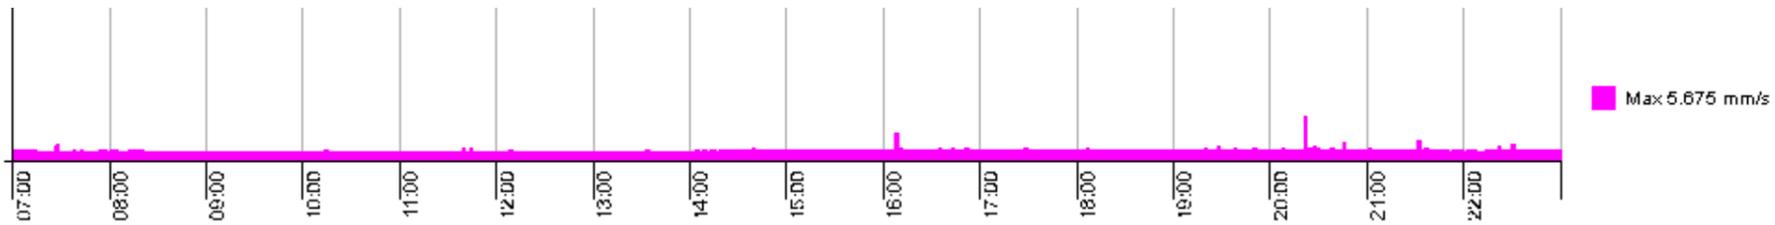
Exceedances on the 7th and 15th of May have been investigated and found to be caused out with construction working hours therefore it is unlikely that a construction related activity was the cause of these events (graph above from the 15/05/2017).

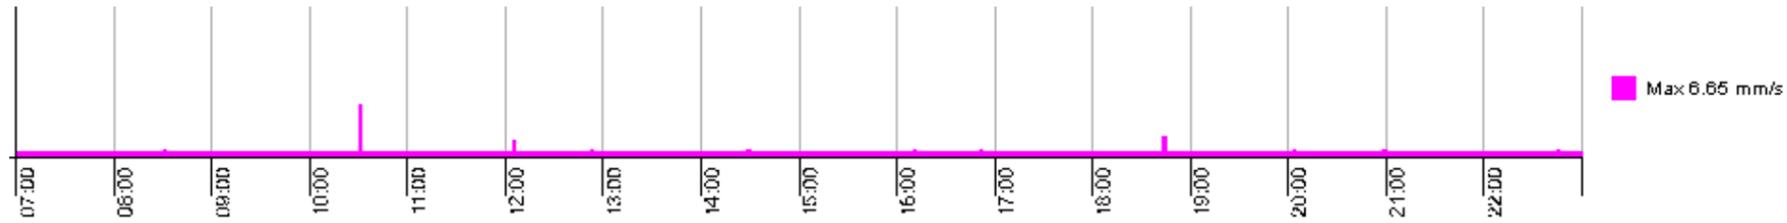
Exceedances on the 6th, 10th, 17th, 22nd, 24th, 25th, 27th and 29th May have been investigated and found to be caused by individual isolated events that are unlikely to have been construction related activities (graph above from the 10/05/2017). With this monitor being located in a public amenity area there is a likelihood that the exceedances seen above might have been caused by pedestrians using the area.

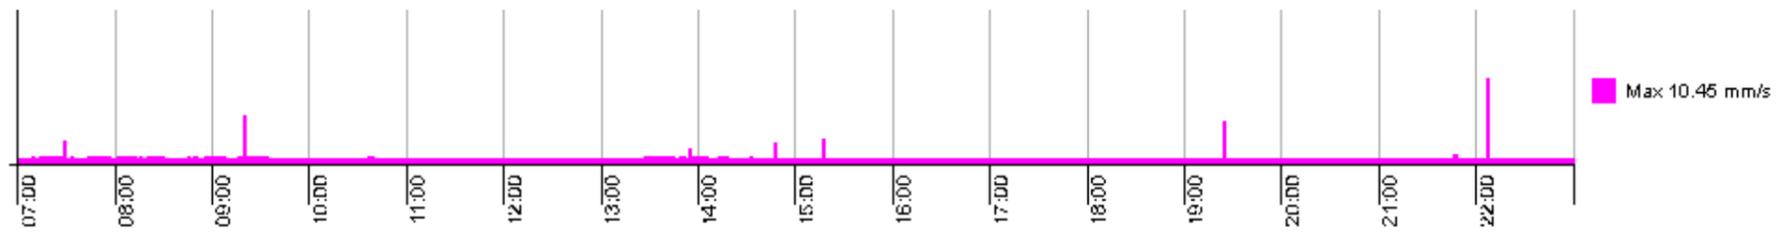
Exceedance on the 20th of May has been investigated and found to be caused out with construction working hours therefore it is unlikely that a construction related activity was the cause of this event (graph above from the 20/05/2017).

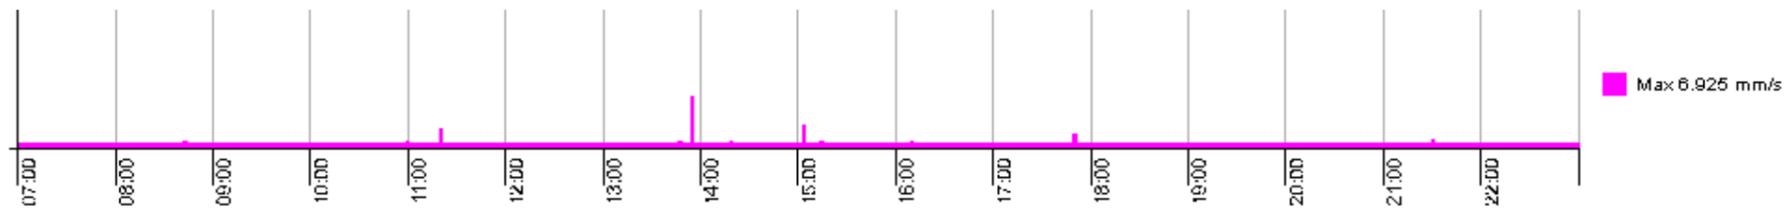
Exceedance on the 3rd of May has been investigated and found to be caused by the environmental department collecting air quality data (graph above from the 03/05/2017).

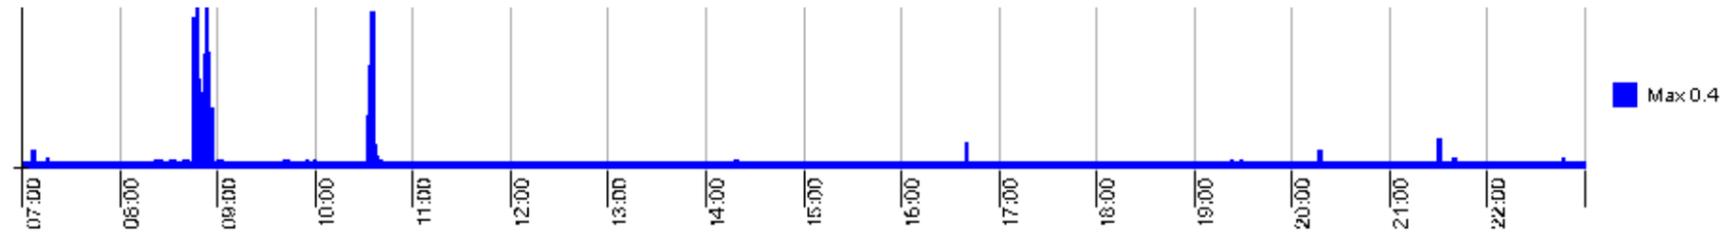
On the 23rd of May there were no exceedances however a high reading of $0.4\text{ms}^{-1.75}$ was recorded. This was investigated and found to be caused by footpath works in close proximity to the vibration monitor, approximately 10m away (graph above from the 23/05/2017). It should be noted that the dwellings are more distant than the monitor to the works. The dwelling closest to the works is approximately 25m away. Therefore, the vibration level at the dwelling is likely to be lower.

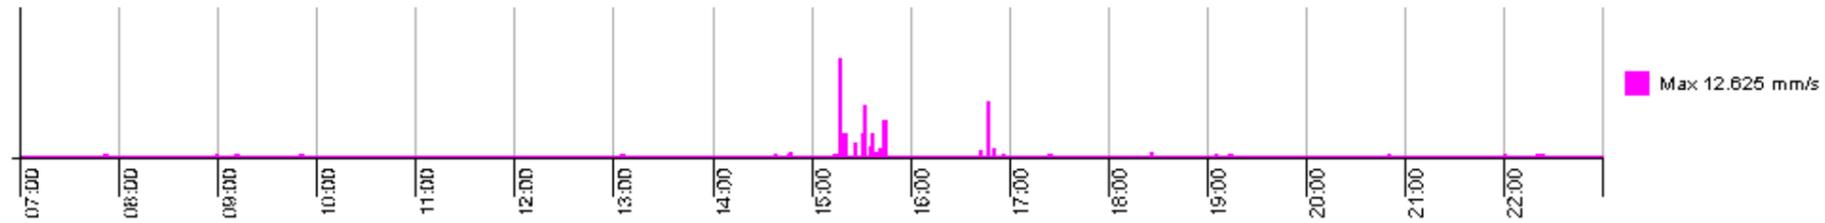
Exceedance on the 3rd of May has been investigated and found to be caused by the environmental department collecting air quality data and carrying out maintenance on noise monitor (graph above from the 03/05/2017).

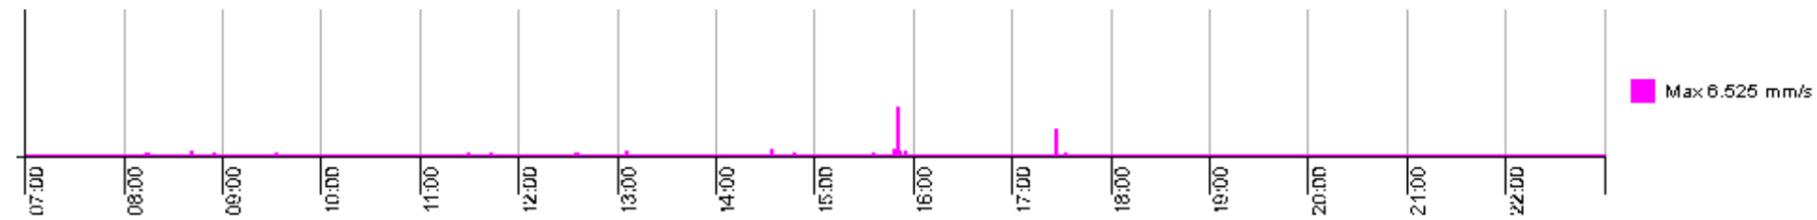
Exceedance on the 24th of May has been investigated and found to be caused by an individual isolated event that is unlikely to have been a construction related activity (graph above from the 24/05/2017). The vibration monitor is located in the residents back garden, therefore resident's activity may have caused this exceedance.

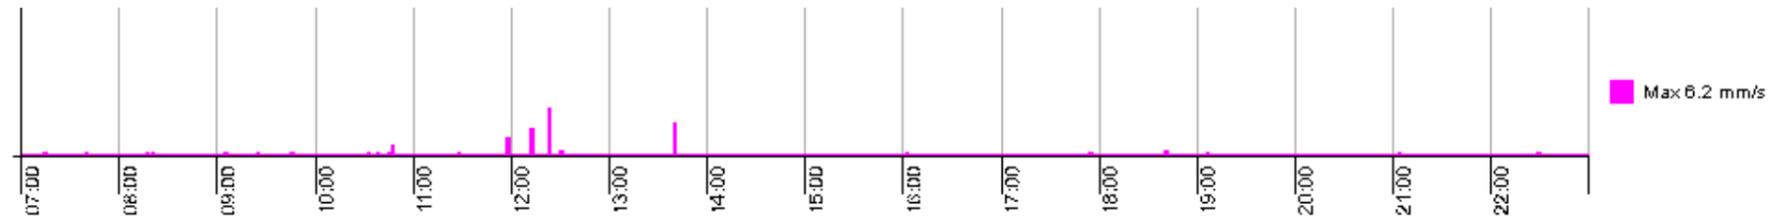
Exceedance on the 15th of May has been investigated and found to be caused by an individual isolated event that is unlikely to have been a construction related activity (graph above from the 15/05/2017). The vibration monitor is located in the residents back garden, therefore resident's activity may have caused this exceedance.

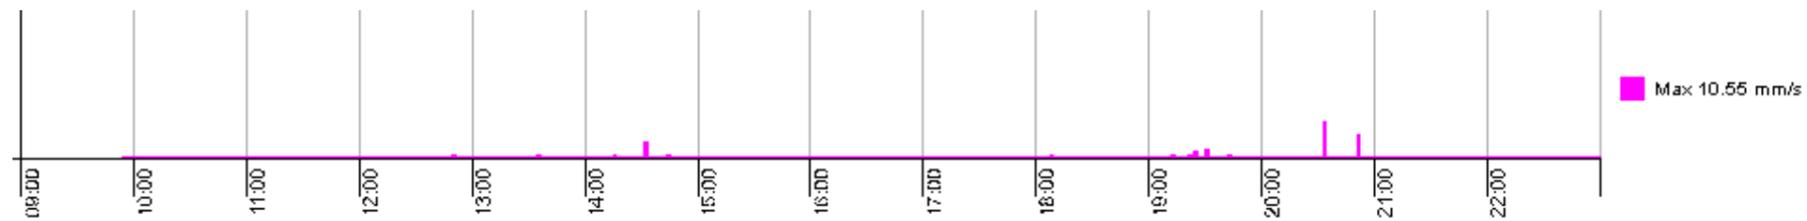
Exceedances on the 1st and 8th of May have been investigated and found to be caused out with construction working hours therefore it is unlikely that a construction related activity was the cause of these events (graph above from the 01/05/2017).

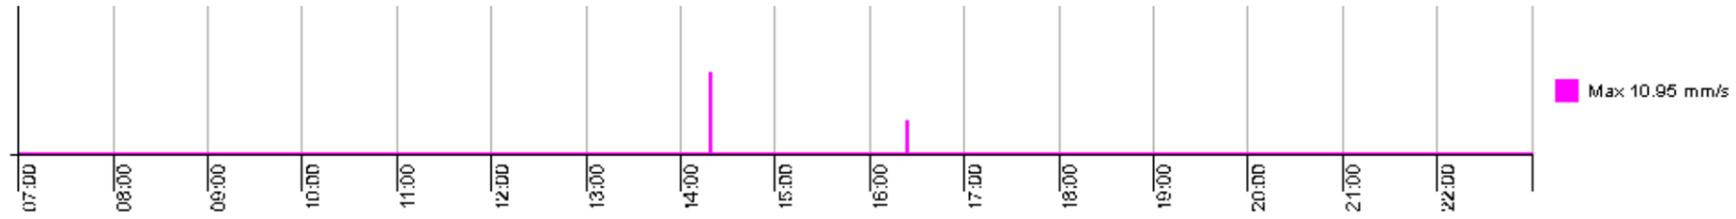
Exceedances throughout May have been investigated and found to be caused by individual isolated events that are unlikely to have been construction related activities (graph above from the 20/05/2017). The vibration monitor is located in the residents back garden, therefore resident's activity may have caused these exceedances.

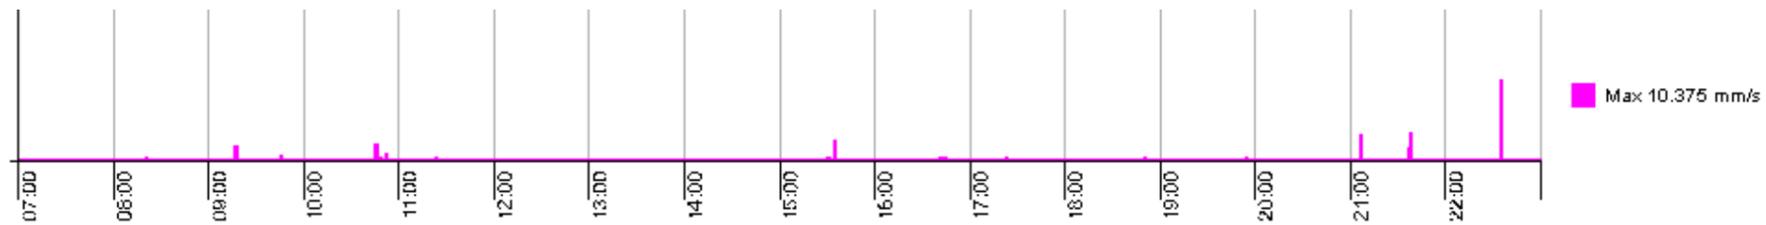
Exceedances on the 9th, 16th, 19th and 22nd of May have been investigated and found to be caused out with construction working hours therefore it is unlikely that a construction related activity was the cause of these events (graph above from the 09/05/2017).

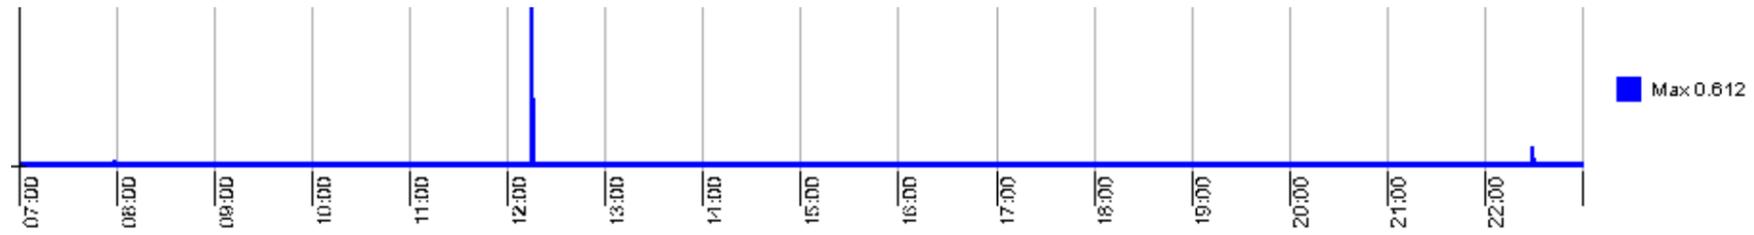
Exceedance on the 8th of May has been investigated and found to be caused by an individual isolated event that is unlikely to have been a construction related activity (graph above from the 08/05/2017). The vibration monitor is located in the residents back garden, therefore resident's activity may have caused this exceedance.

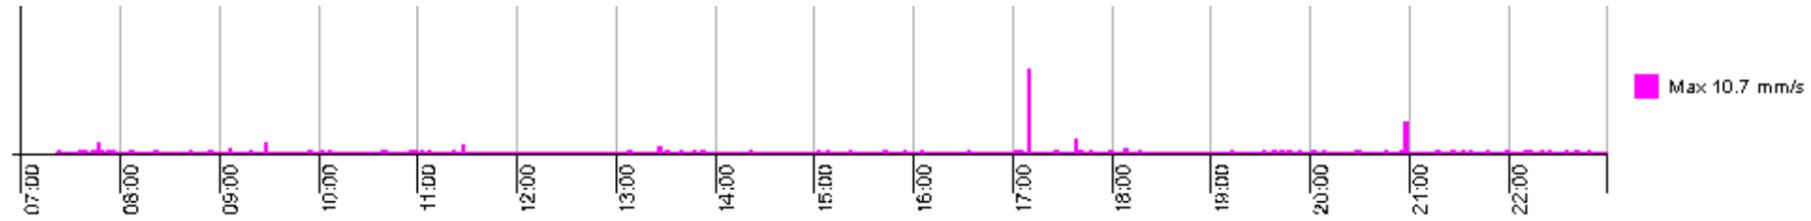
Exceedances on the 1st, 2nd, 4th, 5th, 6th, 7th, 8th, 9th, 10th, 12th, 13th, 14th, 15th, 17th, 18th, 22nd, 23rd, 25th, 26th, 27th, 28th, 29th and 31st of May have been investigated and found to be caused by individual isolated events that are unlikely to have been construction related activities (graph above from the 06/05/2017).

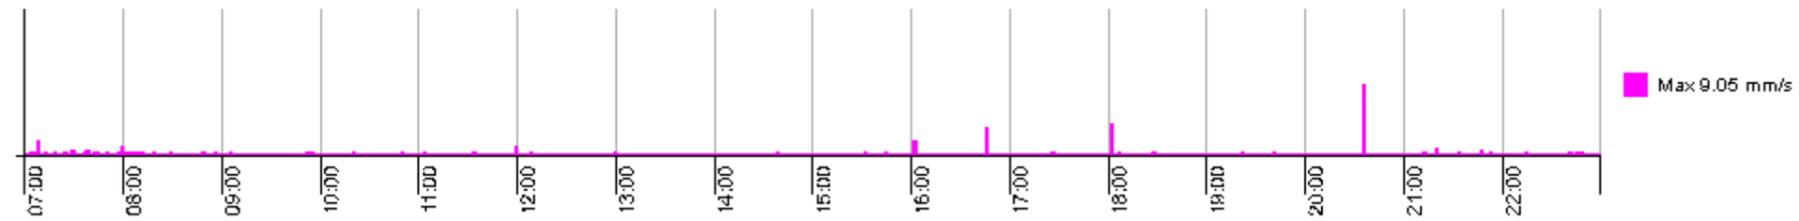
Exceedances on the 11th, 16th, 19th, 20th, 21st and 30th of May have been investigated and found to be caused out with construction working hours therefore it is unlikely that a construction related activity was the cause of these events (graph above from the 11/05/2017).

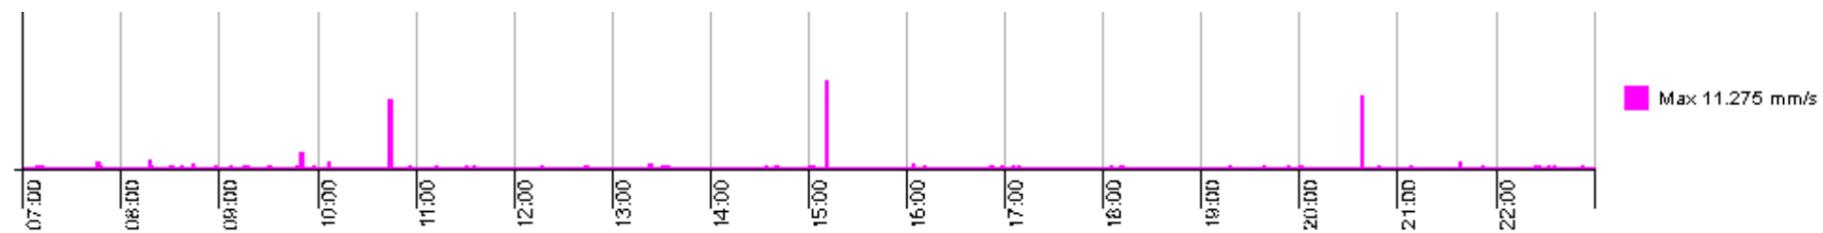
Exceedance at 15:10 on the 24th of May has been investigated and found to be caused by the environmental department collecting air quality data (graph above from the 24/05/2017).
