Queensferry
Crossing

Project FORTH REPLACEMENT CROSSING

VIBRATION MONITORING REPORT

JUNE 2017

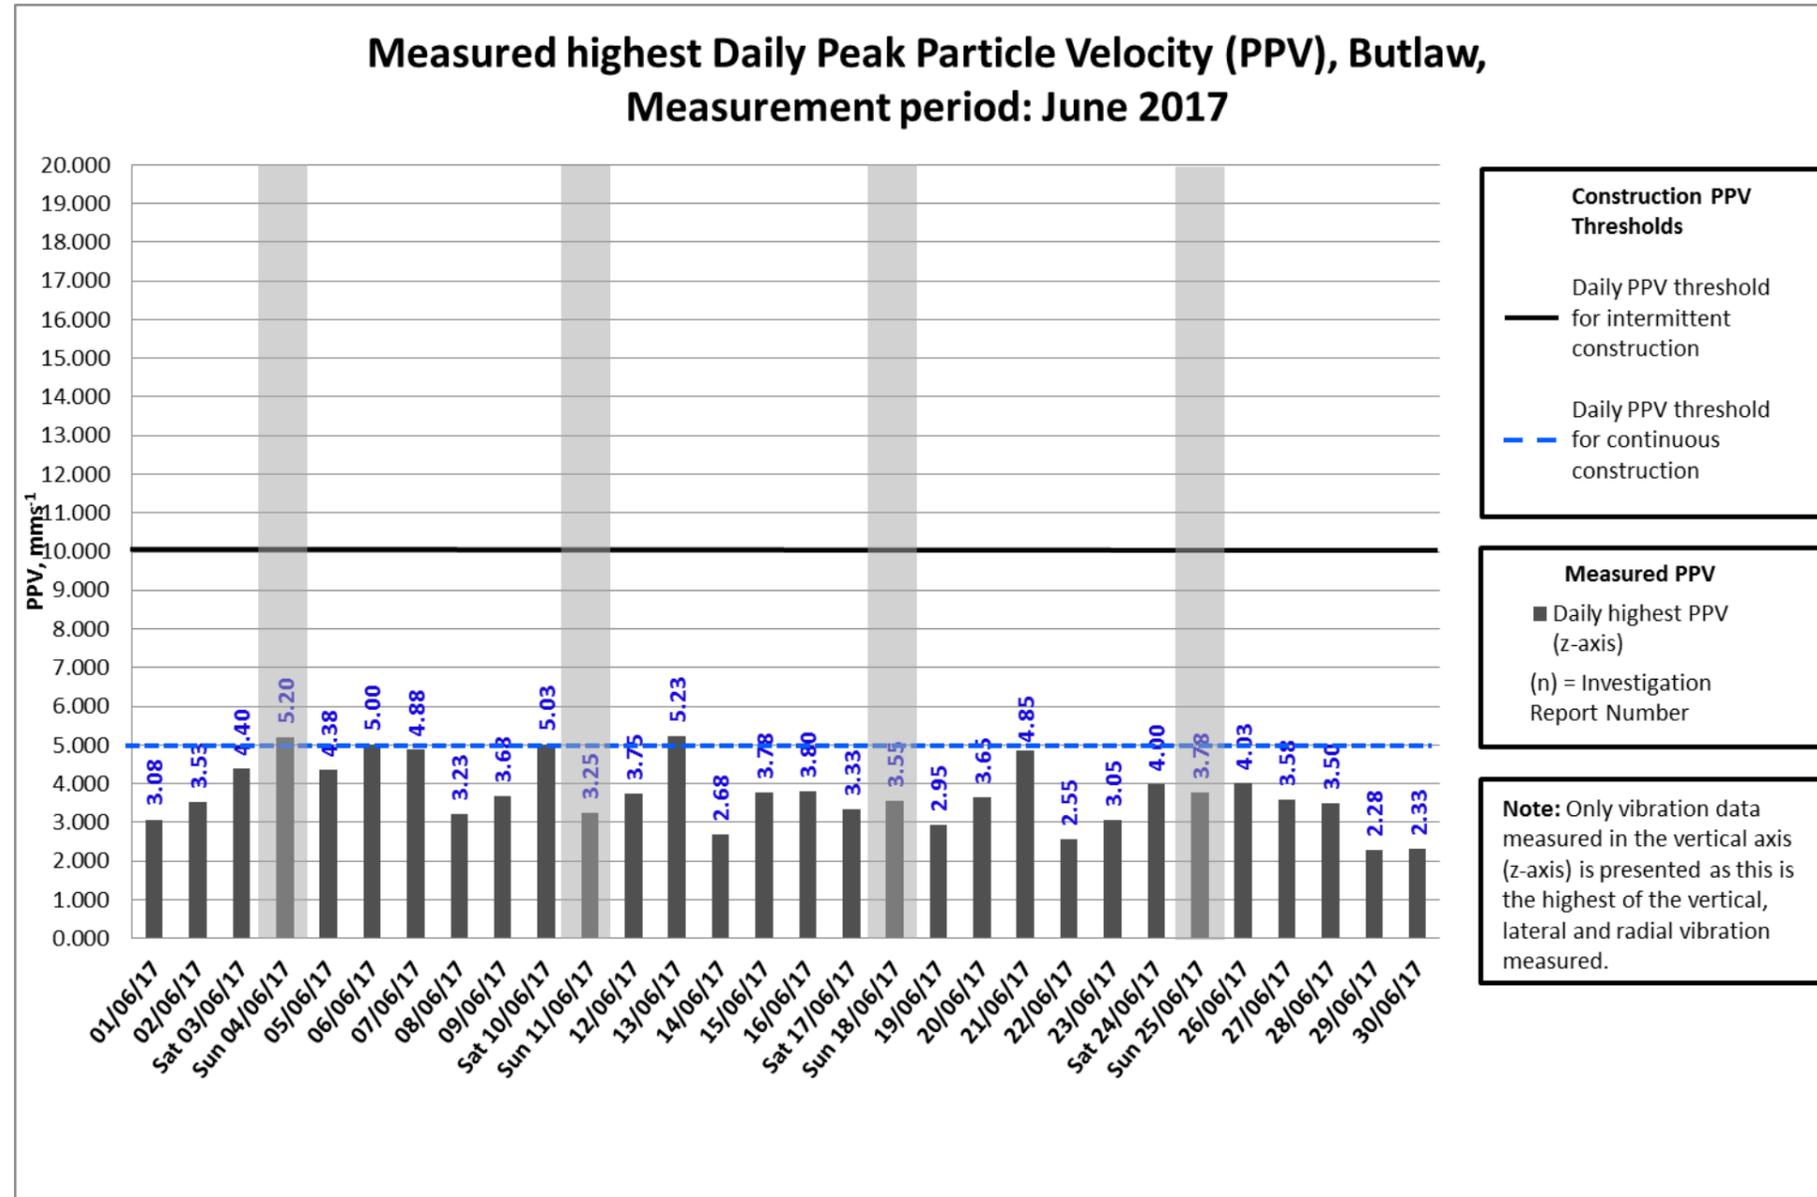
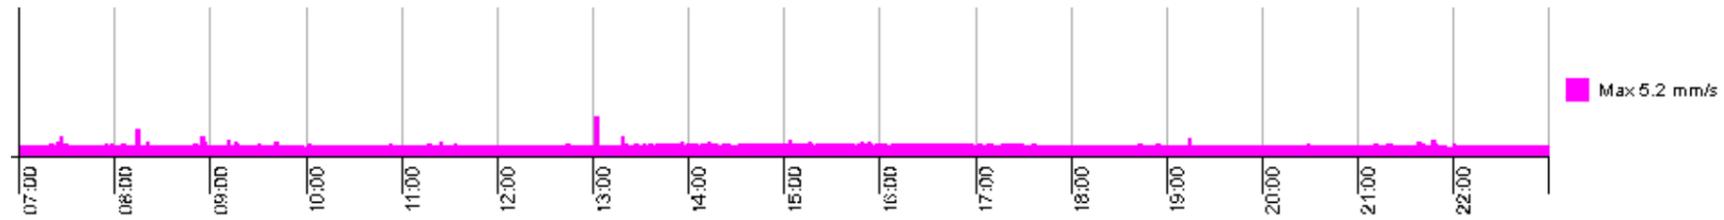
Exceedances on the 4th, 6th, 10th and 13th of June have been investigated and found to be caused by individual isolated events that are unlikely to have been construction related activities (graph above from 04/06/2017). The vibration monitor is located in the residents back garden; therefore resident's activity may have caused these exceedances.

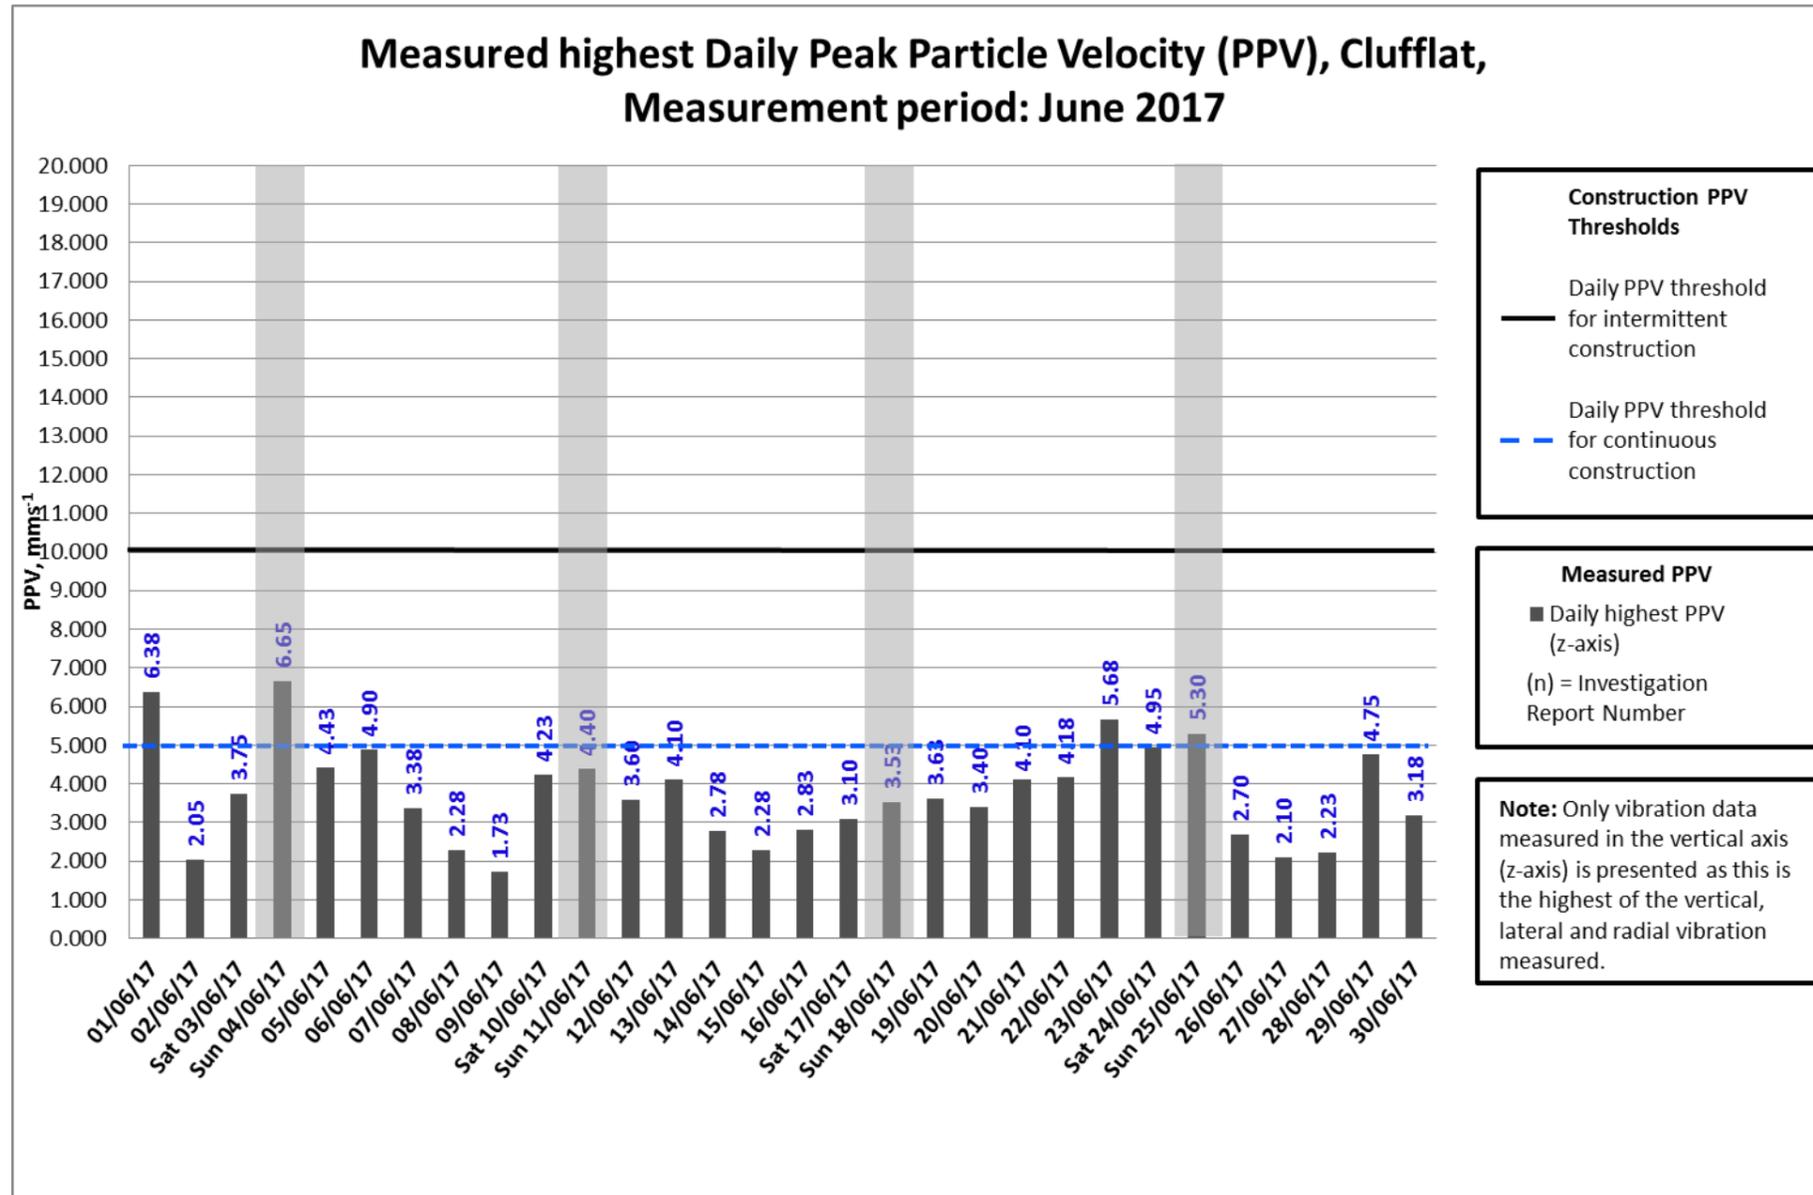
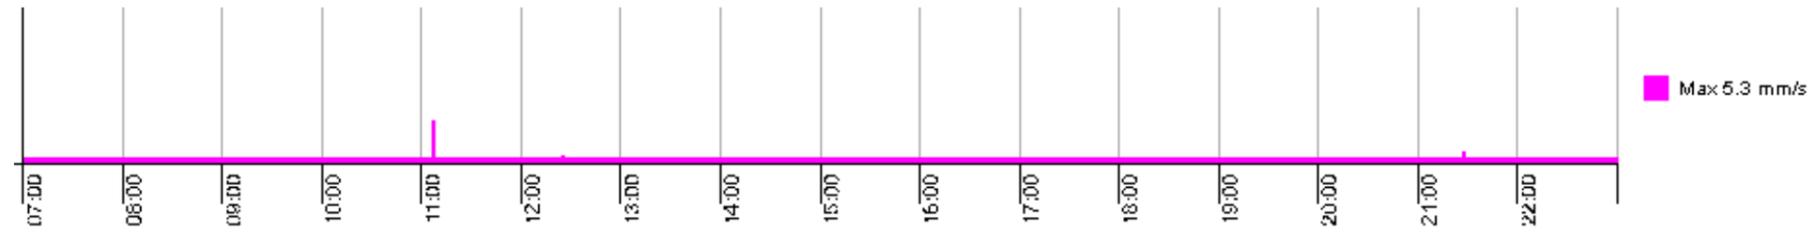
Exceedances on the 1st, 4th, 23rd and 25th of June have been investigated and found to be caused by individual isolated events that are unlikely to have been construction related activities (graph above from the 25/06/2017). With this monitor being located in a public amenity area there is a likelihood that the exceedances seen above might have been caused by pedestrians using the area.

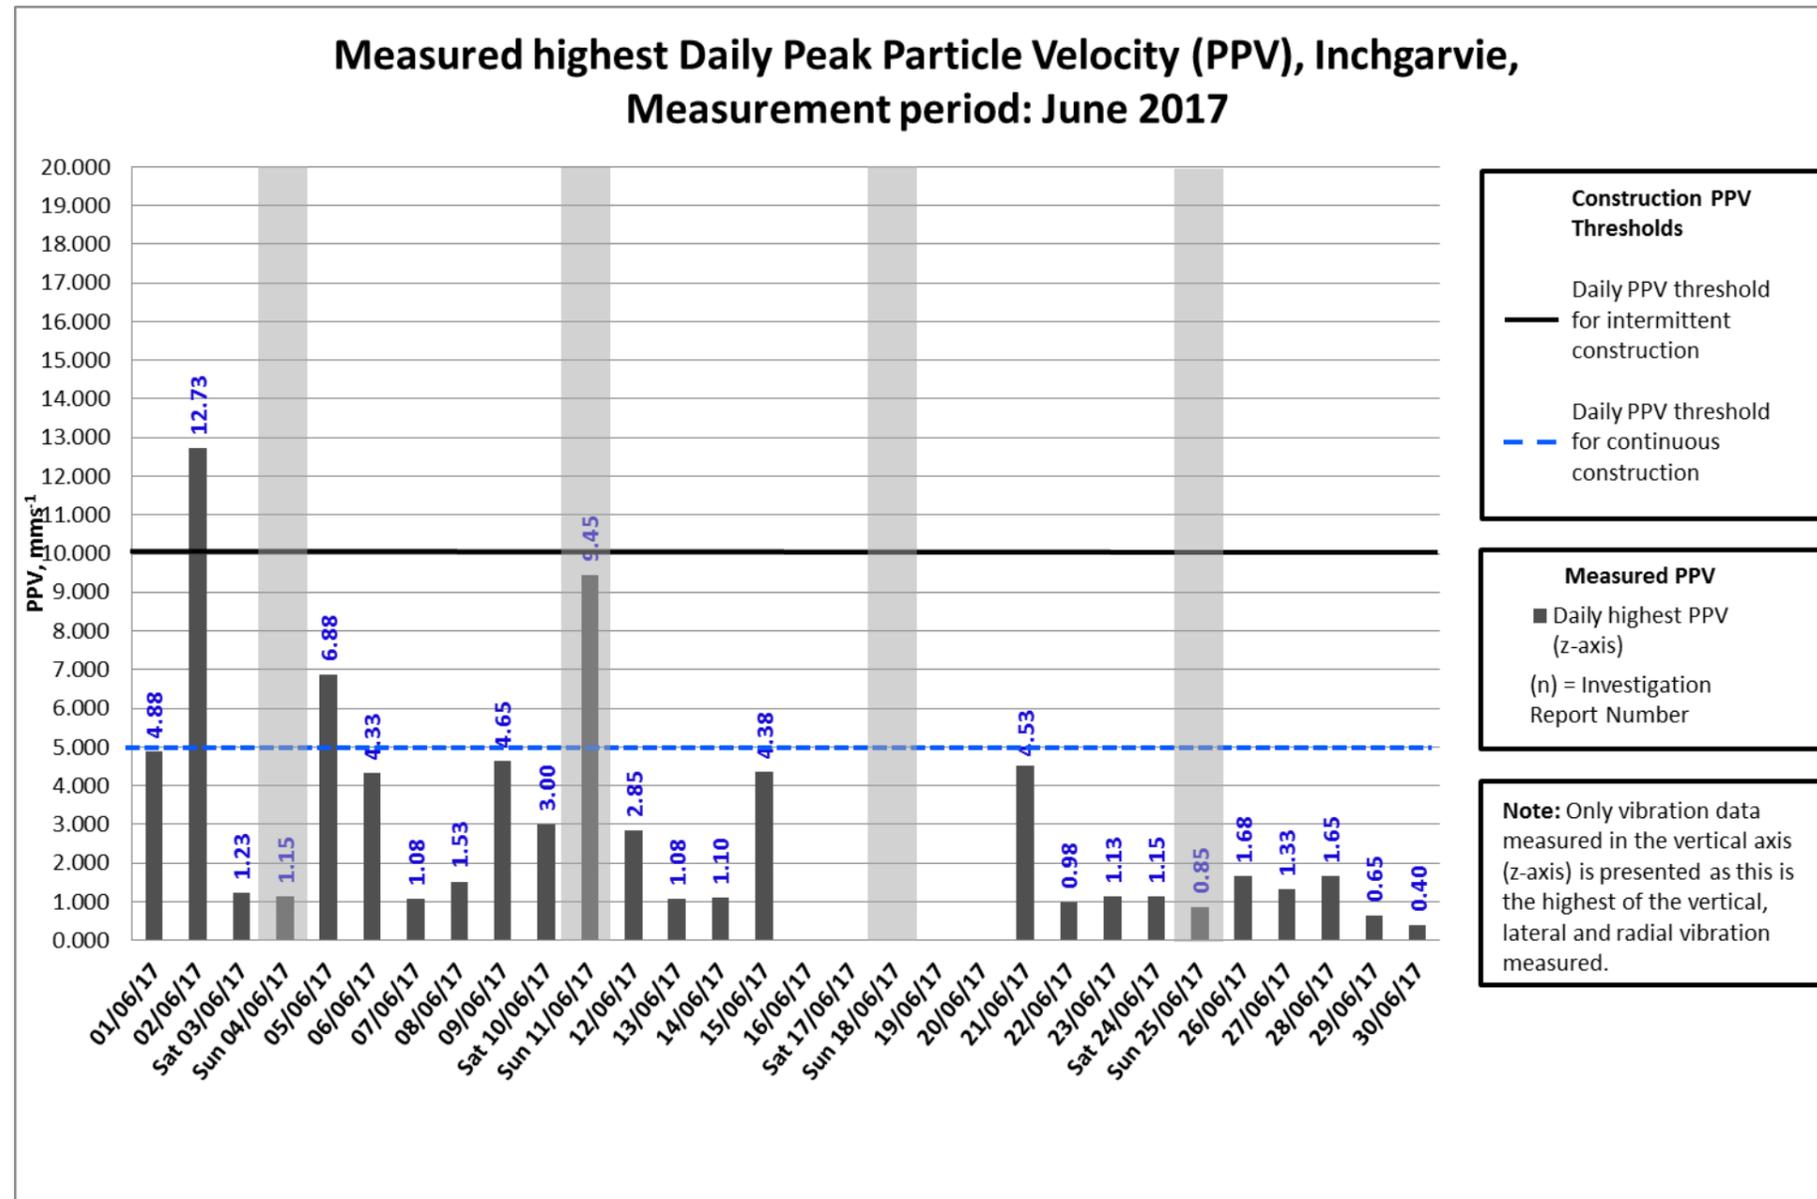
Data missing on the 16th – 20th June caused by electrical issue with monitor.

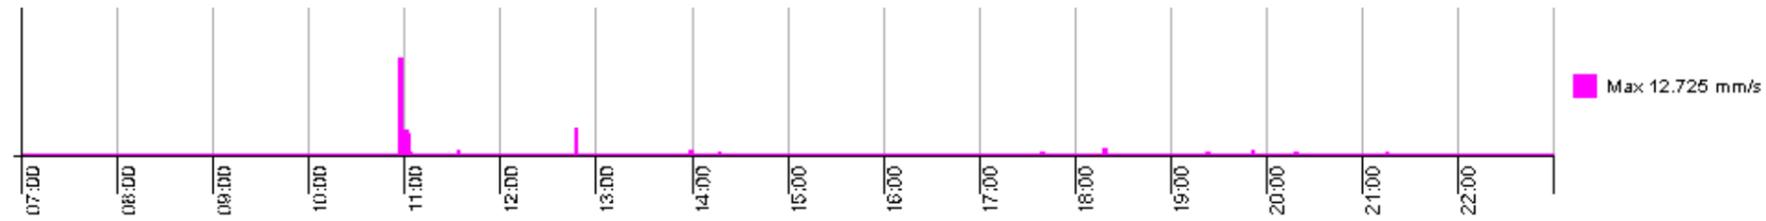
Exceedance on the 2nd of June has been investigated and found to be caused by the environmental team collecting data from noise monitor (graph above from 02/07/2017).

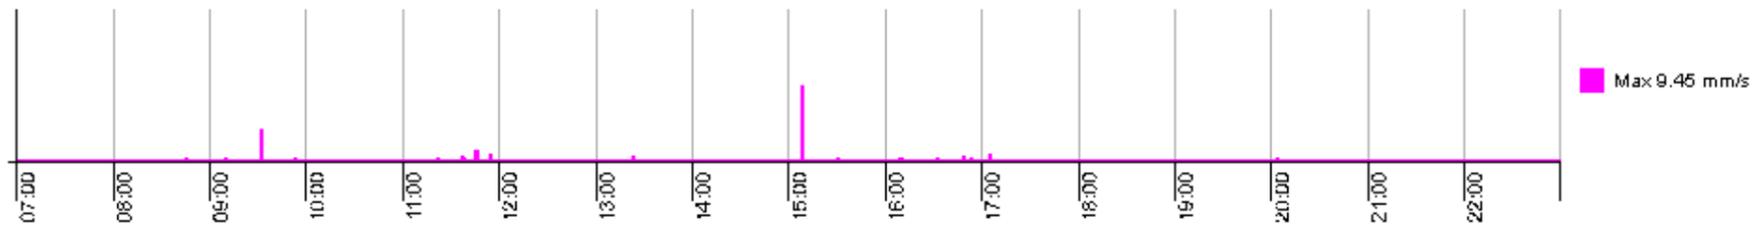
Exceedances on the 5th and 11th of June have been investigated and found to be caused by individual isolated events that are unlikely to have been construction related activities (graph above from 11/07/2017). The vibration monitor is located in the residents back garden, therefore resident's activity may have caused these exceedances.

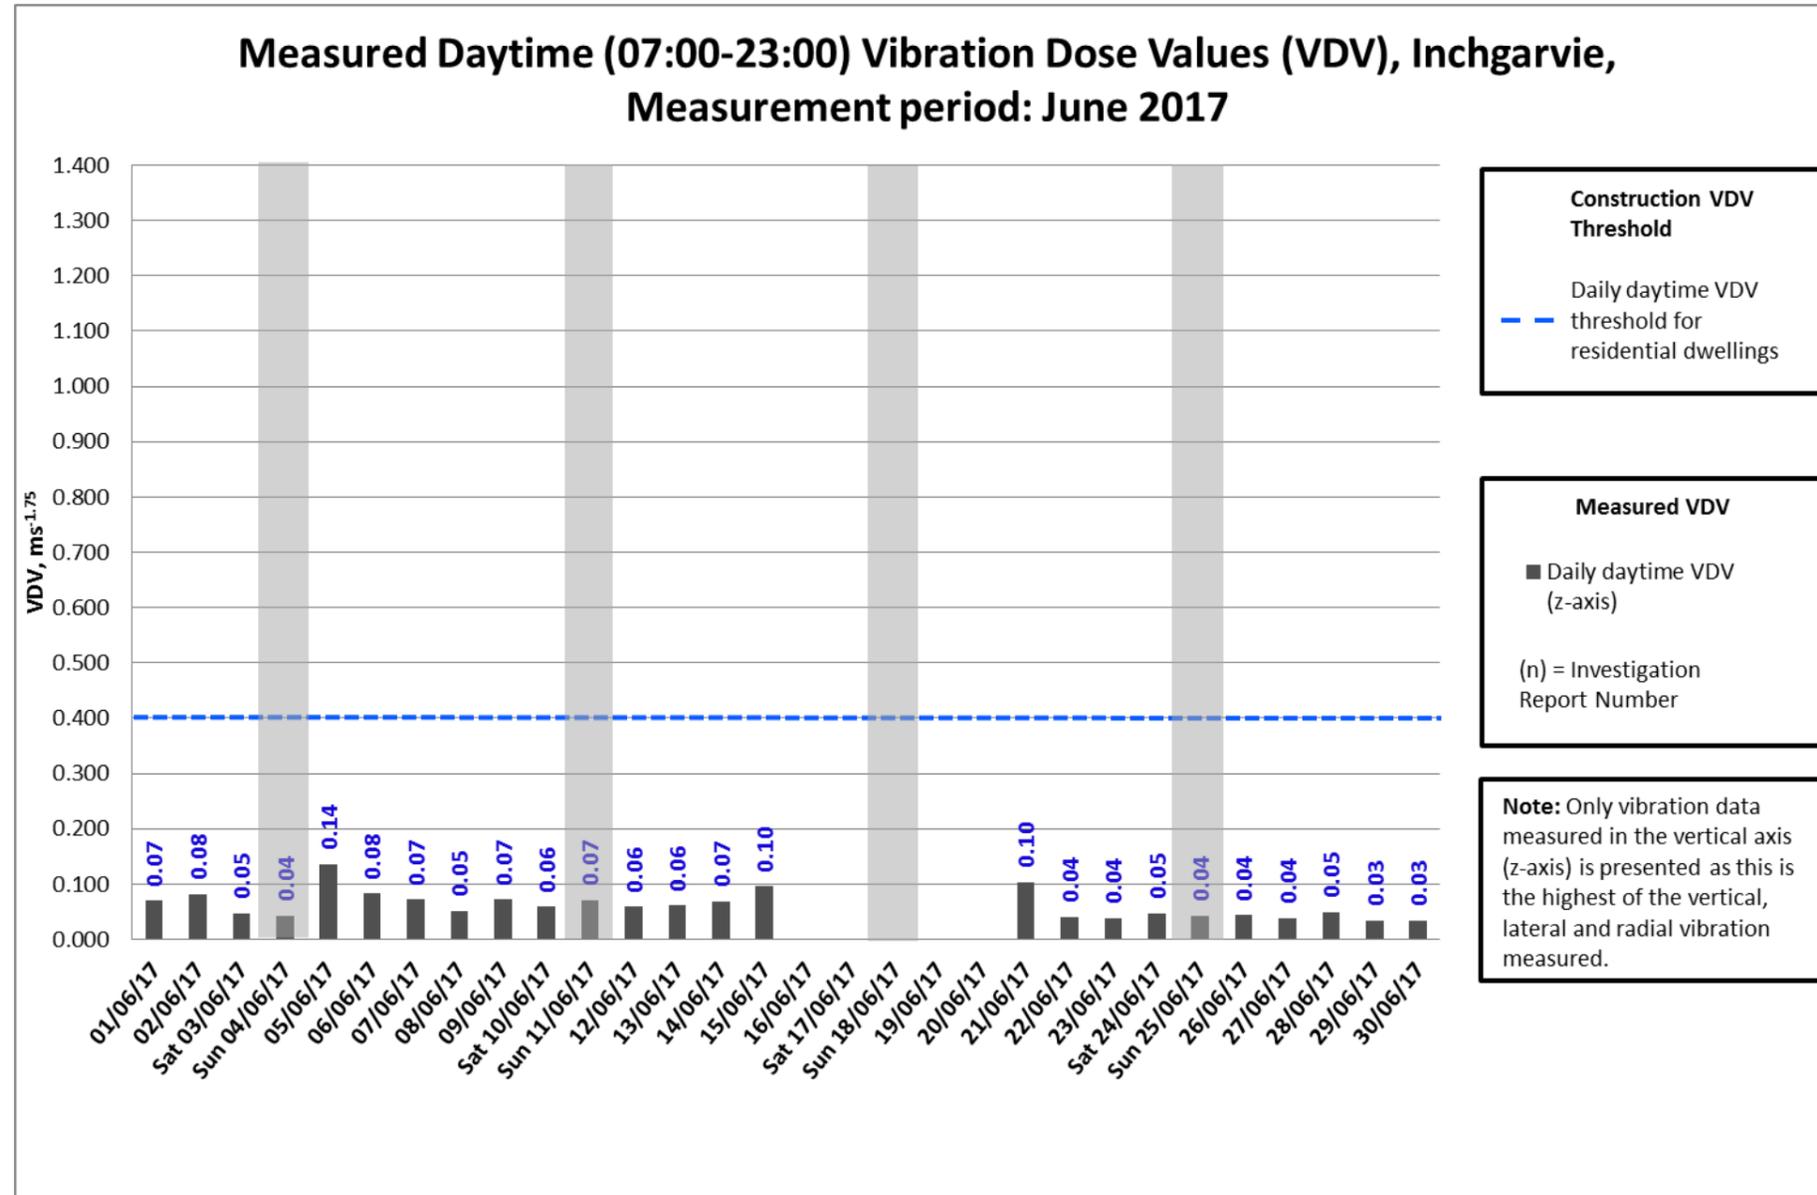
Data missing on the 16th – 20th June caused by electrical issue with monitor.

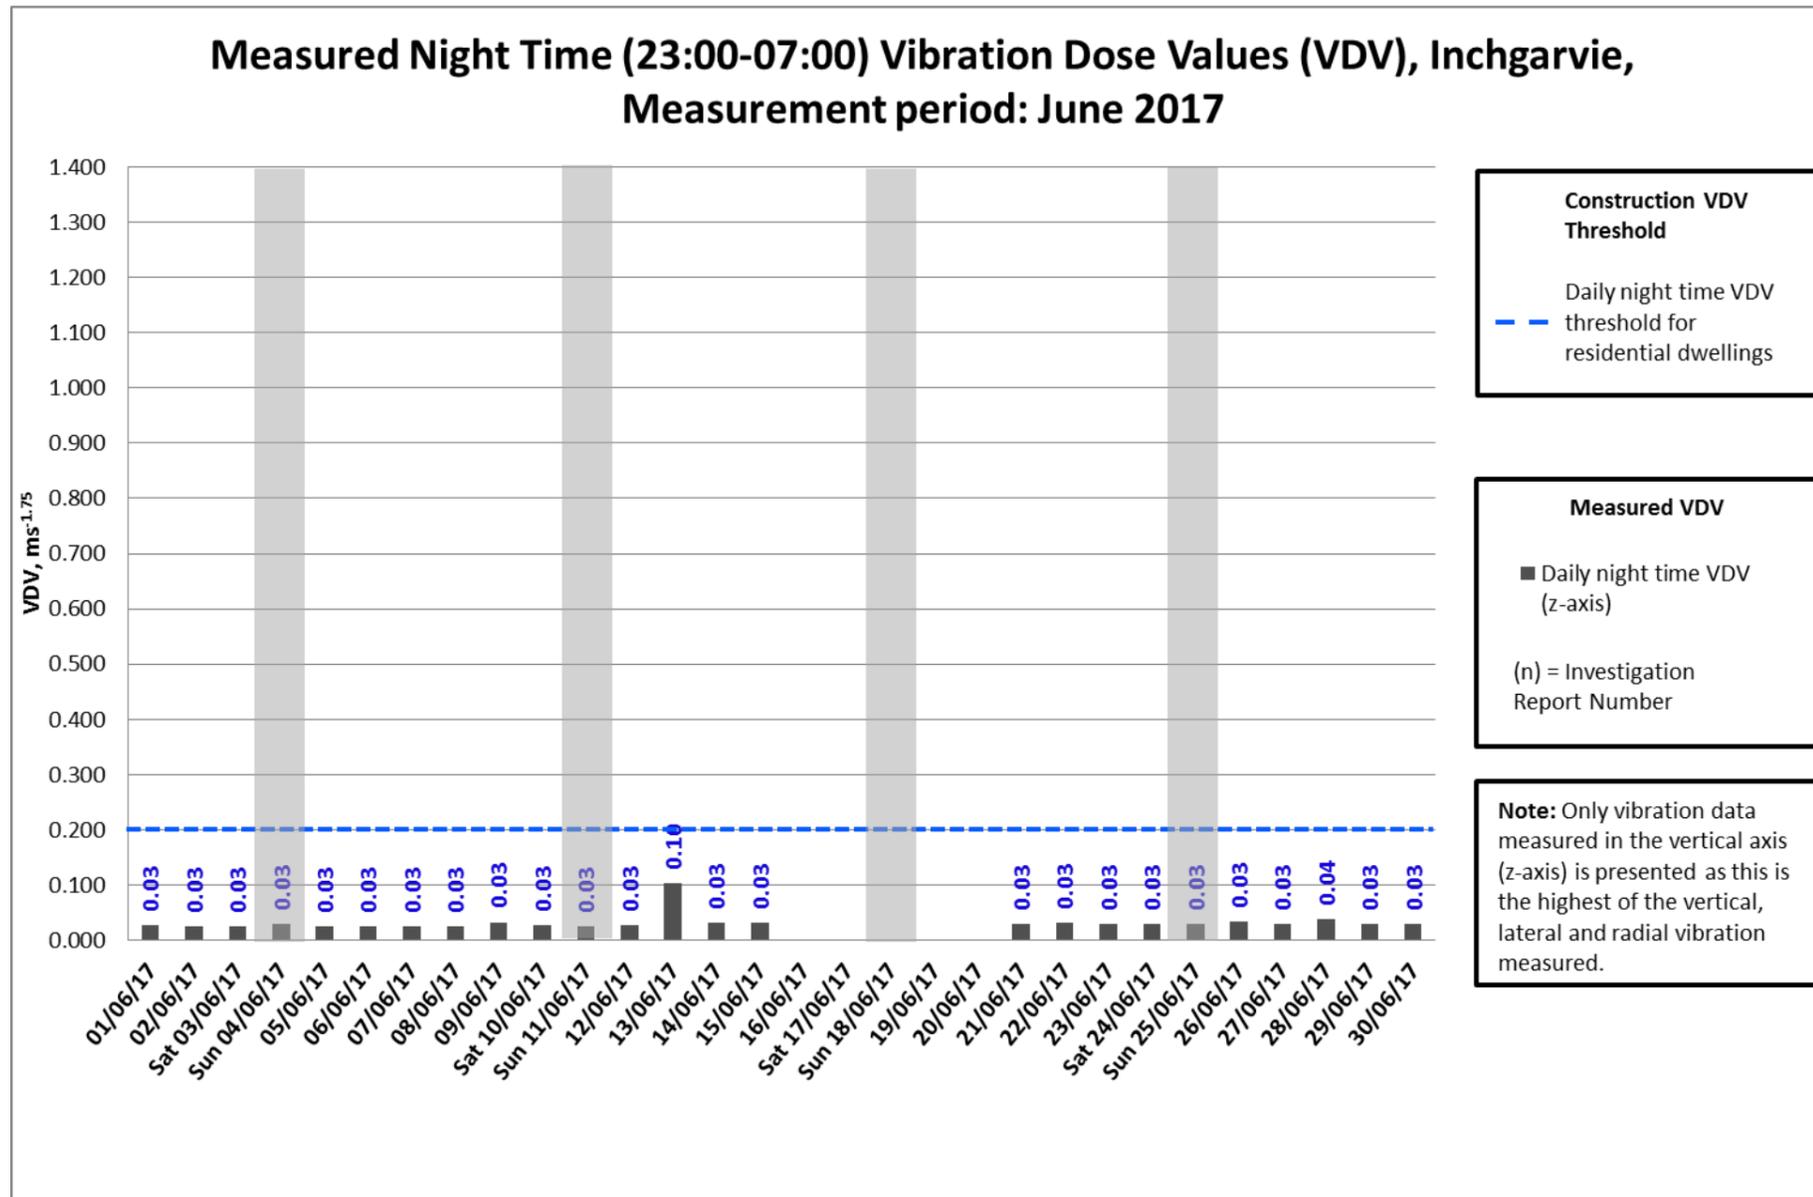
Data missing on the 16th – 20th June caused by electrical issue with monitor.

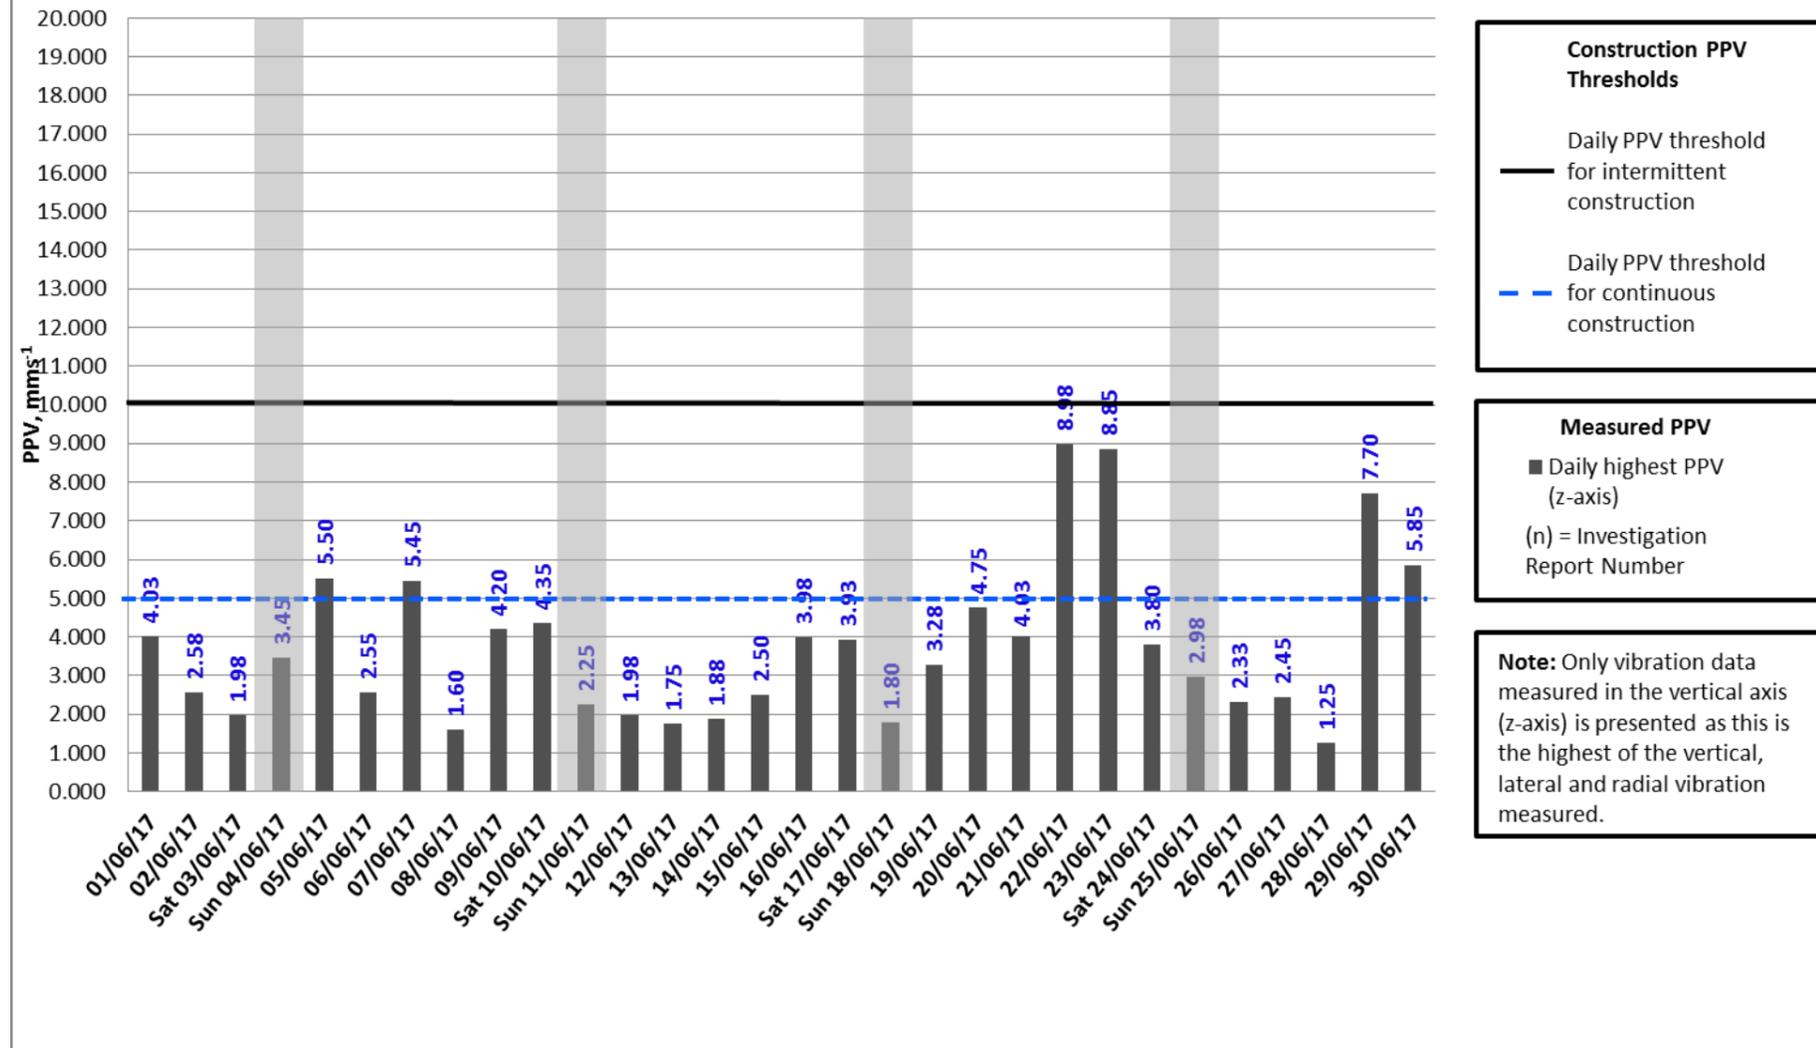
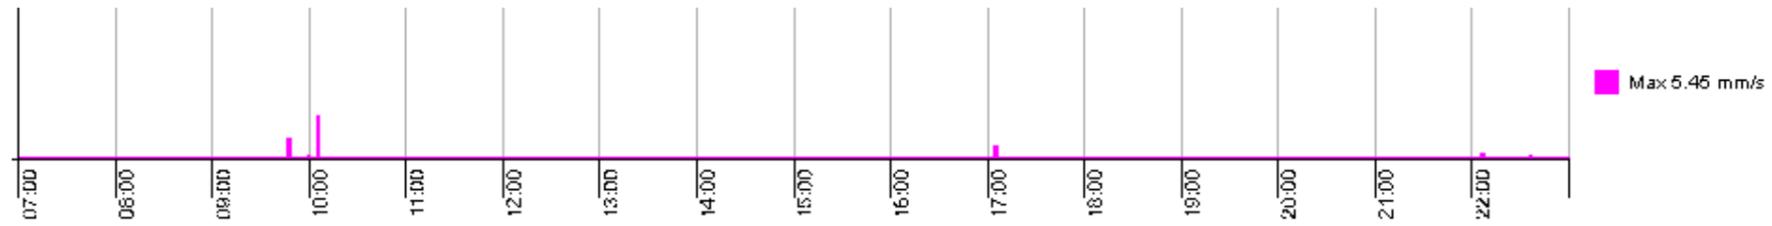
Measured highest Daily Peak Particle Velocity (PPV), Linn Mill, Measurement period: June 2017

Exceedances on the 5th, 7th, 22nd, 23rd and 29th of June have been investigated and found to be caused by individual isolated events that are unlikely to have been construction related activities (graph above from the 07/06/2017). The vibration monitor is located in the residents back garden, therefore resident's activity may have caused these exceedances.

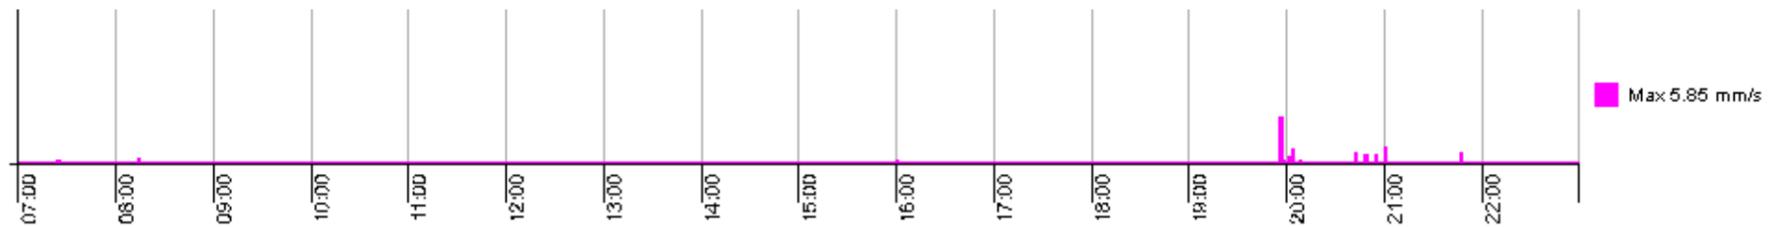
Exceedance on the 30th of June has been investigated and found to be caused out with construction working hours therefore it is unlikely that a construction related activity was the cause of this event (graph above from the 30/06/2017).

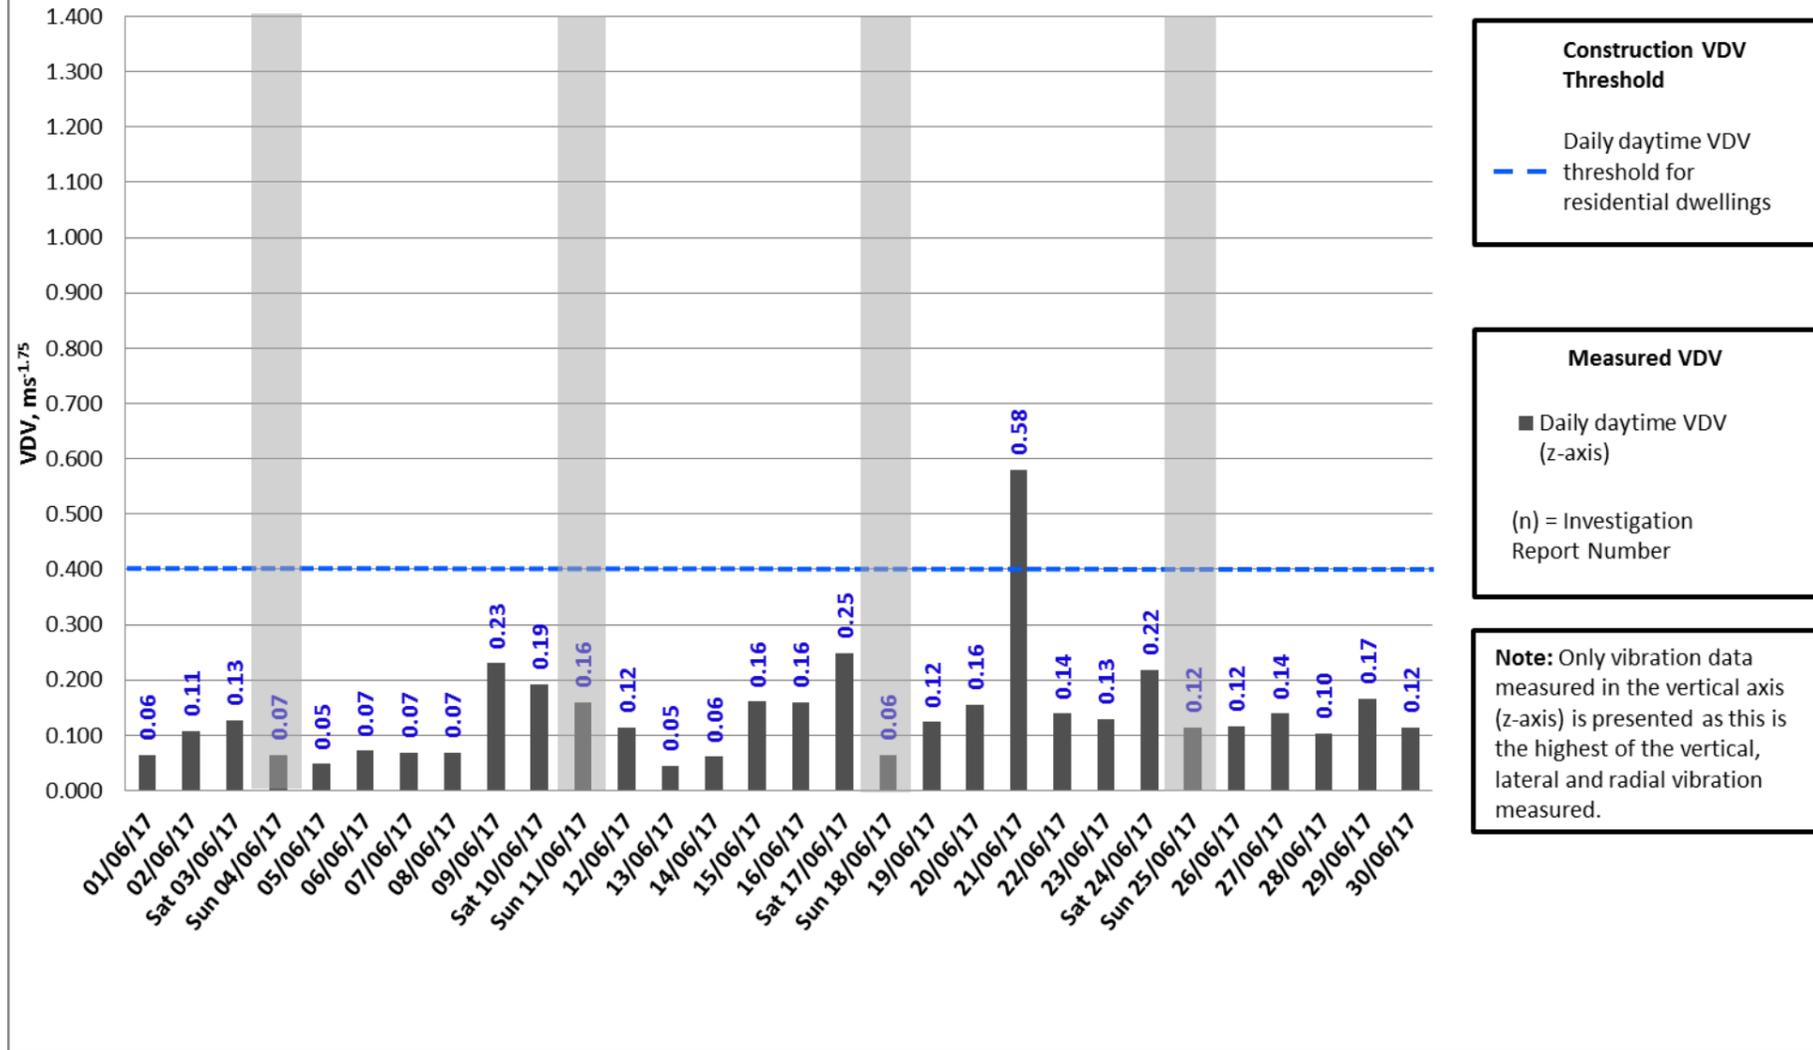
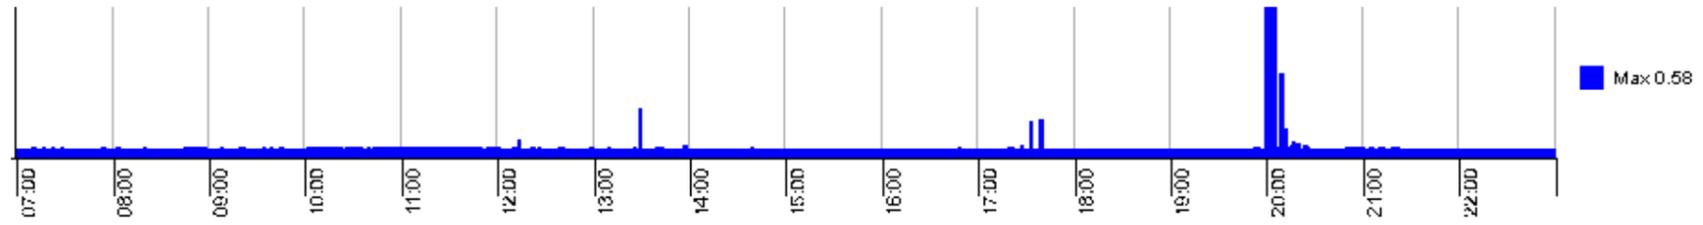
Measured Daytime (07:00-23:00) Vibration Dose Values (VDV), Linn Mill, Measurement period: June 2017

Exceedance on the 21st of June has been investigated and found to be caused out with construction working hours therefore it is unlikely that a construction related activity was the cause of this event (graph above from the 21/06/2017).

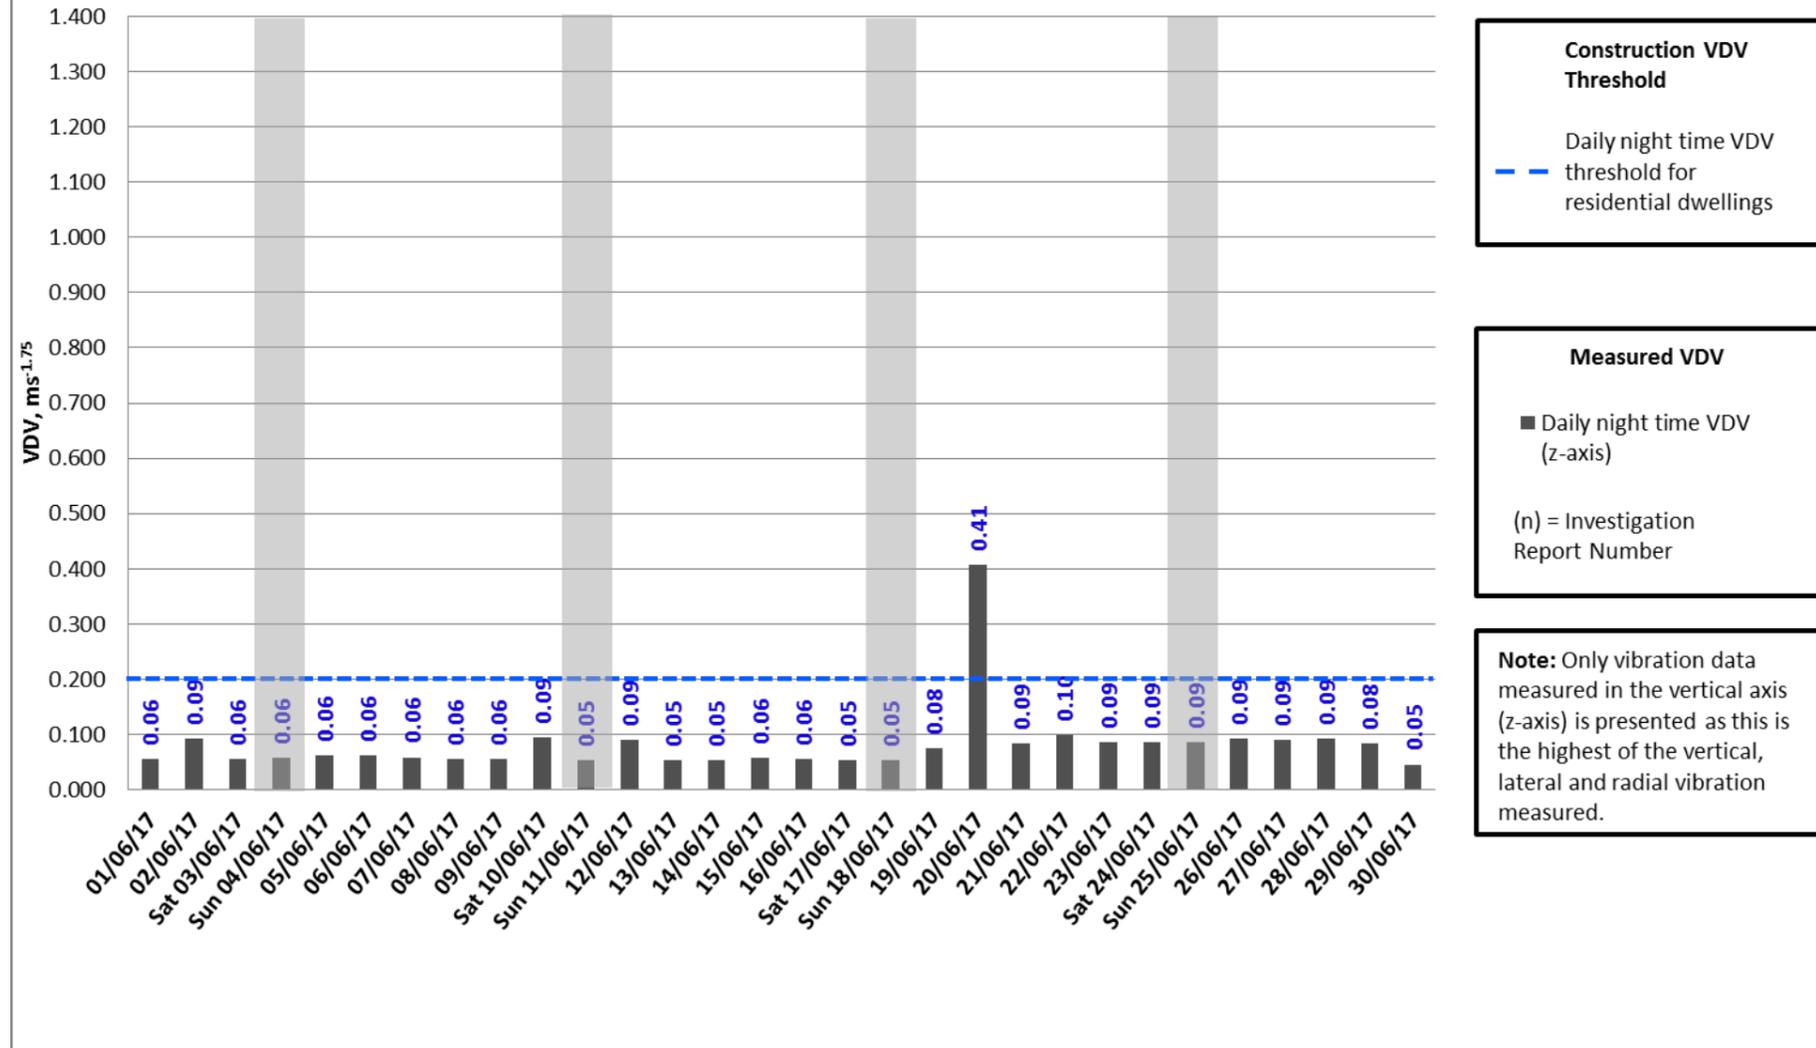
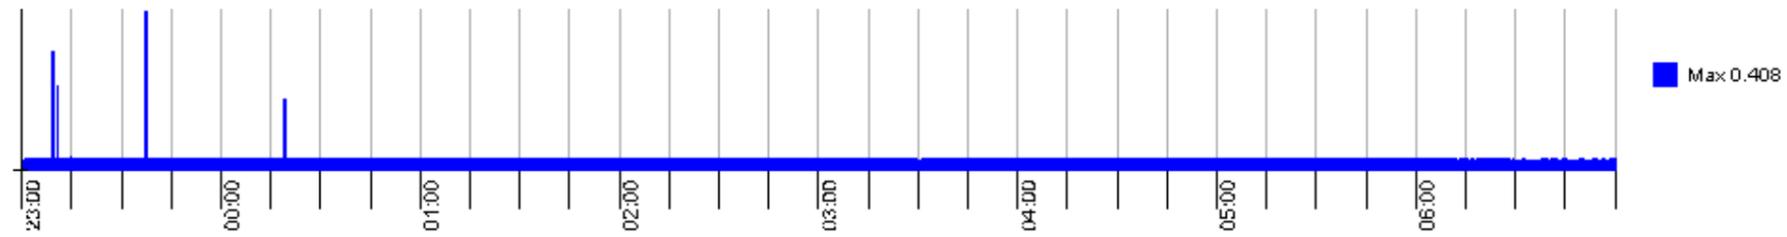
Measured Night Time (23:00-07:00) Vibration Dose Values (VDV), Linn Mill, Measurement period: June 2017

Exceedance on the 20th of June has been investigated and found to be caused out with construction working hours therefore it is unlikely that a construction related activity was the cause of this event (graph above from the 20/06/2017).

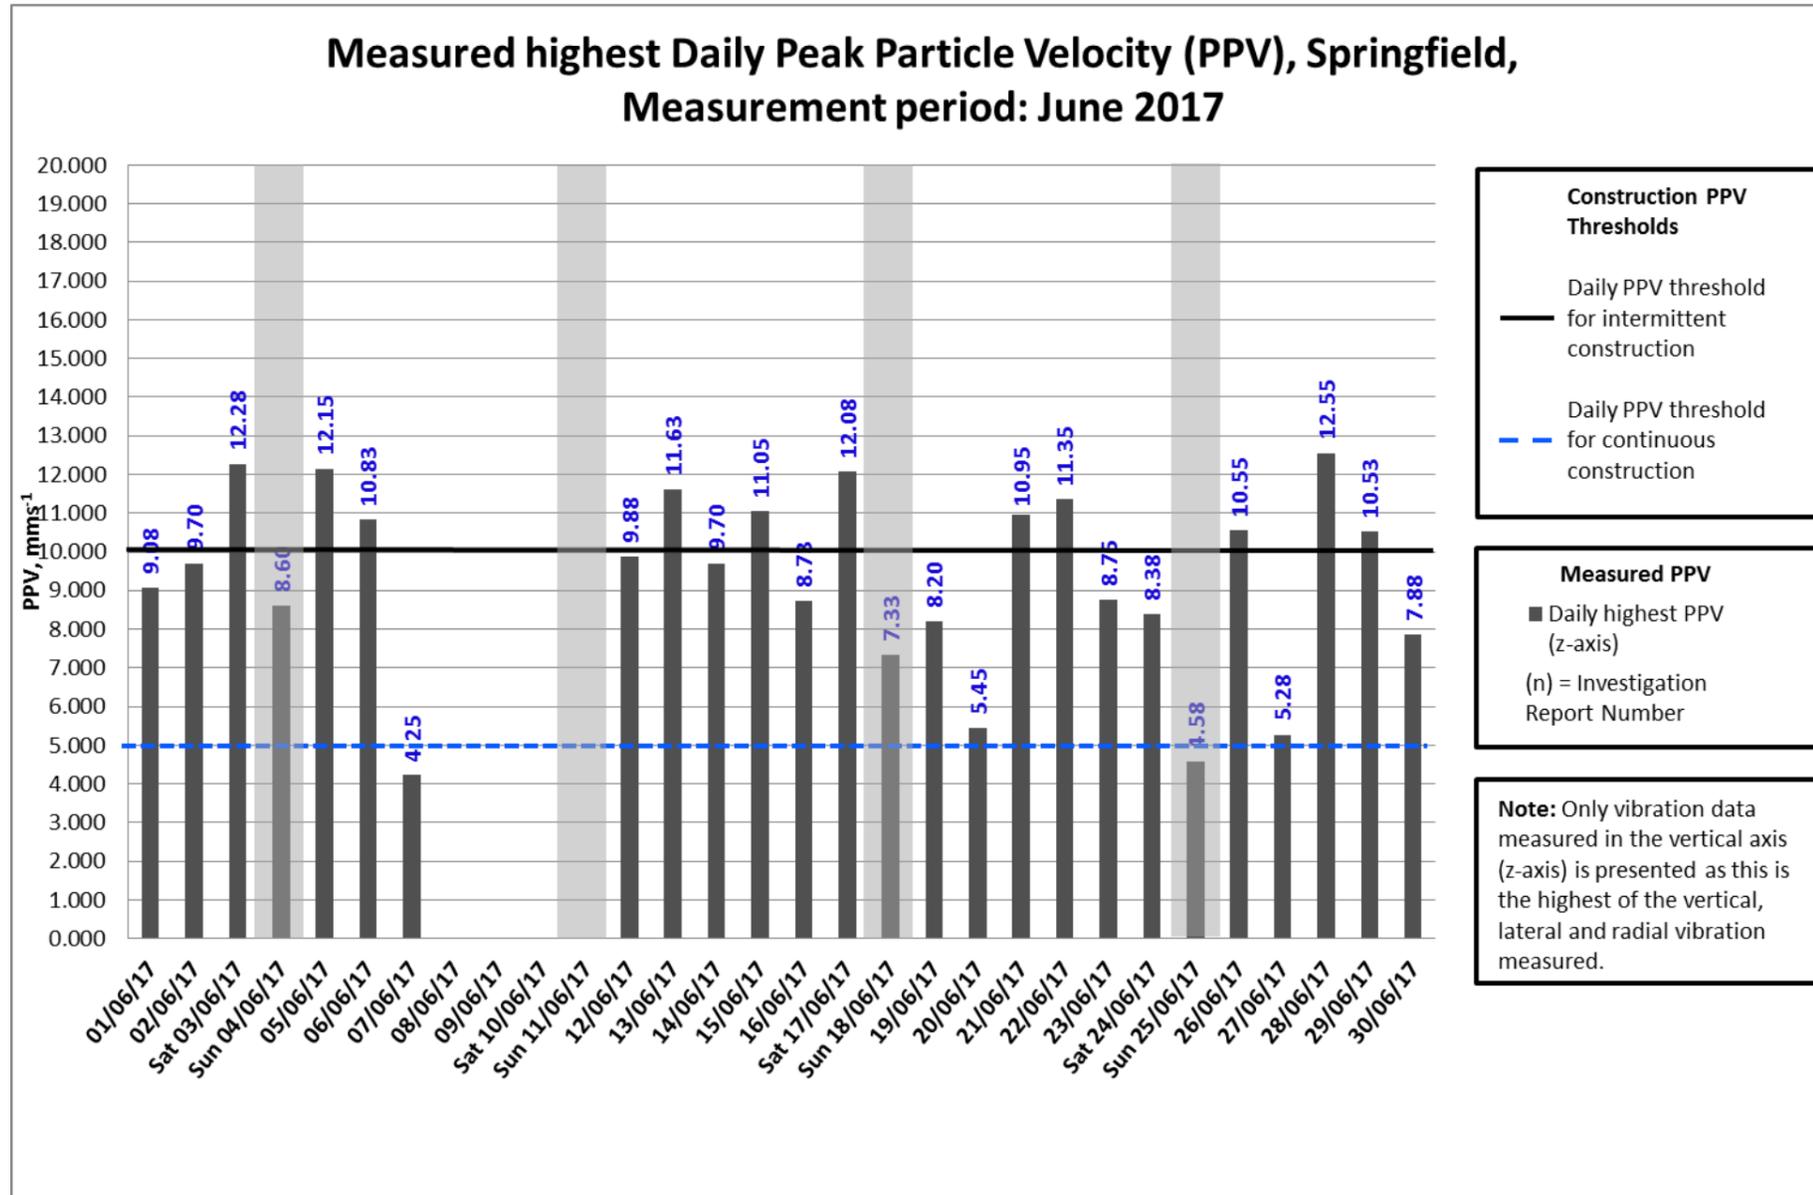
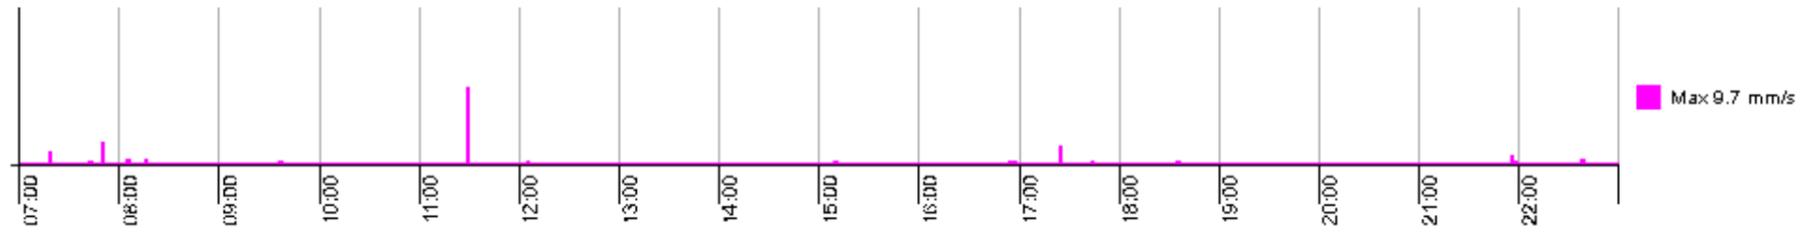
Data missing on the 8th – 11th June was caused by electrical issue with monitor.

Exceedances throughout June have been investigated and found to be caused by individual isolated events that are unlikely to have been construction related activities (graph above from the 14/06/2017). The vibration monitor is located in the residents back garden, therefore resident's activity may have caused these exceedances.
