Queensferry
Crossing

Project FORTH REPLACEMENT CROSSING

VIBRATION MONITORING REPORT

JUNE 2017

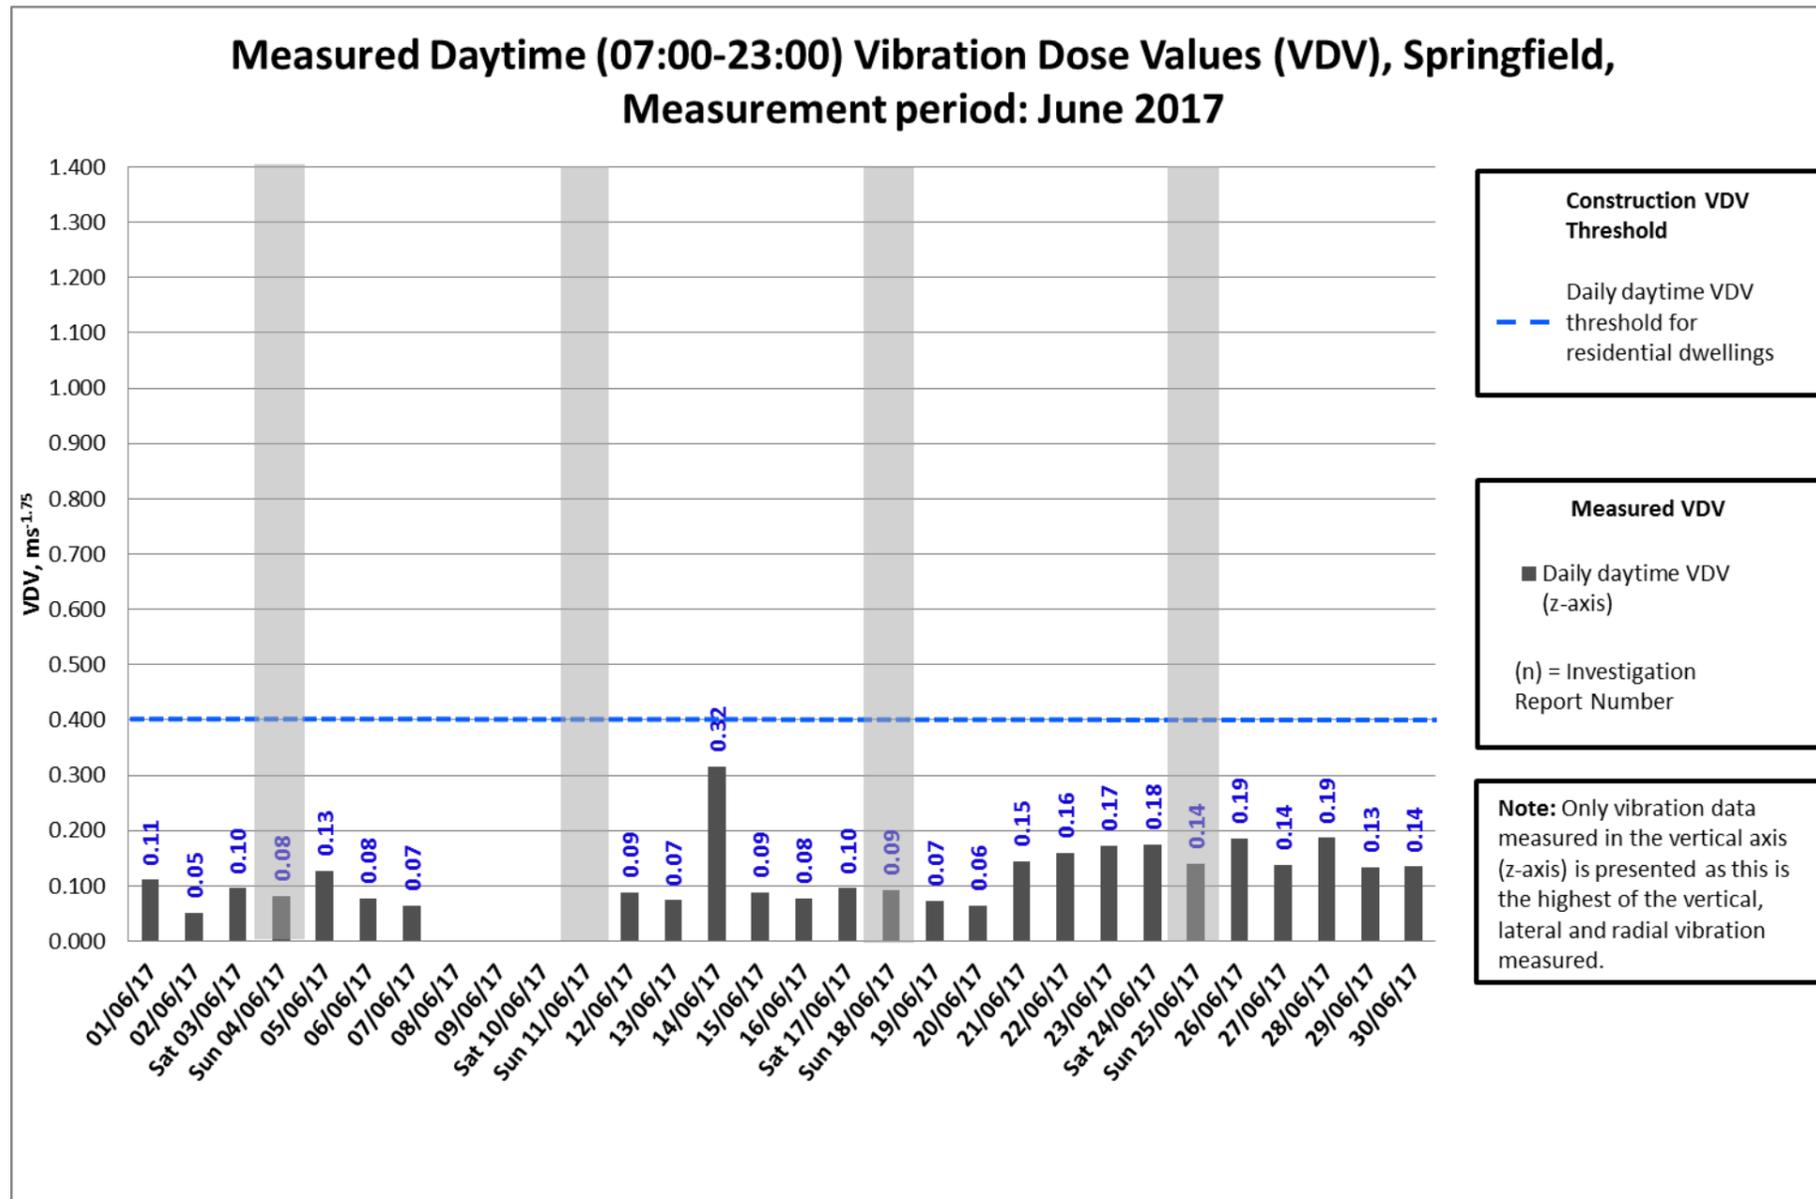
Data missing on the 8th – 11th June was caused by electrical issue with monitor.

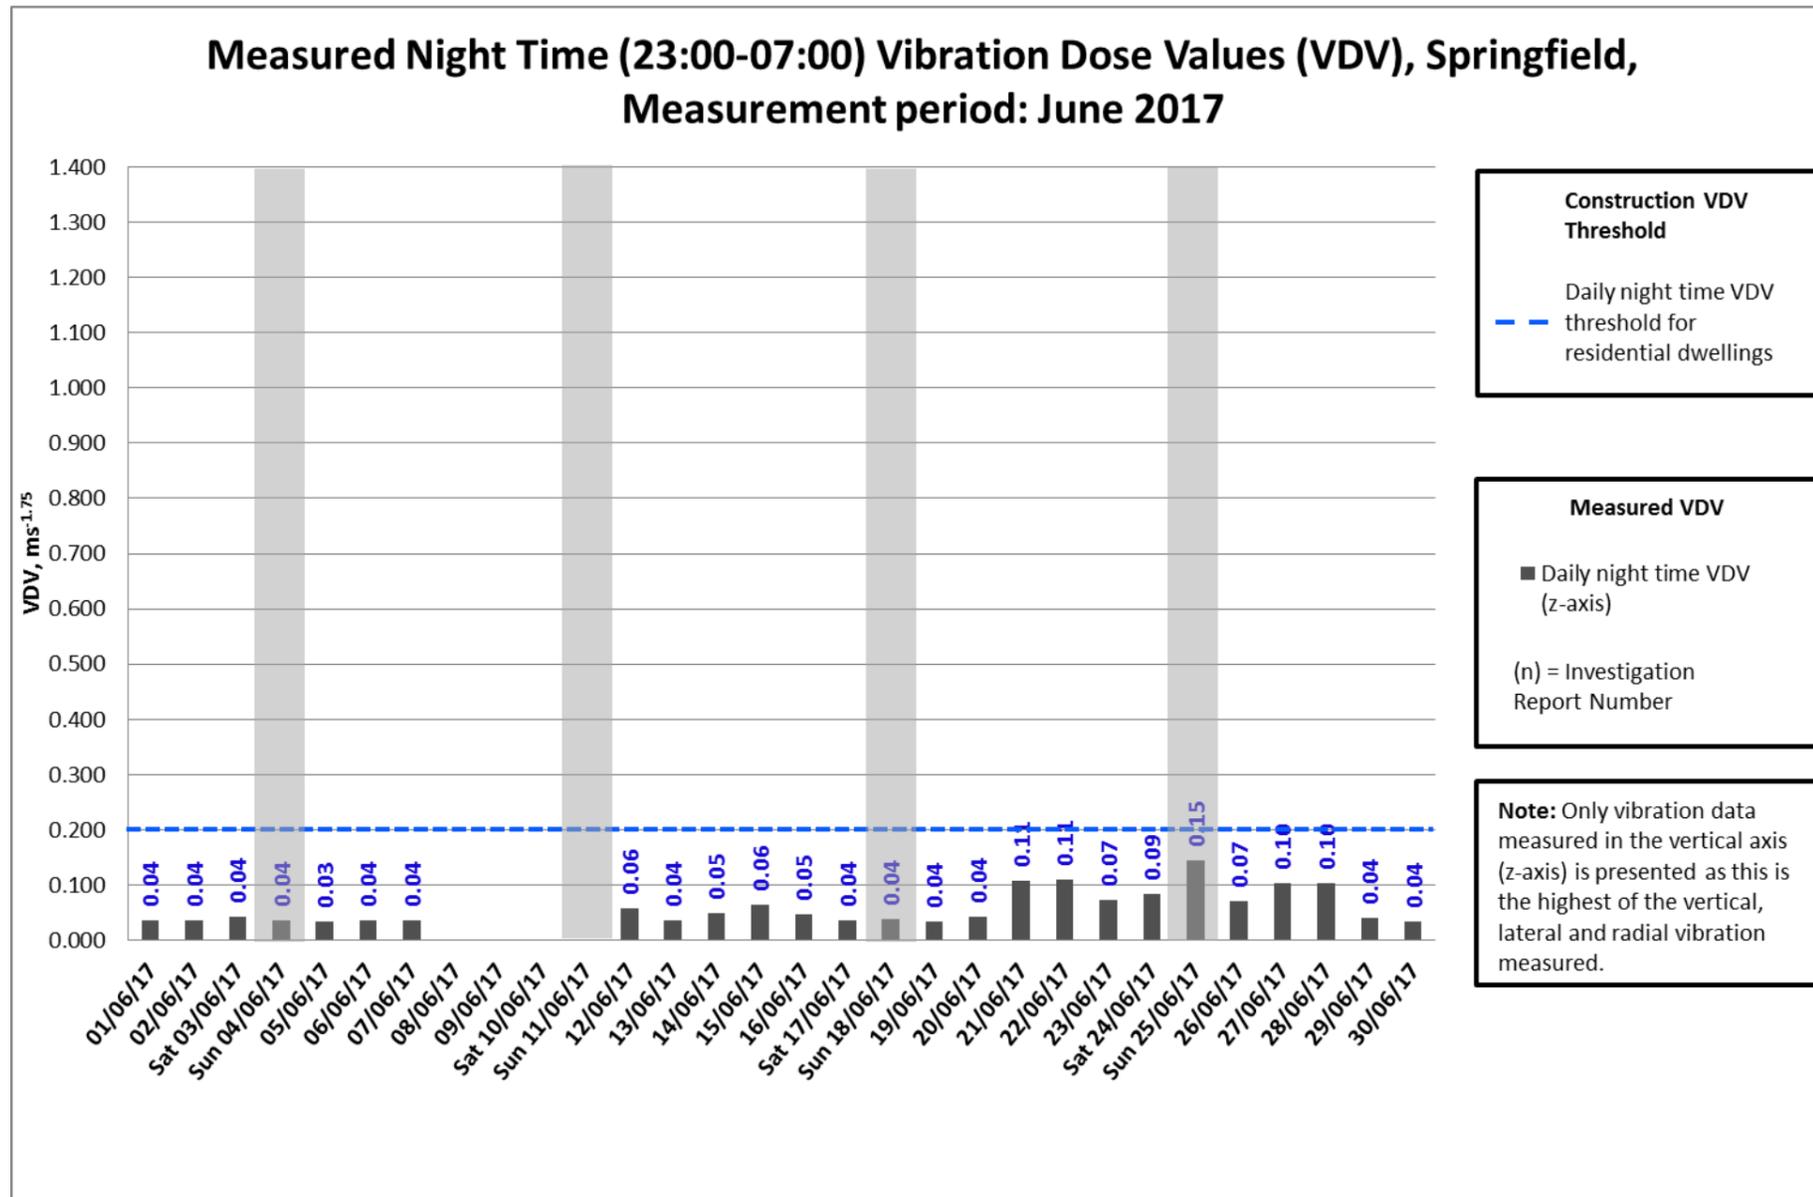
Data missing on the 8th – 11th June was caused by electrical issue with monitor.

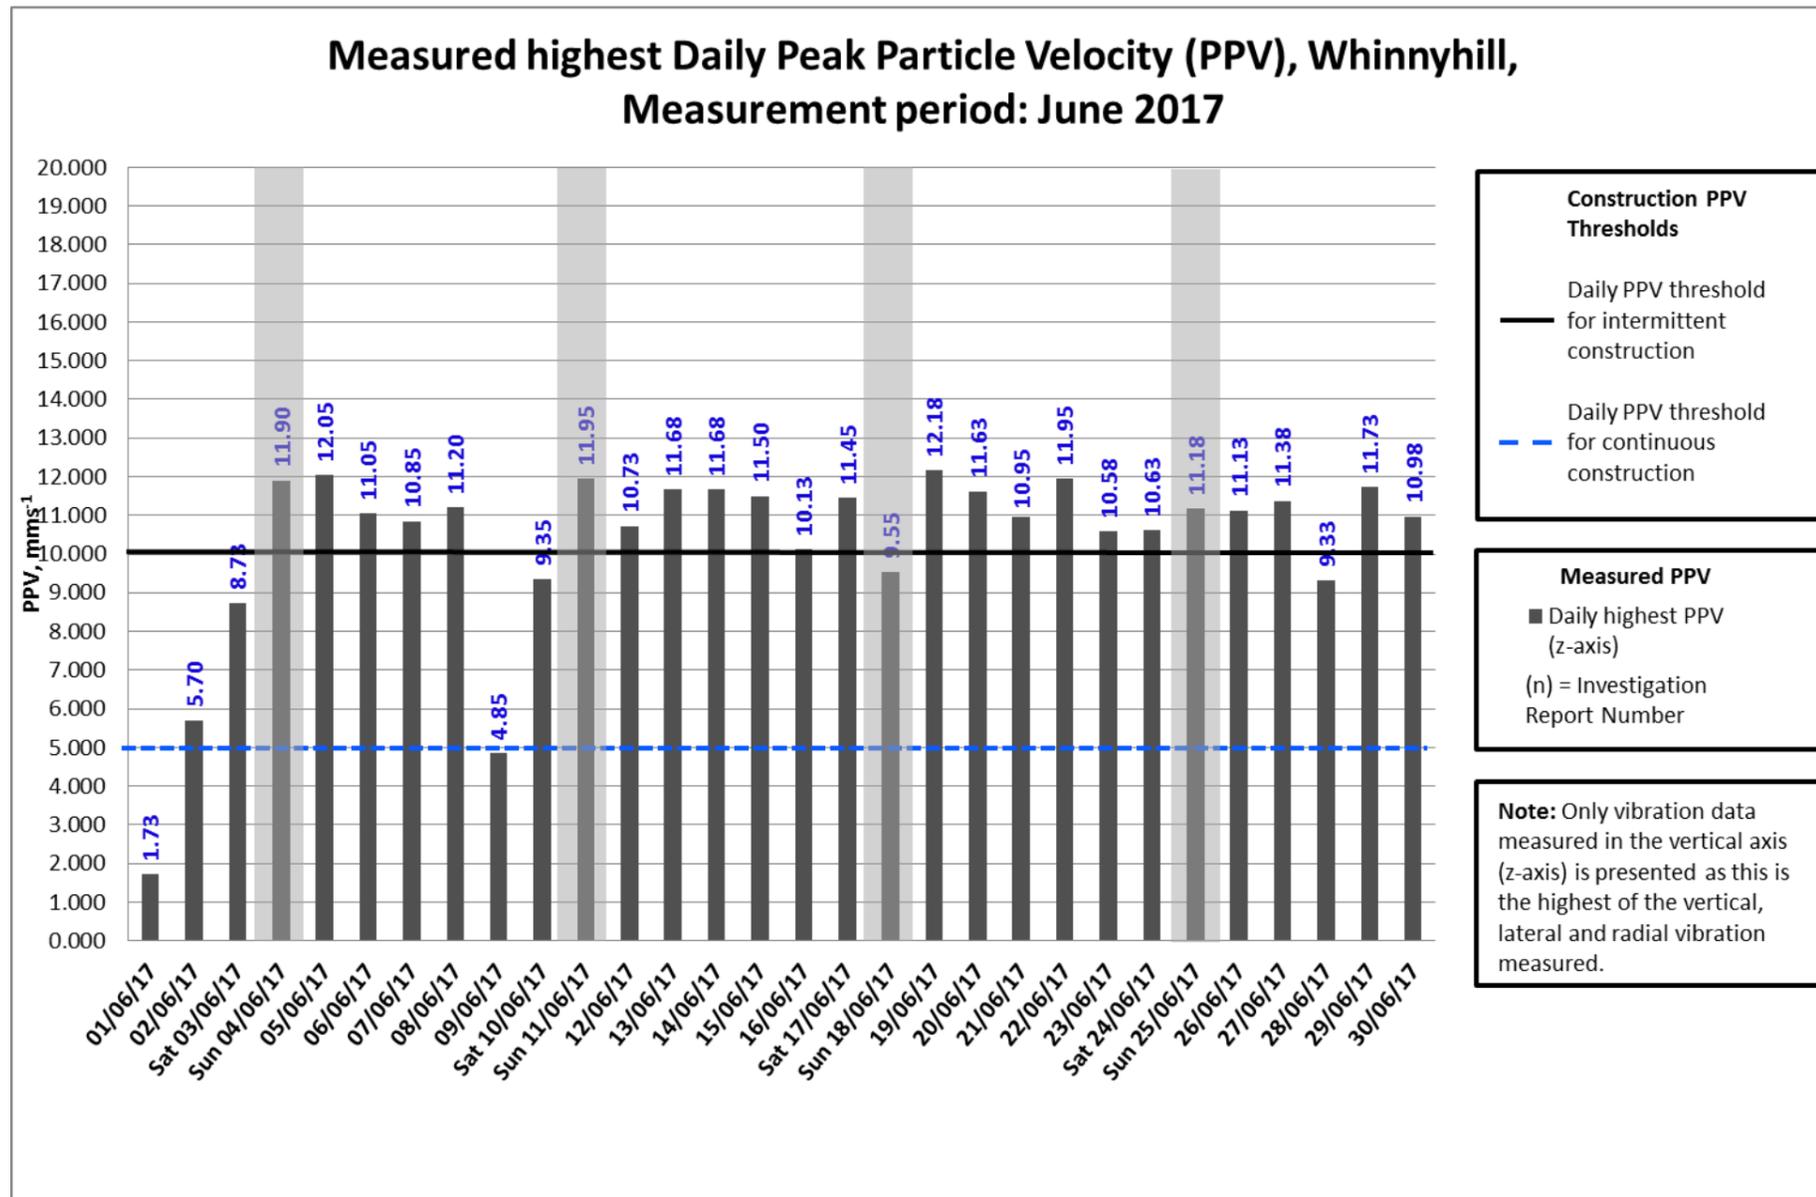
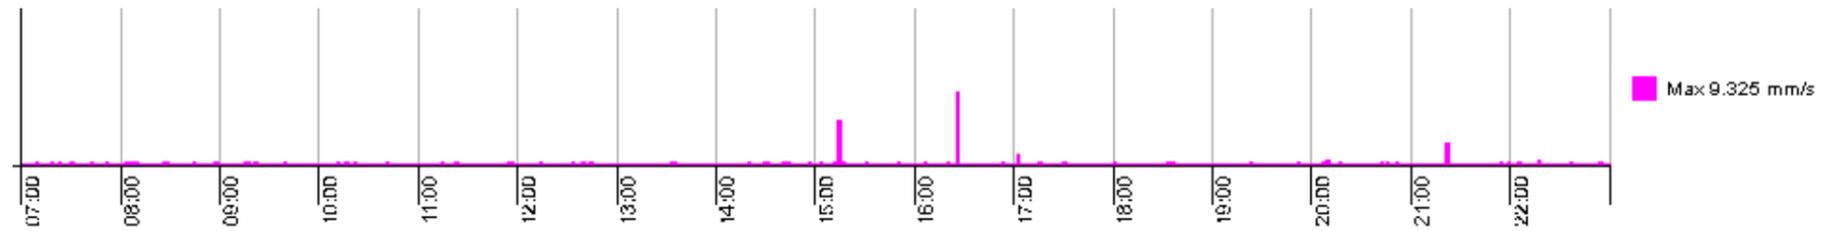
Exceedances on the 2nd, 3rd, 4th, 5th, 6th, 7th, 8th, 10th, 11th, 13th, 14th, 15th, 16th, 17th, 18th, 19th, 20th, 21st, 23rd, 24th, 25th, 27th, 28th and 29th of June have been investigated and found to be caused by individual isolated events that are unlikely to have been construction related activities (graph above from the 28/06/2017).

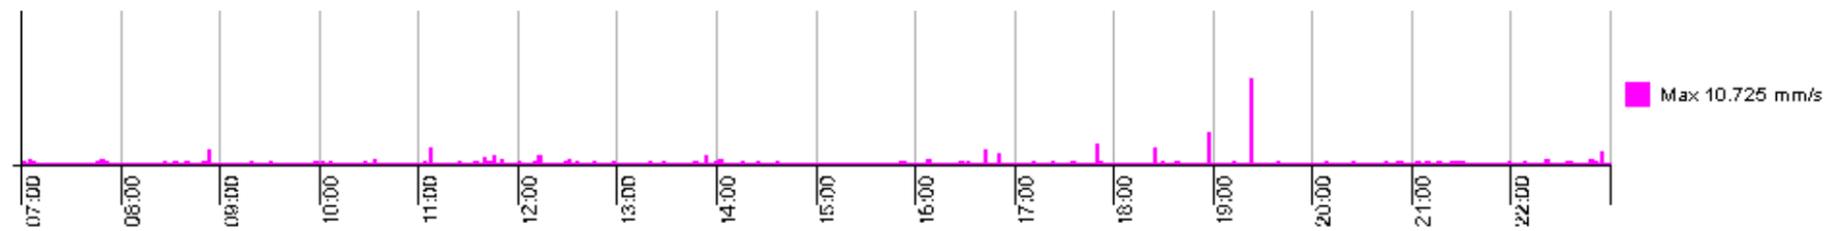
Exceedances on 12th, 22nd, 26th and 30th of June have been investigated and found to be caused out with construction working hours therefore it is unlikely that a construction related activity was the cause of these events (graph above from the 12/06/2017).
