Queensferry  
Crossing

Project FORTH REPLACEMENT CROSSING

VIBRATION MONITORING REPORT

JULY 2017

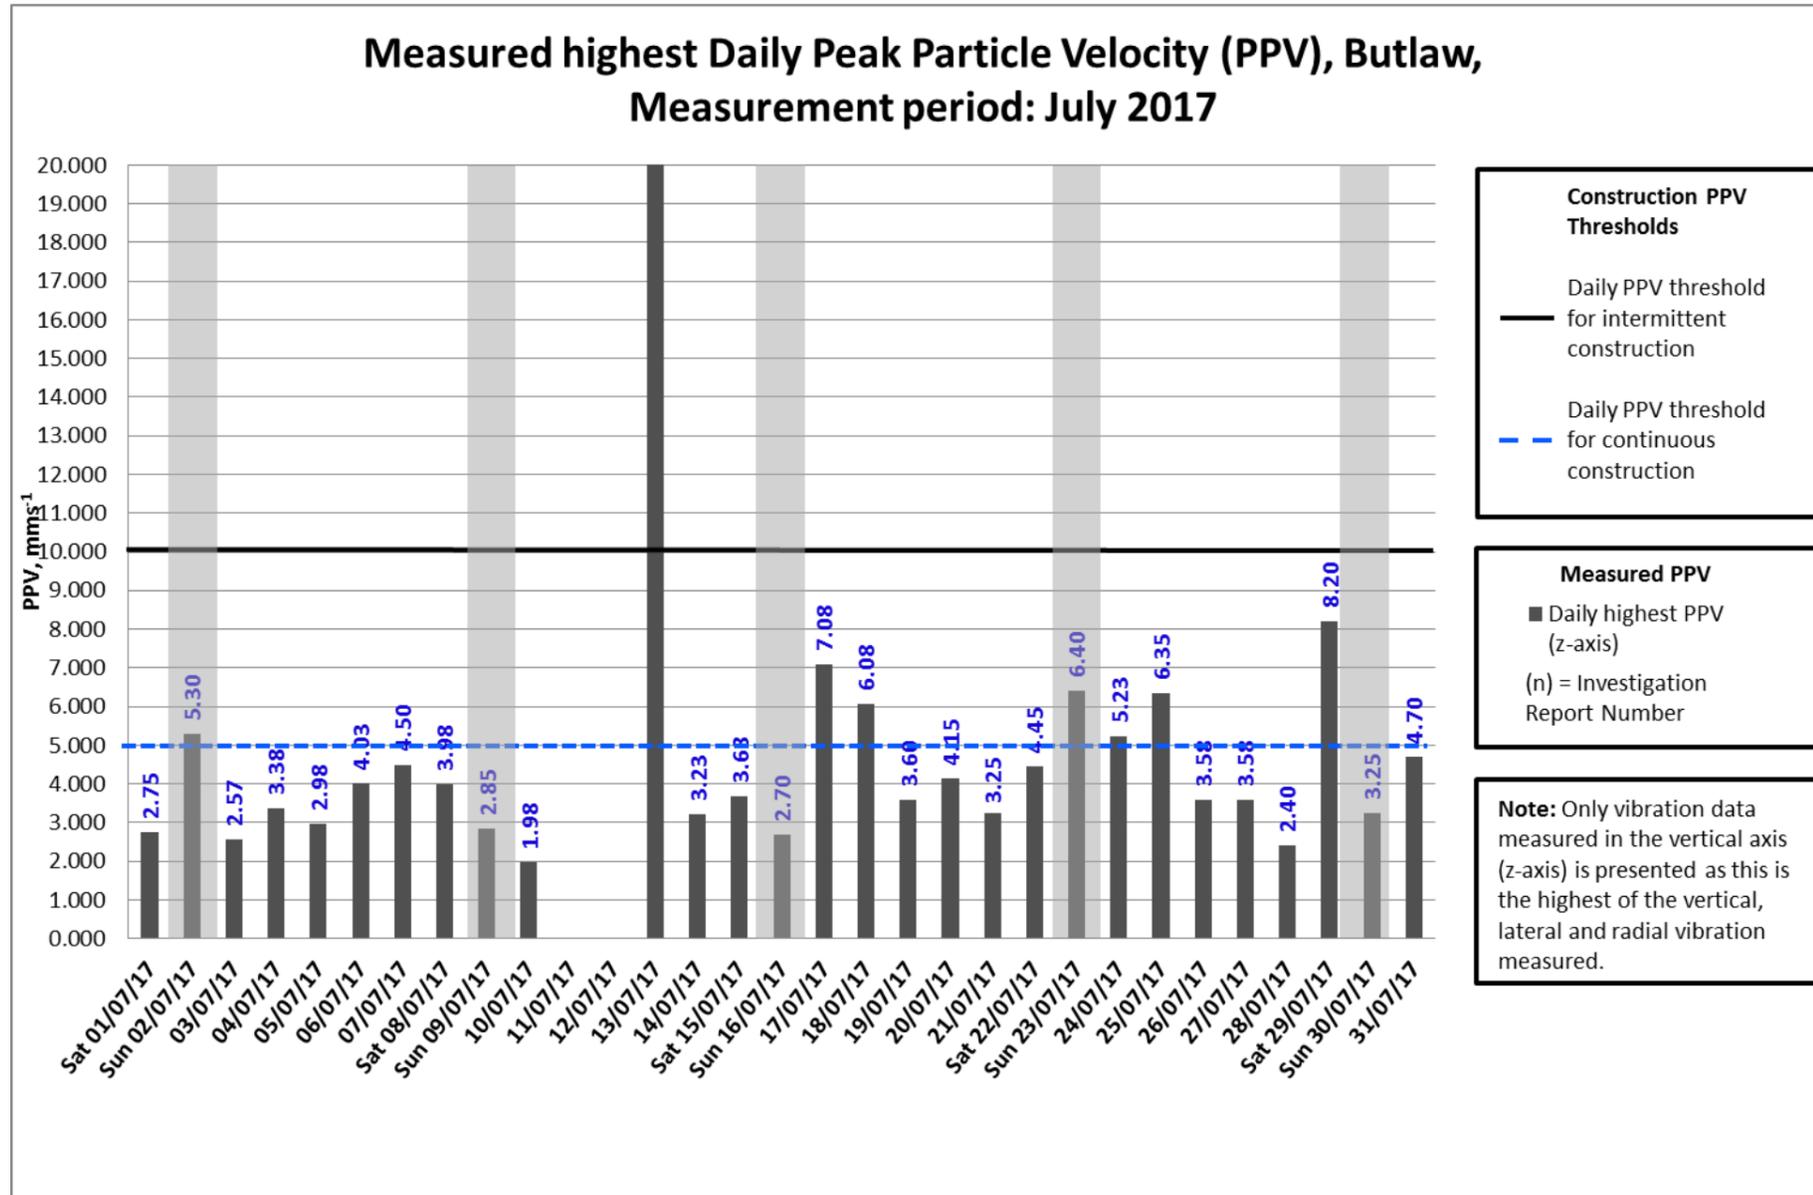
Data missing on the 11<sup>th</sup> – 12<sup>th</sup> July caused by electrical issue with monitor

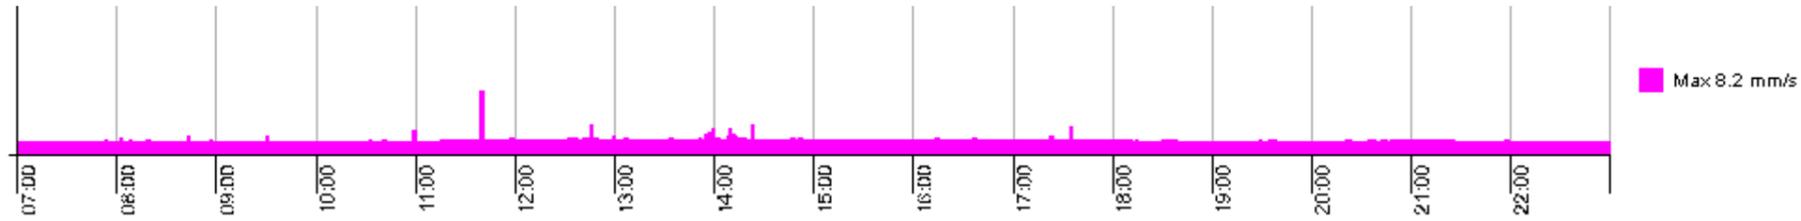
Exceedances on the 2<sup>nd</sup>, 17<sup>th</sup>, 18<sup>th</sup>, 24<sup>th</sup>, 25<sup>th</sup> and 29<sup>th</sup> of July have been investigated and found to be caused by individual isolated events that are unlikely to have been construction related activities (graph above from the 29/07/2017). The vibration monitor is located in the residents back garden, therefore resident's activity may have caused these exceedances.

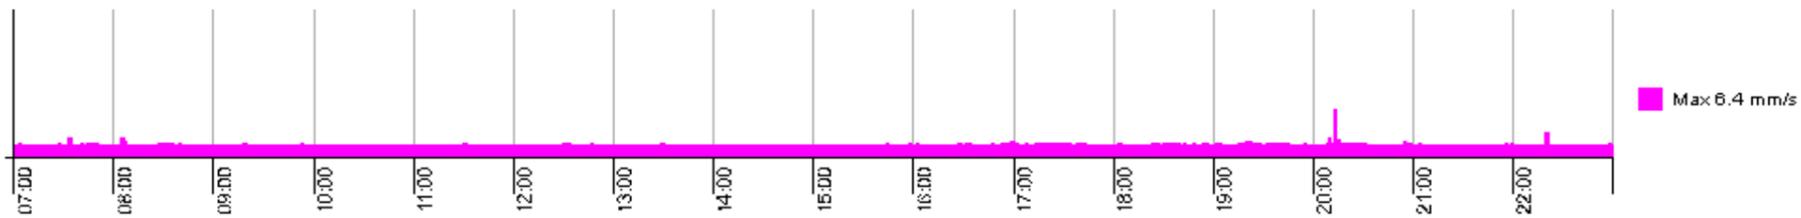
Exceedance on the 23<sup>rd</sup> of July has been investigated and found to be caused out with construction working hours therefore it is unlikely that a construction related activity was the cause of this event (graph above from the 23/07/2017).

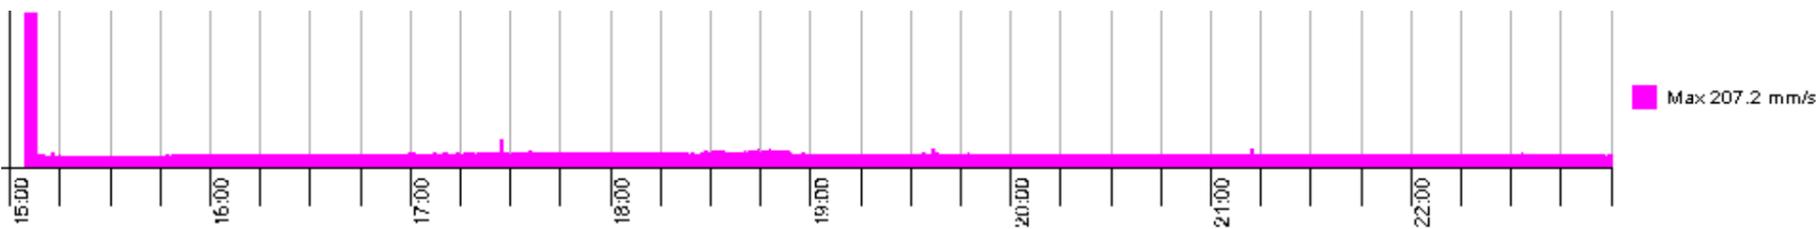
Exceedance on the 13<sup>th</sup> of July has been investigated and found to be caused by the environmental team carrying out maintenance on vibration monitor (graph above from the 13/07/2017).

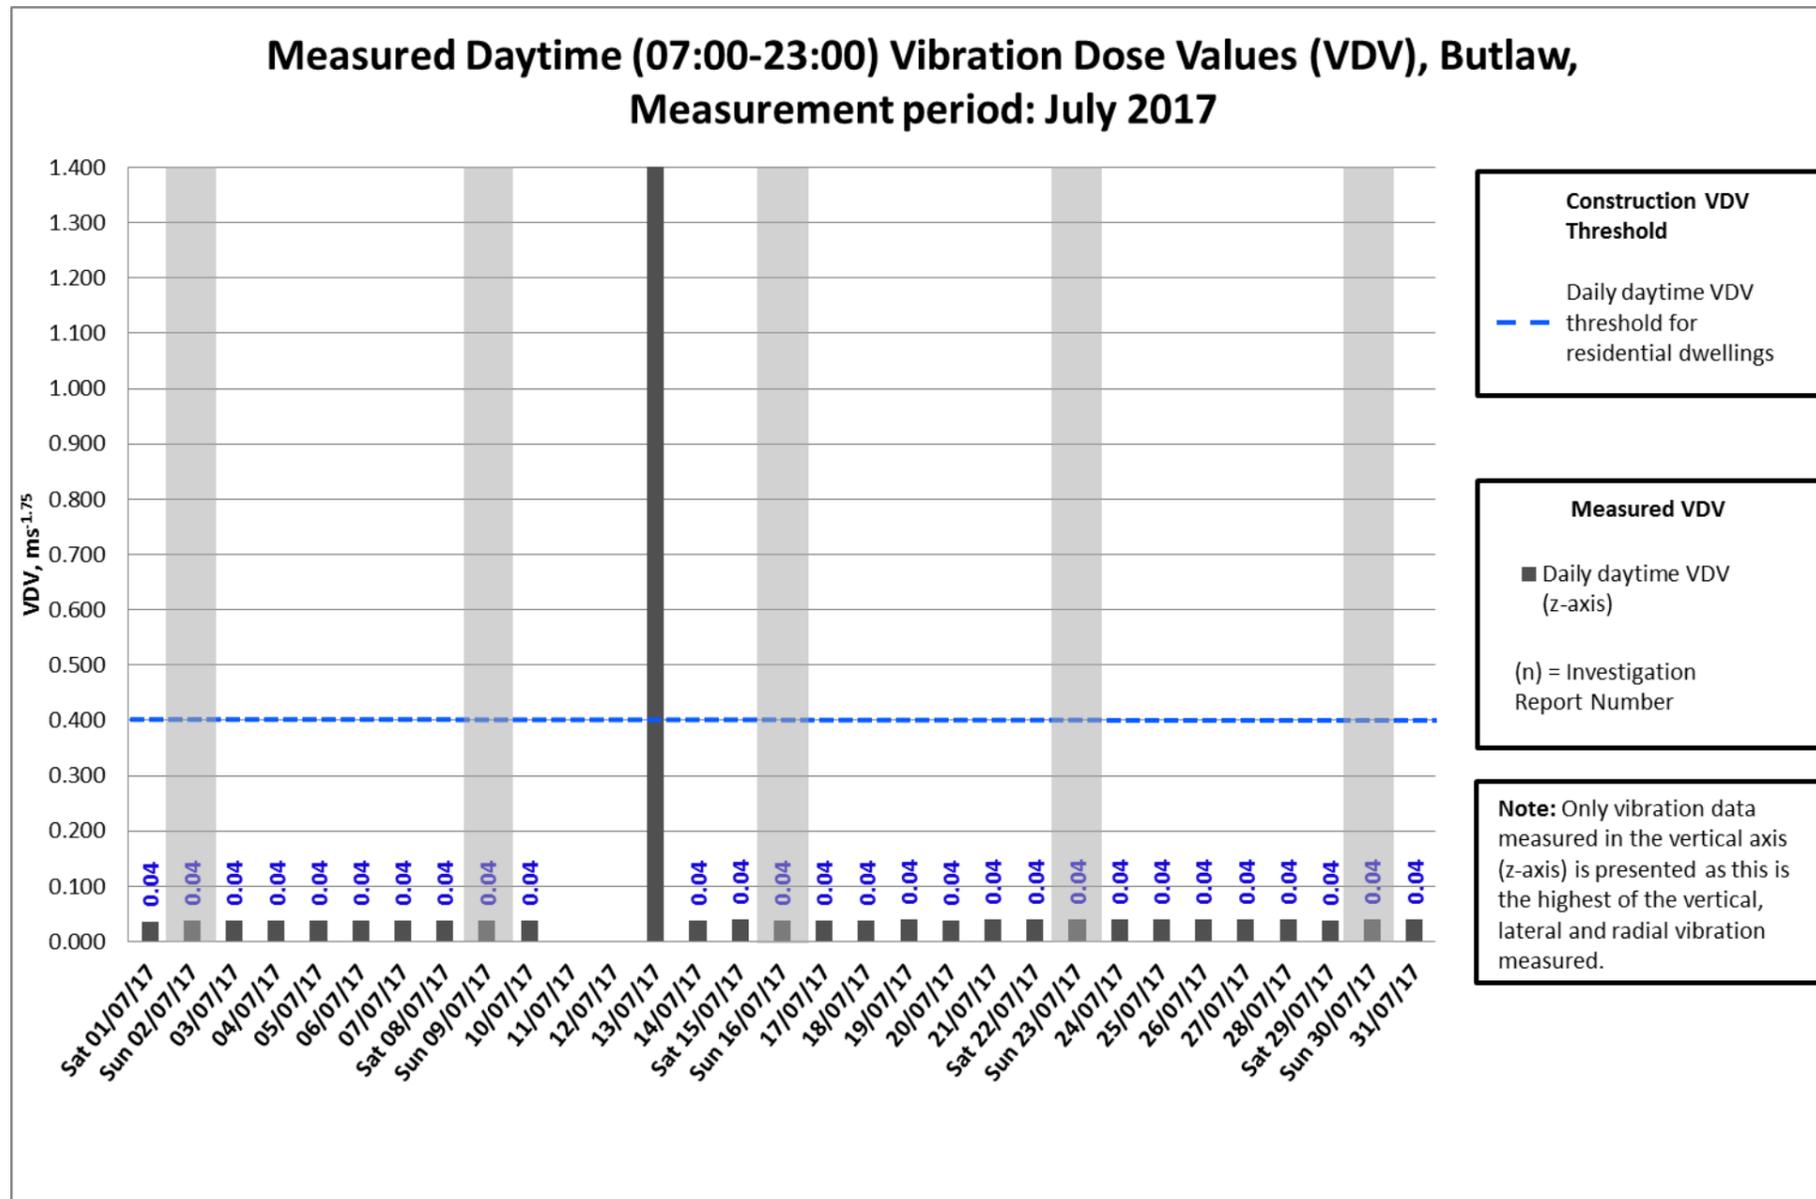
Data missing on the 11<sup>th</sup> – 12<sup>th</sup> July caused by electrical issue with monitor

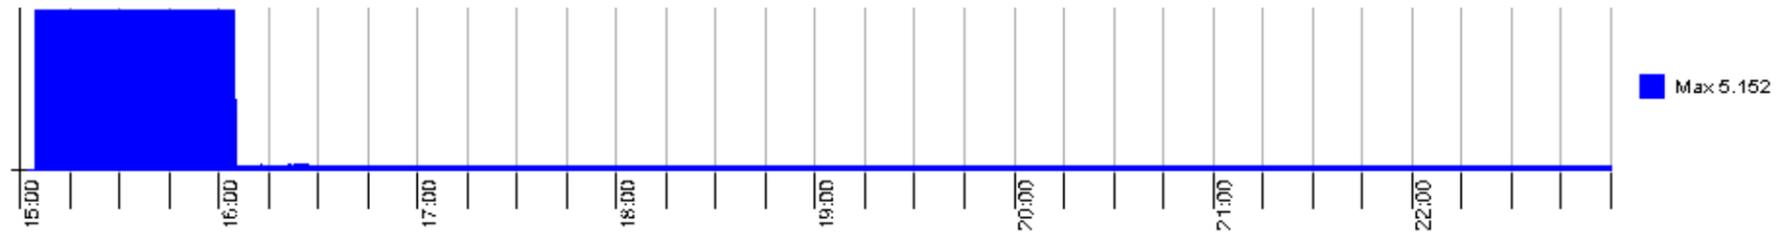
Exceedance on the 13<sup>th</sup> of July has been investigated and found to be caused by the environmental team carrying out maintenance on vibration monitor (graph above from the 13/07/2017).

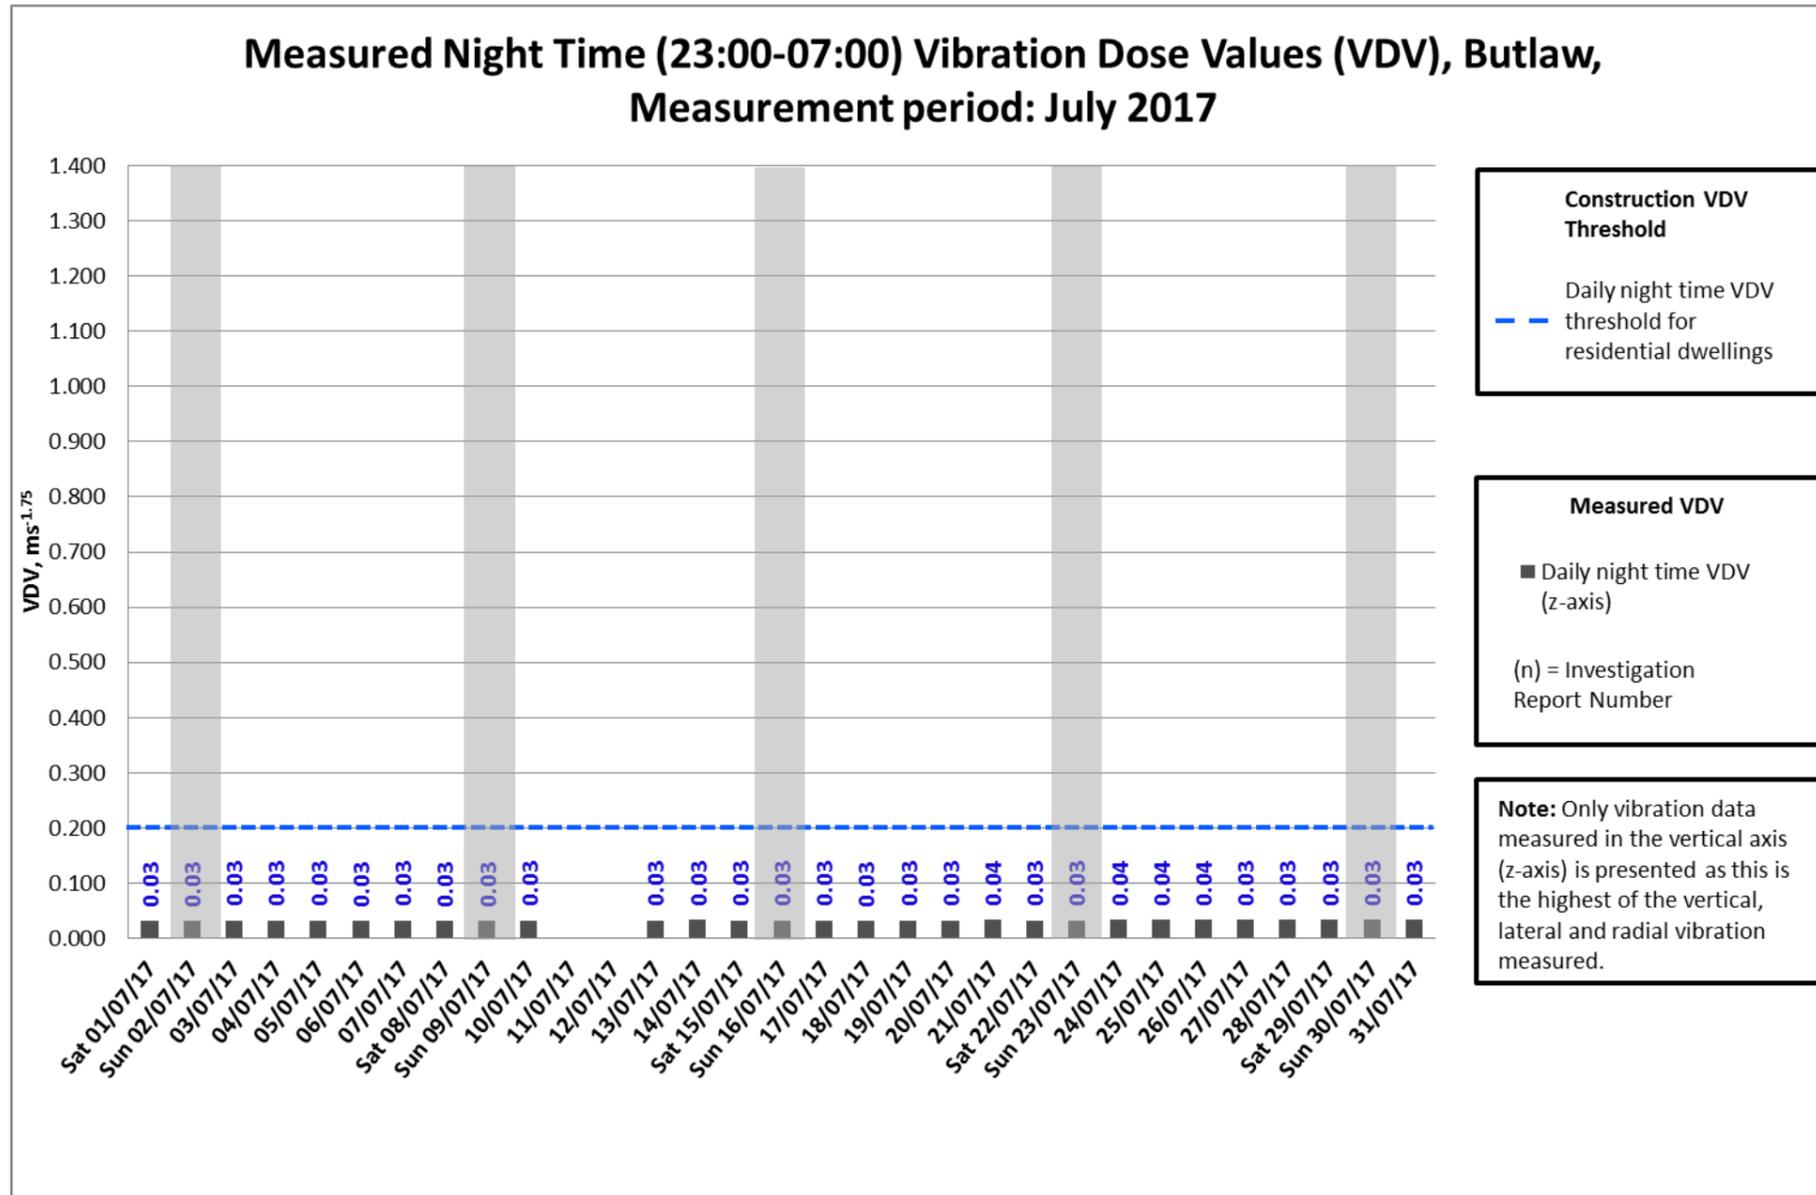
Data missing on the 11<sup>th</sup> – 12<sup>th</sup> July caused by electrical issue with monitor

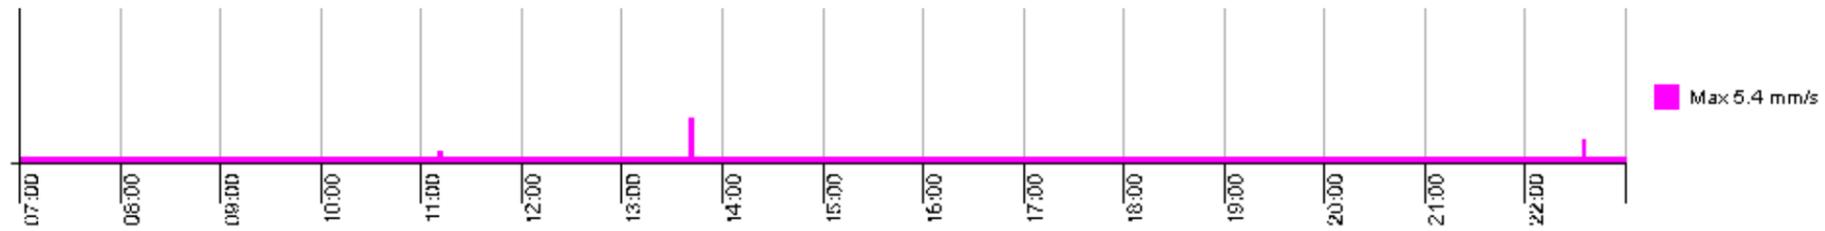
Exceedances on the 1<sup>st</sup>, 3<sup>rd</sup>, 8<sup>th</sup>, 13<sup>th</sup>, 18<sup>th</sup>, 21<sup>st</sup>, 22<sup>nd</sup>, 23<sup>rd</sup> and 29<sup>th</sup> of July have been investigated and found to be caused by individual isolated events that are unlikely to have been construction related activities (graph above from the 29/07/2017). With this monitor being located in a public amenity area there is a likelihood that the exceedances seen above might have been caused by pedestrians using the area.

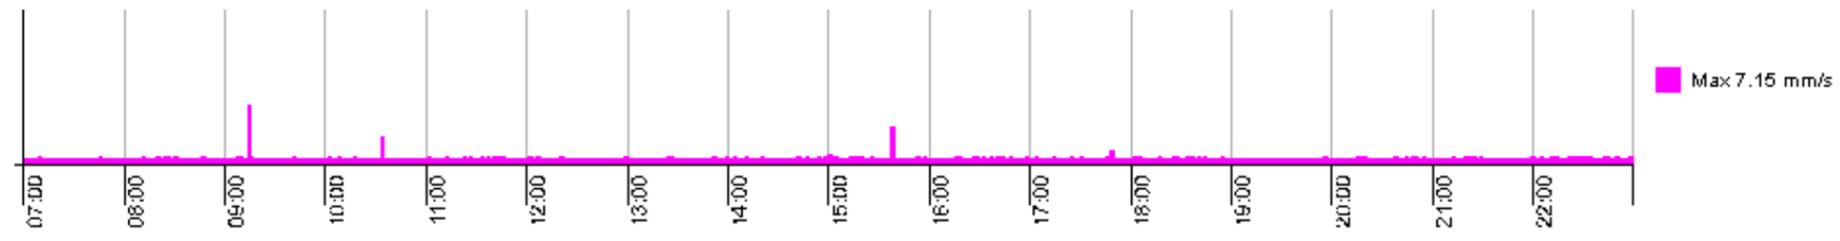
Exceedance on the 10<sup>th</sup> of July has been investigated and found to be caused by the environmental team collecting data from noise monitor (graph above from the 10/07/2017).

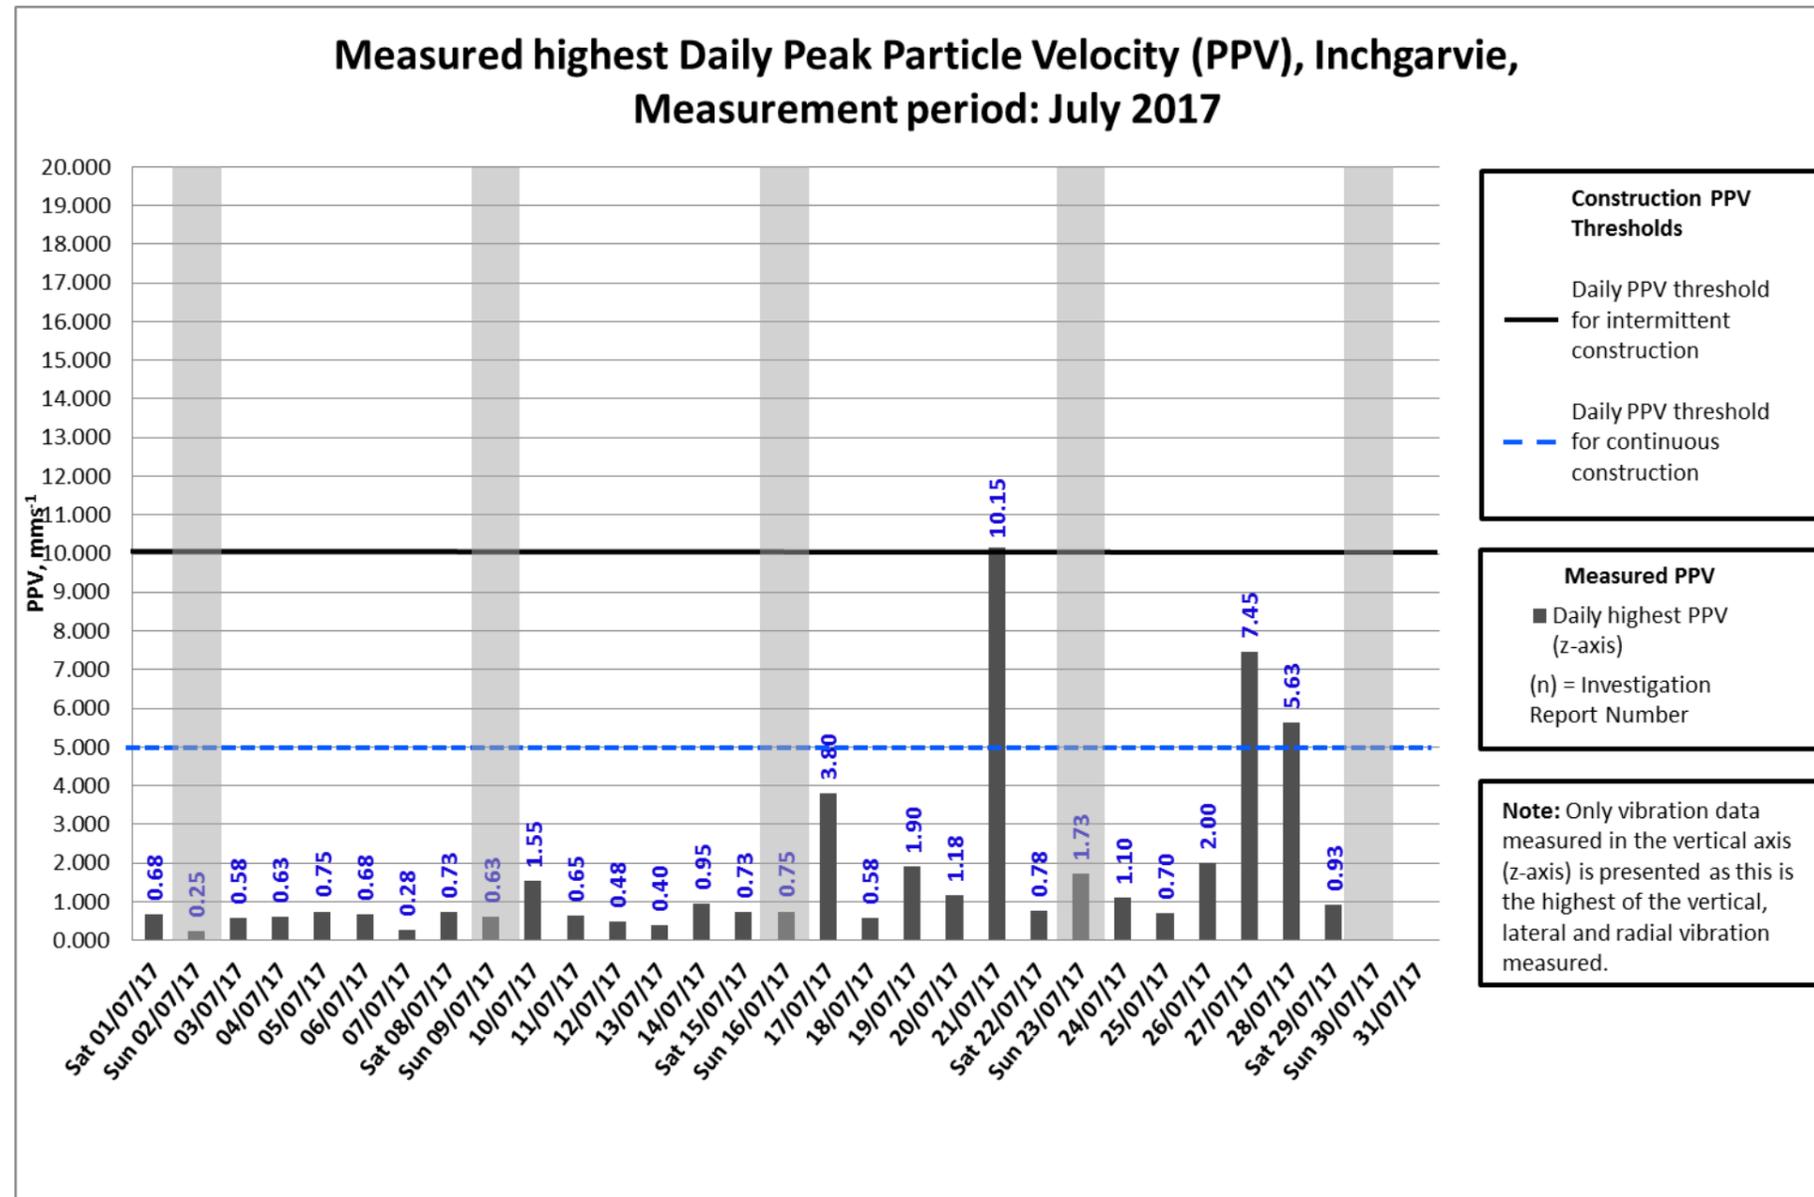
Data missing on the 30<sup>th</sup> – 31<sup>st</sup> July caused by electrical issue with monitor

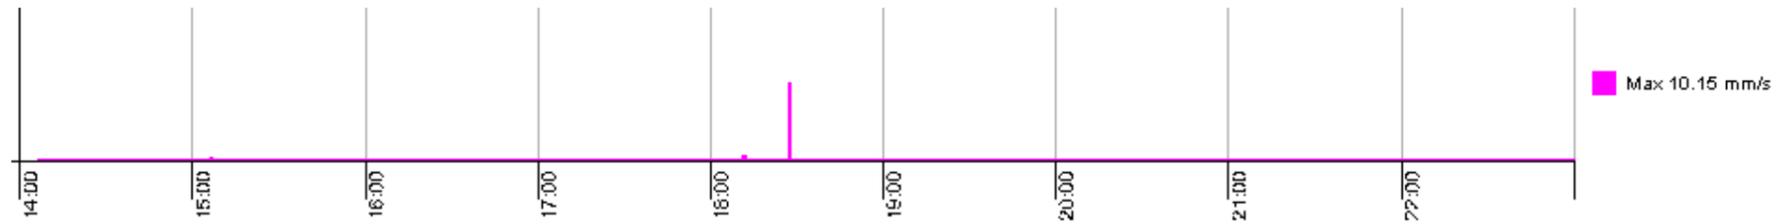
Exceedances on the 21<sup>st</sup> and 28<sup>th</sup> of July have been investigated and found to be caused by individual isolated events that are unlikely to have been construction related activities (graph above from the 21/07/2017). The vibration monitor is located in the residents back garden, therefore resident's activity may have caused these exceedances.

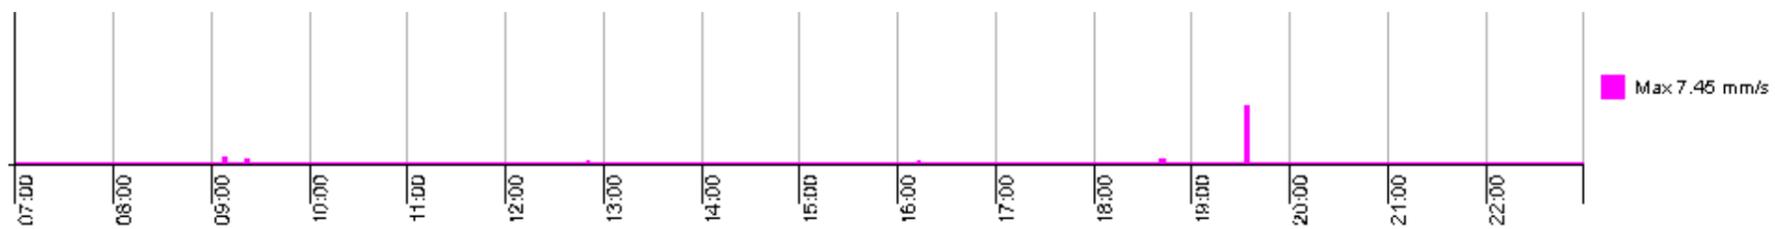
Exceedance on the 27<sup>th</sup> of July has been investigated and found to be caused out with construction working hours therefore it is unlikely that a construction related activity was the cause of this event (graph above from the 27/07/2017).

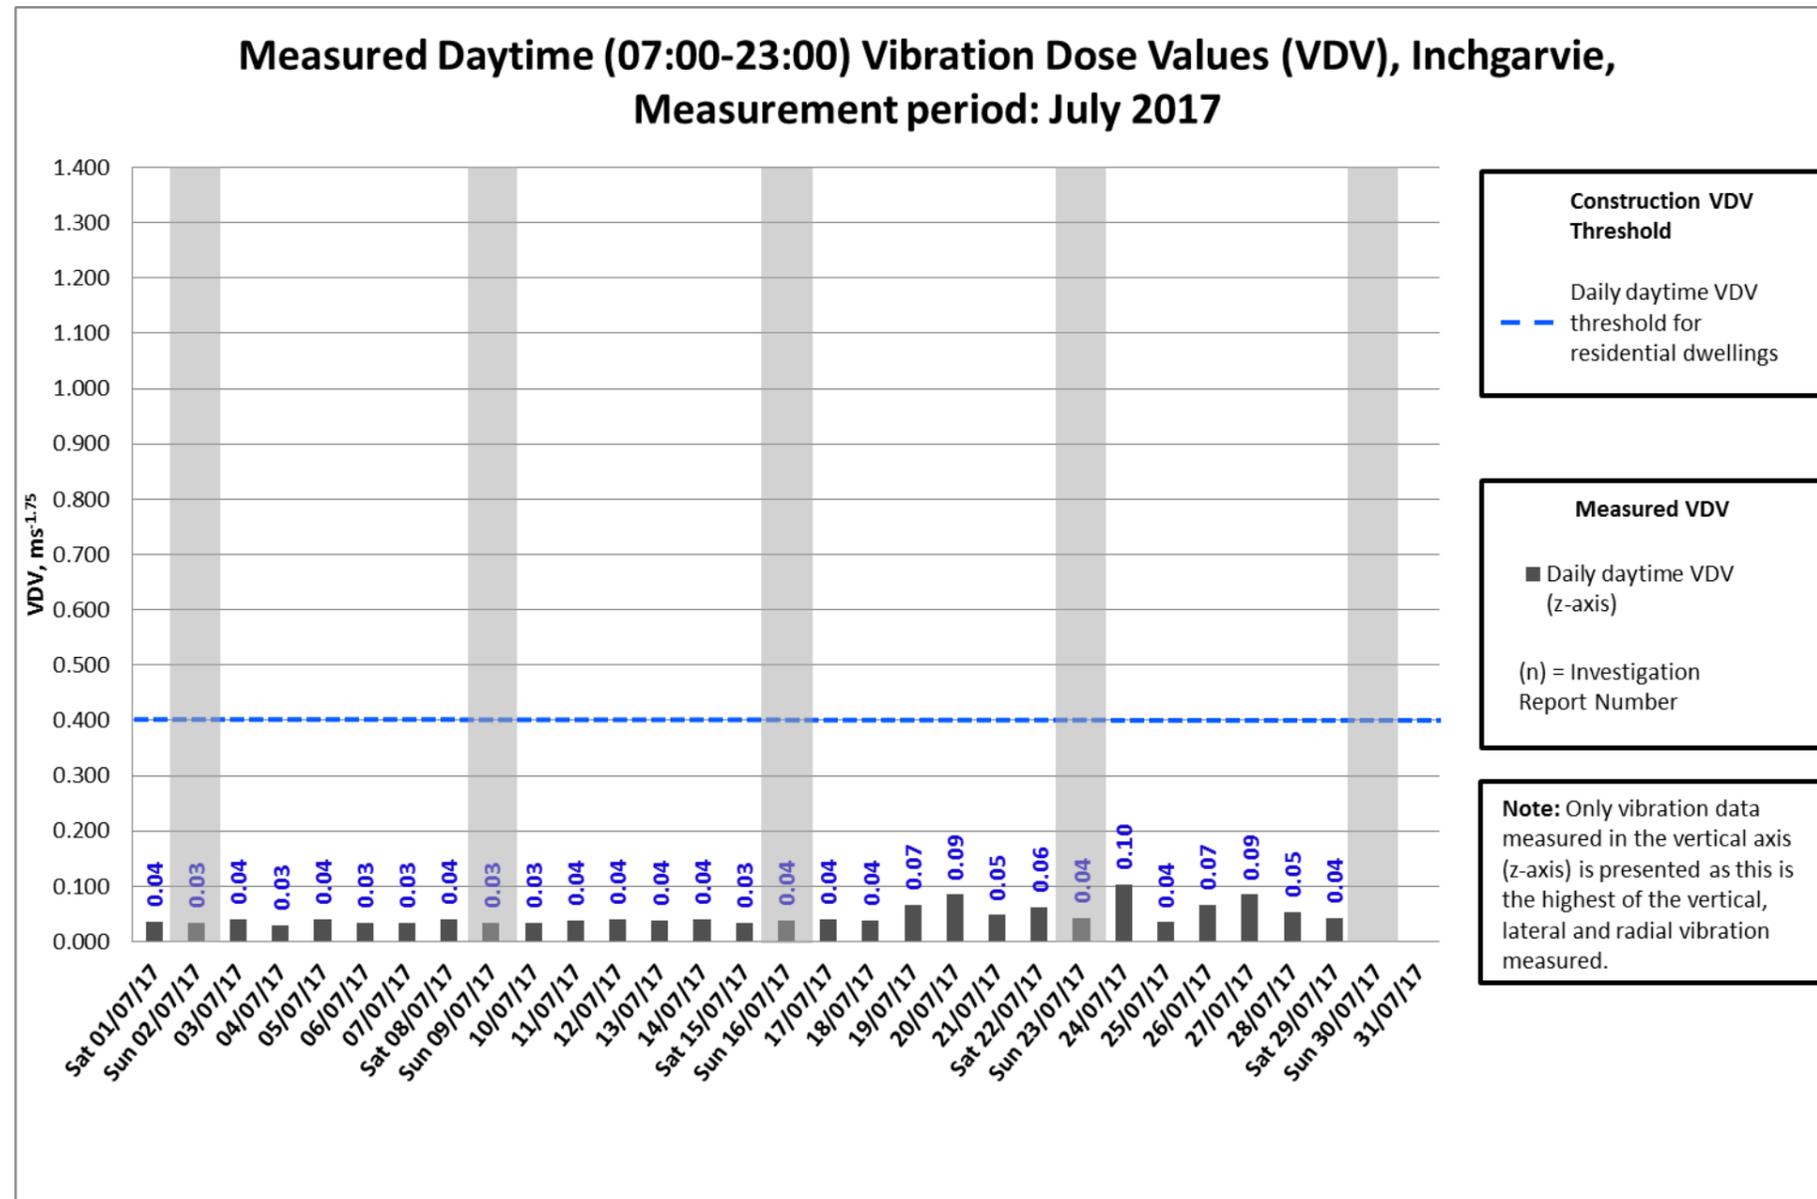
Data missing on the 30<sup>th</sup> – 31<sup>st</sup> of July caused by electrical issue with monitor

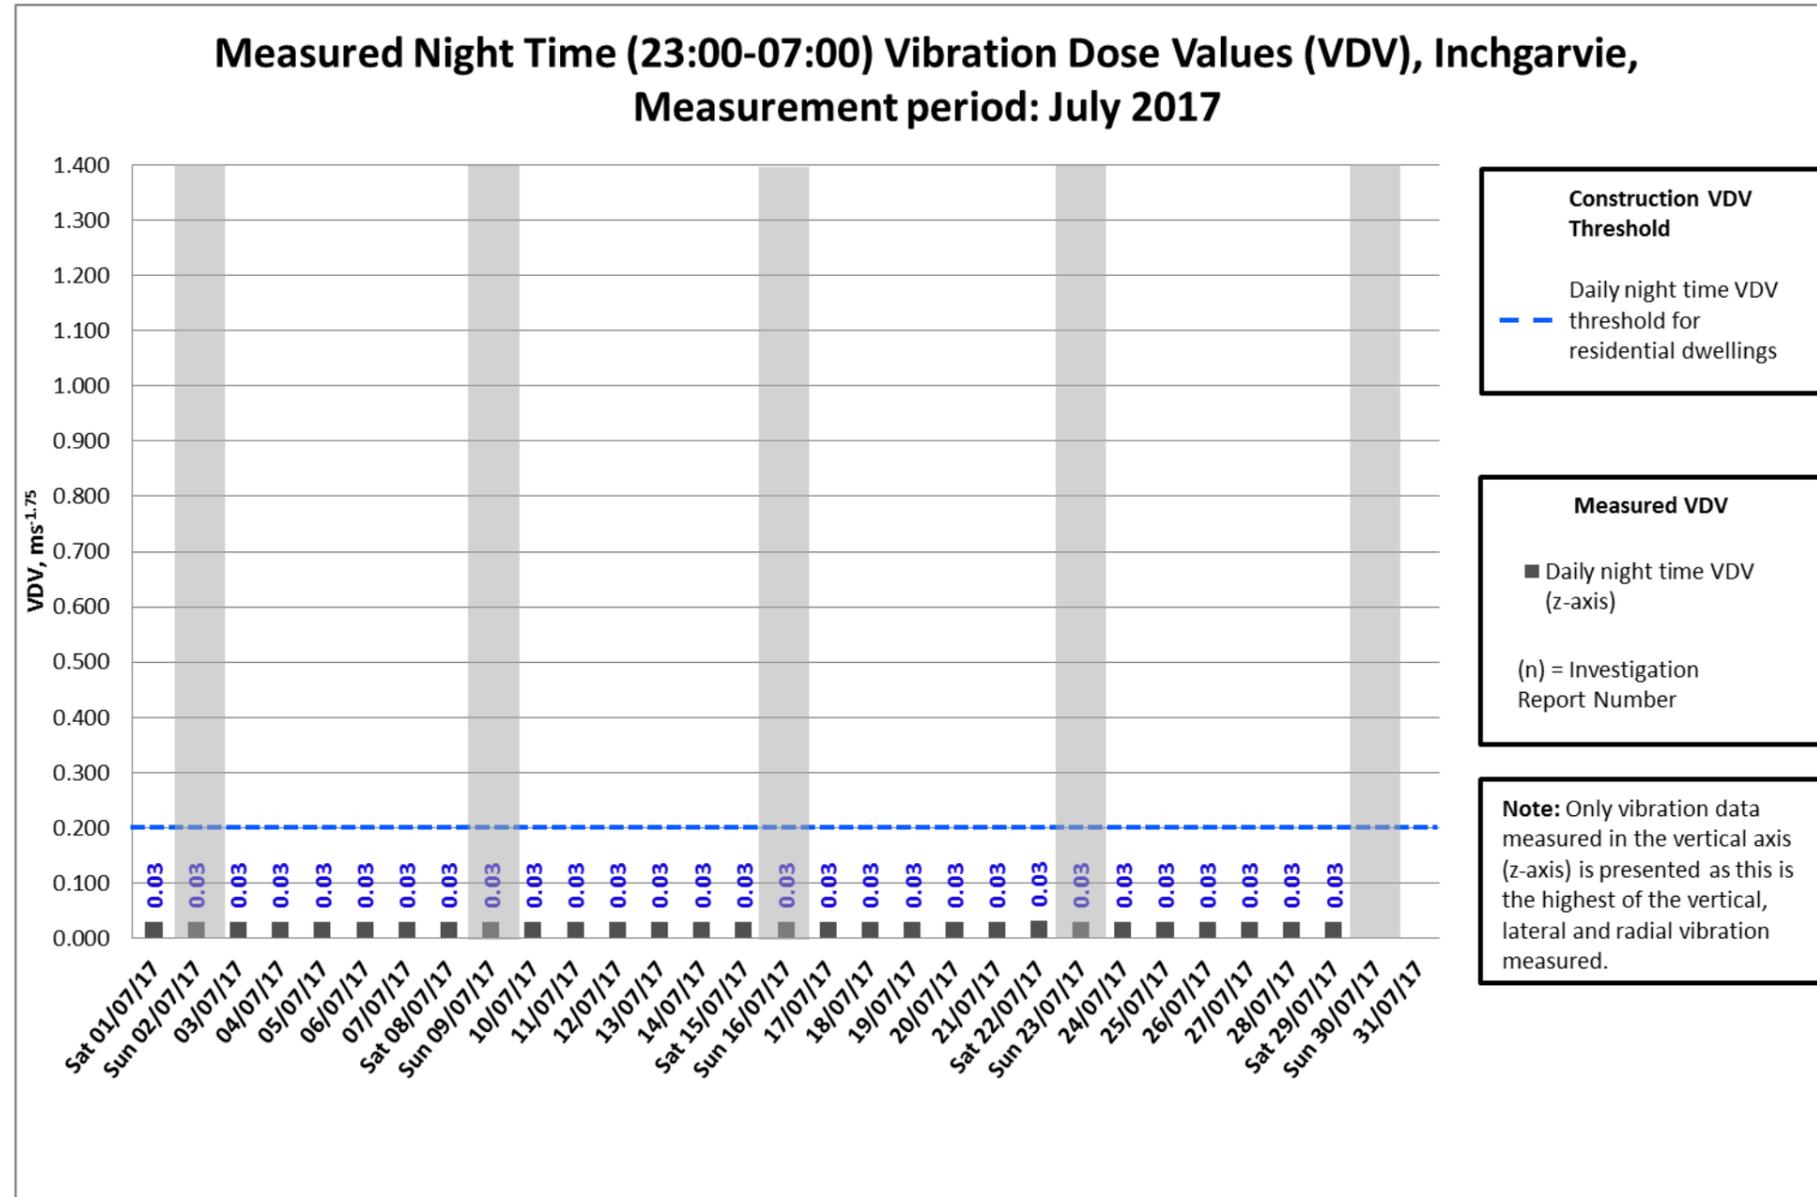
Data missing on the 30<sup>th</sup> – 31<sup>st</sup> of July caused by electrical issue with monitor

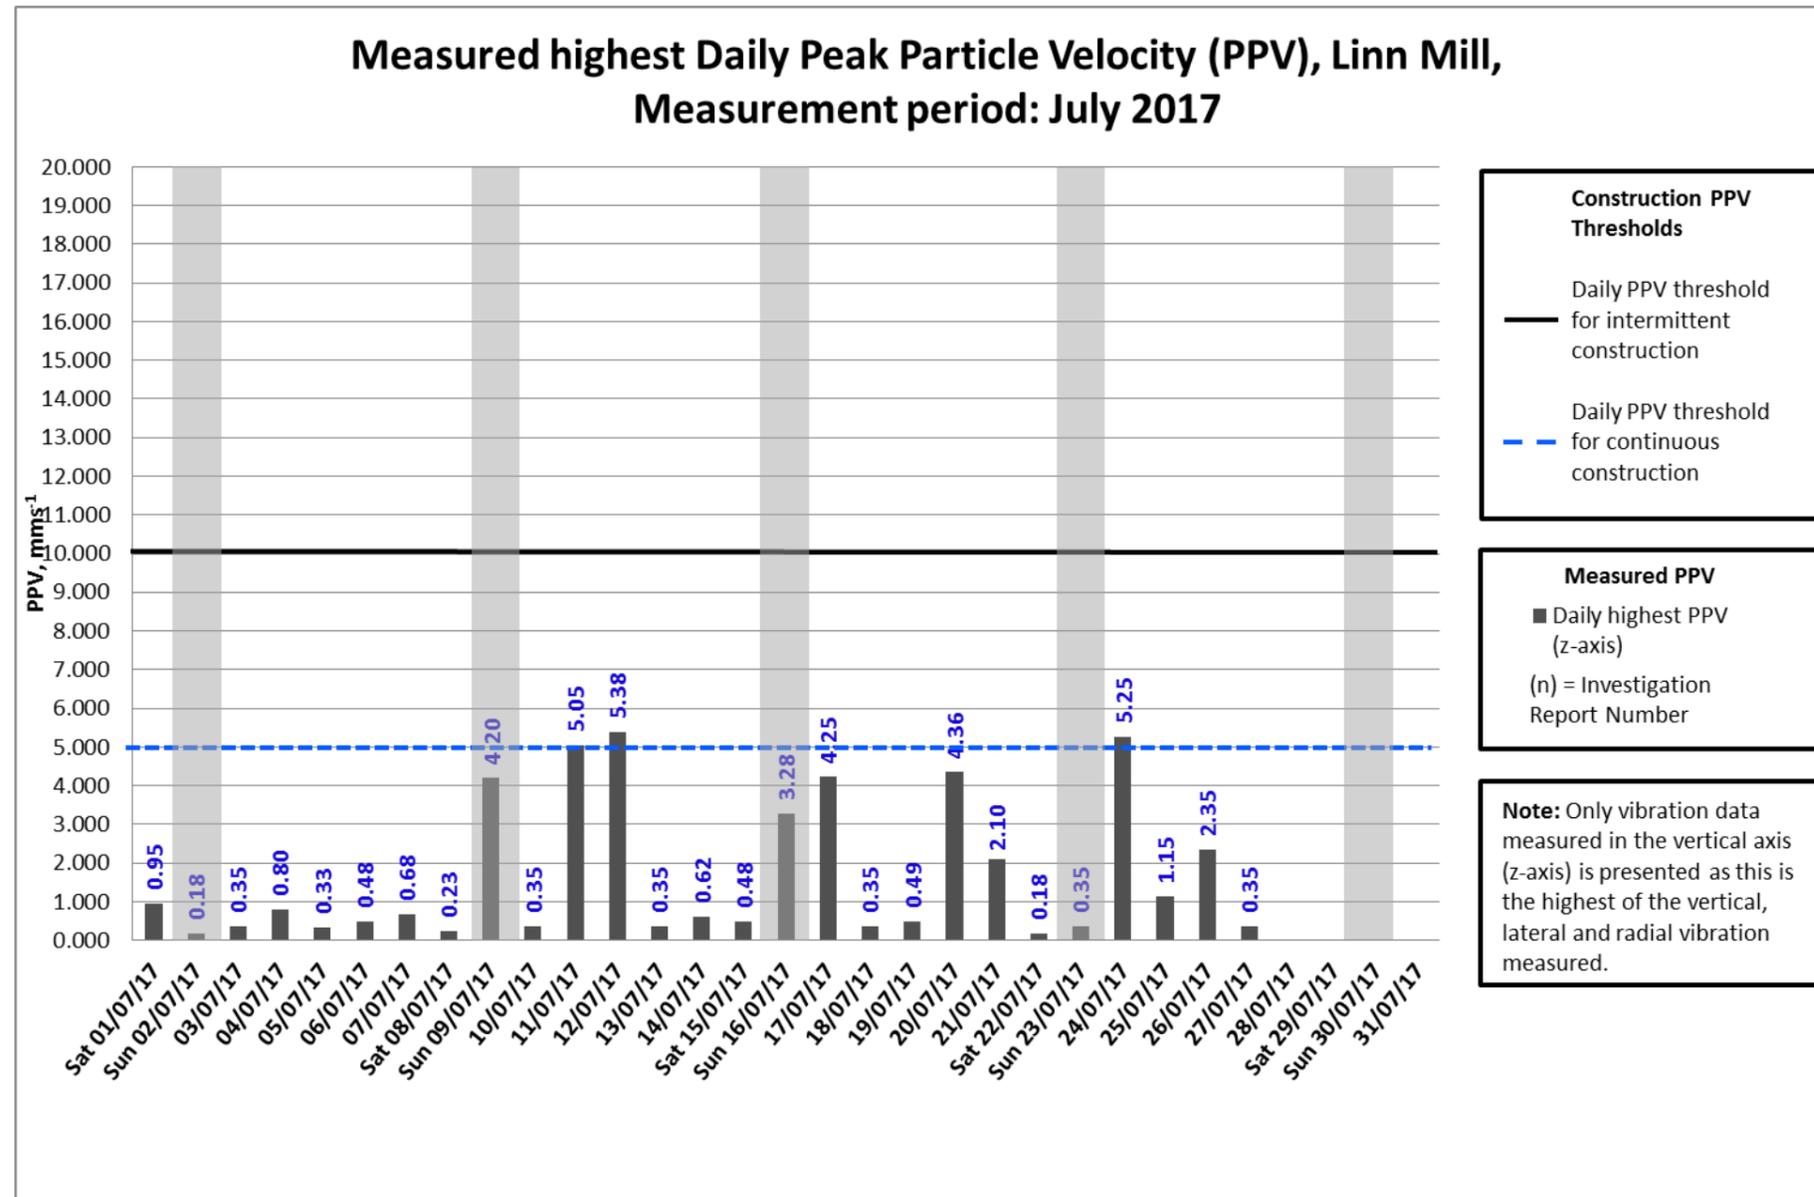
Data missing on the 28<sup>th</sup> – 31<sup>st</sup> of July caused by electrical issue with monitor

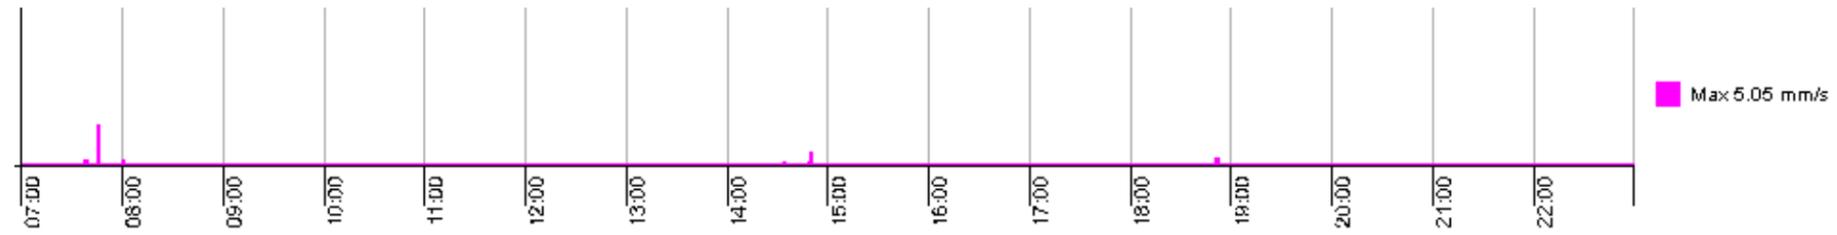
Exceedances on the 11<sup>th</sup>, 12<sup>th</sup> and 24<sup>th</sup> of July have been investigated and found to be caused by individual isolated events that are unlikely to have been construction related activities (graph above from the 11/07/2017).

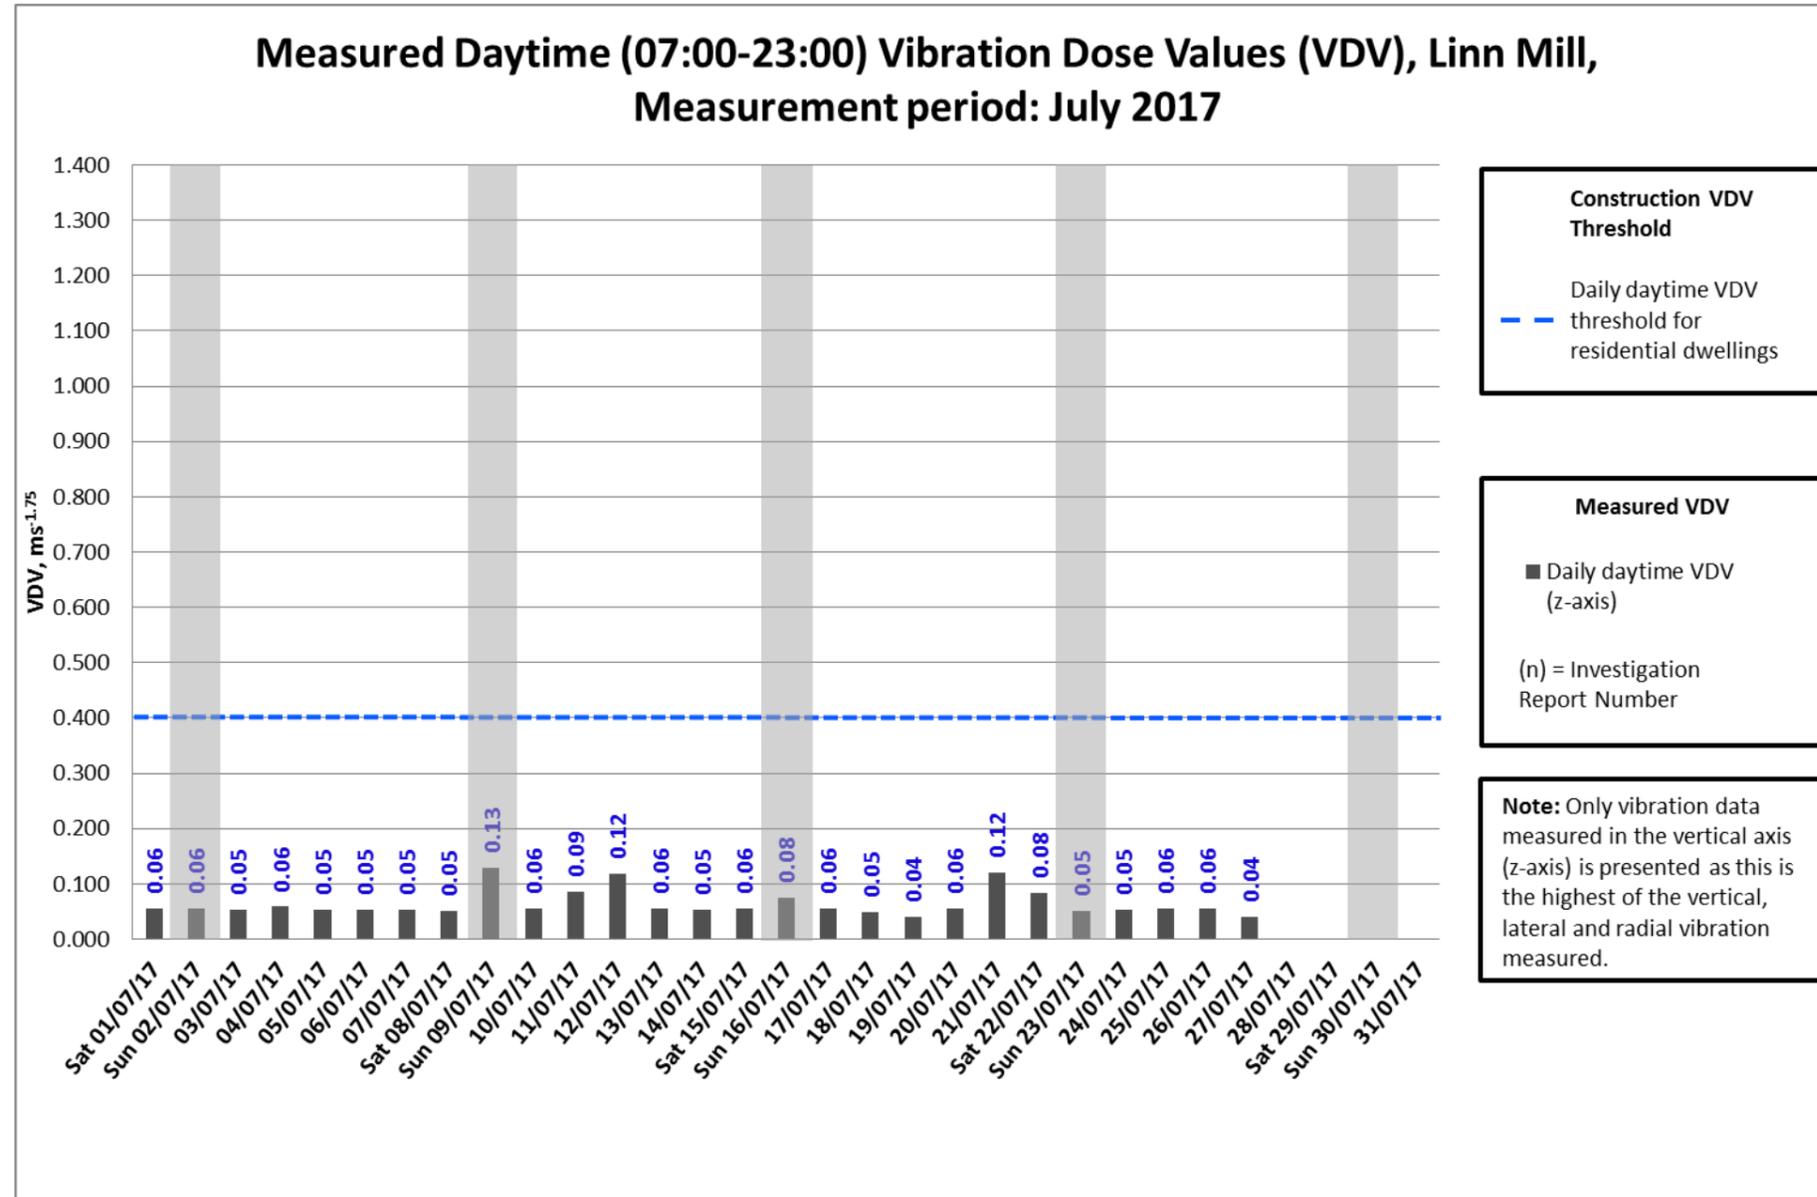
Data missing on the 28<sup>th</sup> – 31<sup>st</sup> of July caused by electrical issue with monitor
