Queensferry  
Crossing

Project FORTH REPLACEMENT CROSSING

VIBRATION MONITORING REPORT

JULY 2017

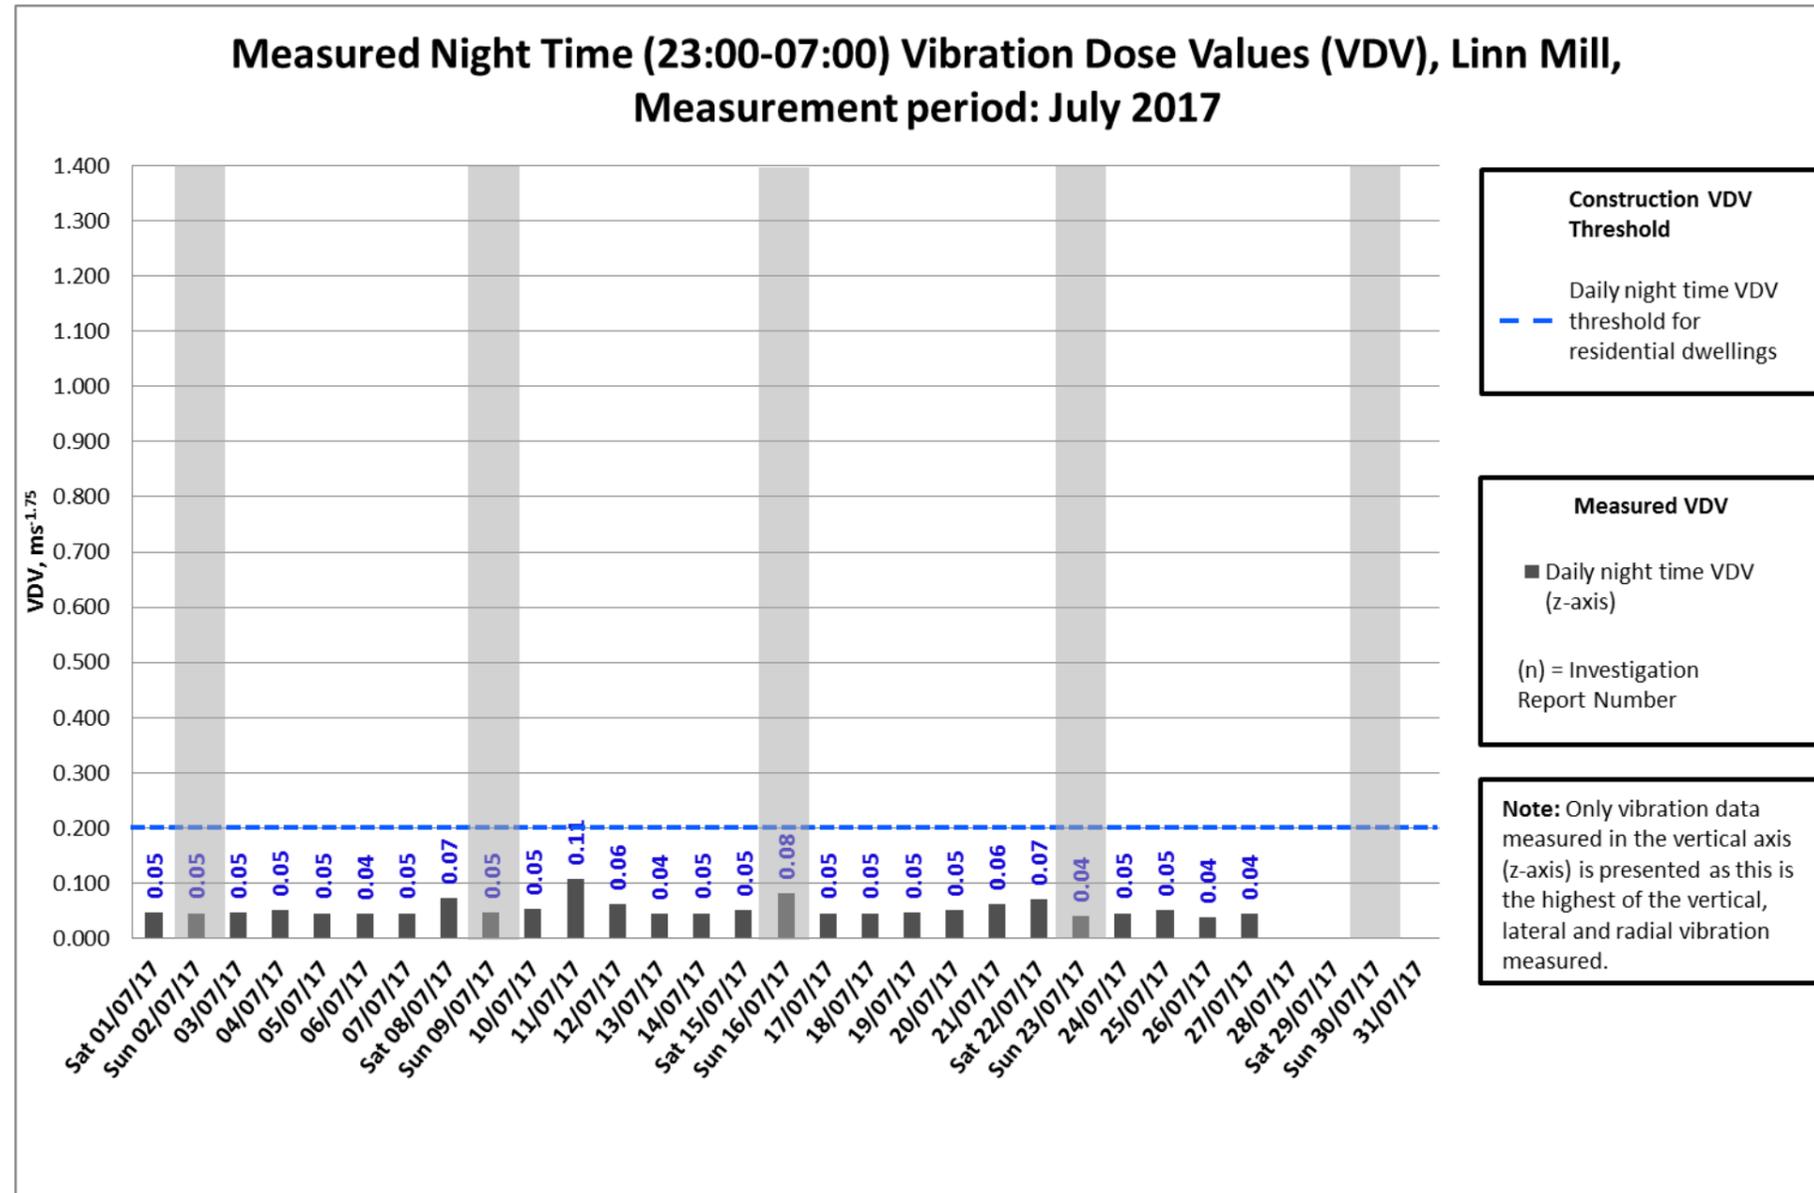
Data missing on the 28<sup>th</sup> – 31<sup>st</sup> of July caused by electrical issue with monitor

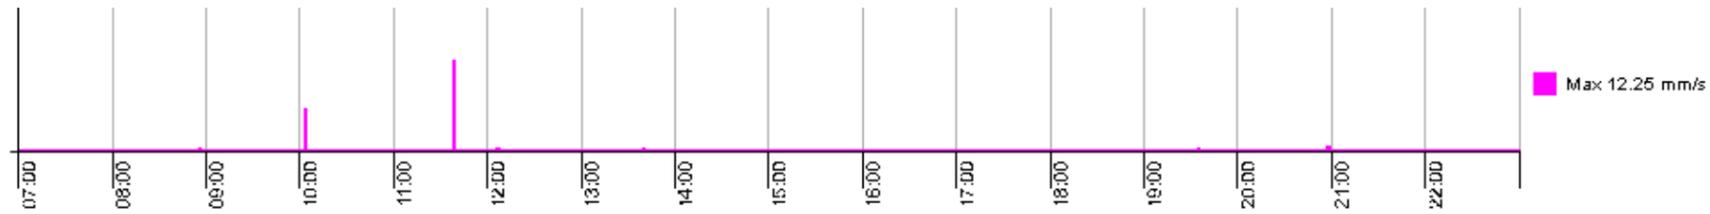
Exceedances on the 1<sup>st</sup>, 2<sup>nd</sup>, 3<sup>rd</sup>, 4<sup>th</sup>, 7<sup>th</sup>, 8<sup>th</sup>, 9<sup>th</sup>, 10<sup>th</sup>, 12<sup>th</sup>, 13<sup>th</sup>, 14<sup>th</sup>, 15<sup>th</sup>, 16<sup>th</sup>, 17<sup>th</sup>, 18<sup>th</sup>, 19<sup>th</sup>, 20<sup>th</sup>, 21<sup>st</sup>, 22<sup>nd</sup>, 23<sup>rd</sup>, 24<sup>th</sup>, 28<sup>th</sup>, 29<sup>th</sup>, 30<sup>th</sup> and 31<sup>st</sup> of July have been investigated and found to be caused by individual isolated events that are unlikely to have been construction related activities (graph above from the 08/07/2017). The vibration monitor is located in the residents back garden, therefore resident's activity may have caused these exceedances. During this period, the closest works to this location was the installation of fences at the East SUDS pond undertaken approx. 300m away.

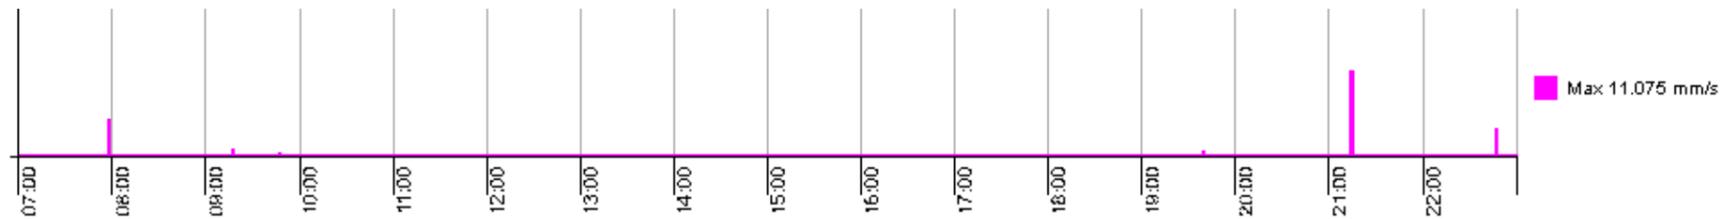
Exceedances on the 5<sup>th</sup>, 6<sup>th</sup>, 25<sup>th</sup> and 26<sup>th</sup> of July have been investigated and found to be caused out with construction working hours therefore it is unlikely that a construction related activity was the cause of these events (graph above from the 05/07/2017).

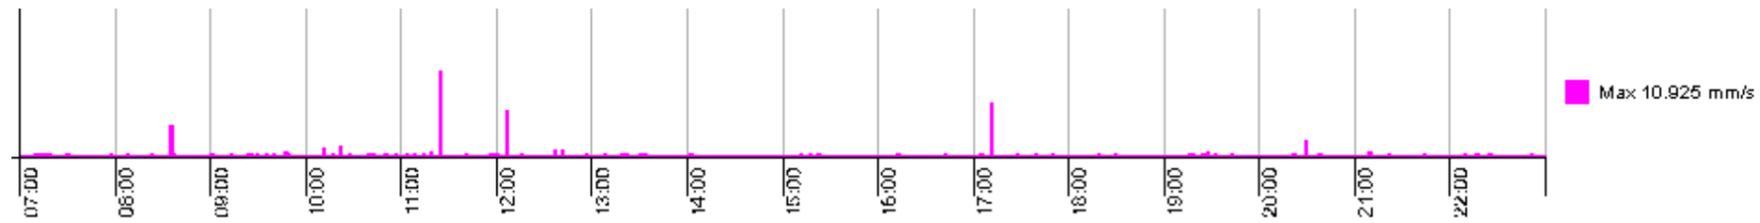
Exceedances on the 1<sup>st</sup>, 2<sup>nd</sup>, 3<sup>rd</sup>, 4<sup>th</sup>, 5<sup>th</sup>, 6<sup>th</sup>, 7<sup>th</sup>, 8<sup>th</sup>, 9<sup>th</sup>, 10<sup>th</sup>, 11<sup>th</sup>, 12<sup>th</sup>, 13<sup>th</sup>, 14<sup>th</sup>, 15<sup>th</sup>, 16<sup>th</sup>, 17<sup>th</sup>, 18<sup>th</sup>, 19<sup>th</sup>, 20<sup>th</sup>, 21<sup>st</sup>, 22<sup>nd</sup>, 23<sup>rd</sup>, 26<sup>th</sup>, 27<sup>th</sup>, 28<sup>th</sup>, 29<sup>th</sup>, 30<sup>th</sup> and 31<sup>st</sup> of July have been investigated and found to be caused by individual isolated events that are unlikely to have been construction related activities (graph above from the 30/07/2017). During this period, the closest works to this location was undertaken approx. 450m away at the Ferrytoll gyratory.

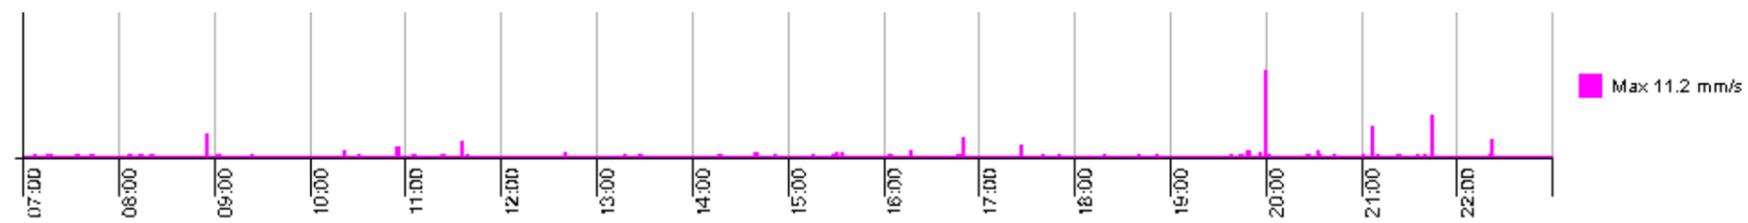
Exceedances on the 24<sup>th</sup> and 25<sup>th</sup> of July have been investigated and found to be caused out with construction working hours therefore it is unlikely that a construction related activity was the cause of these events (graph above from the 24/07/2017).

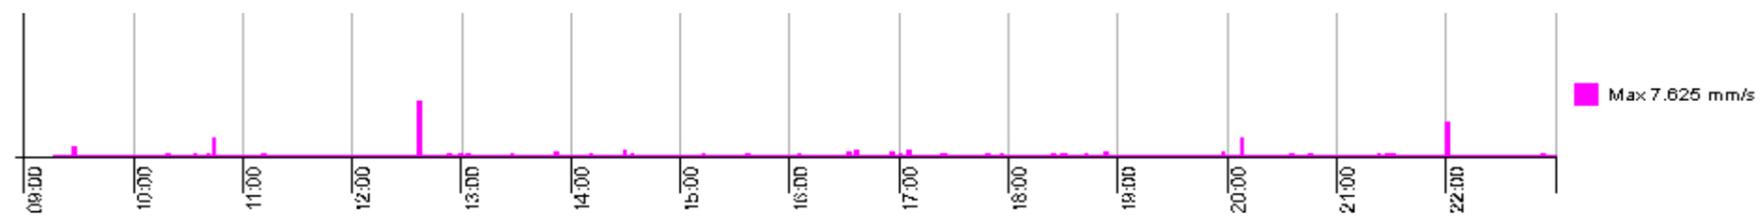
Exceedance on the 3<sup>rd</sup> of July has been investigated and found to be caused by the environmental team collecting data from vibration monitor (graph above from the 03/07/2017).
