Queensferry  
Crossing

Project FORTH REPLACEMENT CROSSING

VIBRATION MONITORING REPORT  
AUGUST 2017

Document number	Rev
<b>REP-00343</b>	<b>00</b>

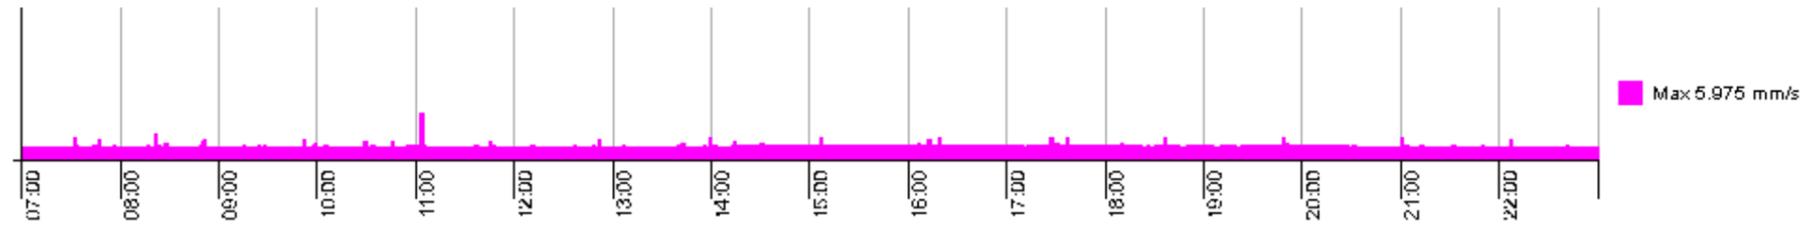
Exceedances on the 1<sup>st</sup>, 3<sup>rd</sup> and 5<sup>th</sup> of August have been investigated and found to be caused by individual isolated events that are unlikely to have been construction related activities (graph above from the 05/08/2017). The vibration monitor is located in the residents back garden, therefore resident's activity may have caused these exceedances.

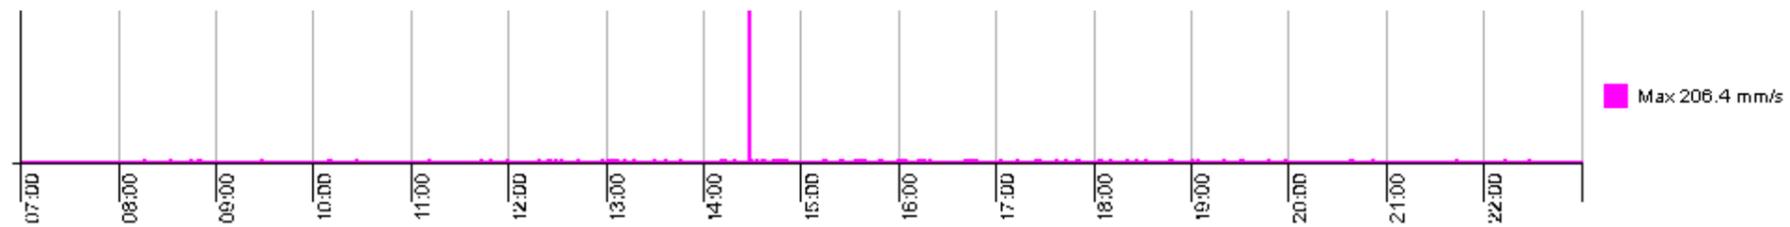
Exceedance on the 31<sup>st</sup> of August has been investigated and found to be caused by the environmental team collecting data from noise monitor.

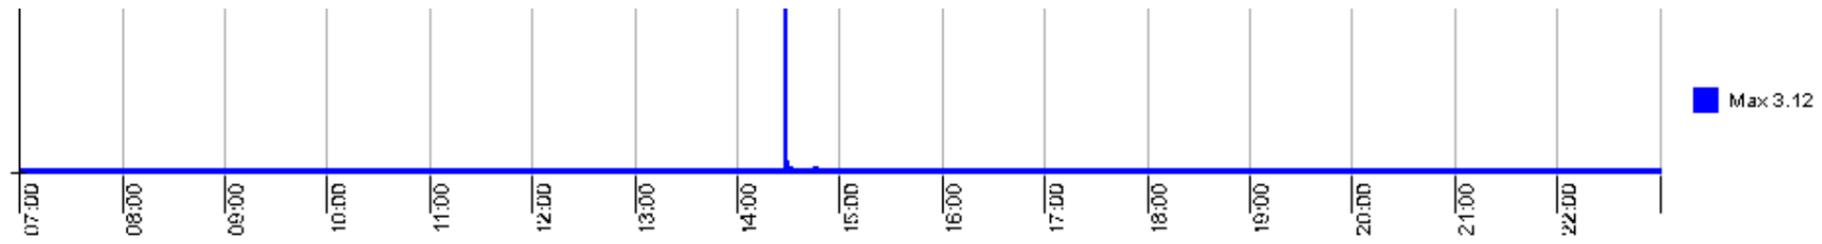
Exceedance on the 31<sup>st</sup> of August has been investigated and found to be caused by the environmental team collecting data from noise monitor.

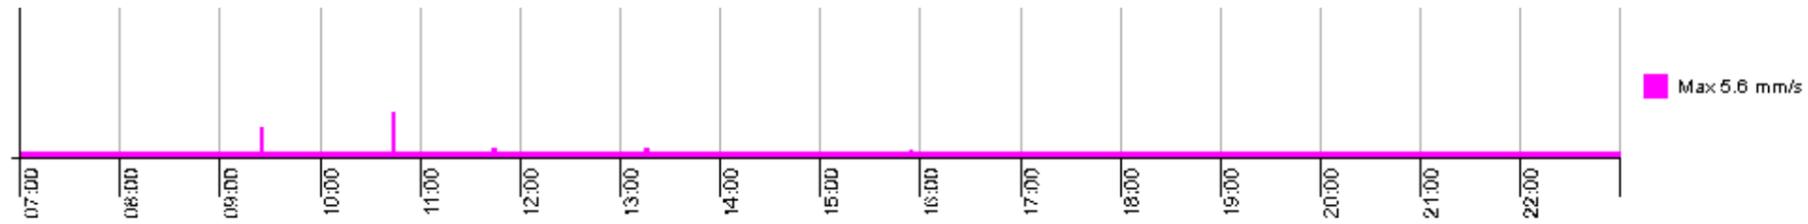
Exceedances on the 2<sup>nd</sup>, 4<sup>th</sup>, 13<sup>th</sup>, 14<sup>th</sup>, 23<sup>rd</sup>, 25<sup>th</sup> and 31<sup>st</sup> of August have been investigated and found to be caused by individual isolated events that are unlikely to have been construction related activities (graph above from the 02/08/2017). With this monitor being located in a public amenity area there is a likelihood that the exceedances seen above might have been caused by pedestrians using the area.

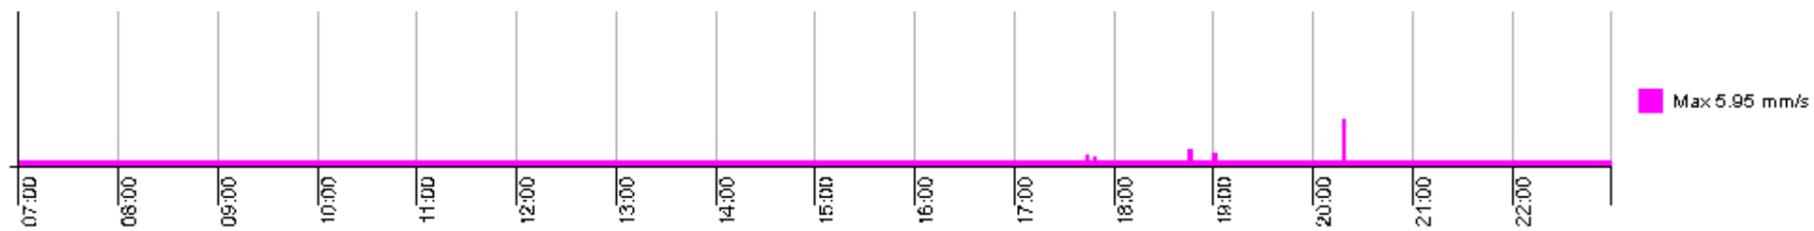
Exceedances on the 6<sup>th</sup>, 15<sup>th</sup>, 20<sup>th</sup> and 26<sup>th</sup> of August have been investigated and found to be caused out with construction working hours therefore it is unlikely that a construction related activity was the cause of these events (graph above from the 20/08/2017).

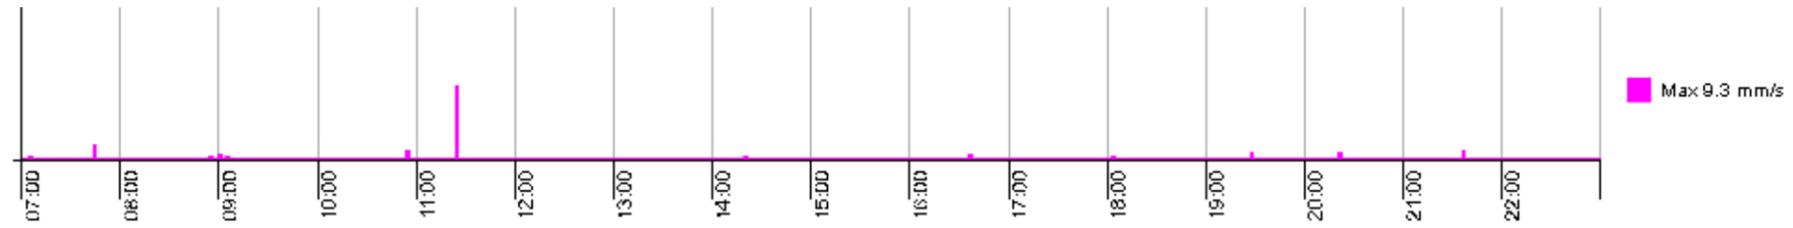
Exceedances on the 1<sup>st</sup>, 10<sup>th</sup>, 12<sup>th</sup>, 13<sup>th</sup>, 14<sup>th</sup>, 15<sup>th</sup>, 18<sup>th</sup>, 19<sup>th</sup> and 25<sup>th</sup> of August have been investigated and found to be caused by individual isolated events that are unlikely to have been construction related activities (graph above from the 18/08/2017). The vibration monitor is located in the residents back garden, therefore resident's activity may have caused these exceedances.

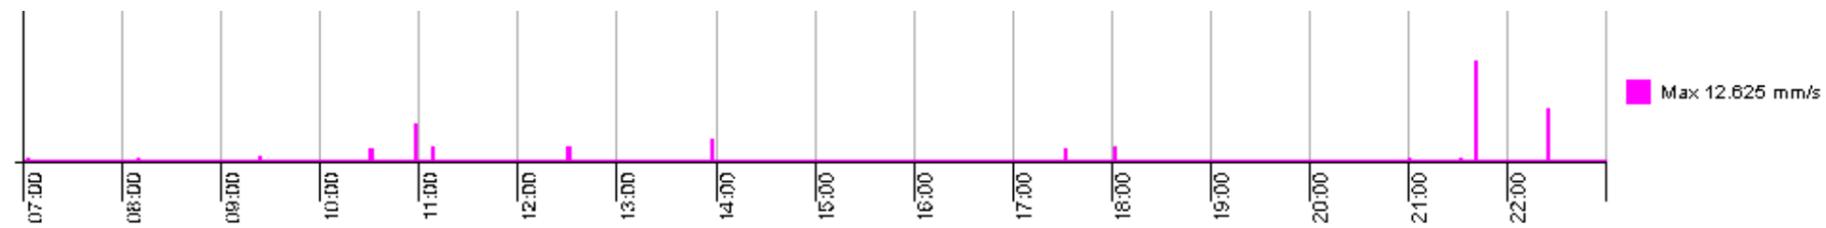
Exceedances on the 29<sup>th</sup> and 30<sup>th</sup> of August have been investigated and found to be caused out with construction working hours therefore it is unlikely that a construction related activity was the cause of these events (graph above from the 29/08/2017).

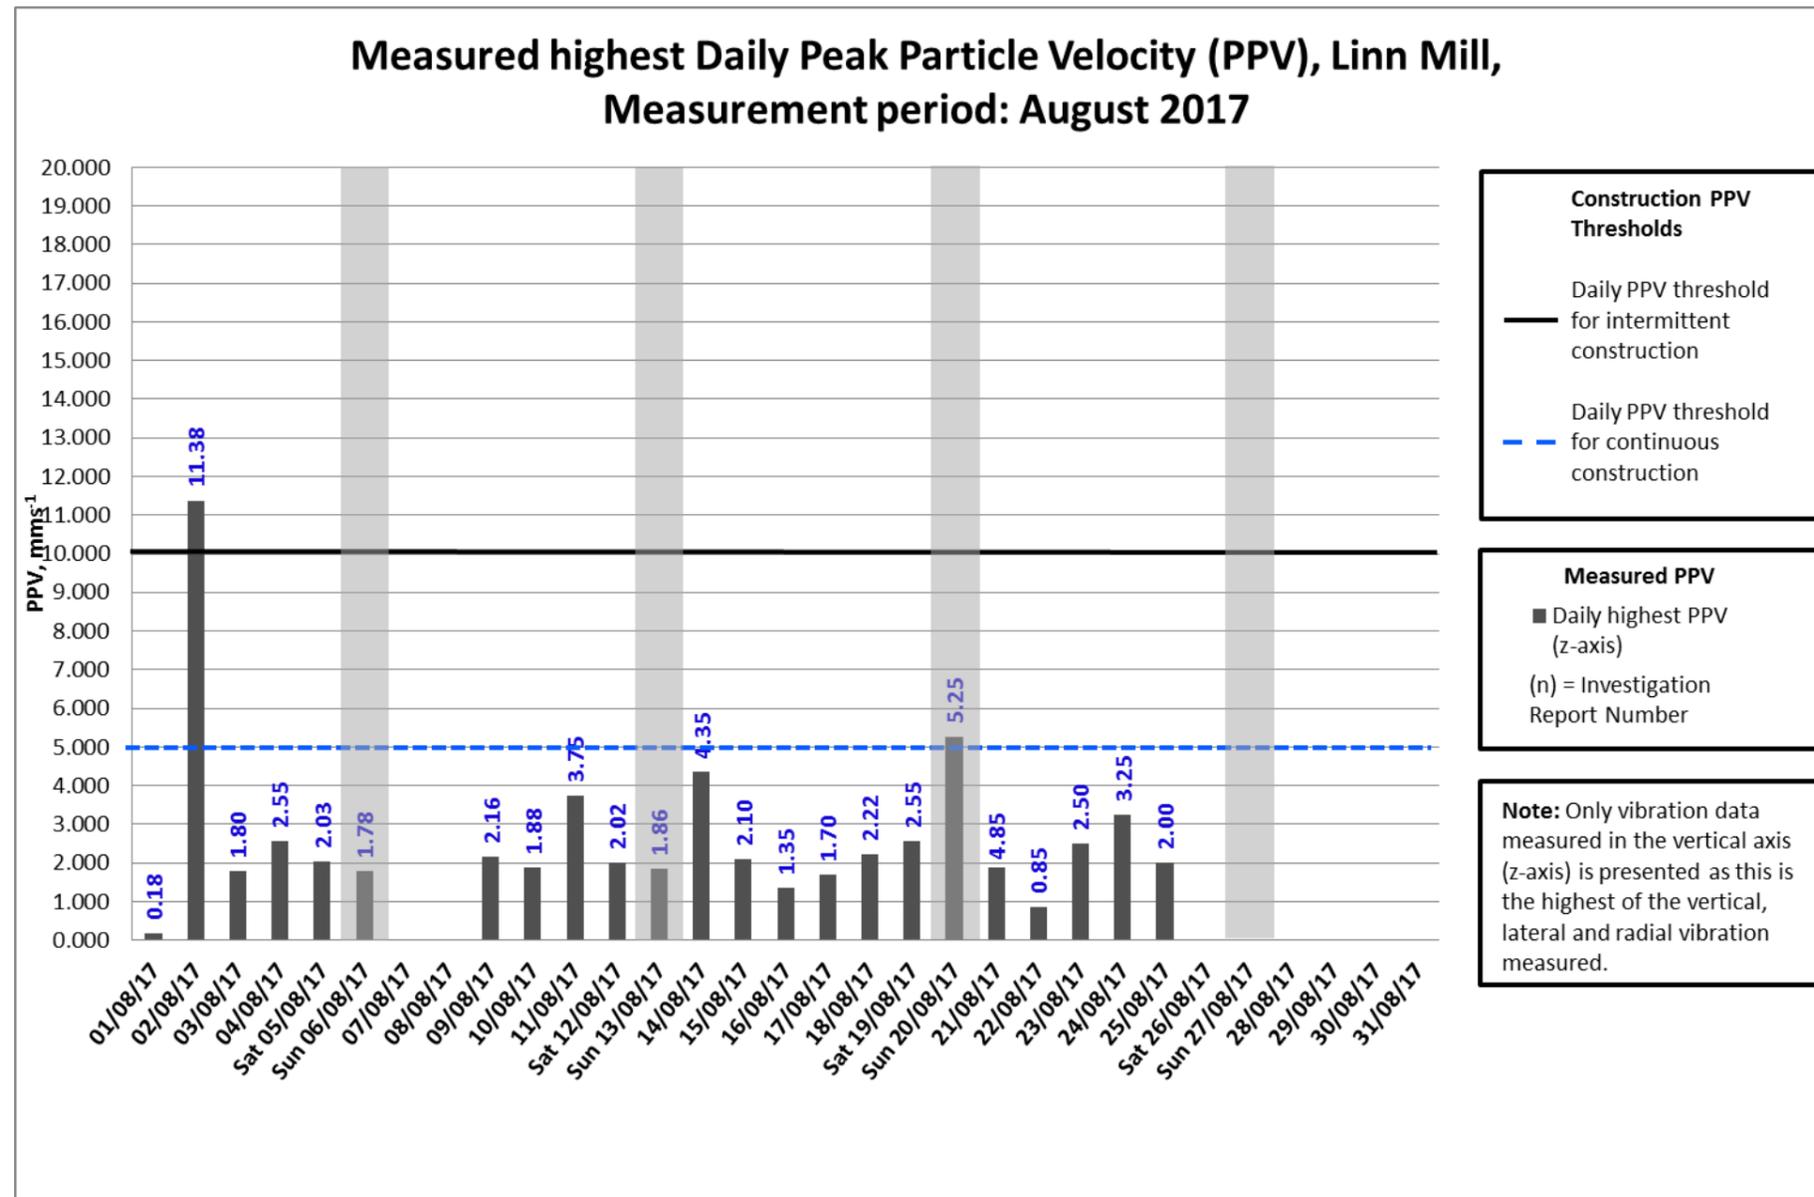
Data missing on the 7<sup>th</sup> - 8<sup>th</sup> August was caused by the annual calibration of the vibration monitor.  
 Data missing on the 26<sup>th</sup> - 31<sup>st</sup> August was caused by electrical issue with monitor.

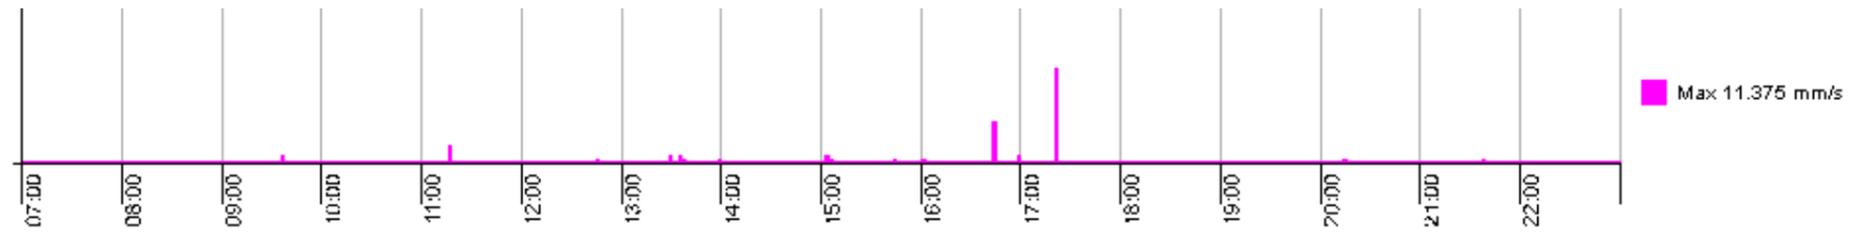
Exceedances on the 2<sup>nd</sup> and 20<sup>th</sup> of August have been investigated and found to be caused by individual isolated events that are unlikely to have been construction related activities (graph above from the 02/08/2017).

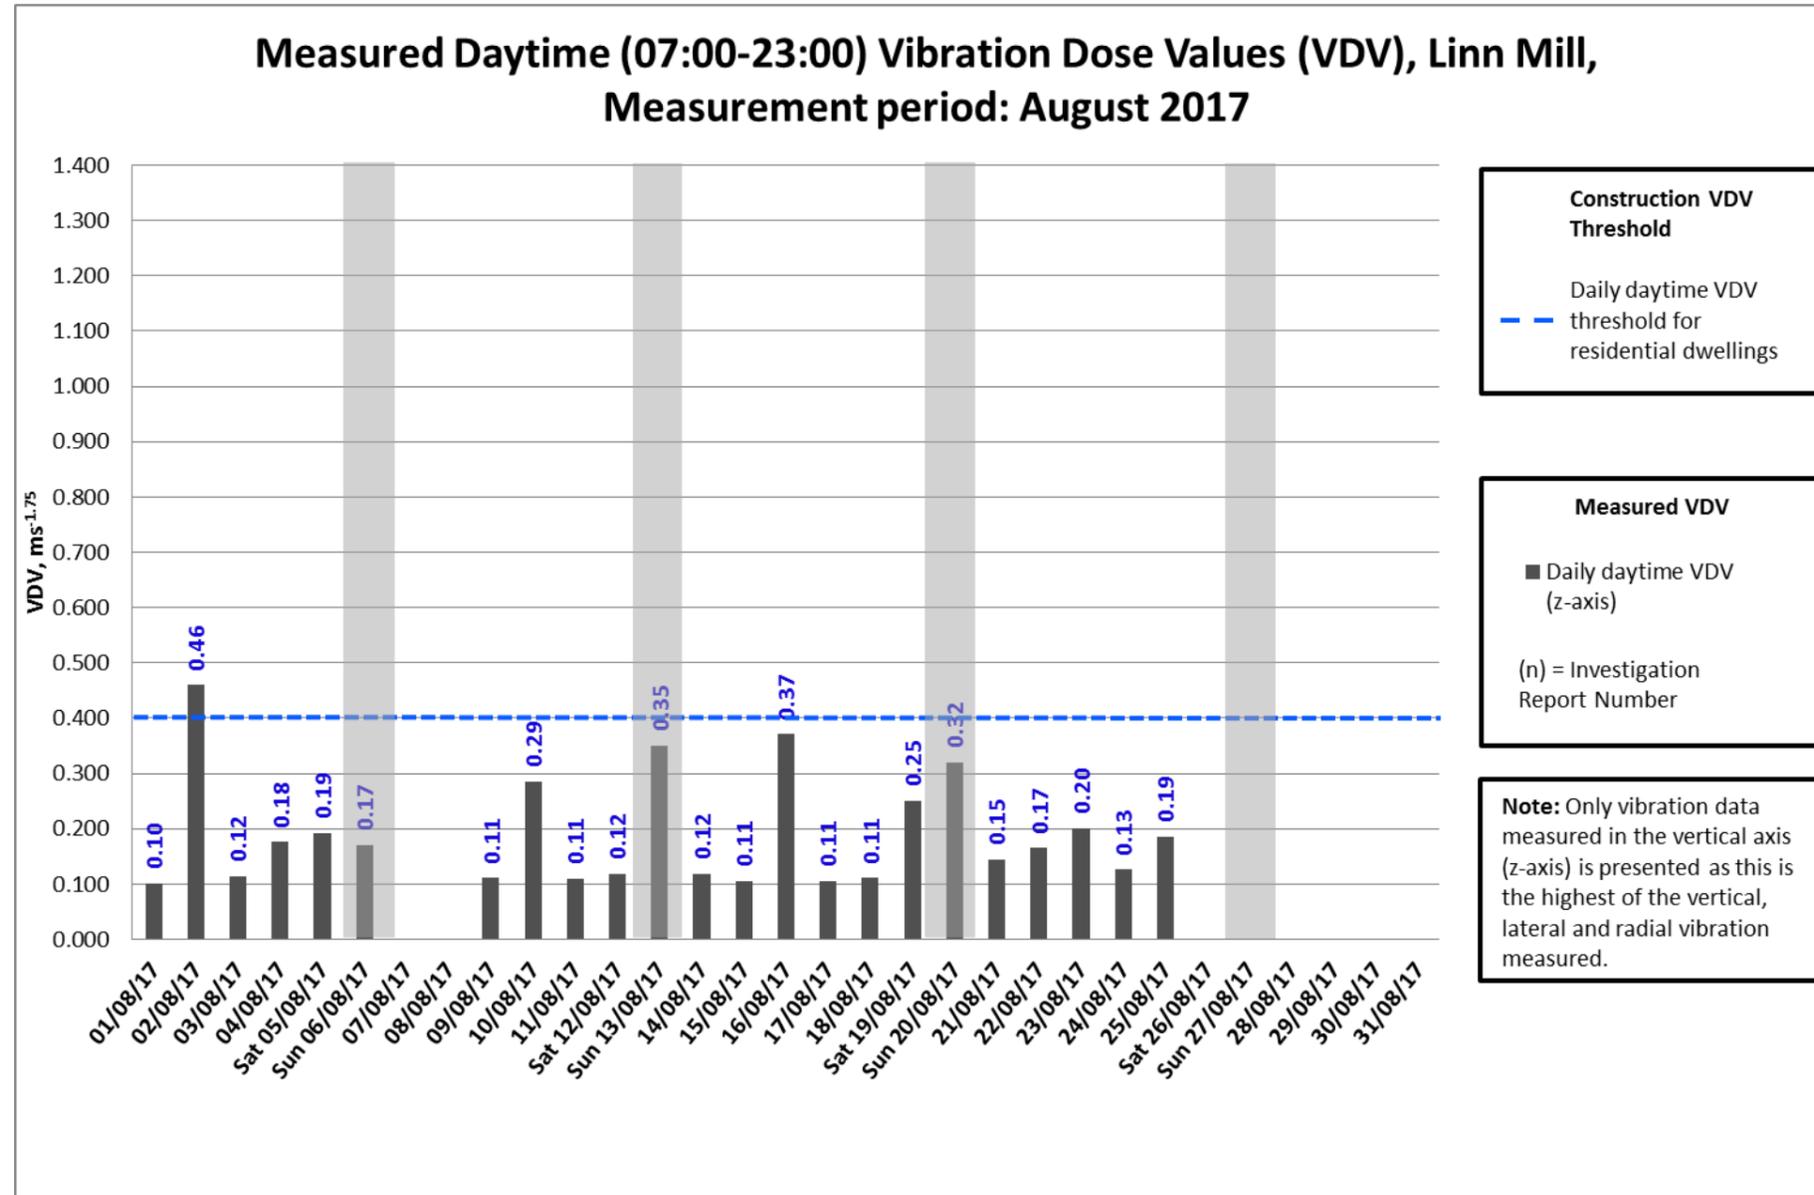
Data missing on the 7<sup>th</sup> - 8<sup>th</sup> August was caused by the annual calibration of the vibration monitor.  
 Data missing on the 26<sup>th</sup> - 31<sup>st</sup> August was caused by electrical issue with monitor.

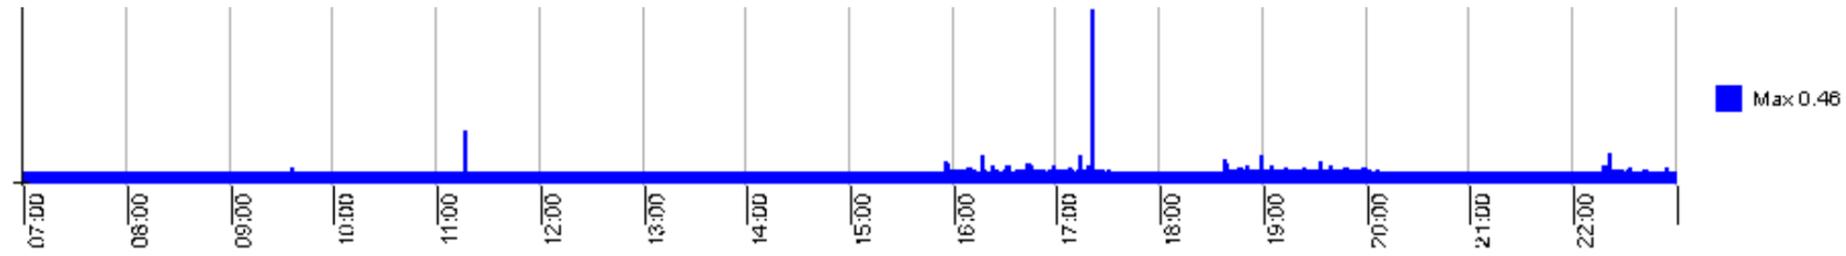
Exceedance on the 2<sup>nd</sup> of August has been investigated and found to be caused by an individual isolated event that is unlikely to have been a construction related activity (graph above from 02/08/2017).

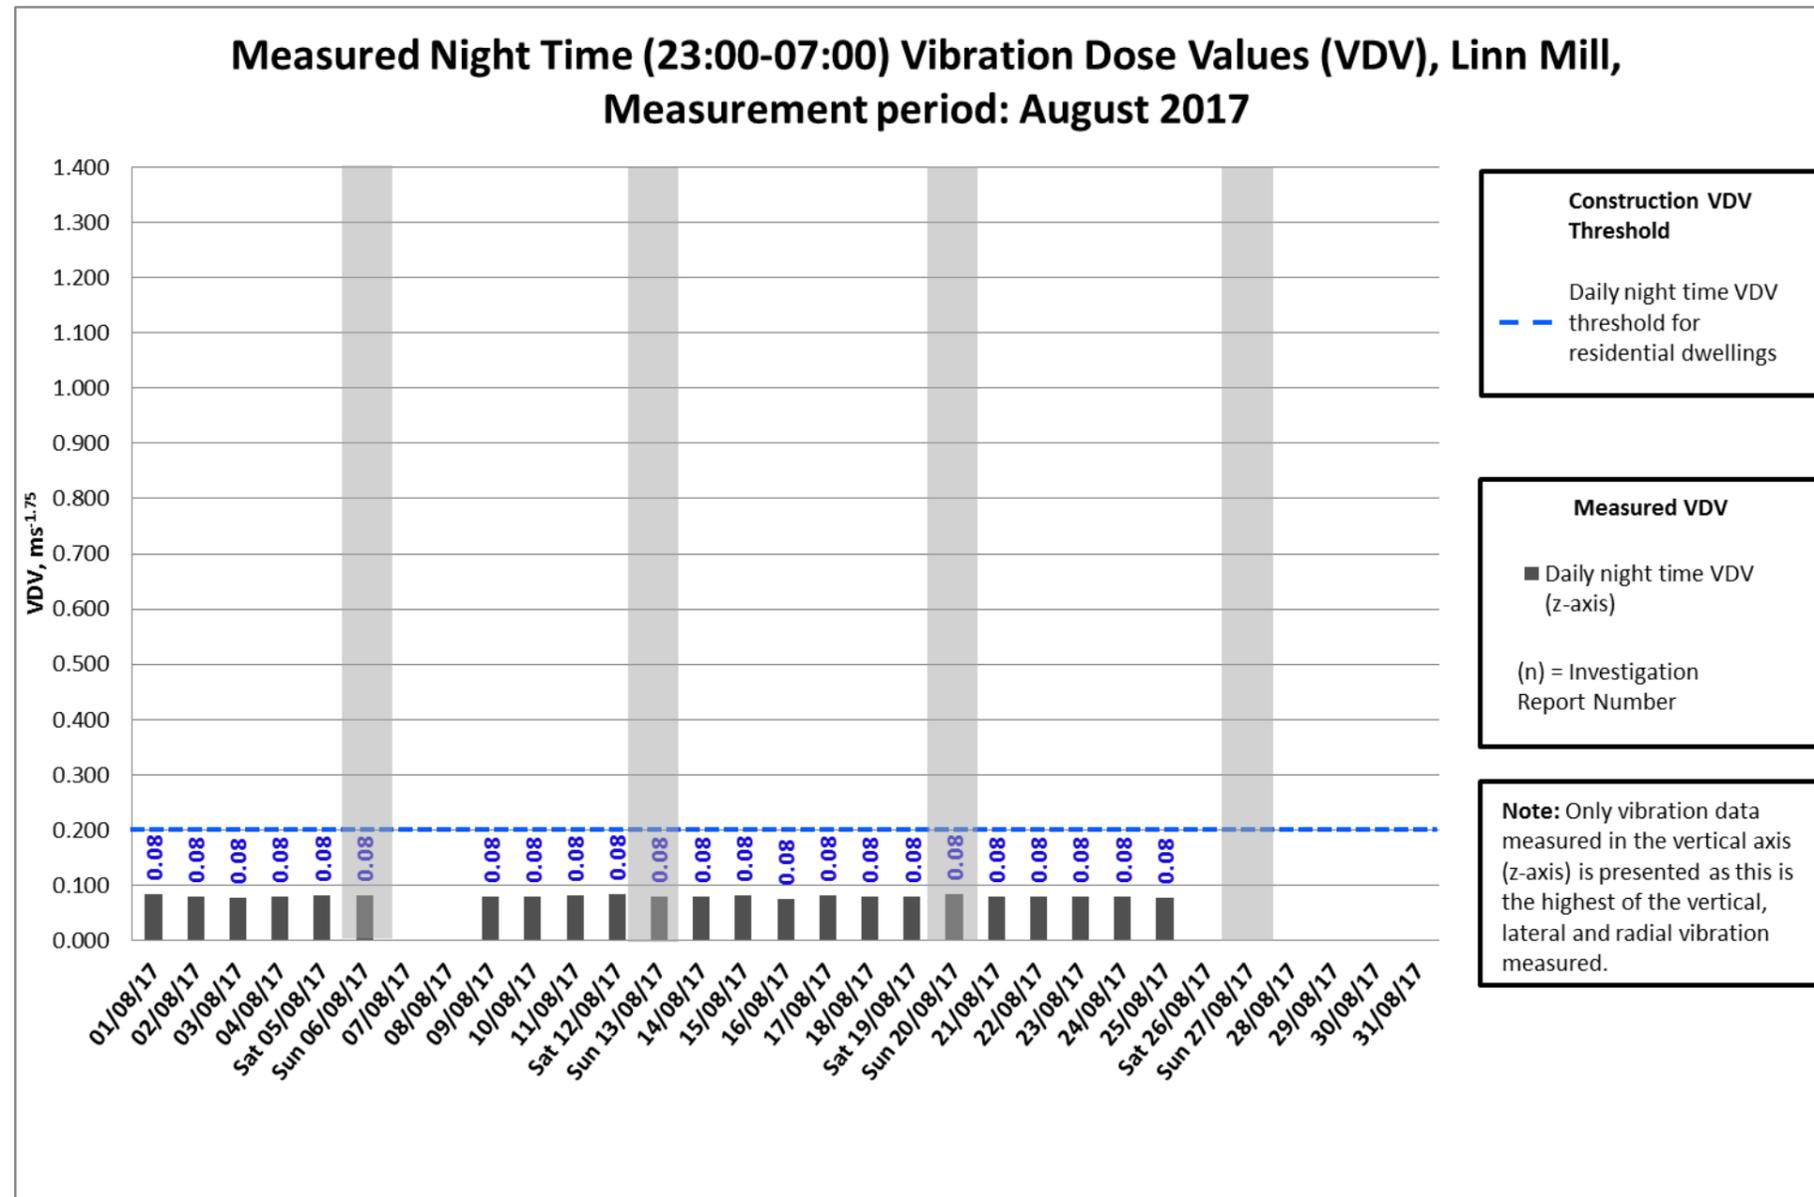
Data missing on the 7<sup>th</sup> - 8<sup>th</sup> August was caused by the annual calibration of the vibration monitor.  
 Data missing on the 26<sup>th</sup> - 31<sup>st</sup> August was caused by electrical issue with monitor.

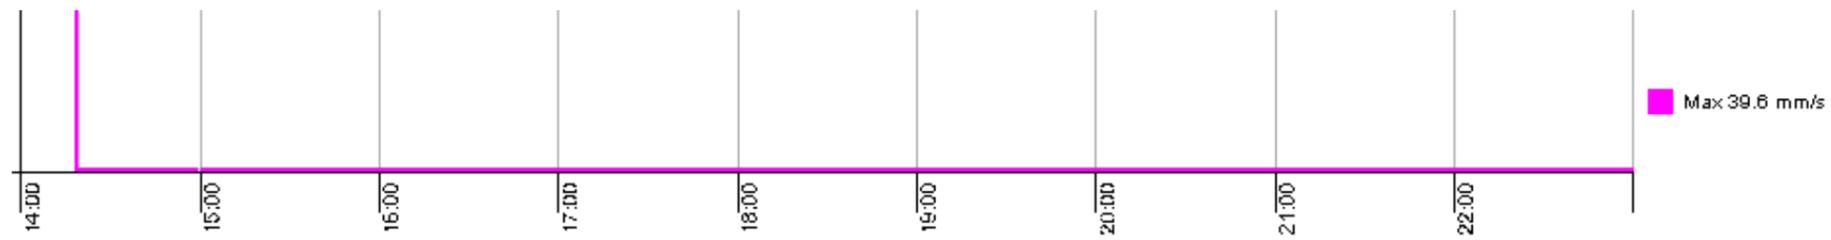
Exceedance on the 9<sup>th</sup> of August has been investigated and found to be caused by the environmental team reinstalling the vibration monitor.

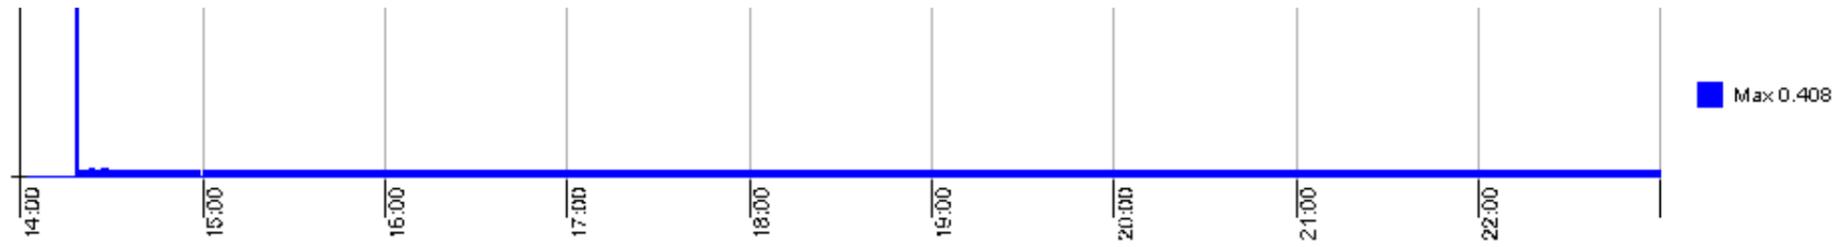
Exceedance on the 9<sup>th</sup> of August has been investigated and found to be caused by the environmental team reinstalling the vibration monitor.

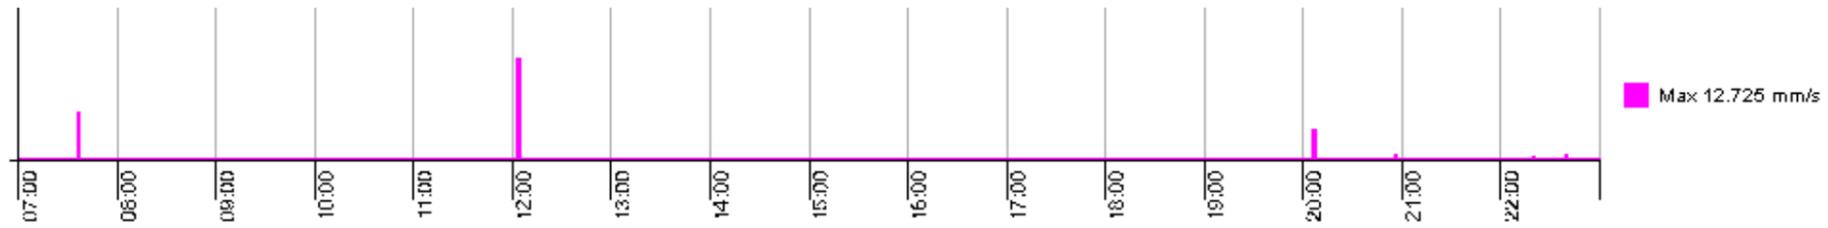
Exceedances throughout August have been investigated and found to be caused by individual isolated events that are unlikely to have been construction related activities (graph above from the 18/08/2017). The vibration monitor is located in the residents back garden, therefore resident's activity may have caused these exceedances.

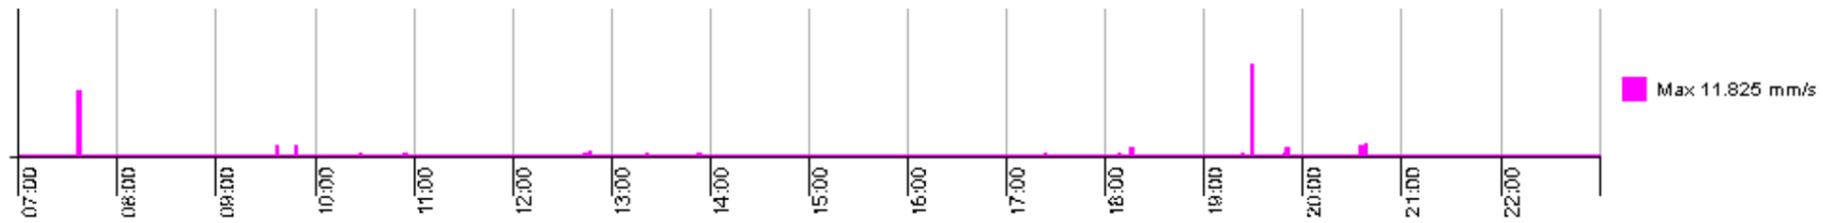
Exceedances on the 23<sup>rd</sup>, 26<sup>th</sup>, 27<sup>th</sup> and 28<sup>th</sup> of August have been investigated and found to be caused out with construction working hours therefore it is unlikely that a construction related activity was the cause of these events (graph above from the 24/08/2017).

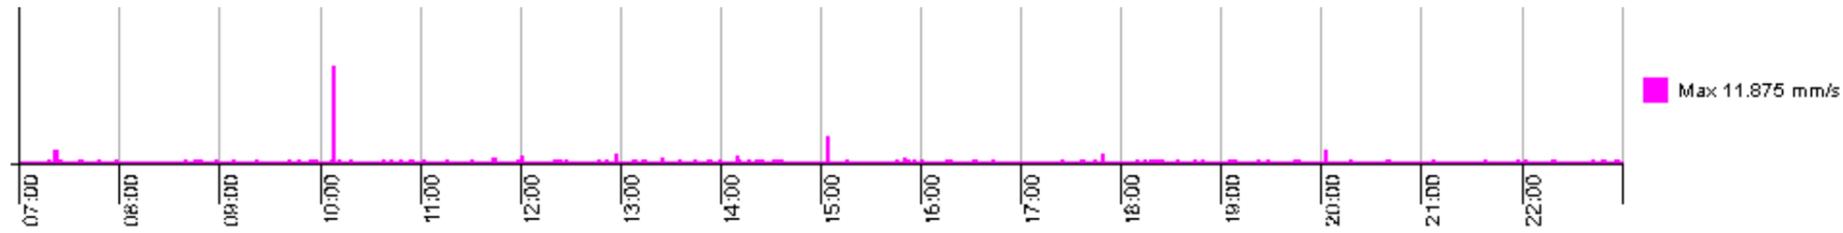
Exceedances throughout August have been investigated and found to be caused by individual isolated events that are unlikely to have been construction related activities (graph above from the 04/08/2017). During this period, the closest works to this location was undertaken approx. 450m away at the Ferrytoll gyratory.

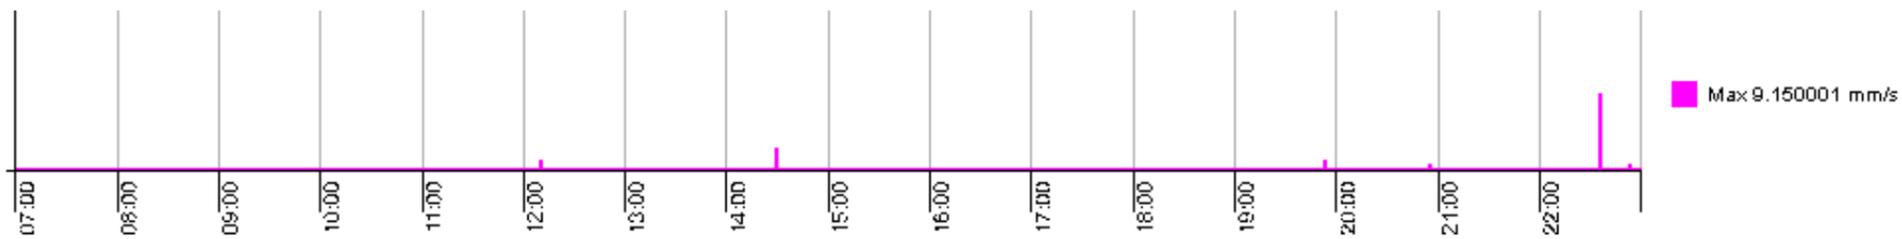
Exceedances on the 2<sup>nd</sup>, 18<sup>th</sup>, 24<sup>th</sup> and 25<sup>th</sup> of August have been investigated and found to be caused out with construction working hours therefore it is unlikely that a construction related activity was the cause of these events (graph above from the 24/08/2017).

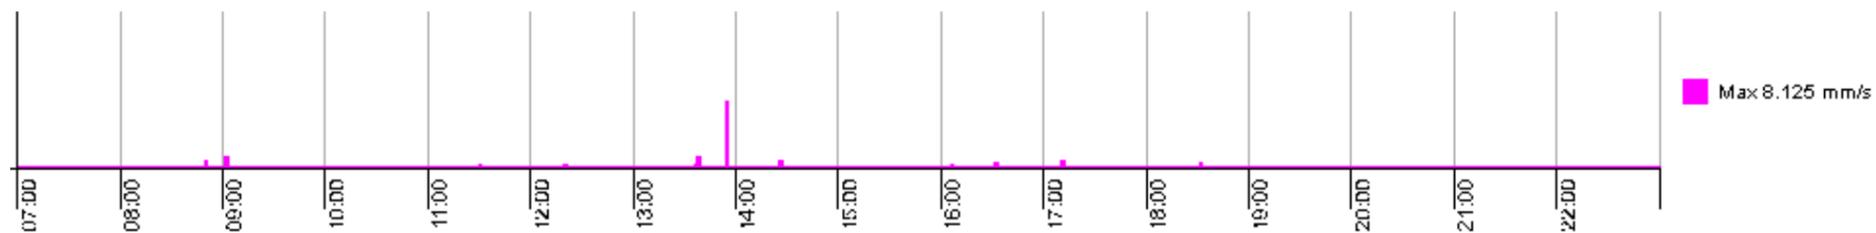
Exceedance on the 23<sup>rd</sup> of August has been investigated and found to be caused by the environmental team collecting air quality samples (graph above from the 23/08/2017).
