# Appendix 11.4

## Hydromorphology Assessment Part 2

**Annex 11.4.3 - Hydromorphological Catchment Assessment - 76**

**PROJECT 8 DALWHINNIE TO CRUBENMORE EIA**  
**DRAWING 11.4.3.2.**  
**Catchment 76 Baseline Assessment**

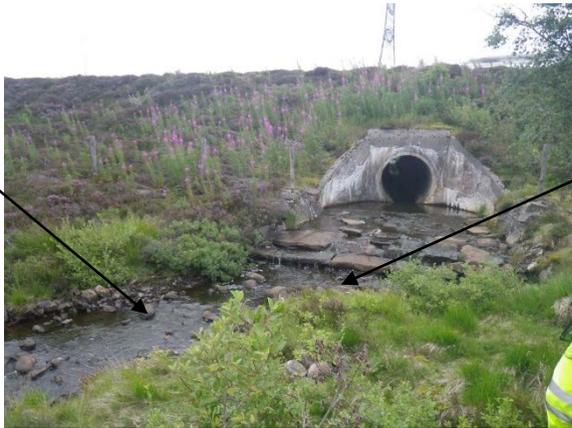
Photograph 11.4.3.38 - No deposition in culvert

Boulders in channel

Small step downstream of apron

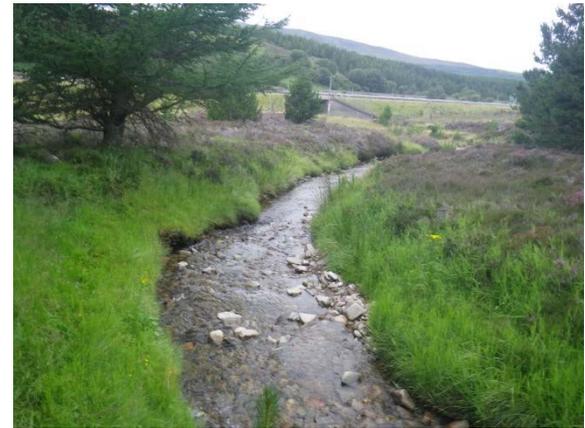
Photograph 11.4.3.39 - Downstream to crossing

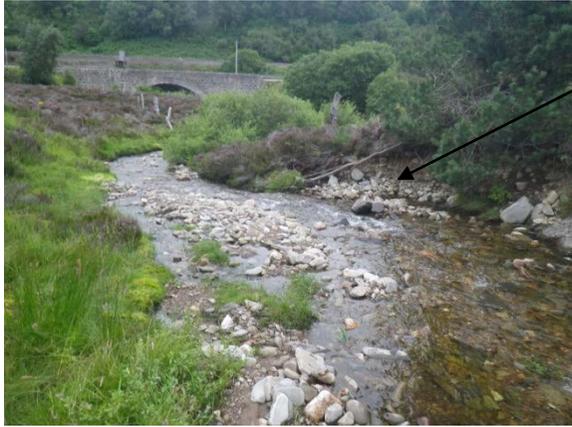
Photograph 11.4.3.40 - Downstream

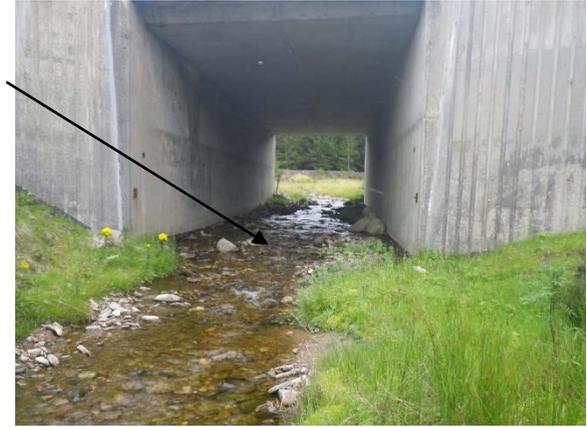
Localised  
erosion  
downstream of  
crossing

Photograph 11.4.3.41 - Upstream to crossing

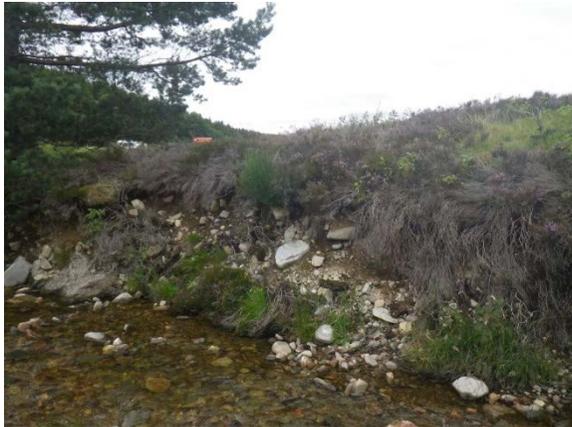
Natural bed

Photograph 11.4.3.42 - Localised erosion  
downstream of crossing

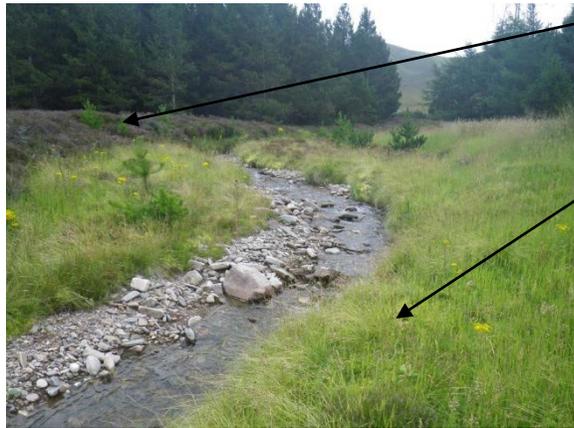
Terrace on right bank side

Steep vegetated banks

Photograph 11.4.3.43 - Upstream to plane bed channel

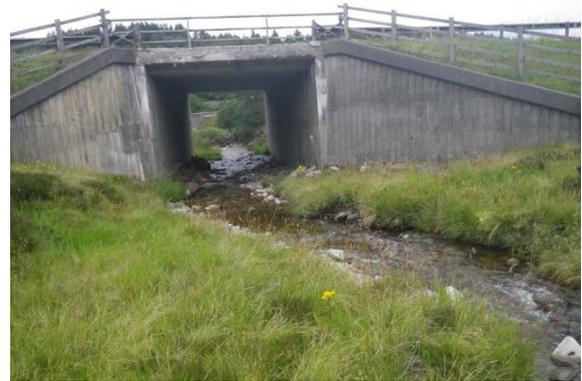
Photograph 11.4.3.44- Downstream to culvert entrance

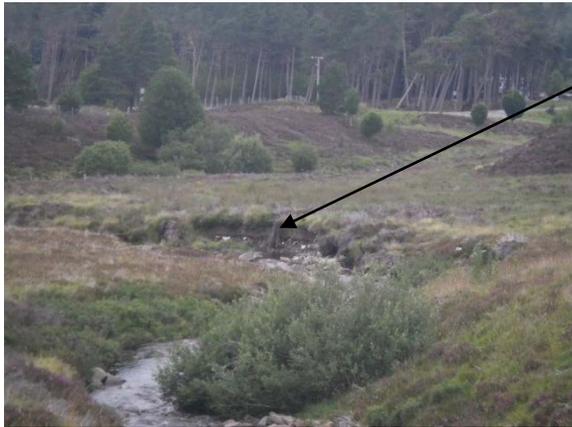
Photograph 11.4.3.45 –Downstream

Localised erosion on outside of bend

Steep high and uniform banks

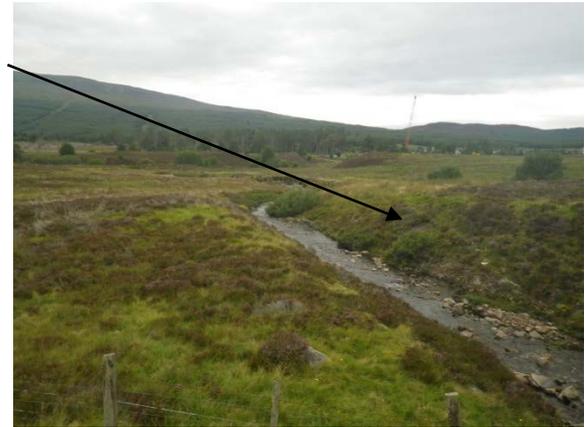
Photograph 11.4.3.46 – Downstream-Plane bed morphology

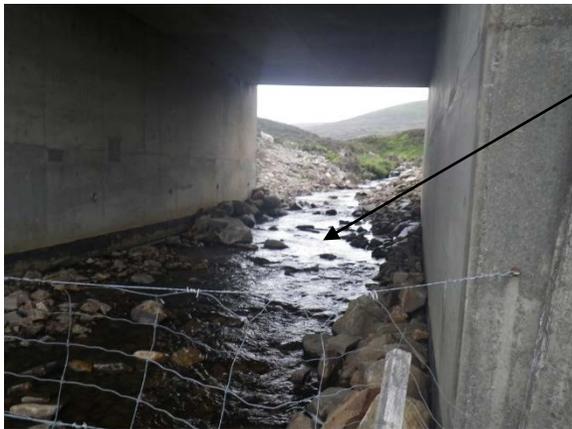
Photograph 11.4.3.47 -Looking Upstream, low flow channel in culvert

Natural bed

Bedrock in channel

Scour to banks at culvert entrance

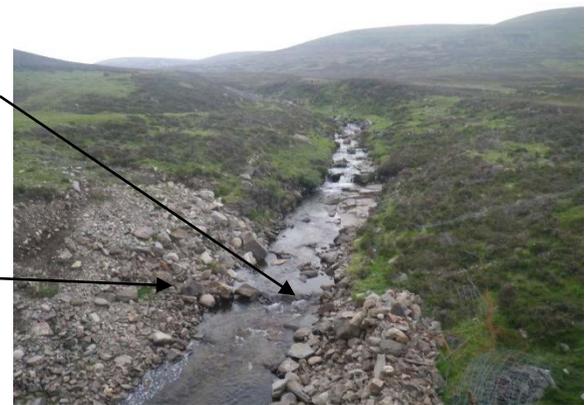
Photograph 11.4.3.48 - Looking upstream, confined channel

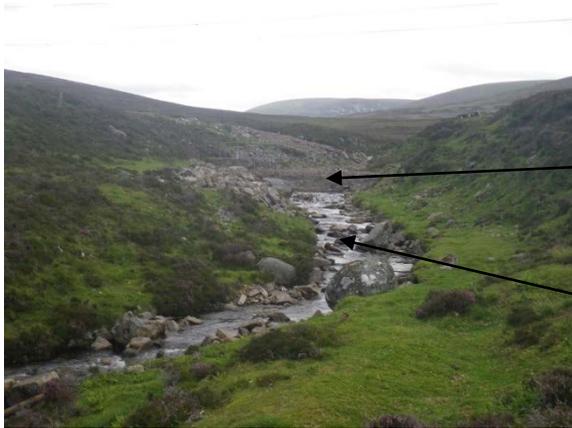
Dam and offtake

Cascade morphology

Photograph 11.4.3.49- Upstream to dam and offtake

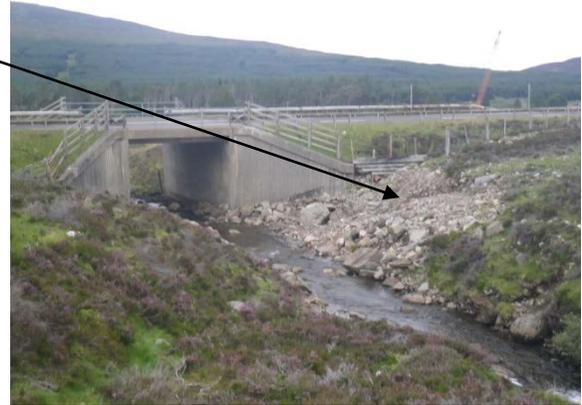
Scour

Photograph 11.4.3.50 - Downstream to crossing

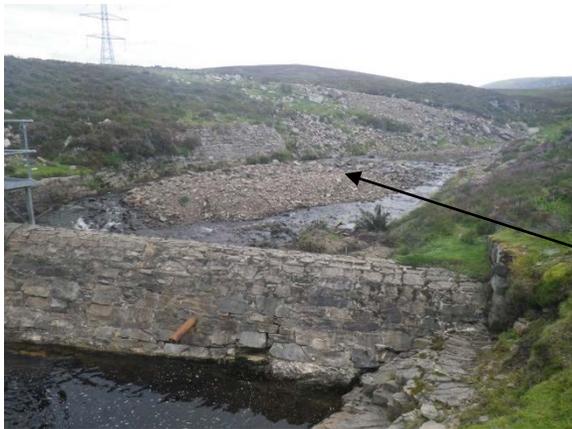
Deposition  
upstream of  
dam, reducing  
channel capacity  
and downstream  
sediment  
transfer

Photograph 11.4.3.51- Dam and offtake

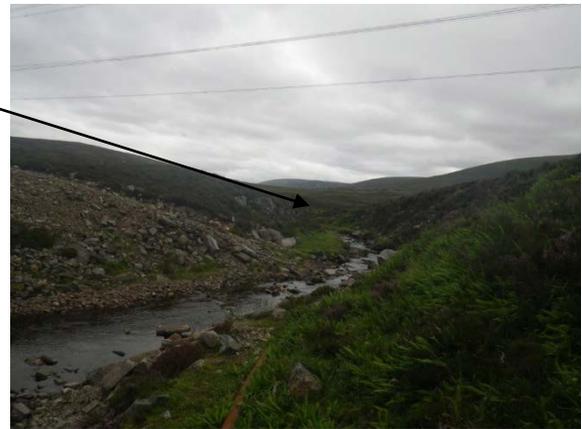
Stable valley  
sides

Photograph 11.4.3.52 - Confined channel by valley sides

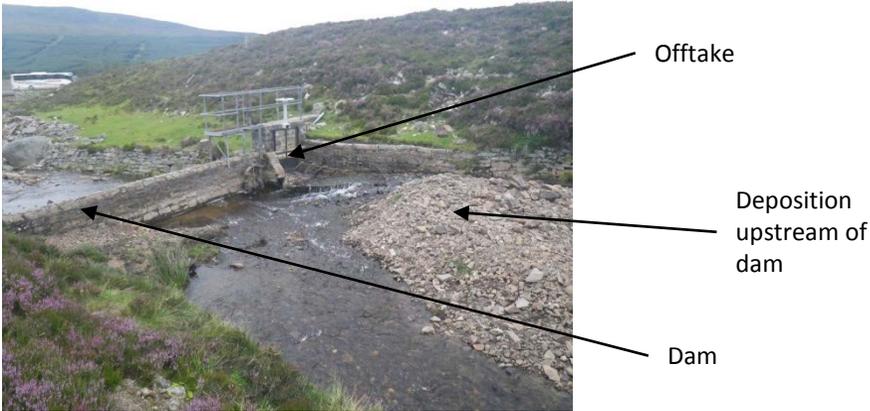
Photograph 11.4.3.53-Deposition upstream of dam

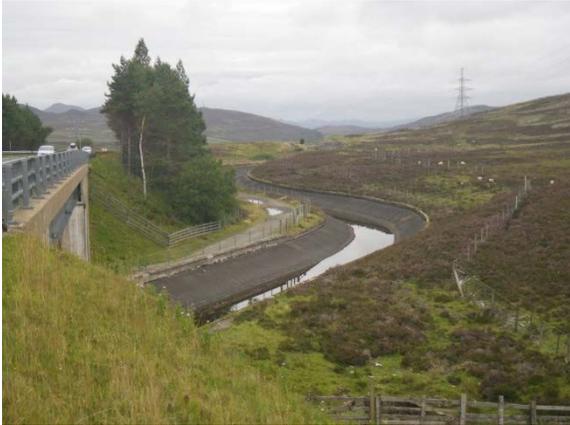
Photograph 11.4.3.54 - Aqueduct

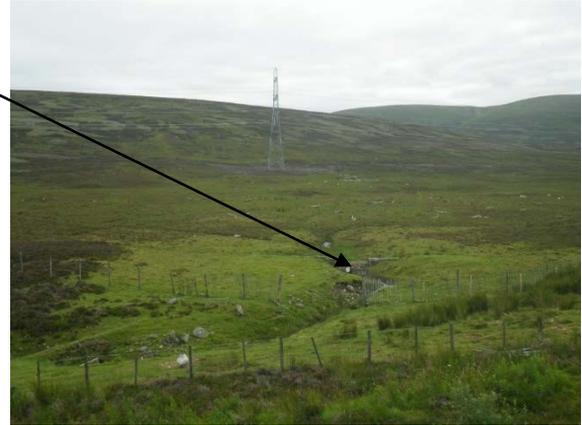
Dam

Photograph 11.4.3.55 - Upstream to catchment.  
Slope reduces before crossing

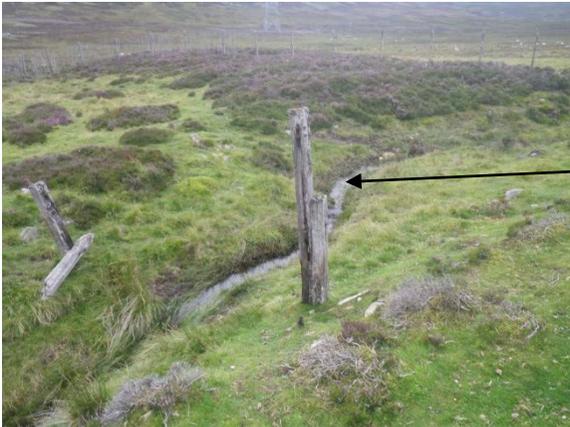
Photograph 11.4.3.56- Channel upstream of crossing

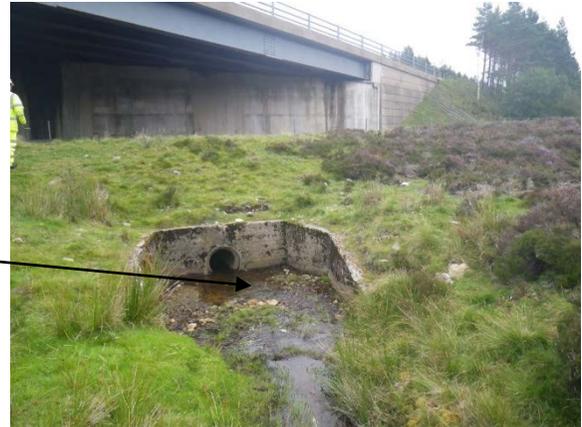
Small channel

Small scale deposition at culvert

Photograph 11.4.3.57 -Downstream to crossing entrance

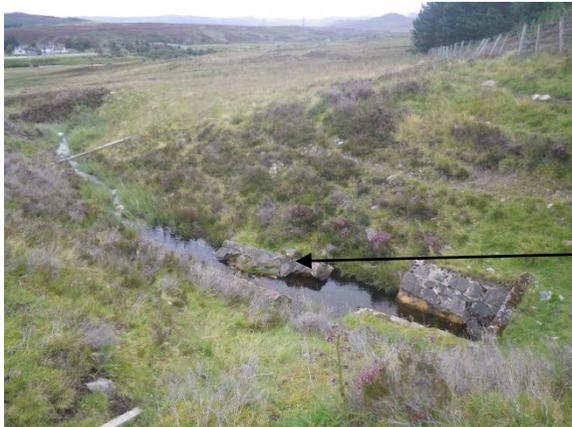
Photograph 11.4.3.60- Culvert exit

Confined channel  
Some scour to exit of crossing

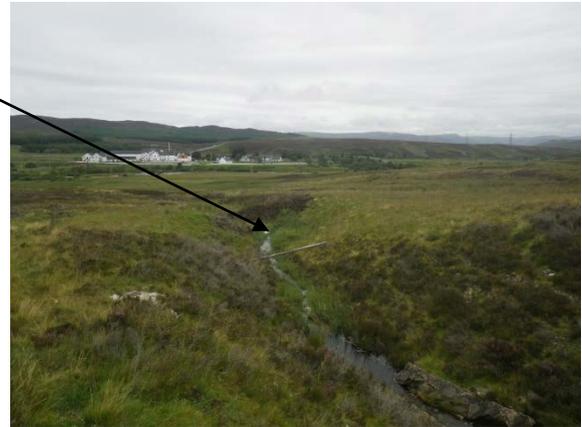
Photograph 11.4.3.61 - Downstream of crossing

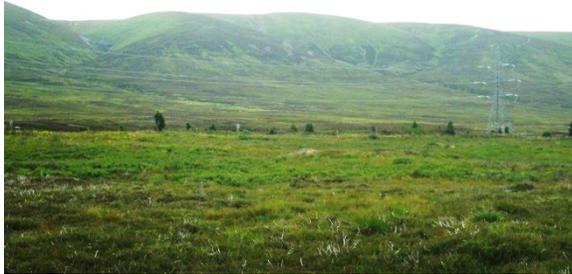
Photograph 11.4.3.62 - Steep upper catchment draining into crossing

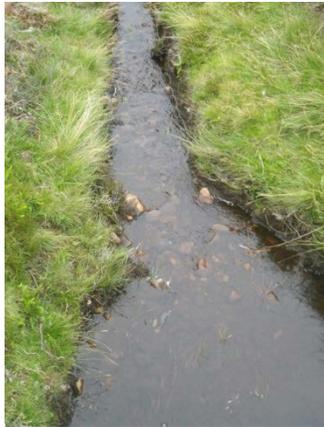
Photograph 11.4.3.64 – Gravel in bed
