# Appendix 11.4

## Hydromorphology Assessment Part 3

**Annex 11.4.3 - Hydromorphological Catchment Assessment - 117**

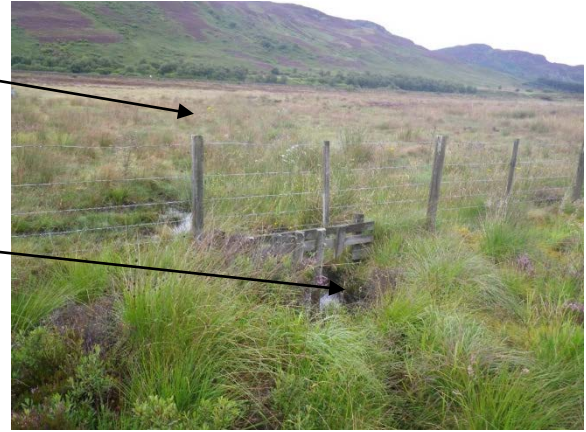
Photograph 11.4.3.106- Upstream to cascade

Cascade

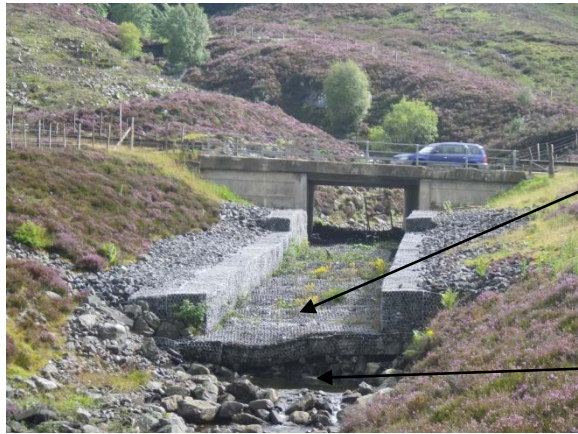
Photograph 11.4.3.108- Upstream to crossing

Flow through rather than over mattress causing collapse

Step-pool channel

Channel incision due to step

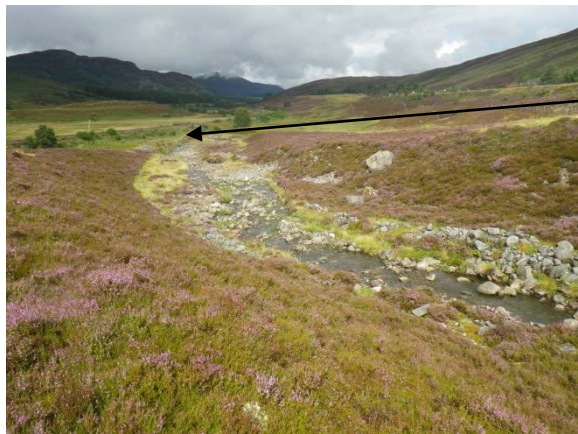
Photograph 11.4.3.110- Downstream

Deposition of sediment where floodplain opens up

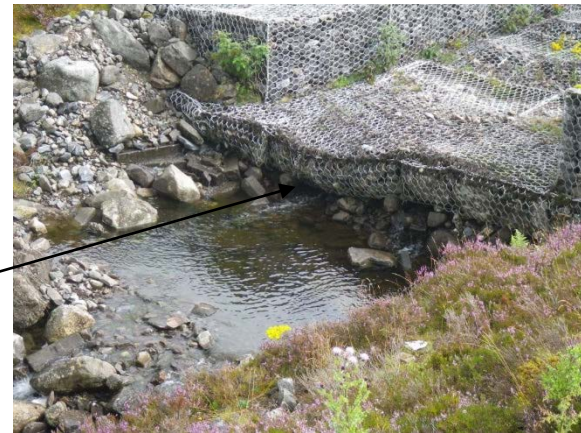
Photograph 11.4.3.111- Area of scour

Flow through mattress scouring below

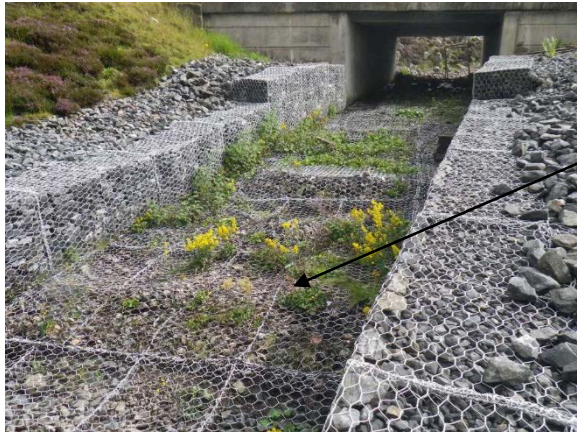
Photograph 11.4.3.112-Upstream

Wave bed forms formed by reworking of gravel in gabions

Step-pool channel

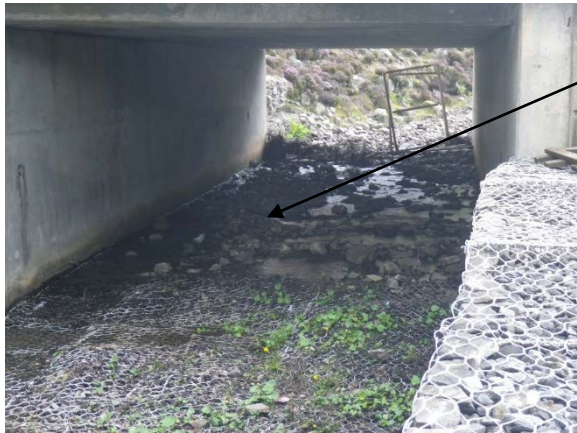
Photograph 11.4.3.114- Upstream

Some cobble deposition over mattress

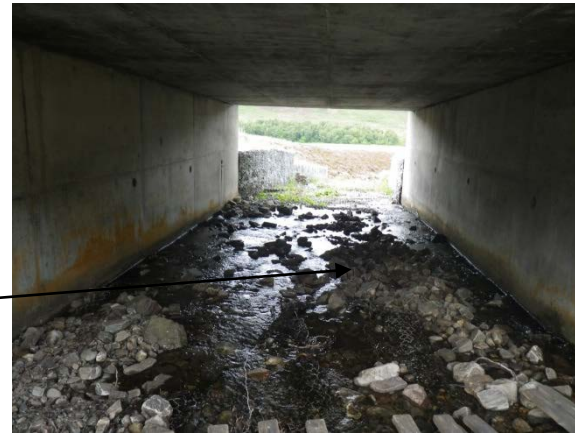
Photograph 11.4.3.115- Downstream under crossing

Some cobble deposition over mattress

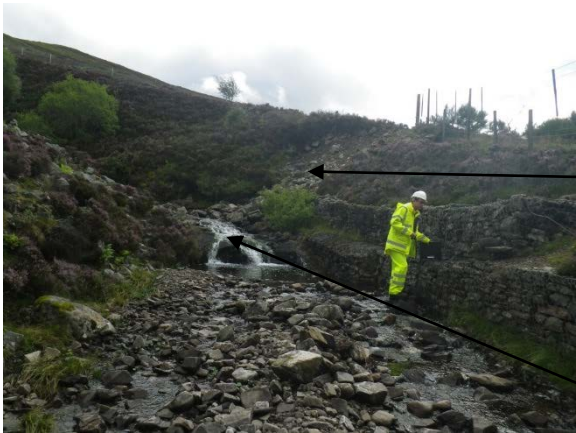
Photograph 11.4.3.116- Upstream to bedrock channel

Gabion bank protection

Valley side erosion

Bedrock

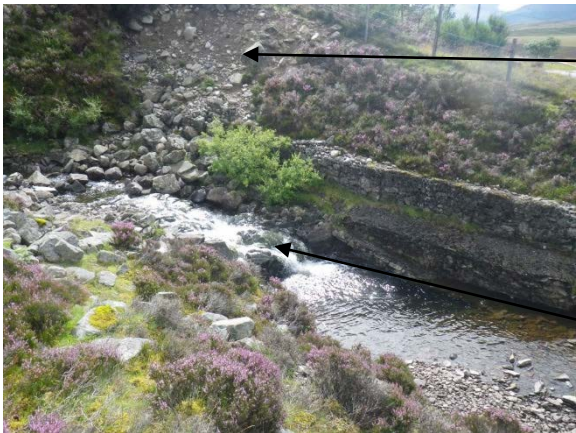
Photograph 11.4.3.118- Left bank

Valley side erosion

Bedrock

Valley side erosion, causing small failure adding sediment to the channel

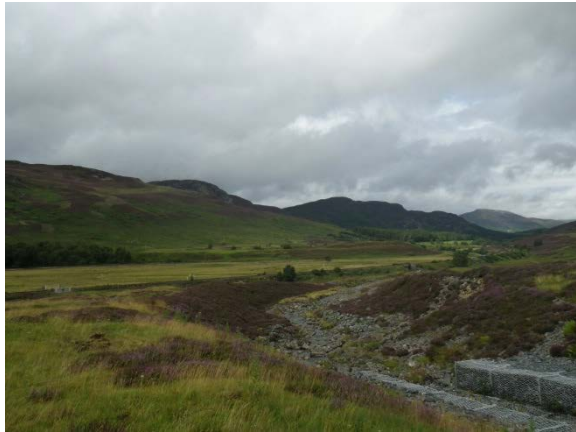
Photograph 11.4.3.120 – Downstream of crossing- steep sided channel

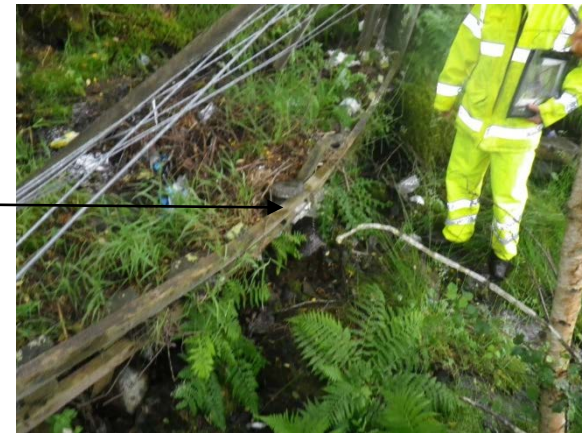
Photograph 11.4.3.129

Debris build up behind fence creating a step in the channel

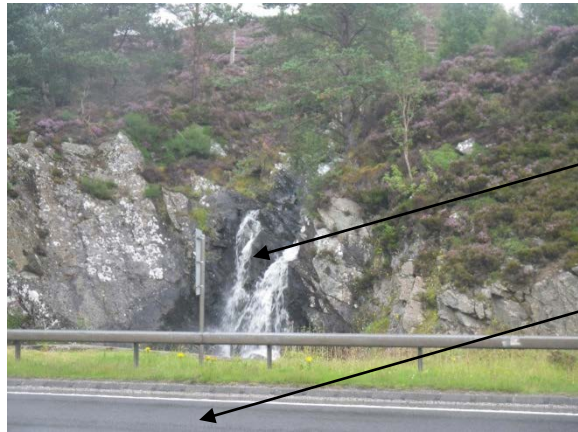
Photograph 11.4.3.136

Bedrock fall

A9
