Appendix 11.4

Hydromorphology Assessment Part 4

Annex 11.4.3 - Hydromorphological Catchment Assessment - 32-35

PROJECT 7 GLEN GARRY TO DALWHINNIE EIA
DRAWING 11.4.3.2.
Catchments 32-35 Baseline Assessment

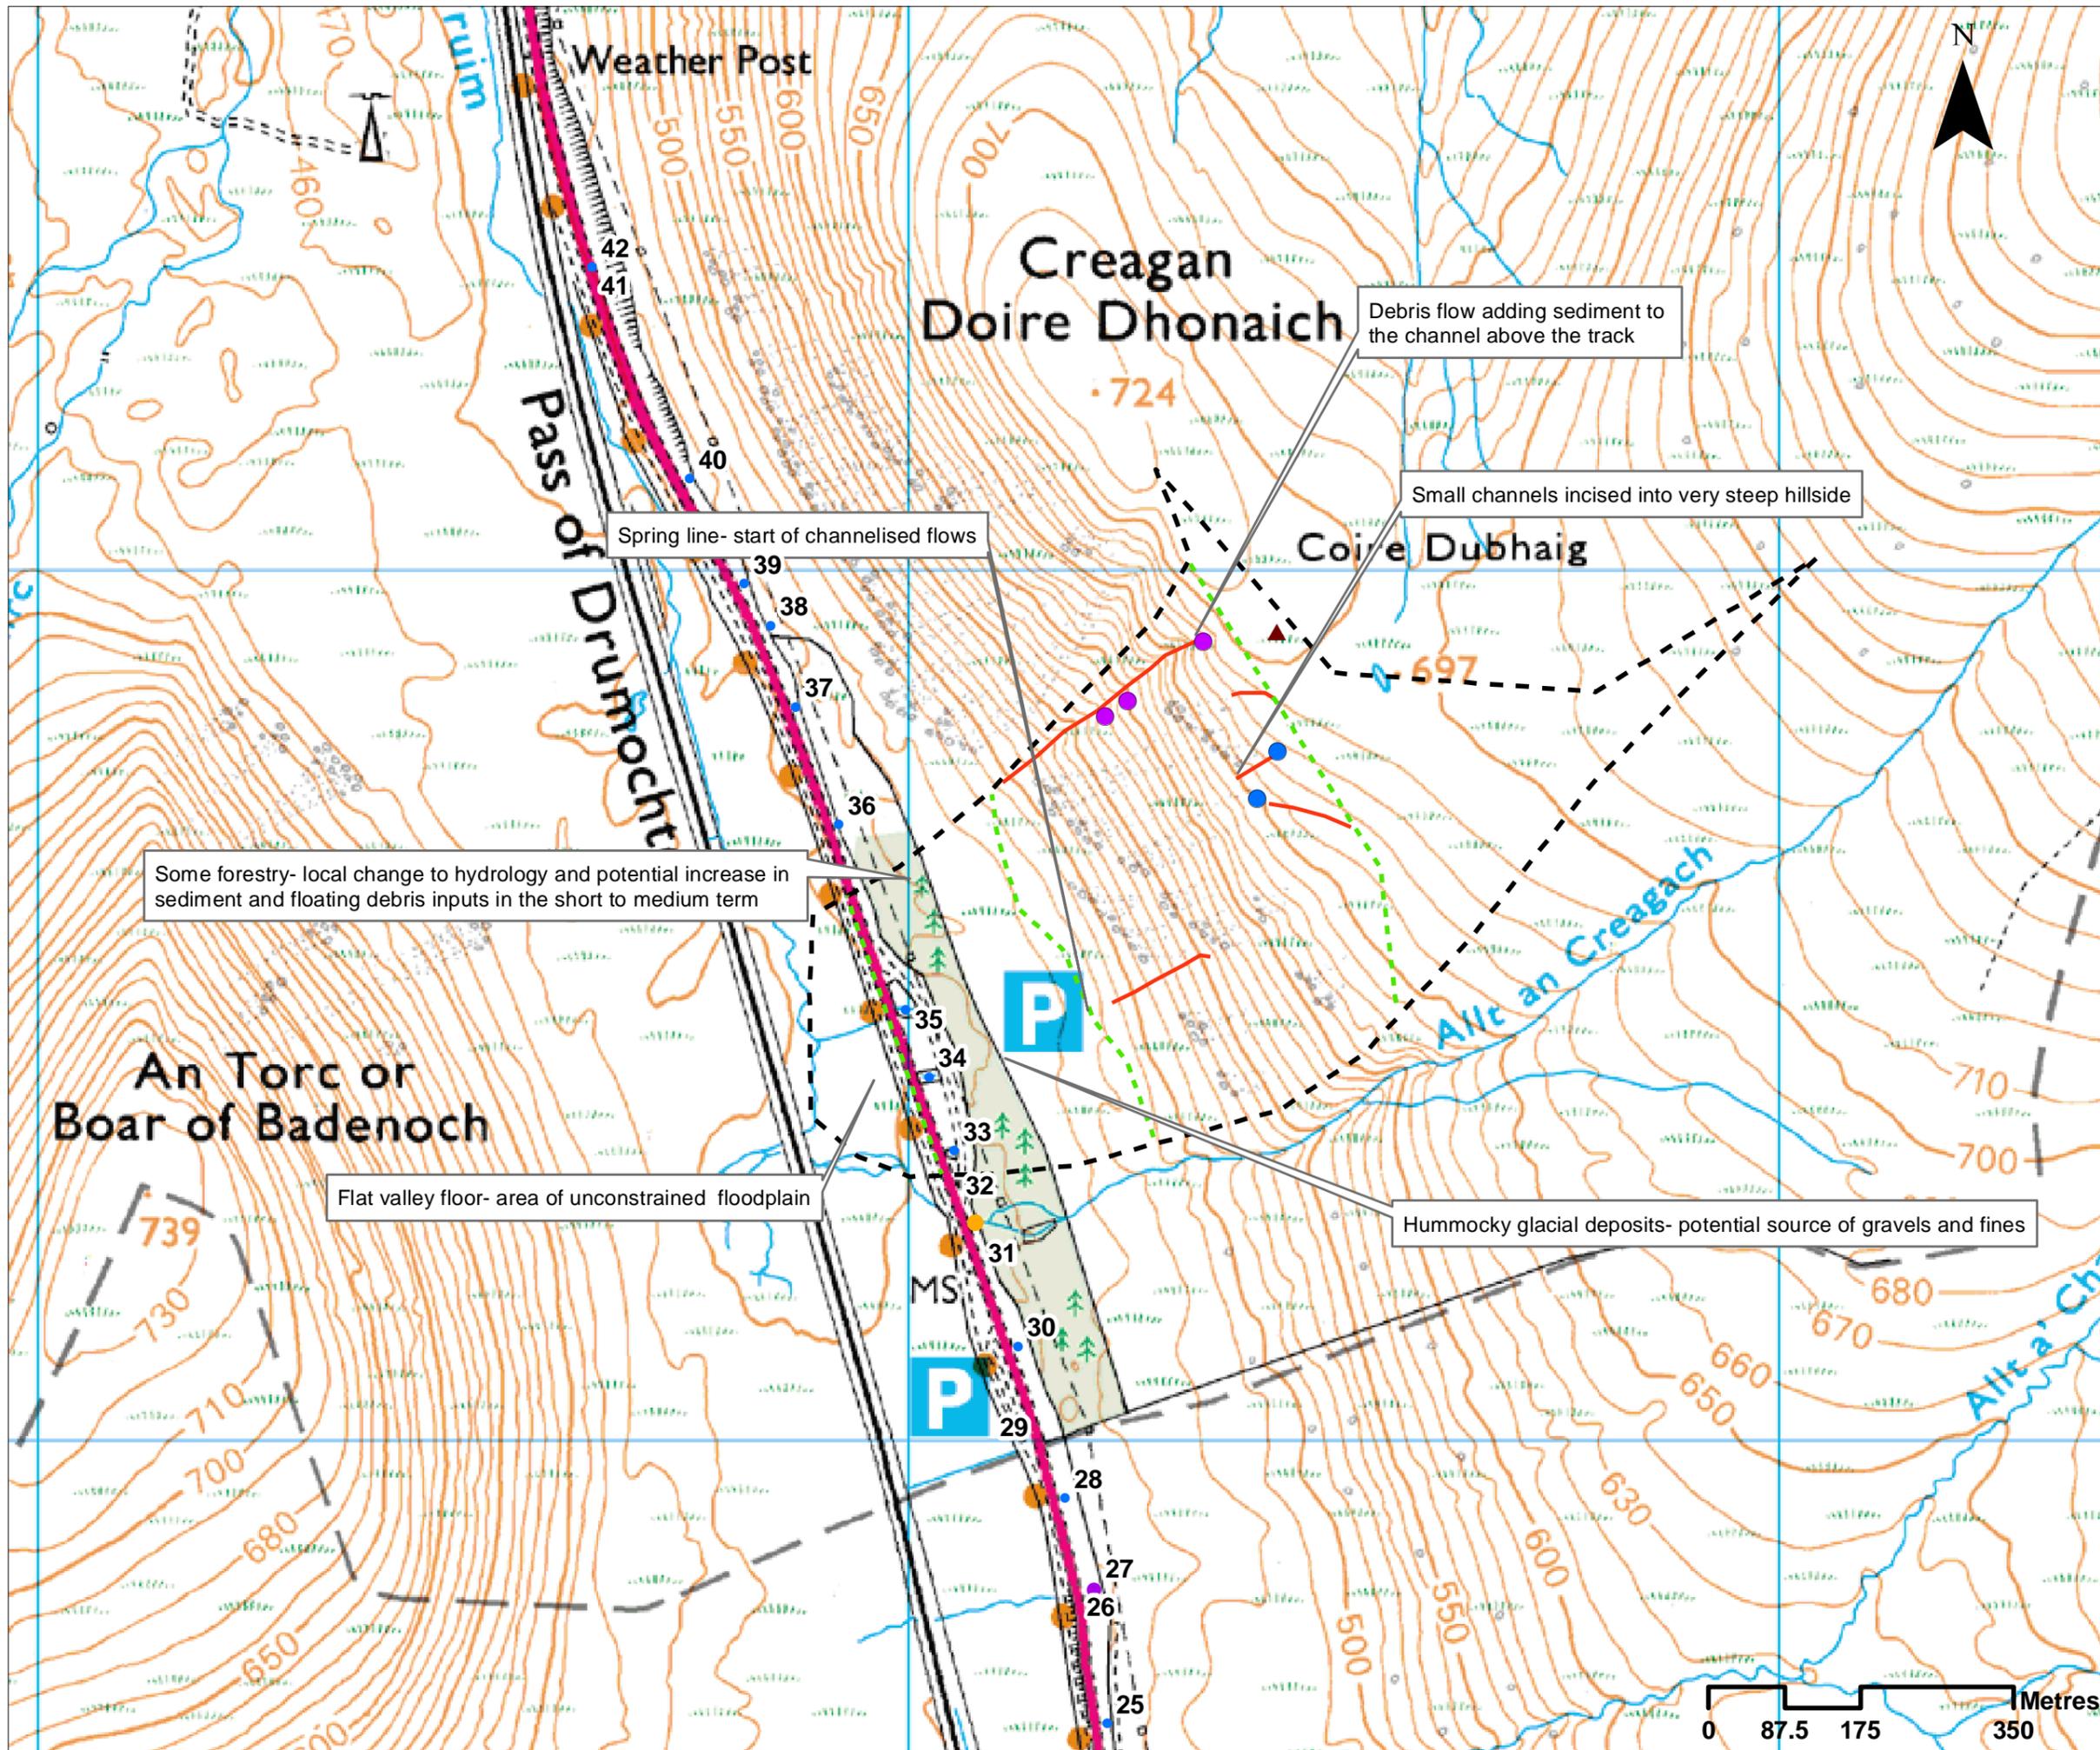
Some forestry- local change to hydrology and potential increase in sediment and floating debris inputs in the short to medium term

Flat valley floor- area of unconstrained floodplain

Debris flow adding sediment to the channel above the track

Small channels incised into very steep hillside

Hummocky glacial deposits- potential source of gravels and fines

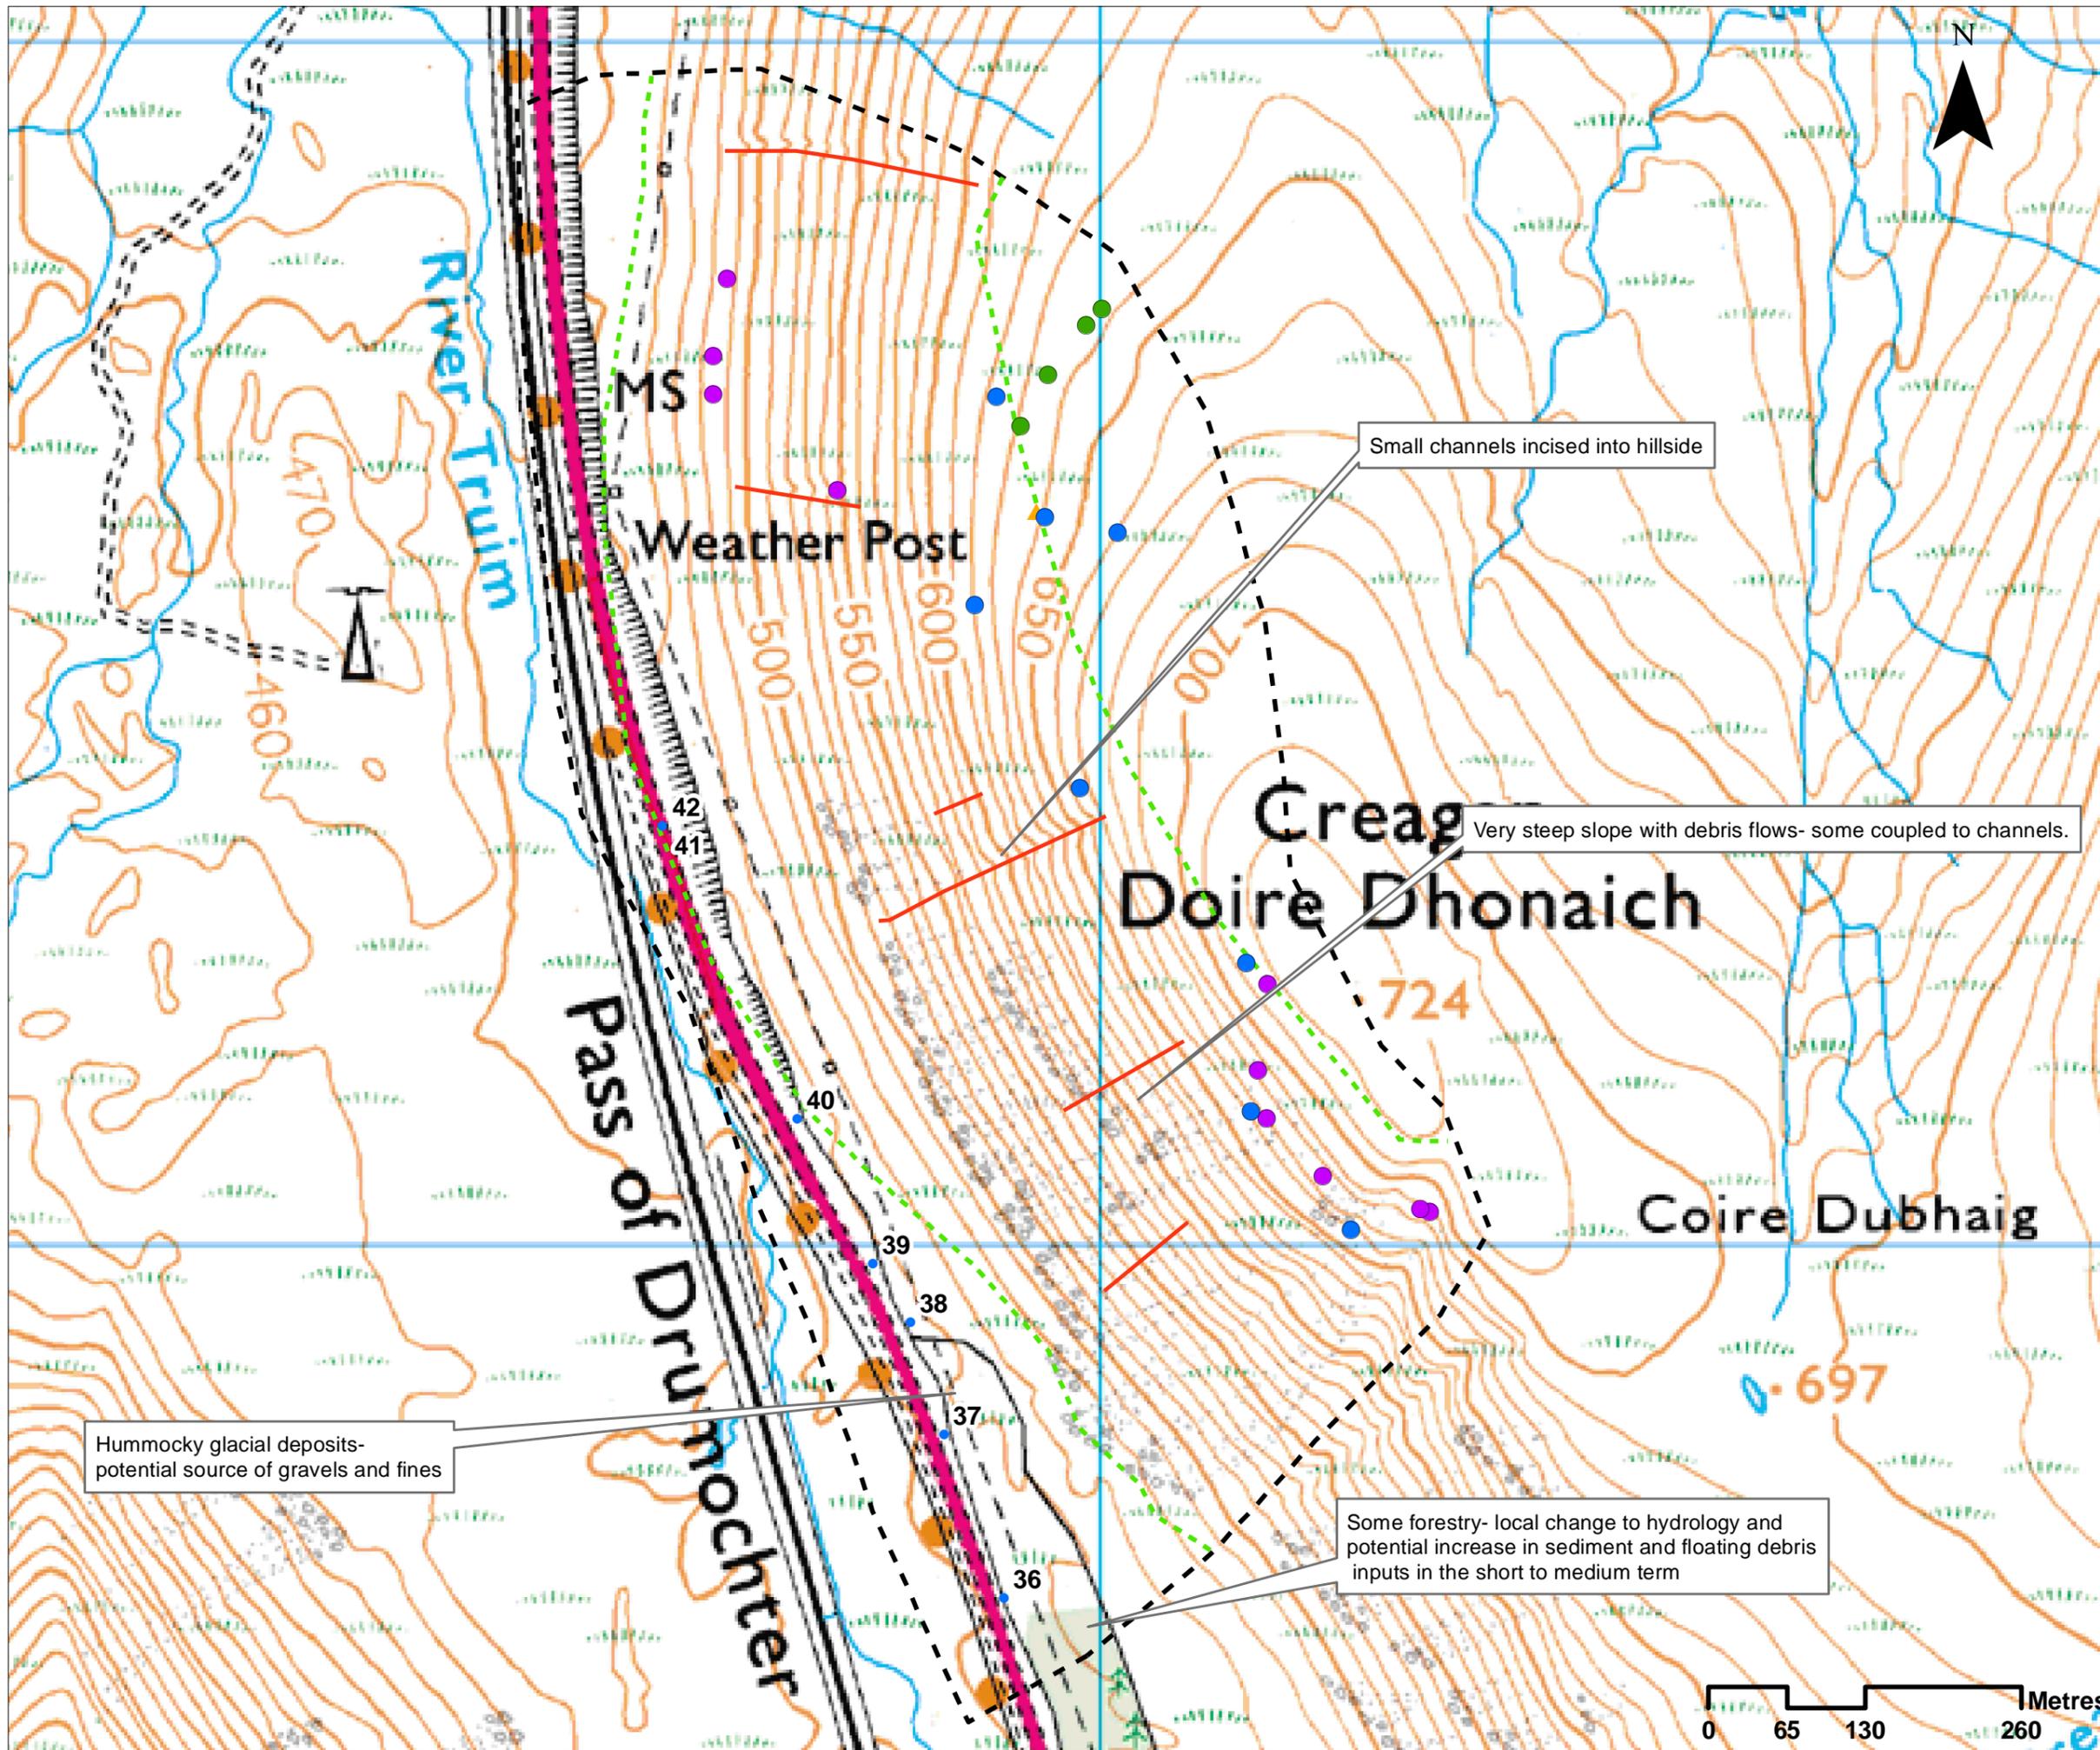
PROJECT 7 GLEN GARRY TO DALWHINNIE EIA
DRAWING 11.4.3.2.
Catchments 36-42 Baseline Assessment

Hummocky glacial deposits- potential source of gravels and fines

Some forestry- local change to hydrology and potential increase in sediment and floating debris inputs in the short to medium term

Small channels incised into hillside

Very steep slope with debris flows- some coupled to channels.

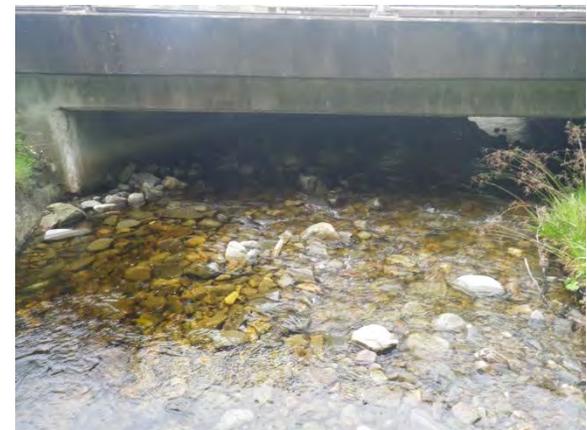
Photograph 11.4.3.82-Downstream into crossing- Gravel and cobble bed

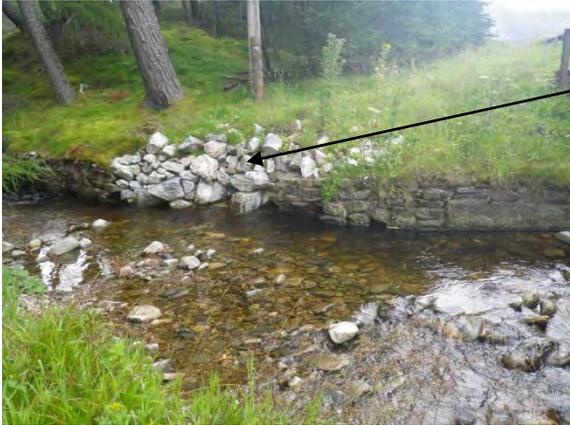
Photograph 11.4.3.83-Left bank

Recent bank protection

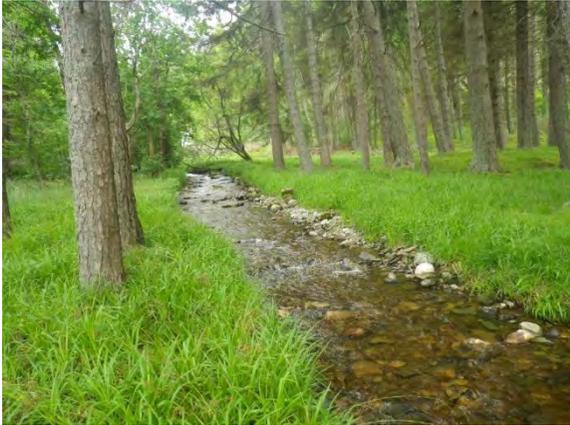
Photograph 11.4.3.84 -Upstream to plain bed channel through wooded floodplain

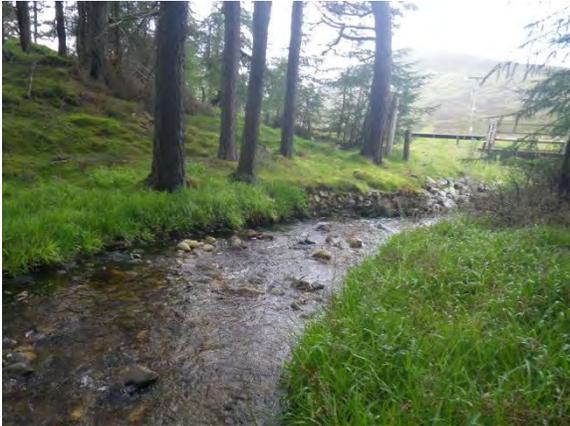
Photograph 11.4.3.85-Downstream to new bank protection

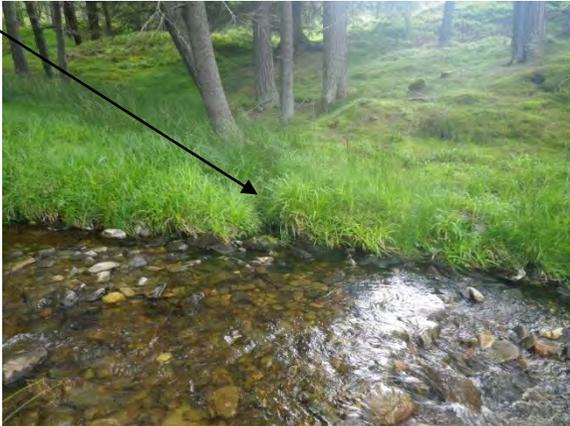
Photograph 11.4.3.86-Tributary inflow

Tributary inflow

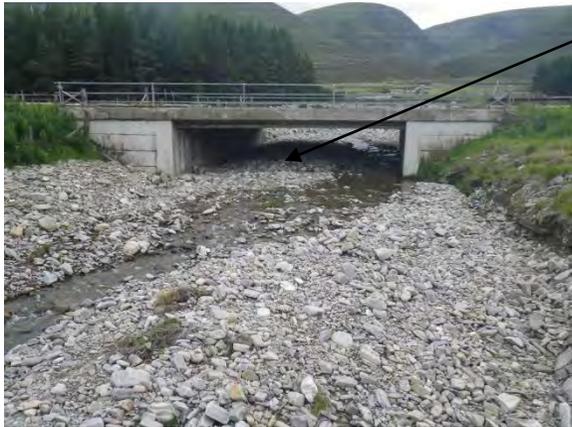
Photograph 11.4.3.87- Upstream towards crossing

Deposition
under bridge

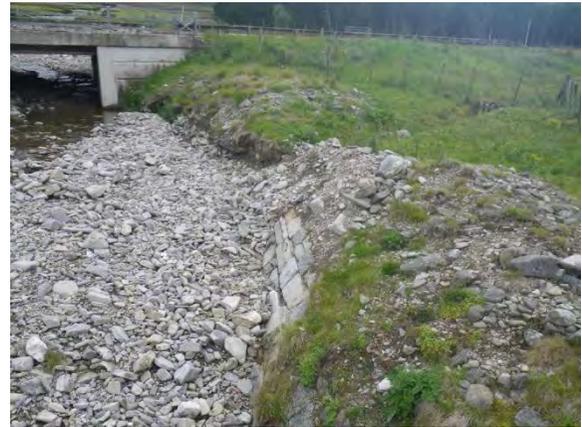
Photograph 11.4.3.88- Erosion of right bank

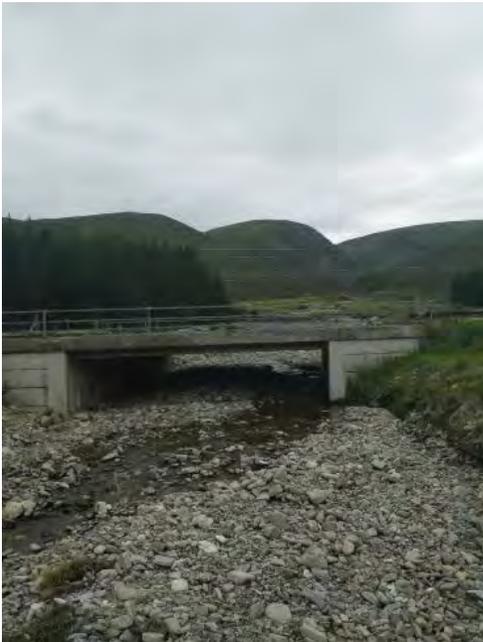
Photograph 11.4.3.89 -Steep catchment
upstream

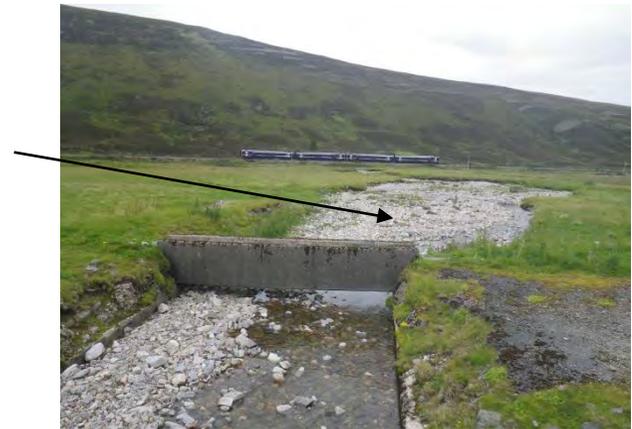
Deposition

Photograph 11.4.3.90- Unknown structure
crossing downstream

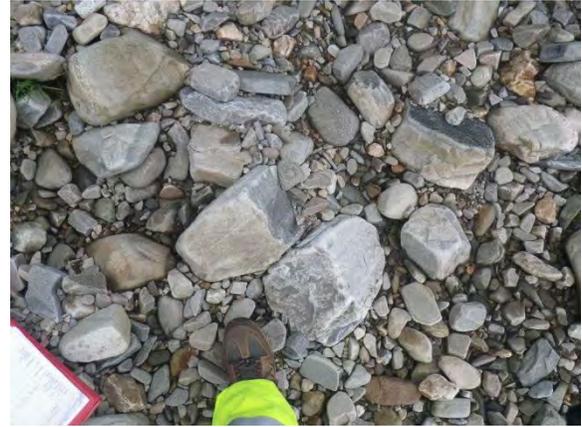
Photograph 11.4.3.92- Bed sediment (Cobbles and boulders)

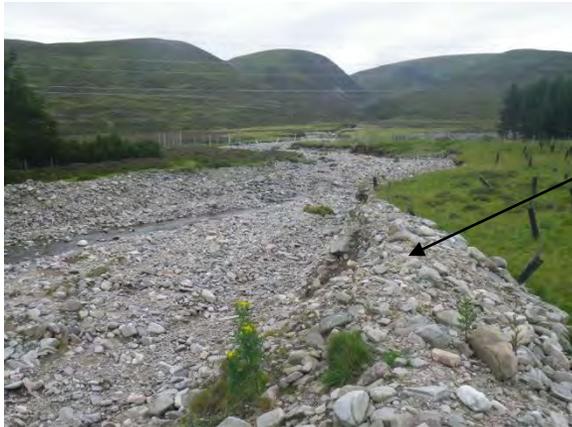
Embankment

Photograph 11.4.3.93- Deposition upstream of crossing

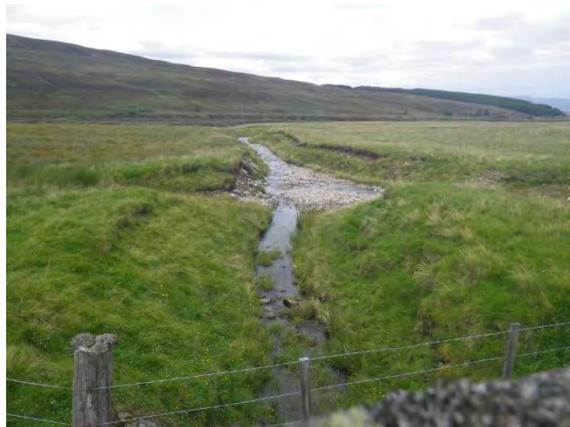
Photograph 11.4.3.95- Downstream to confluence with crossing 64, failing channel banks

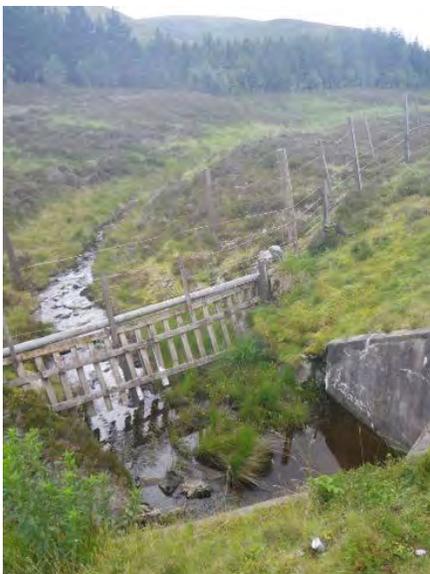
Photograph 11.4.3.96- Upstream of crossing, confined channel
