Appendix 11.4

Hydromorphology
Assessment Part 3

Annex 11.4.4-Hydromorphological Catchment Assessment-146_1

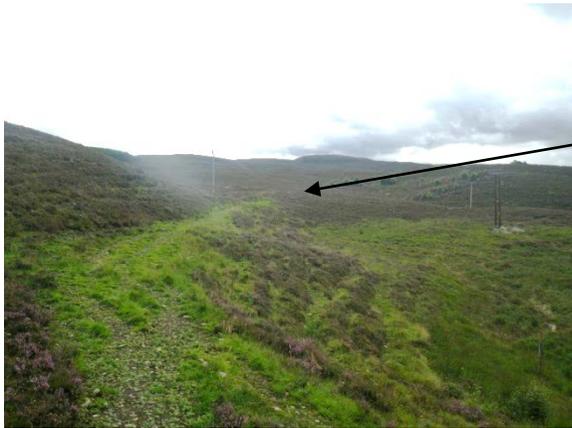
Photograph 11.4.4.26-Upstream to catchment

Moorland
catchment

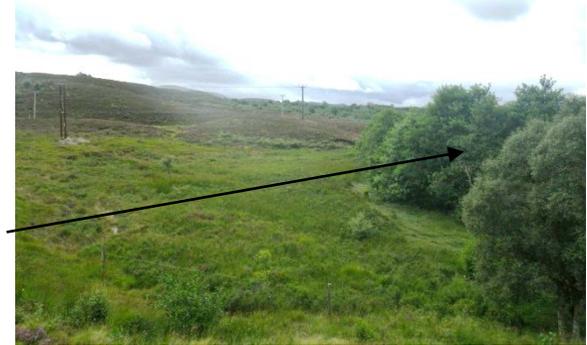
Photograph 11.4.4.27-Upstream to catchment

Tree lined
channel

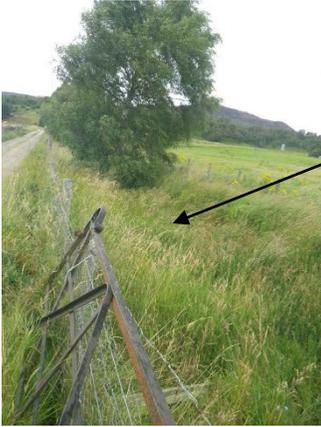
Photograph 11.4.4.28

Channel
along fence
line

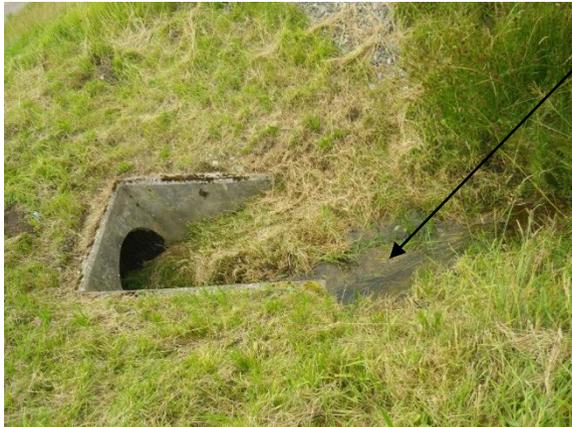
Photograph 11.4.4.30- Crossing exit

Some flow

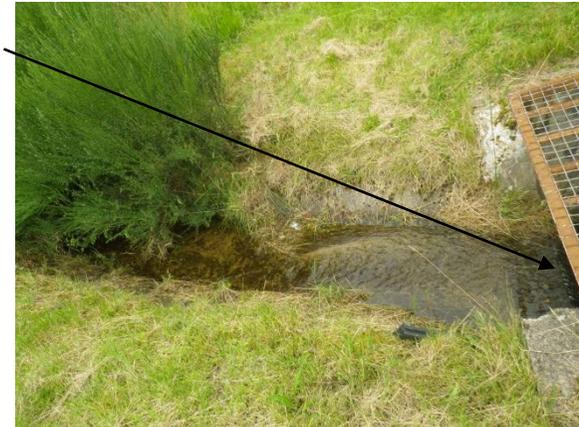
Photograph 31

Entrance to
crossing

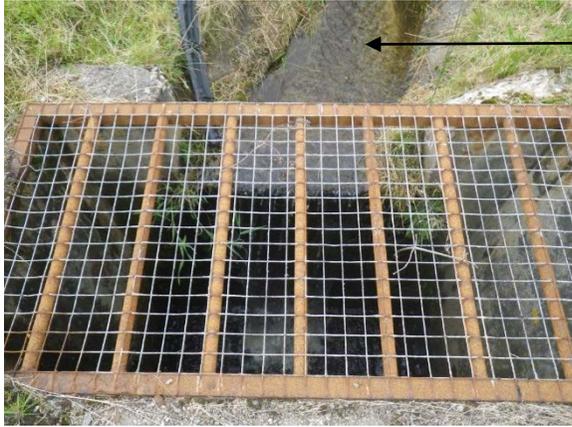
Photograph 11.4.4.32

Concrete
channel
leading to
crossing

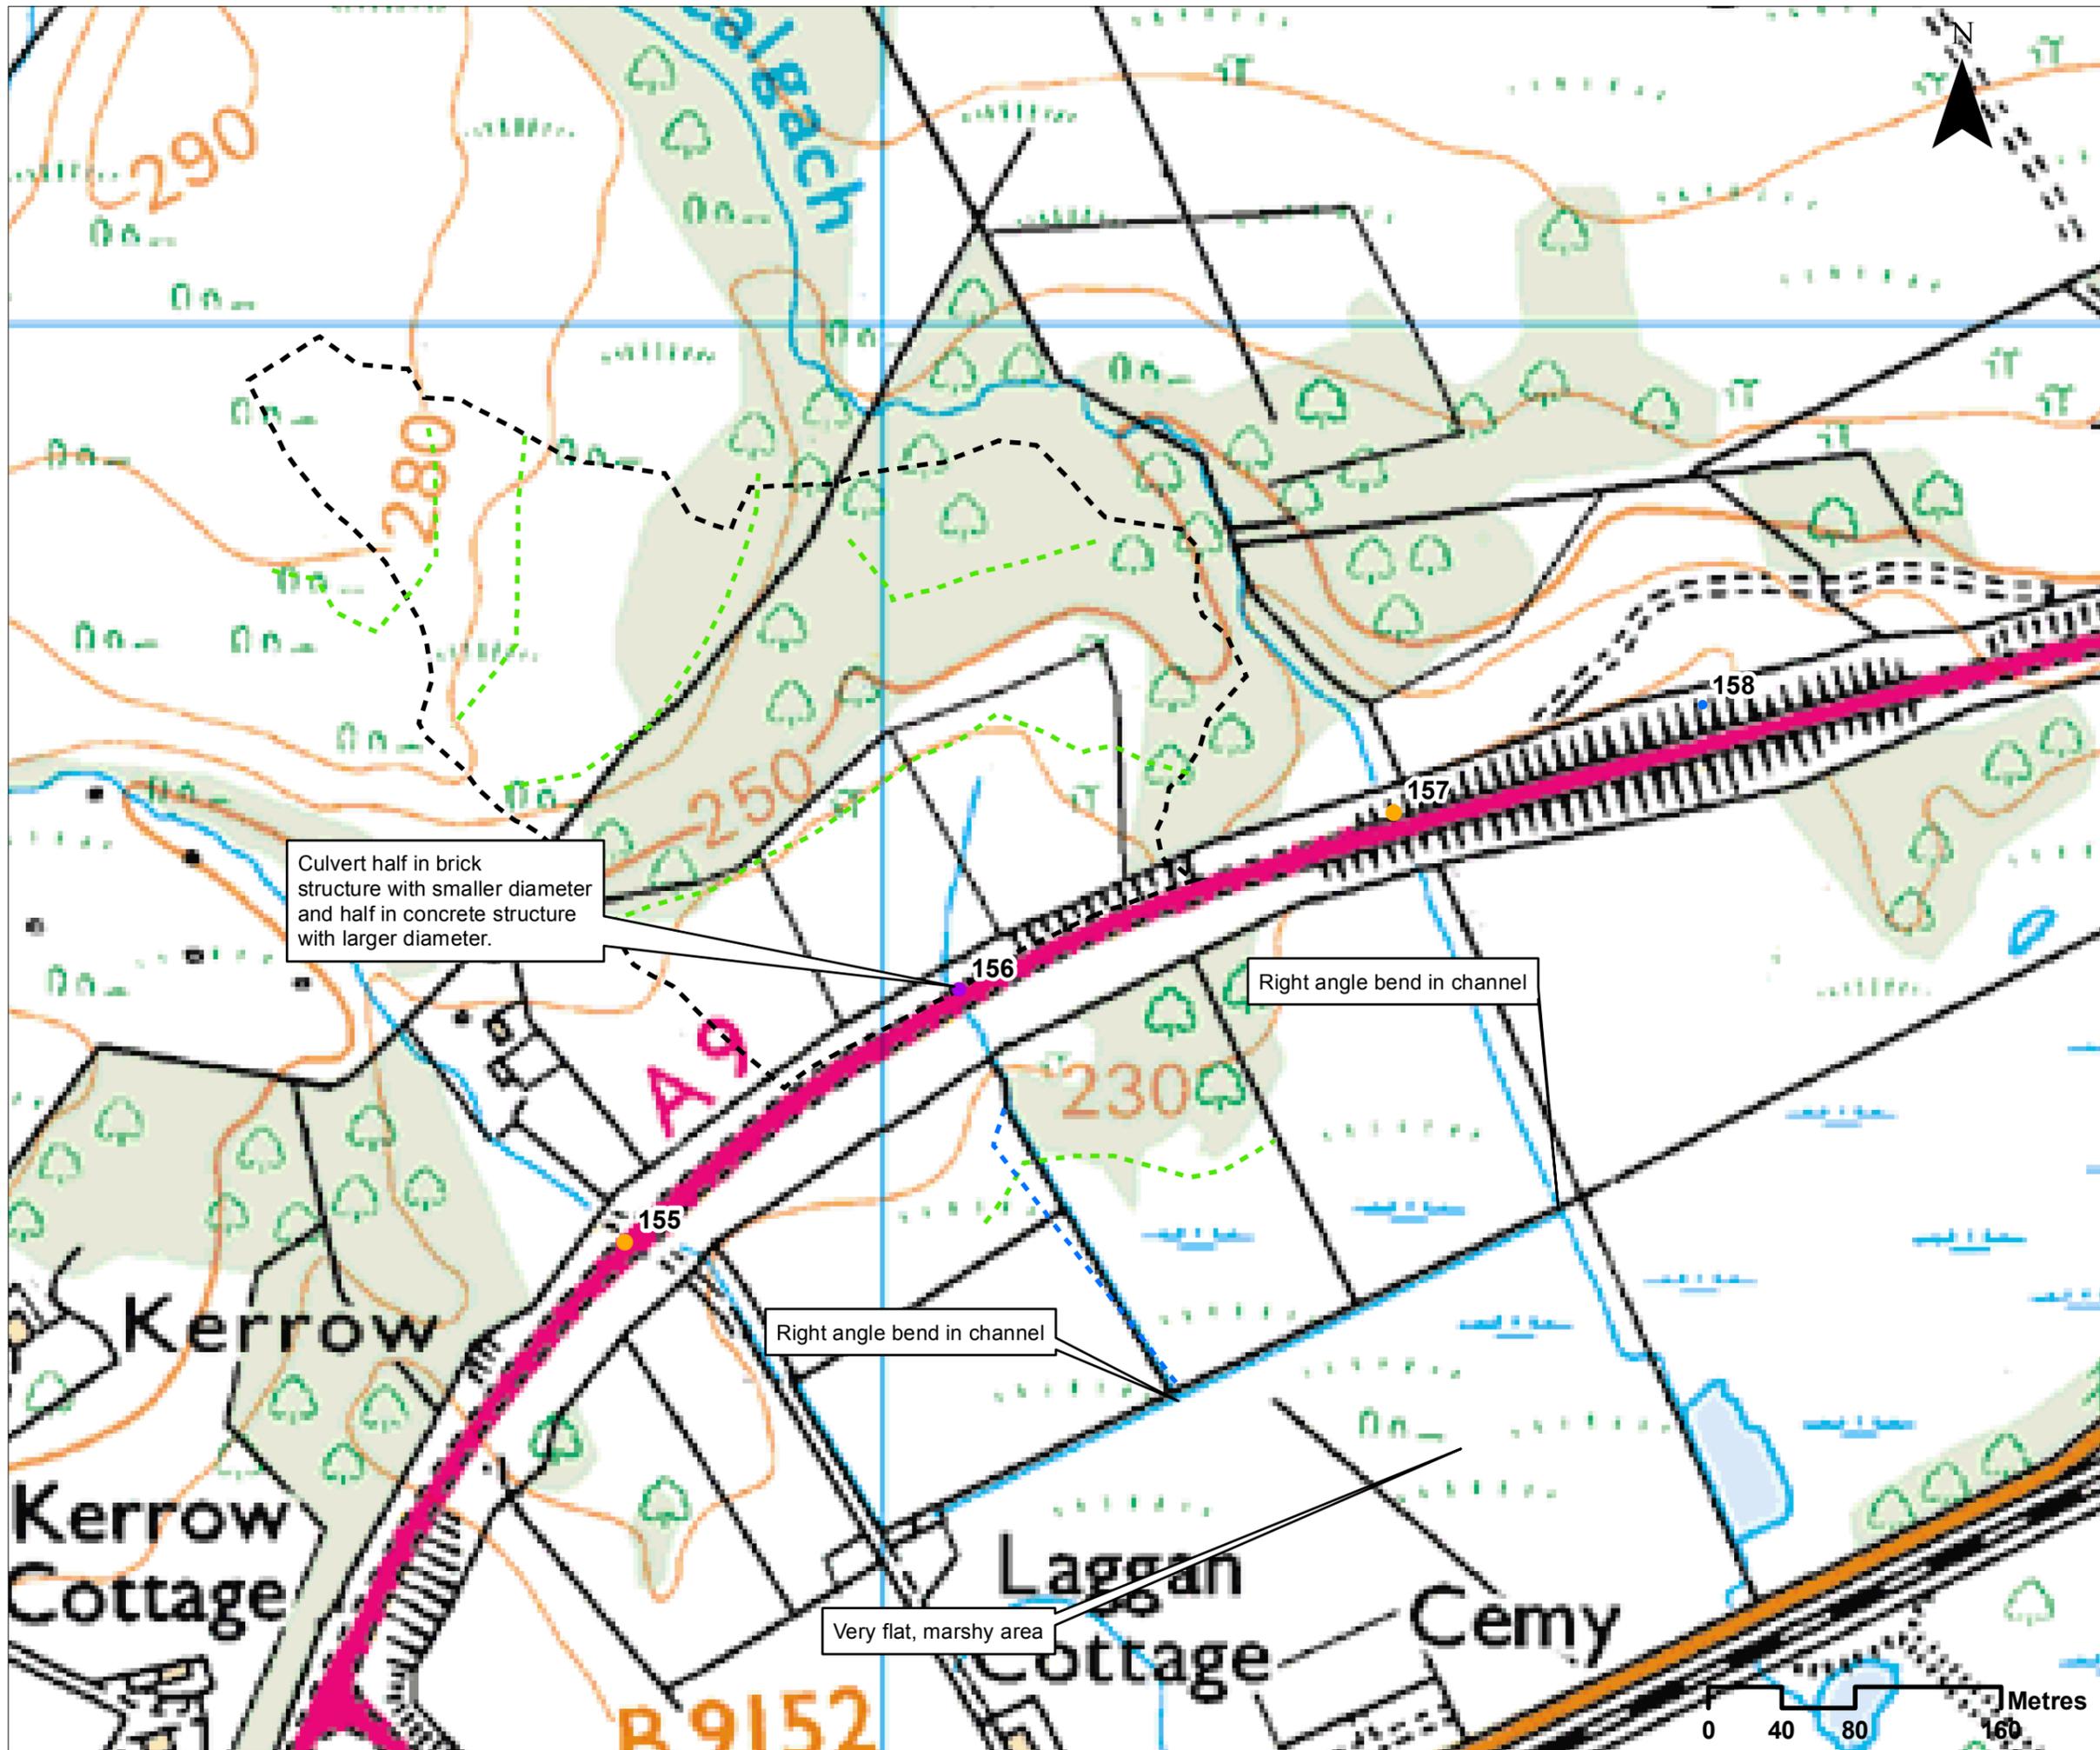
PROJECT 9 CRUBENMORE TO KINCRAIG EIA
DRAWING 11.4.4.2
Catchment 156 Baseline Assessment

Culvert half in brick structure with smaller diameter and half in concrete structure with larger diameter.

Right angle bend in channel

Very flat, marshy area

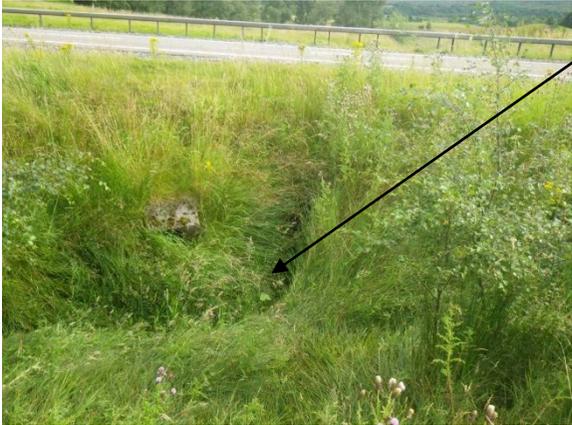
Photograph 11.4.4.33

Culvert entrance

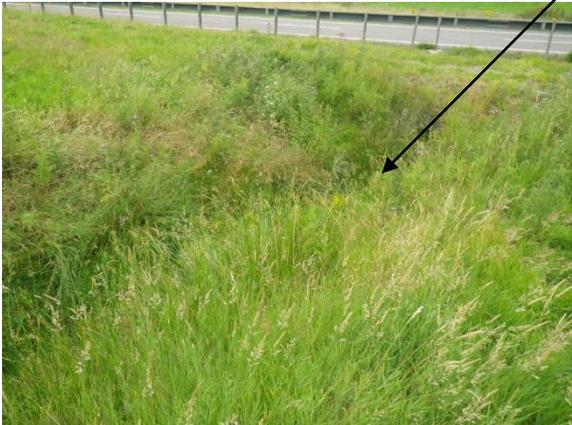
Photograph 11.4.4.35

Culvert exit

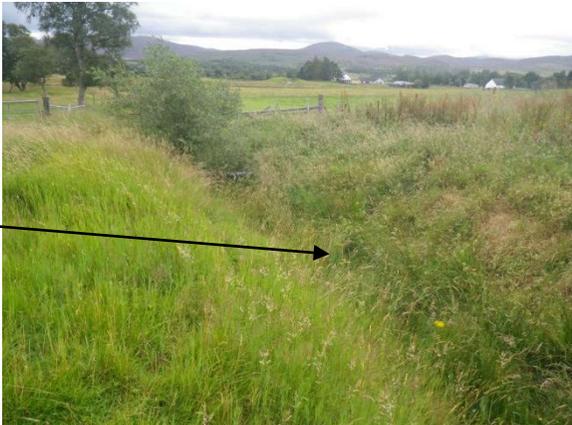
Photograph 11.4.4.36

Downstream from crossing

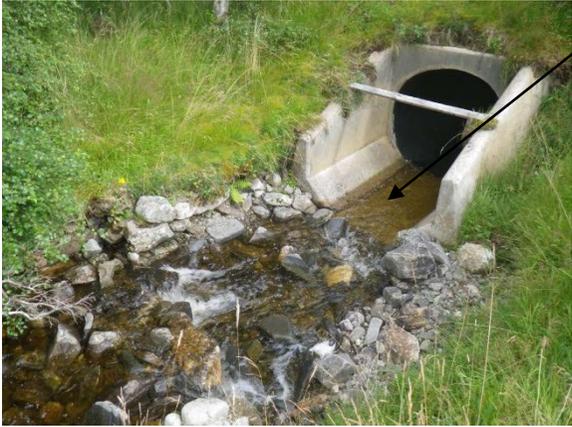
Photograph 11.4.4.37

Culvert entrance

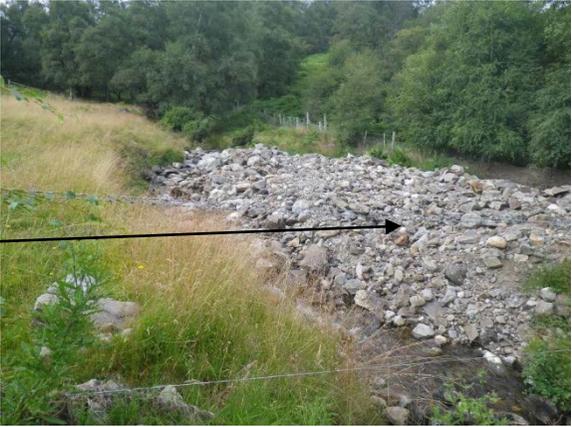
Photograph 11.4.4.38

Large scale deposition of boulders to fines

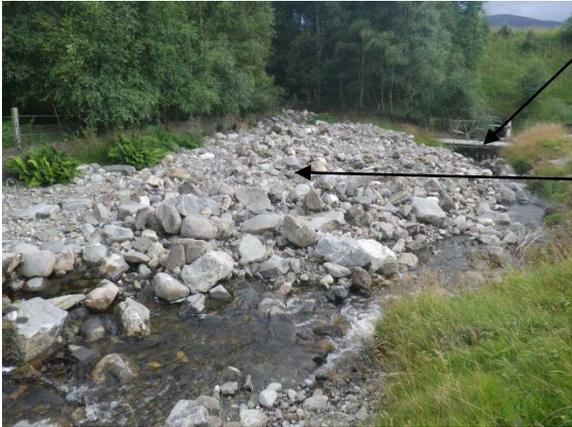
Photograph 11.4.4.39

Culvert entrance

Large scale deposition of boulders to fines

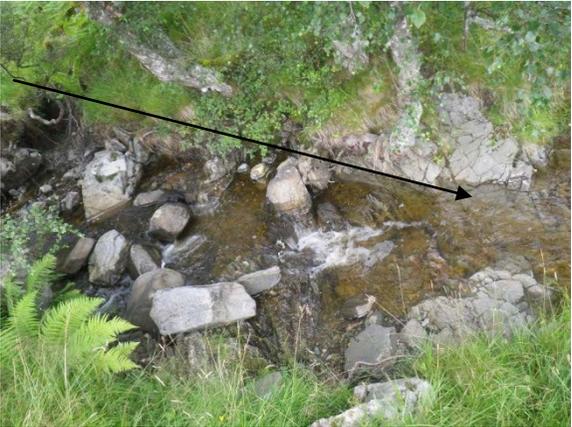
Photograph 11.4.4.40

Channel scoured to bedrock

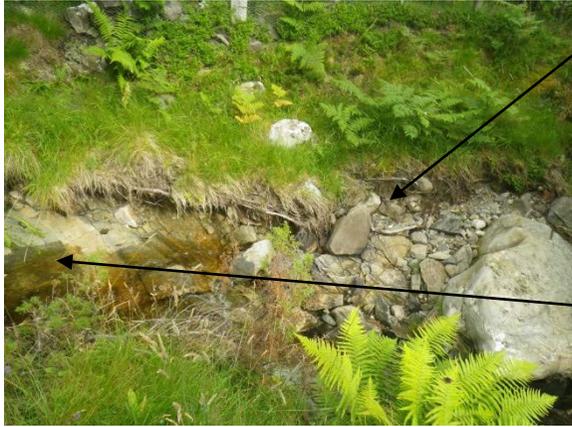
Photograph 11.4.4.41

Erosion of left bank

Incision to bed rock

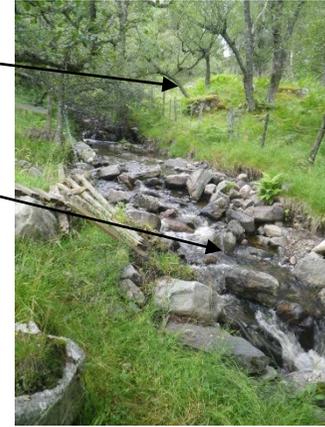
Photograph 11.4.4.42

Wooded valley

Step-pool morphology

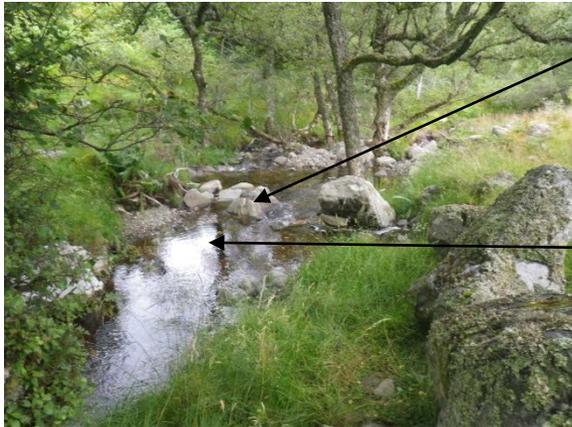
Photograph 11.4.4.43

Boulder step

Pool

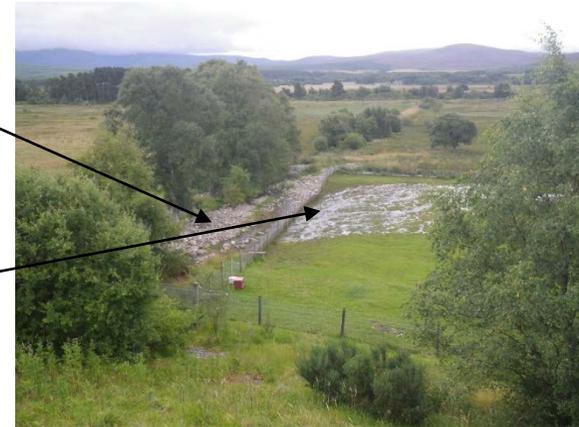
Photograph 11.4.4.44

Large scale deposition downstream of culvert

Change in flow path due to deposition

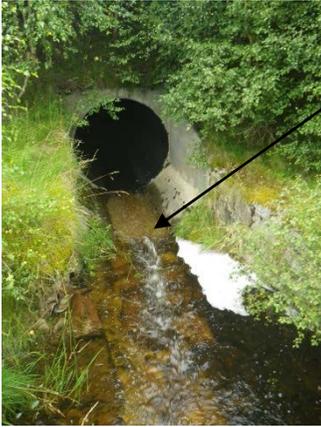
Photograph 11.4.4.45

Culvert exit cleared of sediment

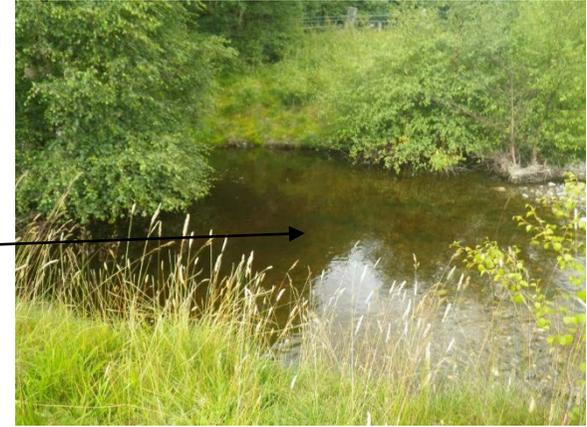
Photograph 11.4.4.46

Large pool just downstream of culvert

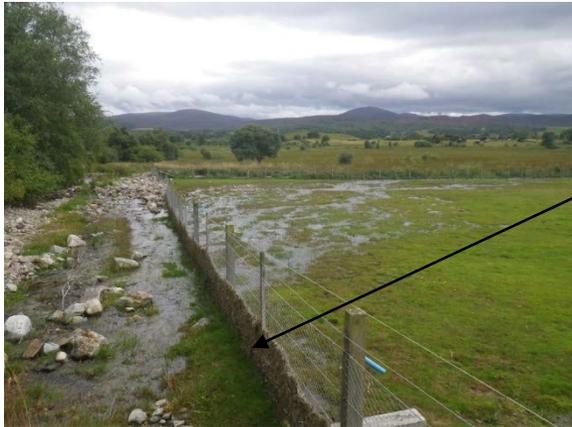
Photograph 11.4.4.47

Flood debris caught on fence

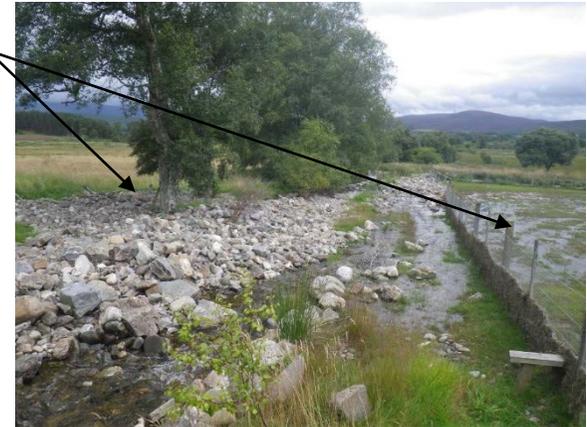
Photograph 11.4.4.48

New flow paths

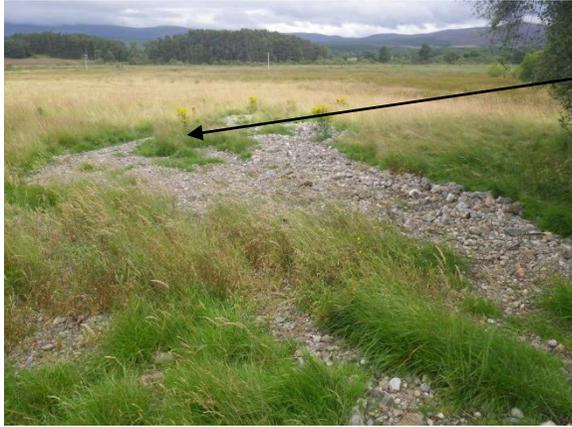
Photograph 11.4.4.49

Gravels on floodplain starting to vegetate

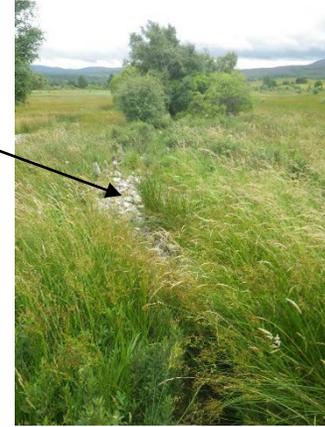
Photograph 11.4.4.50

Channel as mapped currently dry

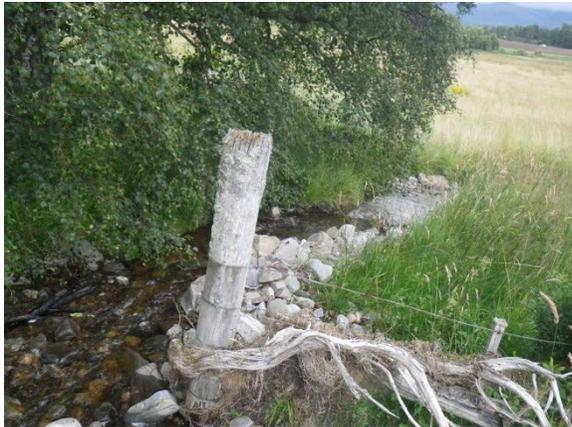
Photograph 11.4.4.51

Gravels on floodplain starting to vegetate
