Project **FORTH REPLACEMENT CROSSING**

AIR QUALITY MONITORING REPORT
OCTOBER 2012

Document number
REP-00073-00

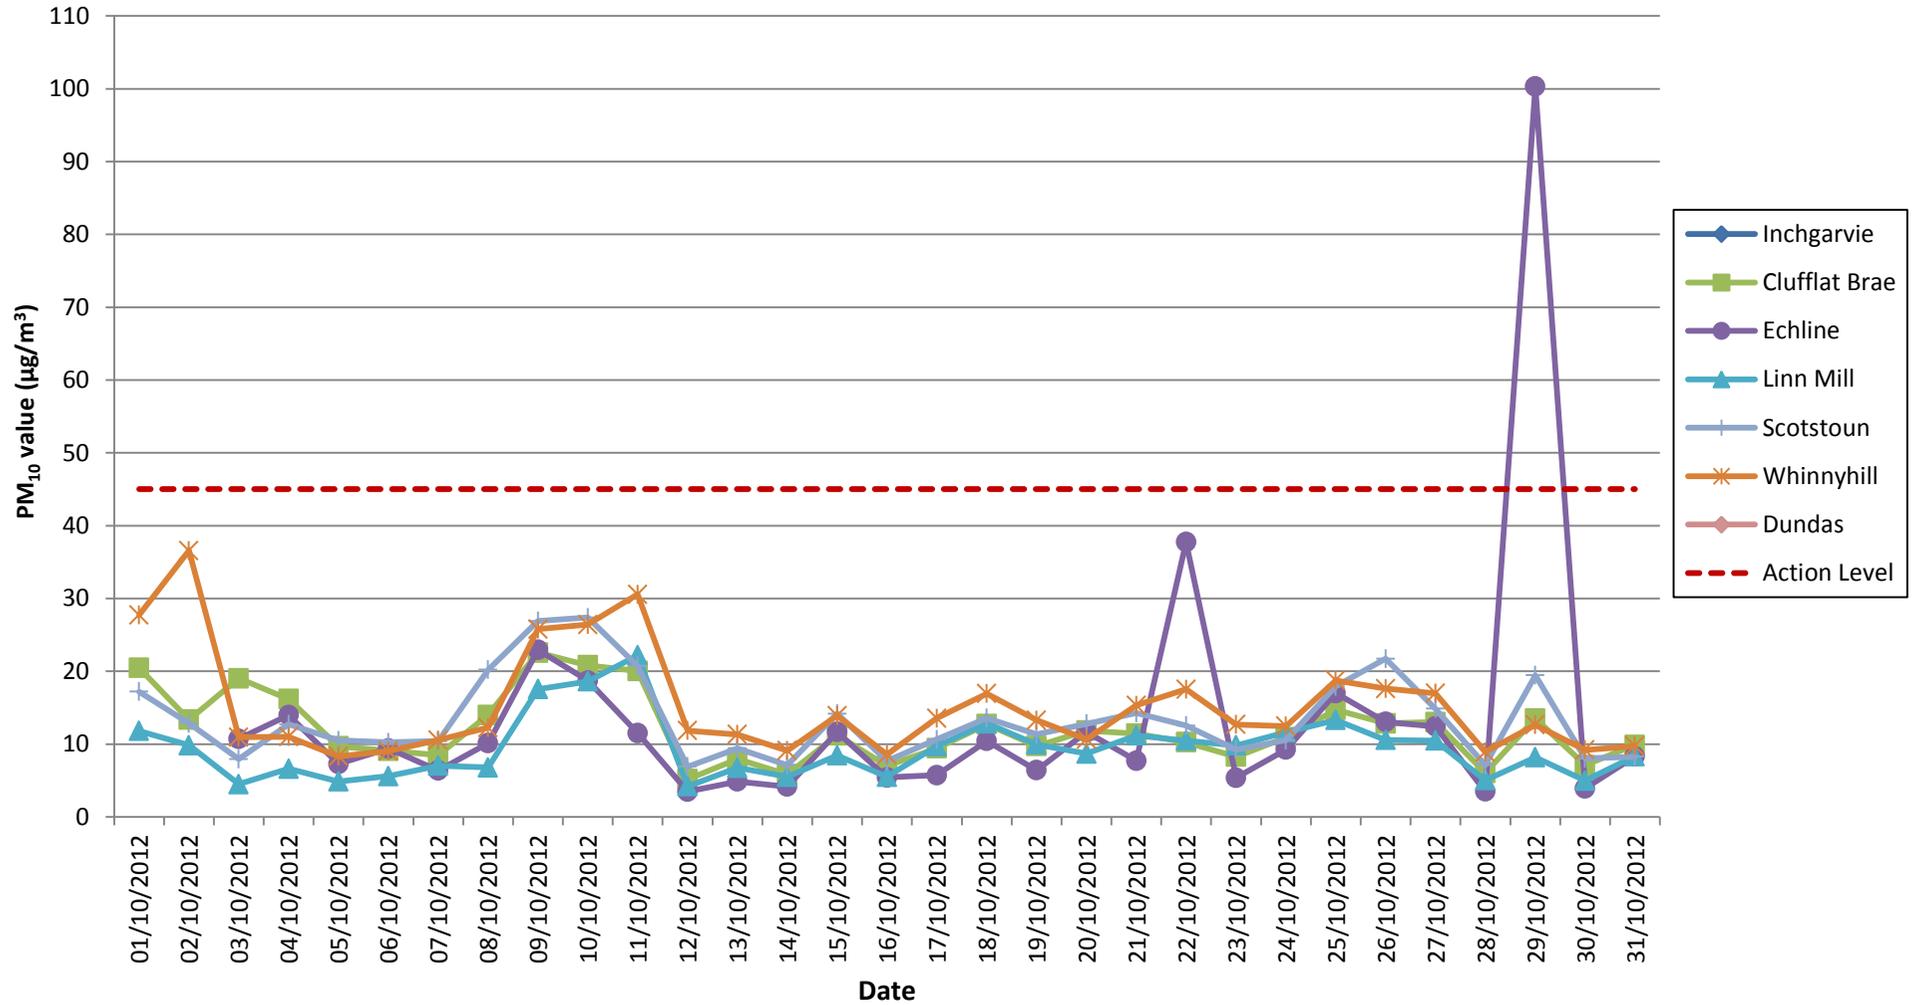
Particulate Matter (PM10) Results for all Monitoring Locations

3.1.1. Light scatter results for October 2012 have been presented in a monthly chart; this can be found in Appendix A. Generally, results show that the PM₁₀ levels were low and largely followed the same pattern across the site. There was an exceedance of the threshold at Echline on 29 October. This exceedance is not considered to be related to construction works in this area, as unrealistically high results occurred during the night (between 02:00 and 05:00 am). The exceedance was from an unidentified local source. However, it should also be noted that there were foggy conditions in the area at the time of the exceedance, which can affect readings (see section 2.2). Another peak (although not an exceedance) was noted on the 22 October at Echline which can also be attributed to foggy conditions, with unrealistically high results noted between 03:00 and 06:00 am.

Note: Due to an error associated with the Dundas device the results for this location have been excluded. Data is missing from Inchgarvie due to an error with the connection accidentally caused by a third party.

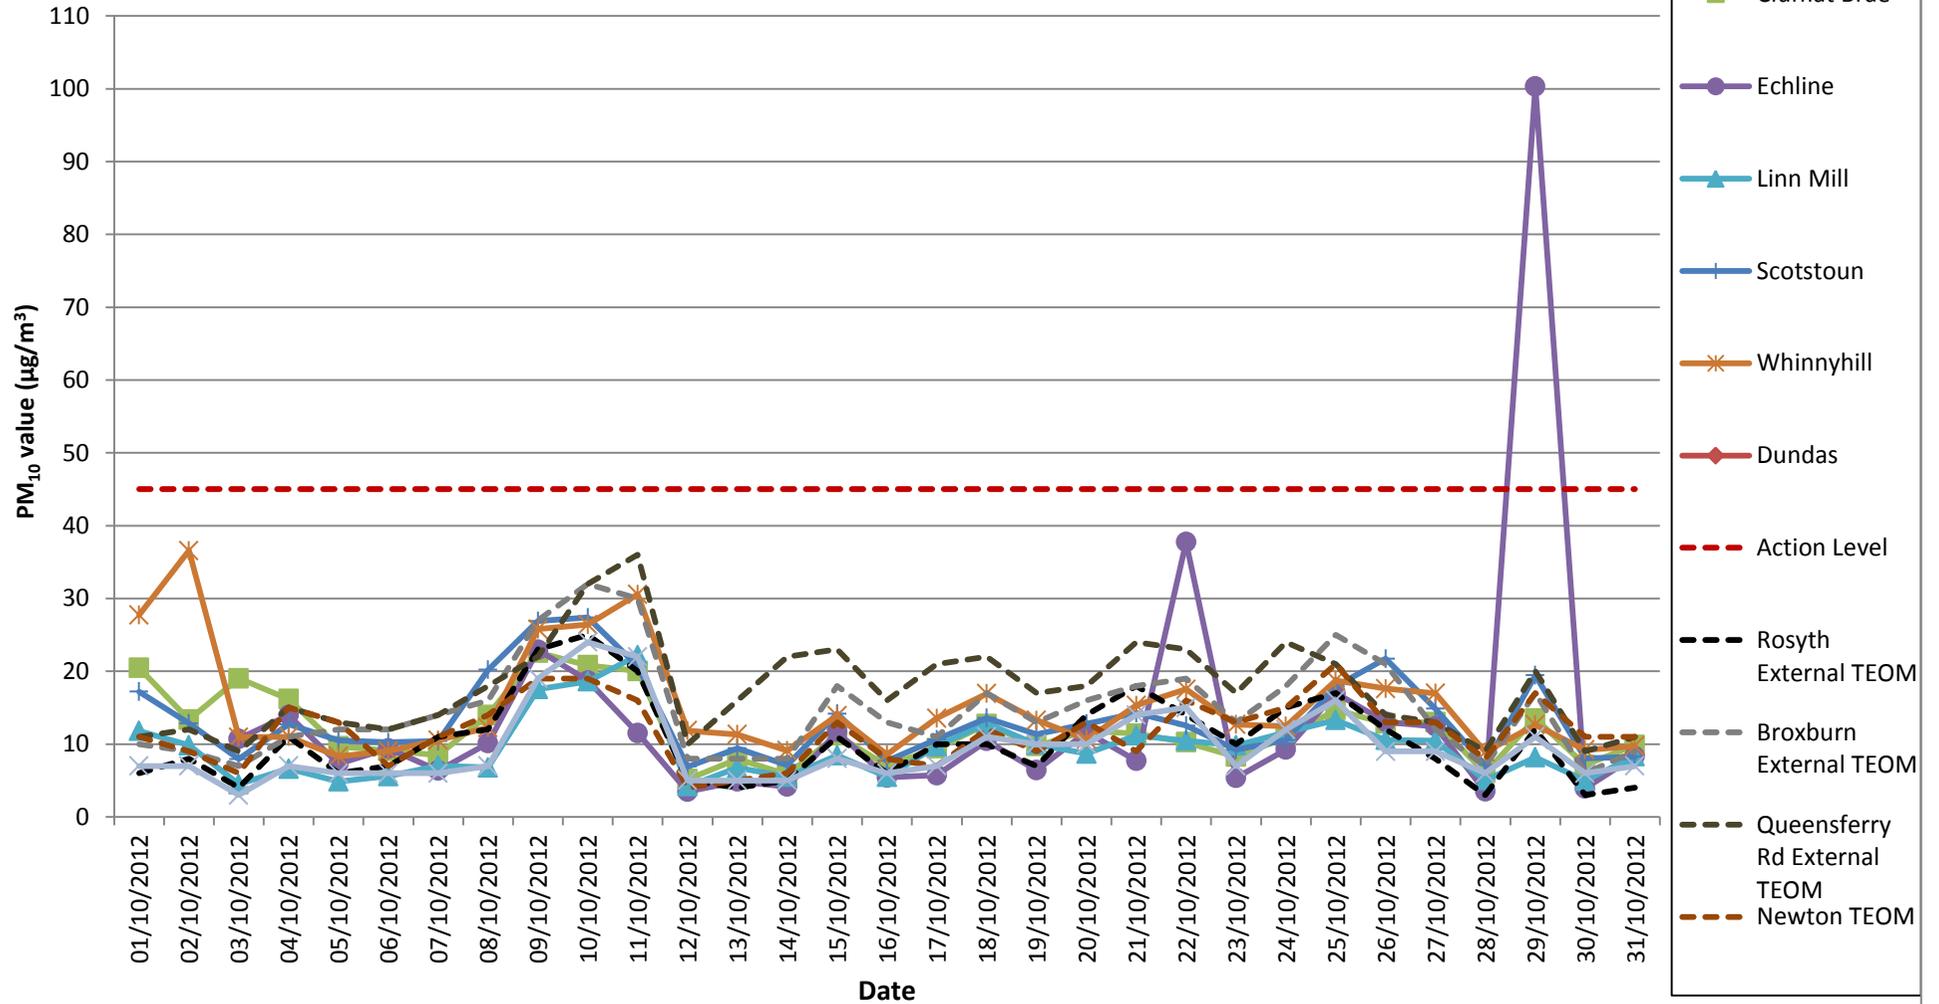
Particulate Matter (PM10) Results including TEOM Results

3.1.2. The PM₁₀ results have also been compared to the daily mean results obtained from the TEOM air quality monitoring stations located in Newton, Rosyth, Broxburn, Queensferry Road, Edinburgh and St Leonards, Edinburgh (an urban background site). The TEOM at Newton was installed by West Lothian Council, facilitated by FCBC, during May. The comparison between the light scatter and TEOM

results demonstrates that both sets of results generally follow the same pattern at similar levels, indicating that the pattern observed throughout October was largely due to regional changes in air quality.

Note: Due to an error associated with the Dundas device the results for this location have been excluded. Data is missing from Inchgarvie due to an error with the connection accidentally caused by a third party.

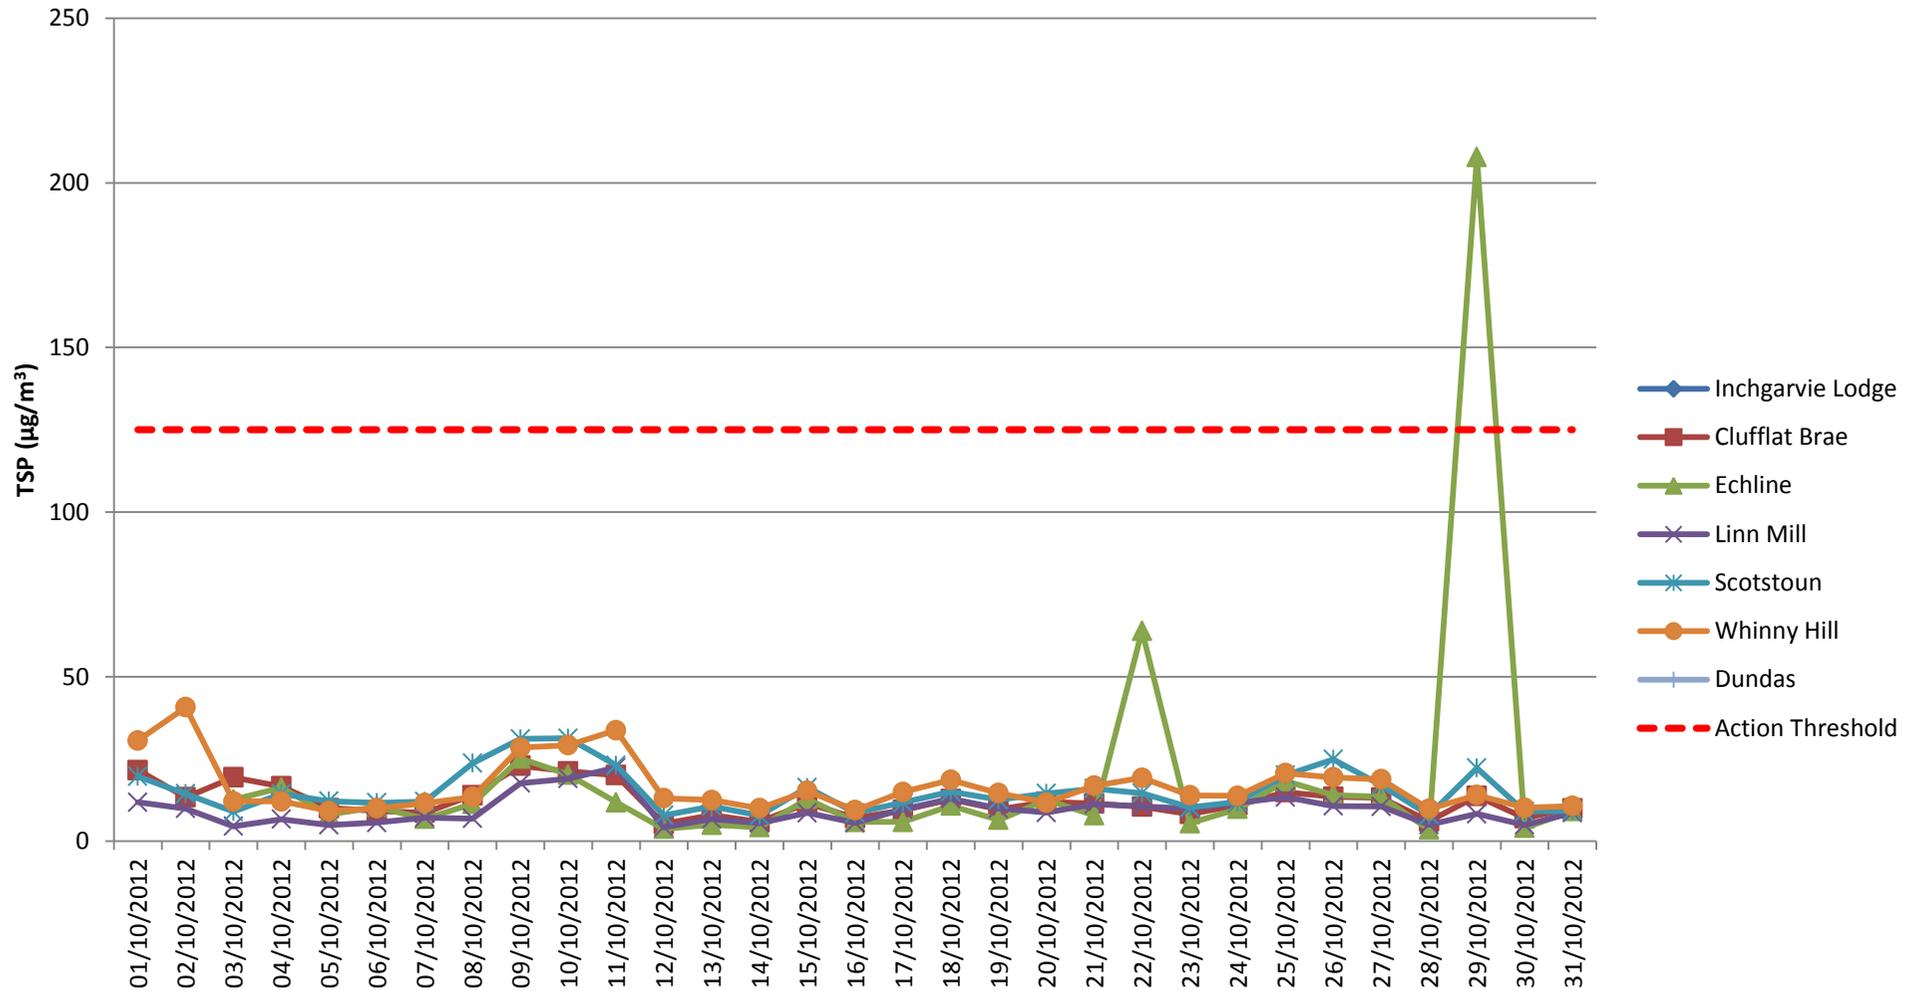
Total Suspended Particles (TSP) Results October 2012

- 3.2.1.** The TSP results for October 2012 have been presented in a monthly chart; this can be found in Appendix B. Largely, the TSP levels at all monitoring locations throughout October were within the threshold level and found to follow a similar pattern across the site. One exceedance of the threshold level did occur at Echline on 29 October, with an additional peak, although not exceeding the threshold level, occurring on 22 October. However, both of these results can be attributed to the errors in the readings caused by the foggy conditions on these dates as discussed in paragraph 3.1.1. All other TSP results were found to follow a similar pattern across the site, demonstrating that in general the levels are influenced by regional changes in TSP levels, rather than construction works.

- 3.2.2.** Due to a device error associated with the measurement of TSP at Dundas, as noted in section 3.1.3, the results for this location have been excluded from the graph. Measurements of TSP throughout October continued to be unrealistically low. FCBC have consulted with

the supplier and have arranged a visit from an engineer in November to resolve the issue. Data is also missing for Inchgarvie due to the loss of power, as noted in paragraph 3.1.3.

Note: Due to errors associated with the TSP results for Dundas, these results have been excluded. Data is missing from Inchgarvie due to an error with the connection accidentally caused by a third party.

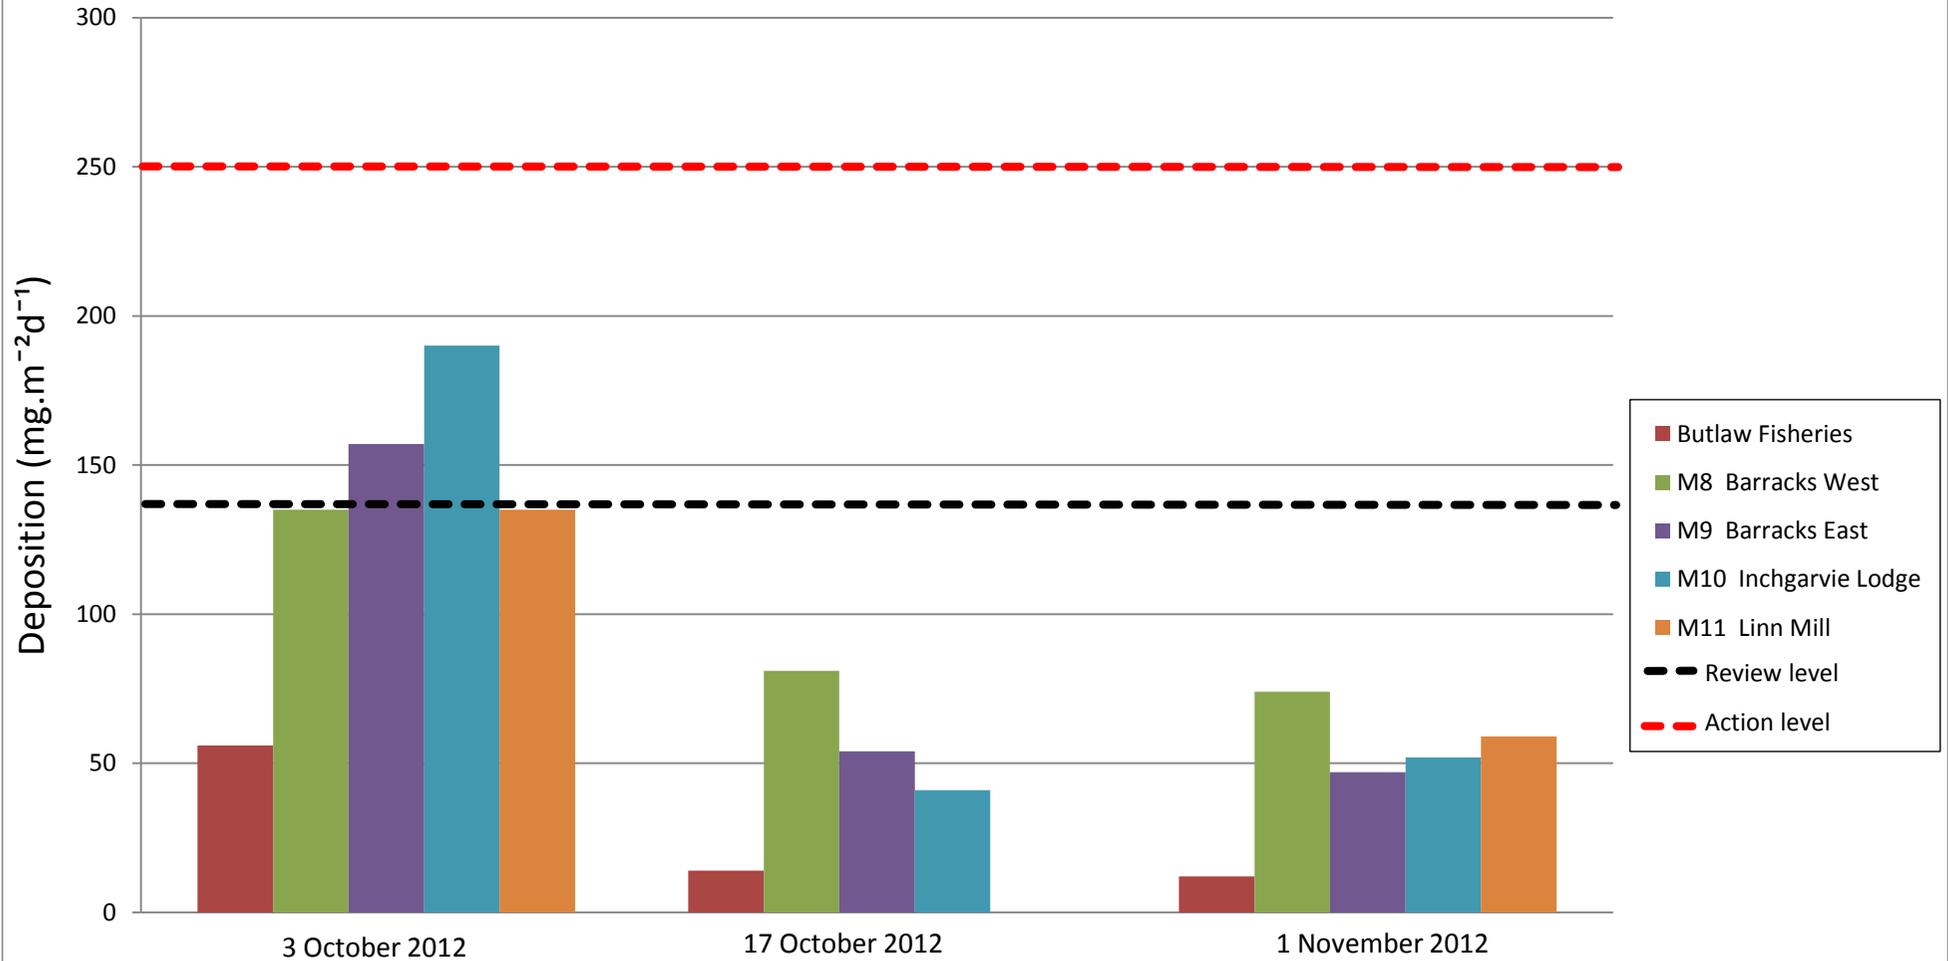
Frisbee Dust Deposition Results: Group 1
Locations: M7 Butlaw Fisheries, M8 Barracks West, M9 Barracks East, M10 Inchgarvie Lodge and M11 Linn Mill

- 3.3.4.** Throughout October the dust deposition rates for all groups were within the site action level threshold. All dust deposition rates for Groups 3, 4 and 5 were also within the lower, site review level threshold. For the period ending on 3 October there were exceedances of the site review level at Barracks East (157 mg.m⁻²d⁻¹) and Inchgarvie Lodge (190 mg.m⁻²d⁻¹) within Group 1 and also Clufflat (174 mg.m⁻²d⁻¹) and Echline (163 mg.m⁻²d⁻¹) within Group 2.

Note: The results for Linn Mill on 17 October are missing due to a sampling error.

- 3.3.5.** Due to the exceedances of the site review level during October, at four different locations, FCBC conducted a review into site wide dust levels and the construction works being undertaken at these locations. As construction works were being undertaken in the areas close to the monitoring locations it is possible, therefore, that the exceedance at this location was caused by dust generated from these works. However, during the fortnight period covered by the collection date on the 3 October, adverse weather conditions were noted, including heavy rainfall and strong winds (please refer to Air Quality Monitoring Report: September 2012 (REP-00062-00) for log of weather conditions at end of September). Wet weather conditions ensured that materials were sufficiently suppressed during this period. It should also be noted that the increased levels may be partially attributable to falling particles from nearby vegetation during the autumn period. Dust logs and inspections (see section 3.4) during the period ensured that dust levels were continually monitored.

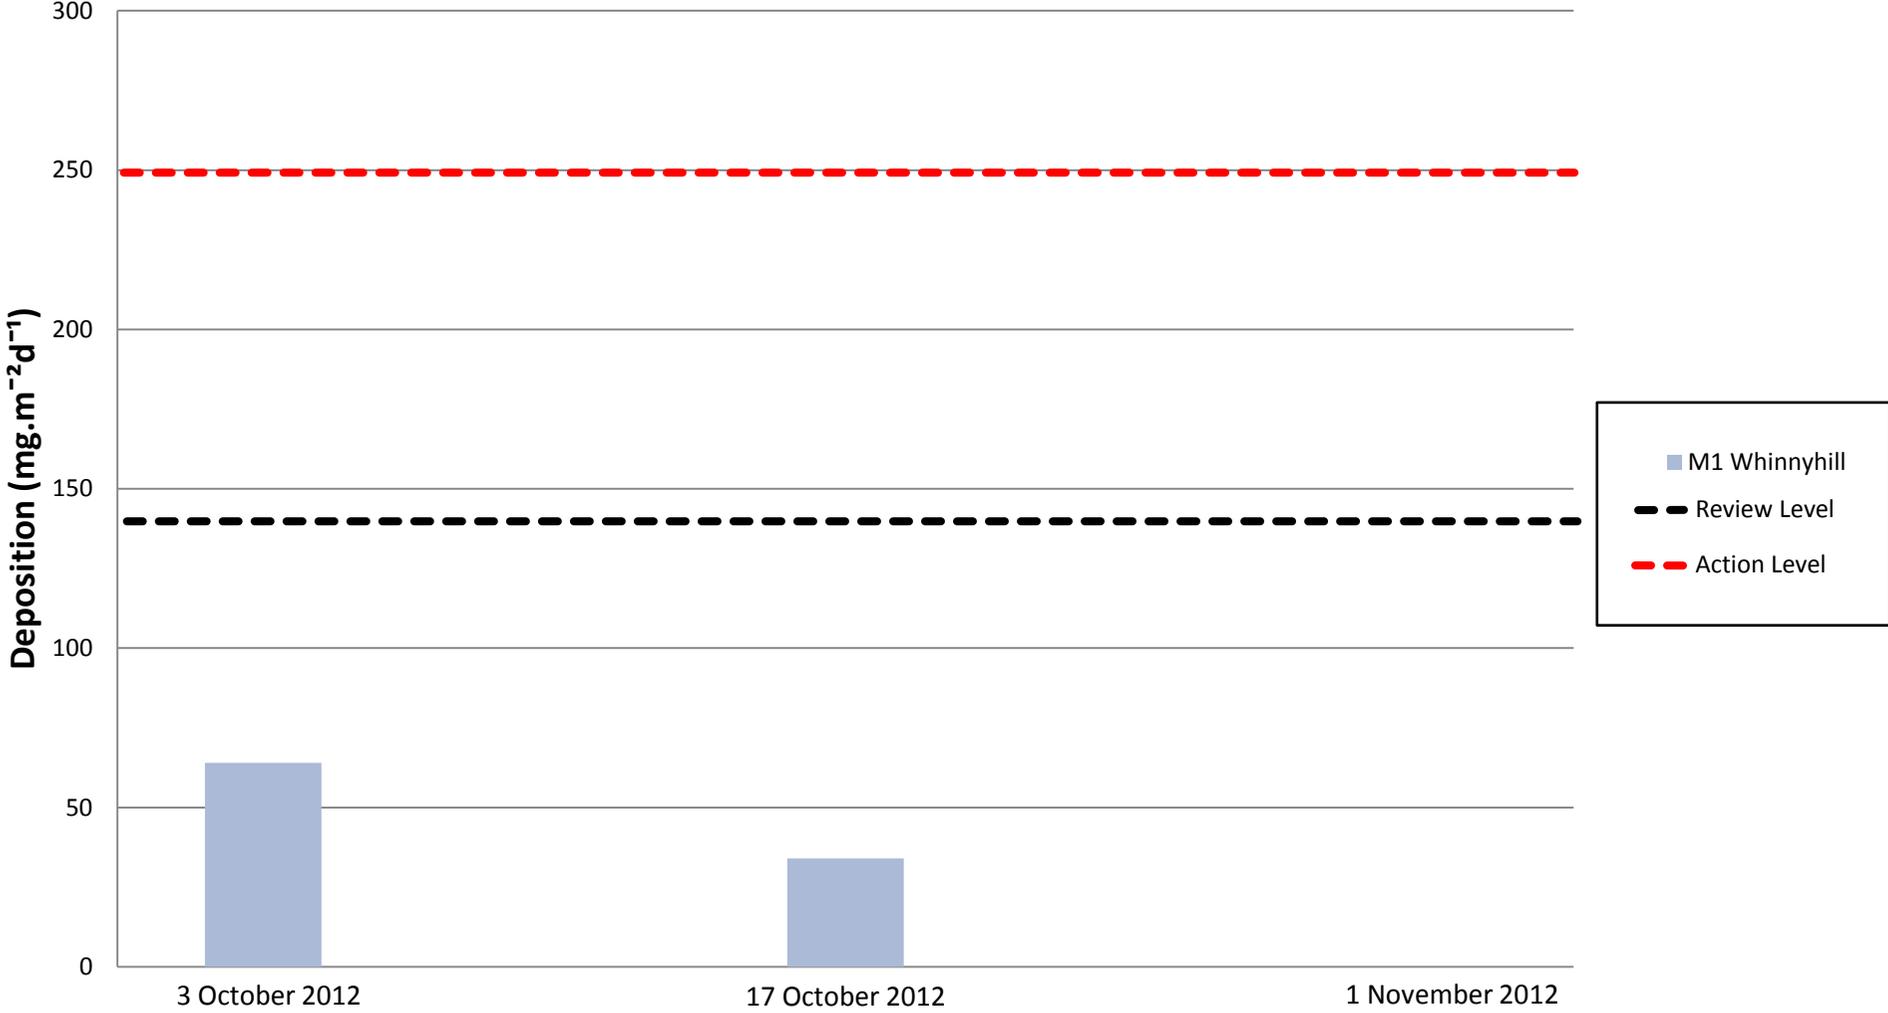
Location: M1 Whinny Hill

Note: The results for 1 November are missing as the Frisbee equipment had fallen over at this location.
