FORTH REPLACEMENT CROSSING

AIR QUALITY MONITORING REPORT
NOVEMBER 2012

REP-00075-00

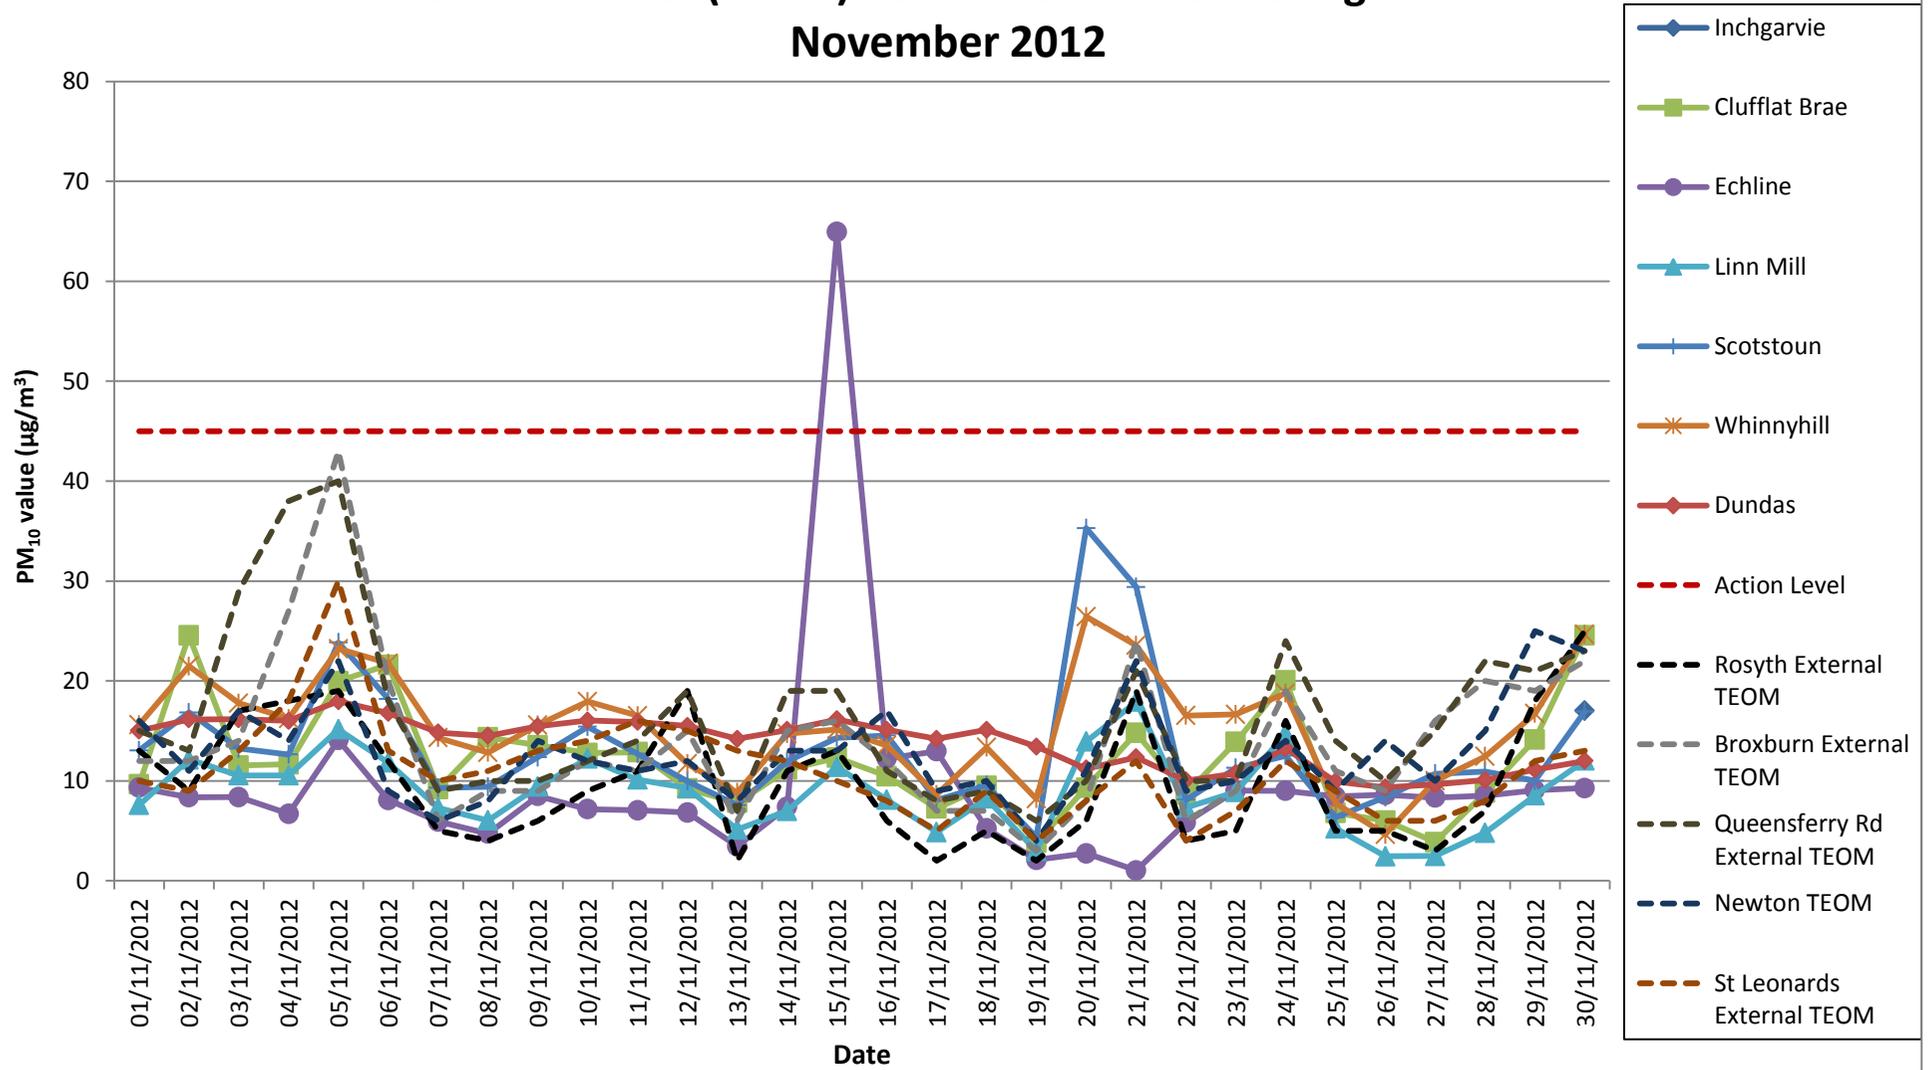
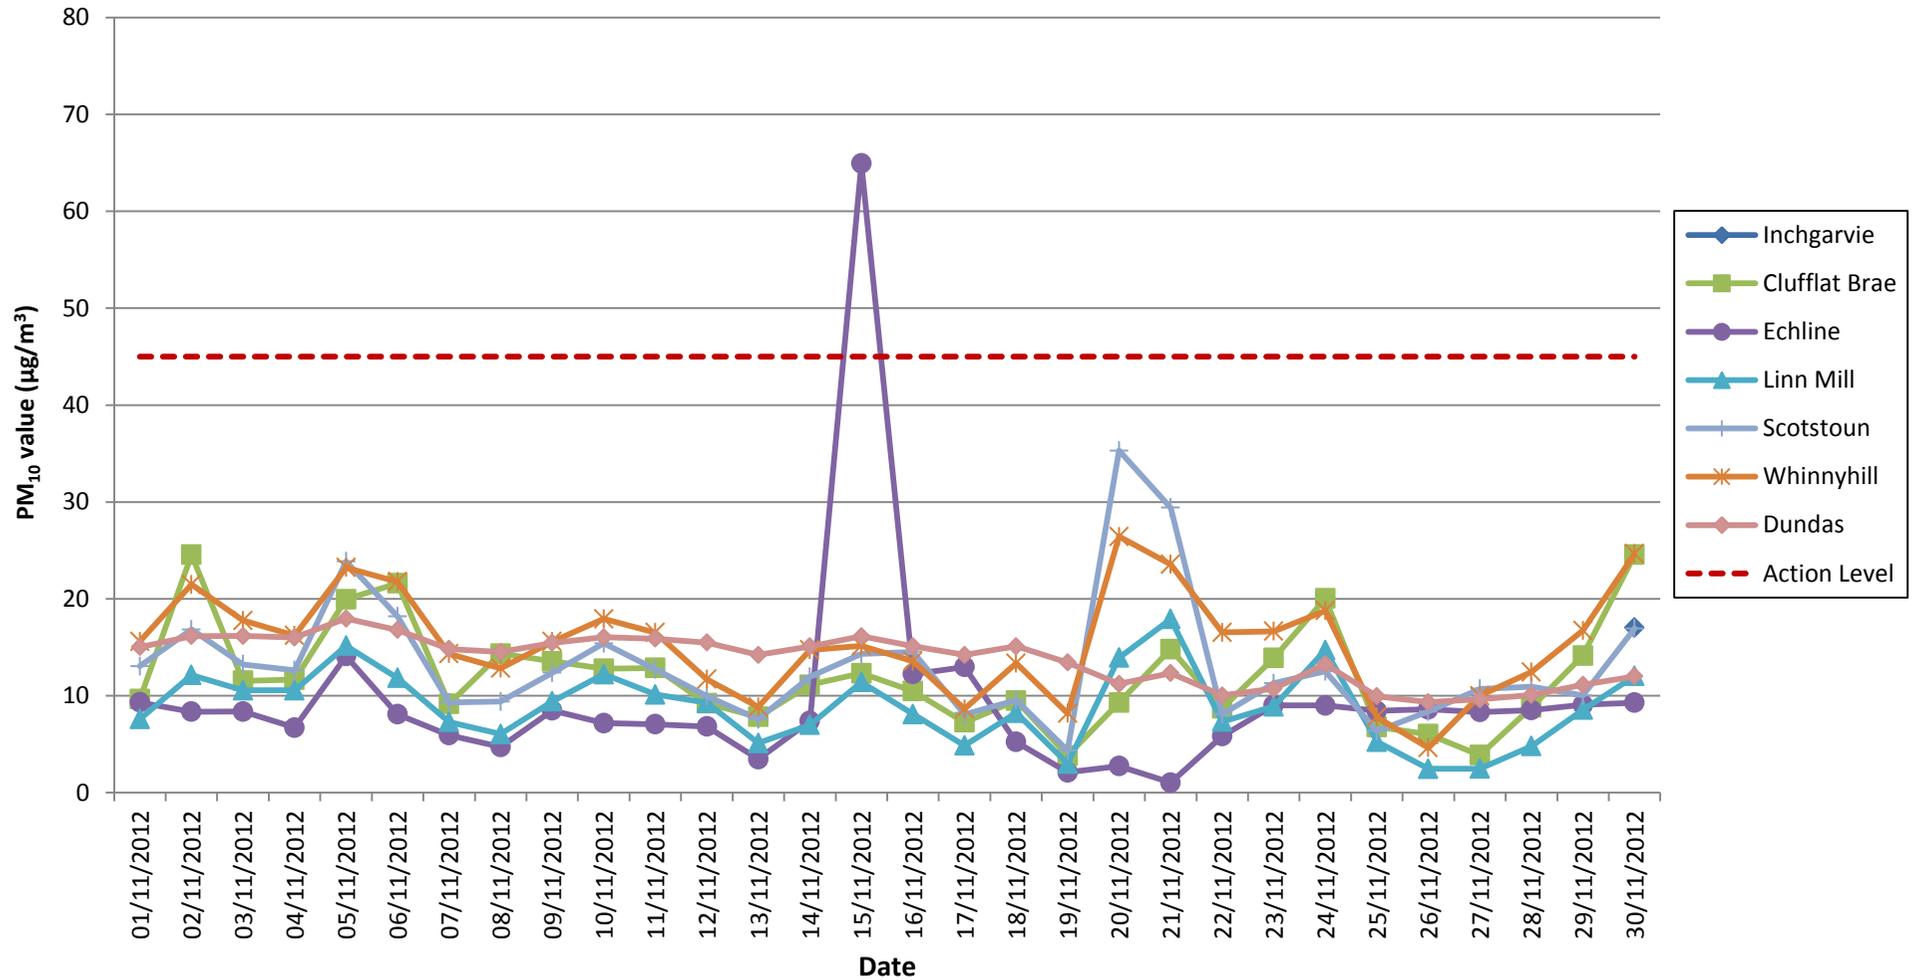
Particulate Matter (PM10) Results for all Monitoring Locations

3.1.1. Light scatter results for November 2012 have been presented in a monthly chart; this can be found in Appendix A. Generally, results show that the PM₁₀ levels were low and largely followed the same pattern across the site. There was a single exceedance of the threshold in November. This occurred at Echline on 15 November. On this date, high levels were recorded only between 04:00 to 06:00 am and 07:00 to 09:00 am. It is believed, therefore, that this is an isolated event that is unlikely to be related to construction works due to the time of day at which the high levels were recorded. It is possible that the results were affected by foggy conditions, with local weather reports showing foggy conditions on this date and humidity levels above 90% recorded between midnight and 12pm at nearby weather stations see paragraph 2.2).. Additionally, the slightly elevated results (although not exceedances) noted at some of the devices, notably Whinny Hill and Scotstoun, on 20 November are associated with the servicing procedure of the devices.

3.1.3. A correction factor has been applied to the data included for Dundas between 1 and 20 November. Results for this location were noted by the Environmental Team to be lower than would be expected and previous consultation with the supplier also identified the raw data readings from the meter as too low. As re-calibration by the supplier did not resolve the errors a correction factor has been applied to the results. A visit by a site engineer was undertaken on the 20 November to service and re-calibrate the device which resolved the issue associated with the device reading too low. Data is also missing for Inchgarvie during November due to a loss of power, accidentally caused by a third party. An electrician visited the site on 30 November to restore the power supply; this device is now fully functioning.

Note: Between 1/11/12 and 20/11/12 a correction factor has been applied to the results obtained from the meter at Dundas following consultation with the supplier. Data is missing from Inchgarvie due to an error with the connection accidentally caused by a third party; power supply was restored on 30/11/12.

Note: Between 1/11/12 and 20/11/12 a correction factor has been applied to the results obtained from the meter at Dundas following consultation with the supplier. Data is missing from Inchgarvie due to an error with the connection accidentally caused by a third party; power was restored to this device on 30/11/12.

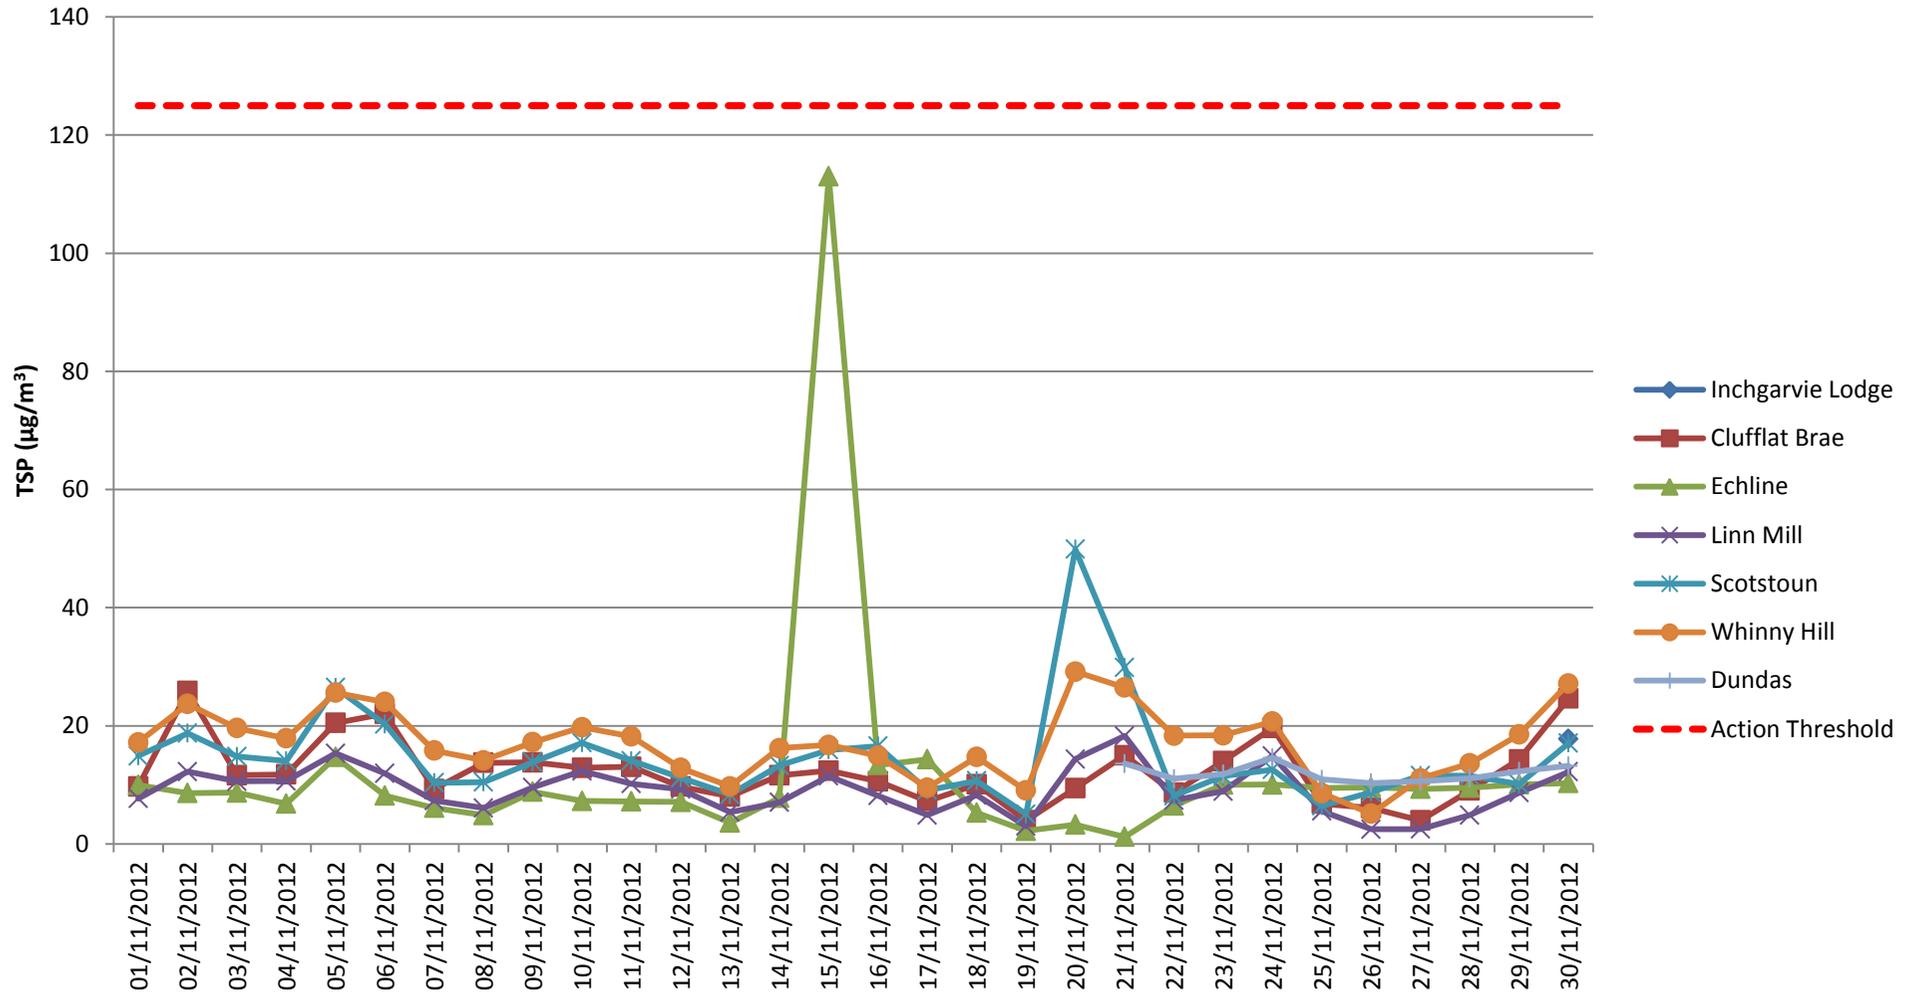
Total Suspended Particles (TSP) Results November 2012

3.2.1. The TSP results for November 2012 have been presented in a monthly chart; this can be found in Appendix B. The TSP levels at all monitoring locations throughout November were within the threshold level and largely found to follow a similar pattern across the site, demonstrating that in general the levels are influenced by regional changes in TSP levels, rather than construction works. Although within the threshold, a peak was recorded at Echline on 15 November. This

is discussed in paragraph 3.1.1 and it is not believed that this was caused by construction works. Also, as noted with regard to the particulate matter results, the slight peaks in the results from some of the devices on 20 November are associated with the servicing of the devices and not likely to be related to construction works.

3.2.2. Due to a device error associated with the measurement of TSP at Dundas the results for this location have been excluded from the graph between 1 and 20 November; prior to servicing, the measurements of TSP were unrealistically low. The site visit from an engineer on 20 November resolved this issue with the device. Data is also missing for Inchgarvie due to the loss of power, as noted in paragraph 3.1.3; power was restored to this device on 30 November.

Note: The meter at Dundas was serviced on 20/11/12 - prior to this there are errors associated with the results and are therefore not included in the graph. Data is missing from Inchgarvie due to an error with the connection accidentally caused by at third party; power was reconnected on 30/11/12.

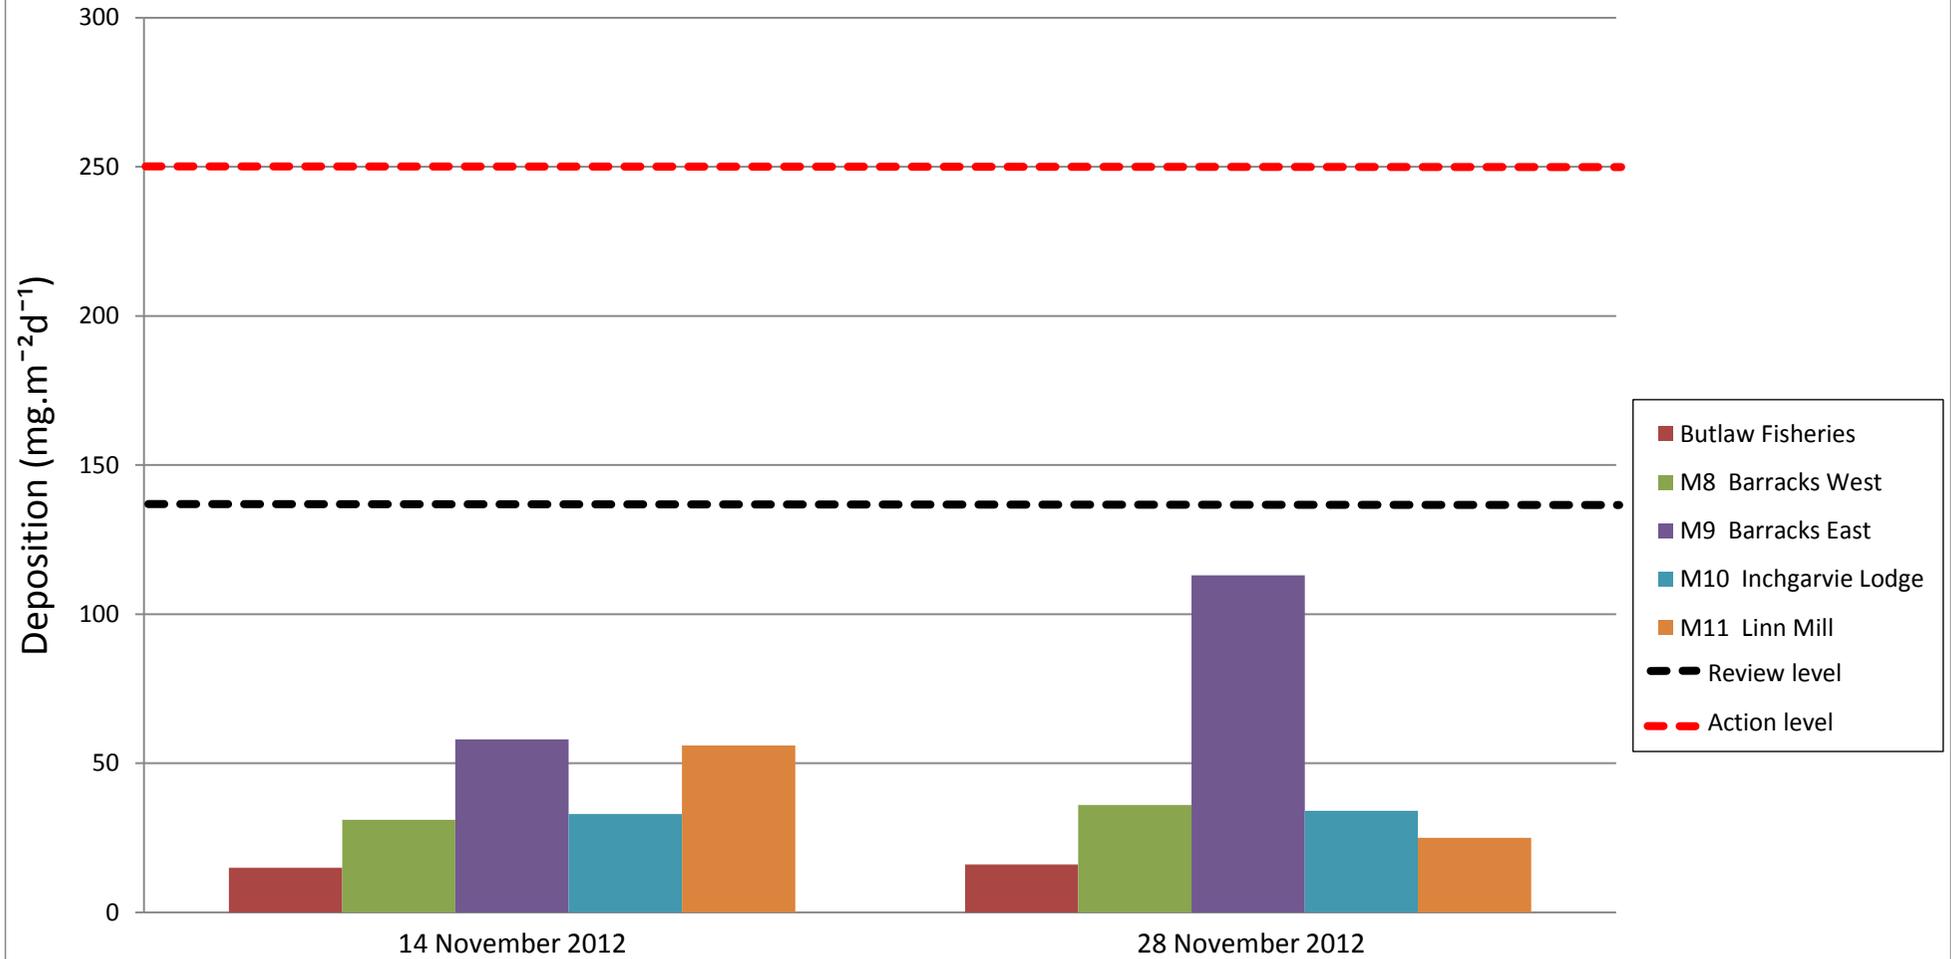
Frisbee Dust Deposition Results: Group 1
Locations: M7 Butlaw Fisheries, M8 Barracks West, M9 Barracks East, M10 Inchgarvie Lodge and M11 Linn Mill

November, there were no exceedances of either the site review level or the site action level across the site.
