**PUBLISHED PROJECT REPORT PPR898**

The performance of road surfacing in  
Scotland

Scottish Inspection Panel Report 2018

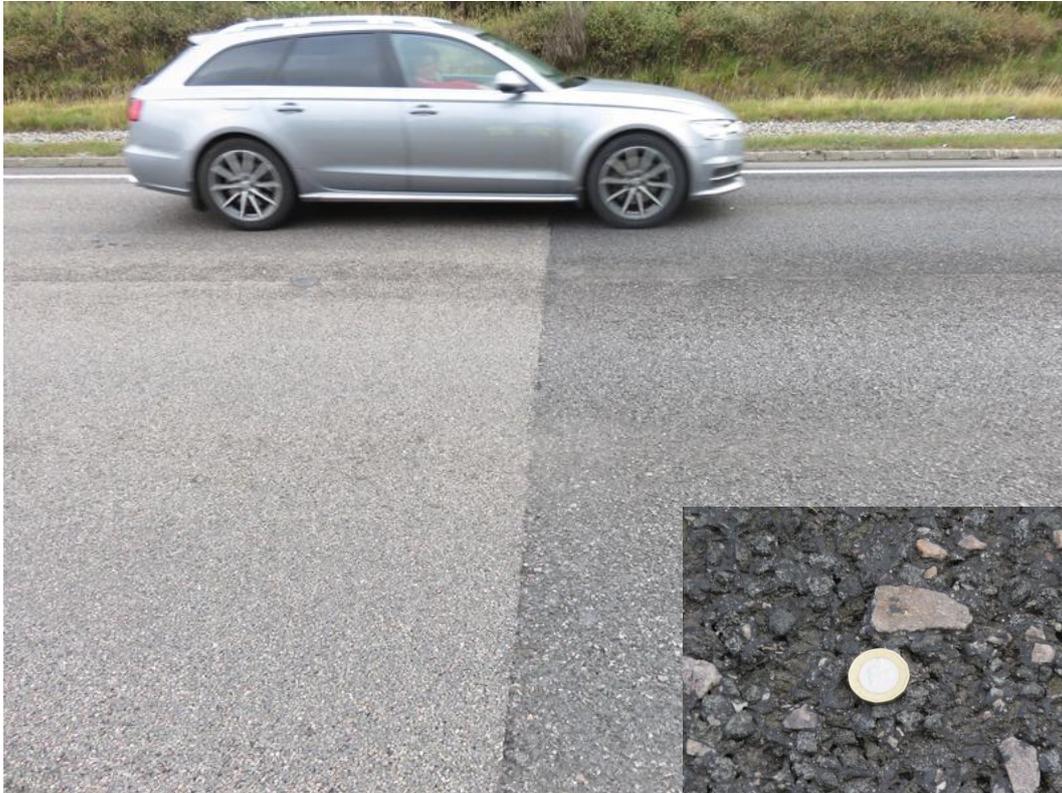
this defect, this compares with only 20% of sites (8) in 2018. An example of aggregate loss from the 2018 survey is shown in Figure 3.5. Although aggregate loss has increased since 2017 it should be noted that the longer-term trend of a decrease in the occurrence of this defect appears to be being maintained.

**Figure 3.5: Aggregate loss at IP43 - material (including close-up) on the right**

The other site showing significant defects was IP43. The 10mm (TSMA) exhibited significant aggregate loss and some oversized aggregate (see Figure 3.5). It was subsequently reported that the laid material was part of an on-going investigation associated with the durability of this mixture.

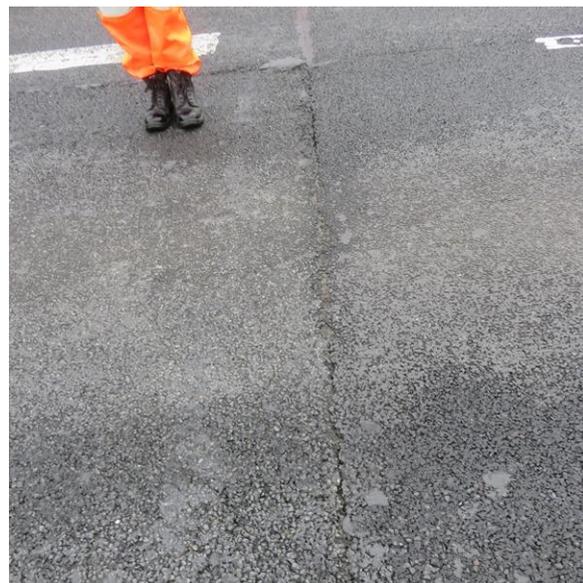
Similarly, more open and/or fretting joints were observed during the 2018 survey. This defect (coded black) has only been recorded since 2011, and the 2018 survey represents the second highest percentage of sites (15%) exhibiting this defect. Evidence from older sites indicates that poorly constructed joints will deteriorate further under the action of weathering and trafficking, resulting in aggregate loss of the adjacent surface course. Figure 3.6 shows an example of poorly constructed longitudinal and transverse joints from the 2018 survey. The surface courses are not tightly tied together and exhibit an open appearance.

**Figure 3.6: Open joint at IP16**

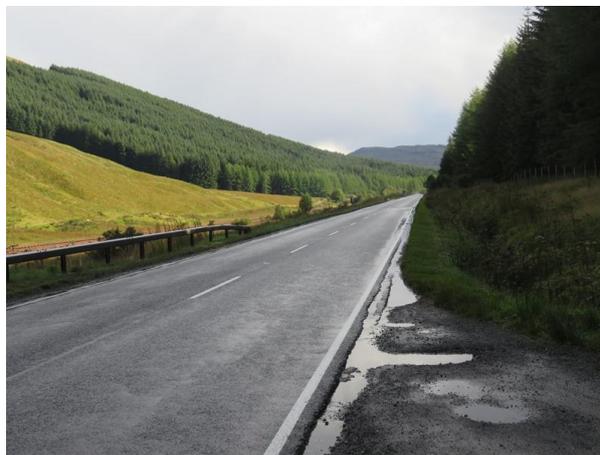
It can be seen from Figure 4.1 that only 7.5% of the sites (3 sites) contained 14mm mixtures. The general reduction in the use of 14mm mixtures over the last few years is partly due to the fact that previous SIP surveys have consistently shown that 14mm mixtures do not perform well, particularly if used on sites that are highly stressed. In the 2018 survey two of the three sites were observed to exhibit at least one defect. Neither site was assessed as being highly stressed: IP45 and IP49 were assessed as light (L) and light to medium (L/M), respectively. Located on the A86 and A82, both sites are situated in rural locations where edge restraint (kerbing) is not provided and where local environmental conditions can be severe, e.g. high levels of precipitation and frost. Both sites were assessed to have an open appearance and judged to have lost aggregate (see Figure 4.3).

**Figure 4.3: IP49 – 14mm (G/M - j, jf)**

- The use of 14mm Clause 942 mixtures in NW Scotland should be restricted to roads that are well drained and carry low traffic stresses. The use of smaller aggregate sizes, although initially more expensive, can be justified through improved performance and an increase in service life.

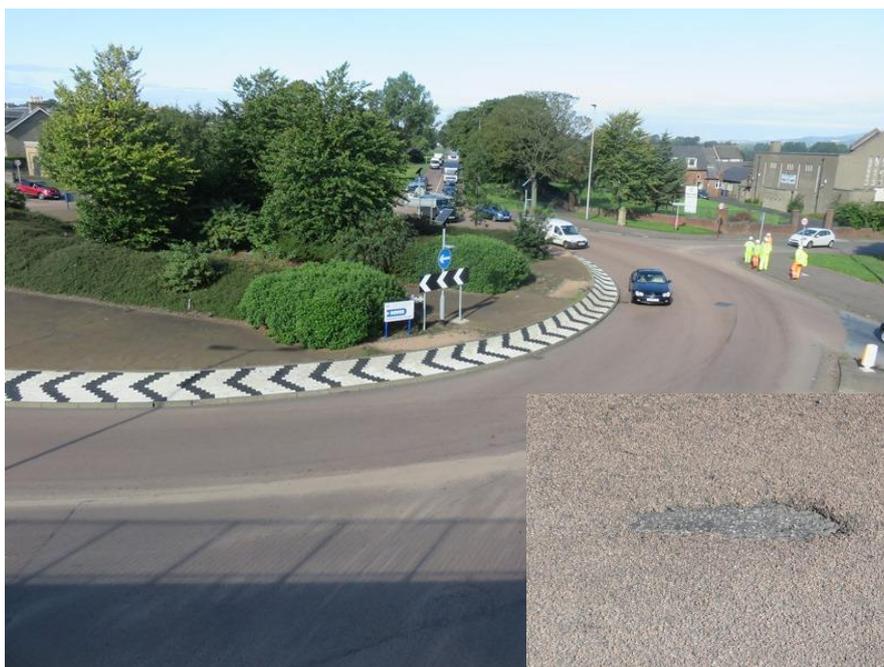
The use of 6mm mixtures is being actively promoted as they are thought to provide enhanced skid resistance and have been assessed to perform well, attracting Excellent or Good (E/G) ratings. Two of the four 6mm sites exhibited defects: IP28 (TAC) and IP33 (TS2010). It is noteworthy that both sites were located on roundabouts, which attract the highest traffic stresses on the network due to a combination of turning and cornering manoeuvres, and heavy braking. Figure 4.4 shows a general view of IP33, the inset shows an isolated area where aggregate loss has resulted in the formation of a shallow pothole.

**Figure 4.4: Site IP33 – 6mm (M - v)**

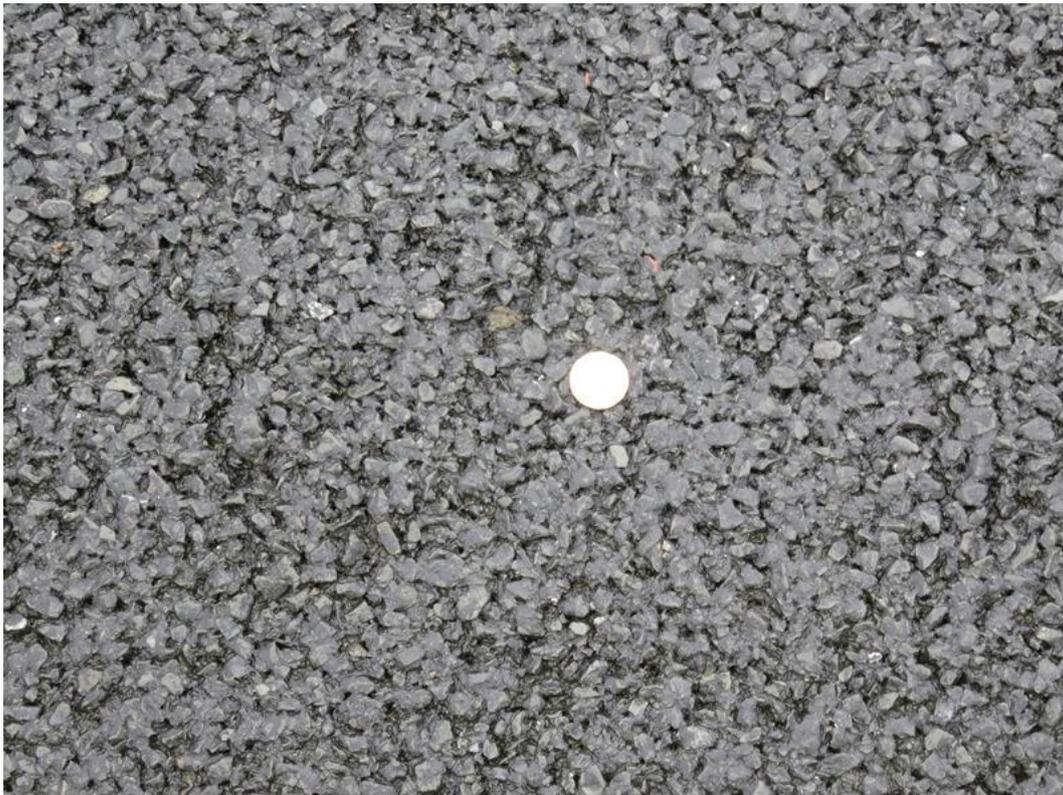
Four sites (10%) surfaced with 10mm mixtures were assessed as having at least one defect. Two sites, IP3 and IP6 (both TS2010) received a G/M mark with a single suffix. Both these sites were assessed during heavy rainfall where the appearance of the surface is difficult to see clearly owing to the presence of standing water. It is possible that these markings could be more severe than might otherwise have been the case if they had been assessed in better weather conditions. Similarly IP13 was given a G/M marking where the recorded suffixes of the individual panel members cancelled each other out, suggesting a borderline mark. However, IP16 (shown in Figure 3.6 and Figure 4.5) was given a Moderate mark with three suffixes (M-vj<sub>o</sub>). The site was located in a remote location on the A7 and the appearance of the material suggested a lean mixture (low bitumen content) with possible signs of being cold during compaction, possibly as a result of a long haul distance.

**Figure 4.5: Site IP16 – 10mm (M - vj<sub>o</sub>) exhibiting a lean and open appearance**

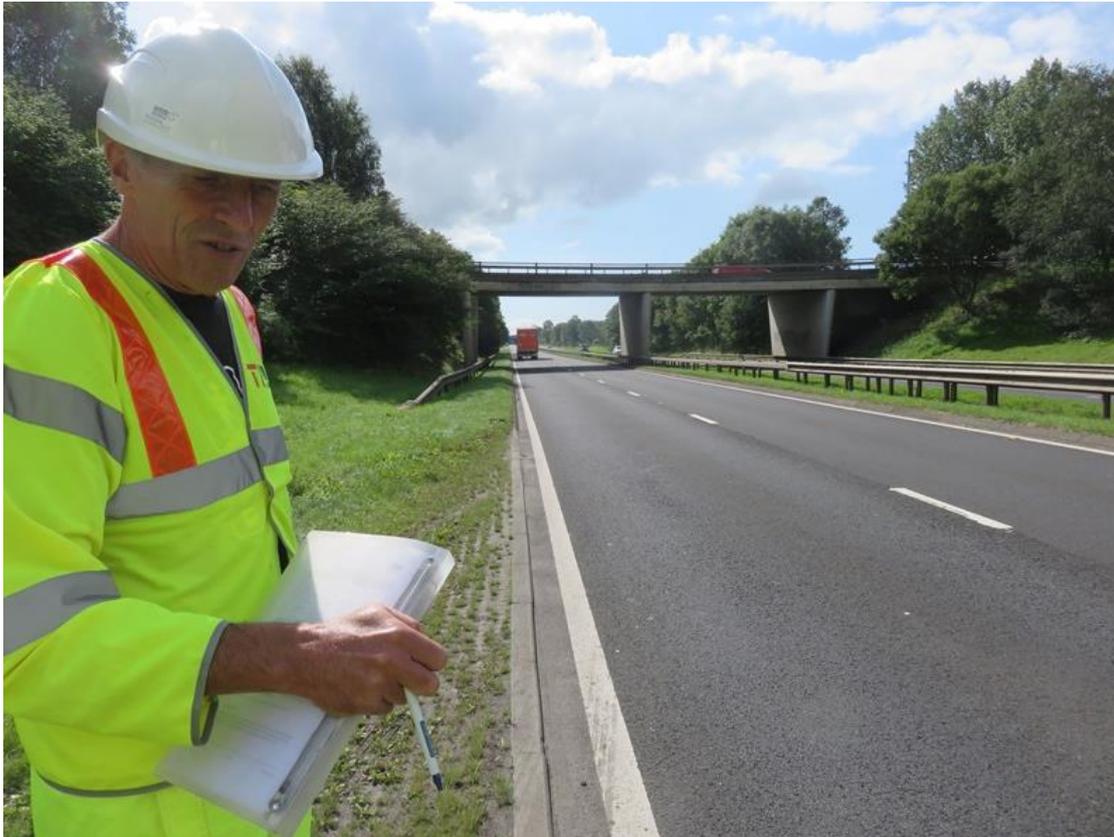
Two sites (5%) were assessed to have significant defects for materials that are only two years old. Site IP23 (TS2010) was broken into two parts as there was clear evidence of a cold load being laid at this site. A continuous linear section on lane one around 40m to 50m in length was clearly observed to have a different appearance from the rest of the scheme which was assessed as Excellent (E). It is important to note that the life of all material, including TS2010, can be compromised by poor working practices. It can be seen from Figure 4.6 that the slow lane (shown to the left of the image) has an open appearance compared to the fast lane (right).

A subsequent discussion by the SIP team led to agreement that this was clearly a cold load, i.e. the material displayed common features associated with laying and compaction of cold material. The consensus of the SIP team was that there is a need for a system or process to stop the laying of cold material to avoid expensive remedial works and consequent disruption to the travelling public. One suggestion was that the use of thermal mapping data, i.e. temperature of material being compacted, could be used to assist the paving team foremen in making a decision to accept or reject material at the time of laying.

**Figure 4.6: Site IP23 – cold load detected in lane one**

- There is a need for a system or process to be introduced that will stop the laying of cold material to avoid expensive remedial works and consequent disruption to the travelling public. It is important to note that the life of all material, including TS2010, can be compromised by poor working practices.

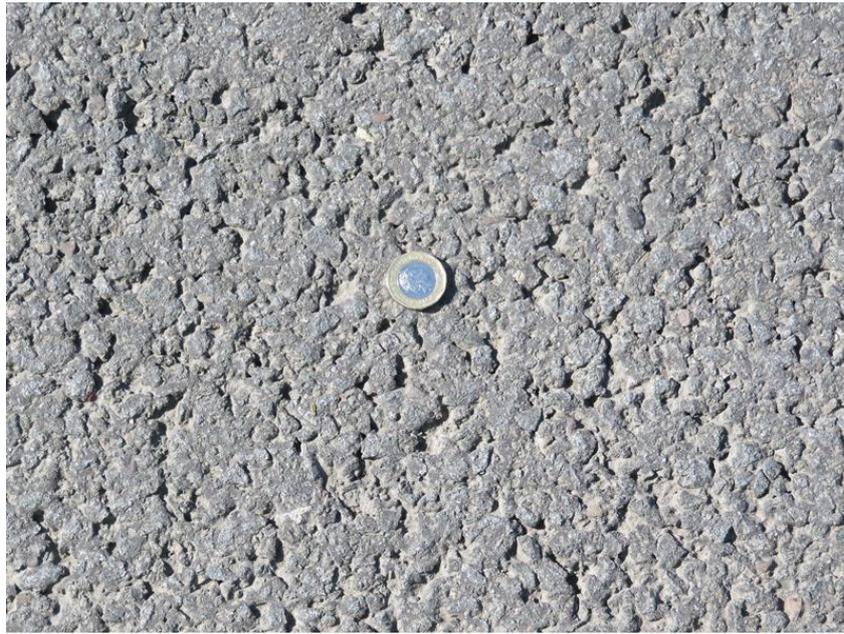
Sixteen older TS2010 sites ranging in age between 4.2 and 7.4 years were assessed by the panel to determine their on-going performance. As shown previously in Figure 3.7, the overall performance of TS2010 continues to be encouraging. Site IP22 is shown in Figure 4.7 and received a unanimous assessment of Excellent (E) after seven years in service.

Figure 4.7: IP22 - marked E at 7.2 year

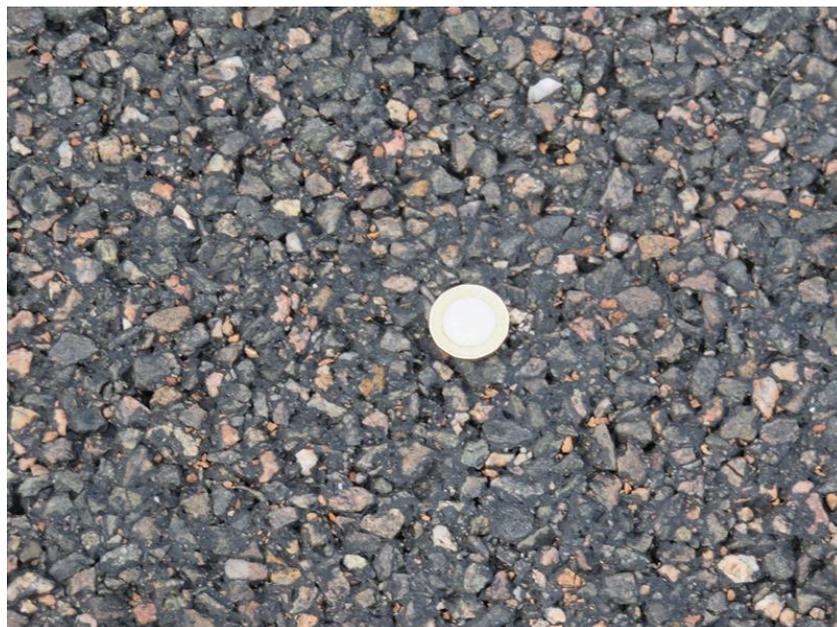
The second site (IPS2) was located on the A9 near Slochd. The site contained a section of TS2010 that was four years old (Figure 4.9). Above average high-speed friction results had been recorded for this material as part of a recent research study (Sanders *et al.*, 2017). The 10mm TS2010 surface course was assessed by the panel as *Good* (G). It was observed that the material exhibited a uniform appearance with a slightly higher surface texture than normal. It will be interesting to observe whether the higher texture is detrimental to the longer-term durability of the material.

Figure 4.9: IPS2 – TS2010 (G)

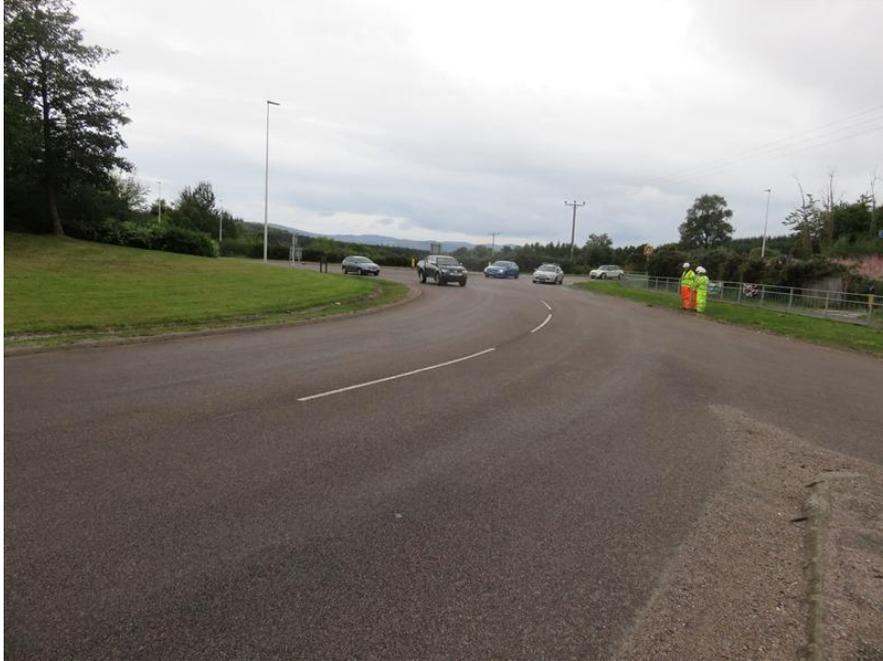
**Figure 4.10: Site IPS3**

The third site (IPS3) was a heavily trafficked roundabout on the A9 north of Inverness (Figure 4.10). A bespoke material design had been developed specifically for the site and comprised a 6mm surface course that contained fibres and a polymer modified bitumen. The panel gave the site a mark of M -vj<sub>f</sub>. The surface course was laid in April 2010 (and was almost 8.5 years old). It was considered to have performed well when taking into consideration its age and the traffic stresses experienced at the site.

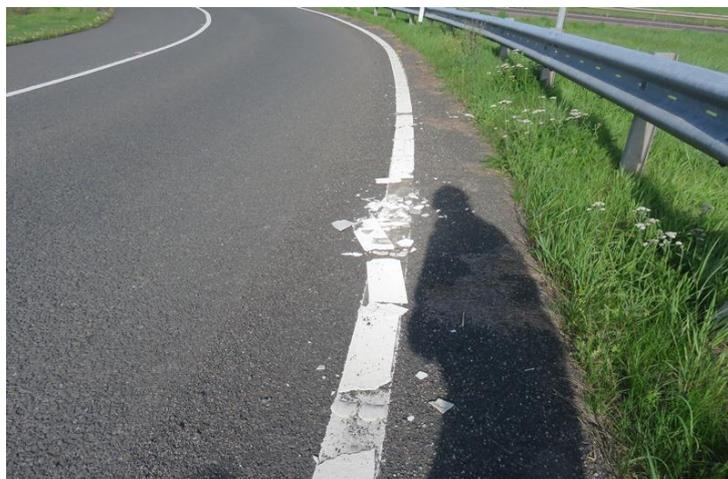
On one site located on the A90 near St Madoes, it was observed that a long section of new thermoplastic road marking material had failed (Figure 4.11). It appeared that the new material had been overlaid onto existing markings, but there was no visible bond between the materials, i.e. the new marking material could be easily dislodged.

**Figure 4.11: Failed road marking**

- The failure of new thermoplastic road marking material should be investigated.
- A survey should be carried out in 2019 to ensure that positive changes continue to be implemented.
