A Proposed Methodology to Characterise the Hazard Posed by Boulders: A Case Study from Glen Croe

B2359902/TGE/REP/01 | 2

12 August 2020

Boulder Hazards Study

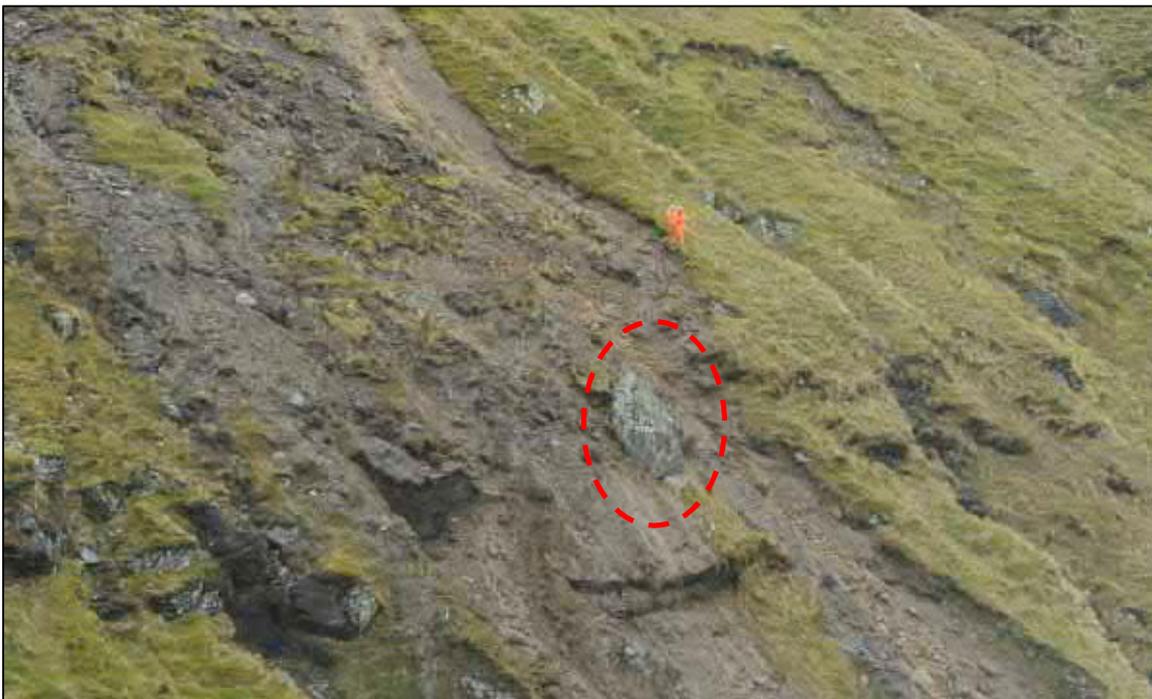
Photograph A-2: Photograph of possible unstable boulder mobilised and deposited on the hillside following the 30 December 2016 debris flow.

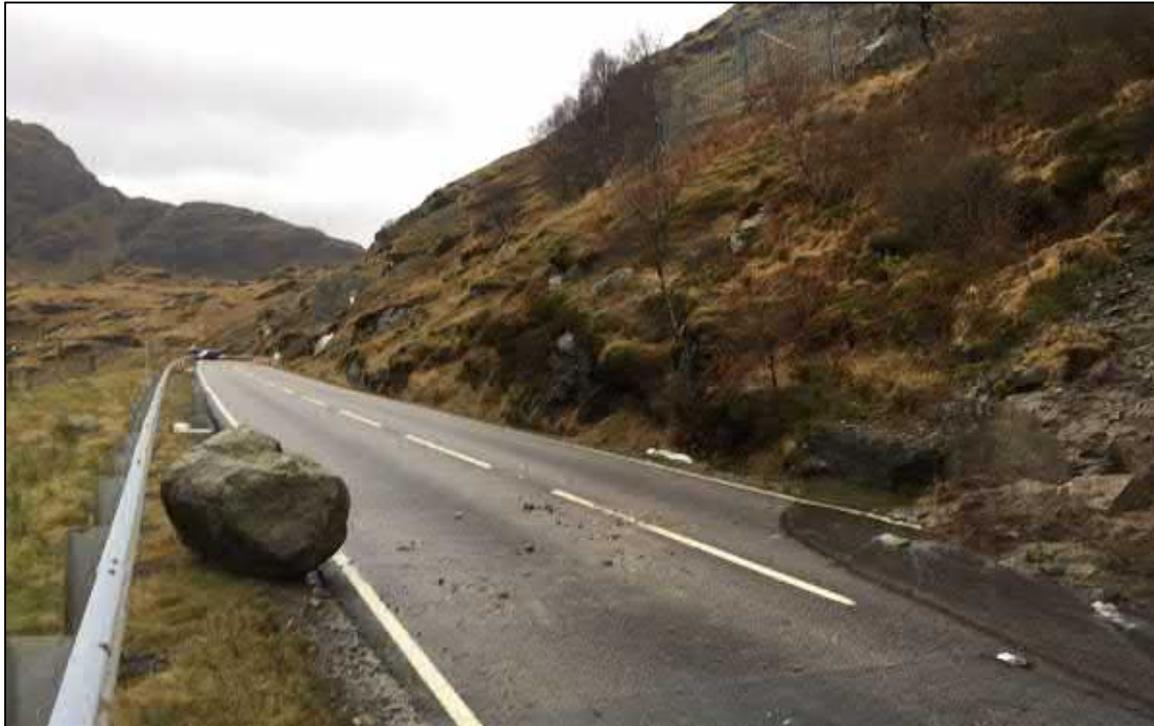
Photograph A-3: Photograph of the boulder that impacted the A83 on 30th December 2015 as a result of soil movement on the slope below the Phase 8 debris barrier.

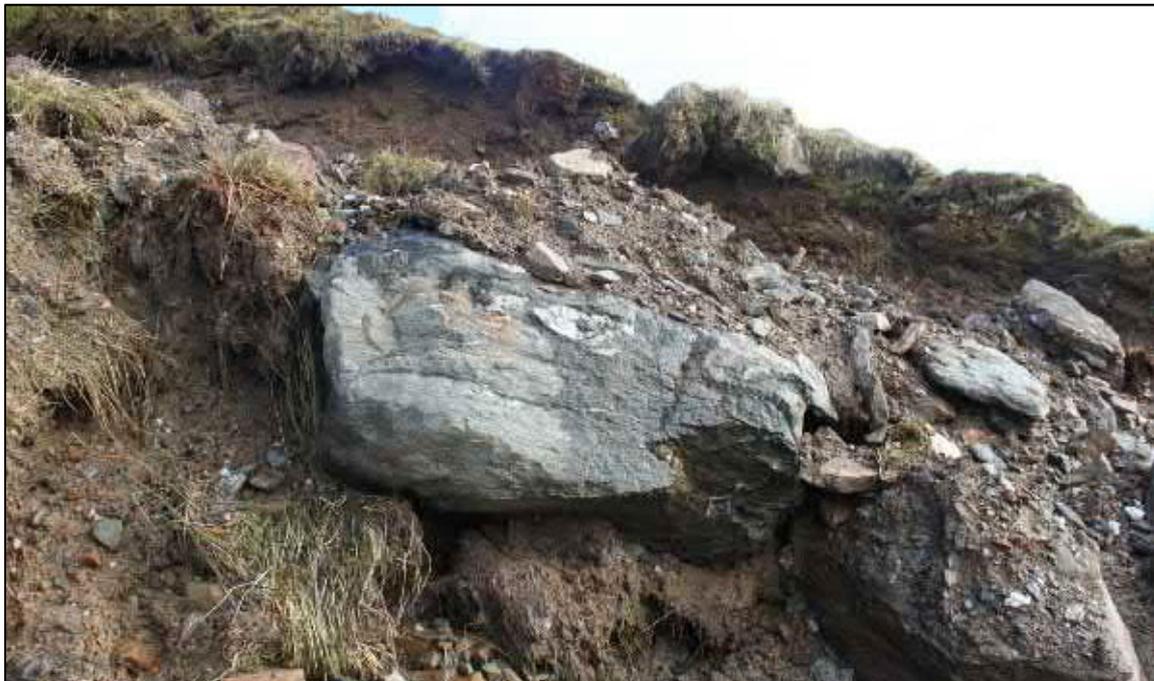
Photograph A-4: Photograph of boulder exposed in the backscarp of the December 2015 debris flow.

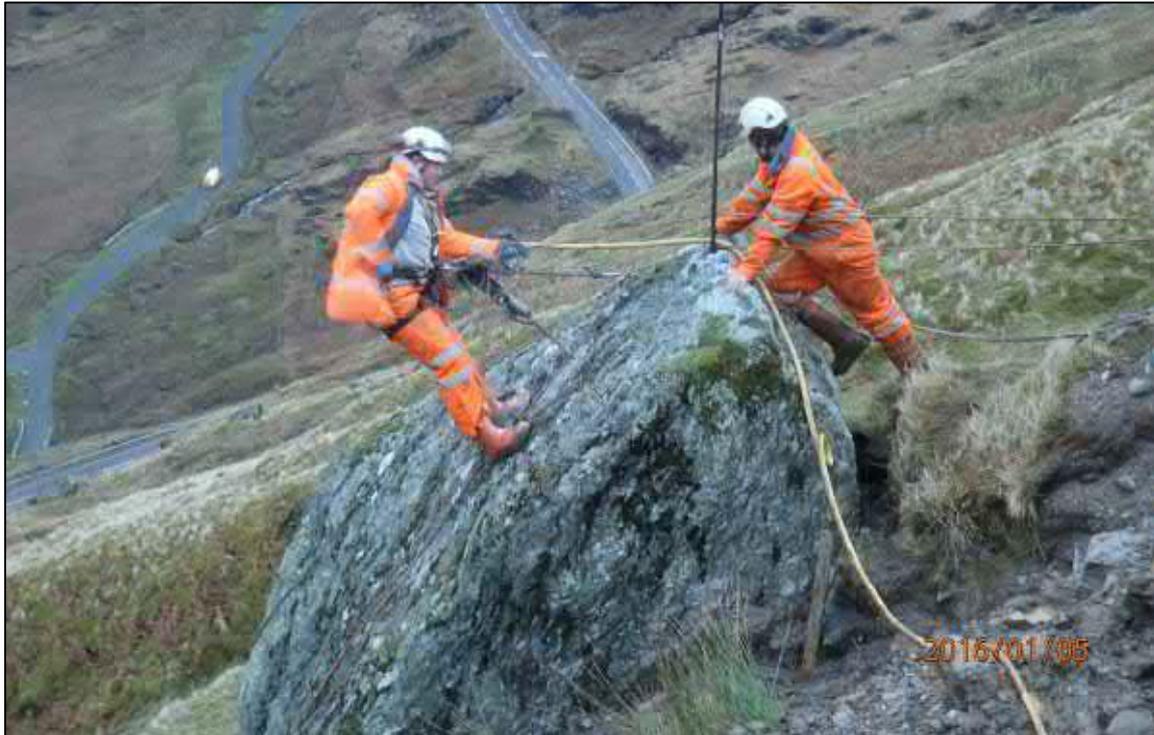
Photograph A-5: Photograph of potentially unstable boulder identified following the December 2015 debris flow being drilled so that it can be broken up using explosives.

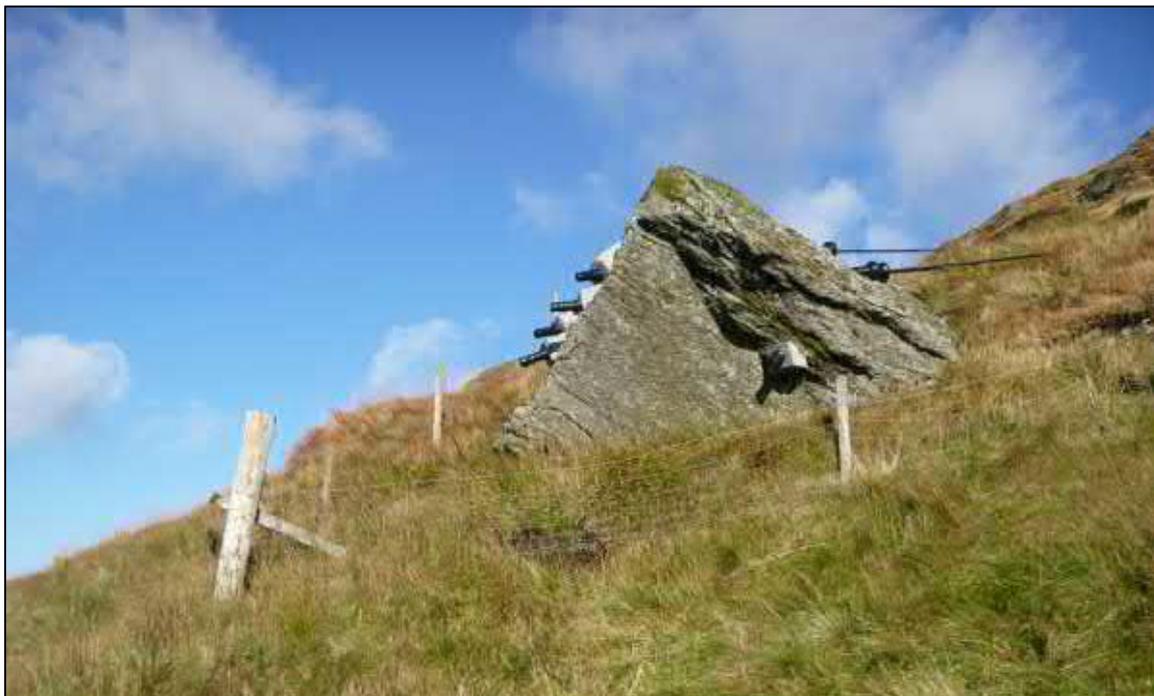
Photograph A-6: Photograph of a potentially unstable boulder following installation of a restraining system in 2015.
