## **PUBLISHED PROJECT REPORT PPR790**

### **Scottish Inspection Panel Report 2015**

**M J McHale**

Transport Scotland, Trunk Roads and Bus Operations Directorate  
(M McLaughlin)

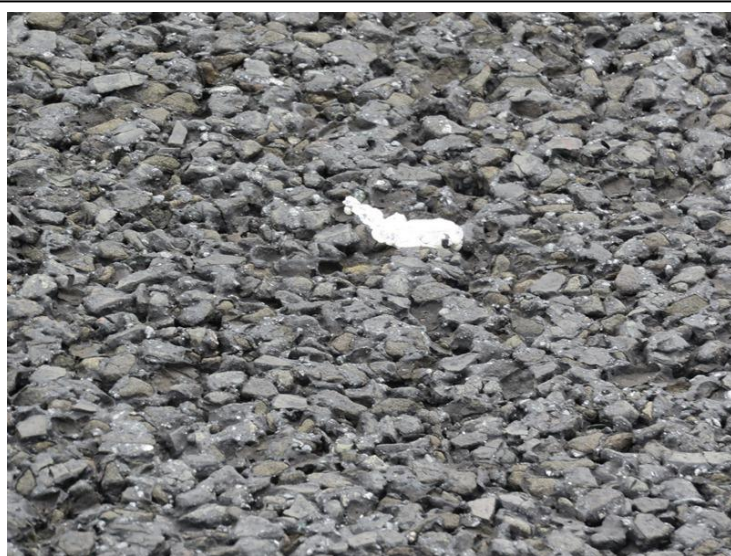
Historically, aggregate loss (coded green) has been the most common defect recorded by the SIP team and efforts to reduce its occurrence have previously been unsuccessful. It can be seen from Figure 3.3 that the percentage of aggregate loss remained reasonably constant between the years 2008-2014. However, in 2015 only three sites

(6% of total) were recorded to exhibit this defect (Figure 3.4). This noteworthy reduction in aggregate loss is very encouraging, particularly in terms of optimizing long-term durability. Possible reasons for this improvement are discussed in Chapter 4.

**Figure 3.4 Aggregate loss at IP4**

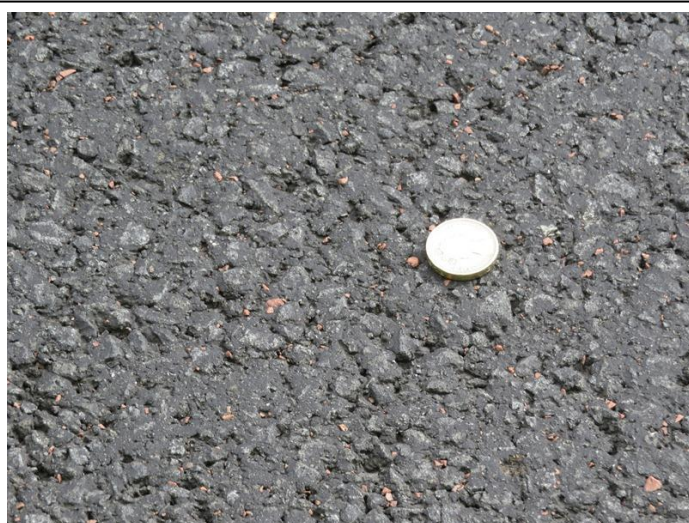
**Figure 4.2 TS2010 at IP3 (mark E)**

have made a major impact on reducing the amount of sites that exhibit aggregate loss. The TS2010 is a dense material which presents a close-knit surface appearance (Figure 4.2). However, it cannot in itself explain the significant reduction seen in aggregate loss across other non-TS2010 sites. It is likely that the road industry have acknowledged the need to close up the appearance of surface courses in general following the introduction of TS2010 and this is reflected in this year's results.

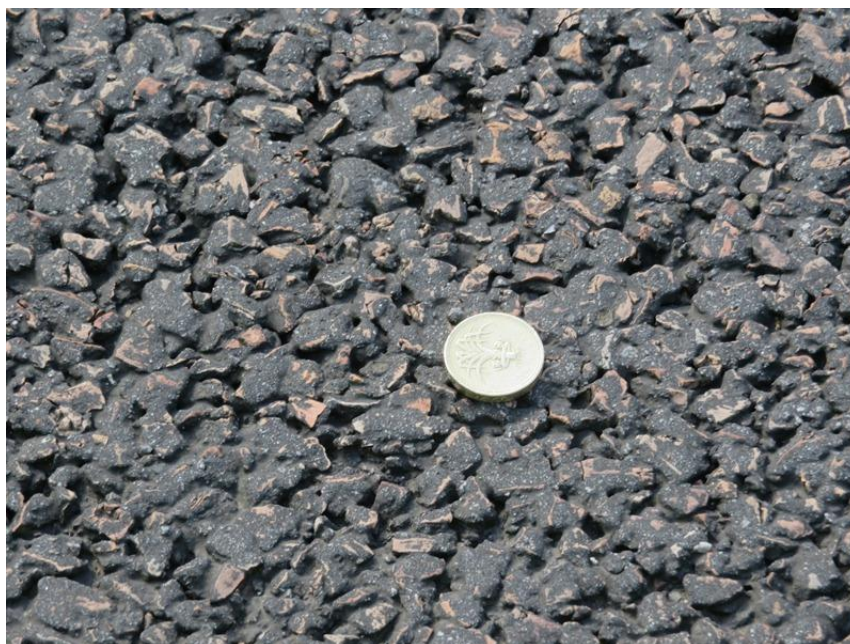
Figure 4.3 shows the performance of different mixtures, based on nominal aggregate size, on sites that were assessed to be Medium-High (M-H) or High (H) in 2015 and 2014. The figure clearly shows that there is a trend towards specifying smaller stone aggregate sizes on highly stressed sites and in general the smaller stone sizes are performing well (Figure 4.4).

**Figure 4.4 Site IP 5 (TAC, 0/ 10 mm) on stress level M-H (mark E)**

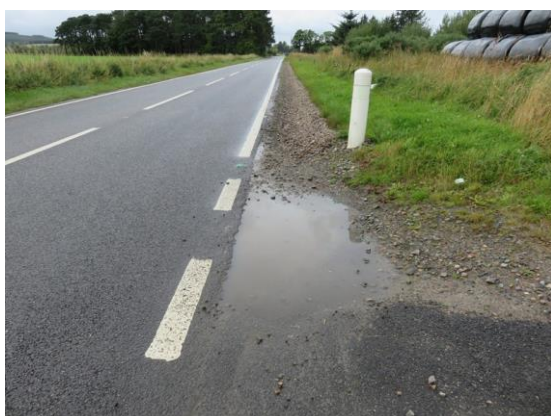
In general drainage on sites located on the busier parts of the road network appeared to be well maintained. However, two incidences of defective drainage were noted on the more rural parts of the network. The installation - of what appeared to be part of a new drainage improvement - on Site IP29 was not working (Figure 4.6). On Site IP30 a gully was observed to be totally choked and overgrown with vegetation (Figure 4.7). It should be stressed that the service life of the surface course and underlying pavement layers will be reduced if drainage is not properly maintained.

**Figure 4.6 Defective drainage (IP29)**

- The timely maintenance and monitoring of drainage systems should be promoted to ensure road user safety and prolong and enhance pavement durability.
- Care should be exercised in adopting strategies to save money based on partial repairs.

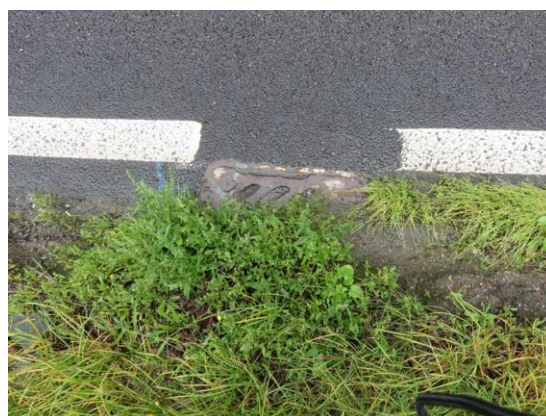
**Figure 4.7 Choked gully (IP30)**

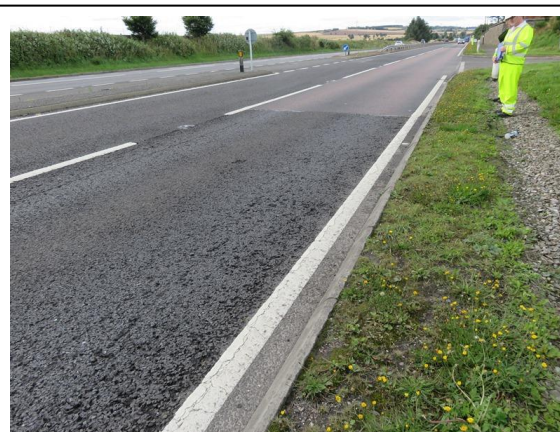
Only discontinuous sections (patches) of the slow lane at IP25 had been repaired (Figure 4.8). It is likely that the basis for this decision was based on funding constraints. However, the remaining surfacing was observed to be in a very poor condition and two potholes had resulted. It is possible that the poorly deteriorated and clearly permeable

**Figure 4.8 Part repair (IP25)**

material could prematurely damage the new inlay. This should be borne in mind when adopting this strategy for repairs.

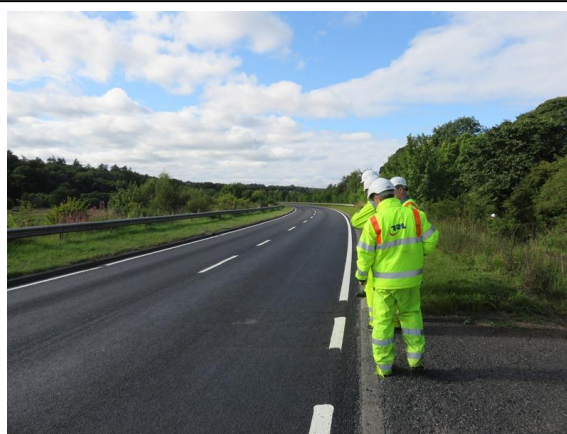
The SIP team inspected a spray on road preservation treatment (Figure 4.9) that is designed to prolong the life span of surfaced dressed roads by further securing the chippings to improve chip retention. Limited information was available but it is understood that a specially formulated polymer modified bitumen emulsion is applied to the new dressing by using the conventional spray tankers. The SIP team assessed the current condition of the treatment as *Good*. Surface dressing sites assessed previously by the panel on the trunk road network have not been successful. It is possible that a technique such as this may provide benefits such minimising the risk of early failure due to stripping.

**Figure 4.9 Treated surface dressing**

- Preservation treatments that minimise the risk of early failure of surface dressing should be investigated further.
- The results from the 2015 SIP survey have demonstrated that improvements to surface courses are being made, such as improving durability through the reduction of aggregate loss and achieving better joint construction. With the increased use of TS2010 it is anticipated that further improvements can be made. As such, future visual inspections should be continued to ensure positive changes continue to be implemented.
