Project **FORTH REPLACEMENT CROSSING**

VIBRATION MONITORING REPORT
JULY 2015

REP-00241 Rev
02

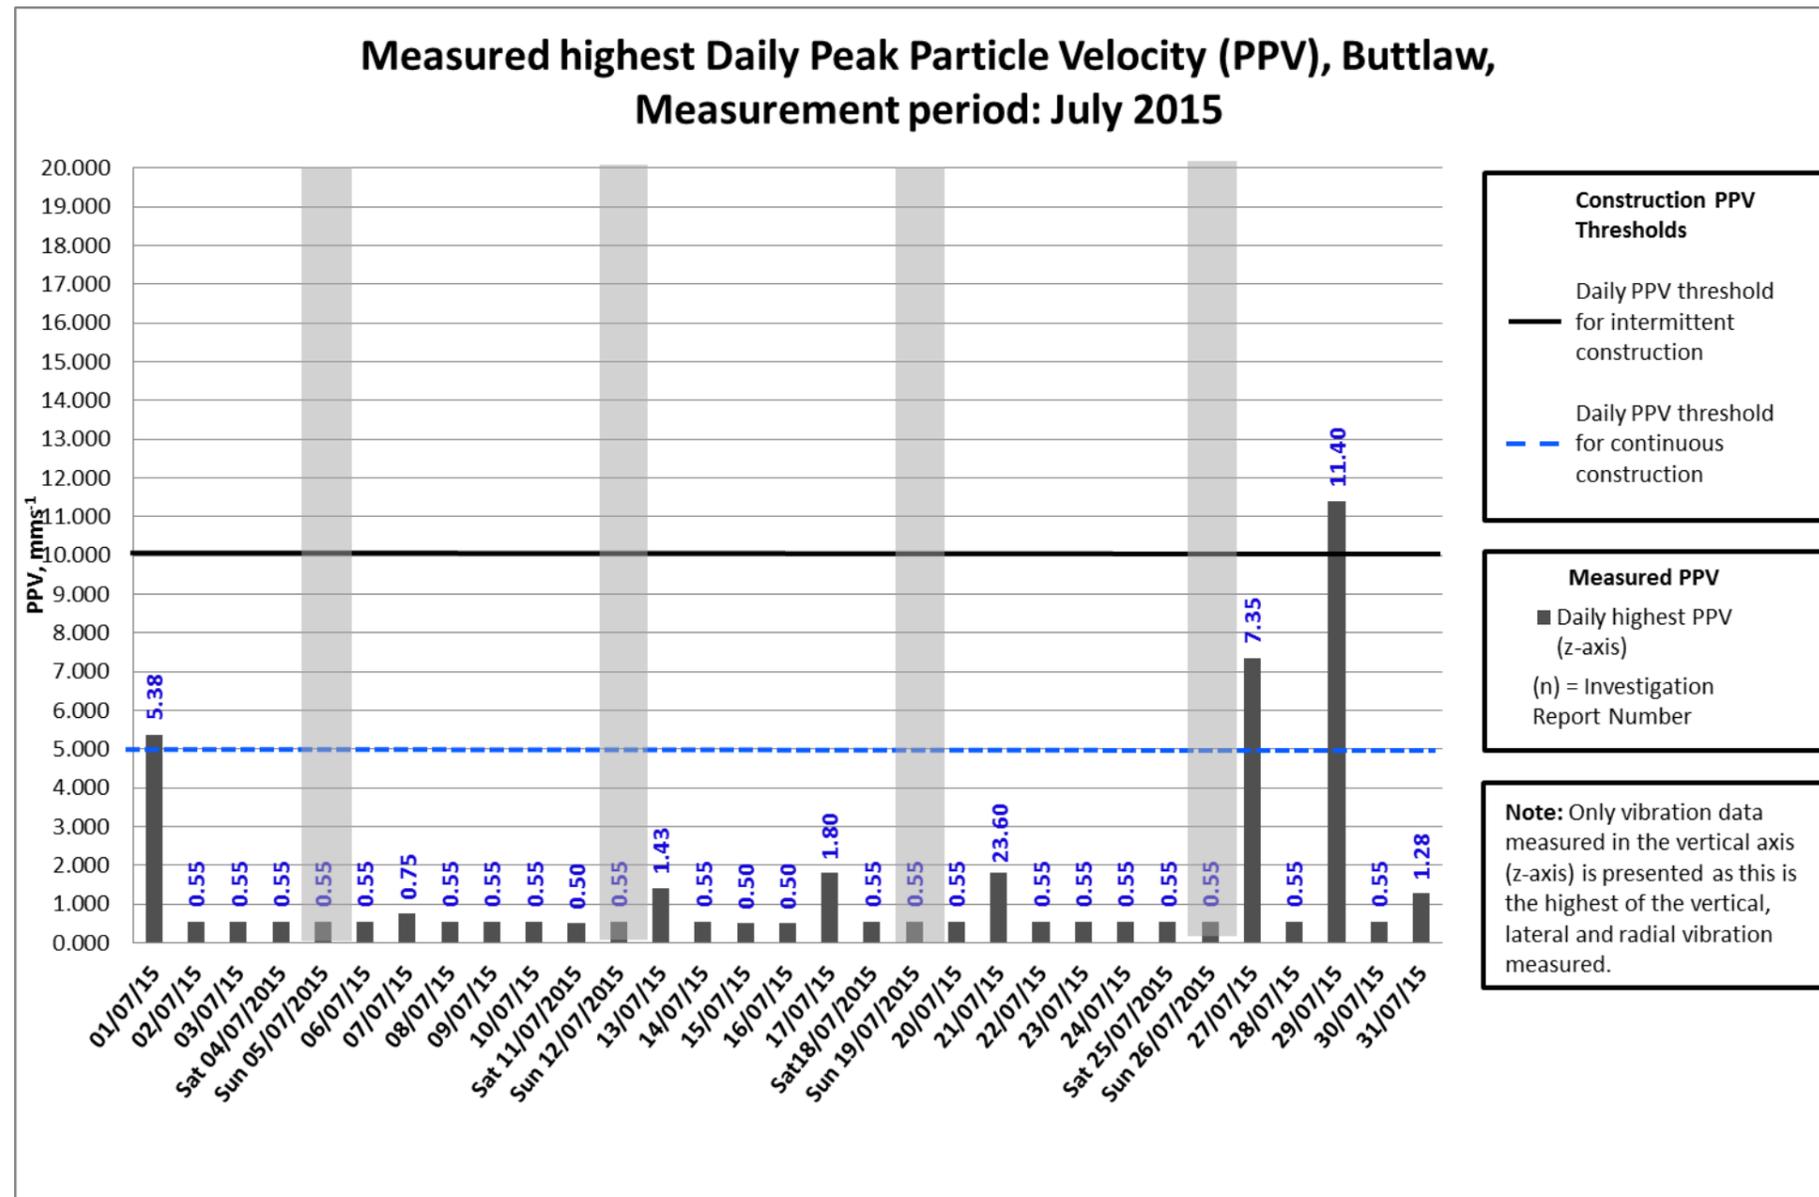
- Exceedance on the 01/07/15 was caused due to data being extracted from the vibration monitor, Graph from that day seen above.
- Exceedance on the 27/07/2015 and the 29/07/2015 were caused due to maintenance being carried out on the adjacent noise monitor.

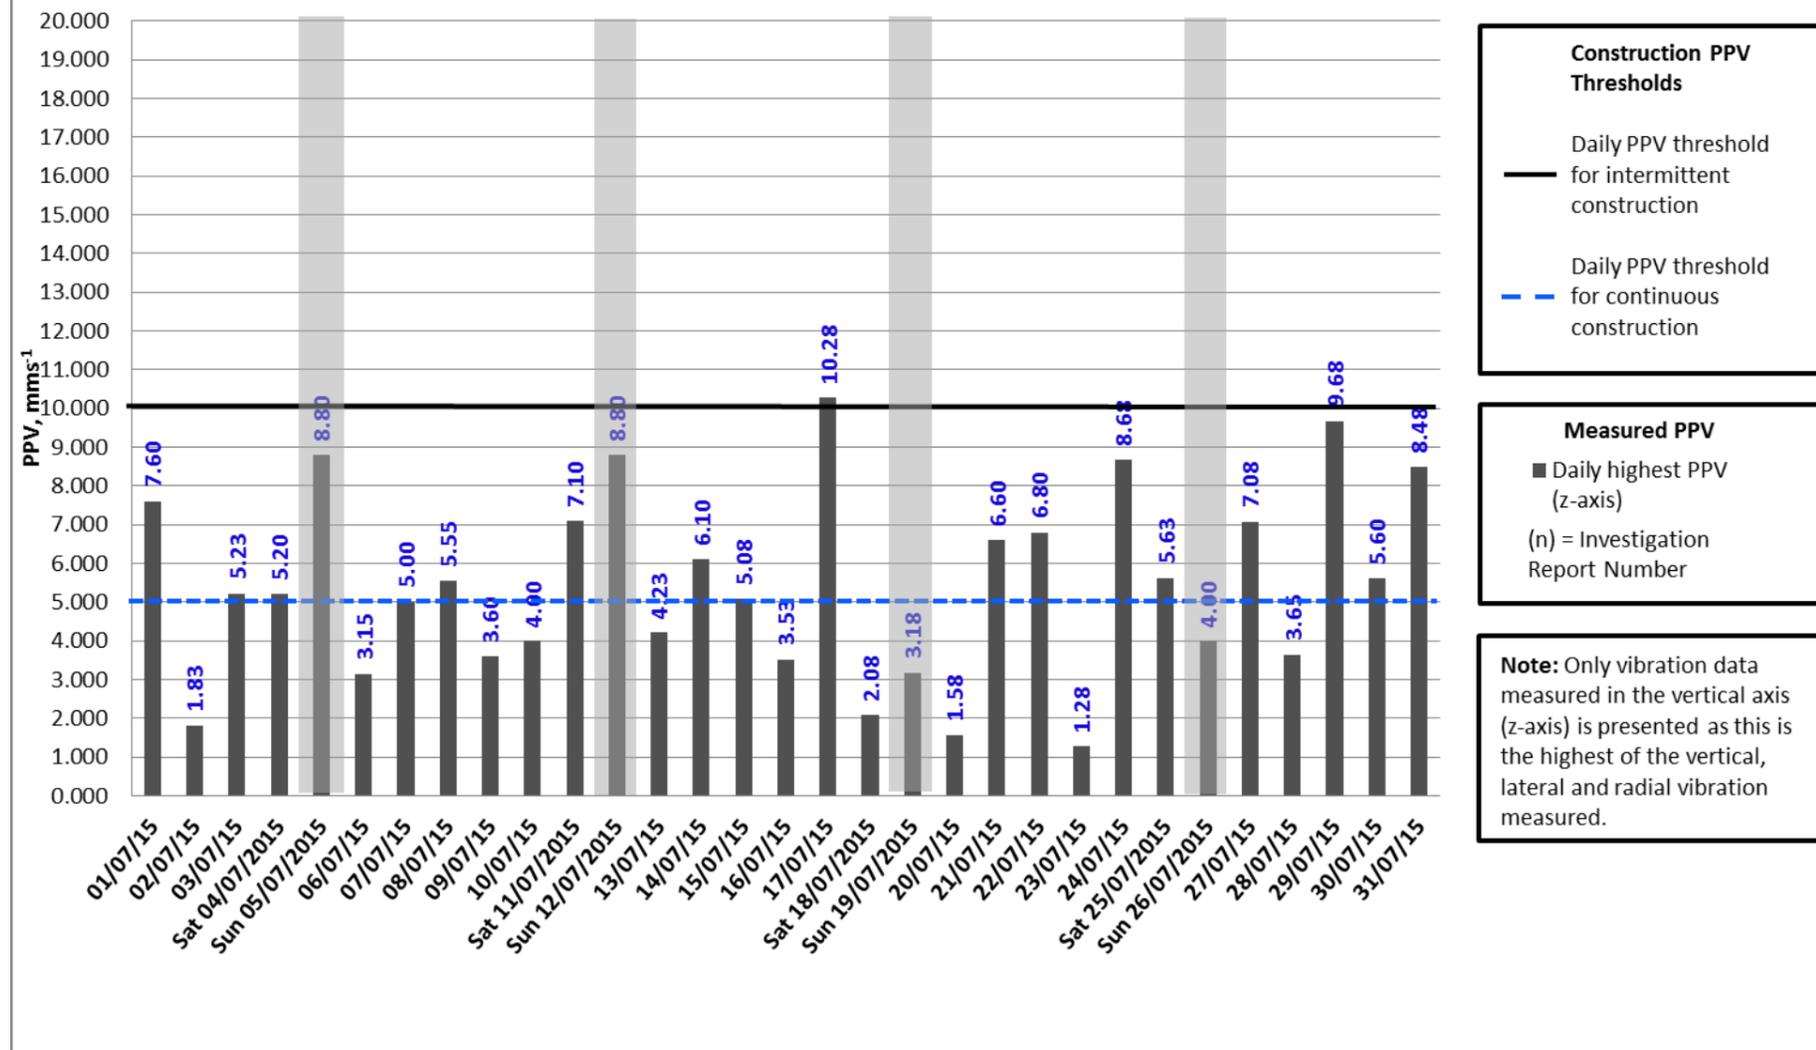
Measured highest Daily Peak Particle Velocity (PPV), Clufflat Brae, Measurement period: July 2015

Exceedances on the 01/07/2015, 03/07/2015, 04/07/2015, 05/07/2015, 07/07/2015, 08/07/2015, 11/07/2015, 12/07/2015, 14/07/2015, 15/07/2015, 21/07/2015 and on the 22/07/2015 have been investigated and found to be individual isolated events that are not continuous and that are within the intermittent threshold

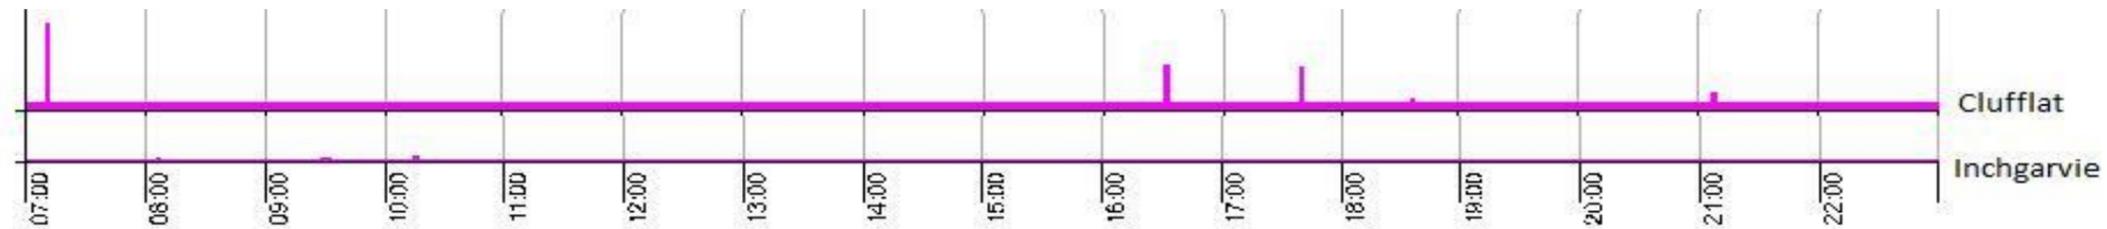
Investigations into the vibration on the 17/07/2015 has found that the exceedance occurred -out of working hours. Also by referencing the graph above from that day on the two monitors, it can be seen that over the 60 meter distance between the two monitors there was no similarity which would indicate that the exceedance was due to localised vibration sources close to the monitor.

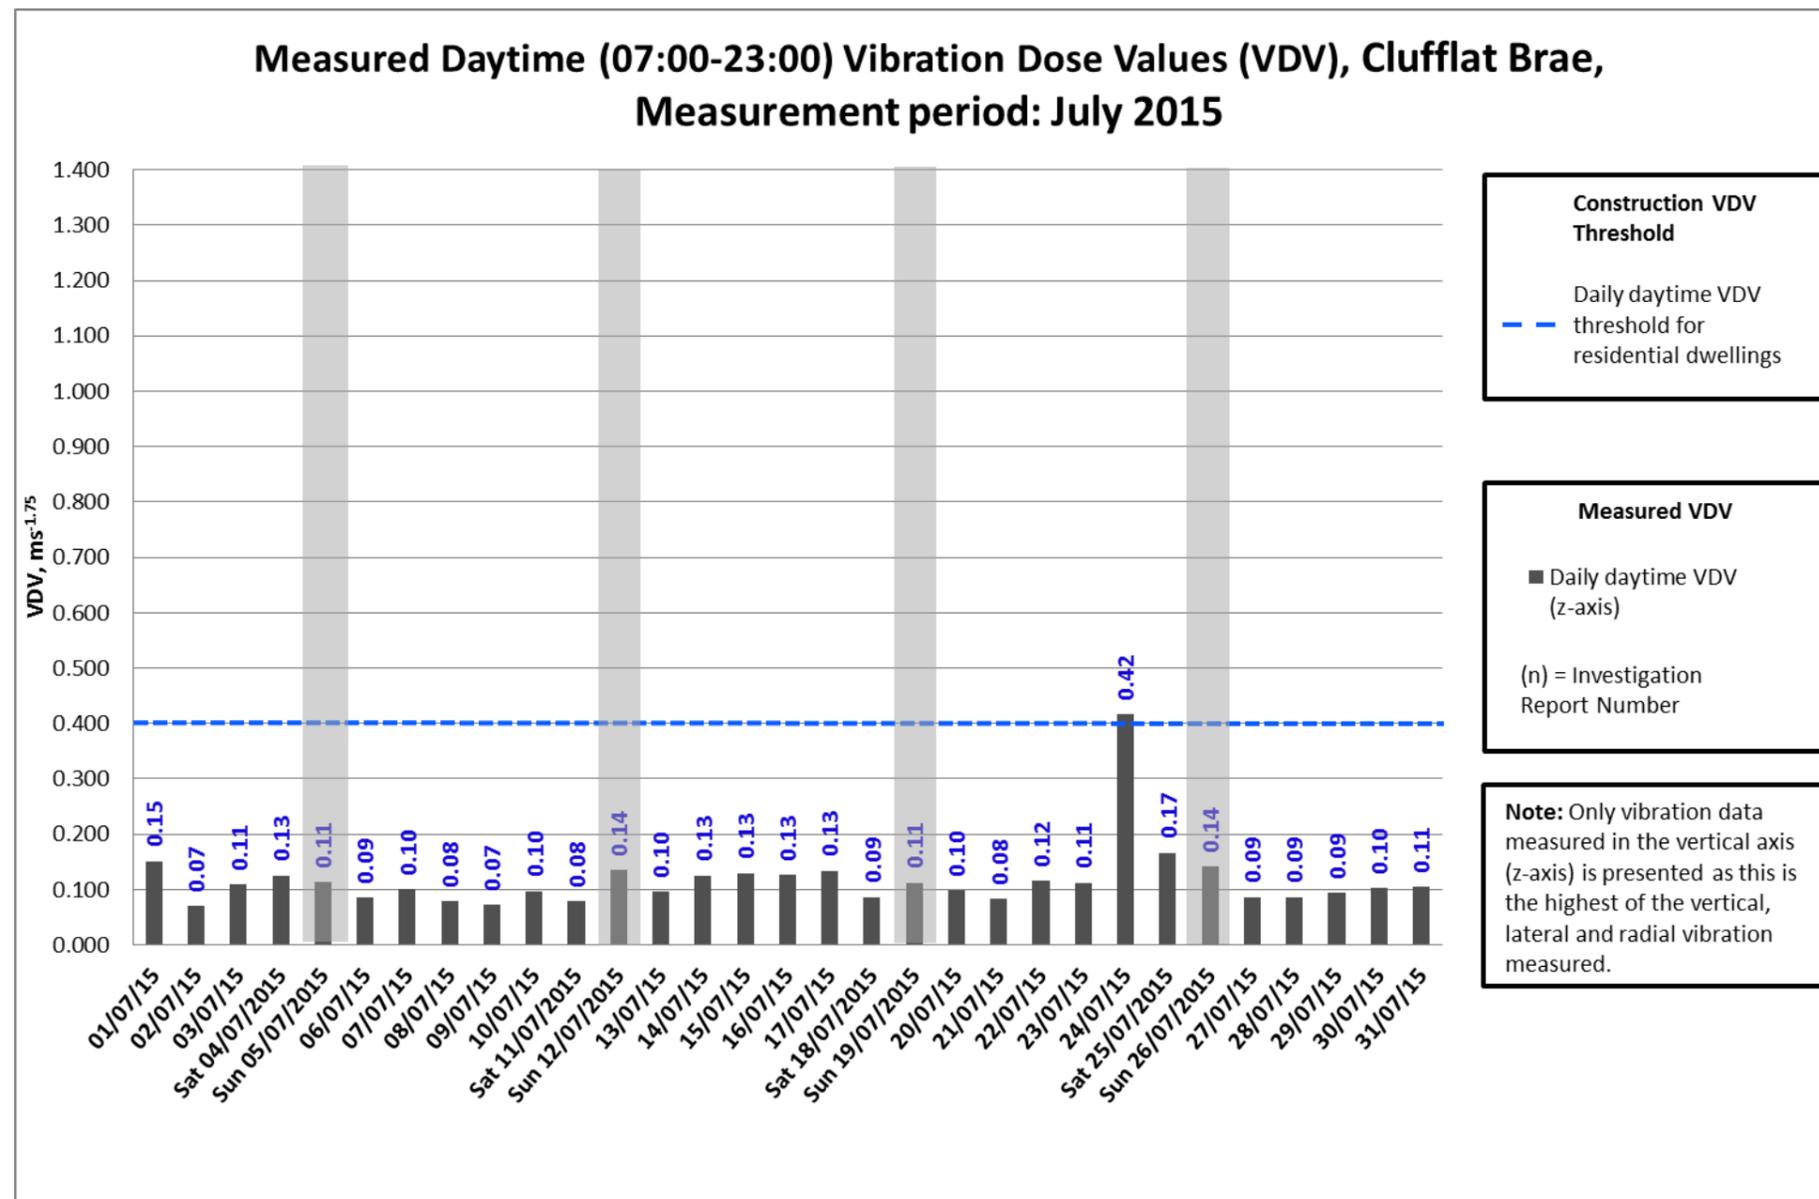
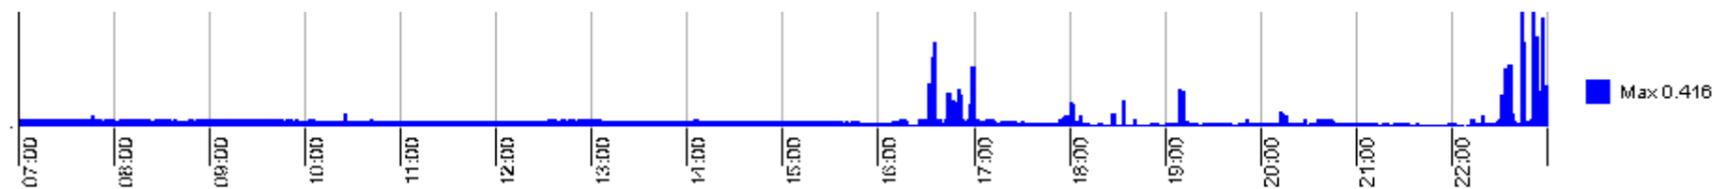
Exceedance on the 24/07/2015 starts at 16:30hrs and continues into the night. Due to the times of the vibration it is apparent that it was not caused by construction works but more likely to be activity close to the monitor (graph shown above).

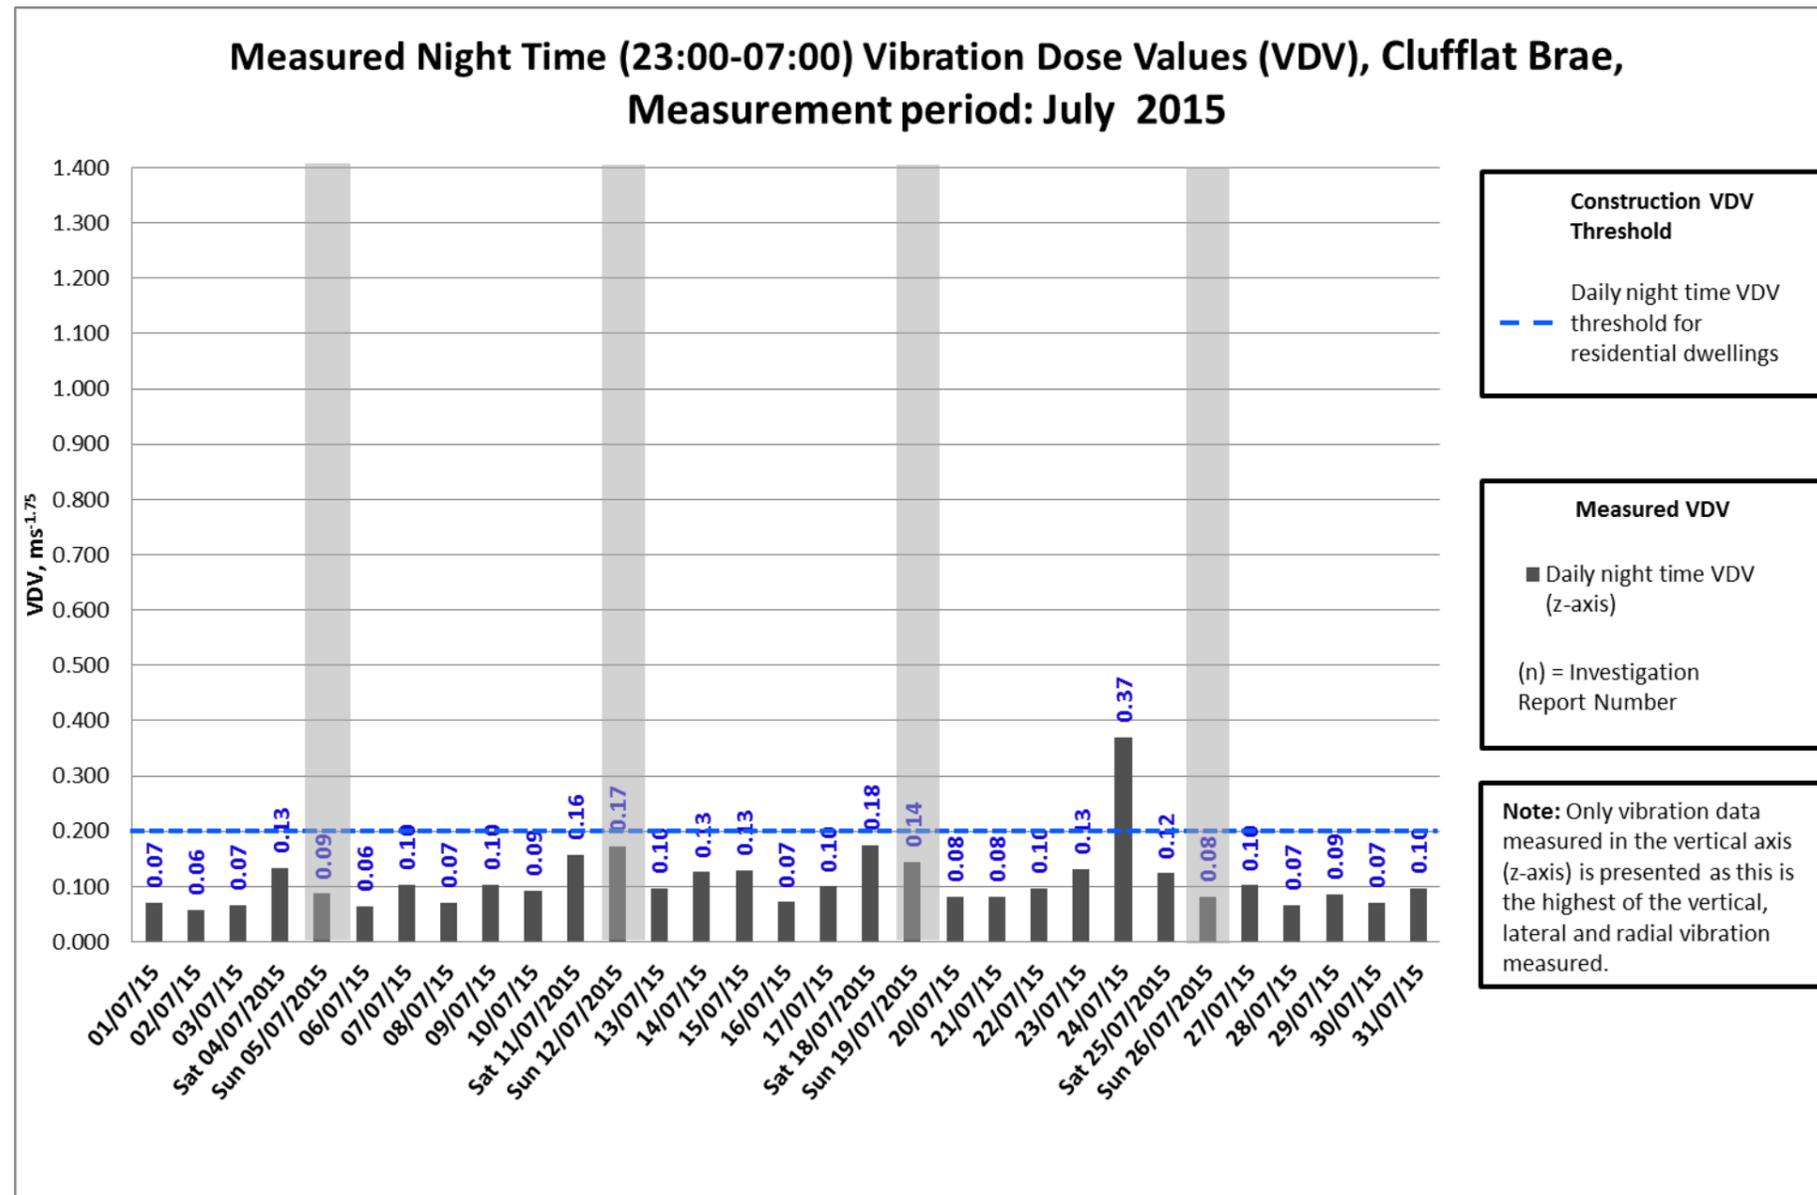
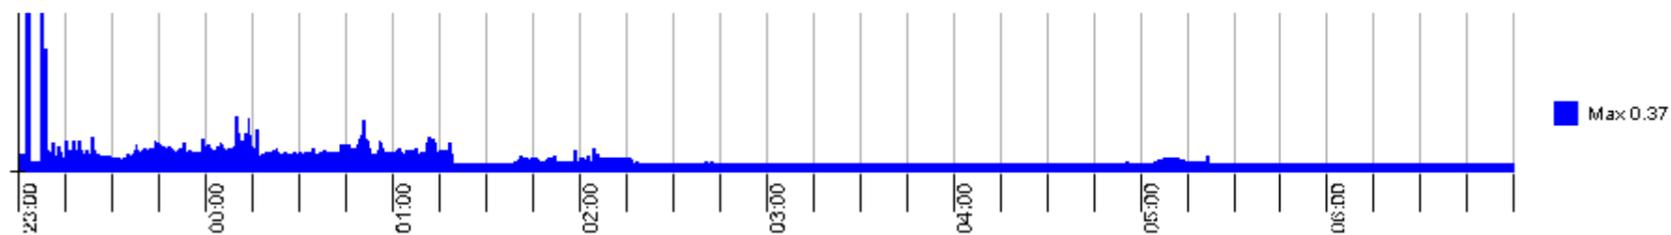
The Exceedance on the 24/07/2015 was a continuation of the event from the VDV daytime graph, and not caused by any construction activities (graph shown above).

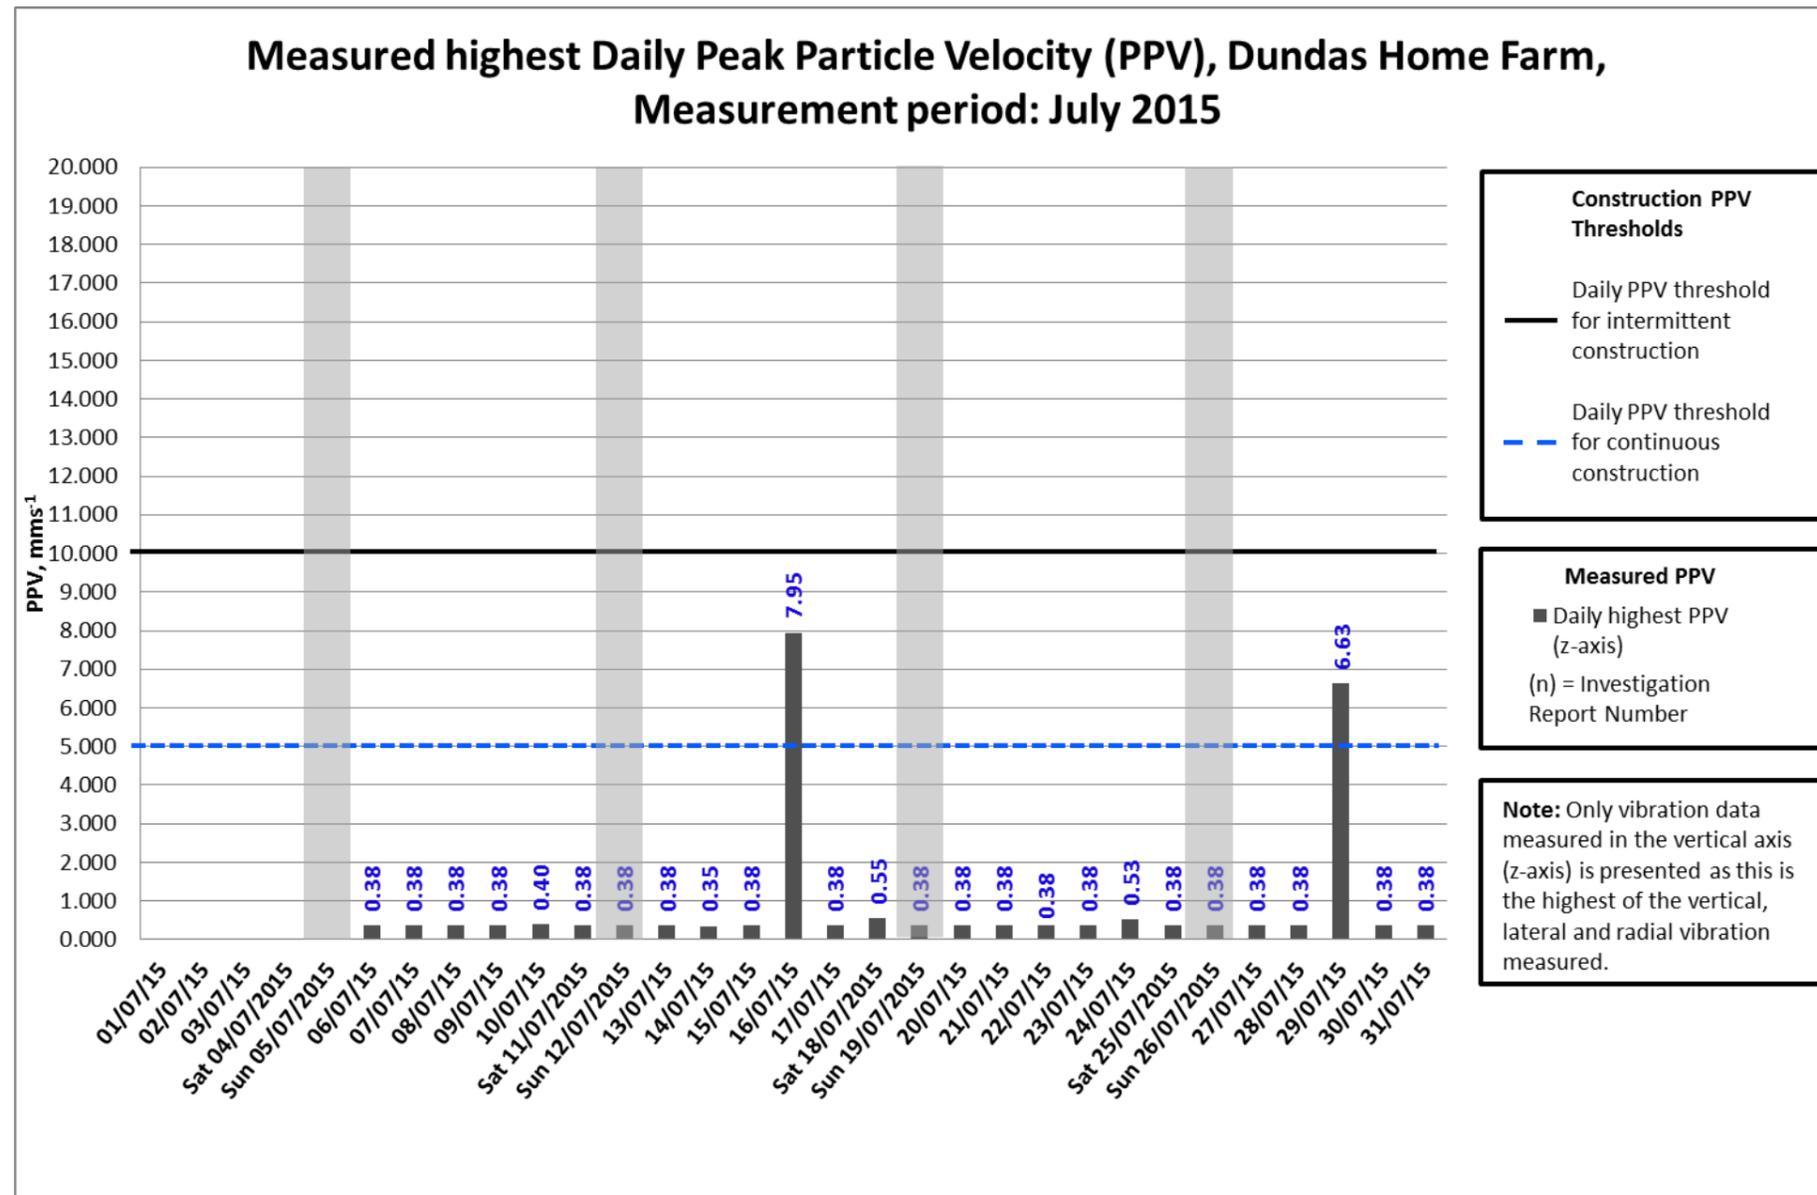
Due to Electrical work being carried out by the Scottish Power at the top of Dundas farm road, a power loss meant that no data was recorded between 1st and 5th July.

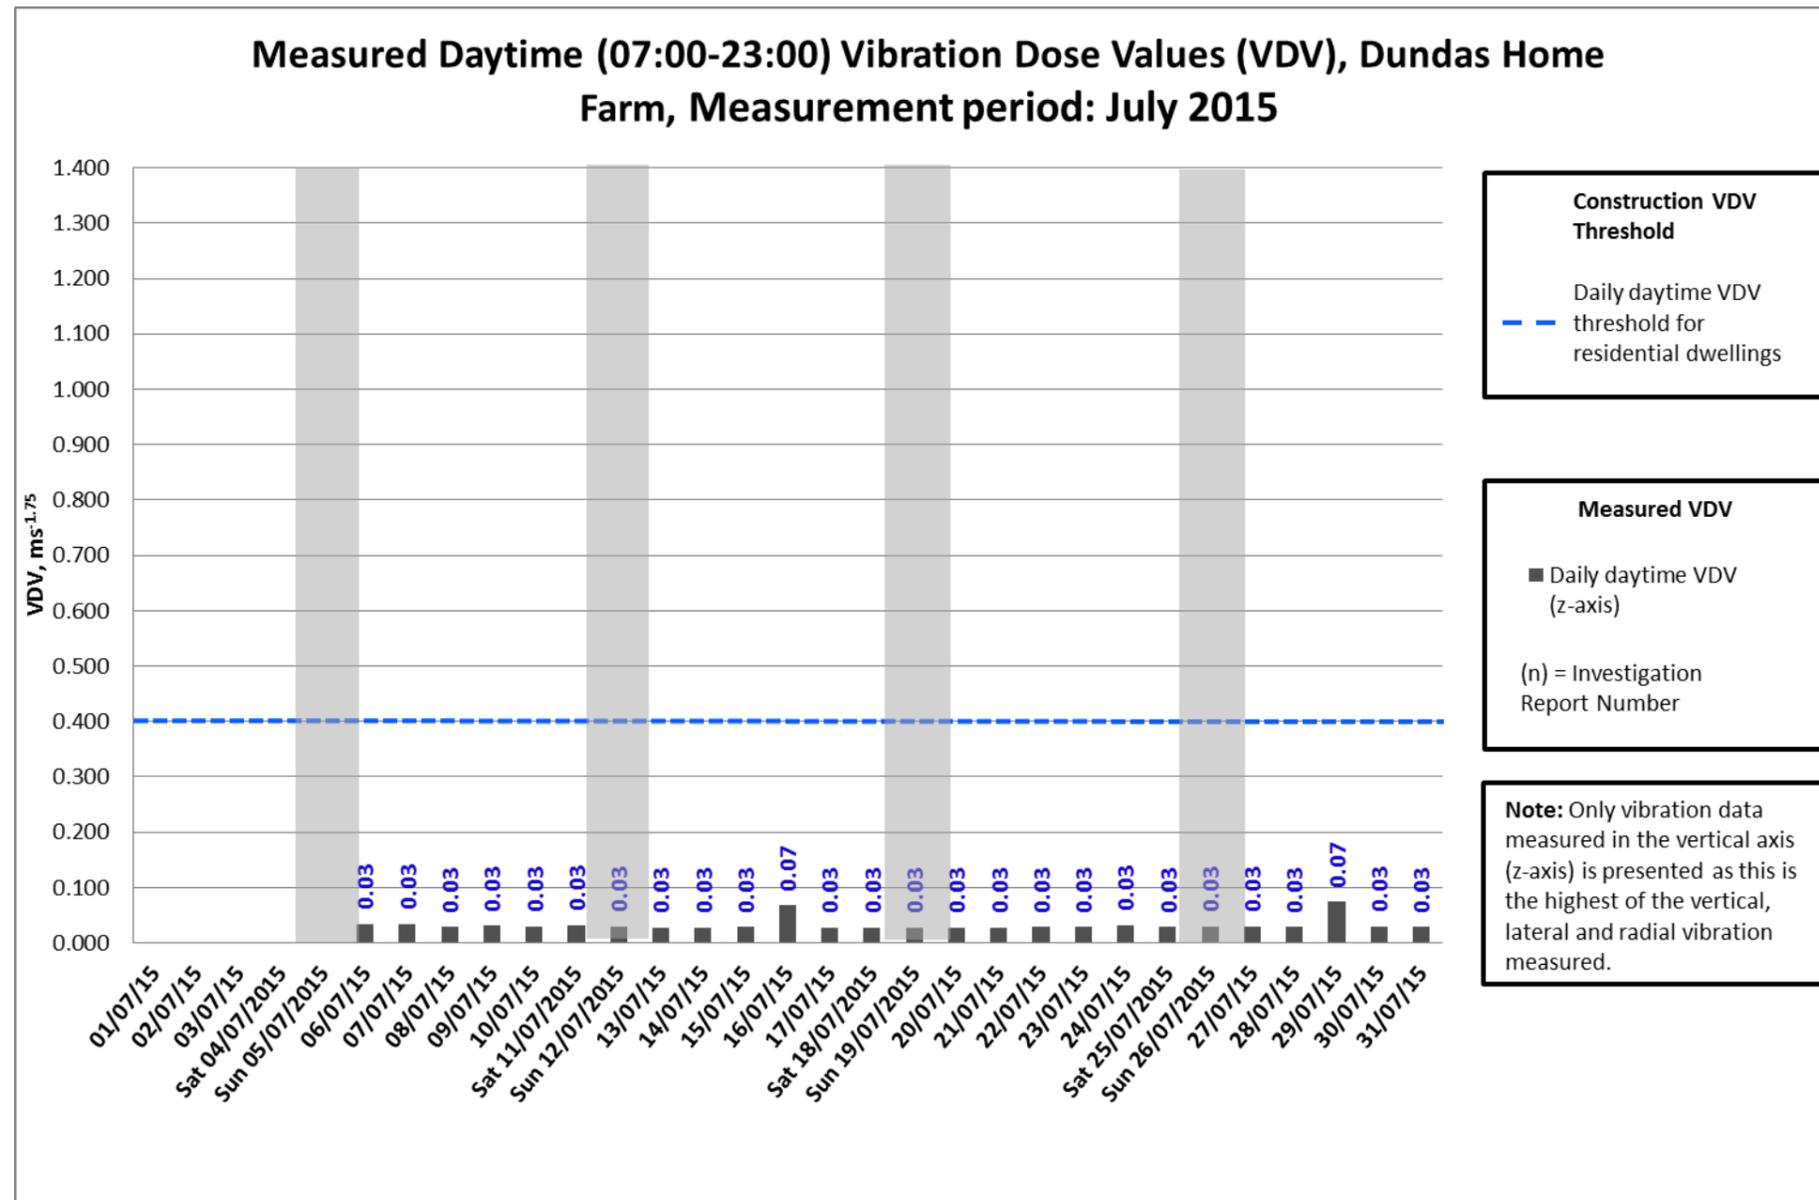
Due to Electrical work being carried out by Scottish Power at the top of Dundas farm road, no data was recorded between 1st and 5th July.

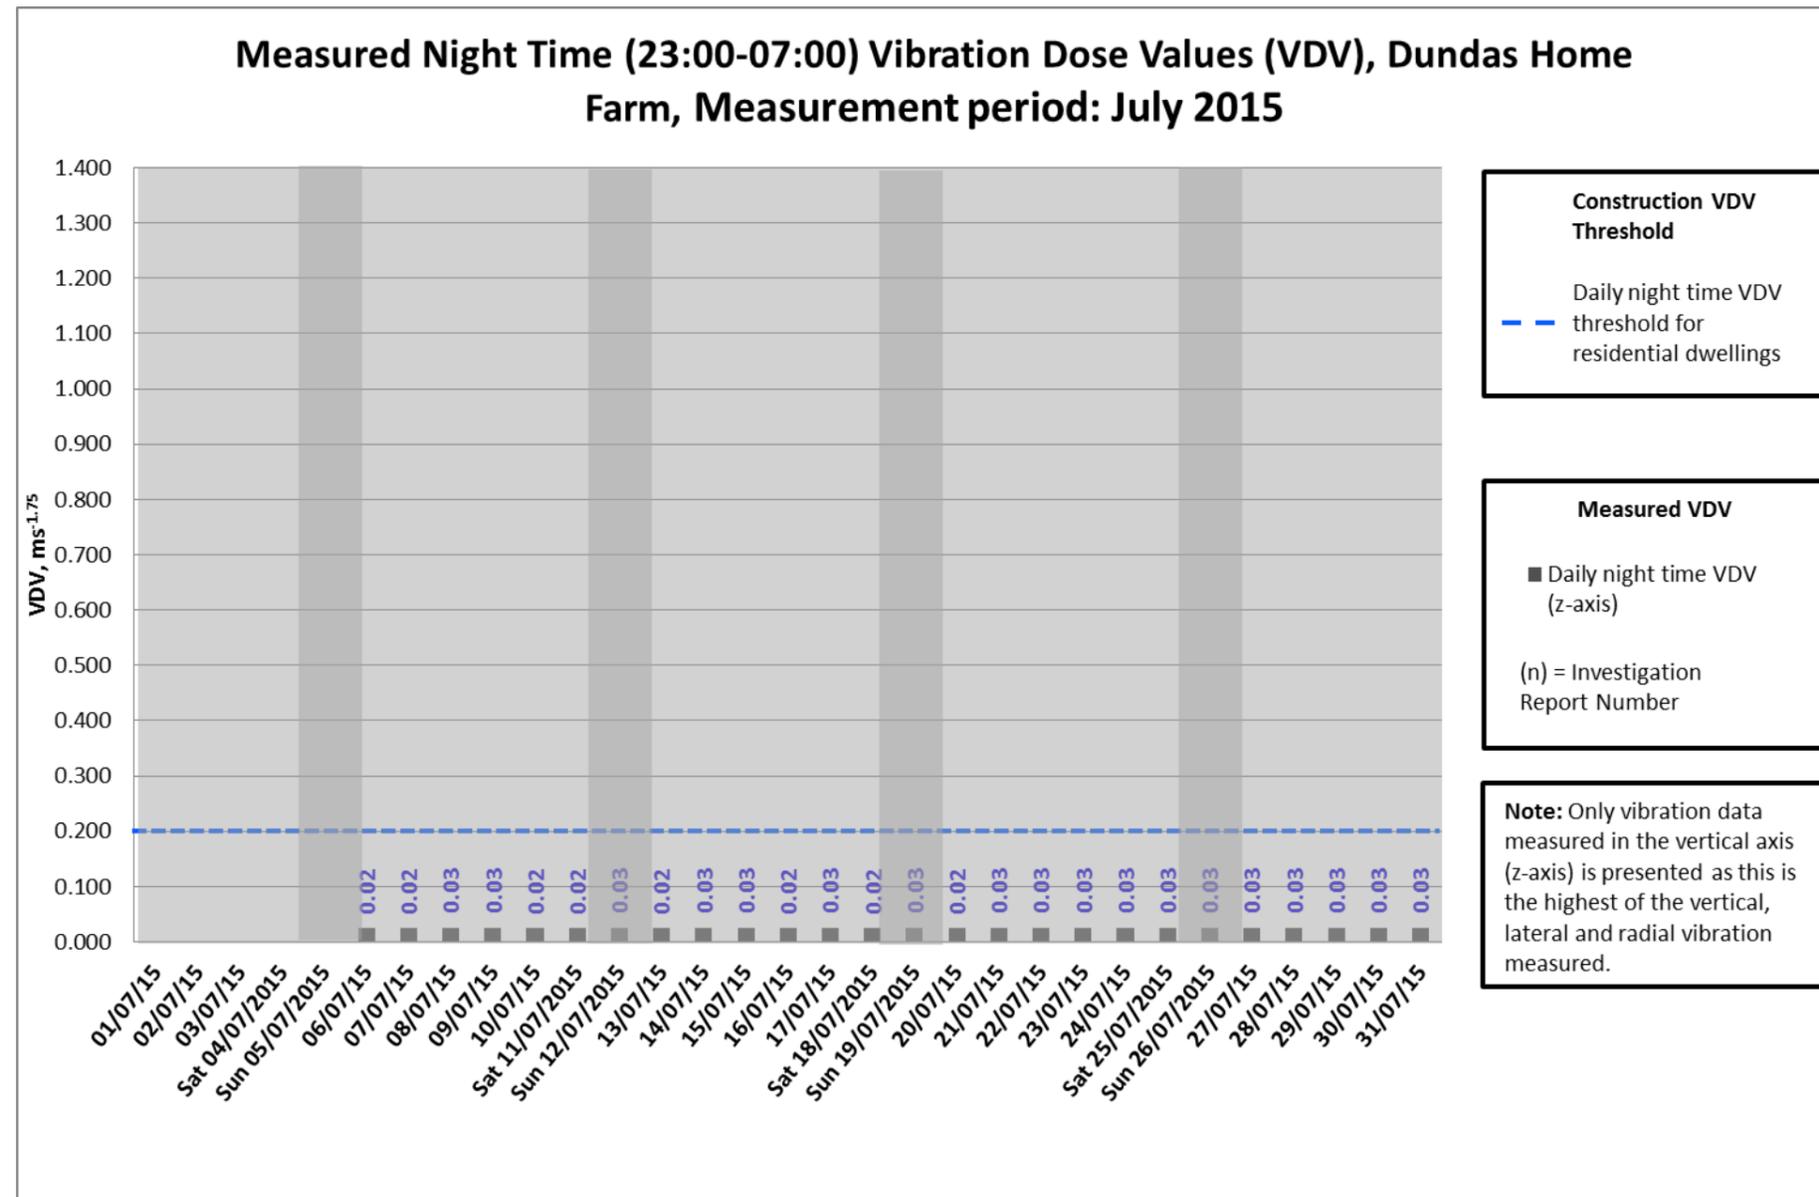
Due to Electrical work being carried out by Scottish Power at the top of Dundas farm road, no data was recorded between 1st and 5th July.

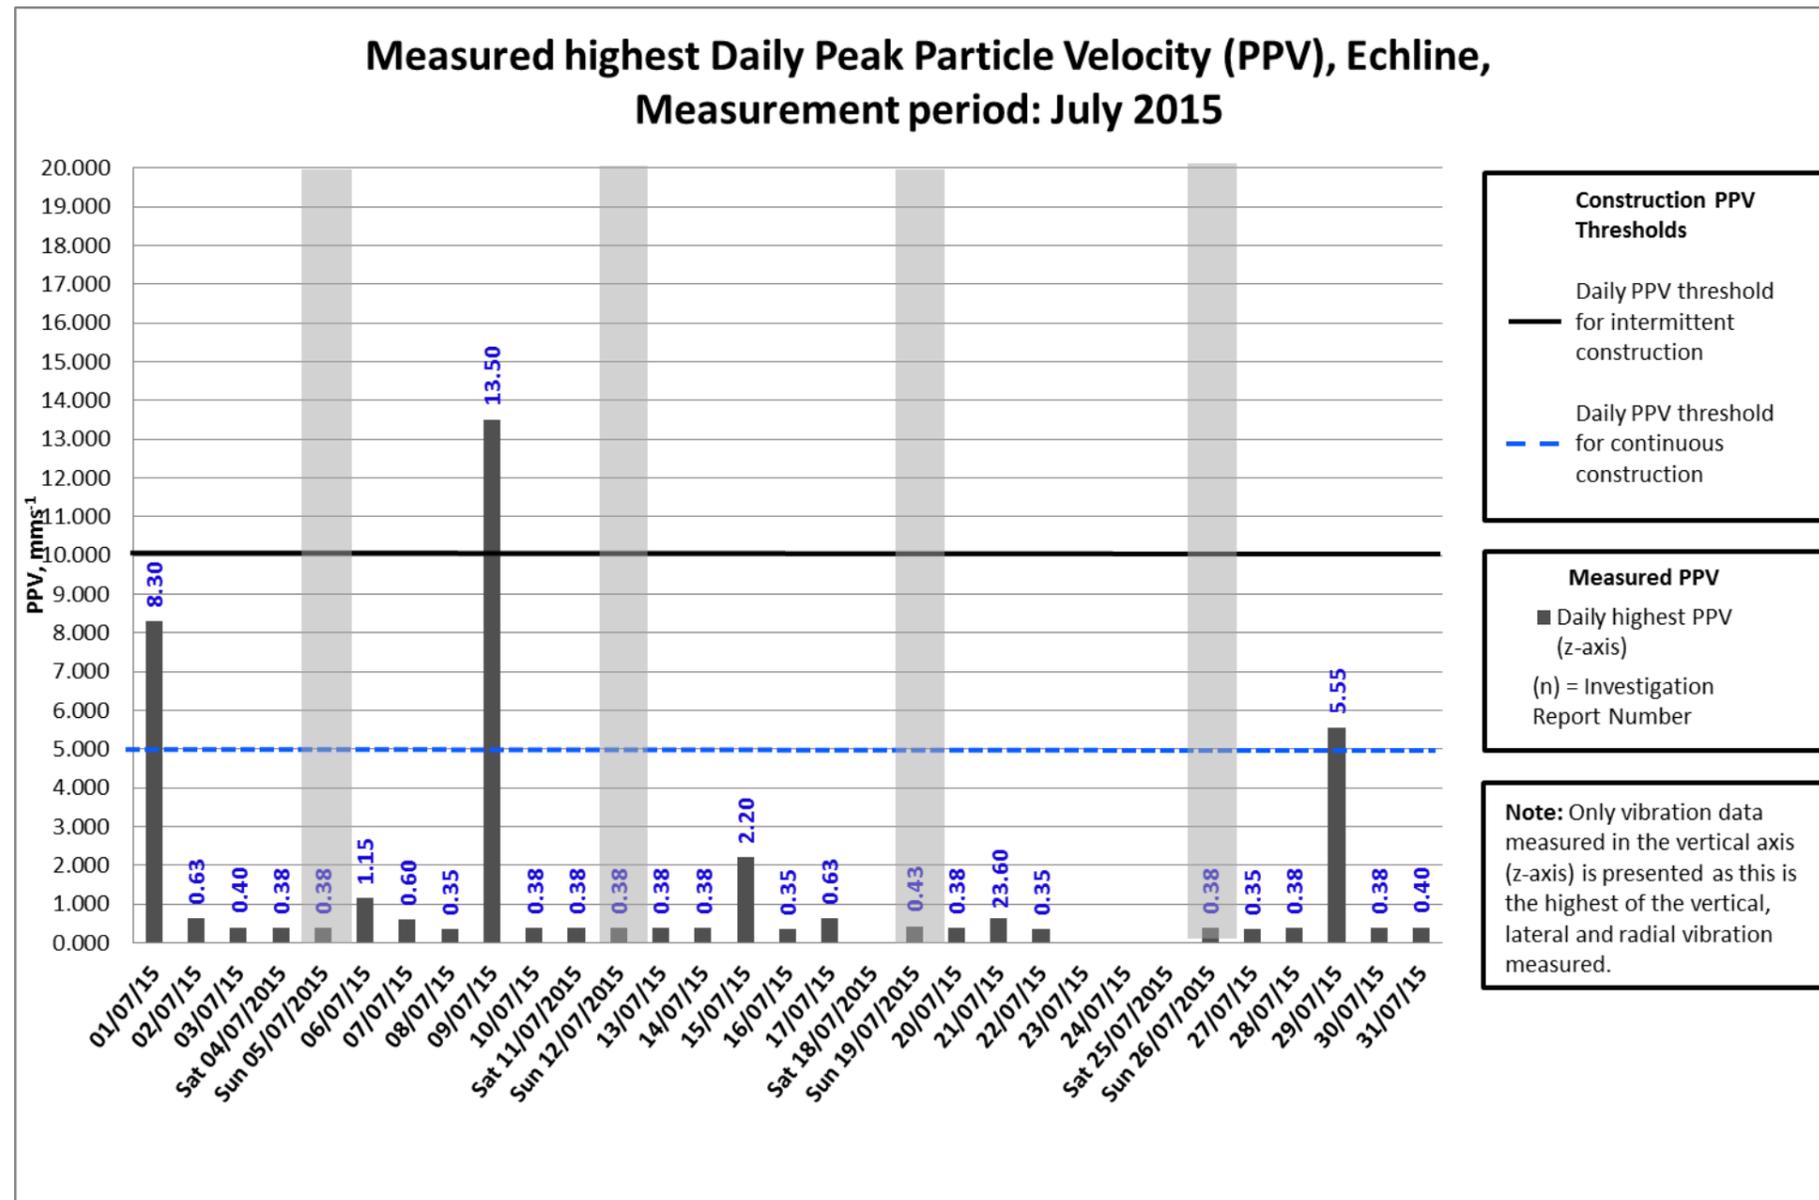
As seen from above (on the 01/07/2015) the exceedances on the 01/07/2015 and the 29/07/2015 was caused due to maintenance works being carried out on the vibration monitor, and has no connection with construction works.

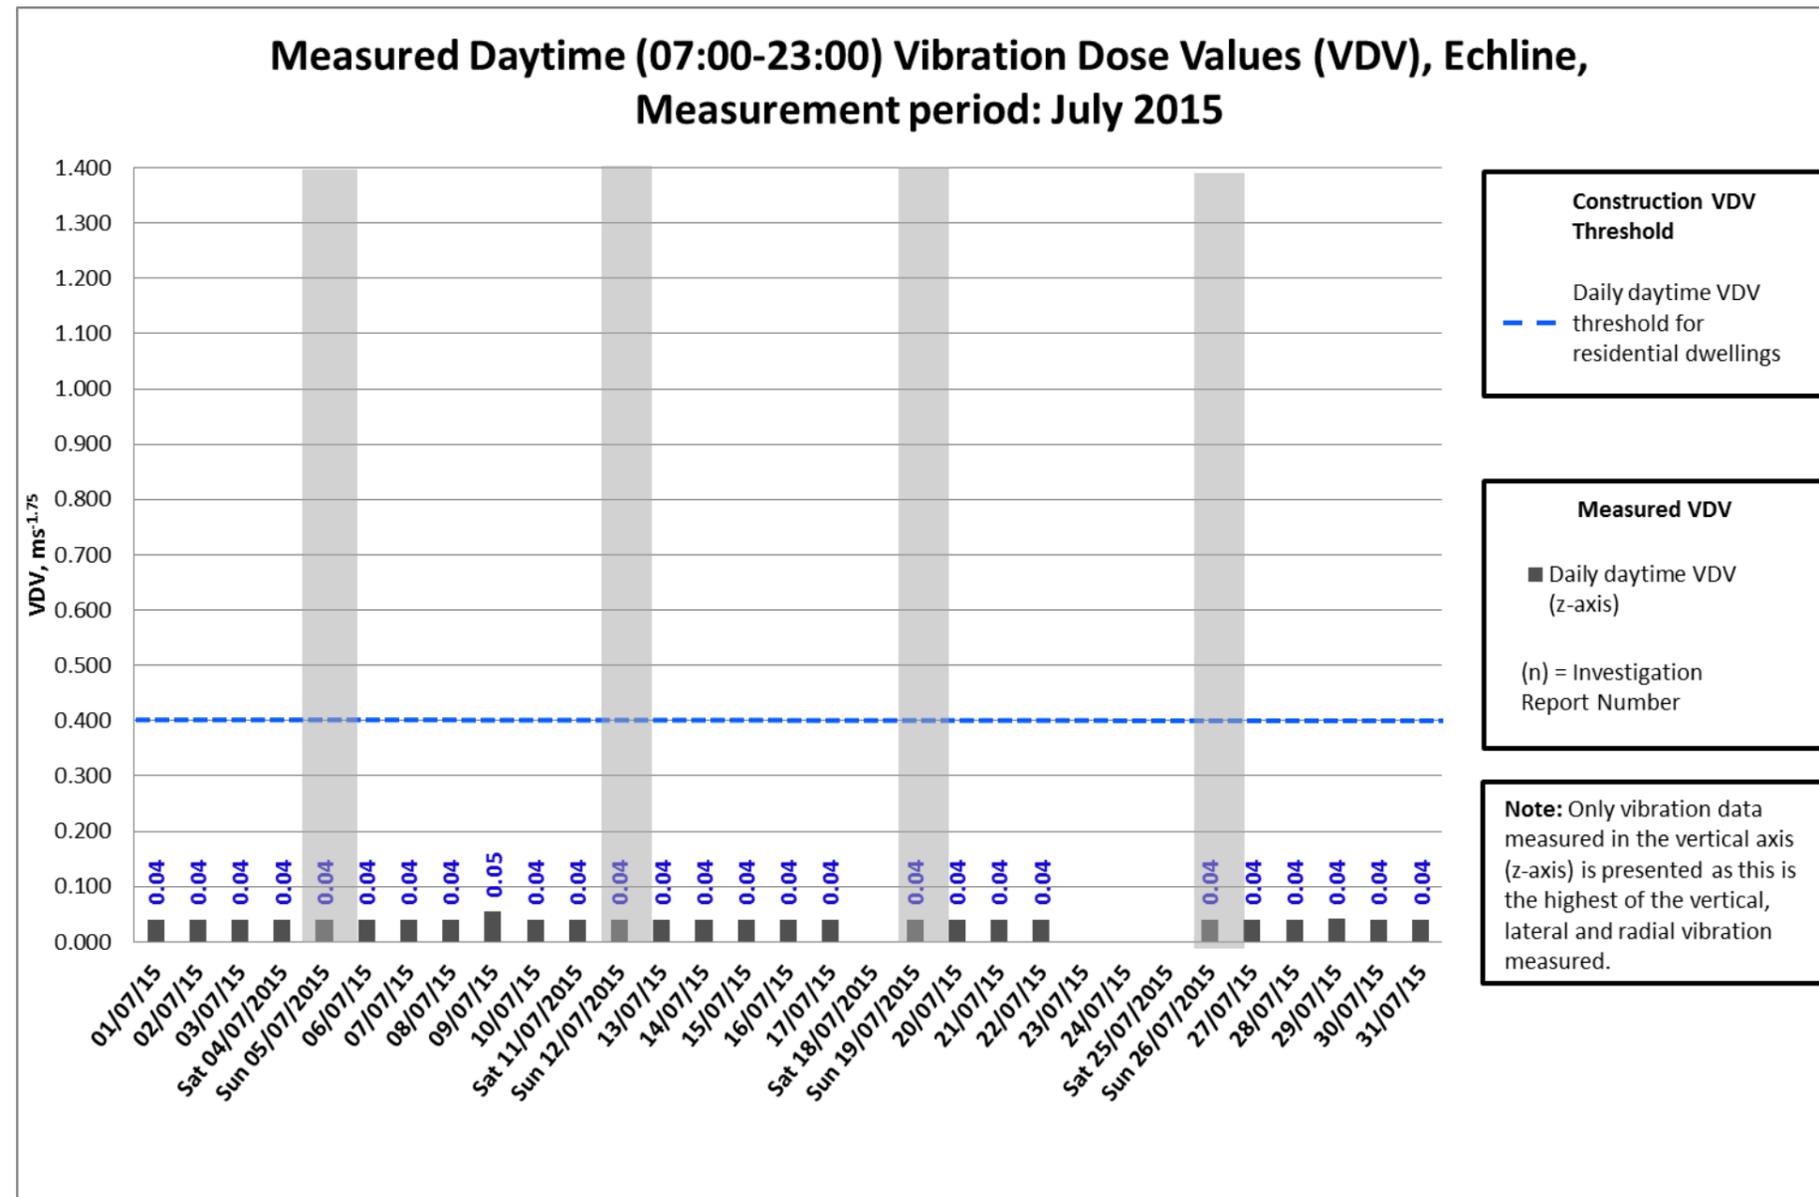
Missing data on the- 18/07/2015, 23/07/2015, 24/07/2015 and the 25/07/2015 was due to data being corrupt on the vibration monitor.

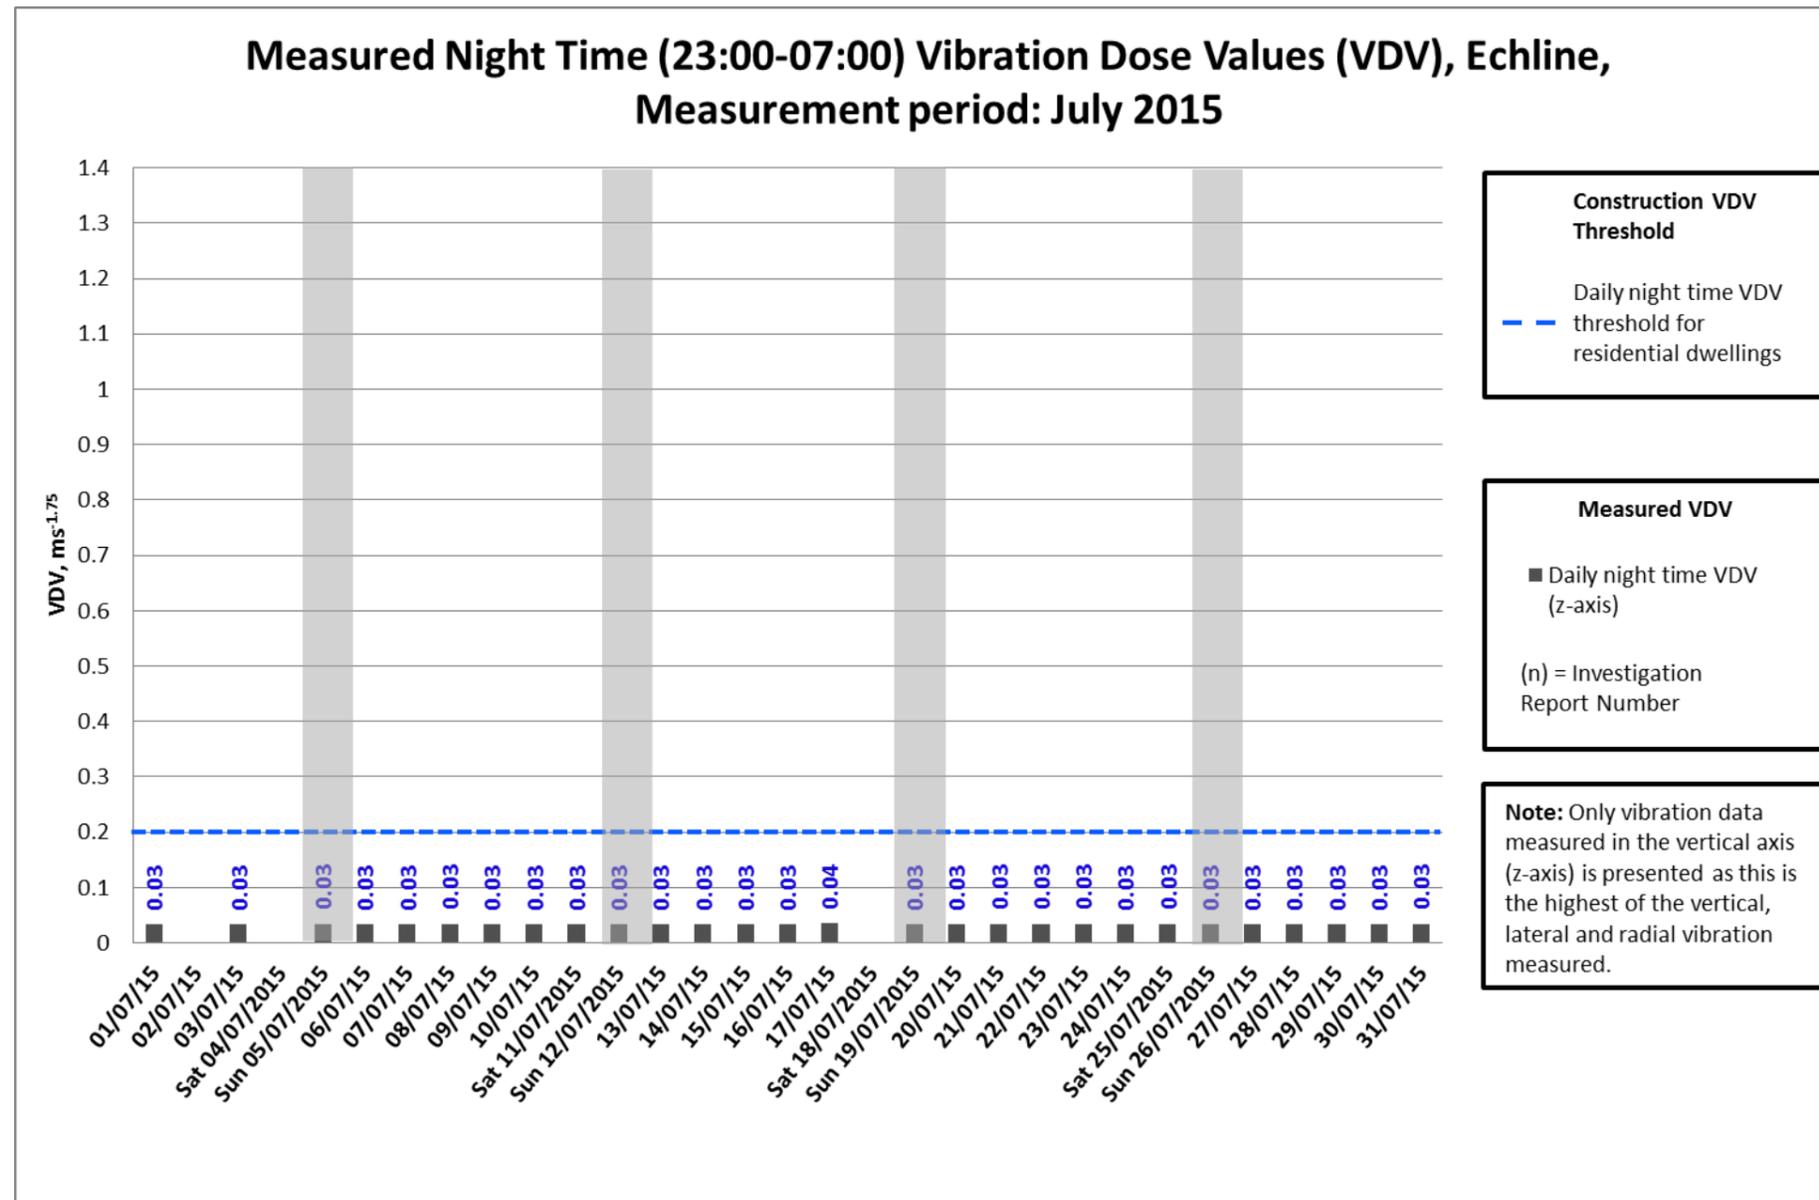
Missing data on the -18/07/2015, 23/07/2015, 24/07/2015 and the 25/07/2015 was due to data being corrupt on the vibration monitor.
