Project **FORTH REPLACEMENT CROSSING**

VIBRATION MONITORING REPORT
JULY 2015

REP-00241 Rev
02

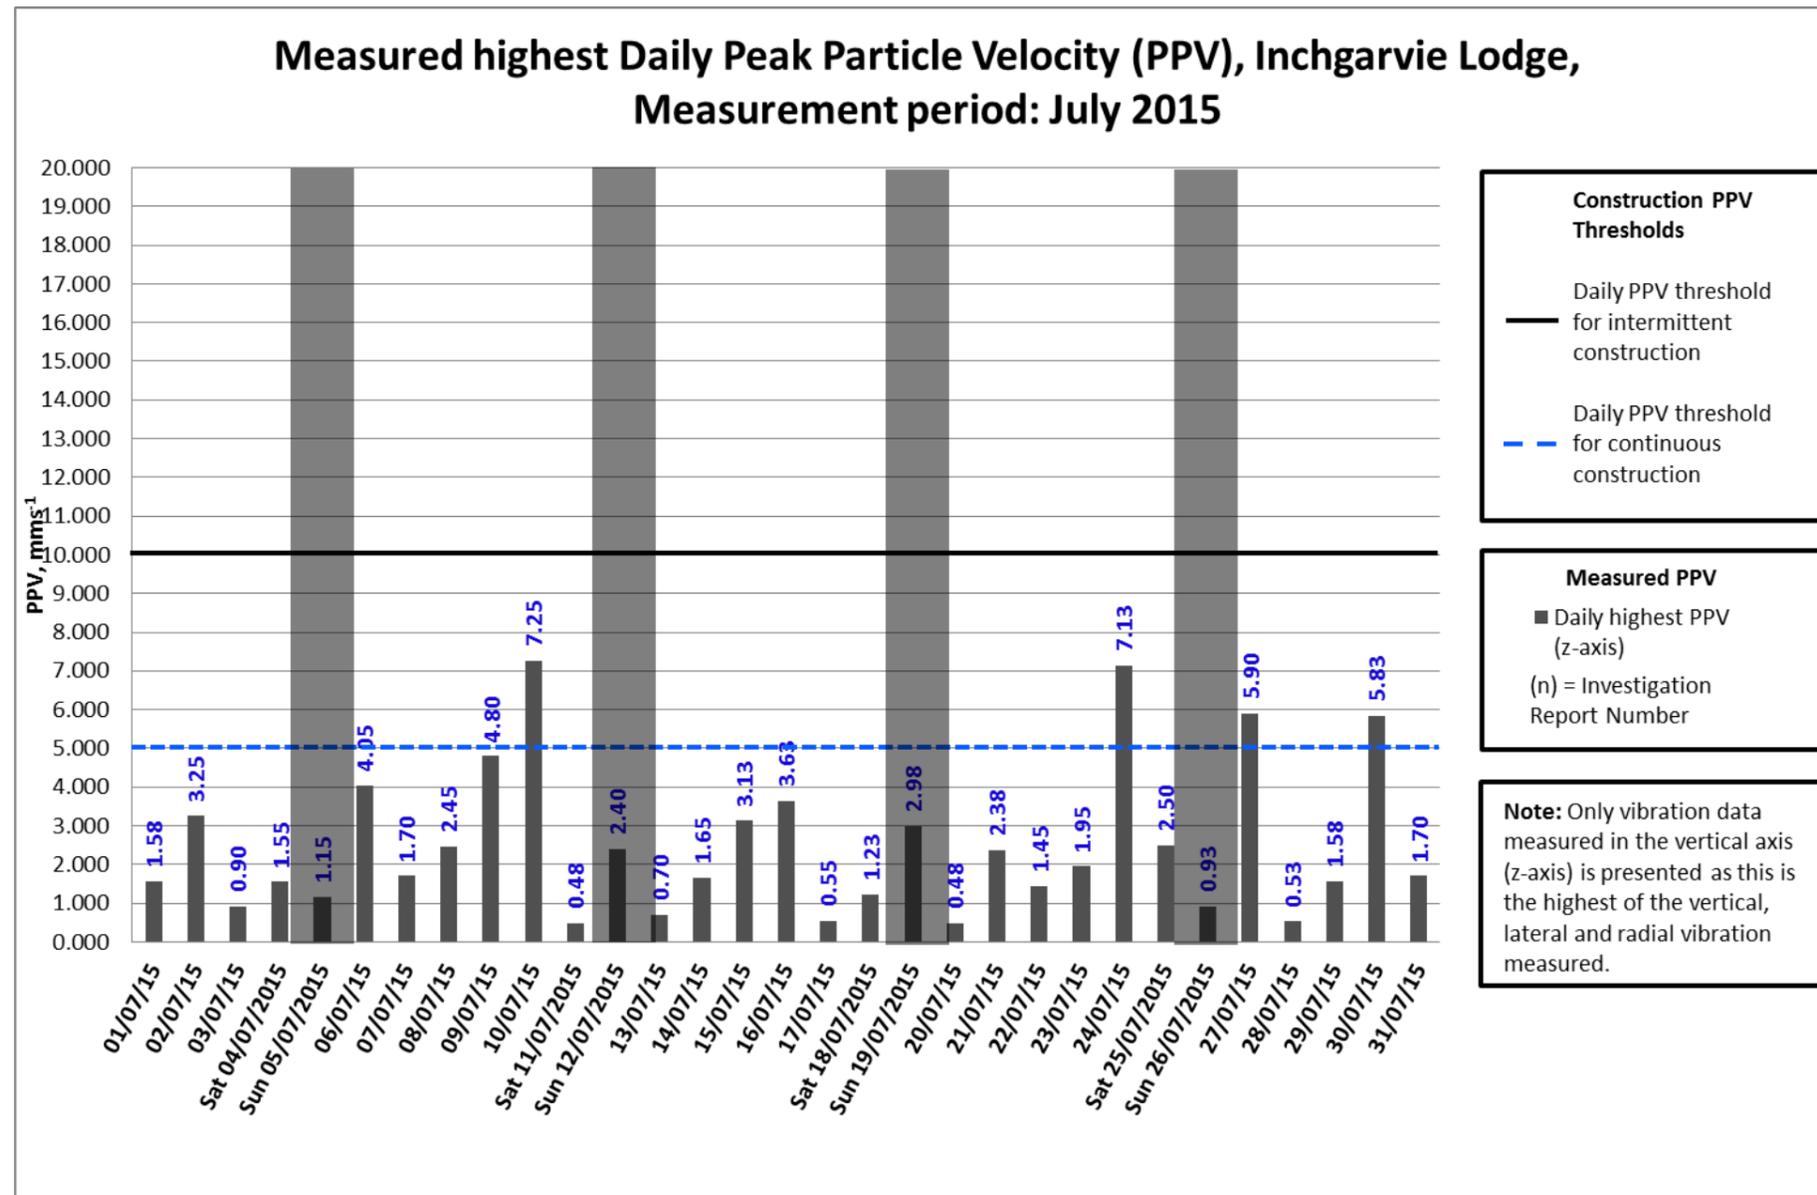
Exceedance on the 10/07/2015 has been investigated and found to have occurred outside of construction working hours.

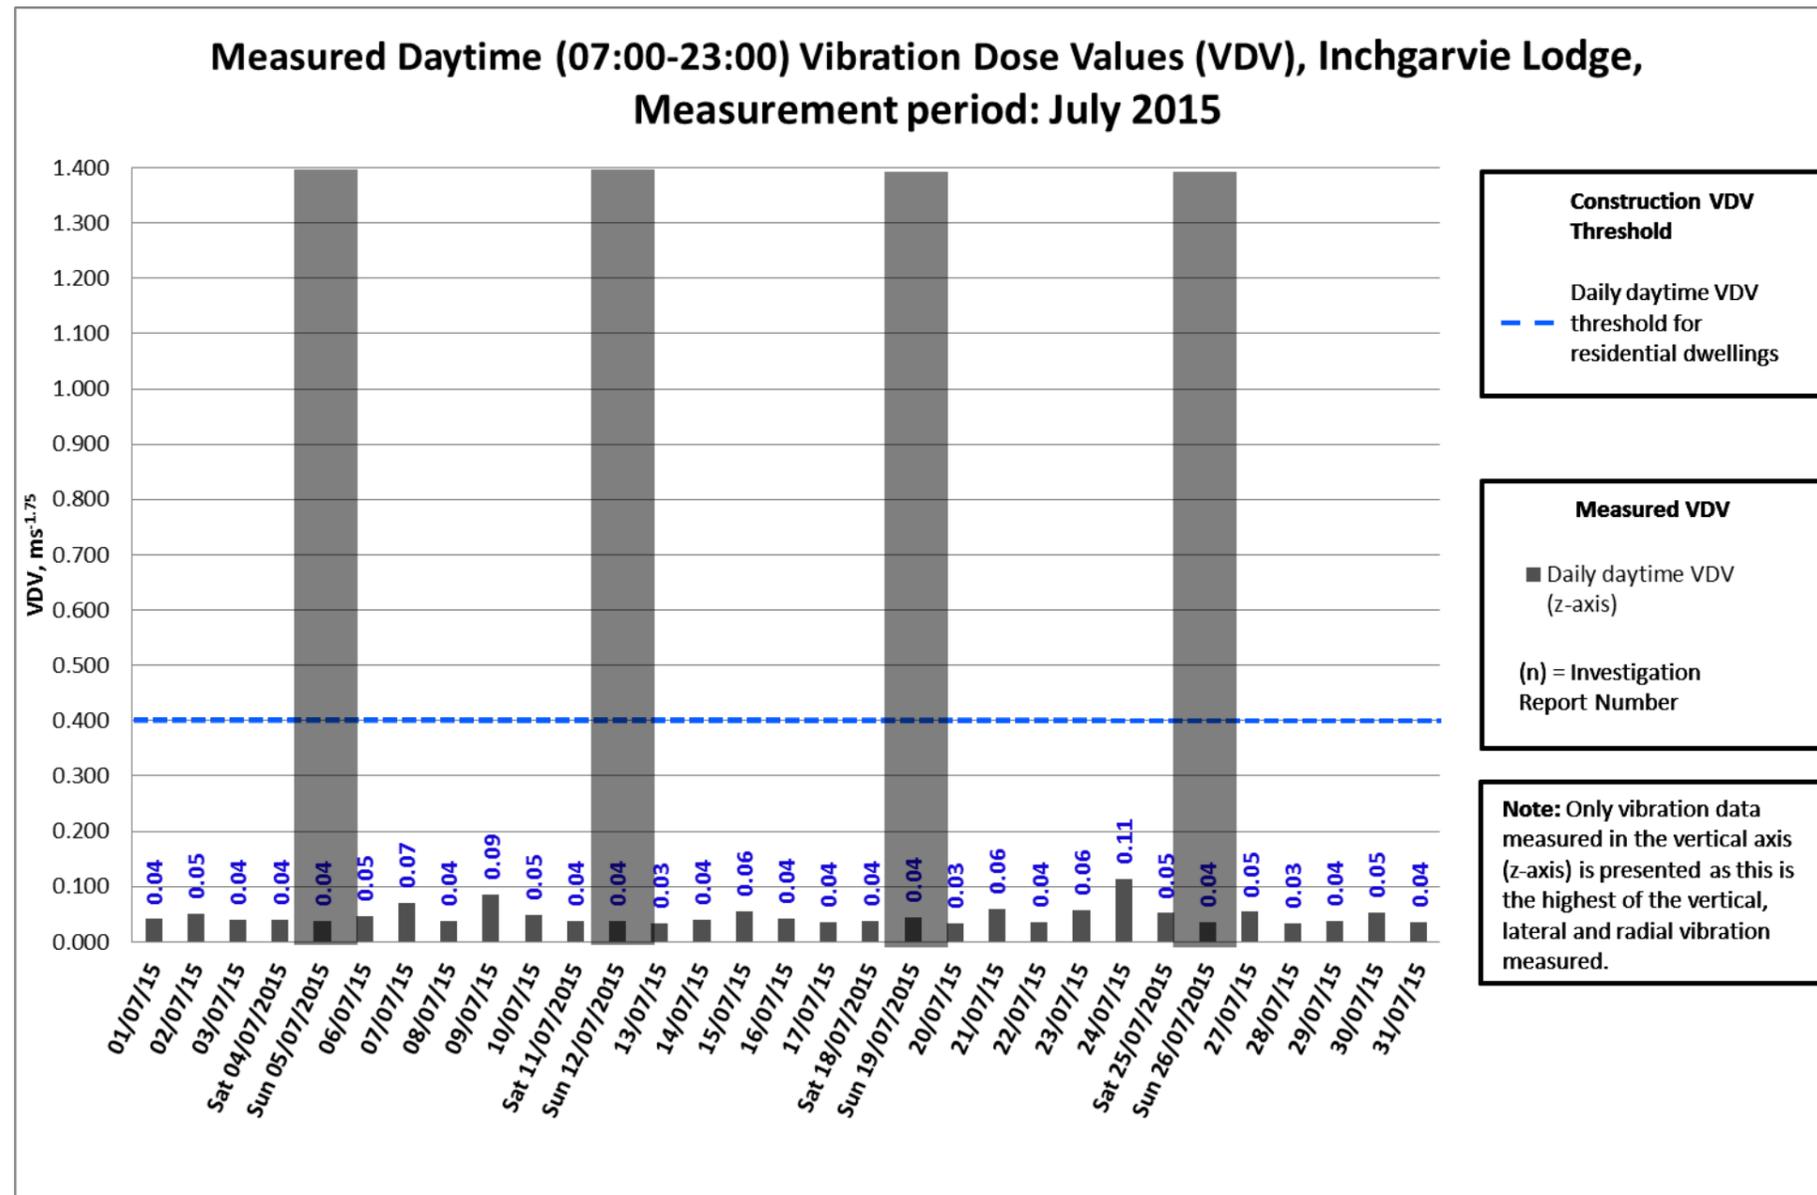
Exceedance on the 27/07/2015 and the 30/07/2015 (30/07/2015 as seen from above), was investigated and found to be an exceedance occurring outside of working hours, and not due to construction related activity.

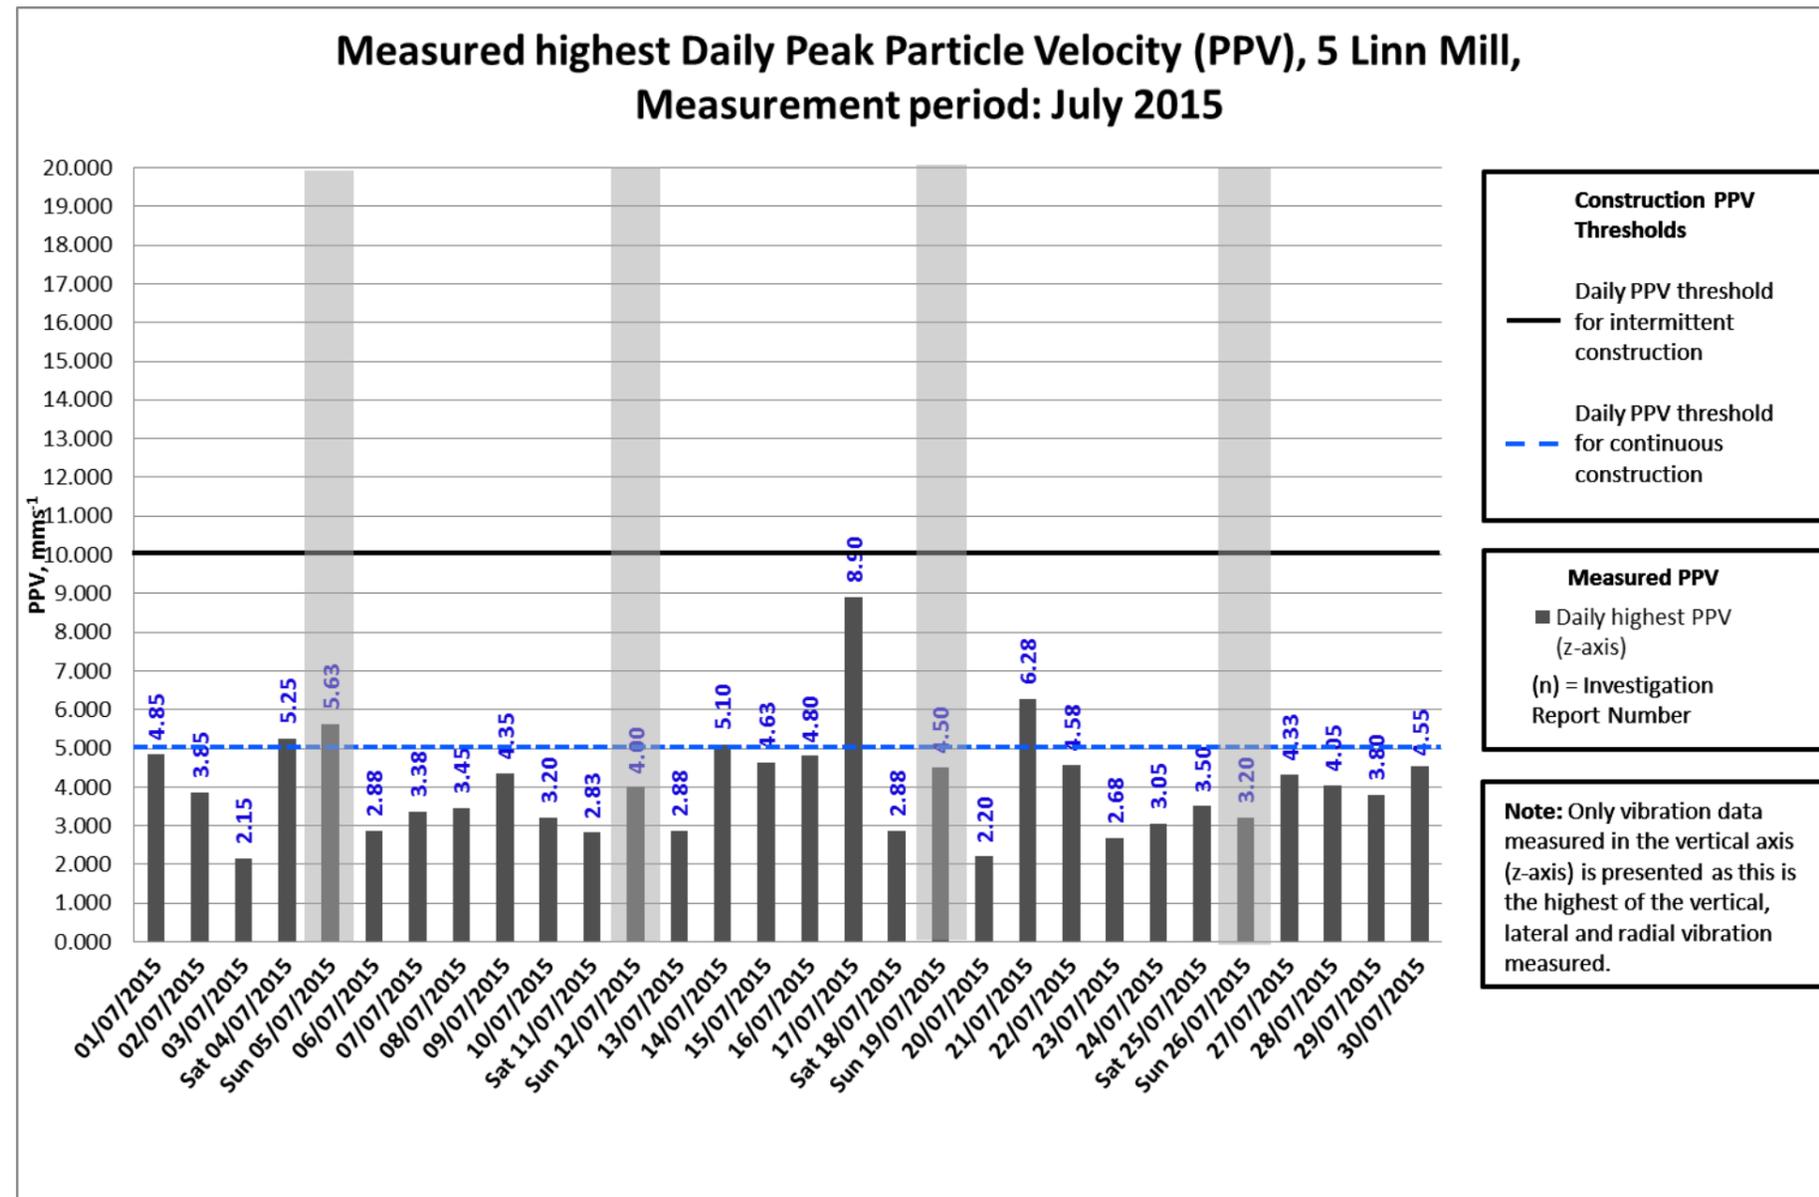
Exceedances on the 04/07/2015, 05/07/2015 and on the 14/07/2015 (graph above from the 04/07/2015) have been investigated and found to be out with working hours, and -therefore are unlikely to be related to construction.

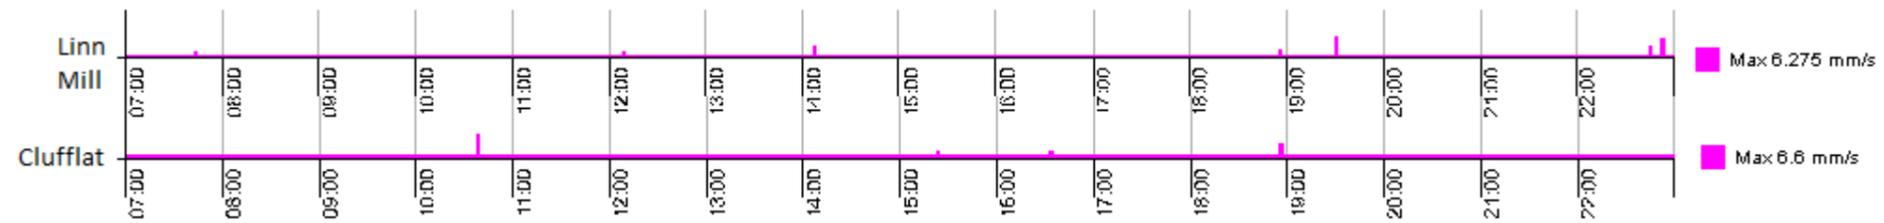
Exceedances on the 17/07/2015 and the 21/07/2015 (graph above from the 21/07/2015) have been investigated and found not to be related to construction activities. Linn mill monitor is 165 metres from the closest works, Clufflat is 200 metres from the same works.

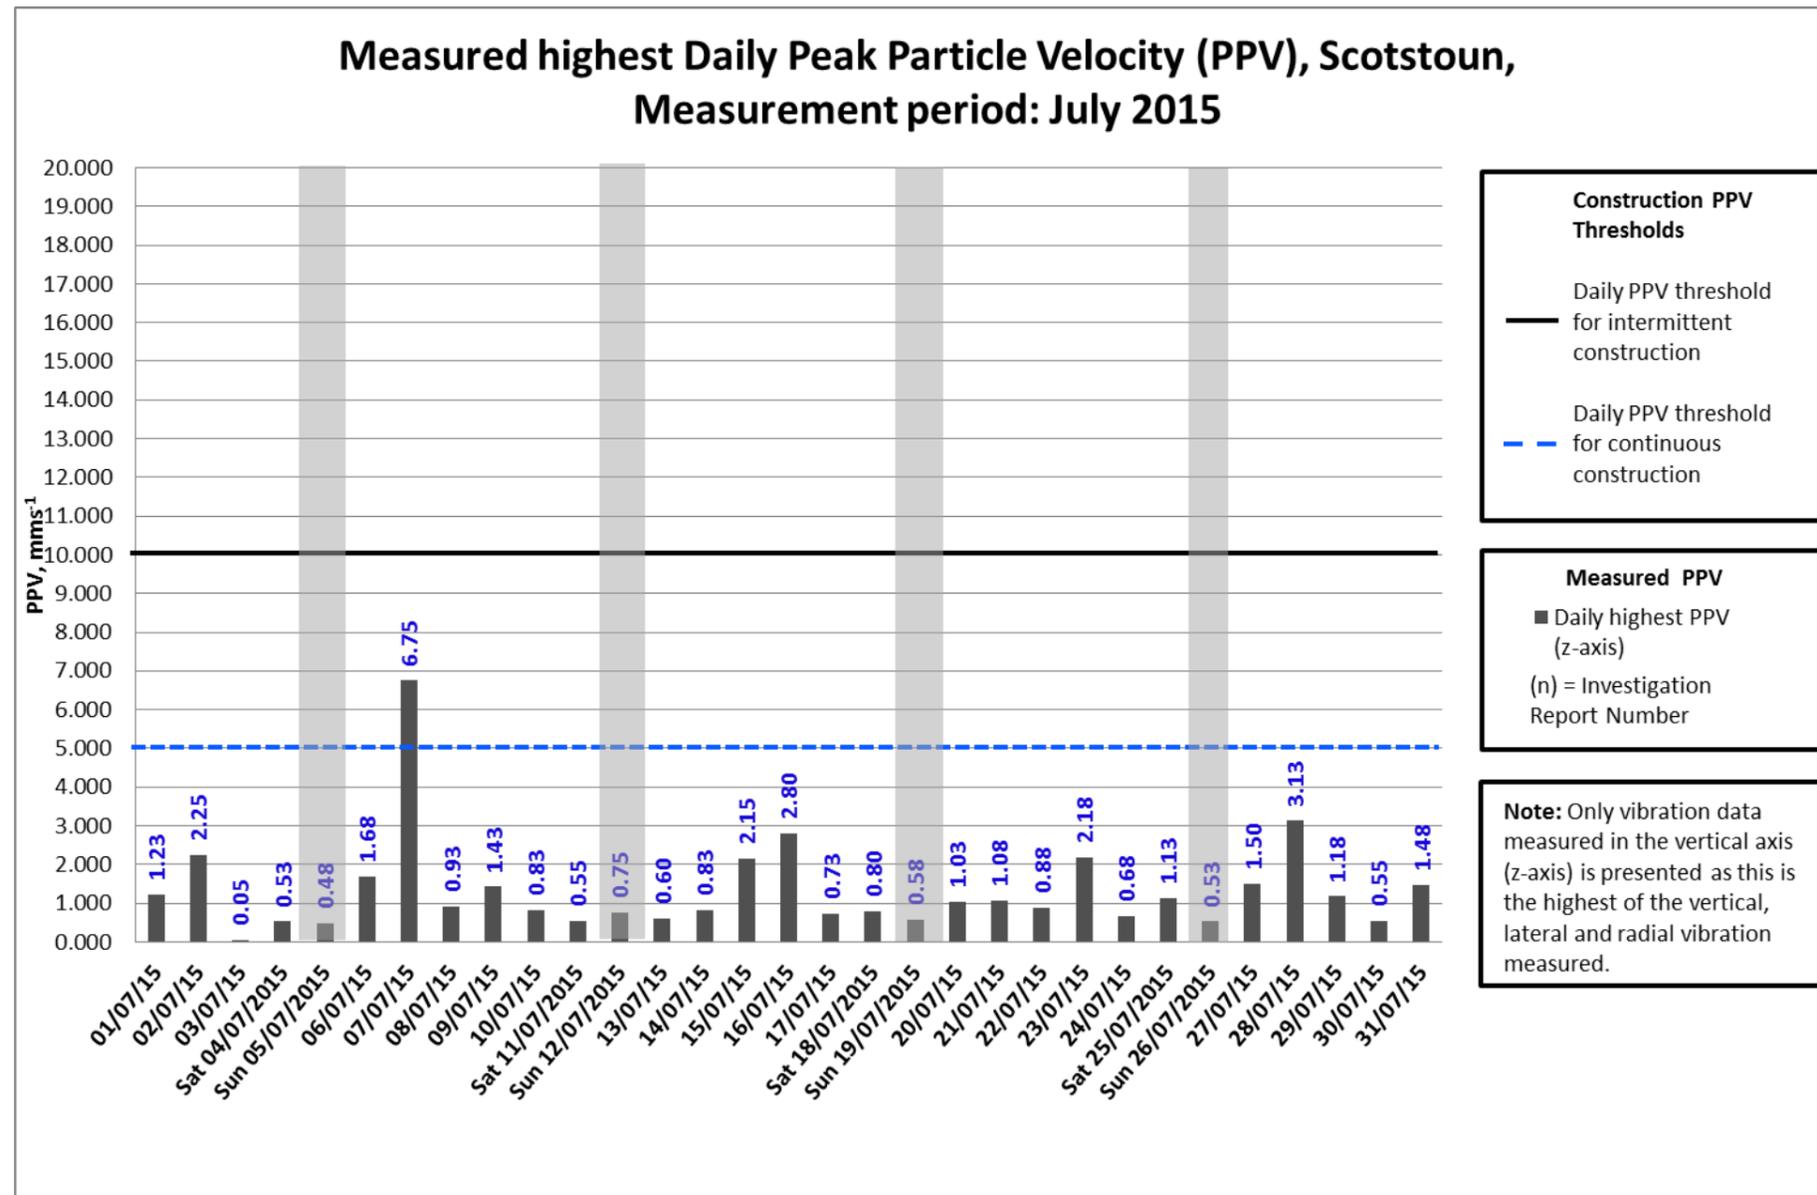
An investigation into the exceedance on the 07/07/2015 has been inconclusive in identification of the possible source of vibration. The exceedance was however intermittent in nature, which falls within the exceedance level.

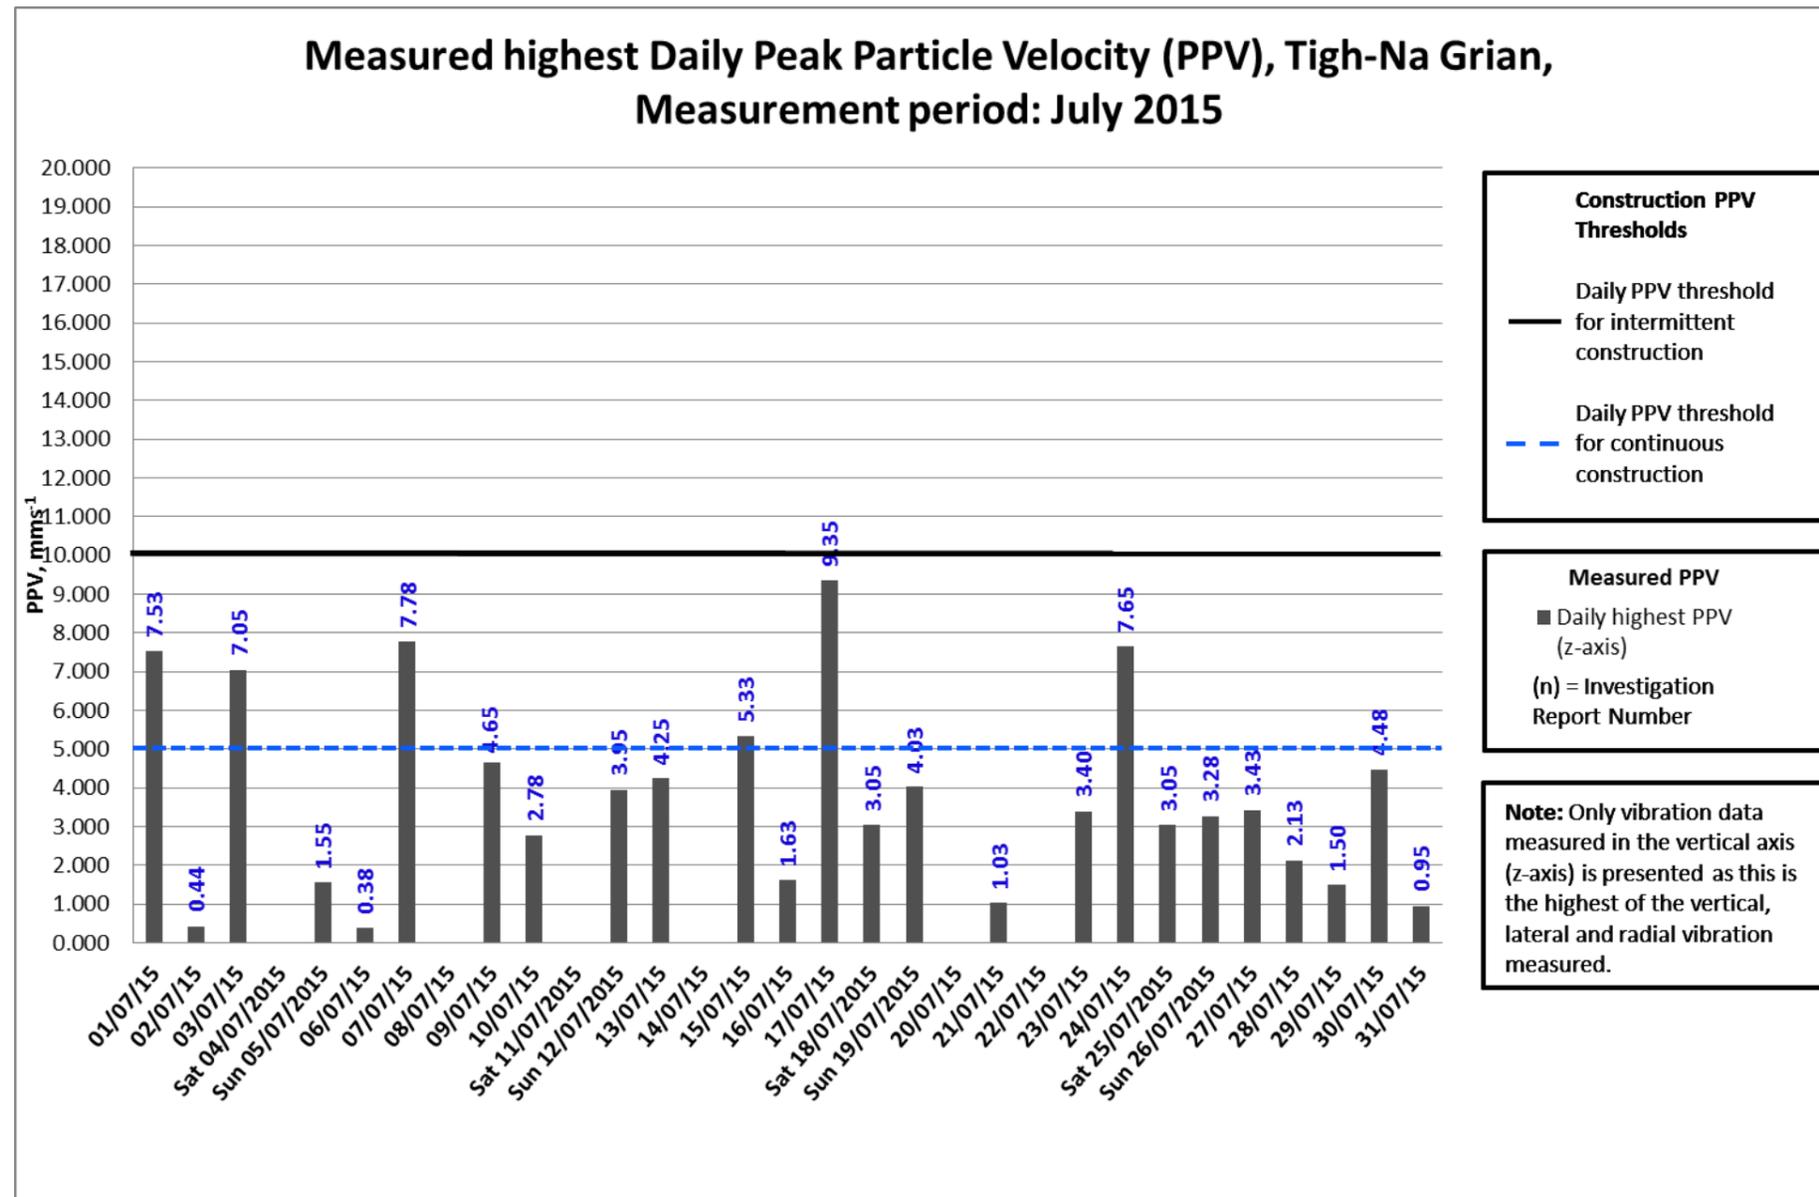
All exceedances have been investigated and have been found to be individual 'intermittent' exceedances and not constant (reference graph above from the 01/07/2015). The source of the vibration is unknown but all exceedances are within thresholds.

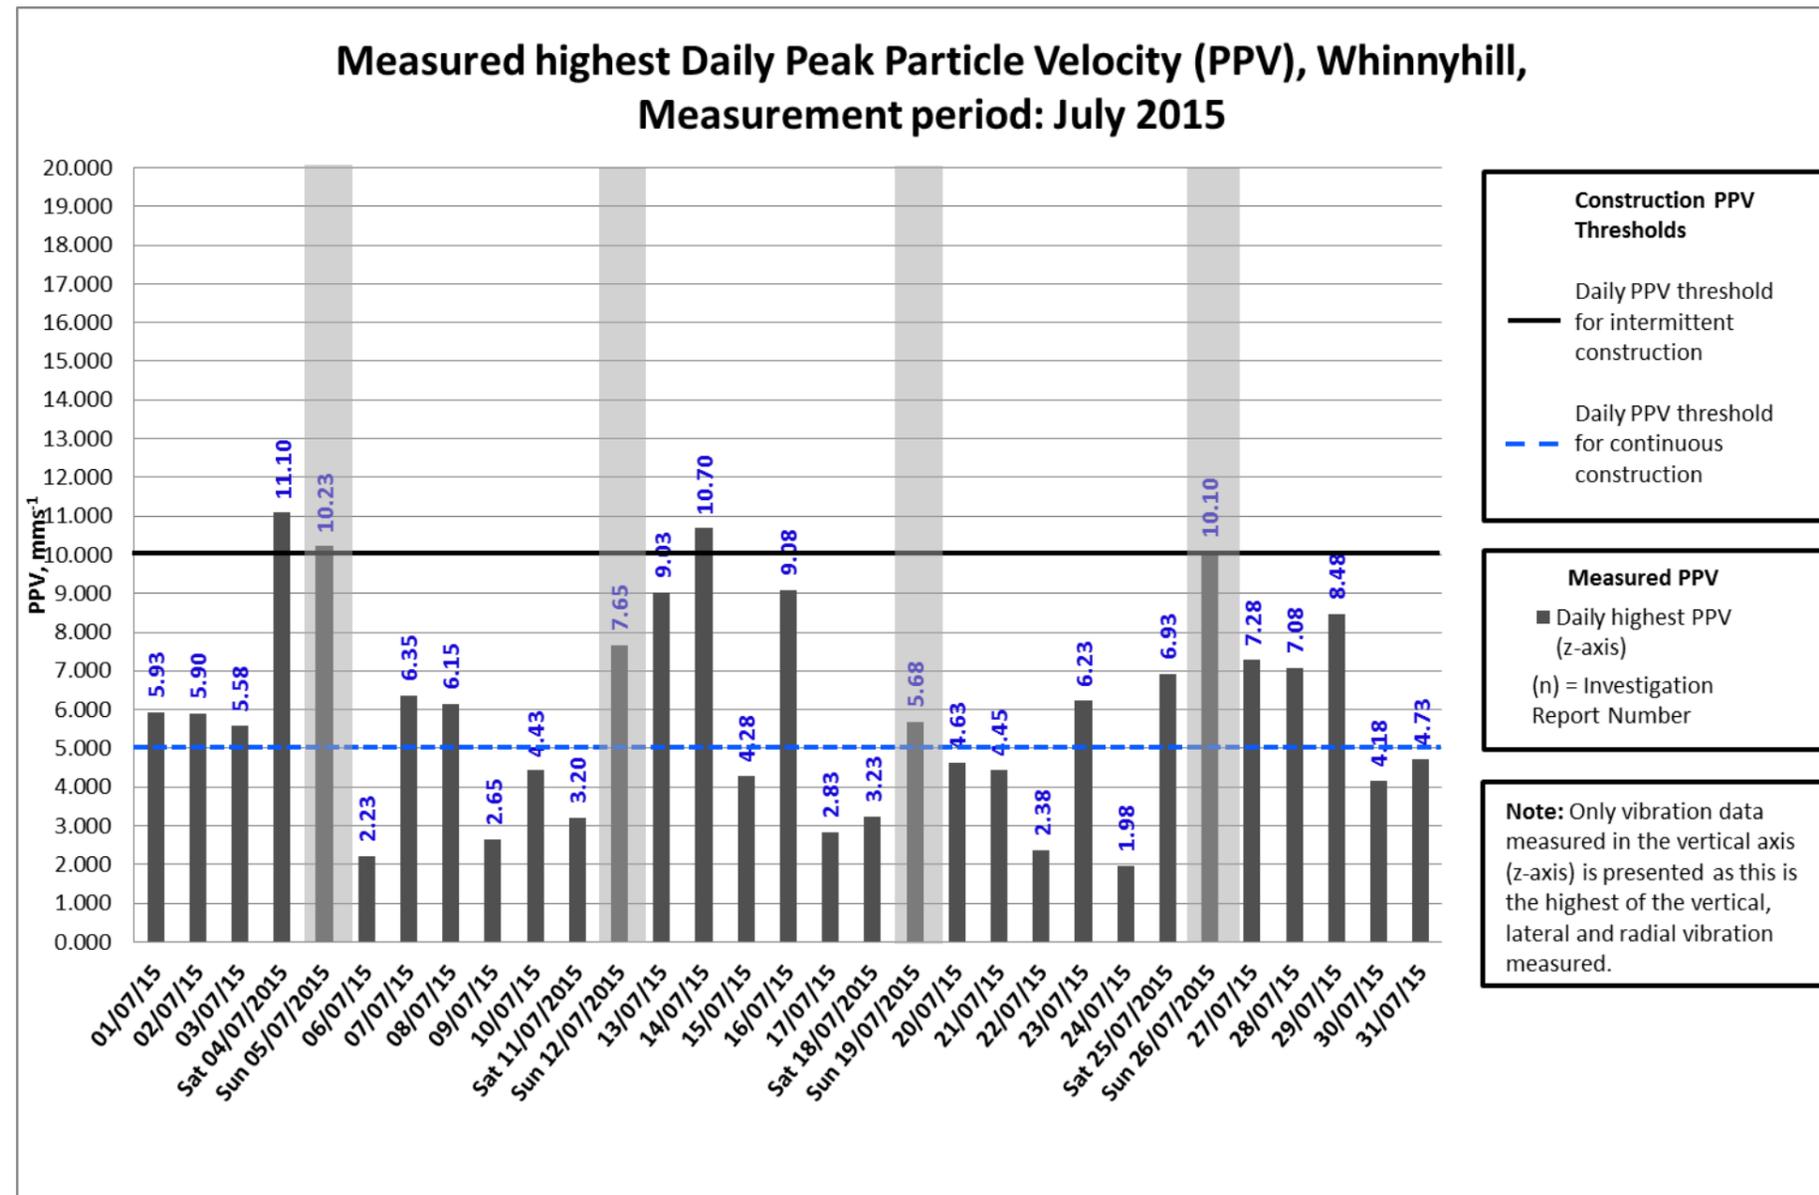
Exceedances on the 01/07/2015, 02/07/2015, 03/07/2015, 04/07/2015, 07/07/2015, 08/07/2015, 12/07/2015, 13/07/2015, 14/07/2015, 16/07/2015, 19/07/2015, 23/07/2015, 25/07/2015, 27/07/2015, 28/07/2015 and on the 29/07/2015 have been investigated and have been found to be isolated events (graph above from the 01/07/2015). The source of the vibration is unknown due to the intervening distance from the closest works (140 meters) it is highly unlikely to be construction related. Due to the sensitivity of the monitors, it is more likely the vibration was caused due to localised vibration sources near or close to the monitor.

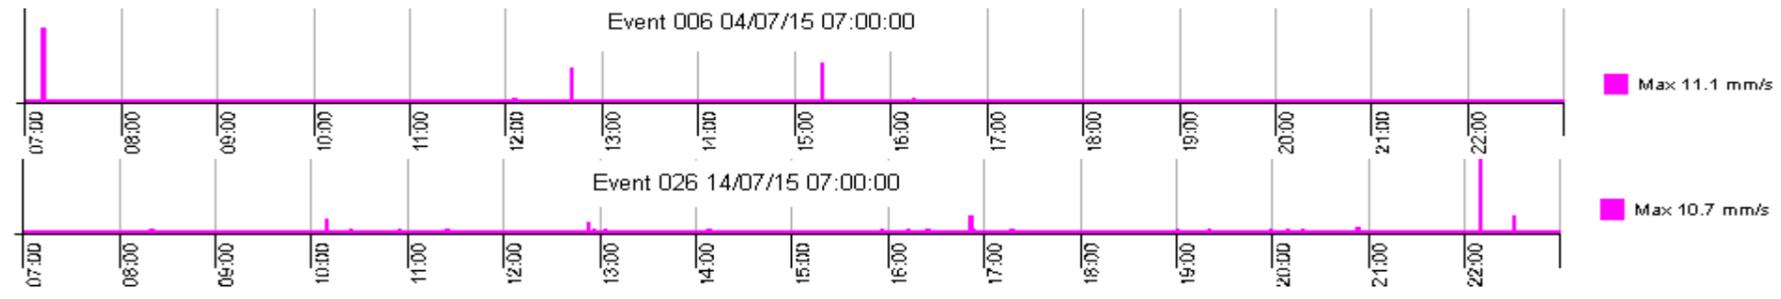
Exceedances on the 04/07/2015 and on the 14/07/2015 have been investigated and found to be out with working hours (as seen above) and highly unlikely to be related to construction.

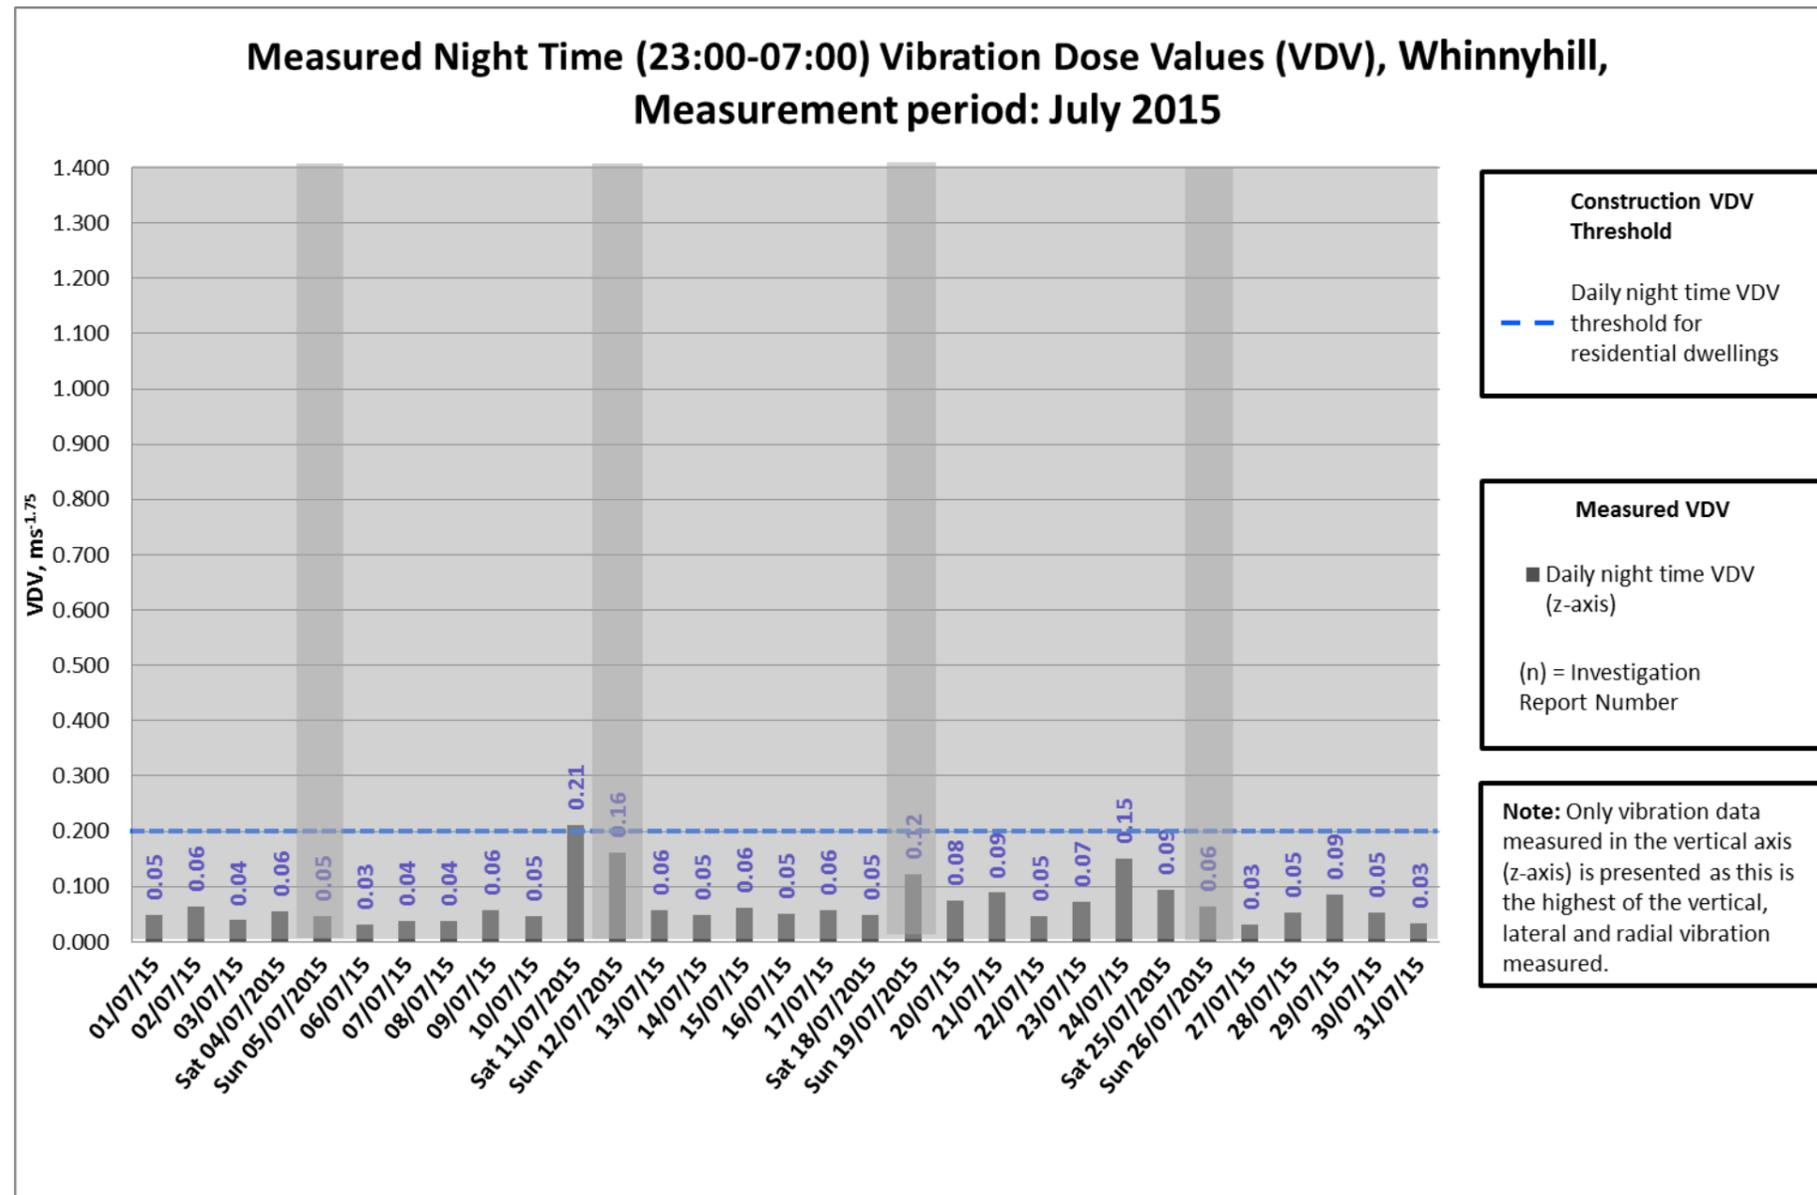
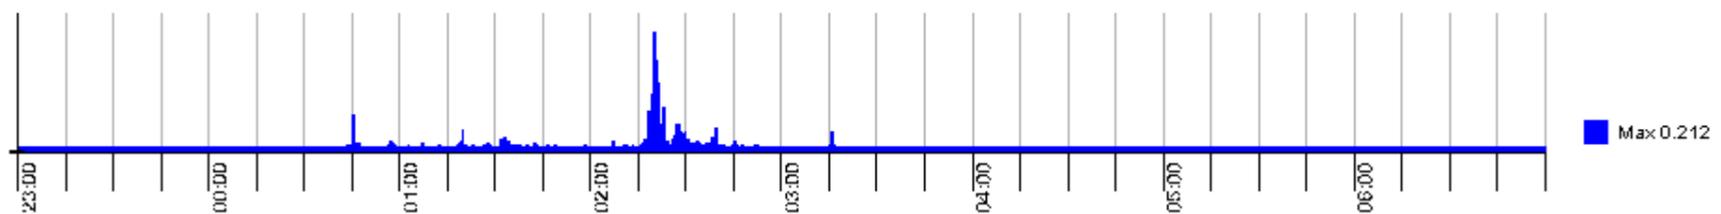
The vibration exceedance on the 11/07/2015 has been investigated. The exceedance occurred out with construction working hours.
