Project **FORTH REPLACEMENT CROSSING**

**VIBRATION MONITORING REPORT
AUGUST 2015**

Document number	Rev
REP-00246	01

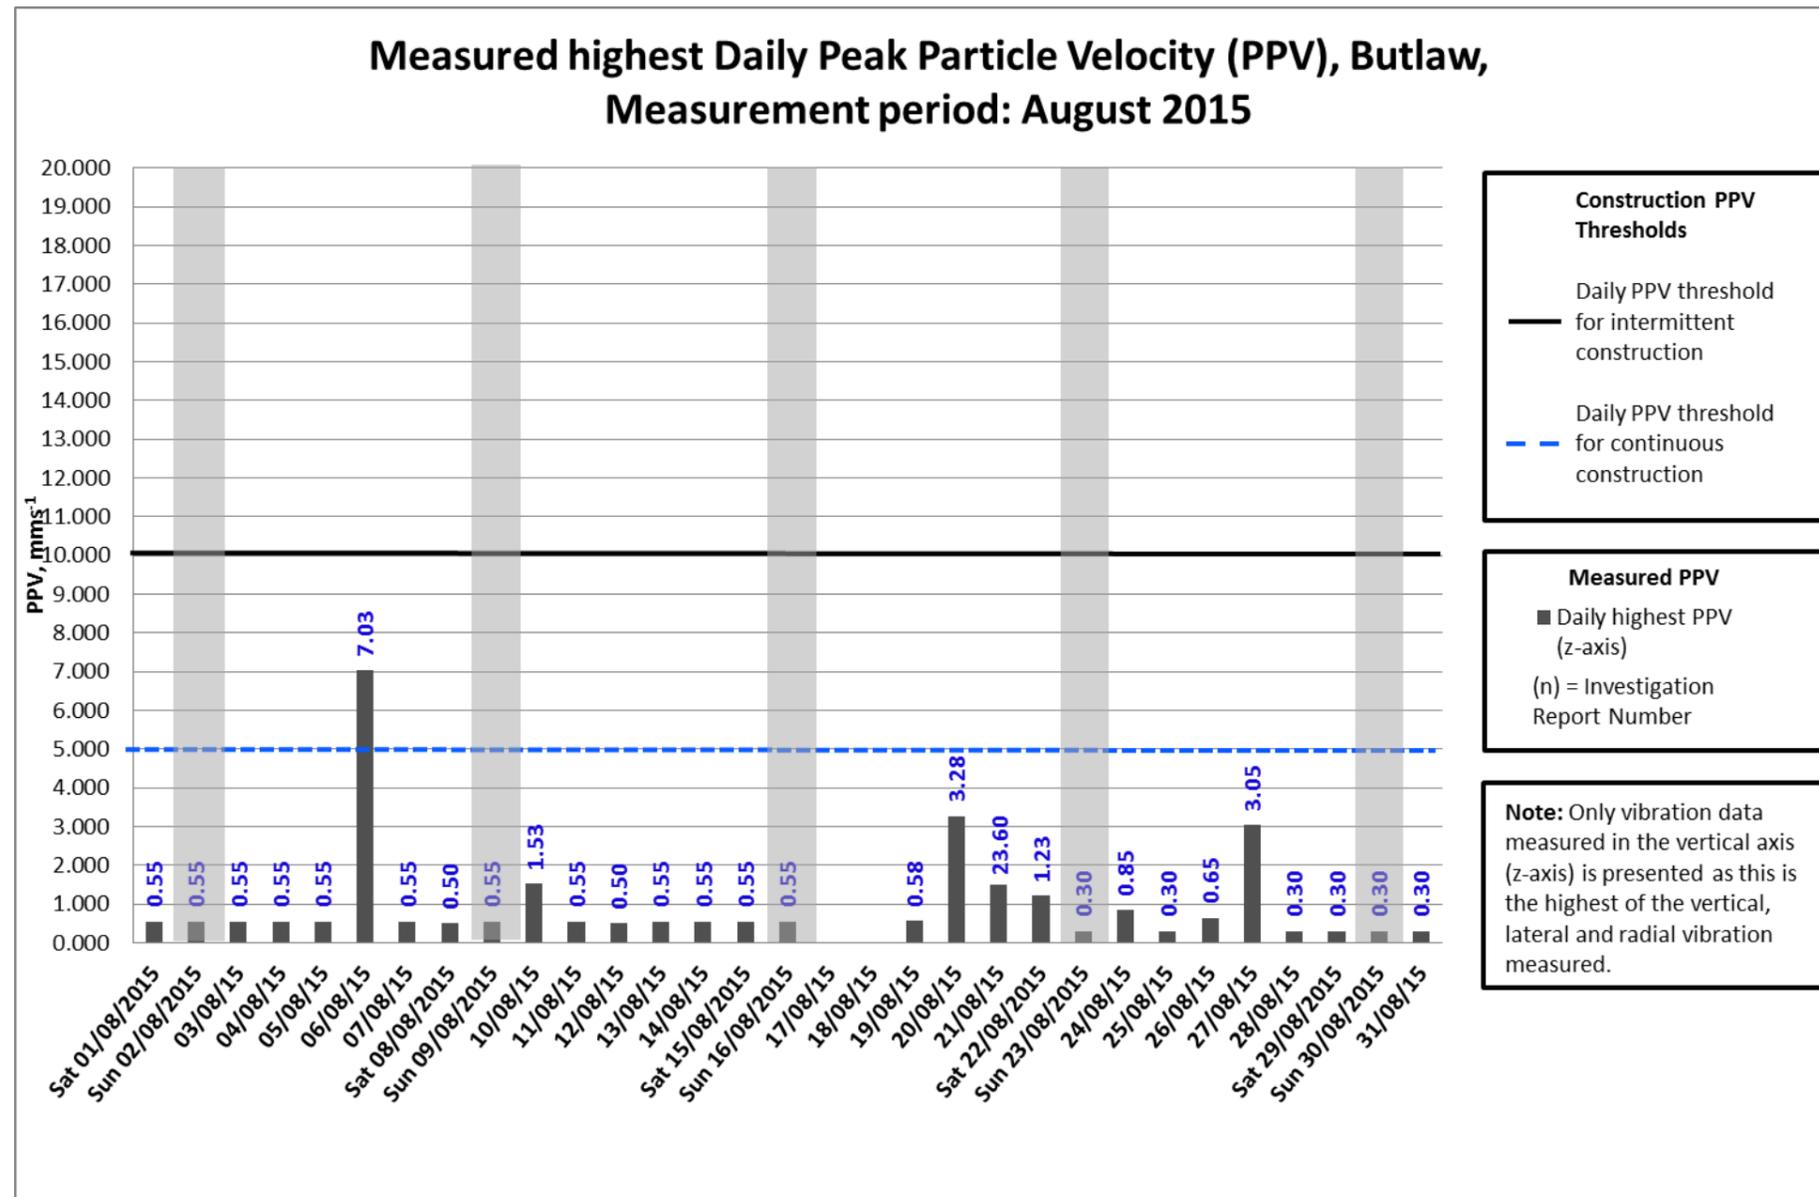
Investigations have found the exceedance on the 06/08/2015 was likely to be caused by maintenance on the noise monitor near by the vibration monitor and is unlikely to be caused by construction related activities.

Missing data on the 17/08/2015 to the 18/08/2015 was due to the vibration monitor getting its yearly calibration.

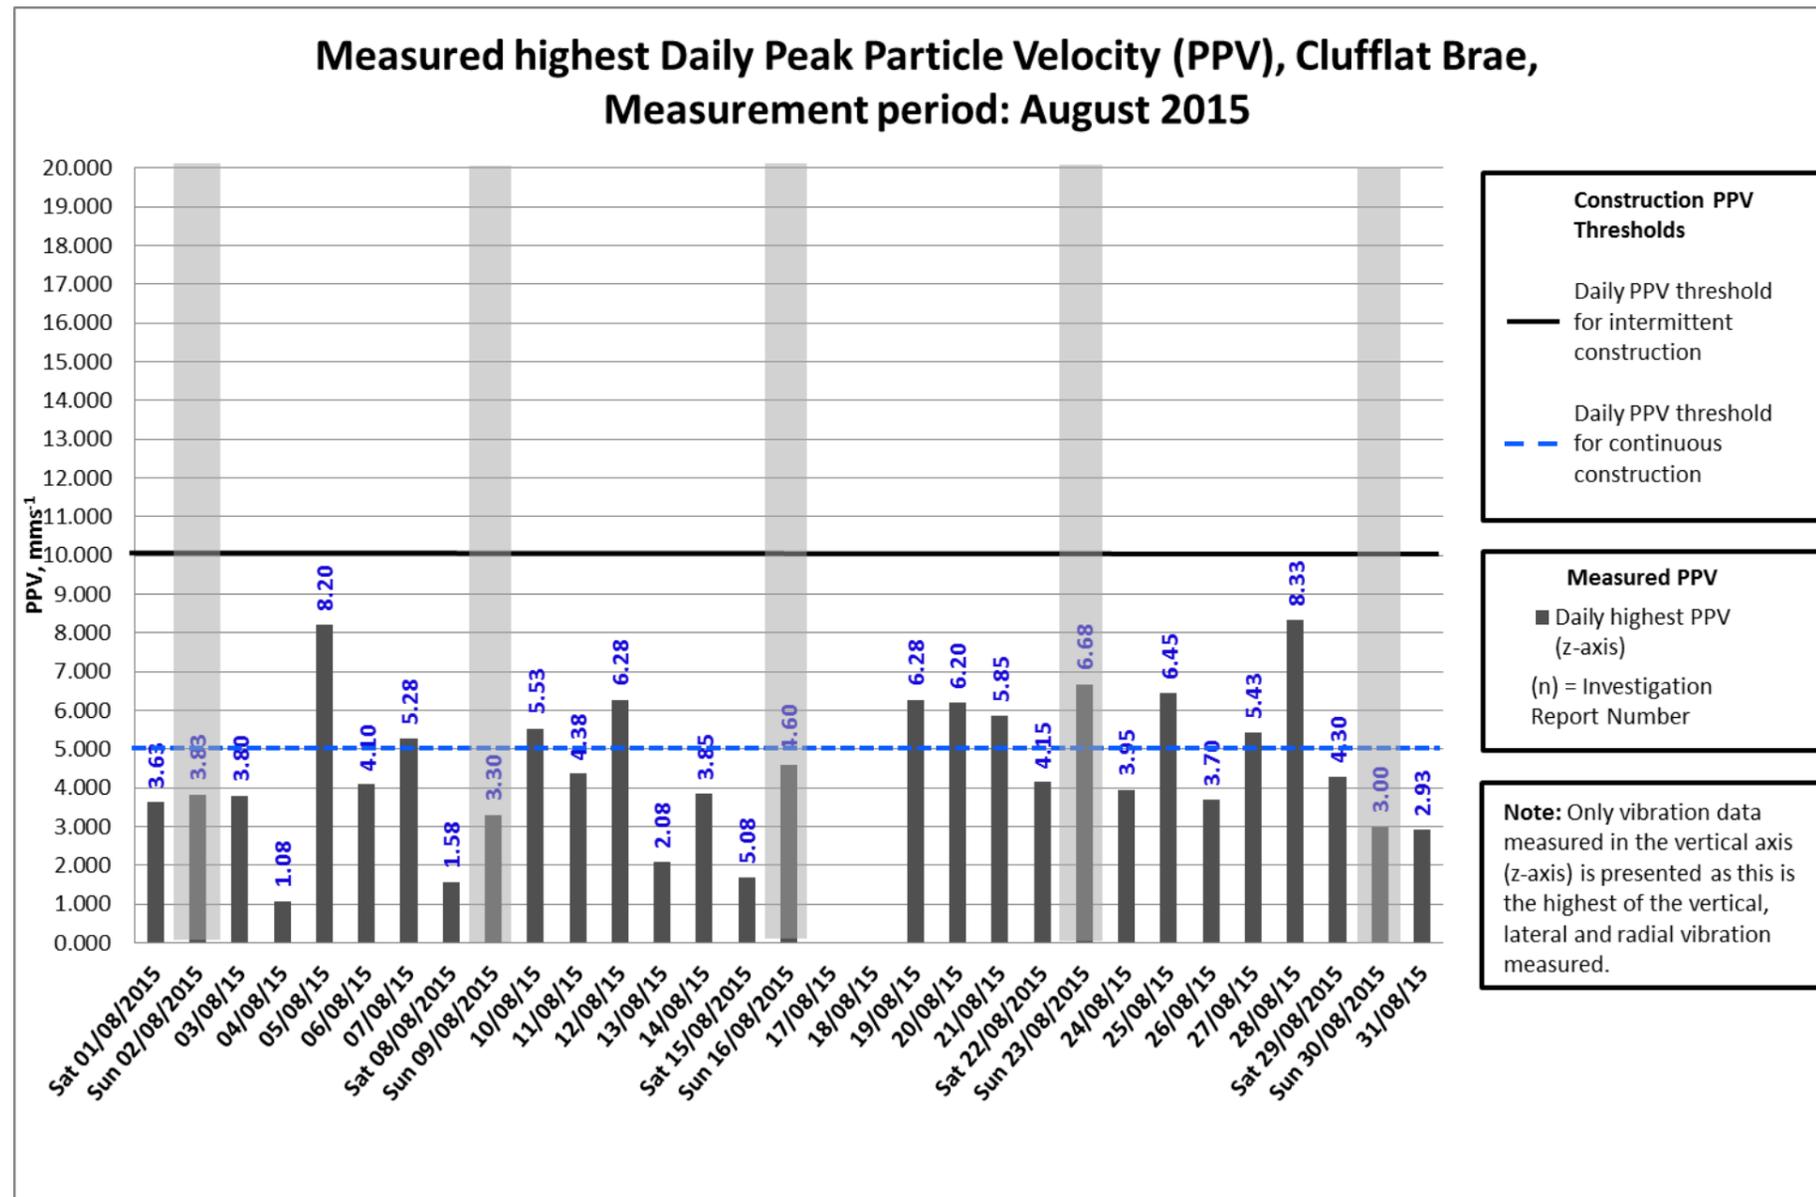
Exceedances on the 05/08/2015, 07/08/2015, 10/08/2015, 12/08/2015, 19/08/2015, 20/08/2015, 21/08/2015, 23/08/2015, 25/08/2015, 27/08/2015 and 28/08/2015 have been investigated and found to be one off isolated events (graph above from the 07/08/2015).

Missing data on the 17/08/2015 to the 18/08/2015 was due to the vibration monitor getting its yearly calibration.

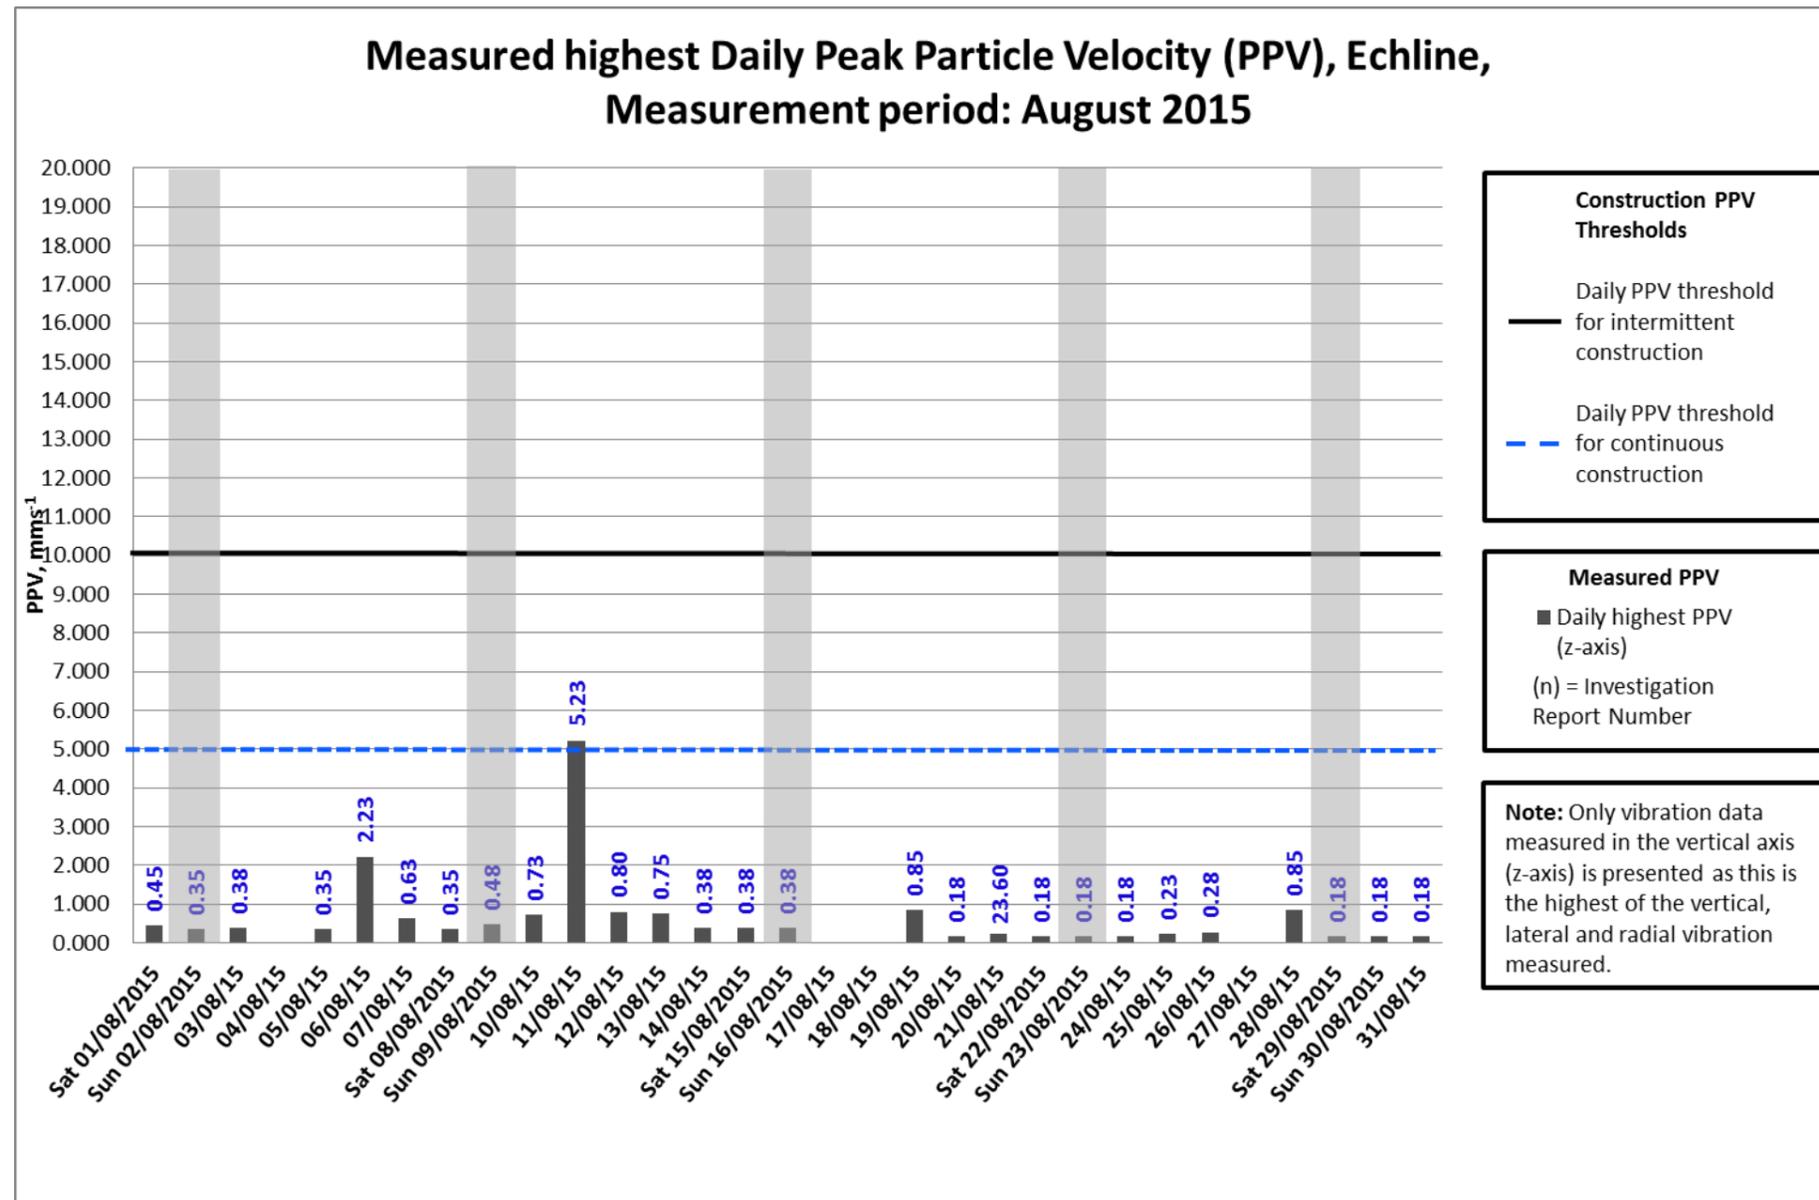
Exceedance on the 11/08/2015 has been investigated and found to be an isolated event which is unlikely to be related to construction activity's (reference graph above from that day).

Missing data on the 17/08/2015 to the 18/08/2015 was due to the vibration monitor getting its yearly calibration.

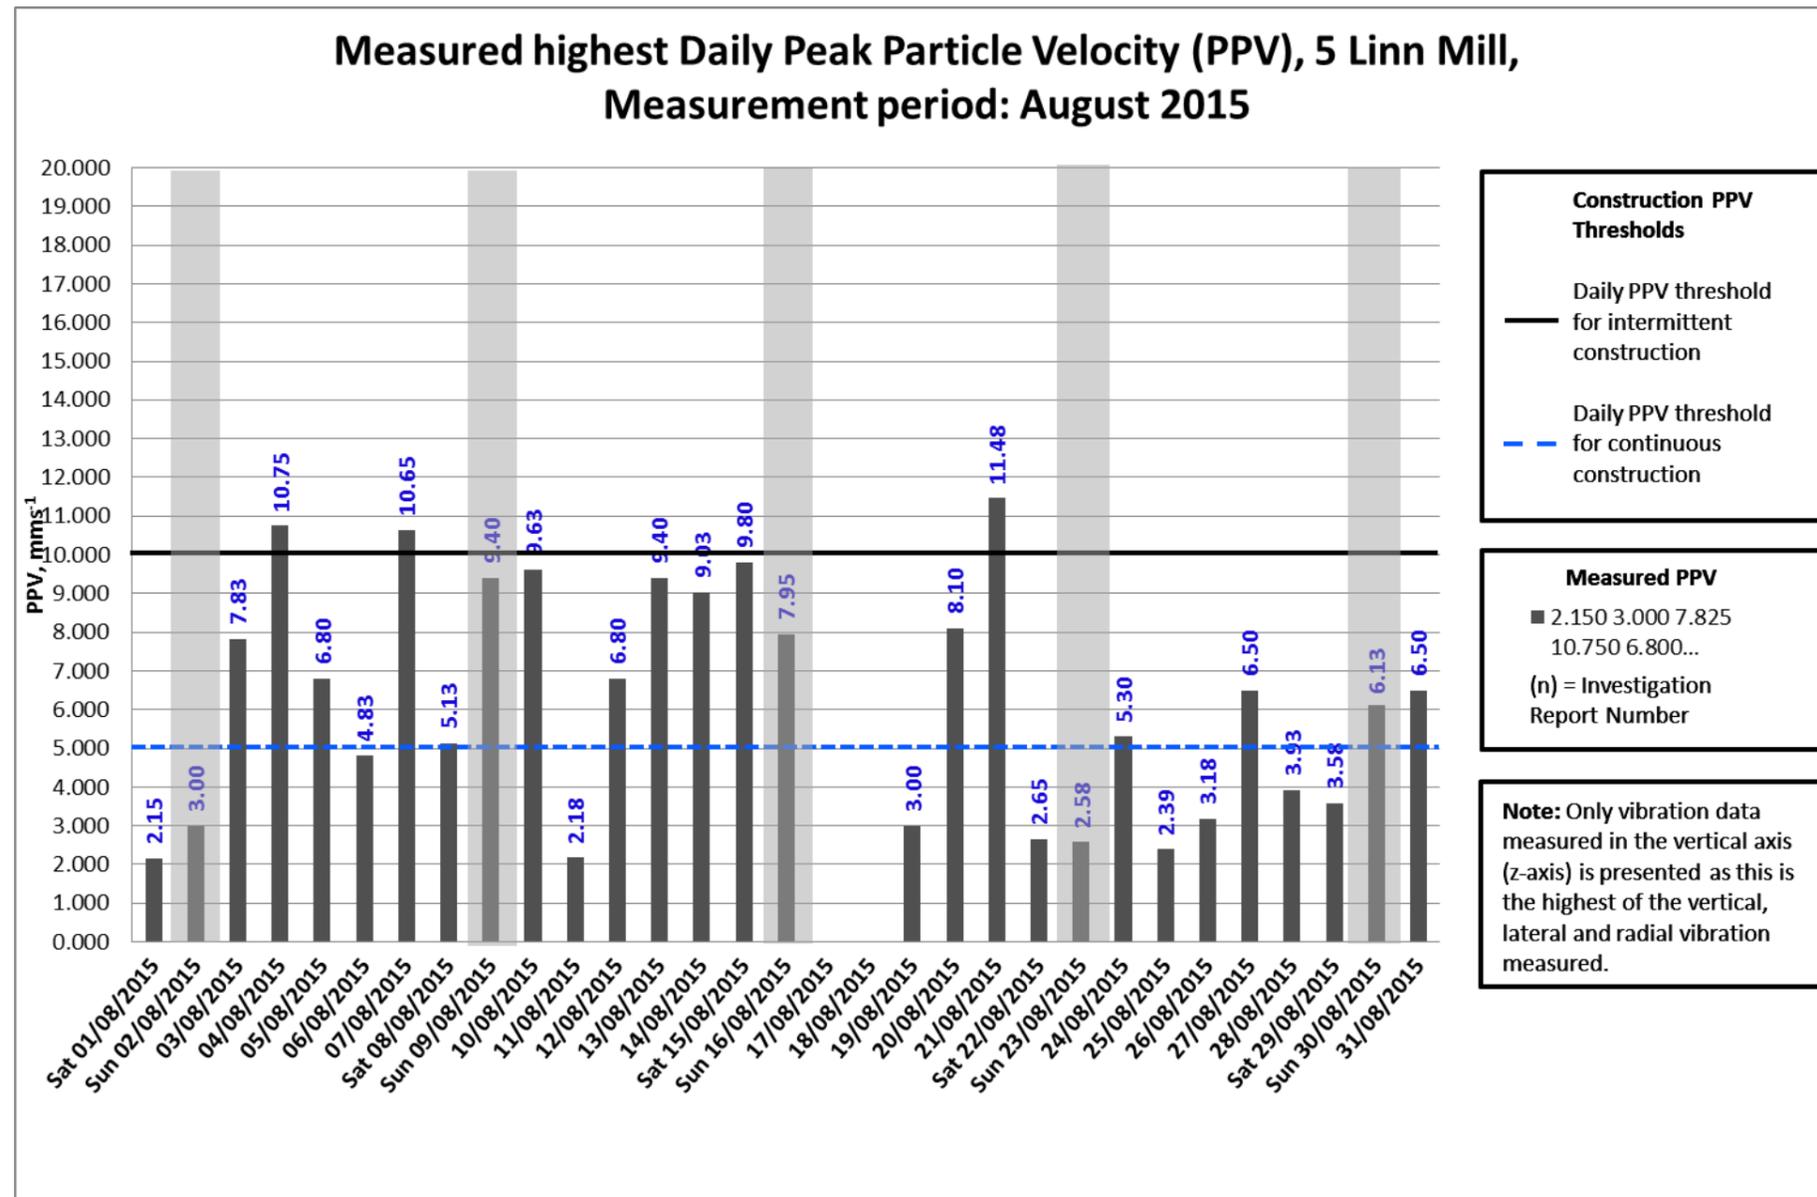
Exceedances on the 03/08/2015, 08/08/2015, 09/08/2015, 10/08/2015, 13/08/2015, 14/08/2015, 15/08/2015, 16/08/2015, 20/08/2015, 21/08/2015, 24/08/2015, 27/08/2015, 30/08/2015 and 31/08/2015 have been investigated and found to be one off isolated events that are likely to be caused by movement near by the monitor rather than construction related activities.

Exceedance on the 04/08/2015 has been investigated and found to be out of construction working hours and is more likely to be caused by movement near by the monitor.

Exceedance on the 07/08/2015 has been investigated and no similar exceedances were observed on the time traces of other vibration monitors in the nearby surrounding area. Investigations also revealed no construction related exceedance at that time on the noise monitor at Linn Mill, situated 45 meters closer to the construction site, which could have helped to identify the source of the plant that may have generated the high vibration levels recorded.

Exceedance on the 21/08/2015 has been investigated and found to be an isolated event with no similar exceedances at that time on the surrounding vibration monitors. Investigations also found no construction related exceedances at that time on the noise monitor at Linn Mill which is 45 meters closer to the construction site

Missing data on the 17/08/2015 to the 18/08/2015 was due to the vibration monitor getting its yearly calibration.

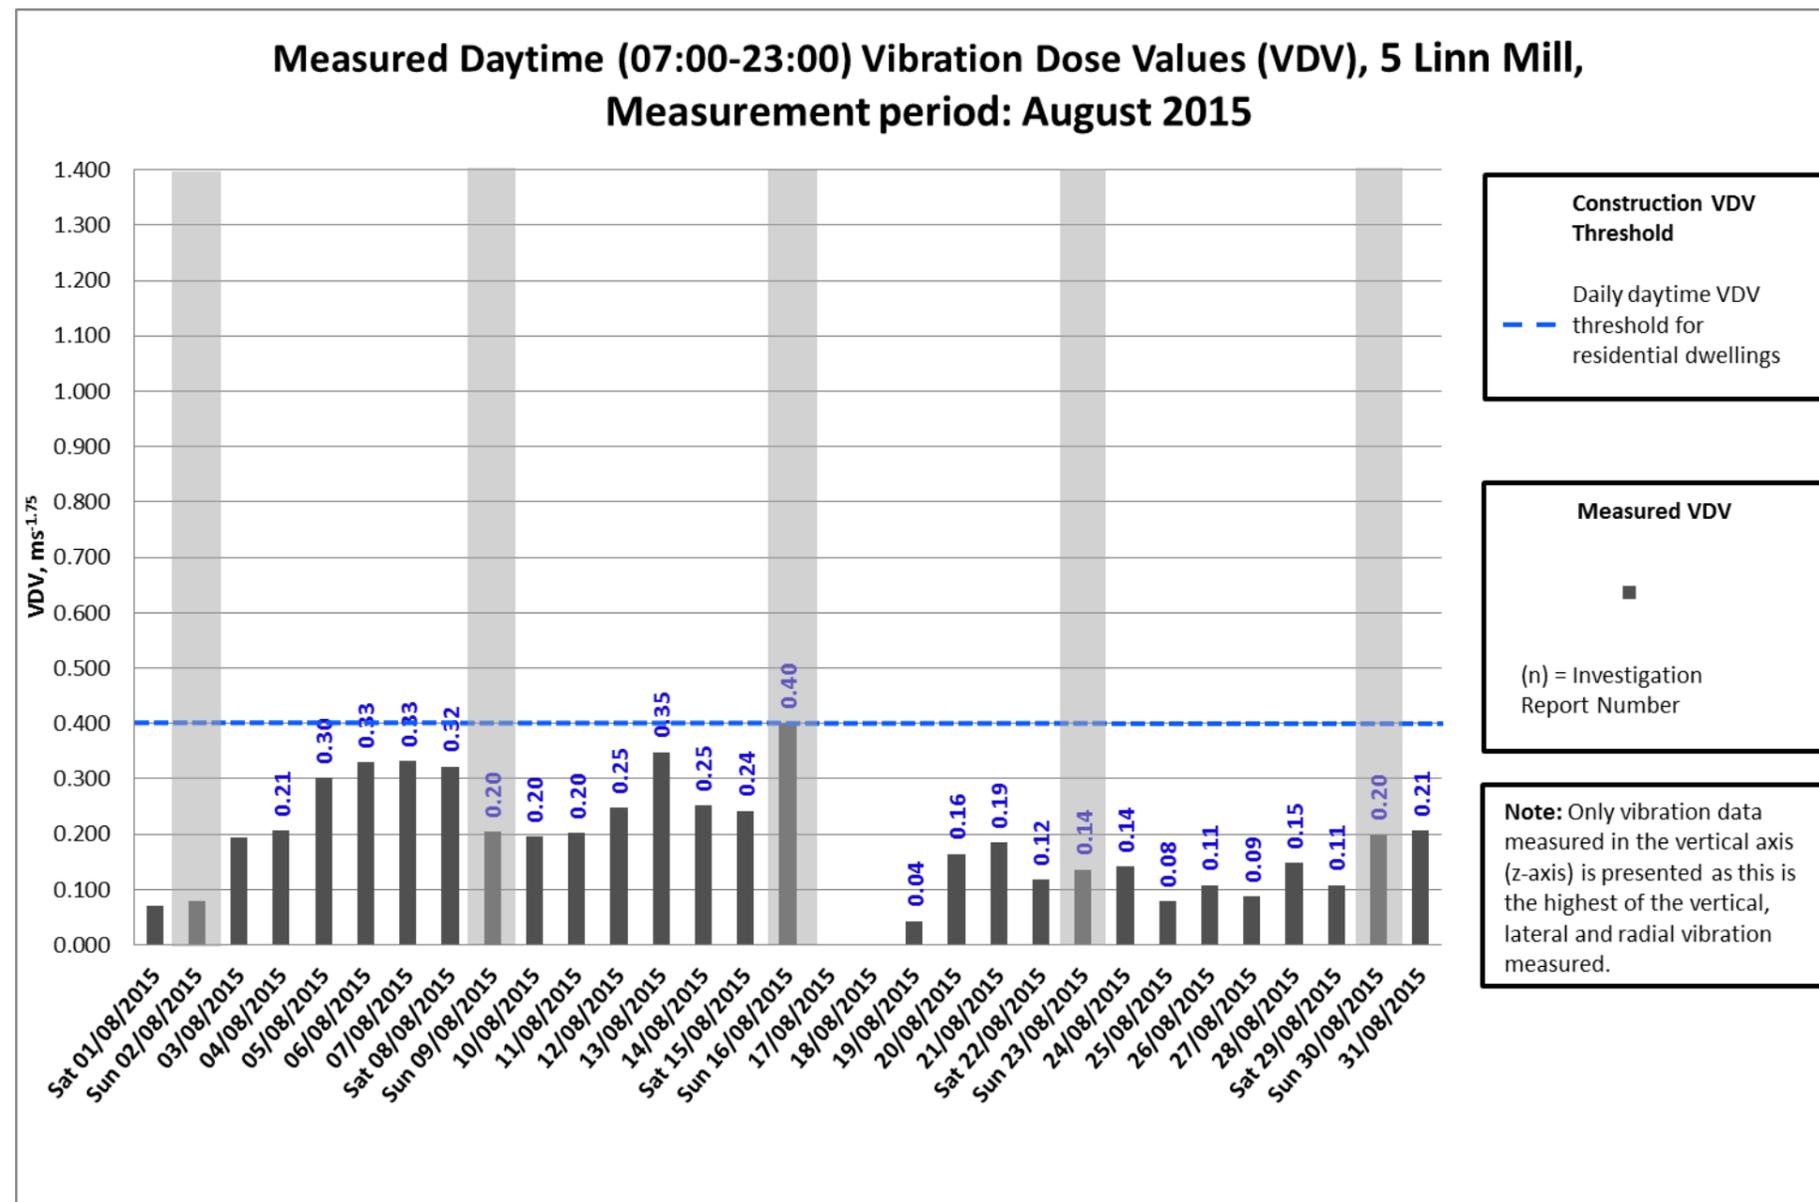
Exceedance on the 16/08/2015 found on the graph above is out with construction working hours and is unlikely to be construction related and more likely to be movement near by the vibration monitor.

Missing data on the 17/08/2015 to the 18/08/2015 was due to the vibration monitor getting its yearly calibration.

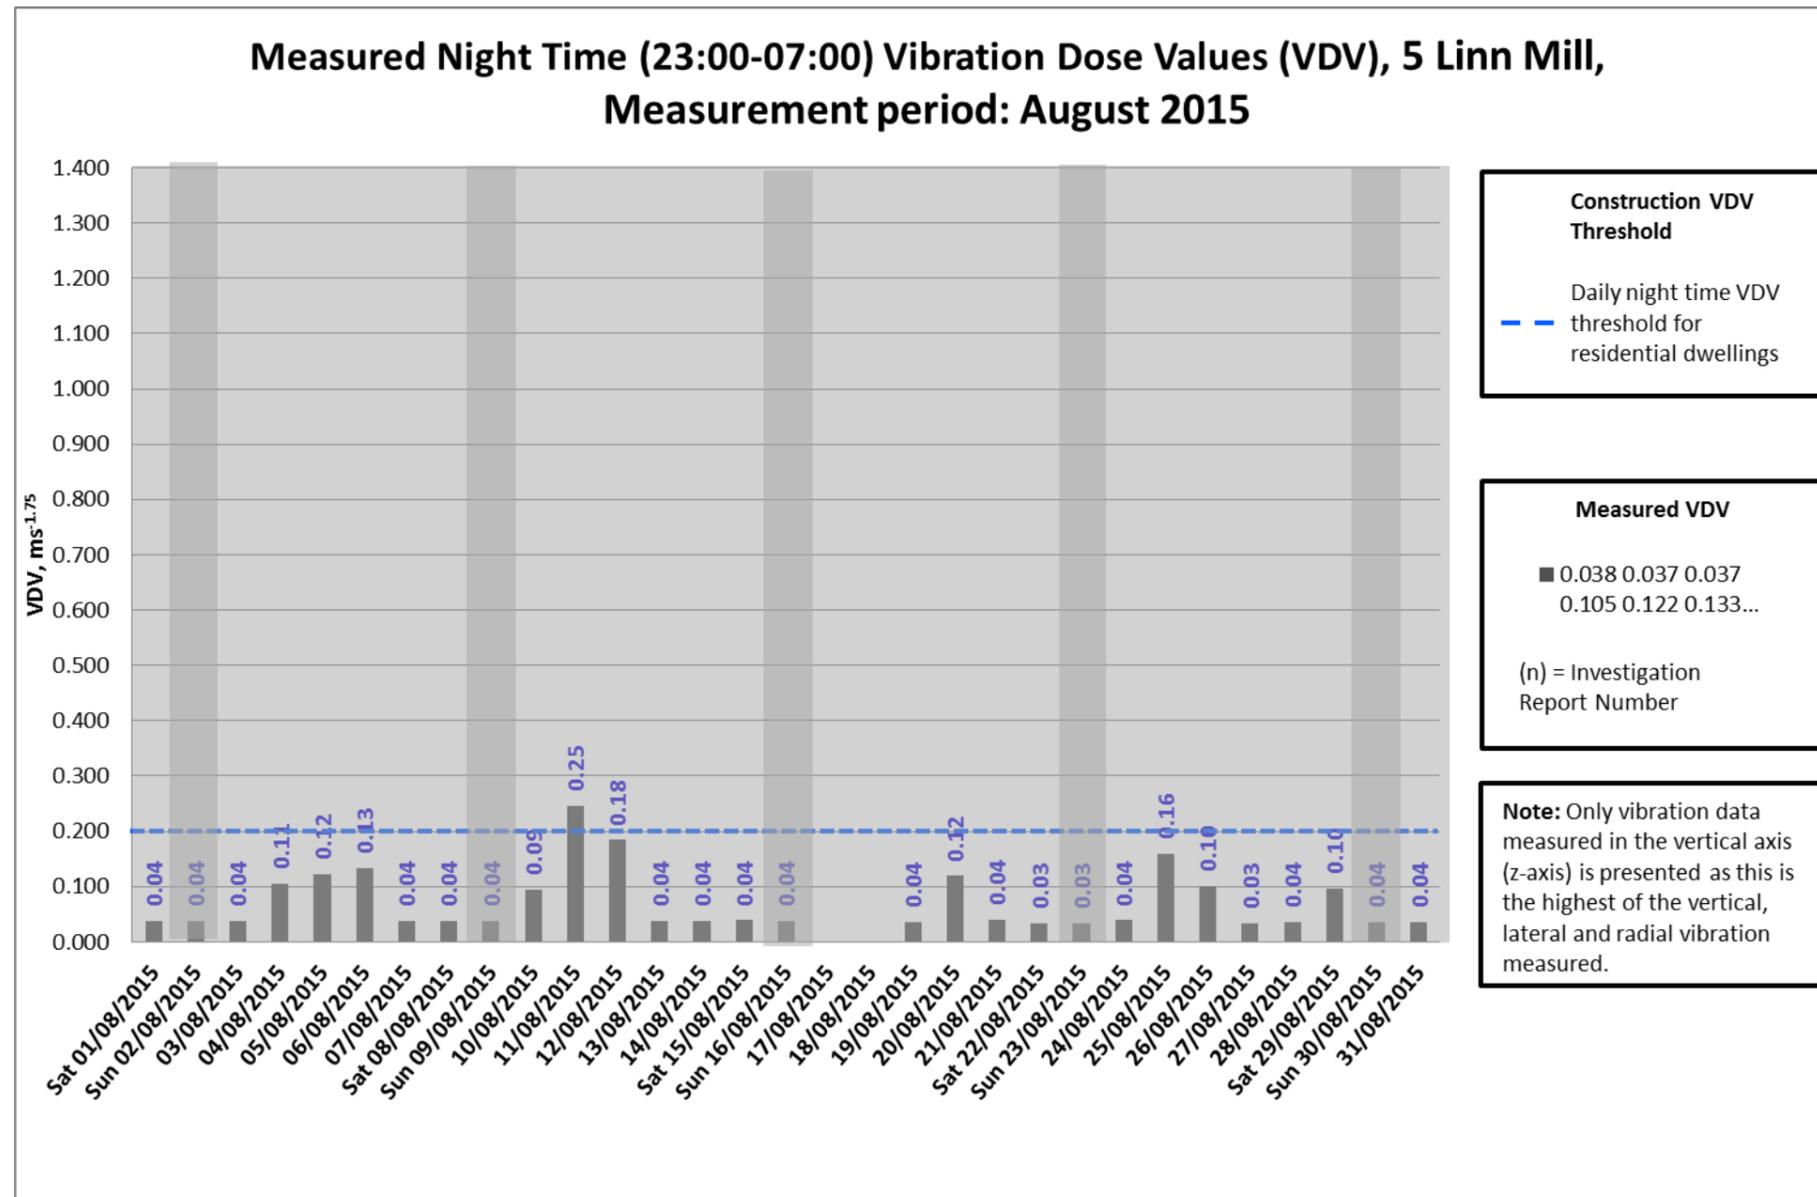
Exceedance on the 11/08/2015 has been investigated and found to be out of construction working hours and is more likely to be caused by movement near by the monitor (graph above). Missing data on the 17/08/2015 to the 18/08/2015 was due to the vibration monitor getting its yearly calibration.

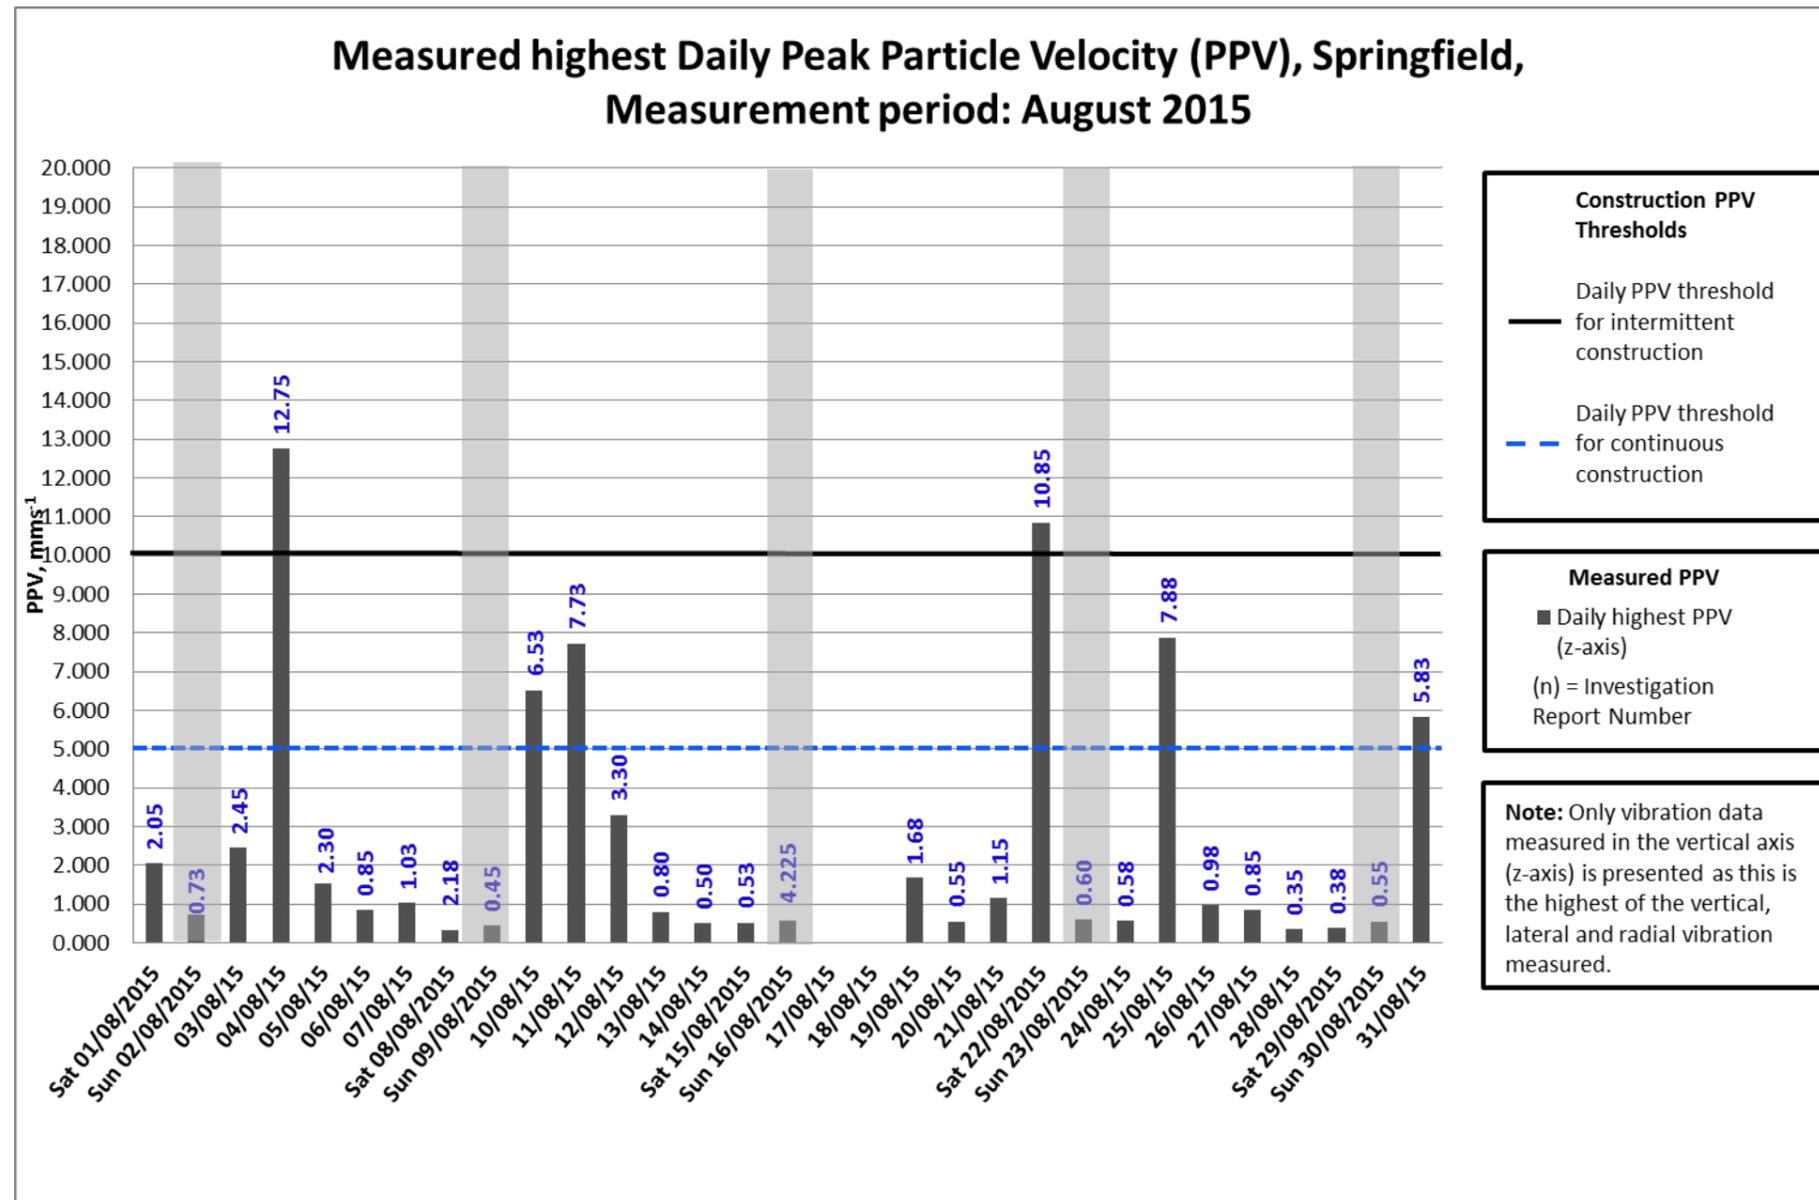
Exceedances on the 10/08/2015, 11/08/2015, 25/08/2015 and 31/08/2015 have been investigated and found to be individual isolated events which are unlikely to be construction related. Due to the location of the monitor it is likely to be movement nearby the monitor due to the location being in a residents garden (as seen from the graph above from 10/08/2015).

Exceedance on the 04/08/2015 has been investigated and found to be out of construction working hours and highly unlikely to be caused by construction related activities.

Exceedance on the 22/09/2015 has been investigated and the exceedance is likely to be caused by movement nearby the vibration monitor as residents were heard on the noise monitor at that time.

Missing data on the 17/08/2015 to the 18/08/2015 was due to the vibration monitor getting its yearly calibration.

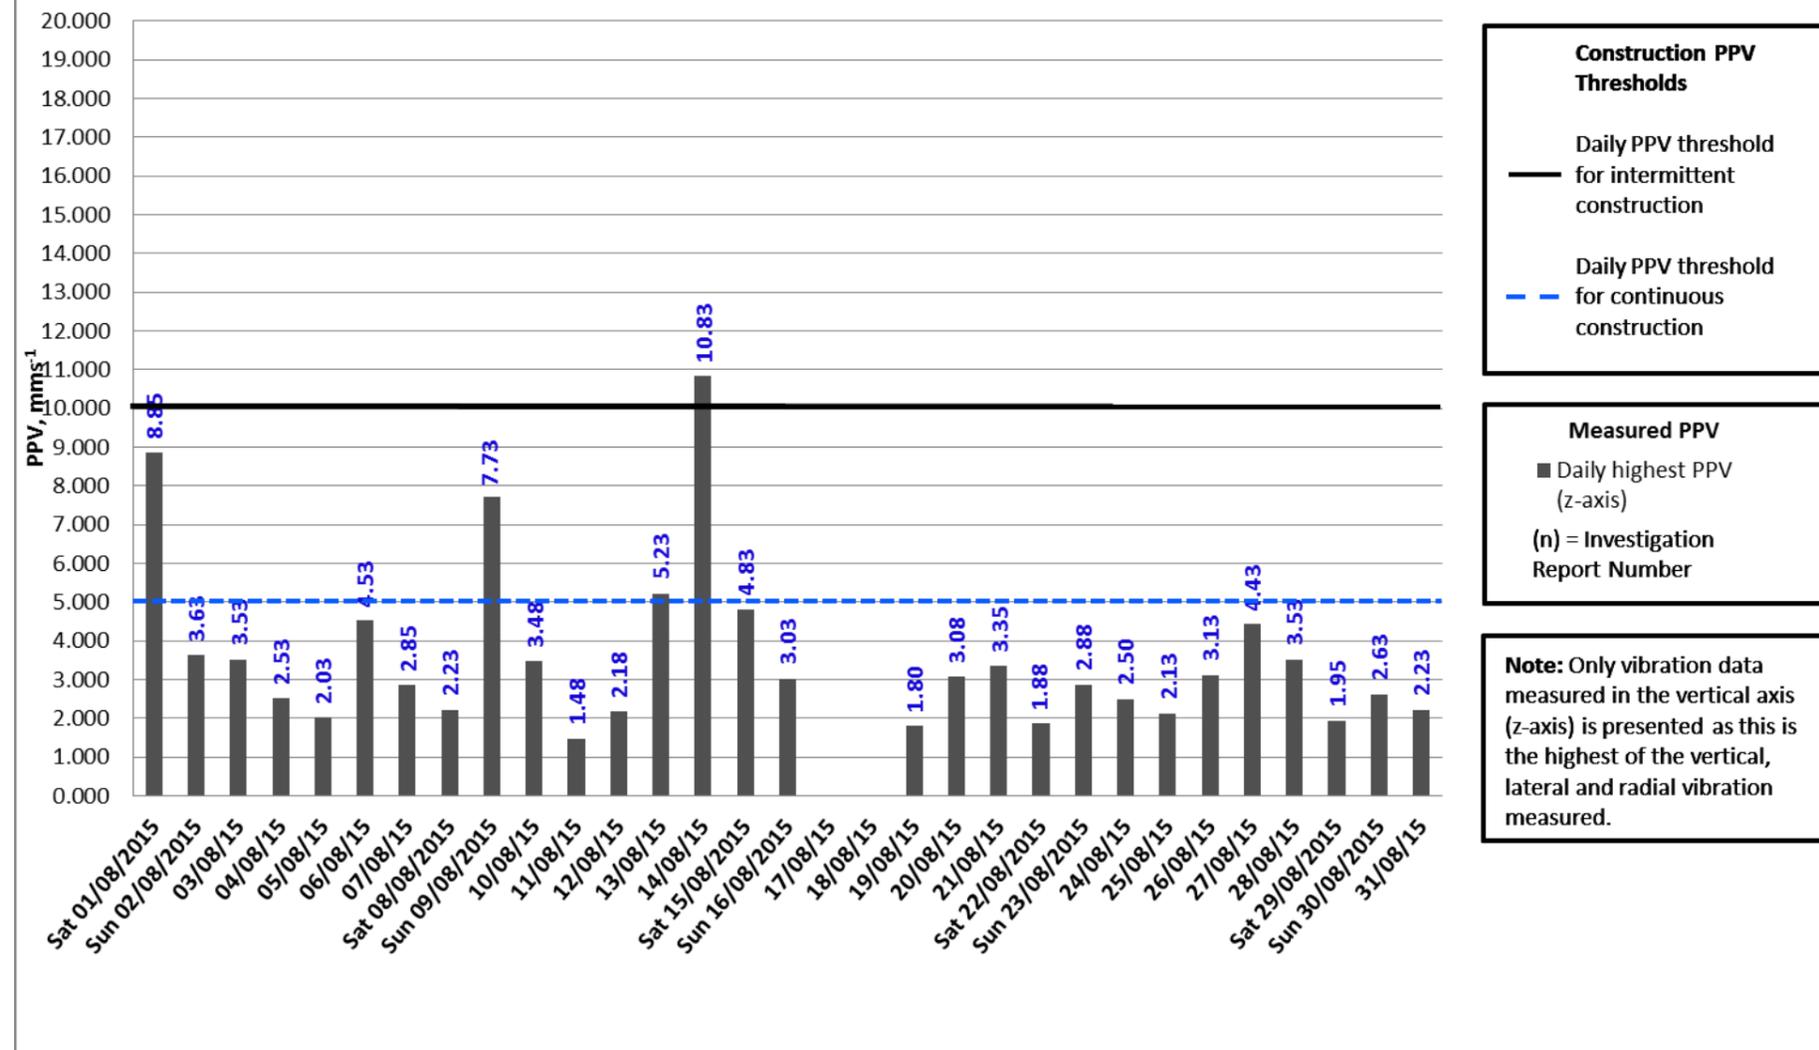
Measured highest Daily Peak Particle Velocity (PPV), Tigh-Na Grian, Measurement period: August 2015

Exceedances on the 01/08/2015, 09/08/2015 and on the 13/08/2015 have been investigated (graph above from the 01/08/2015) and all have been found to be isolated events unlikely to be related to construction due to no machinery that can create high vibration within 400 metres of the vibration monitor.

Exceedance on the 14/08/2015 has been investigated and found to be an isolated event which is unlikely to be construction related due to the high level of the exceedance and due to the distance between the closest works and the monitor (250 meters away).

Missing data on the 17/08/2015 to the 18/08/2015 was due to the vibration monitor getting its yearly calibration.

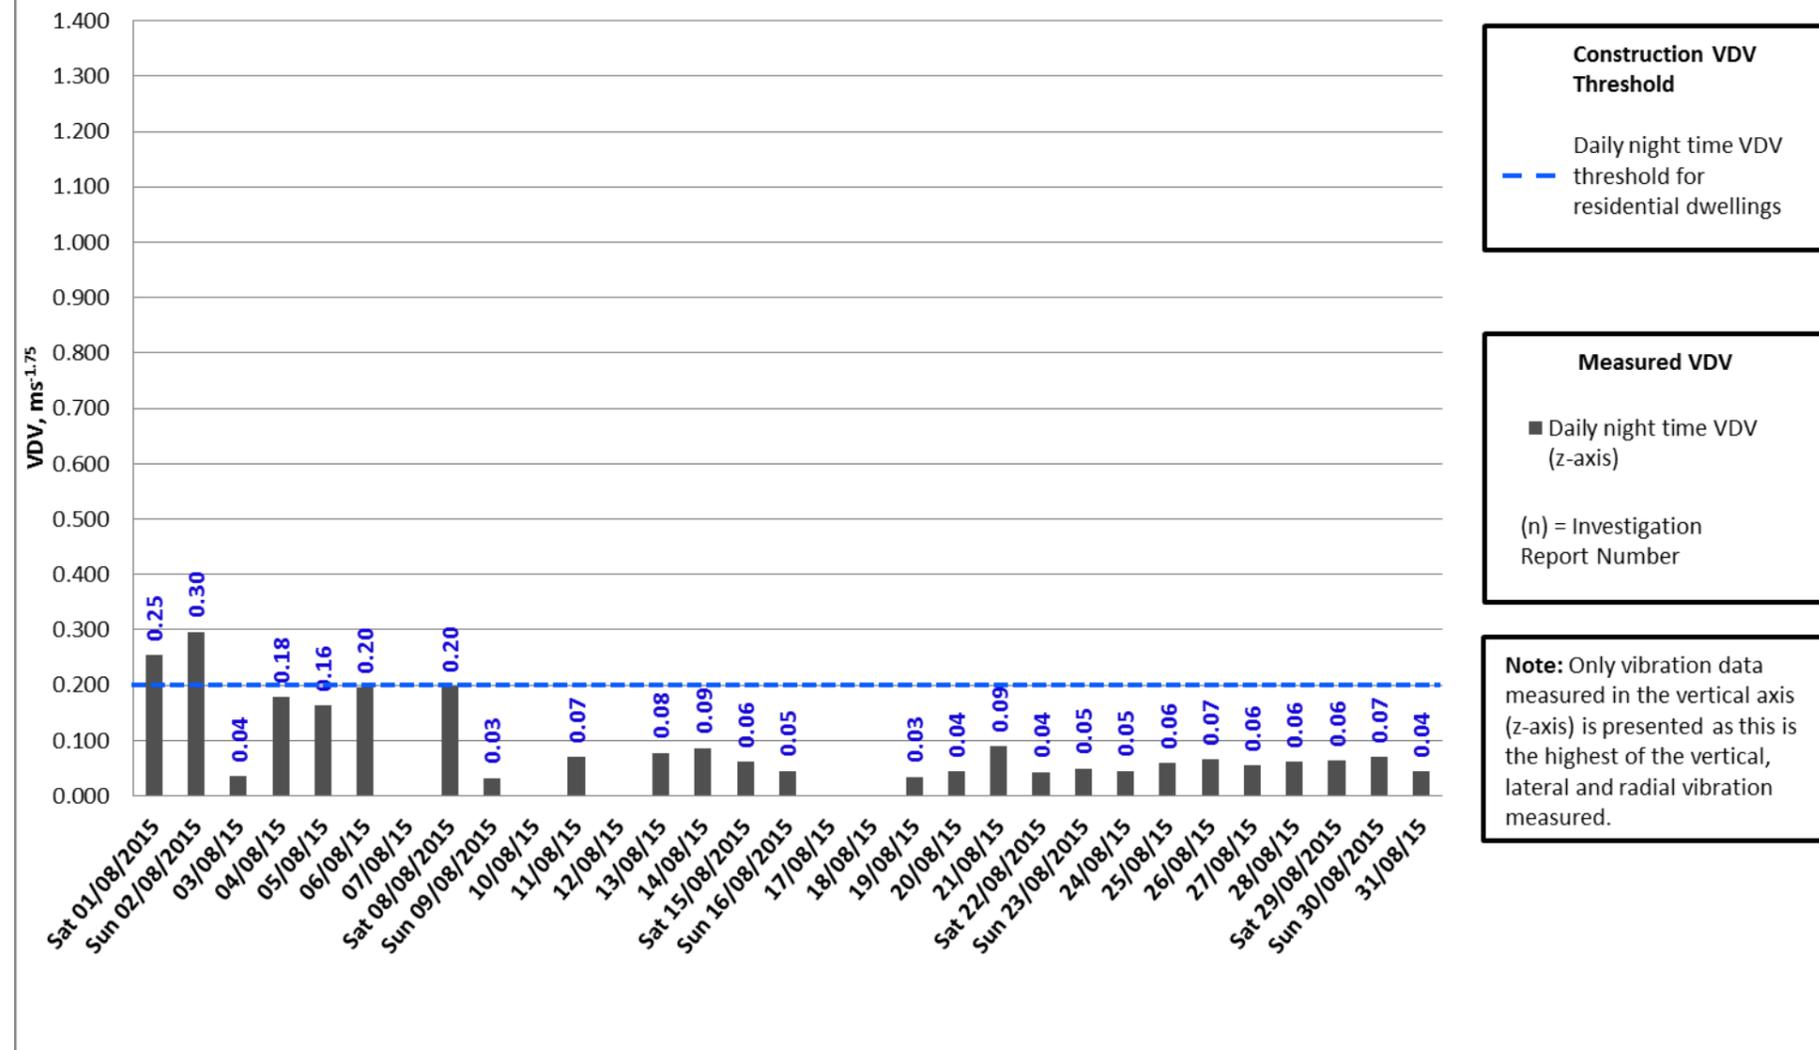
Measured Night Time (23:00-07:00) Vibration Dose Values (VDV), Tigh-Na Grian, Measurement period: August 2015

Exceedances on the 01/08/2015 and on the 02/08/2015 have been investigated and found to be the continued trend from last month that has been investigated and found not to be construction related, the investigation from last month states- “Investigations into the vibration exceedances that started on the 25/07/2015 to the 31/07/2015 (trend starts on the 15/07/2015) have proved inconclusive. However it is noted that the vibration is constant during day and night periods. All construction work within a 300 meter radius of the monitor has been investigated and found not to be using any vibration inducing equipment. The noise monitor at this location during similar times shows no matching trend or noise exceedances related to construction”.

Exceedances on the 06/08/2015 and on the 08/08/2015 have been investigated and found not to be exceedances due to the graph rounding up to 2 decimal places, the actual figures are as follows 06/08/2015 was 0.196 and on the 08/08/2015 was 0.198.

Missing data on the 17/08/2015 to the 18/08/2015 was due to the vibration monitor getting its yearly calibration.
 Missing data on the 07/08/2015, 10/08/2015 and 12/08/2015 was due to corrupt data on the vibration monitor

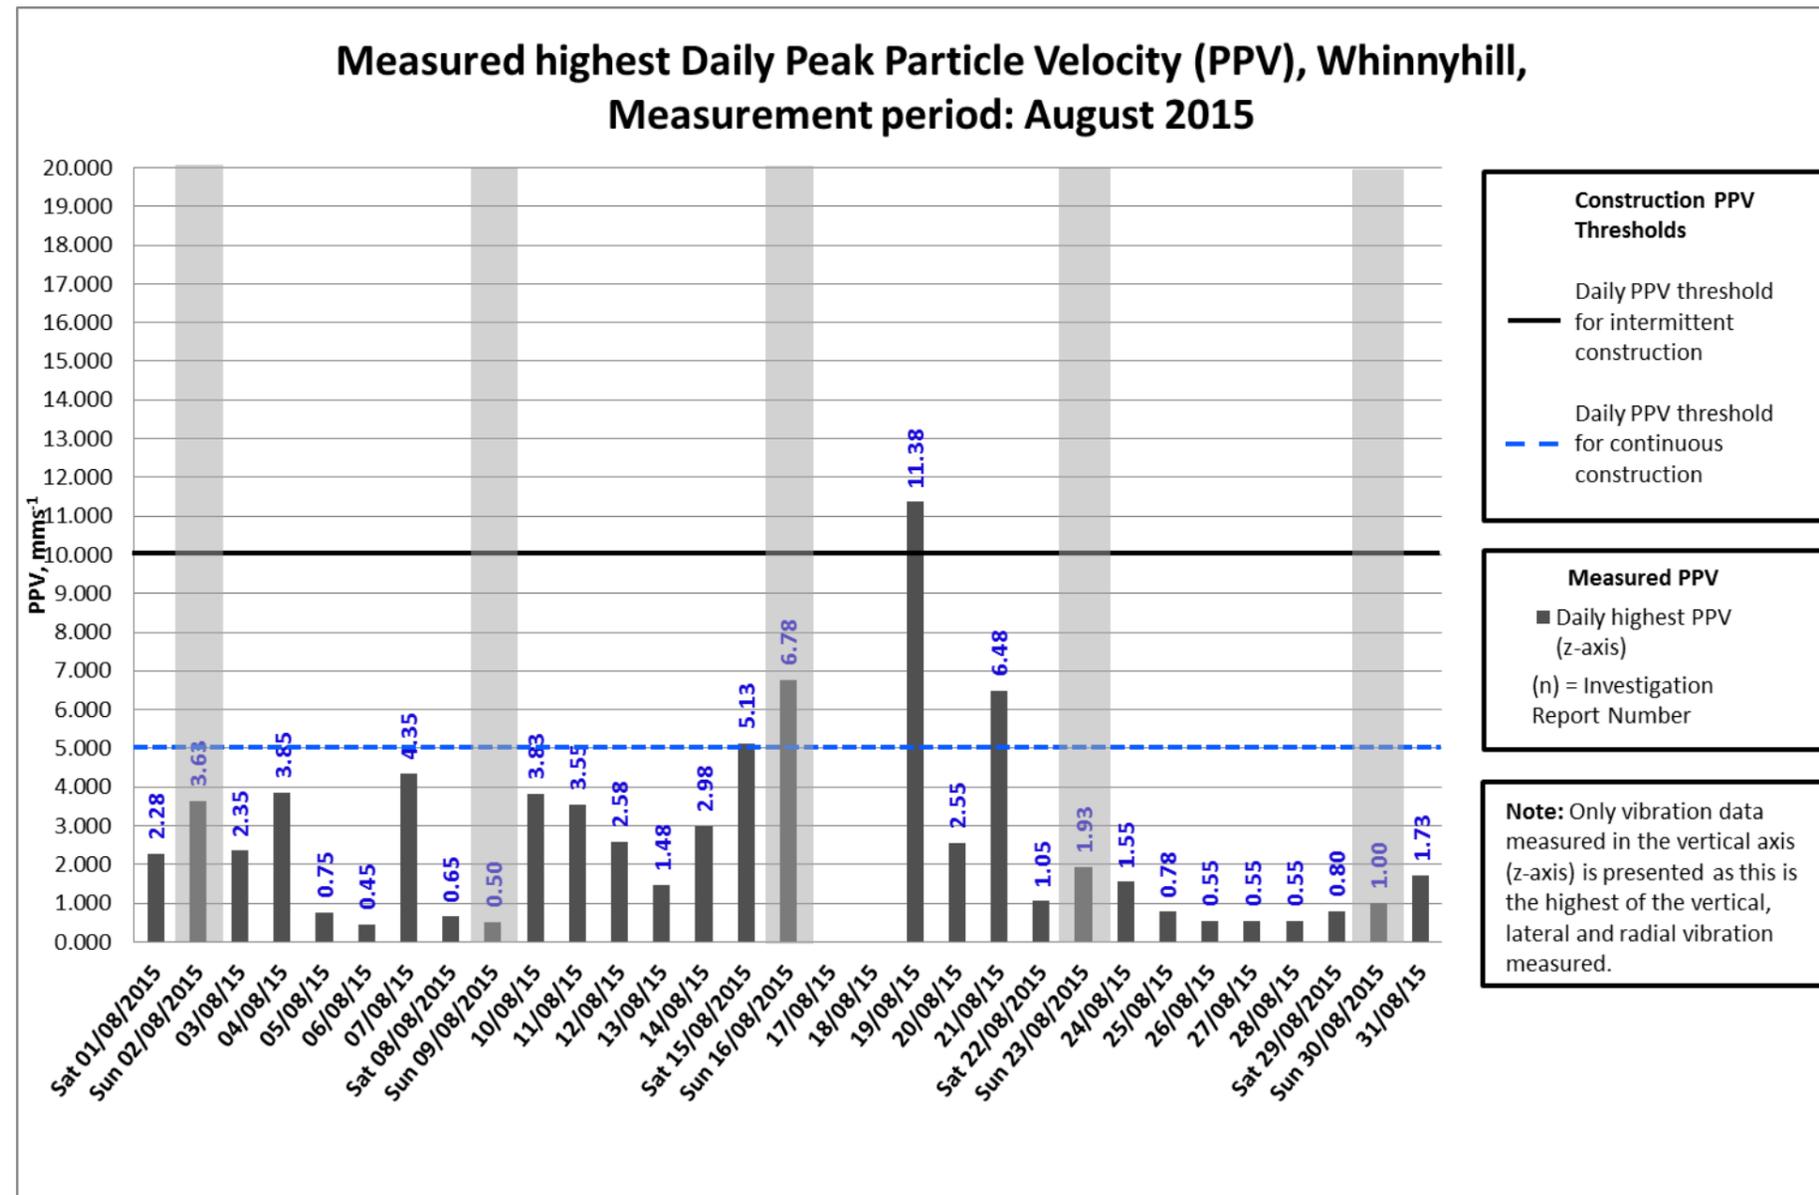
Exceedances on the 15/08/2015, 16/08/2015 and on the 21/08/2015 have been investigated and found to be isolated events unlikely to be related to construction activities due to the distance away from the works (120 meters away) (graph above from the 15/08/2015).

Exceedance on the 19/08/2015 has been investigated and found to be an isolated event that is unlikely to be construction related due to the distance away from the works (120 meters away).

Missing data on the 17/08/2015 to the 18/08/2015 was due to the vibration monitor getting its yearly calibration.
