Queensferry  
Crossing

Project FORTH REPLACEMENT CROSSING

VIBRATION MONITORING REPORT

JULY 2016

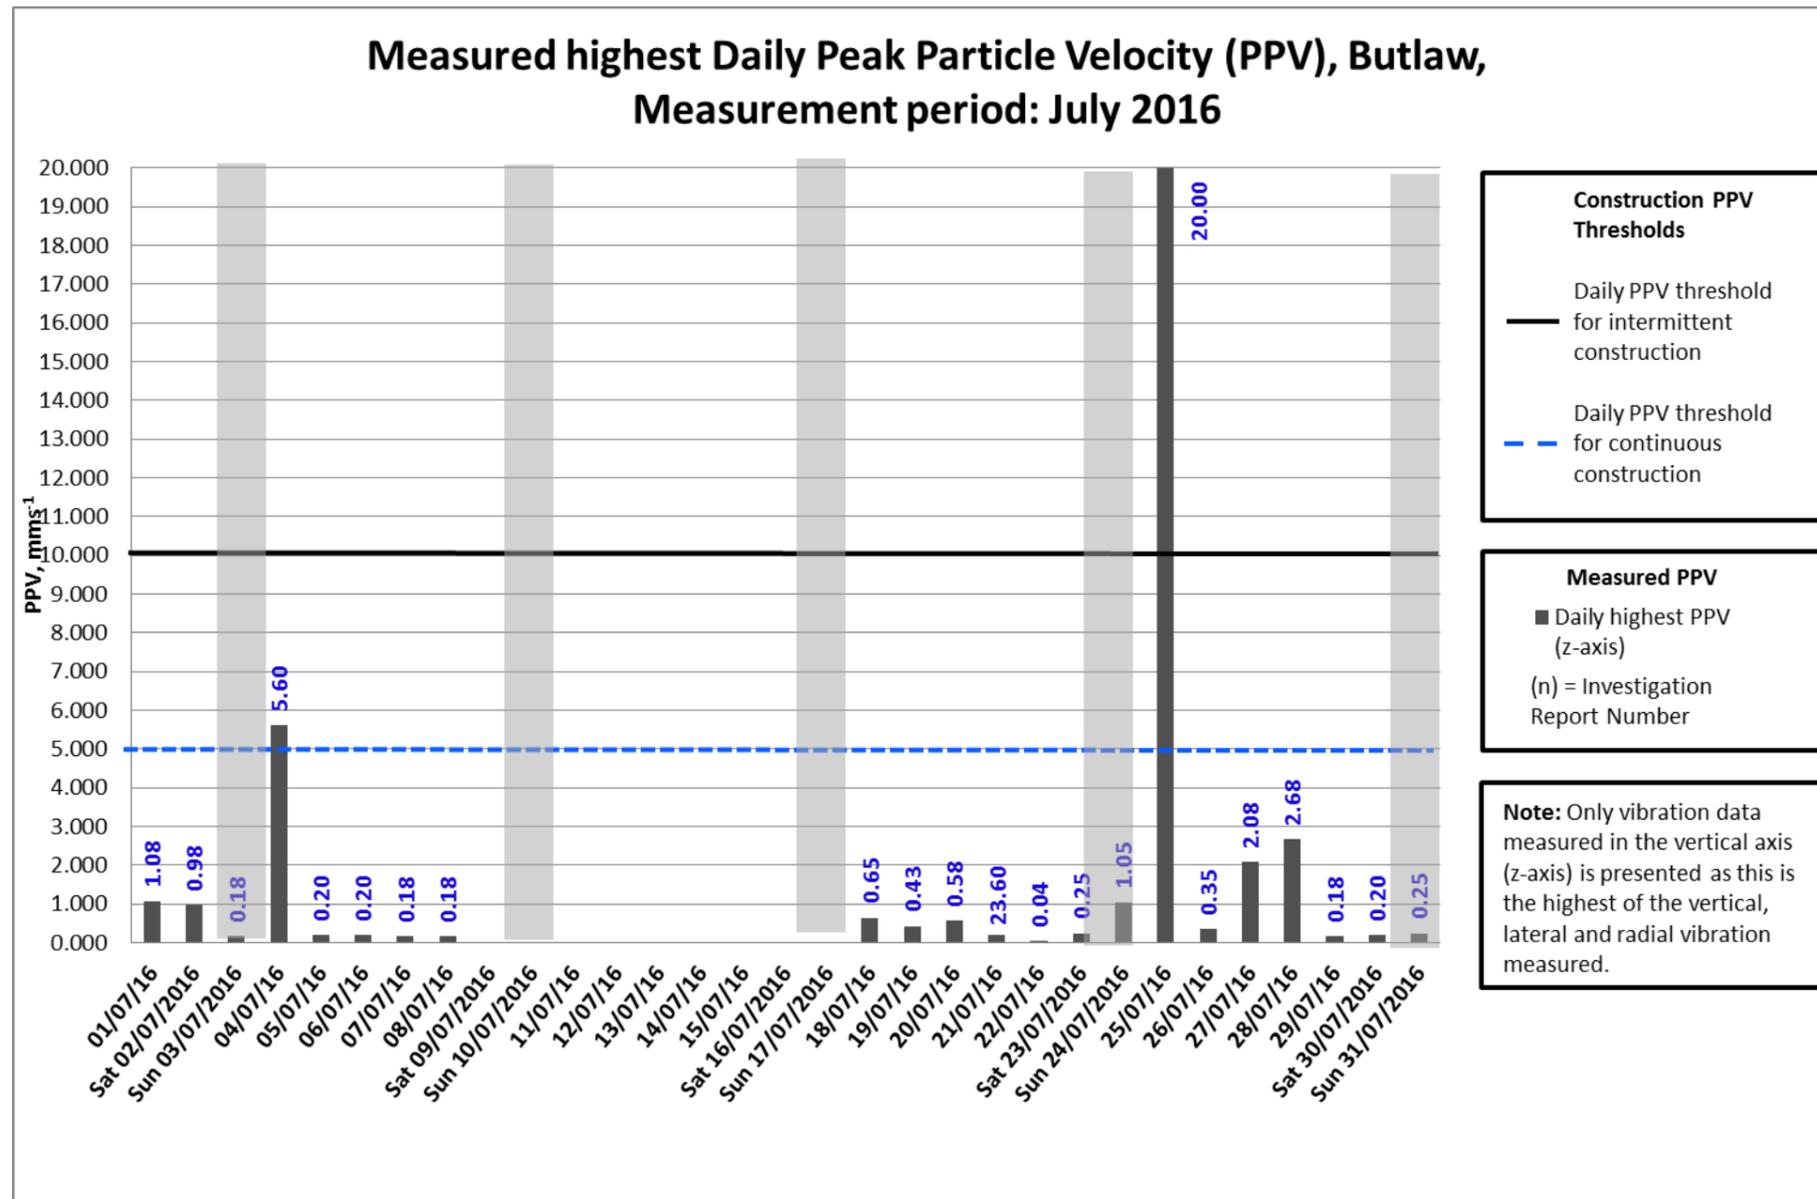
Exceedance on the 4<sup>th</sup> of July has been investigated and found to be caused by the environmental department carrying out monitor maintenance on the noise monitor. Due to the proximity of the noise monitor to the transducers (part of the device that picks up the vibration) movement made by the environmental department was picked up (graph above from the 04/07/2016).

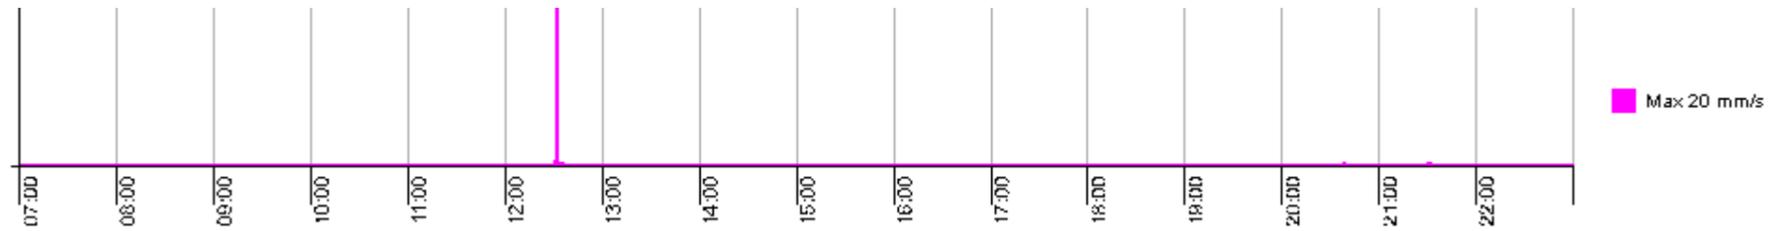
Exceedance on the 25<sup>th</sup> of July has been investigated and found to be caused by the residential gardener cutting the grass where the vibration monitor is located.

Data missing from the 9<sup>th</sup> to the 17<sup>th</sup> of July was caused by a power issue at the monitor location. This was resolved by a member of the environmental department on the 18<sup>th</sup> of July.

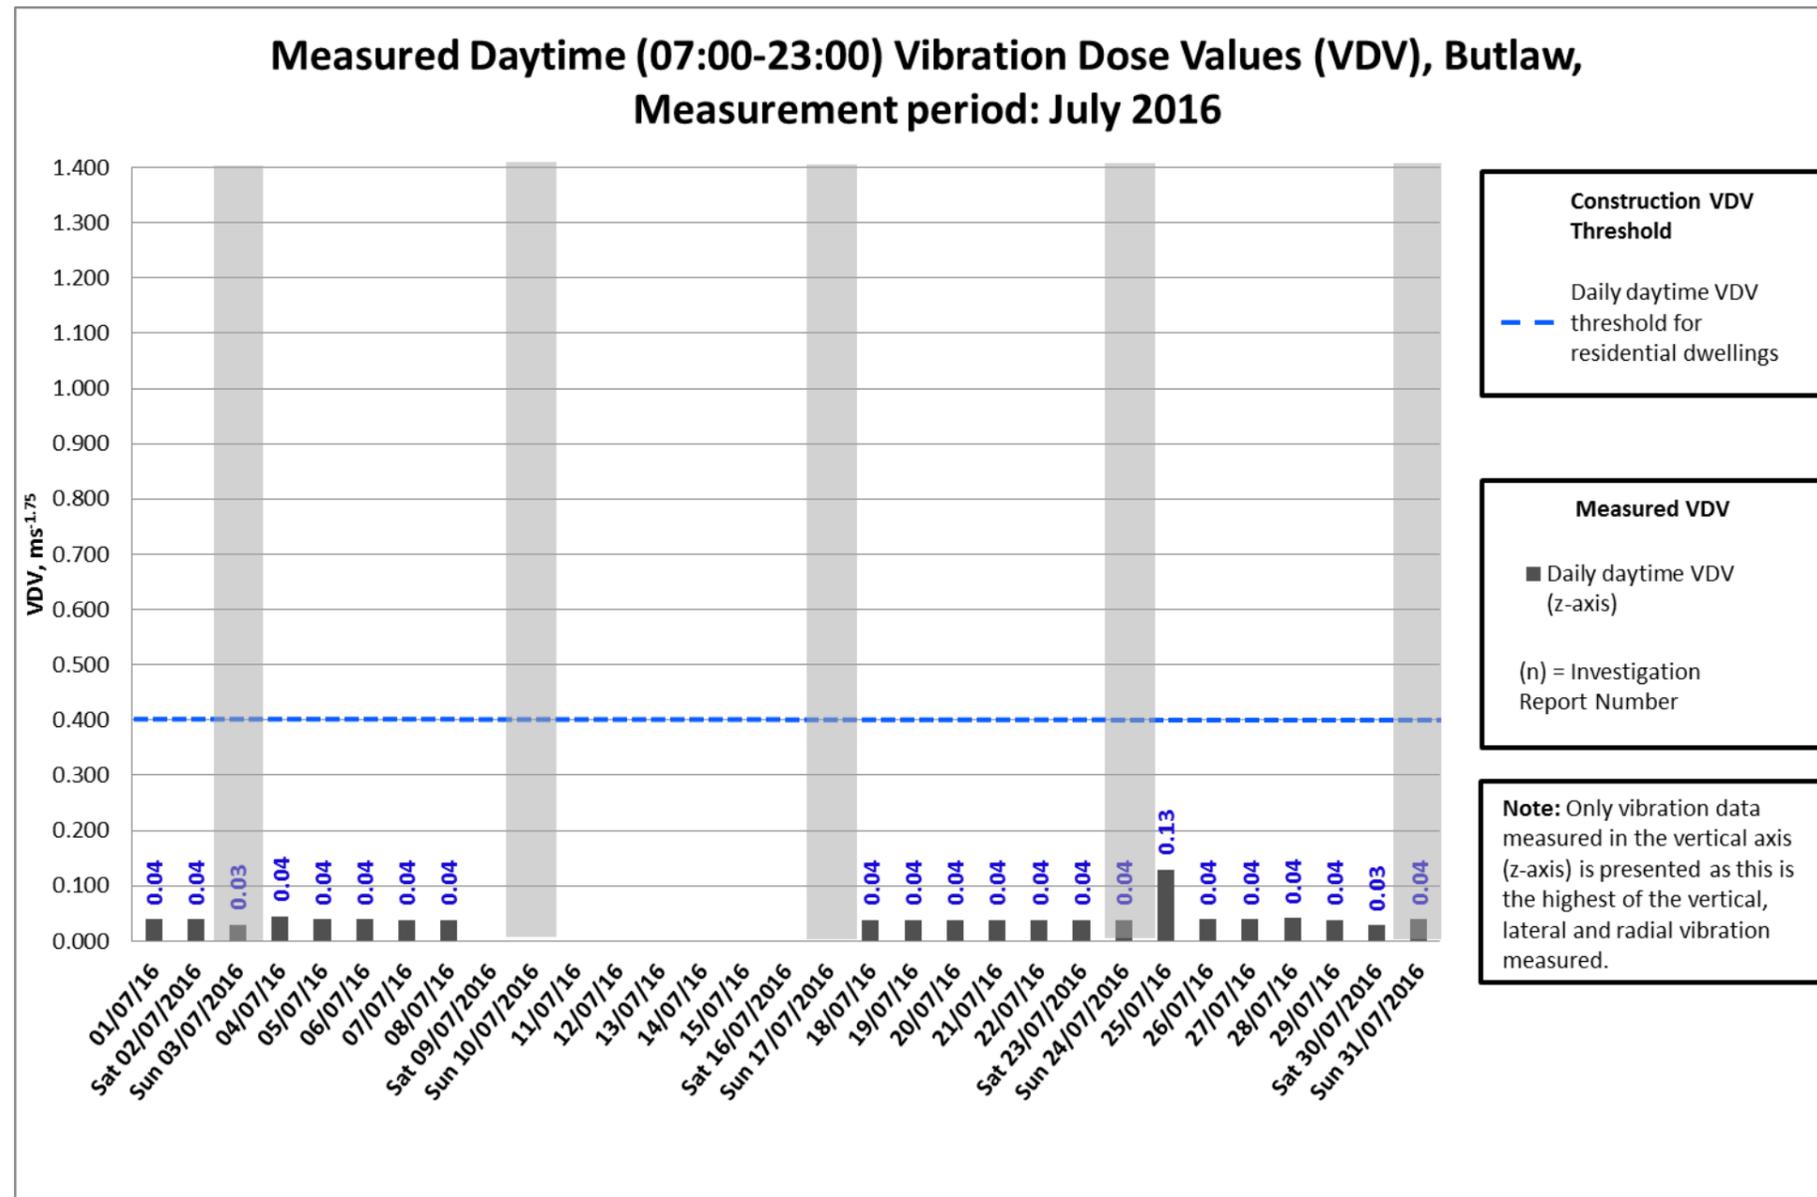
Data missing from the 9<sup>th</sup> to the 17<sup>th</sup> of July was caused by a power issue at the monitor location. This was resolved by a member of the environmental department on the 18<sup>th</sup> of July.

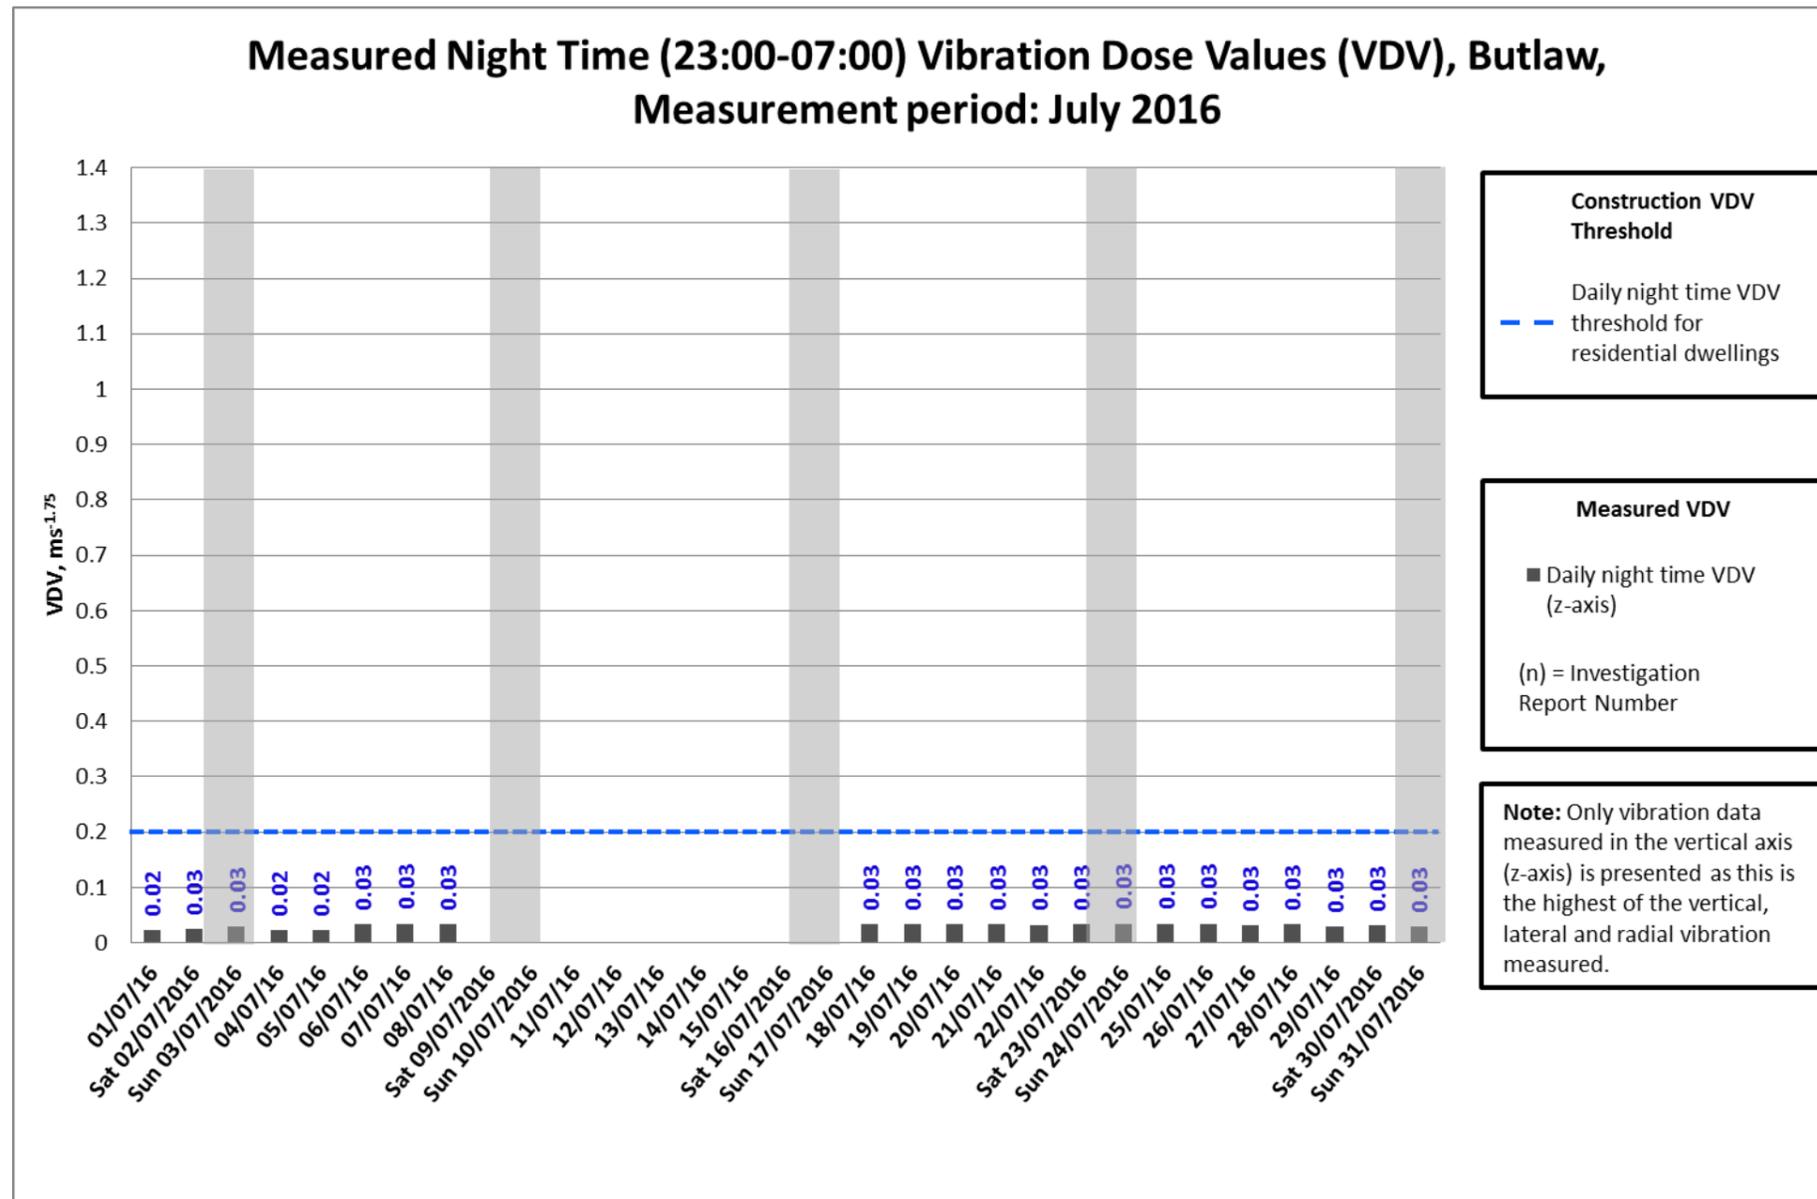
Data missing from the 9<sup>th</sup> to the 17<sup>th</sup> of July was caused by a power issue at the monitor location. This was resolved by a member of the environmental department on the 18<sup>th</sup> of July.

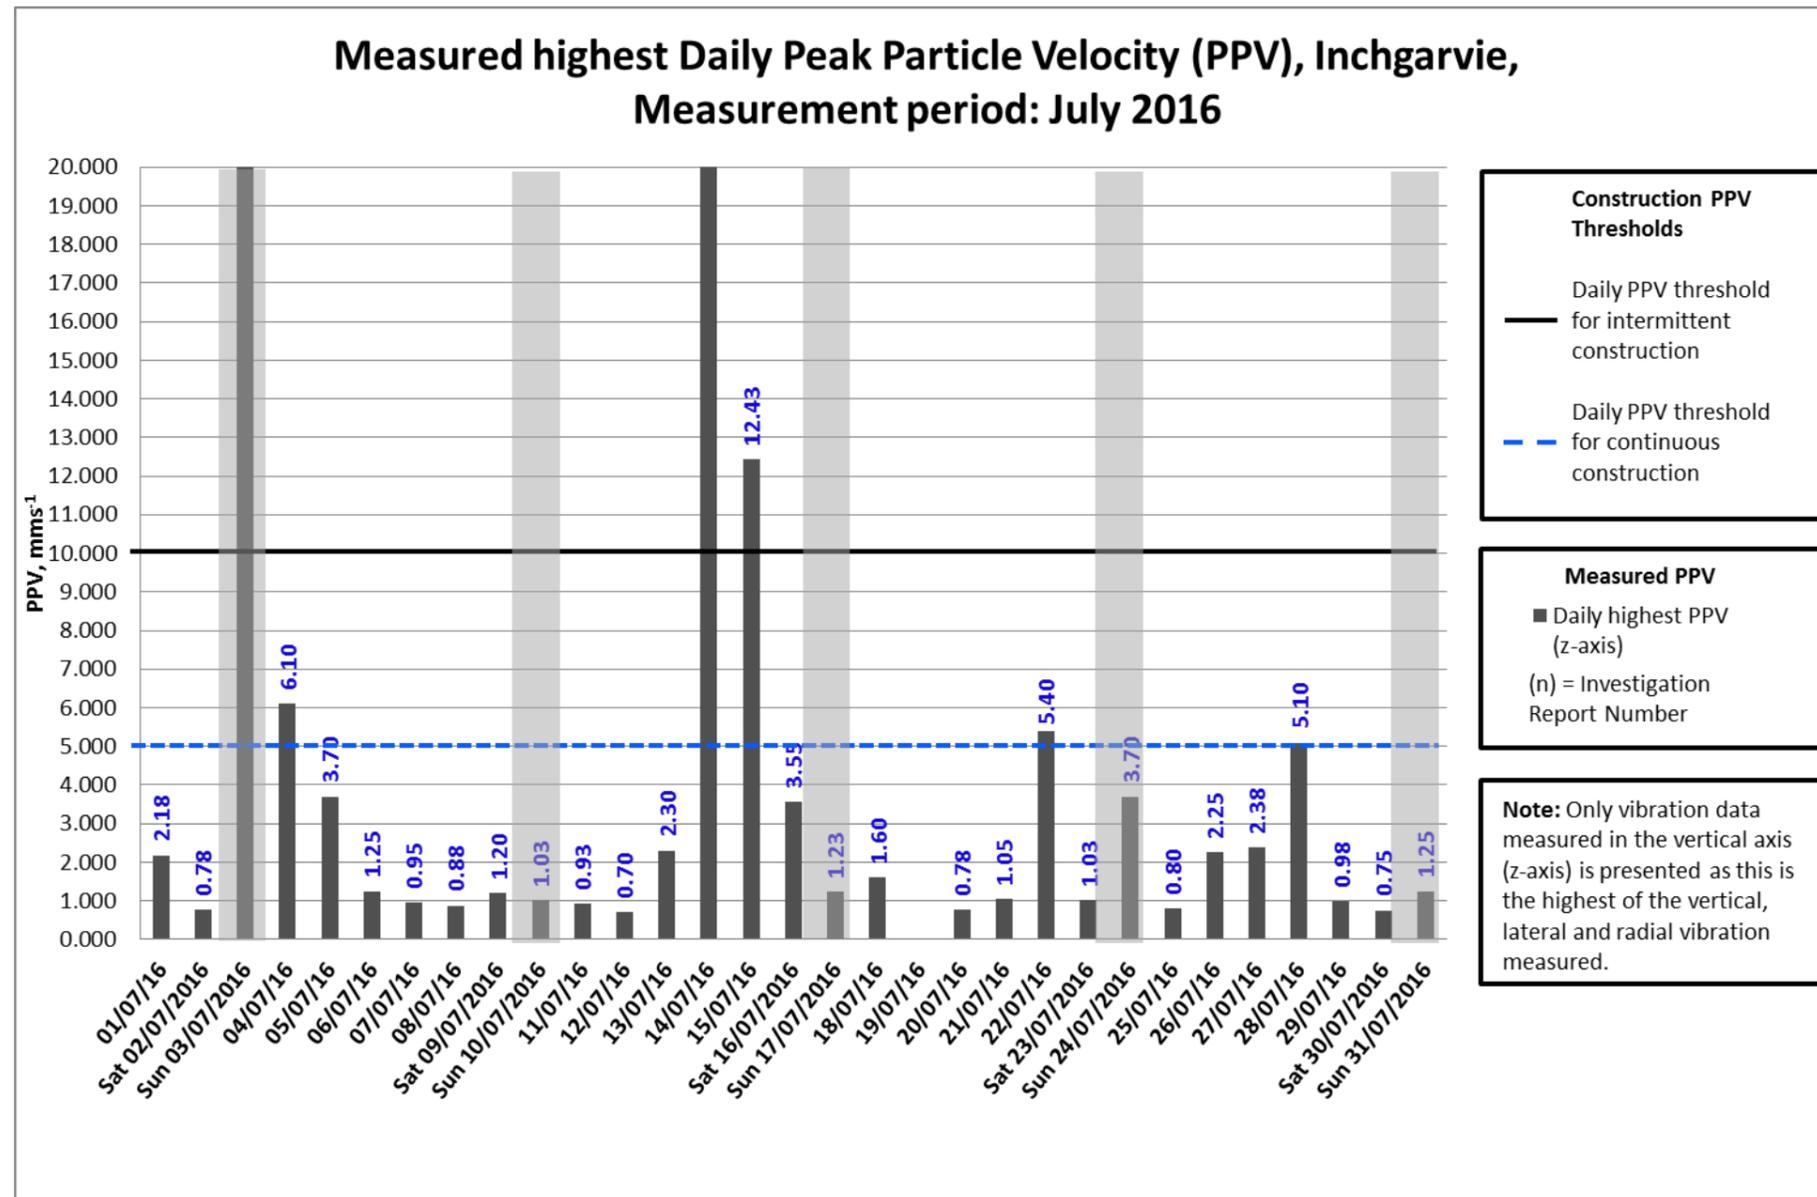
Exceedances on the 3<sup>rd</sup>, 4<sup>th</sup>, 22<sup>nd</sup> and 28<sup>th</sup> of July have been investigated and found to be caused out with construction working hours and therefore it is unlikely that construction related activity was the cause of these events (graph above from the 22/07/2016).

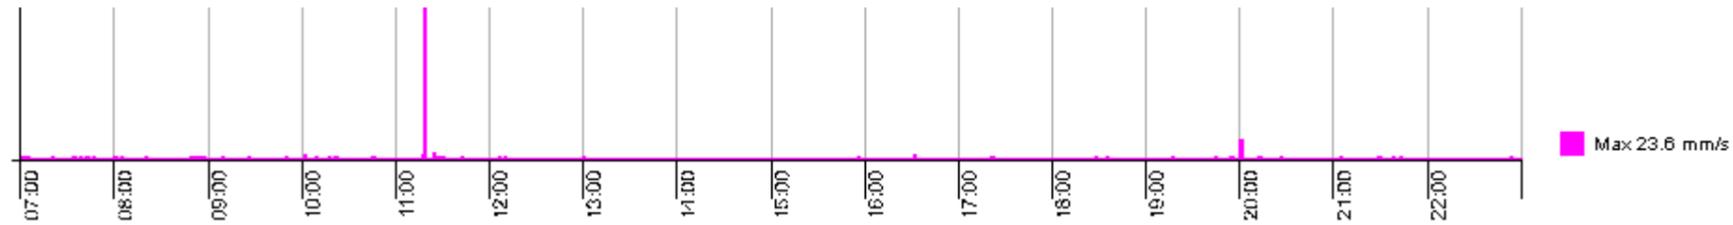
Exceedances on the 14<sup>th</sup> and 15<sup>th</sup> of July have been investigated and found to be caused by individual isolated events that are unlikely to have been construction related activities (graph above from the 14/07/2016).

During this period, the resident at the property where the monitor is situated had ongoing private construction works. It is likely that exceedances within the graph above were caused by the works at the property rather than the construction of the new crossing and supporting infrastructure.

Data missing on the 19<sup>th</sup> of July was caused by a power issue at the monitor location. This was resolved by a member of the environmental department on the 20<sup>th</sup> of July.

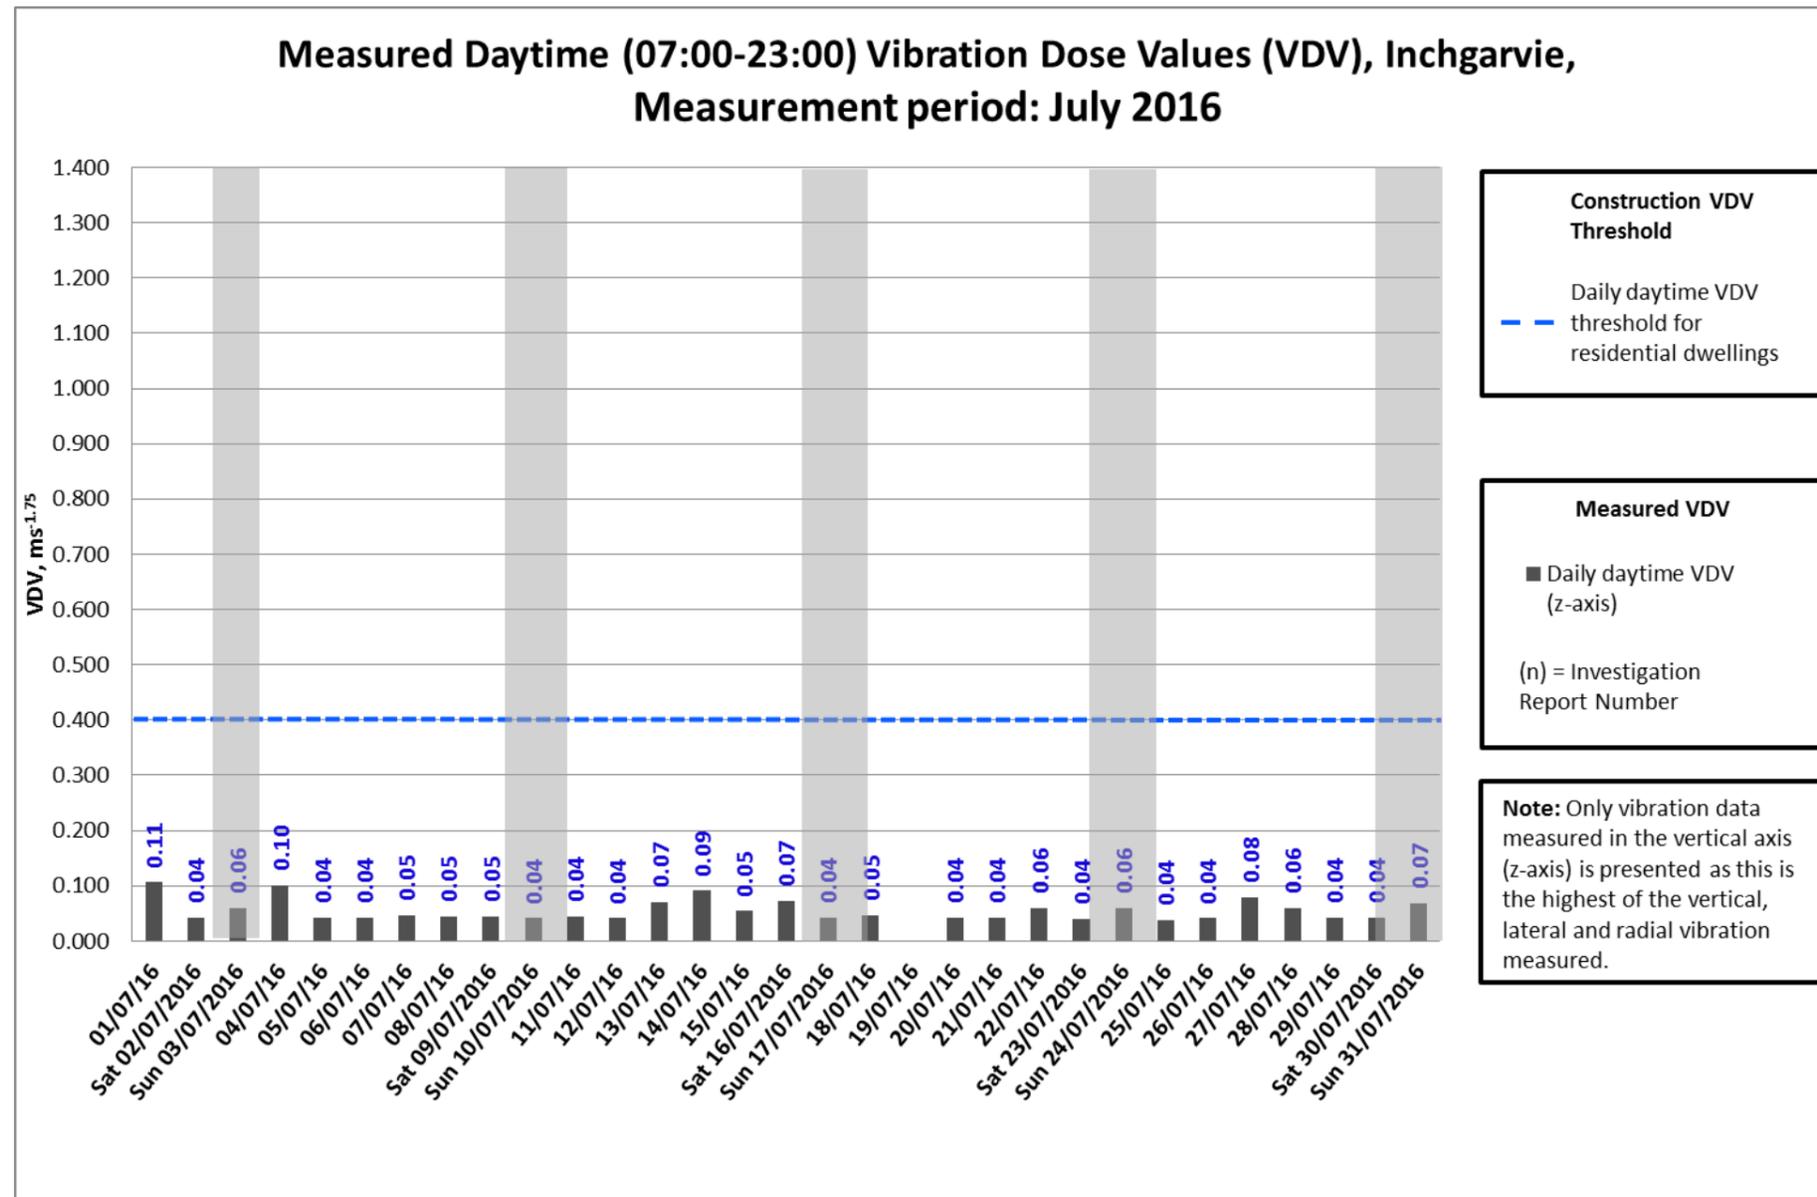
Data missing on the 19<sup>th</sup> of July was caused by a power issue at the monitor location. This was resolved by a member of the environmental department on the 20<sup>th</sup> of July.

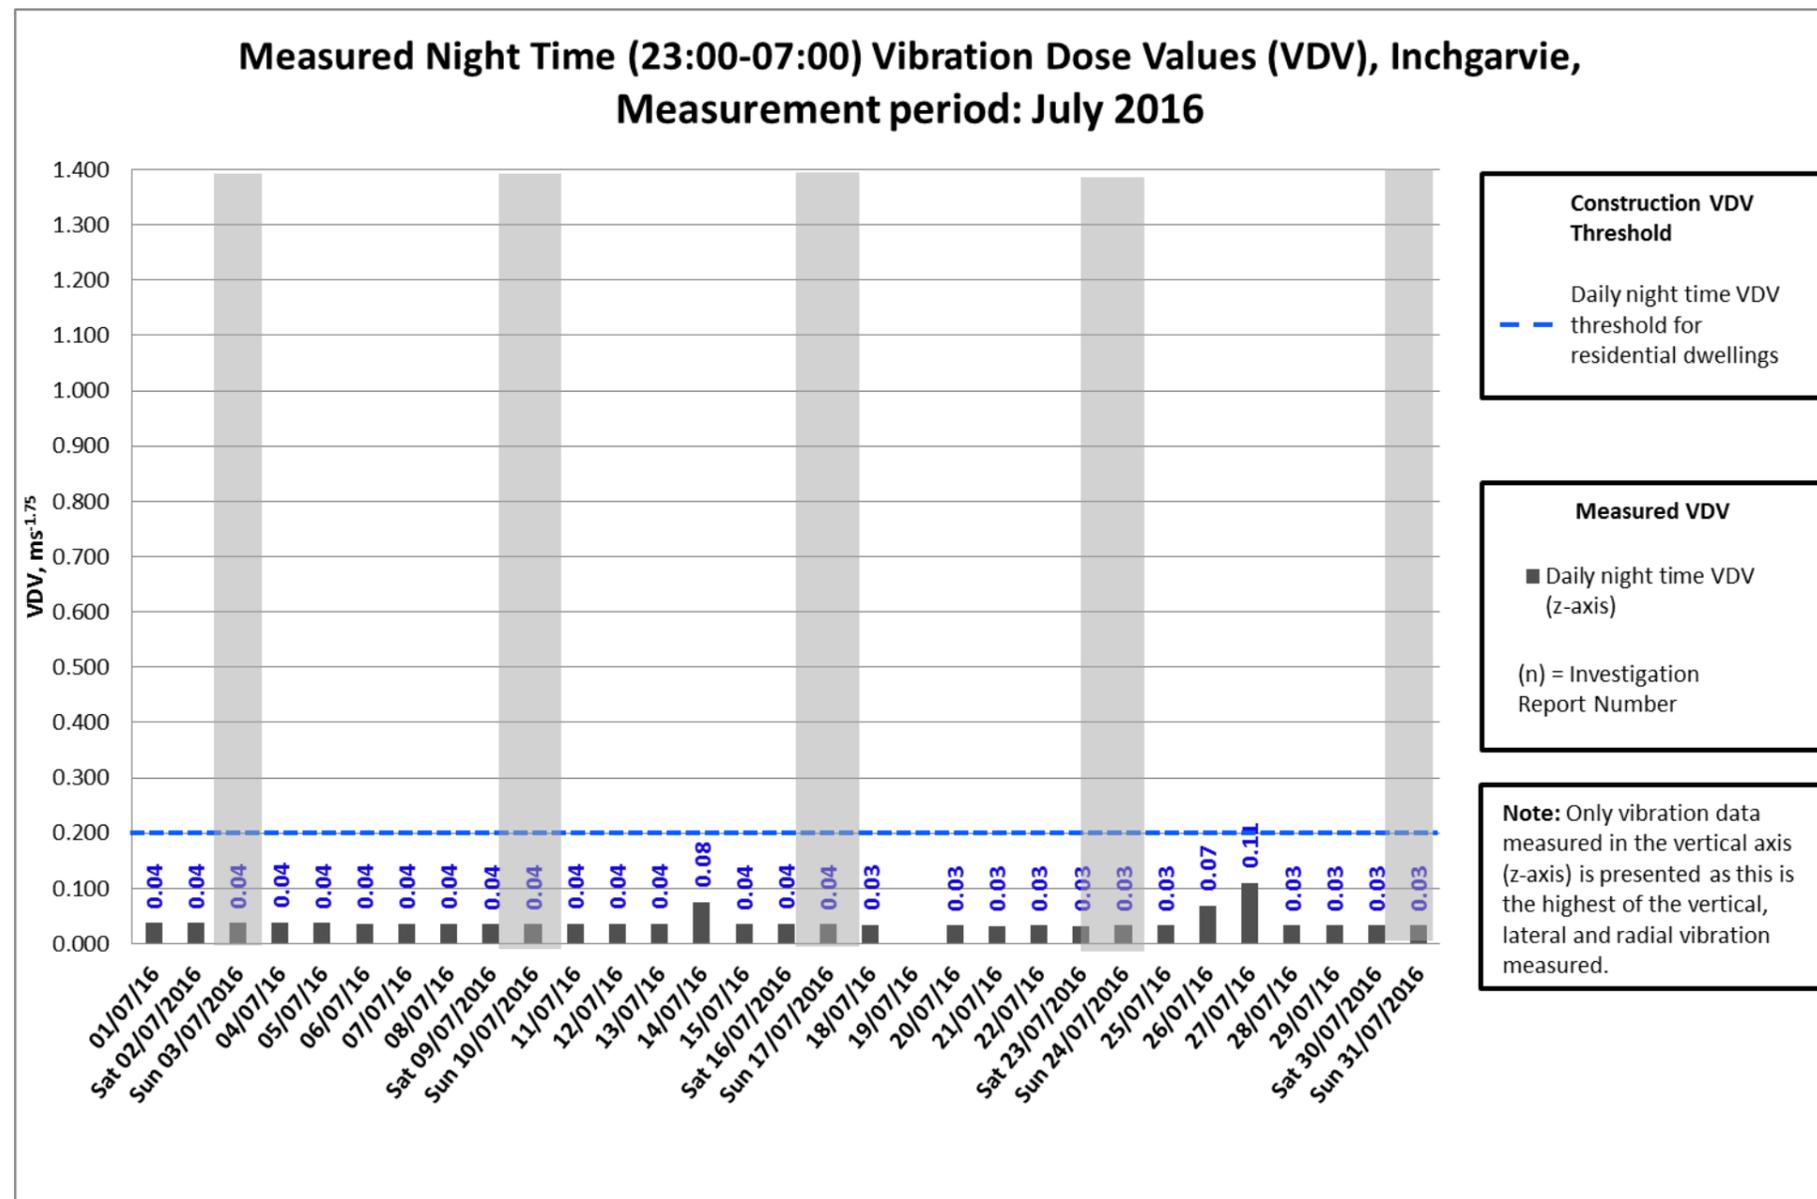
Data missing on the 19<sup>th</sup> of July was caused by a power issue at the monitor location. This was resolved by a member of the environmental department on the 20<sup>th</sup> of July.

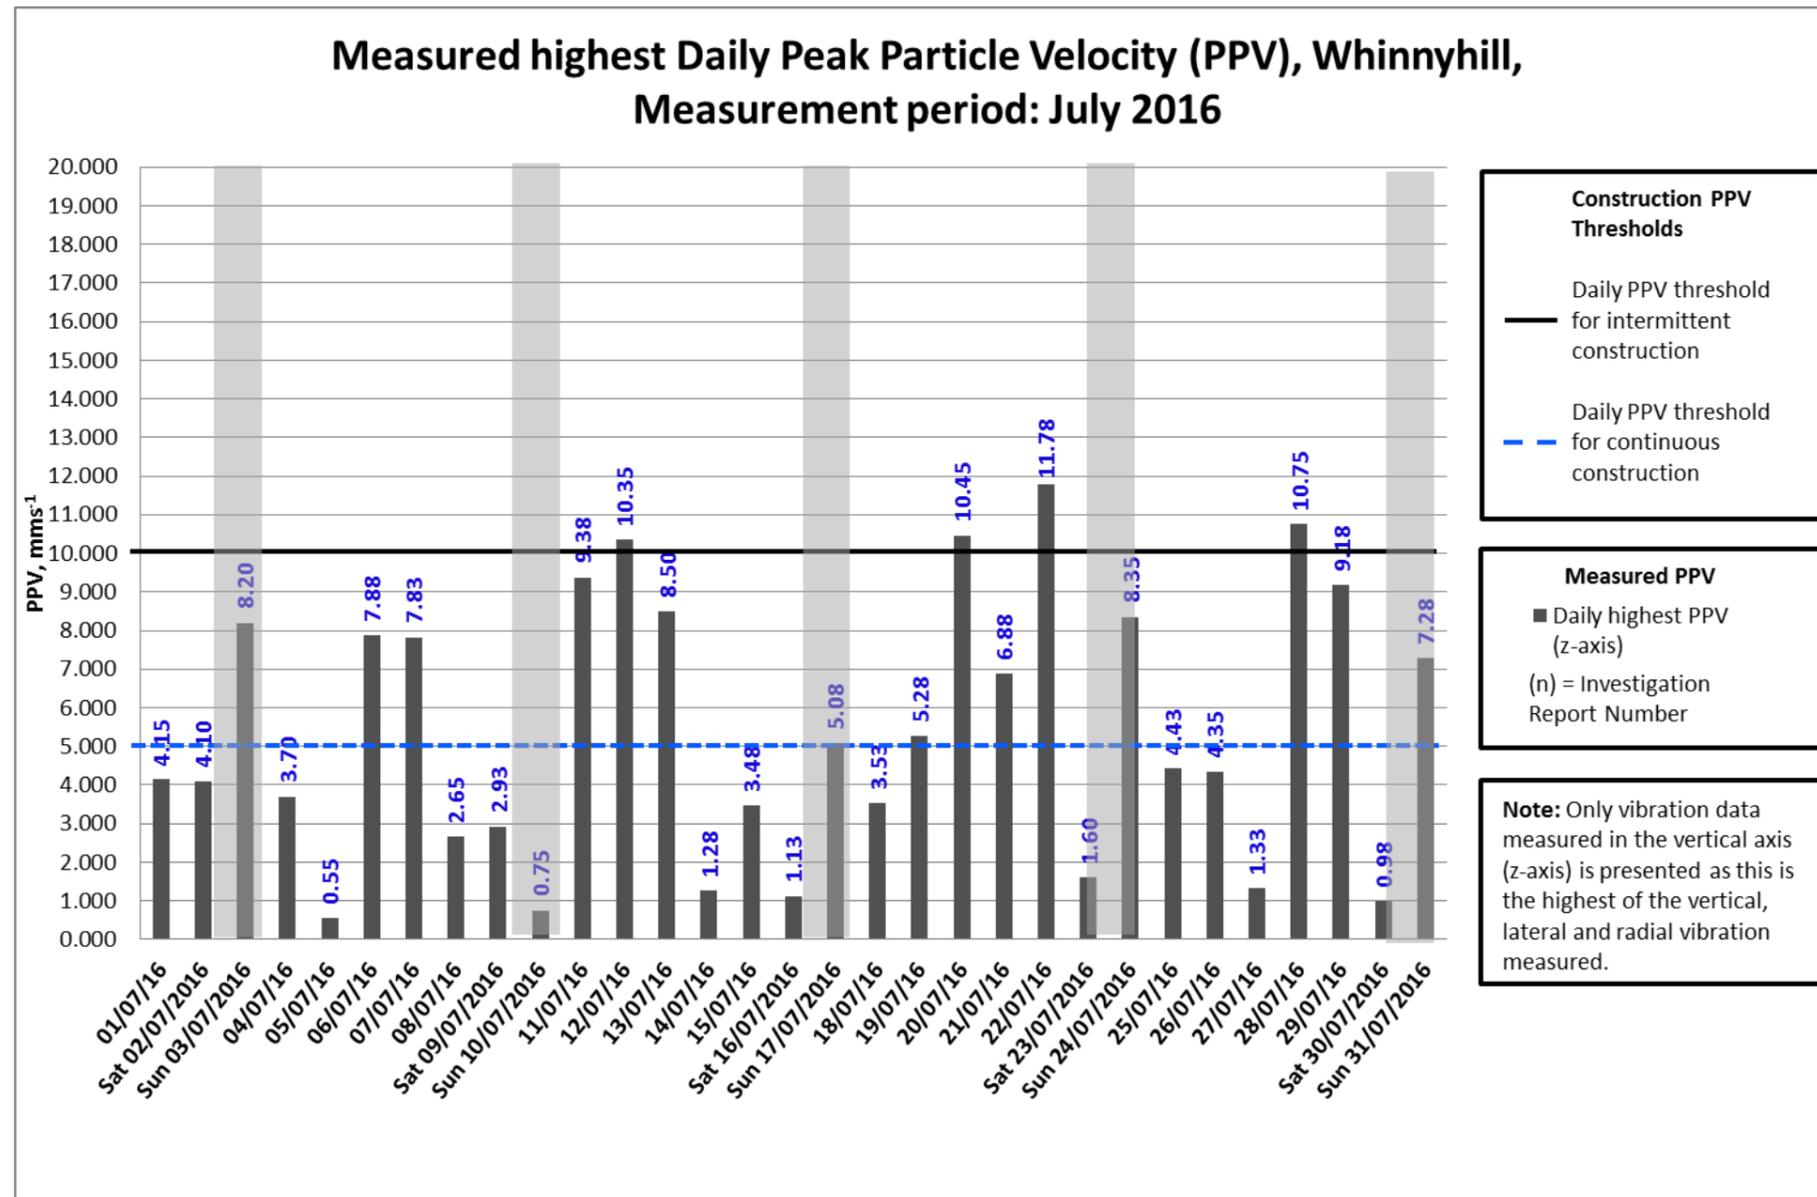
Exceedances on the 3<sup>rd</sup>, 11<sup>th</sup>, 17<sup>th</sup>, 21<sup>st</sup>, 24<sup>th</sup> and 31<sup>st</sup> of July have been investigated and found to be caused out with construction working hours and therefore it is unlikely that construction related activity was the cause of these events (graph above from the 11/07/2016).

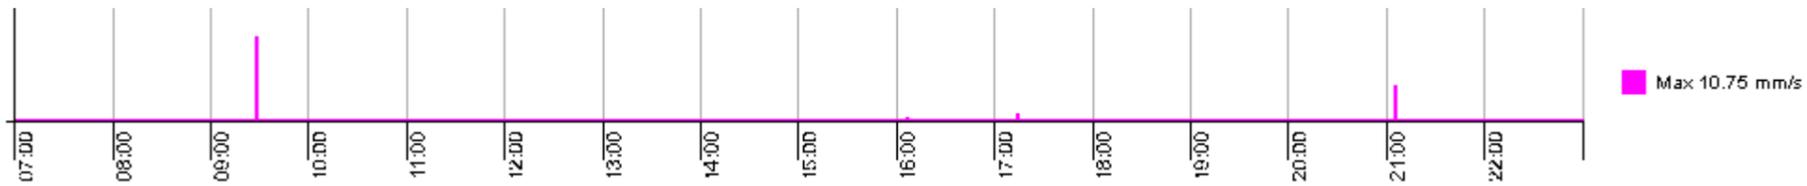
Exceedances on the 6<sup>th</sup>, 7<sup>th</sup>, 12<sup>th</sup>, 13<sup>th</sup>, 19<sup>th</sup>, 20<sup>th</sup>, 22<sup>nd</sup>, 28<sup>th</sup> and 29<sup>th</sup> of July have been investigated and found to be caused by individual isolated events that are unlikely to have been construction related activities (graph above from the 28/07/2016).
