Project **FORTH REPLACEMENT CROSSING**

VIBRATION MONITORING REPORT
JUNE 2016

Document number	Rev
REP-00284	00

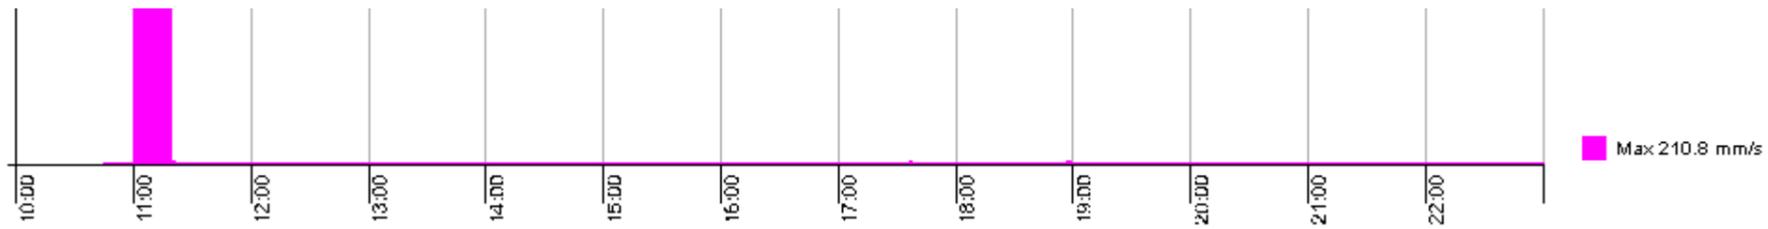
Exceedance on the 1st of June has been investigated and found to be caused by the environmental department downloading data from the Vibration monitor. Due to the proximity of the vibration storage device and the transducers (part of the device that picks up the vibration) movement made by the environmental department was picked up (graph above from the 01/06/2016).

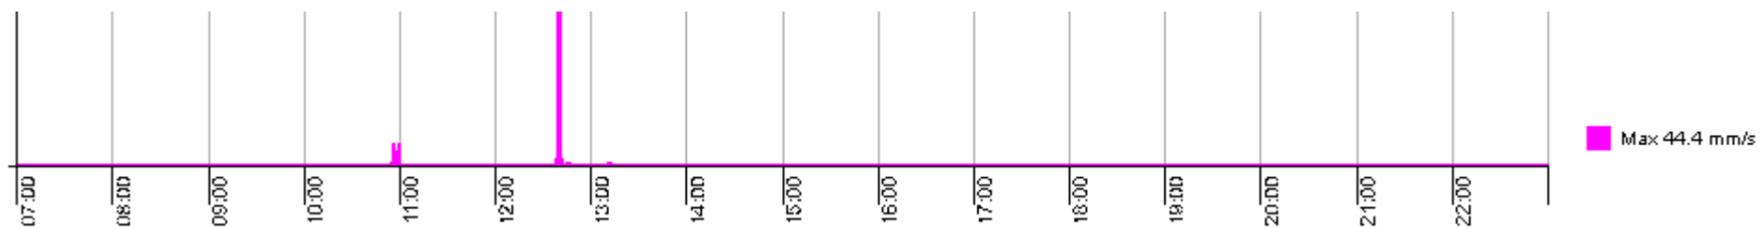
Exceedance on the 13th of June has been investigated and found to be caused by the resident cutting the grass. Due to the location of the vibration monitor this activity has been picked up (graph above from the 13/06/2016).

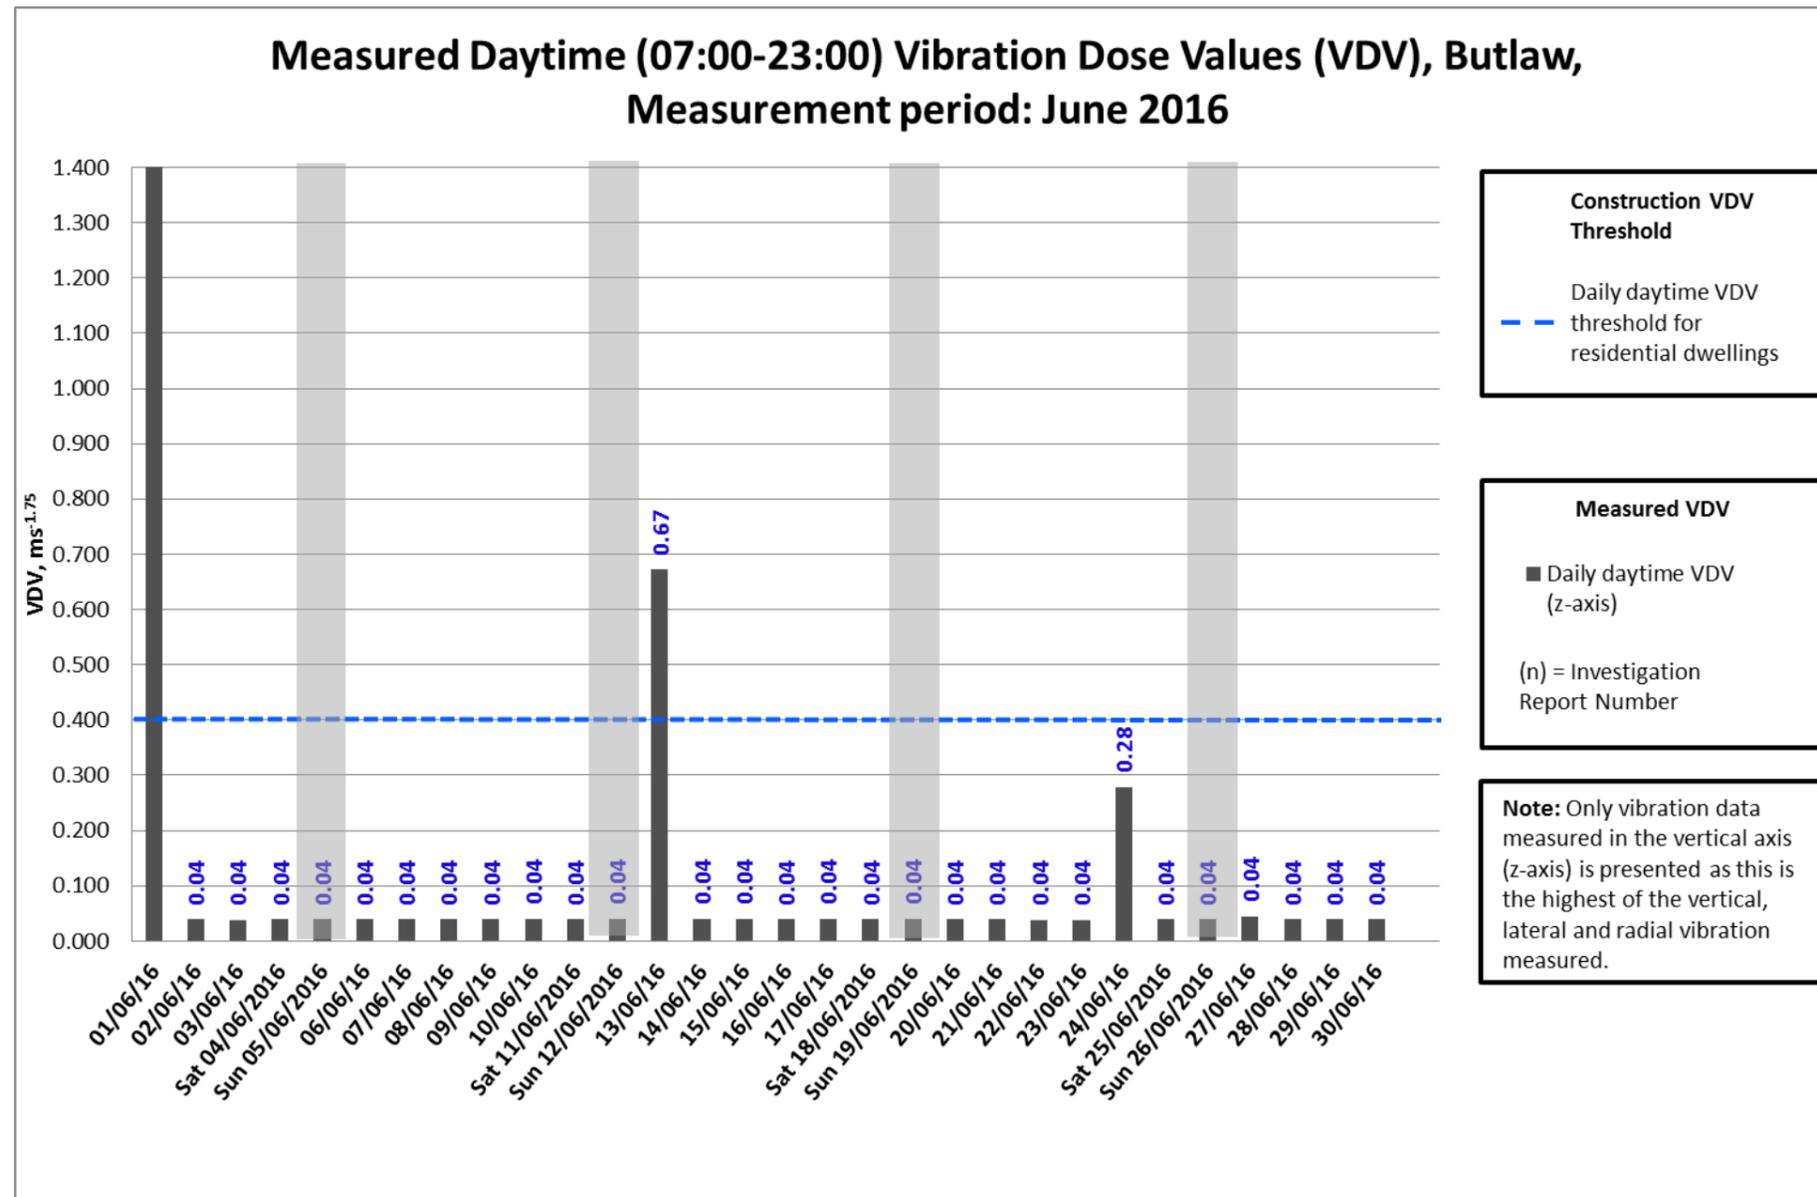
Exceedances on the 1st and 13th of June have been investigated and found to be caused by the same incidents described above (reference Butlaw PPV graph).

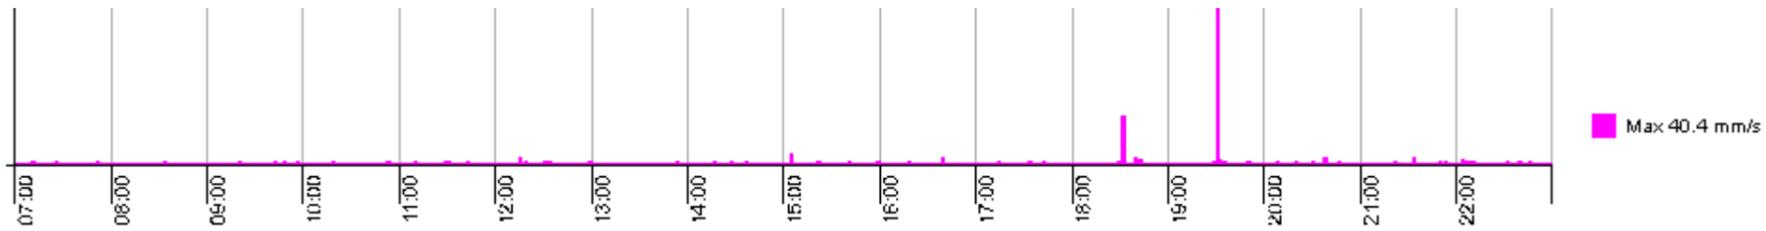
Exceedances on the 21st and 23rd of June have been investigated and found to be caused out with construction working hours and therefore it is unlikely that construction related activity was the cause of these (graph above from the 23/06/2016).

During this period, the resident at the property where the monitor is situated had ongoing private construction works. It is likely that exceedances within the graph above were caused by the works at the property rather than the construction of the new crossing and supporting infrastructure.

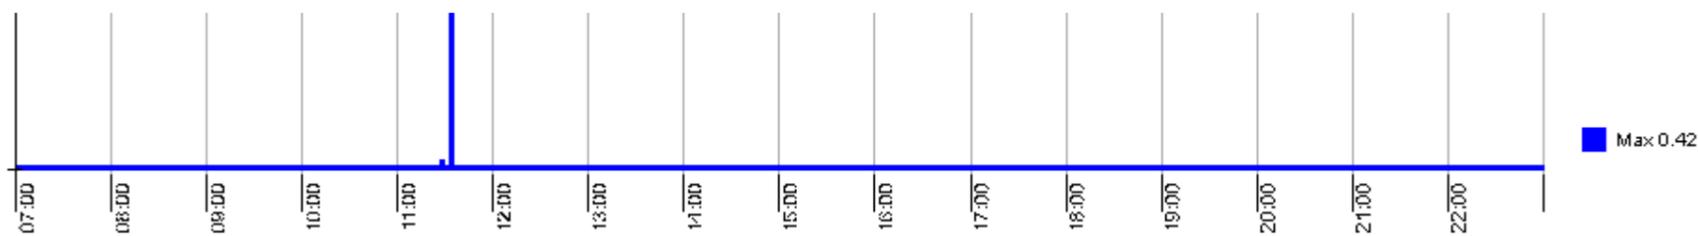
Exceedance on the 10th of June has been investigated and found to have been caused by an individual isolated event unlikely to have been related to construction activities (graph above from the 10/06/2016).

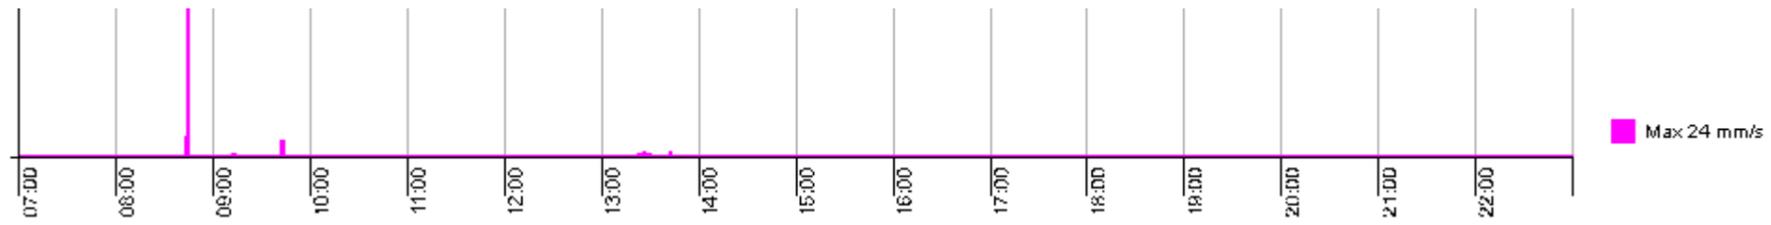
Exceedances on the 2nd, 3rd, 4th, 9th, 10th, 11th, 14th, 17th, 22nd, 27th, 29th and 30th of June have been investigated and found to have been caused by individual isolated events that are unlikely to have been construction related activities (graph above from the 22/06/2016).
