Queensferry  
Crossing

Project FORTH REPLACEMENT CROSSING

VIBRATION MONITORING REPORT  
MAY 2016

<p>Document status</p> <p style="font-size: 1.5em; font-weight: bold;">FOR REVIEW</p>	
Made by Michael Richardson	Checked By: Steven Westwater
Initials: MRN	Initials: SWR
Document number <b>REP-00280</b>	Rev <b>00</b>

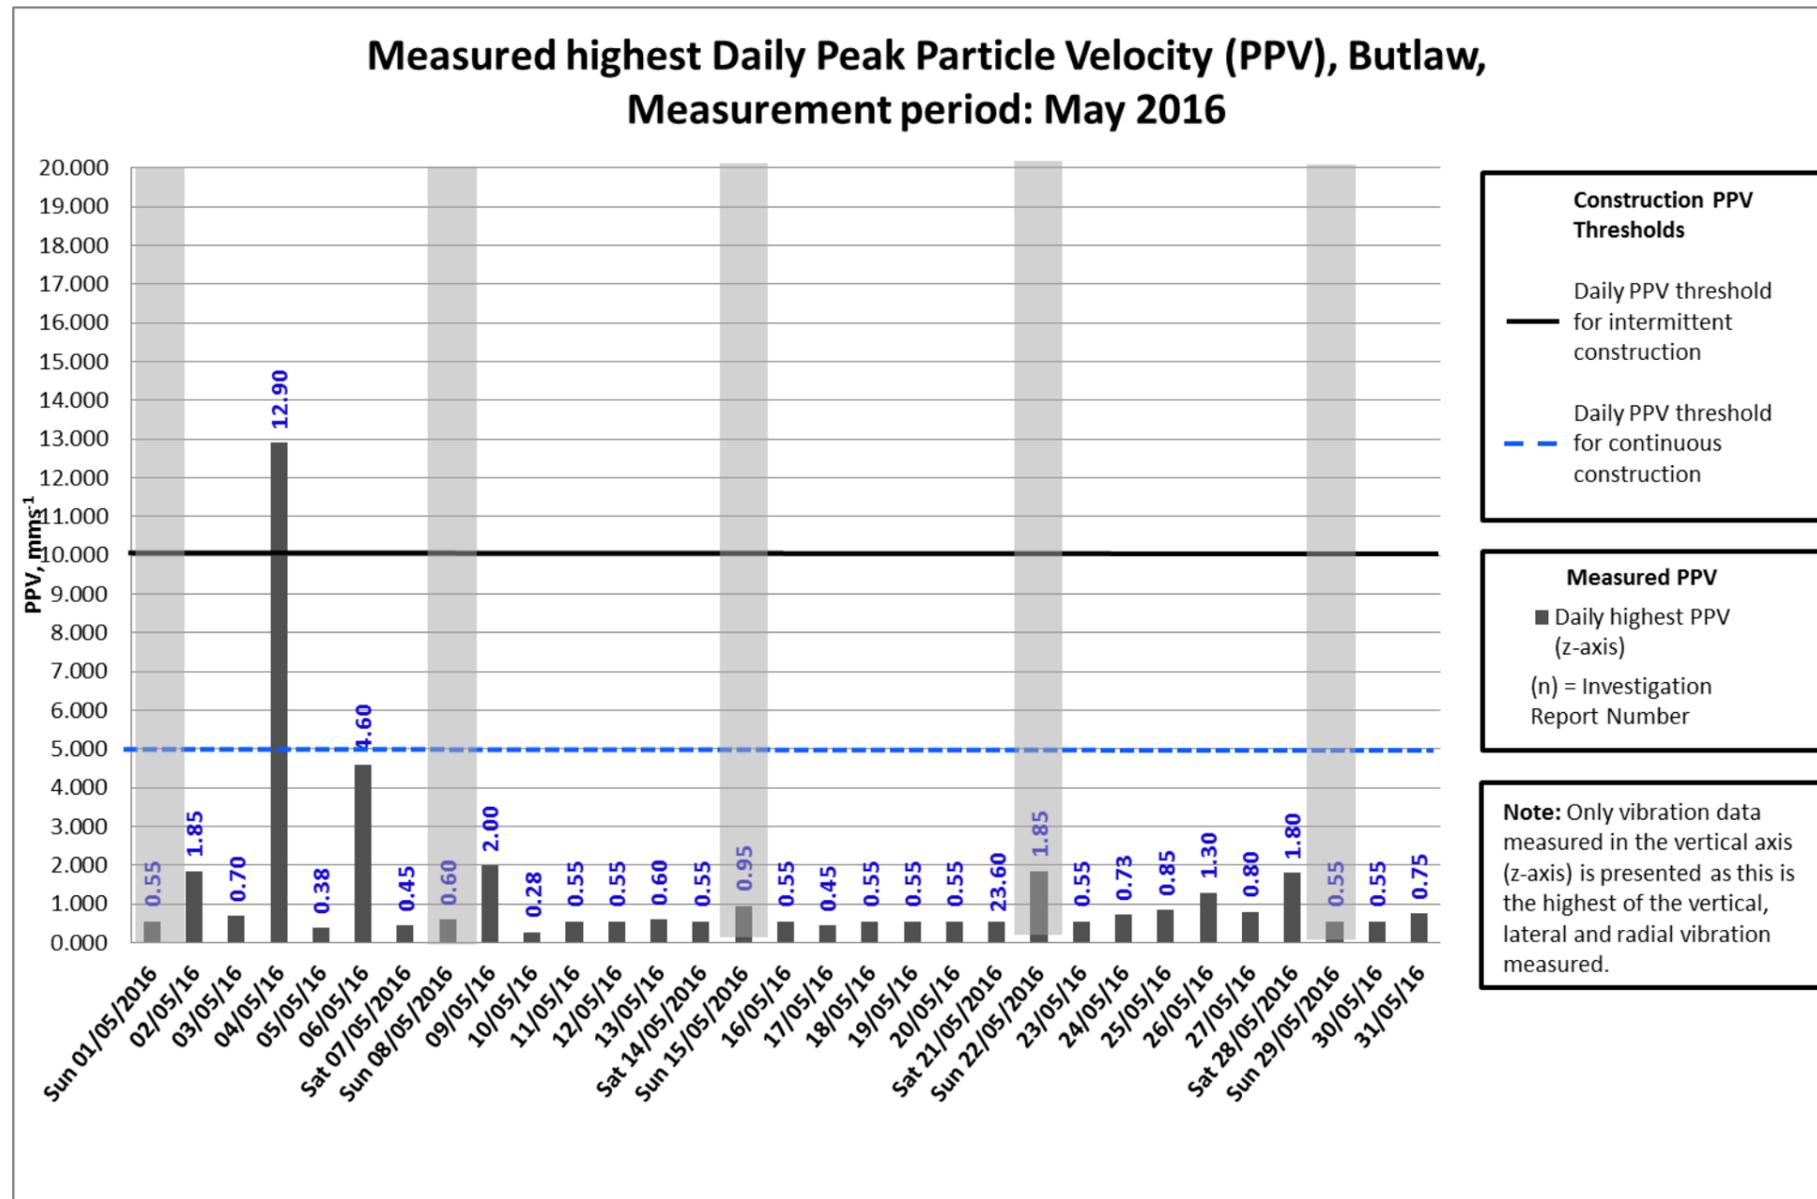
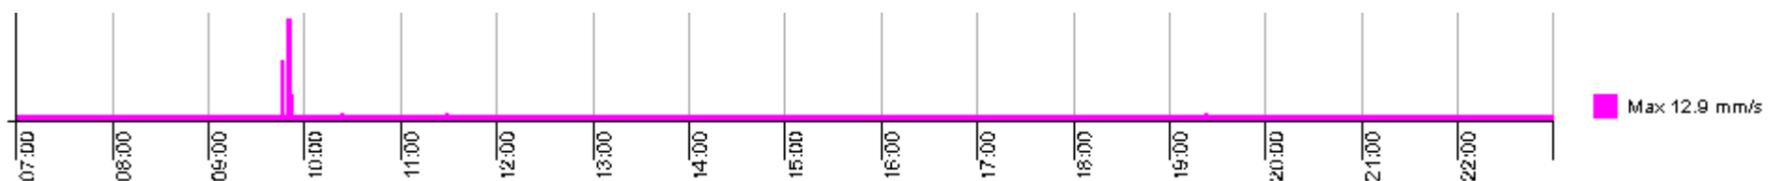
Exceedance on the 4<sup>th</sup> of May has been investigated and found to be caused by the environmental department carrying out maintenance on the noise monitor. Due to the proximity of the noise monitor to the vibration monitor activity from the environmental department was picked up (graph above from the 04/05/2016).

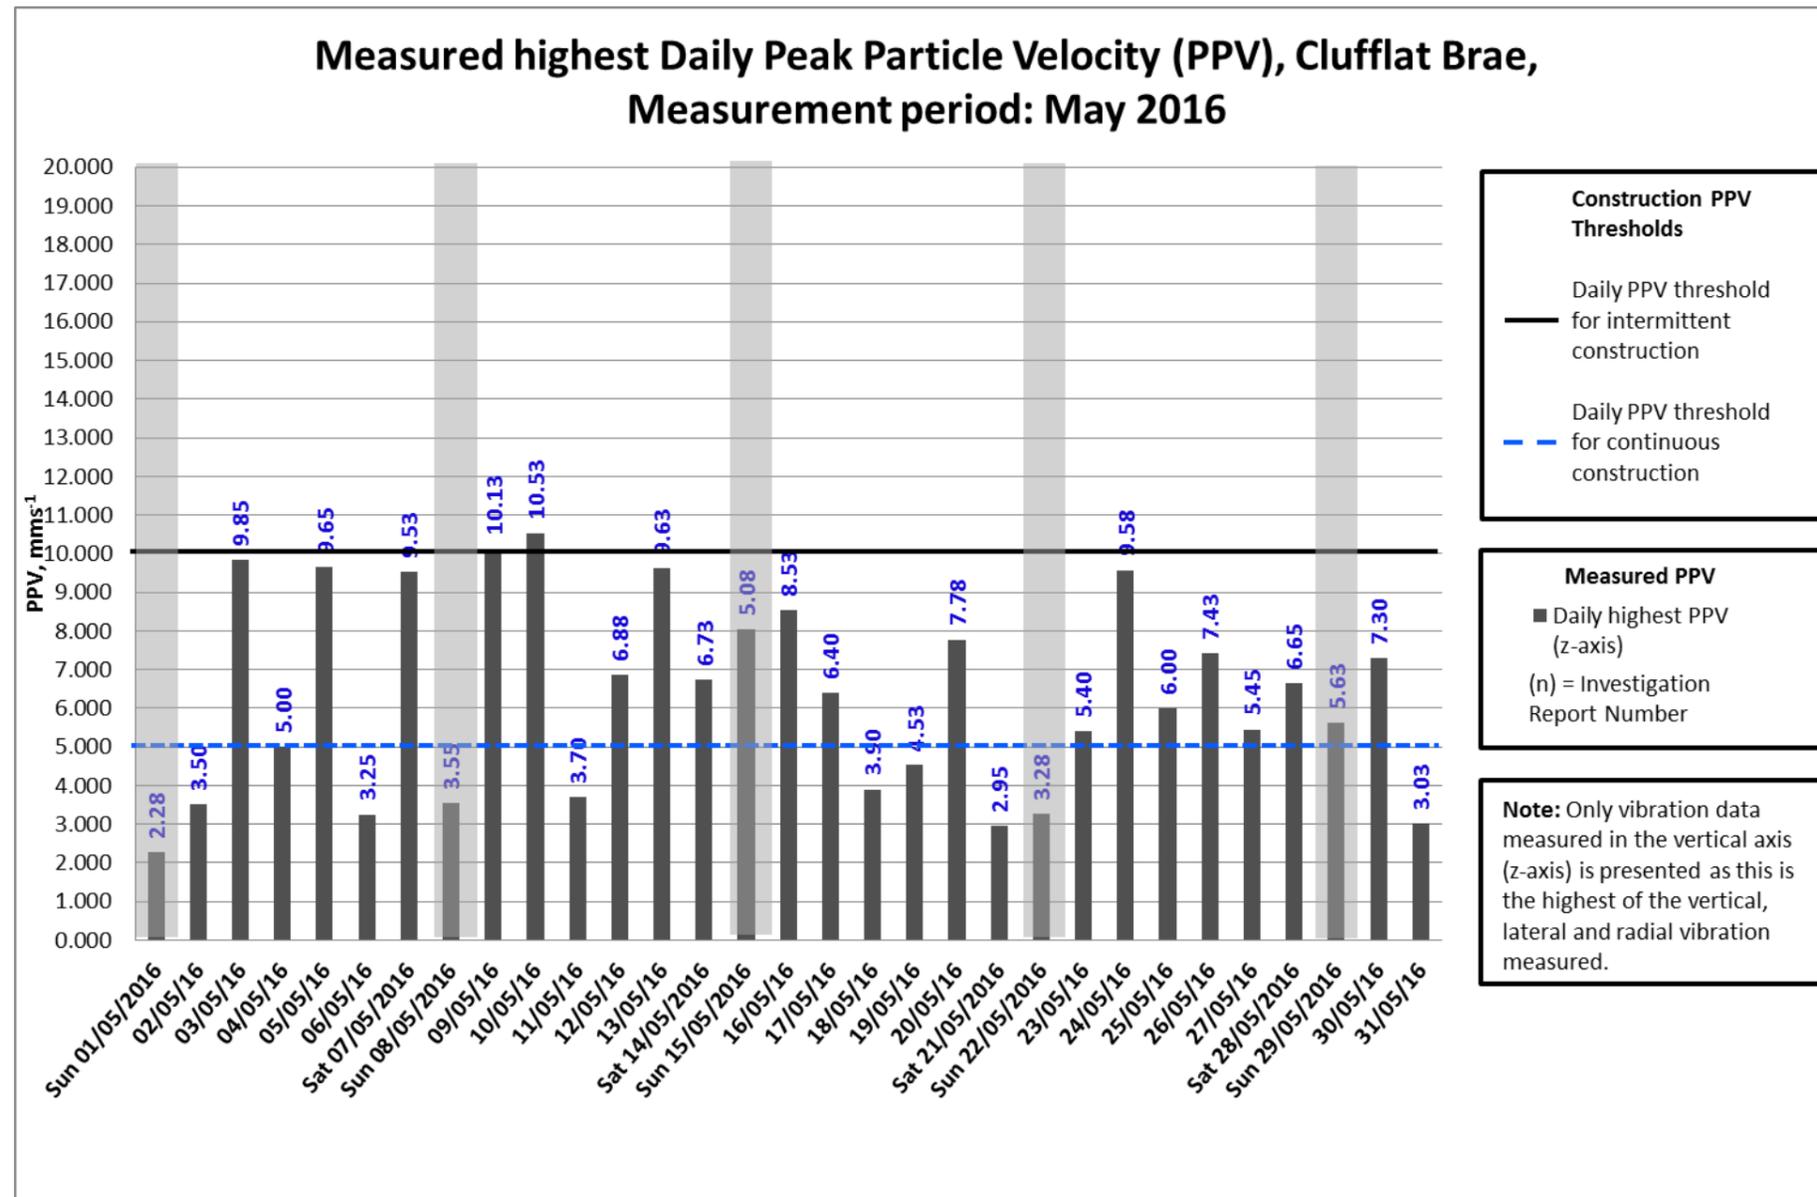
Exceedances on the 3<sup>rd</sup>, 10<sup>th</sup>, 12<sup>th</sup>, 15<sup>th</sup> and 24<sup>th</sup> of May have been investigated and found to be caused out with construction working hours and therefore it is unlikely that construction related activity was the cause of these (graph above from the 03/05/2016).

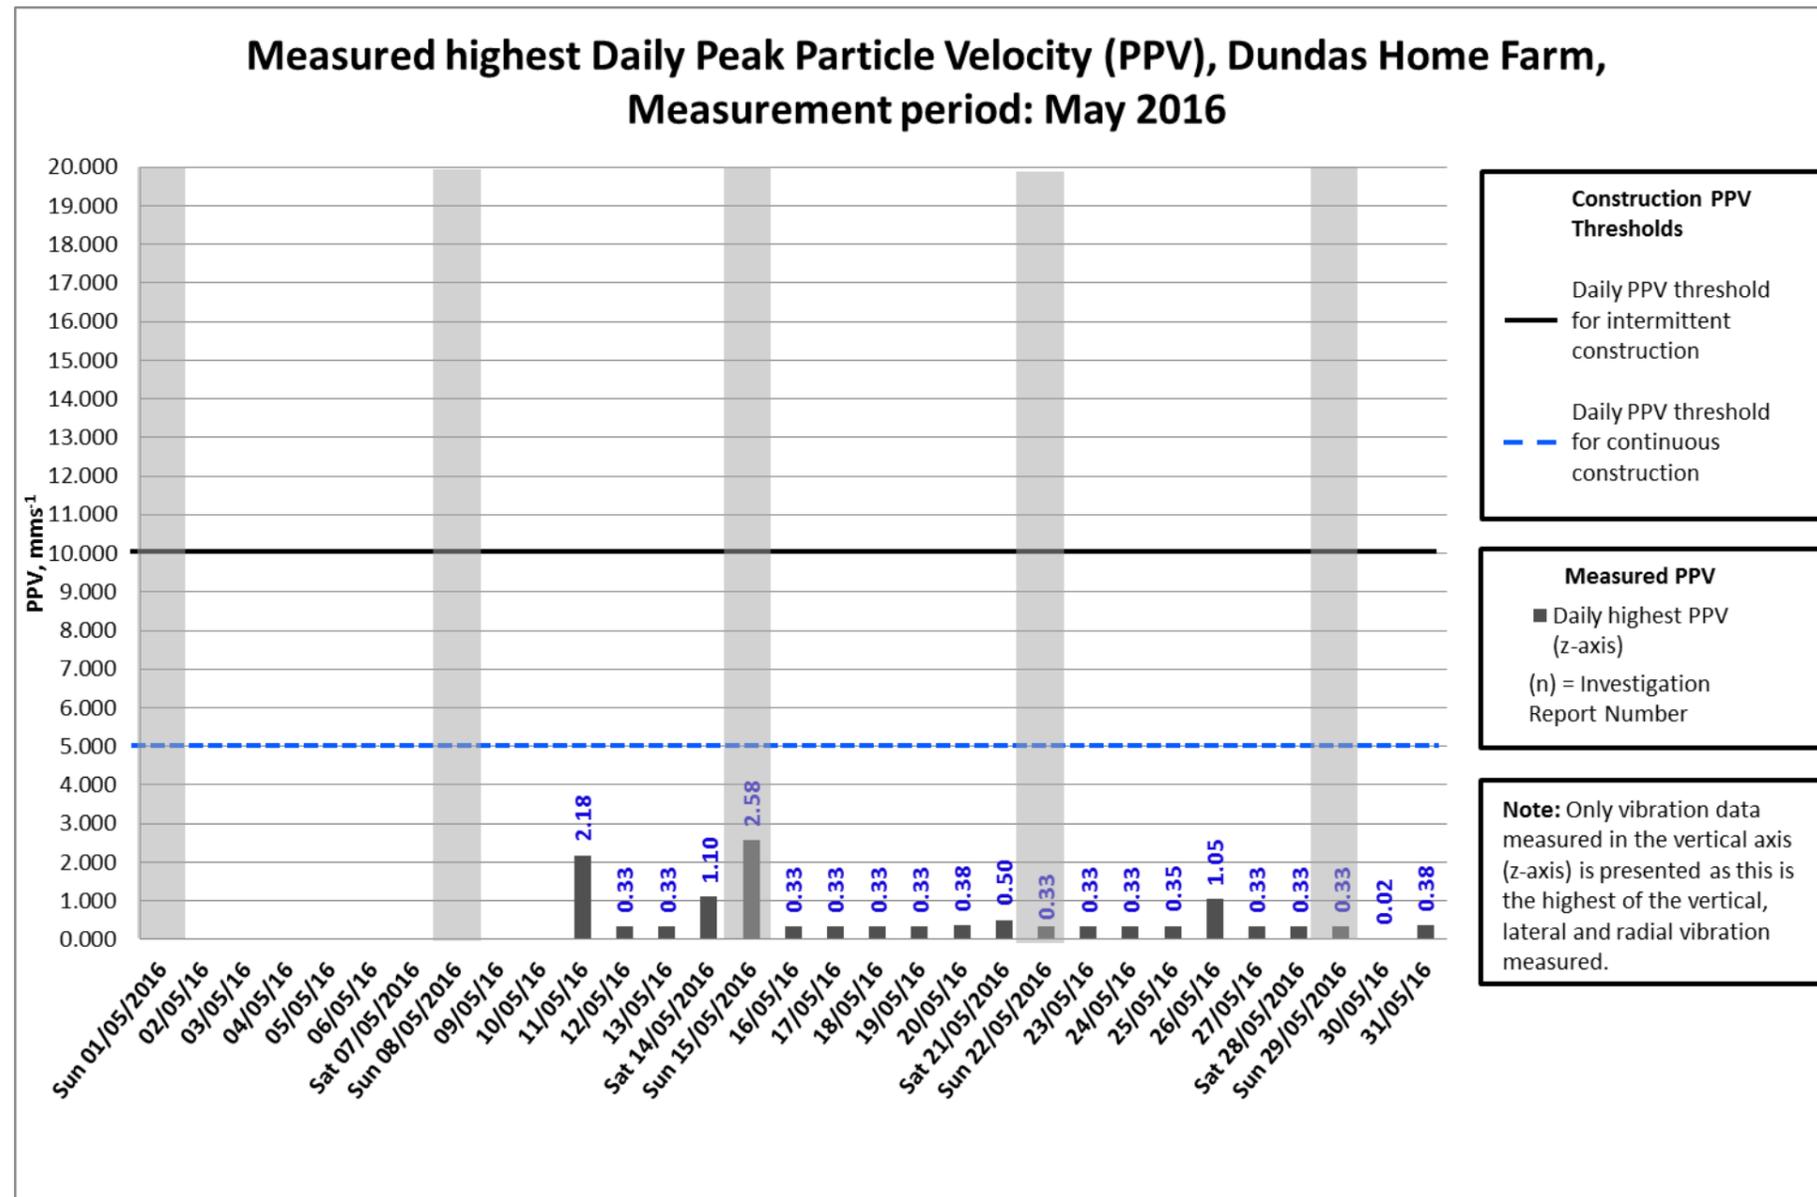
Data missing from the 1<sup>st</sup> to the 10<sup>th</sup> of May was caused by power issue at the monitor location. This has since been resolved on the 11<sup>th</sup> of May.

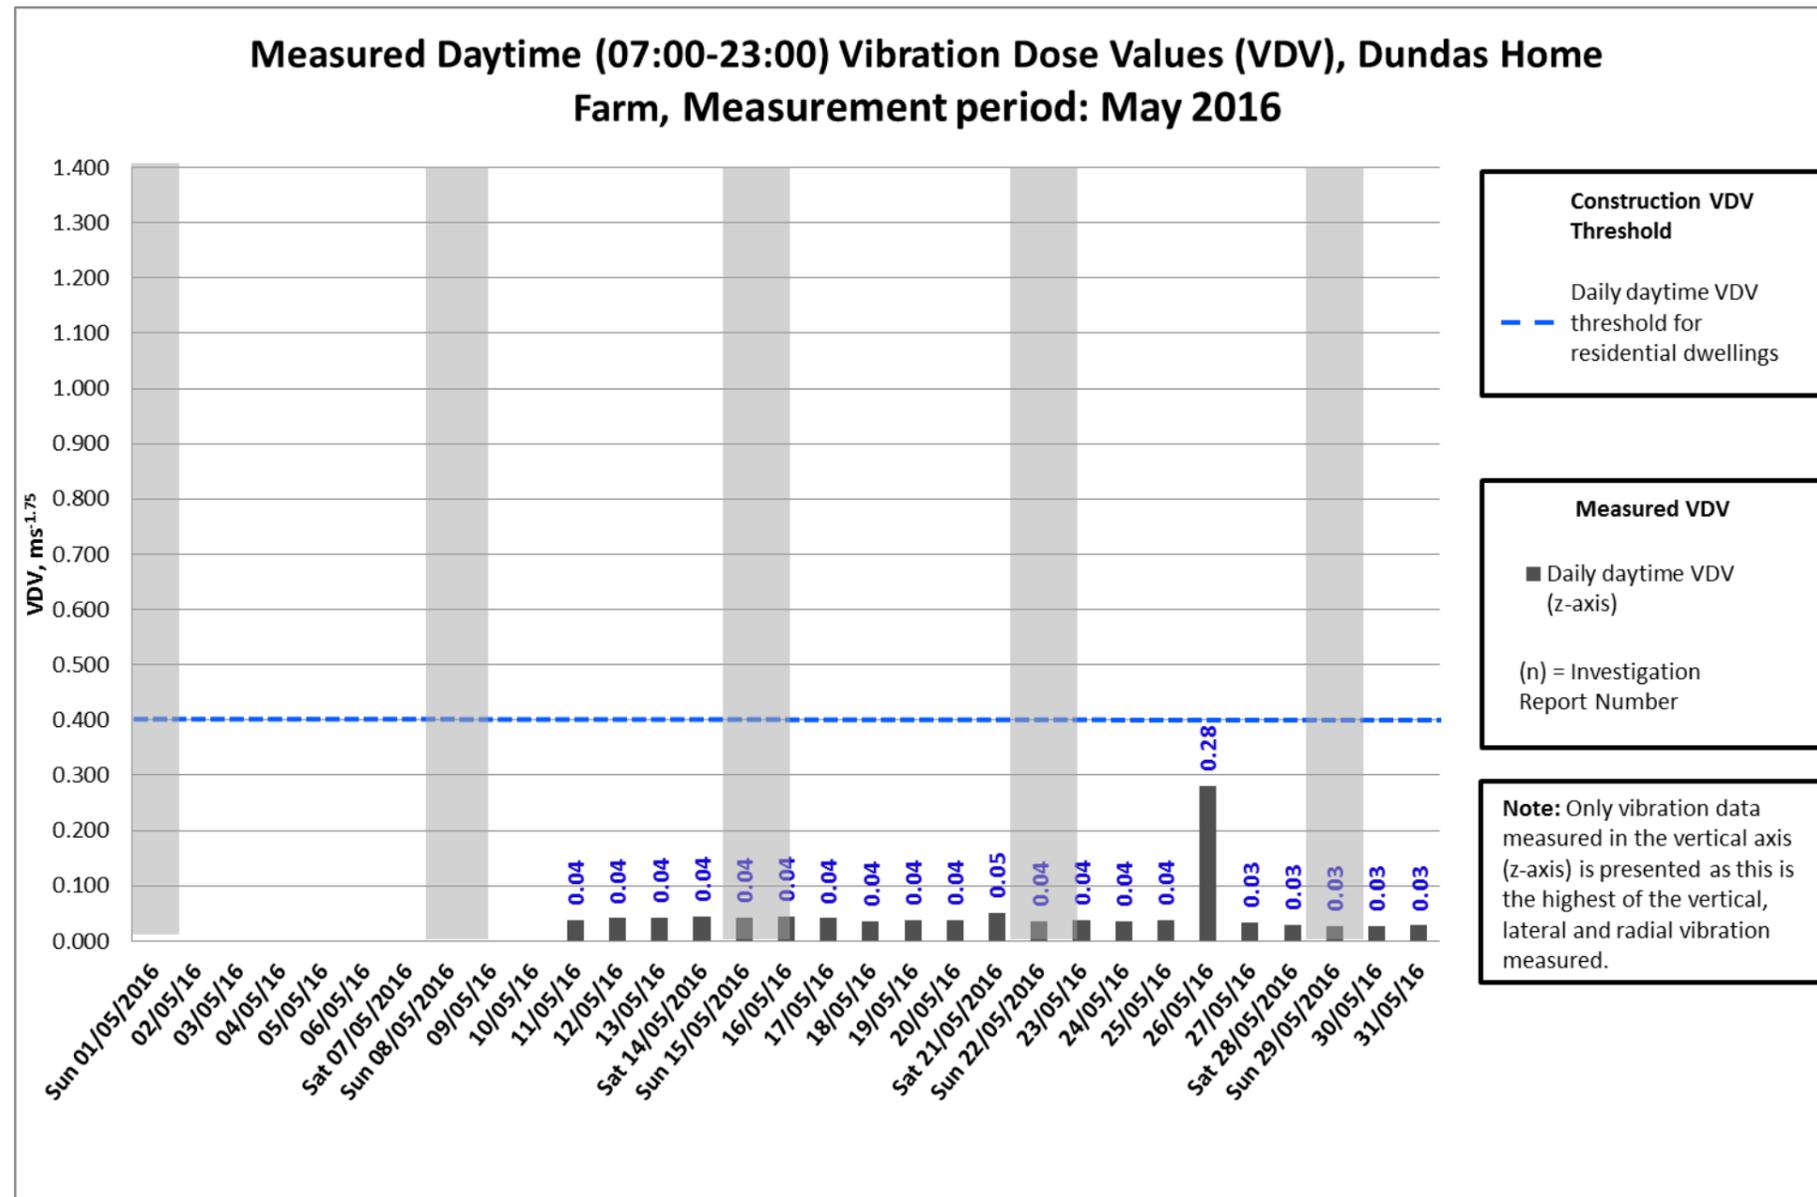
Data missing from the 1<sup>st</sup> to the 10<sup>th</sup> of May was caused by power issue at the monitor location. This has since been resolved on the 11<sup>th</sup> of May.

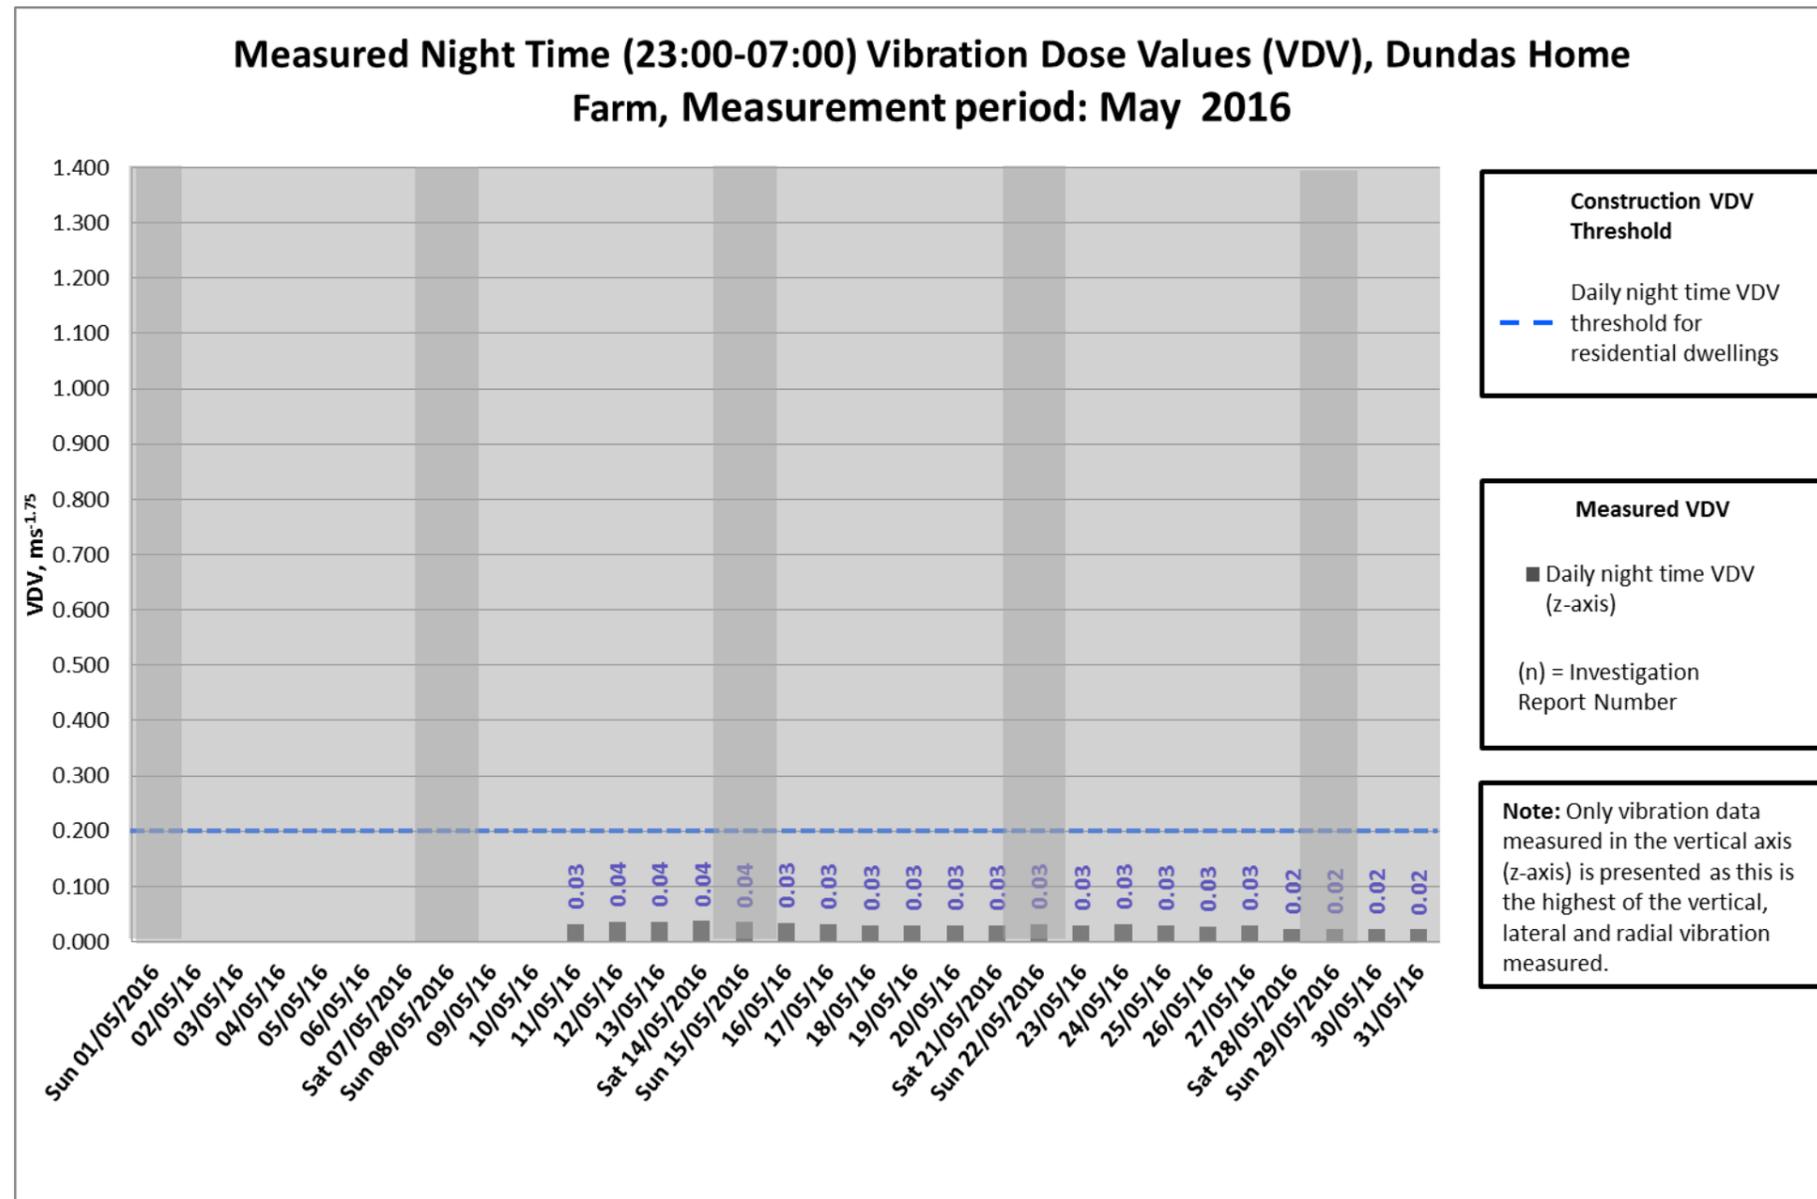
Data missing from the 1<sup>st</sup> to the 10<sup>th</sup> of May was caused by power issue at the monitor location. This has since been resolved on the 11<sup>th</sup> of May.

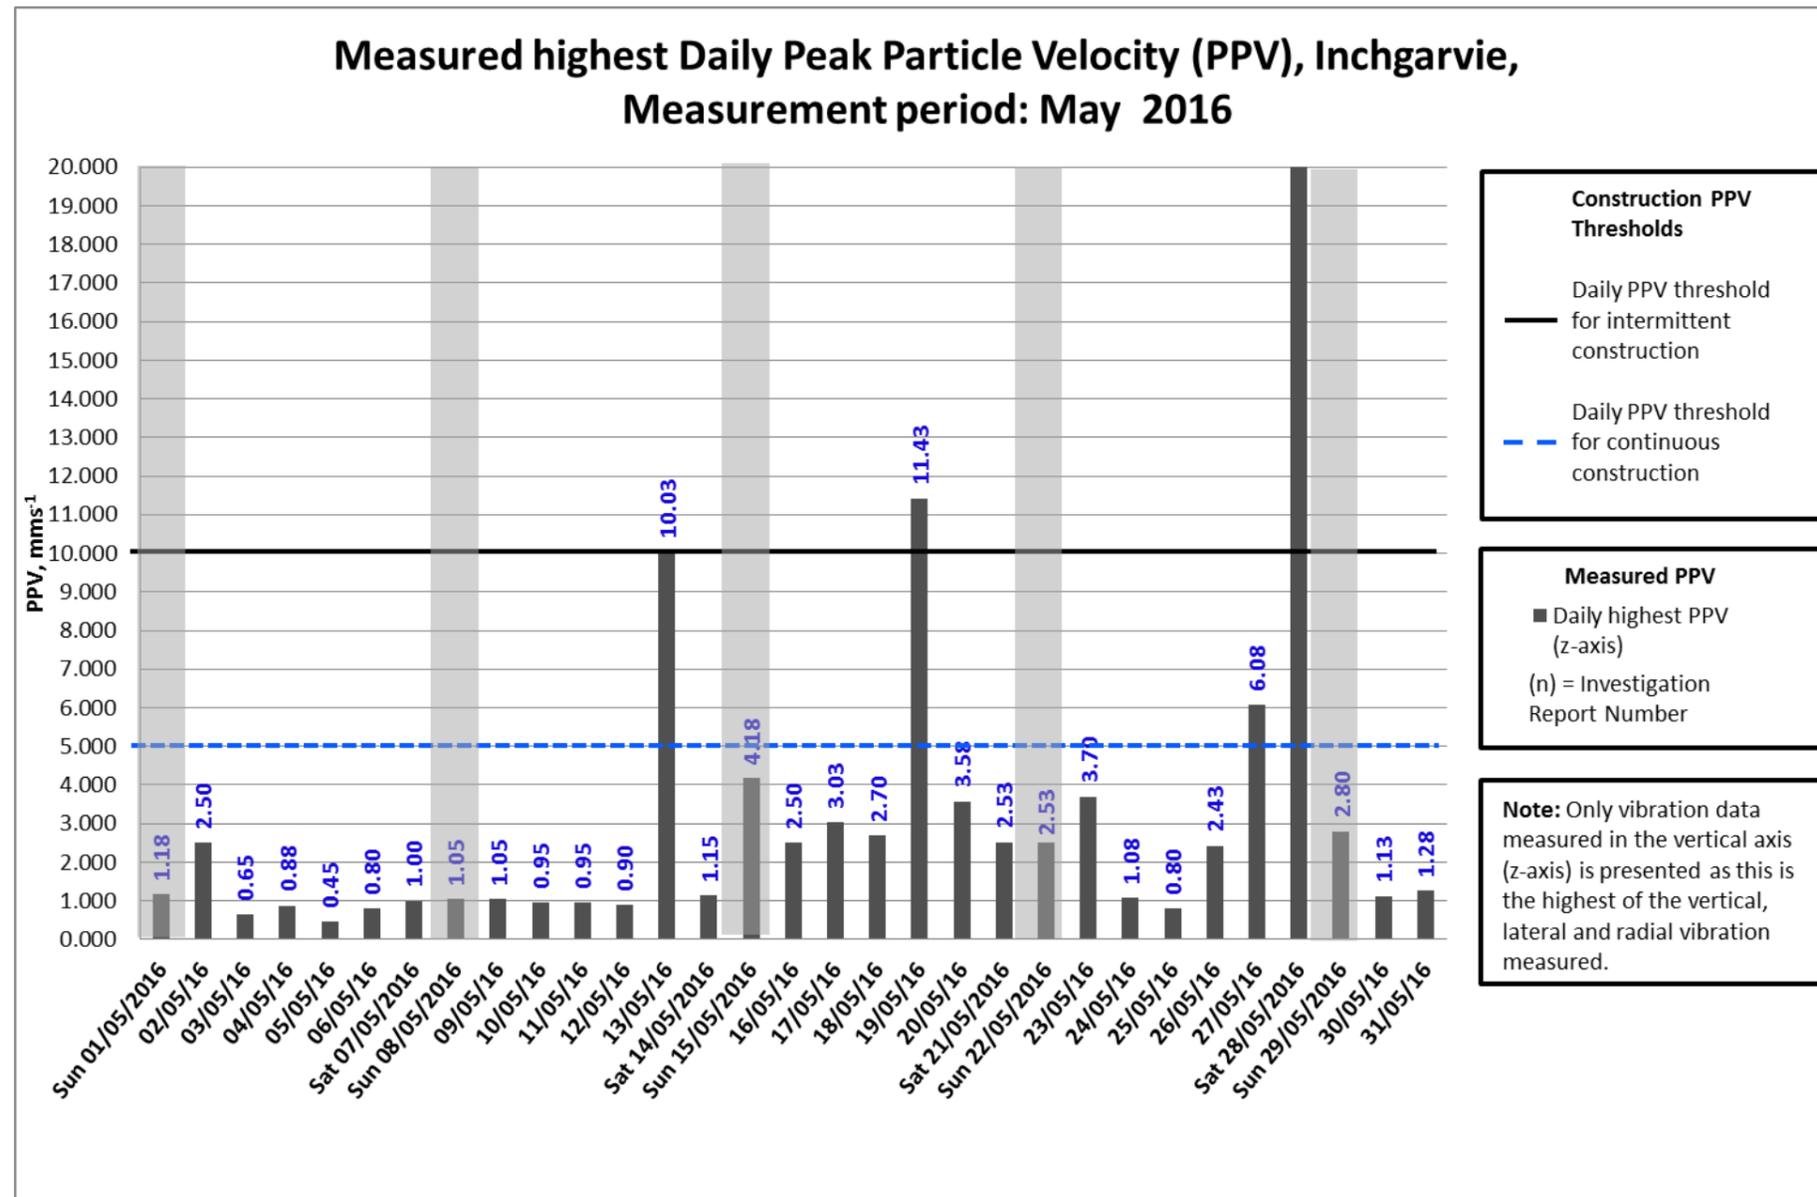
Exceedances on the 13<sup>th</sup> and 19<sup>th</sup> of May have been investigated and found to be caused out with construction working hours and therefore it is unlikely that construction related activity was the cause of these (graph above from the 13/05/2016).

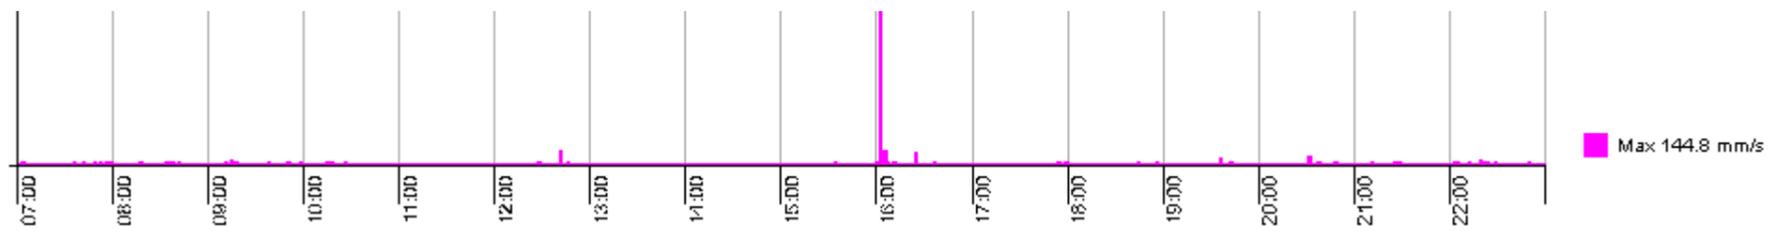
Exceedances on the 27<sup>th</sup> and 28<sup>th</sup> of May have been investigated and found to be caused by individual isolated events that are unlikely to have been construction related activities (graph above from the 28/05/2016).

During this period the resident at the property, where the monitor is situated, has ongoing private construction works. It is likely that exceedances within the graph above were caused by the works on the property rather than the construction of the new crossing and supporting infrastructure.

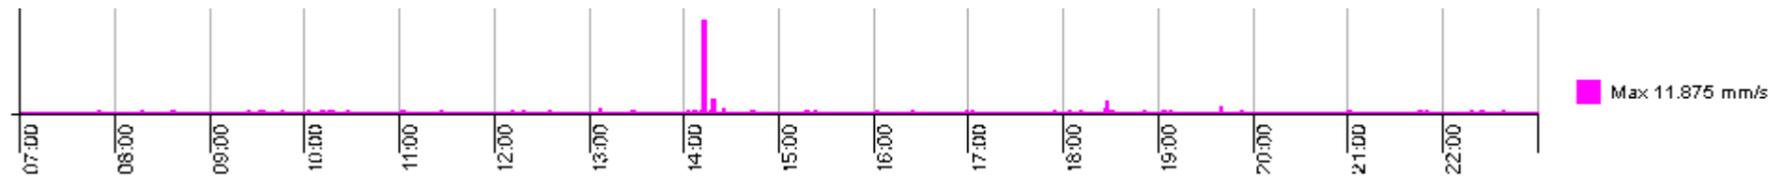
Exceedances on the 3<sup>rd</sup>, 4<sup>th</sup>, 12<sup>th</sup>, 14<sup>th</sup>, 17<sup>th</sup>, 18<sup>th</sup> and 27<sup>th</sup> of May have been investigated and found to be caused by individual isolated events that are unlikely to have been construction related activities (graph above from the 12/05/2016).

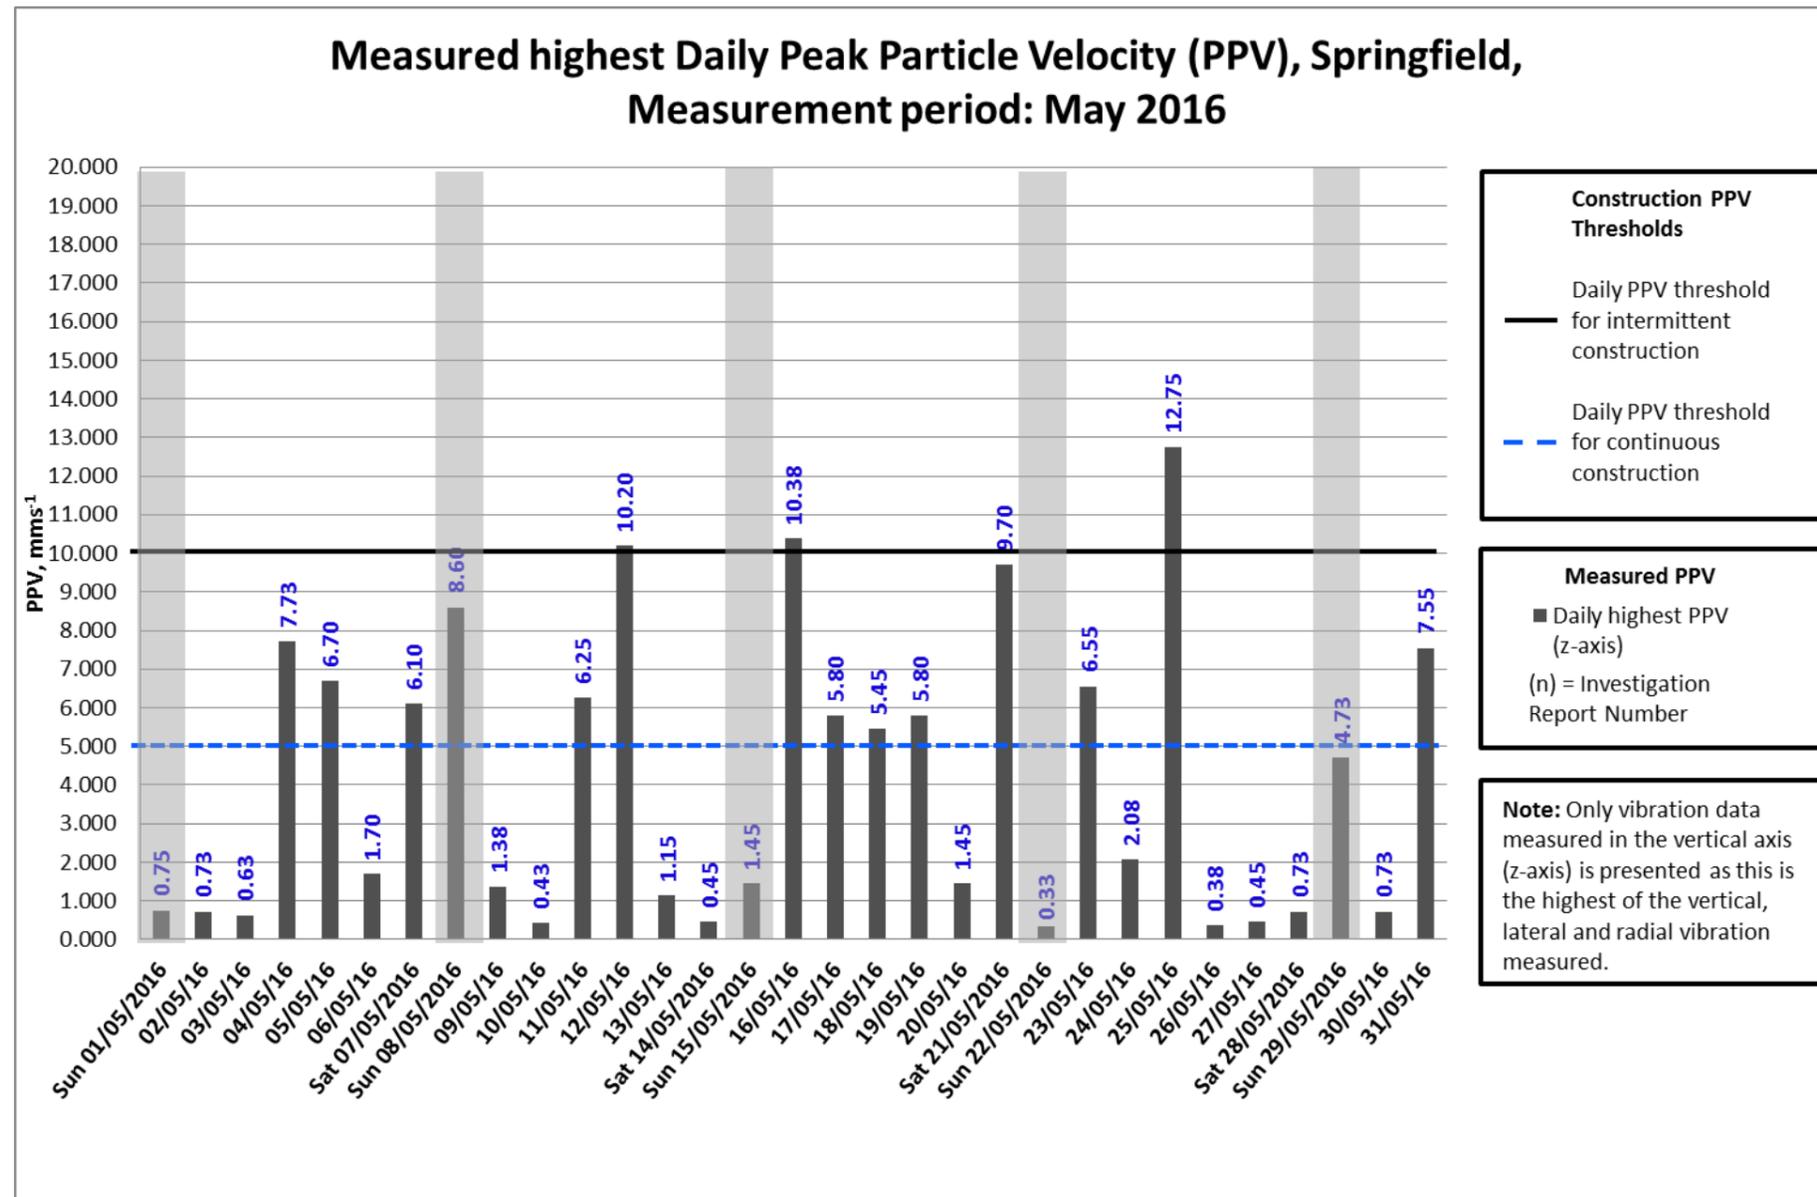
Exceedances on the 4<sup>th</sup>, 7<sup>th</sup>, 11<sup>th</sup>, 12<sup>th</sup>, 17<sup>th</sup>, 21<sup>st</sup>, 23<sup>rd</sup>, 25<sup>th</sup> and 31<sup>st</sup> of May have been investigated and found to be caused by individual isolated events that are unlikely to have been construction related activities (graph above from the 12/05/2016) .

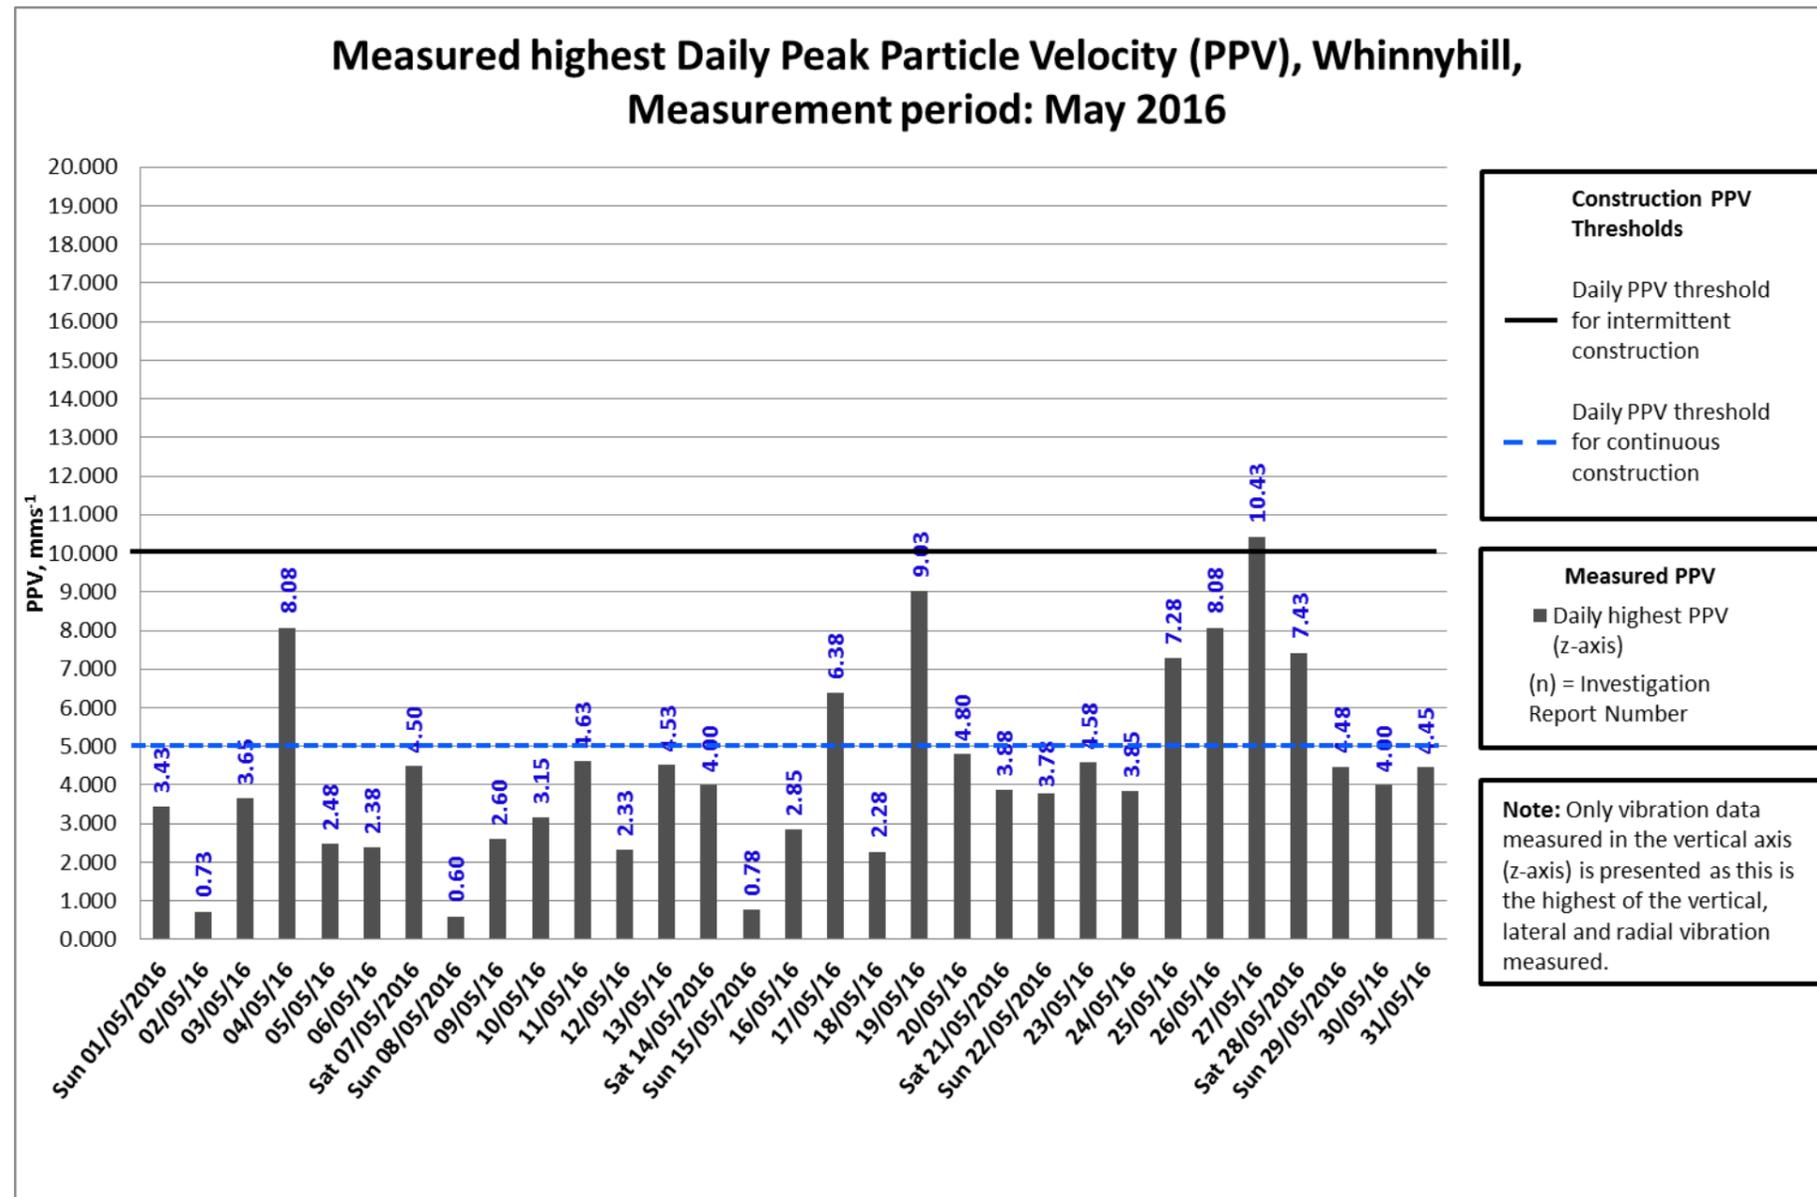
Exceedances on the 17<sup>th</sup>, 19<sup>th</sup>, 25<sup>th</sup>, 26<sup>th</sup>, 27<sup>th</sup> and 28<sup>th</sup> of May have been investigated and found to be caused by individual isolated events that are unlikely to have been construction related activities (graph above from the 17/05/2016).
