Project **FORTH REPLACEMENT CROSSING**

**VIBRATION MONITORING REPORT
NOVEMBER 2015**

Document number	Rev
REP-00260	00

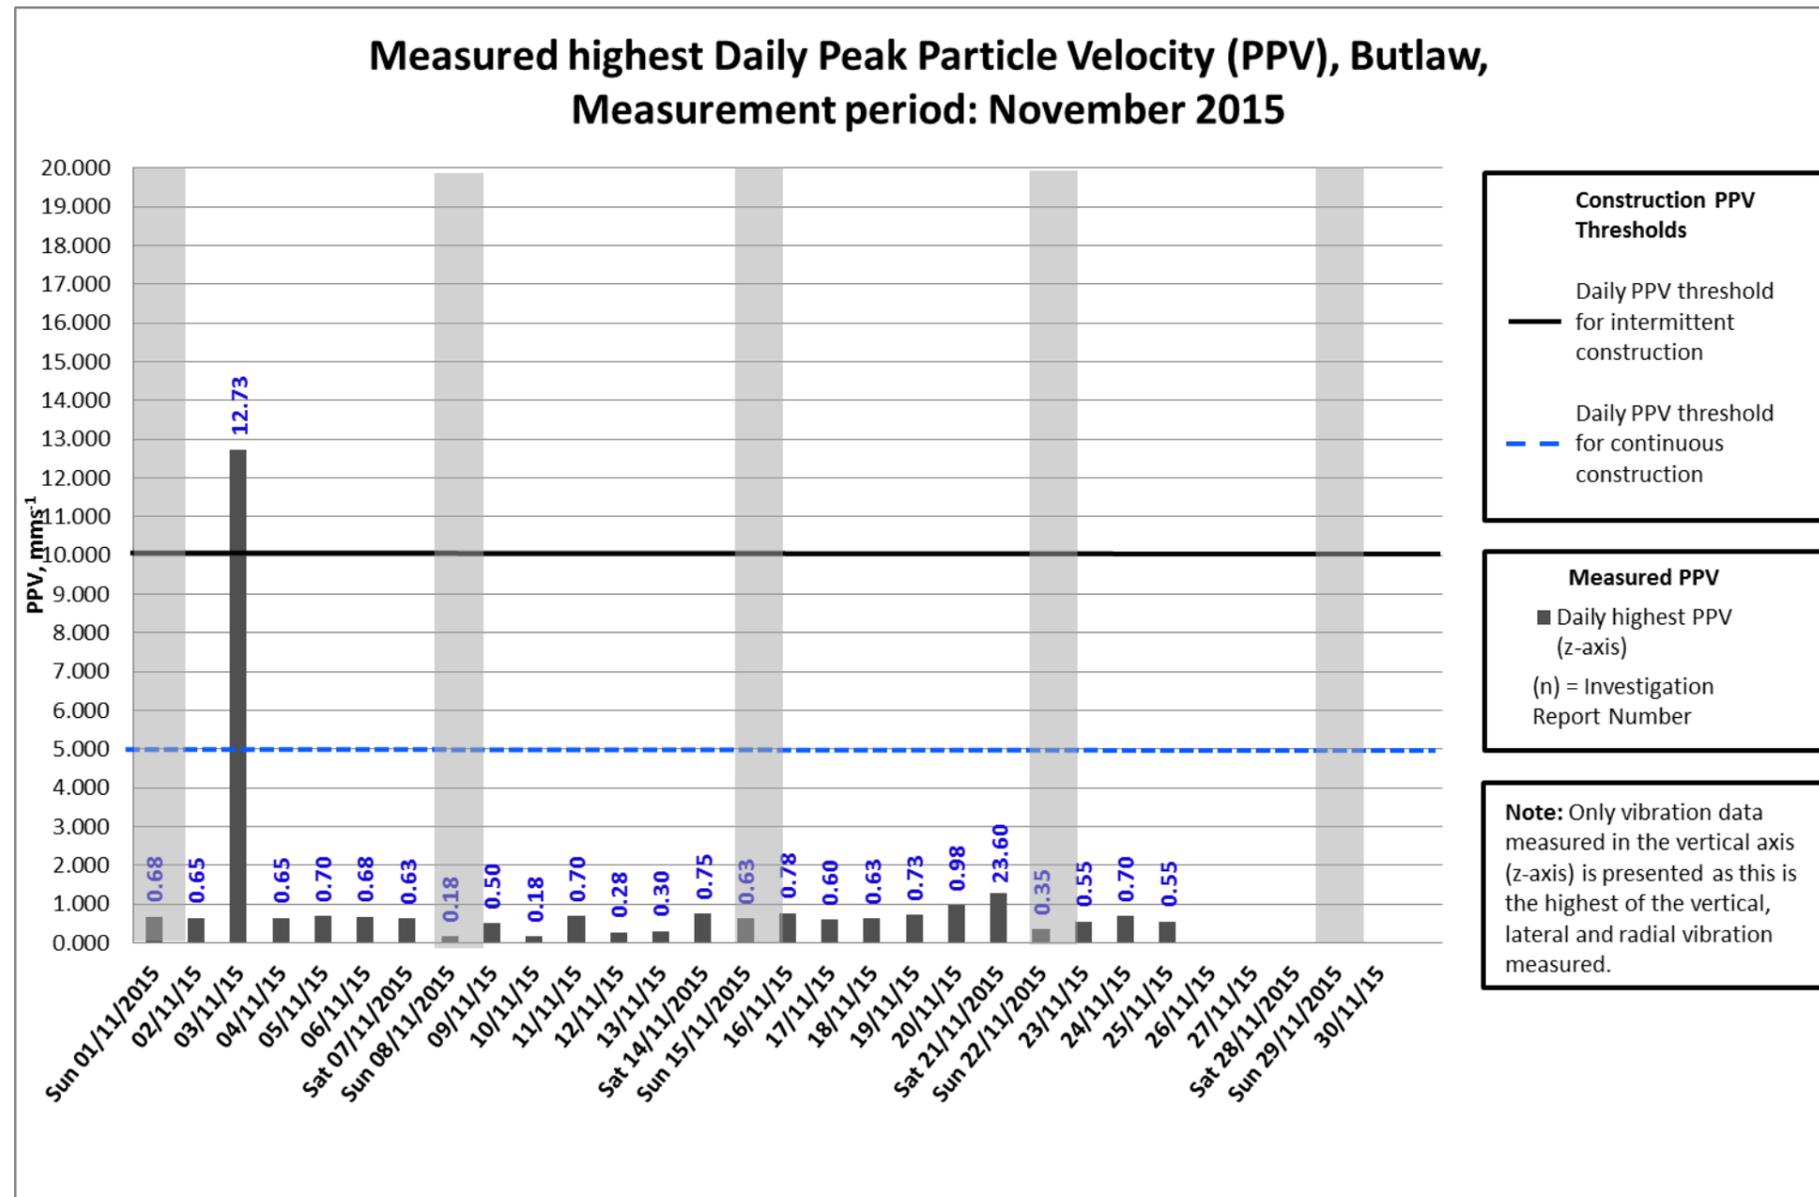
Exceedance on the 03/11/15 has been investigated and found that the exceedance was out with working hours and highly unlikely to be caused by construction related activities.

Vibration levels missing from 26/11/15-30/11/15 was caused by a power fault at the monitor this has since been repaired.

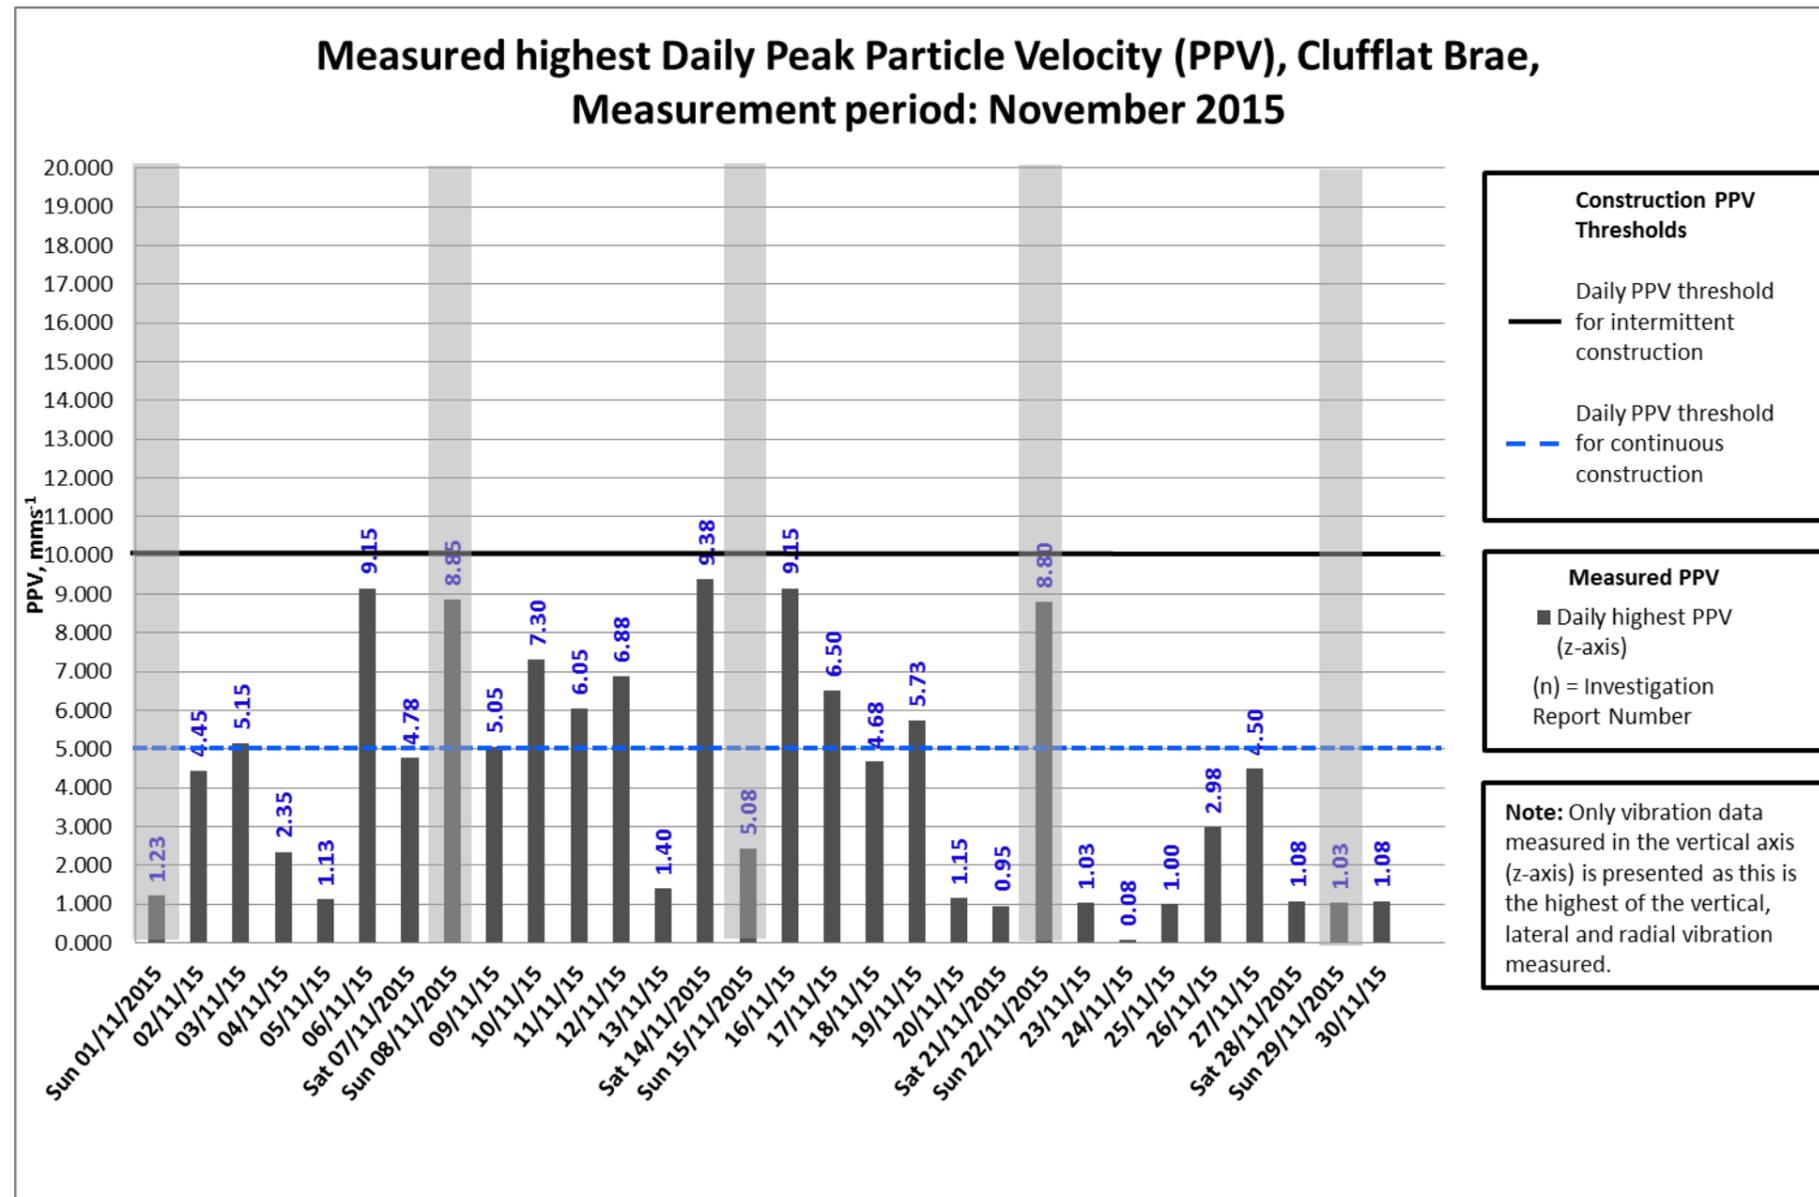
Exceedance on the 3rd, 6th, 9th, 10th, 11th, 12th, 14th, 16th, 17th, and 19th of November have been investigated and found to be one off isolated events which are highly unlikely to be caused by construction related activities (graph above from the 06/11/2015).

Exceedances on the 8th and 22nd of November were caused on a day that is out of normal working hours and are highly unlikely to be caused by construction related activities.

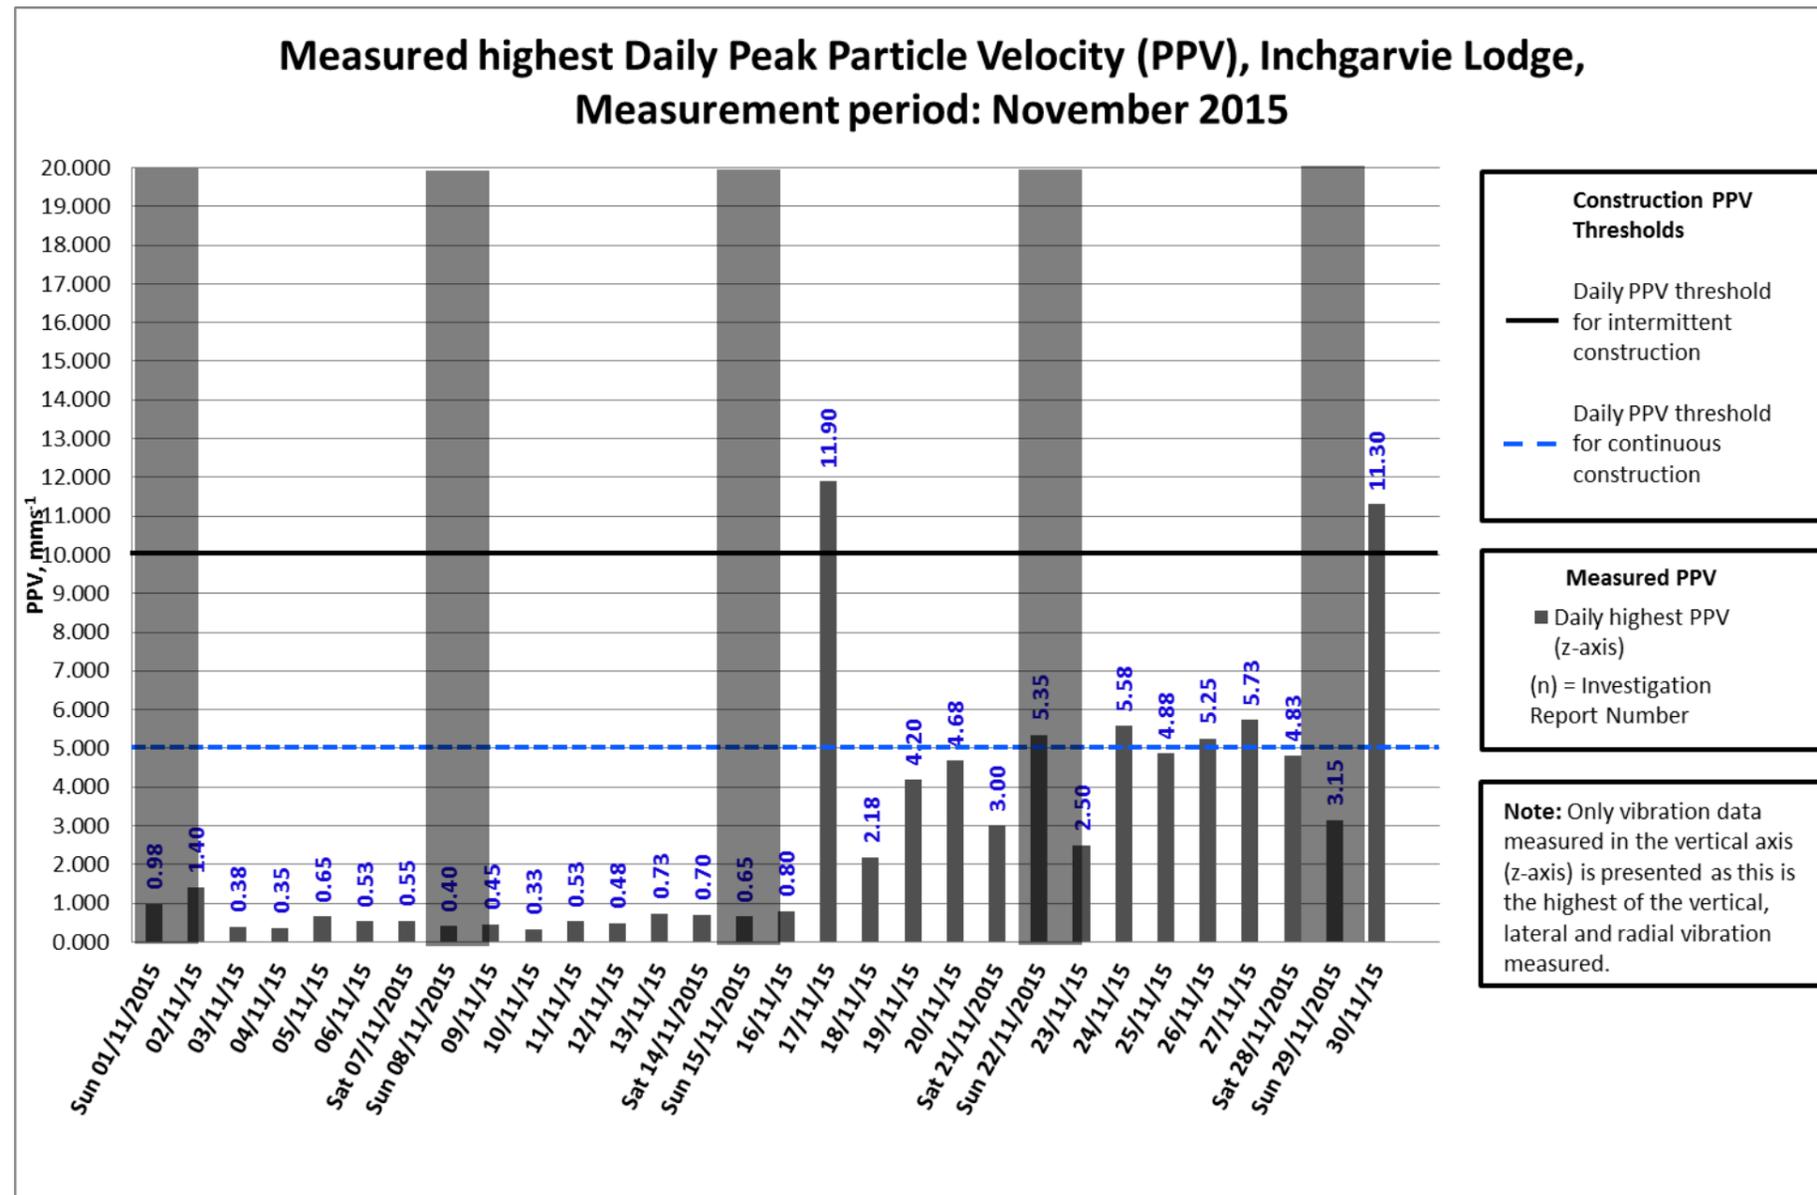
Exceedances on the 17th, 26th, and 27th have been investigated and found to be caused by isolated events that are highly unlikely to be caused by construction related activities.

Exceedances on the 22nd, 24th and 30th have been investigated and found to be out with working hours and are highly unlikely to be caused by construction related activities.

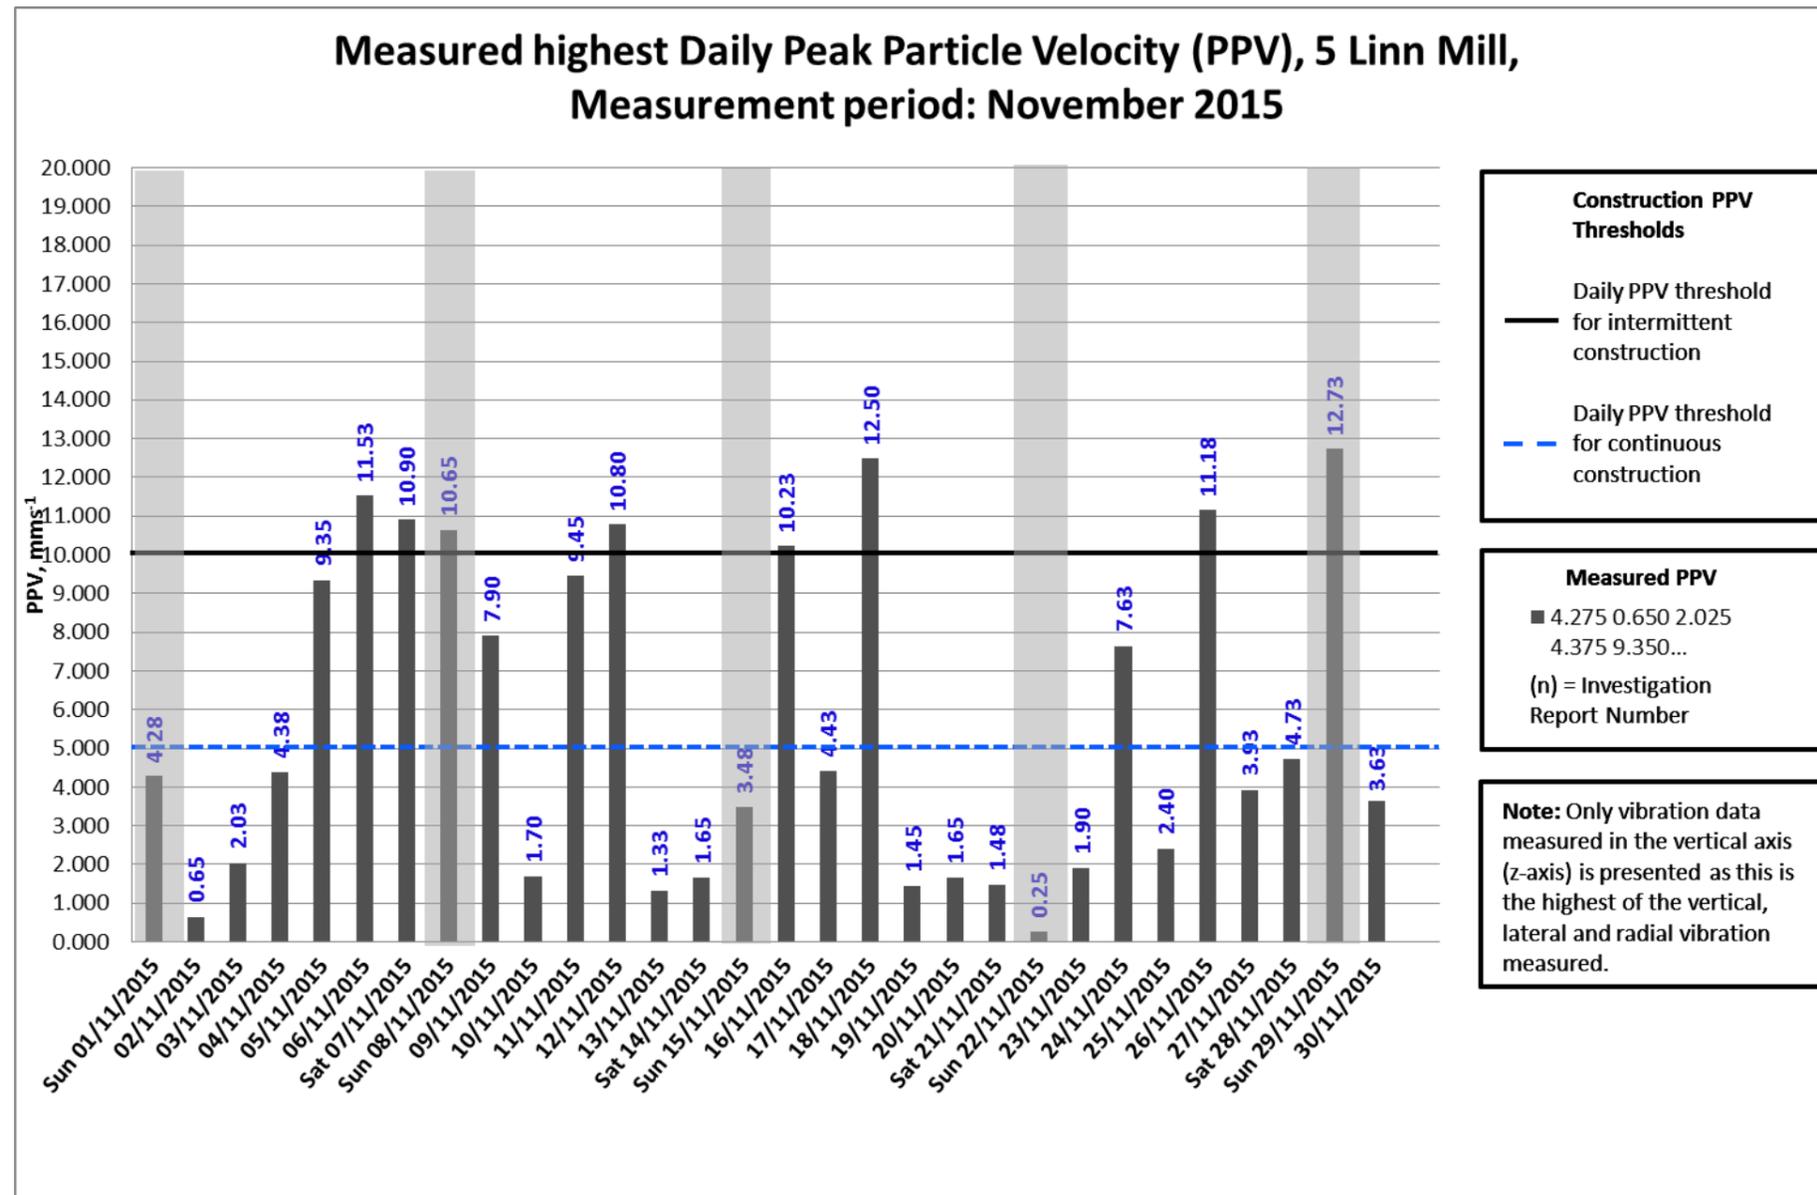
Exceedances on the 5th, 7th, 9th, 12th, 16th, and 26th have been investigated and the results are inconclusive to the defined source of the vibration however these intermittent vibration levels are highly likely to have been caused by the local residents movement to get logs from his/her log store outside which is located closely to FCBC's vibration monitor (graph above from the 07/11/2015).

Exceedances on the 8th, 11th, and 29th have been investigated and found to be out with construction working hours and is highly unlikely to be caused by construction related activities (graph above from the 11/11/2015).

Exceedances on the 6th, 18th and 24th have been investigated and found to be one off isolated events which are highly unlikely to be caused by construction related activities (graph above from the 06/11/2015).

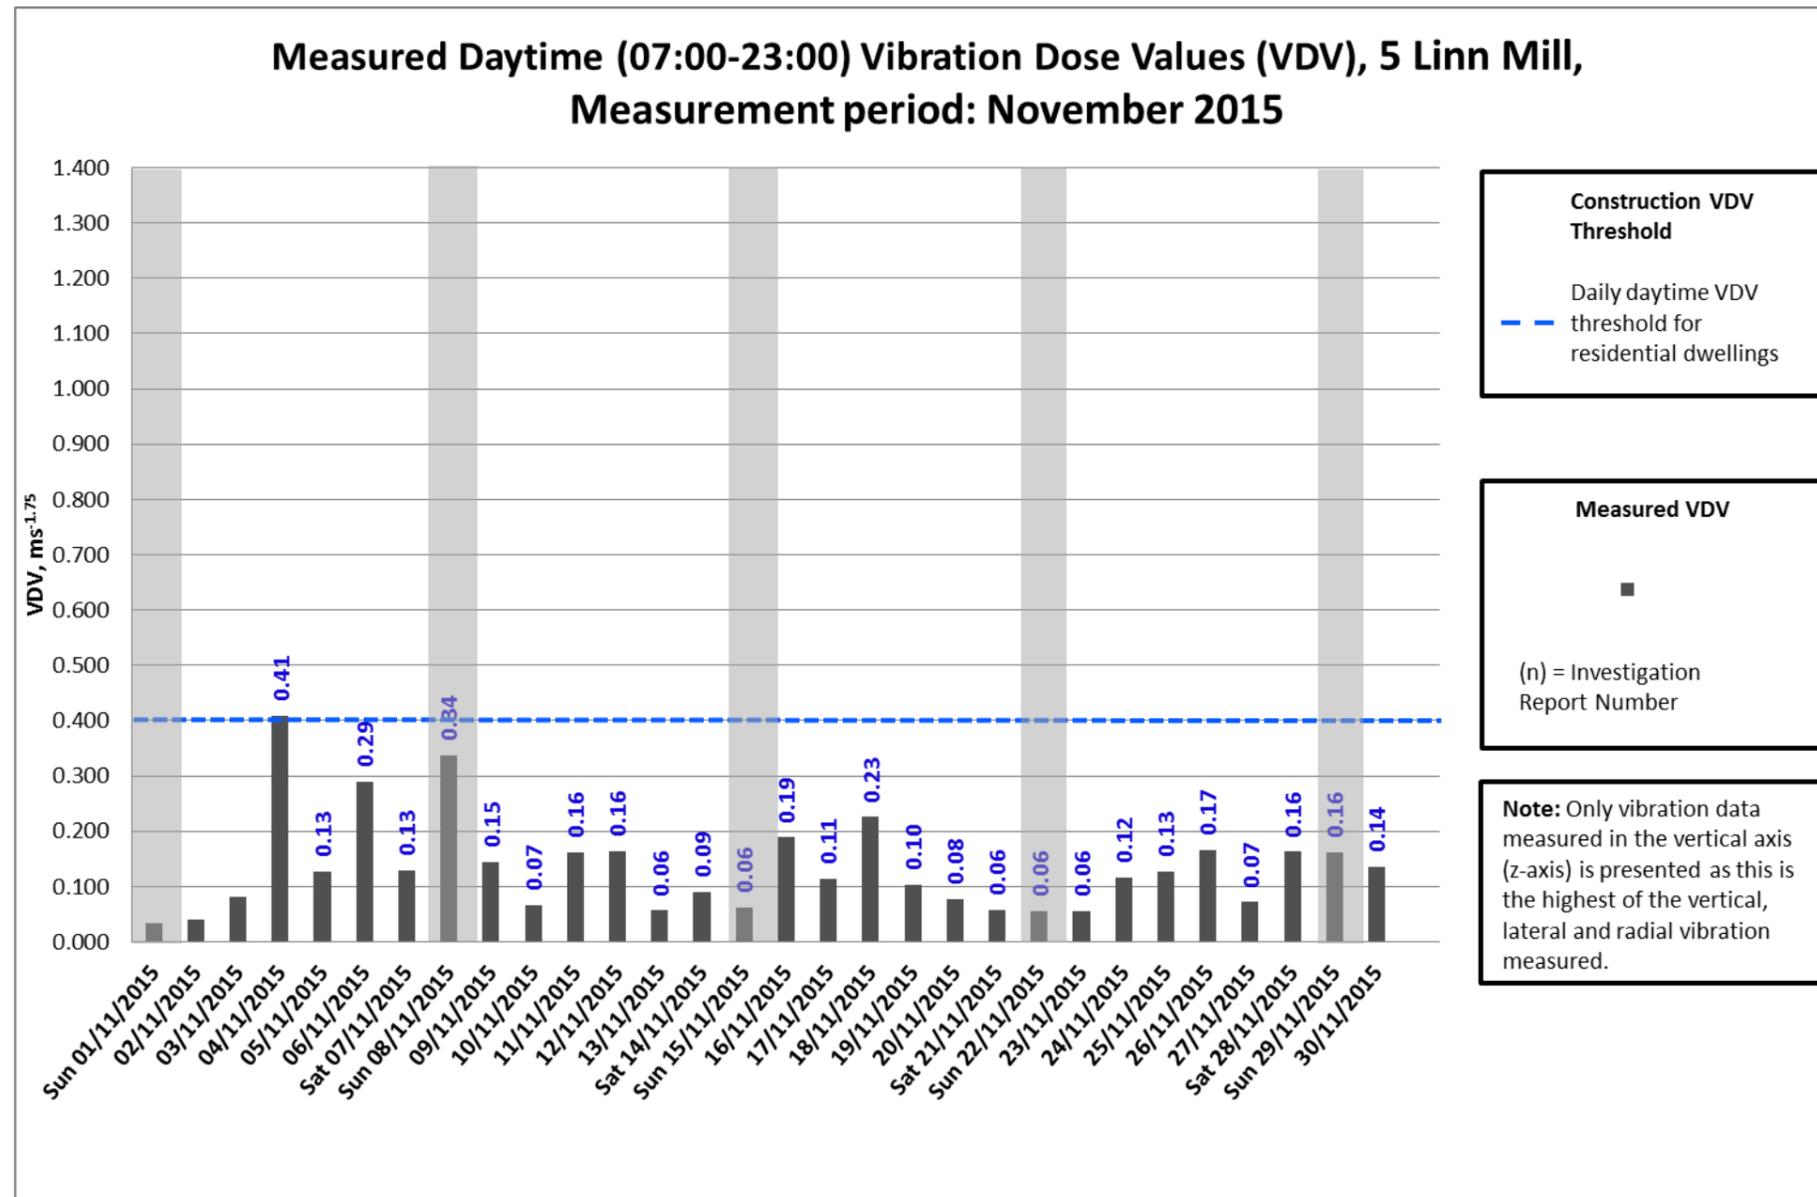
Exceedance on the 04/11/2015 has been investigated and the results are inconclusive to the defined source of the vibration however these two isolated events are highly likely to have been caused by the local residents movement to get logs from his/her log store outside which is located closely to FCBC's vibration monitor.

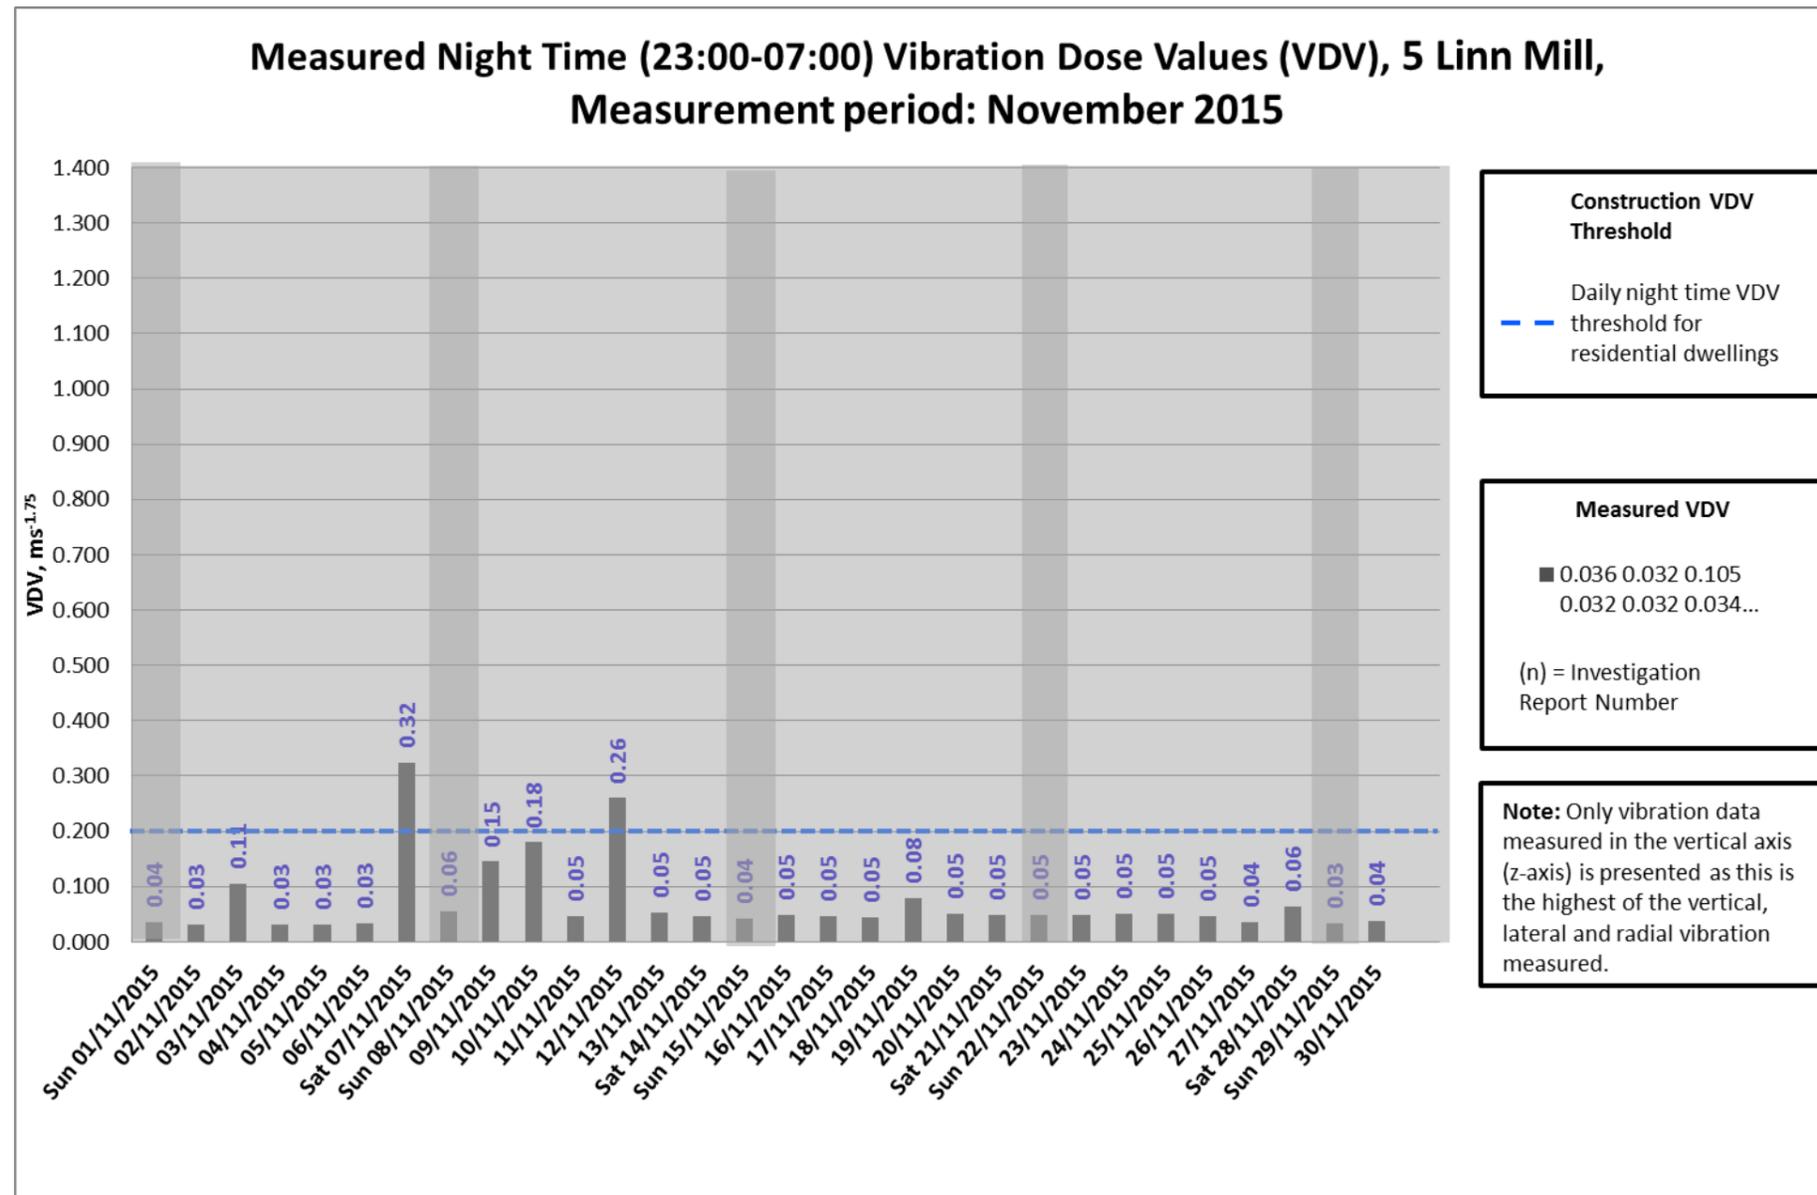
Exceedance on the 7th and 12th of November have been investigated and found to be one off isolated events out with construction working hours and are highly unlikely to have been caused by construction related activities (graph above from the 07/11/2015).

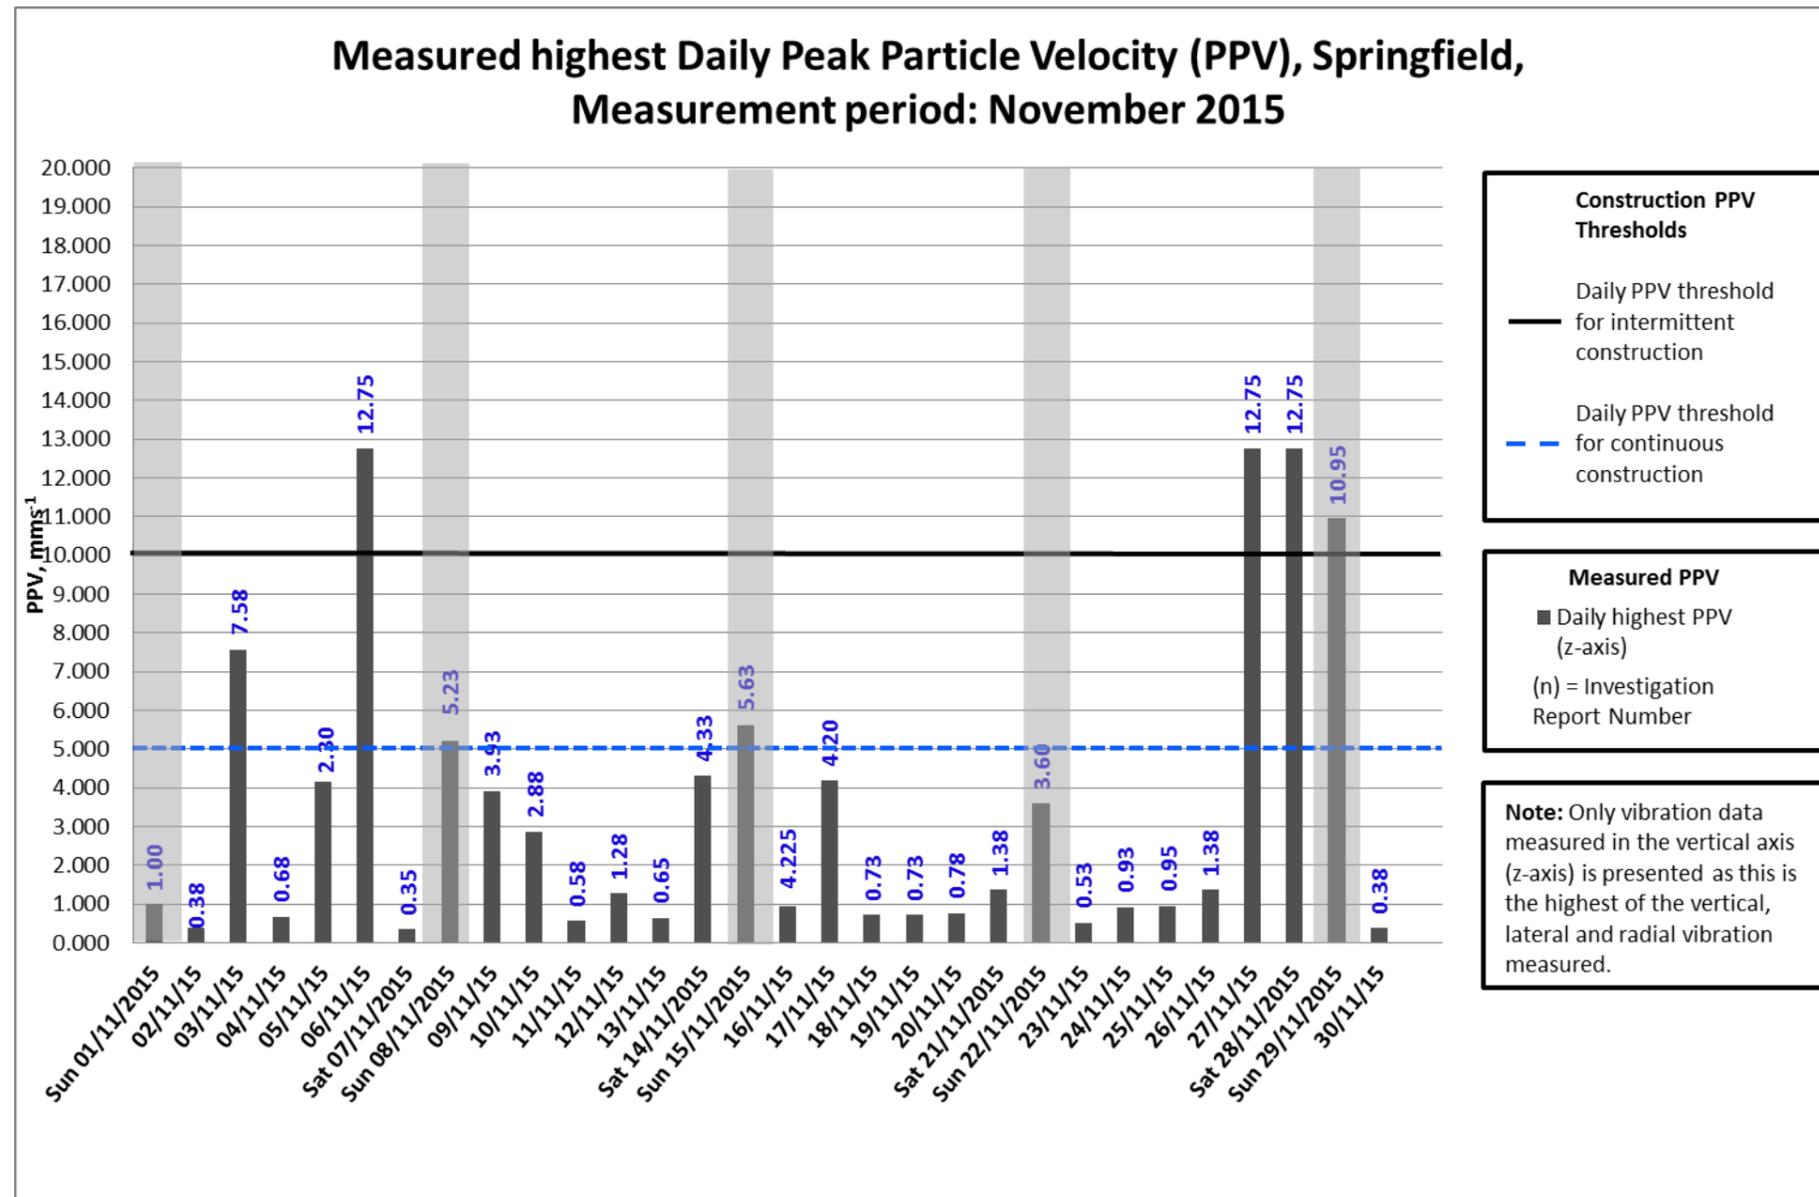
Exceedances on the 3rd, 6th, and 28th have been investigated and found to be caused by one off isolated events that are highly unlikely to have been caused by construction related activities (graph above from the 06/11/2015).

Exceedance on the 8th, 15th, 27th, and 29th have been investigated and found to be out with construction working hours and are highly unlikely to have been caused by construction related activities (graph above from the 27/11/2015).

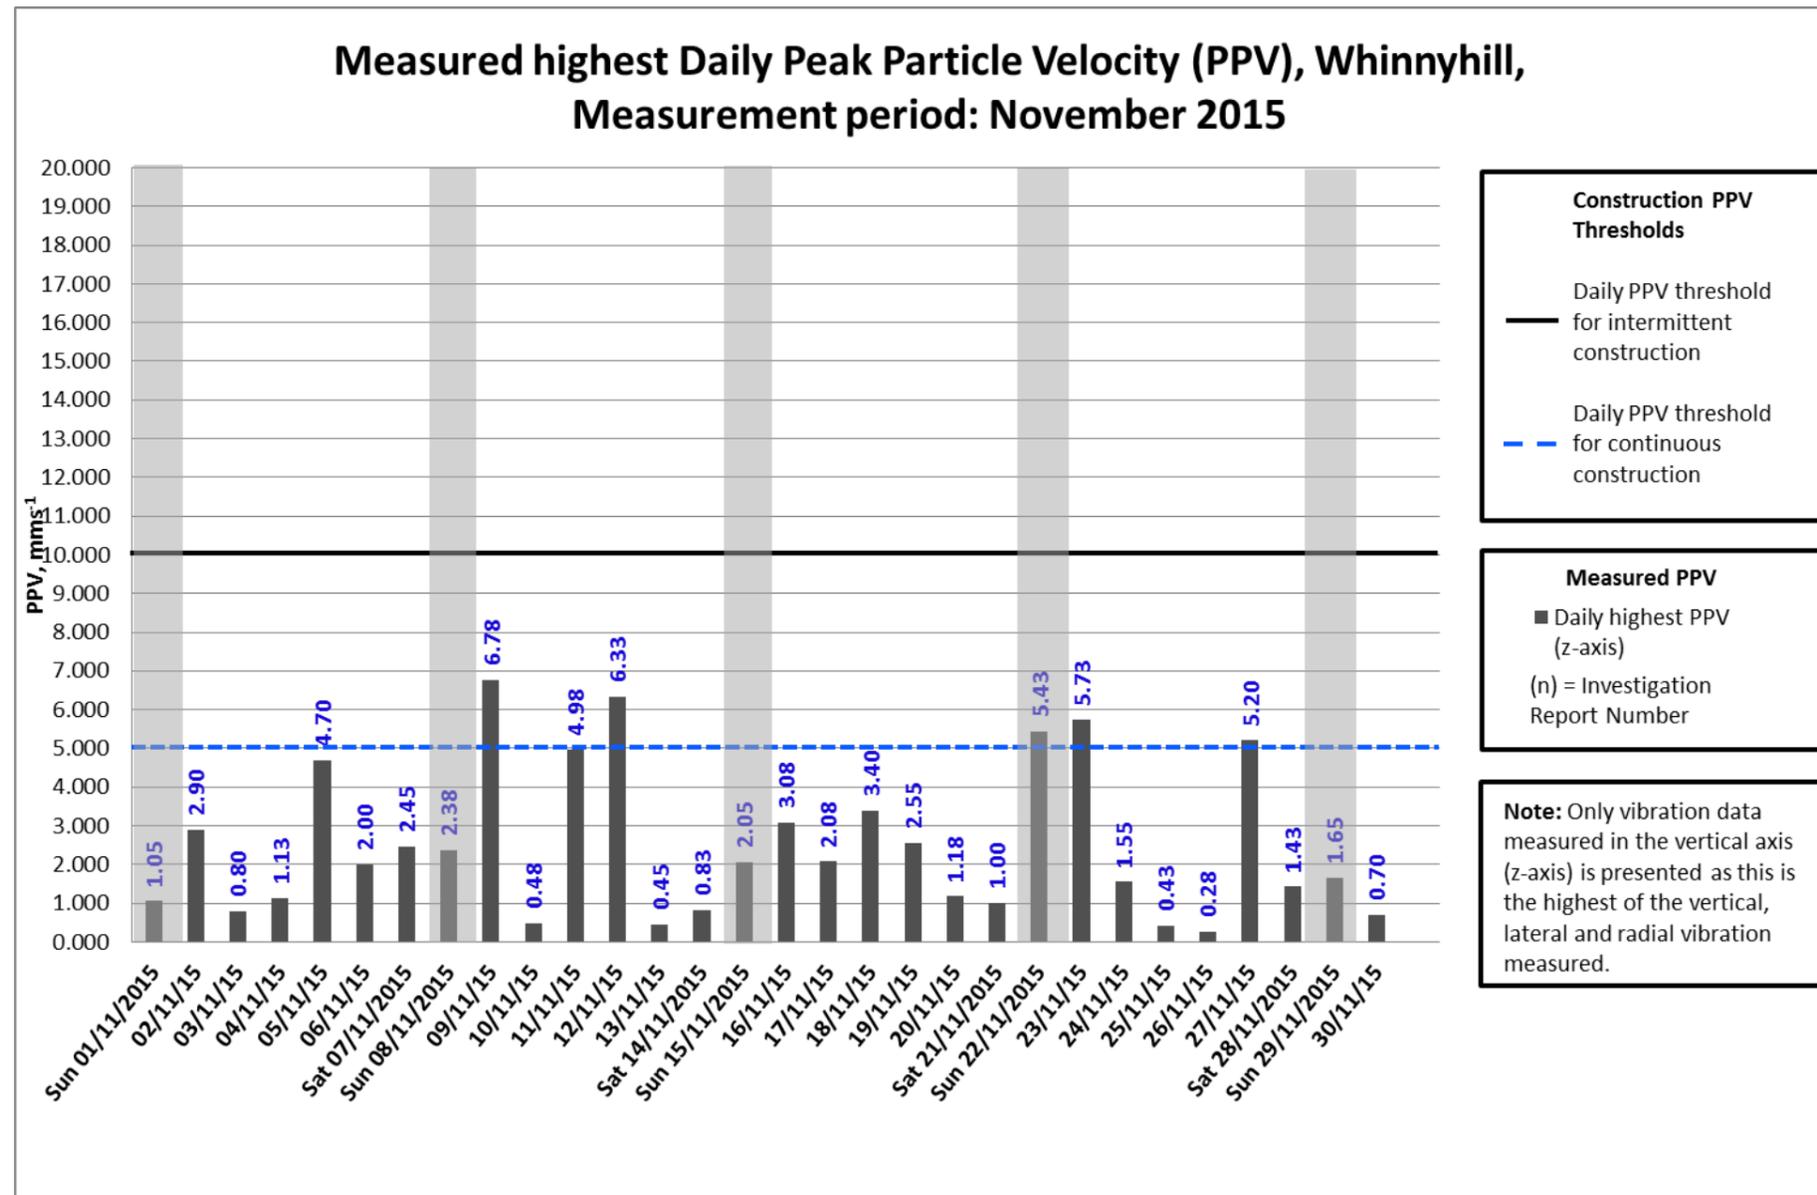
Exceedances on the 9th, 12th, and 22nd of November have been investigated and found to be caused out with construction working hours and are highly unlikely to be caused by construction related activities (graph above from the 09/11/2015).

Exceedances on the 23rd and 27th of November have been investigated and found to be individual isolated events that are highly unlikely to be cause by construction related activities (graph above from the 27/11/2015).
