Project **FORTH REPLACEMENT CROSSING**

VIBRATION MONITORING REPORT
OCTOBER 2016

Document status		FOR REVIEW	
Made by David Clark		Checked By: Steven Westwater	
Initials: DCK		Initials: SWR	
Document number			Rev
REP-00297			00
This document is intellectual property of FCBC Construction JV. Copying, distribution, usage, and information on contents of this are forbidden unless explicitly authorized.

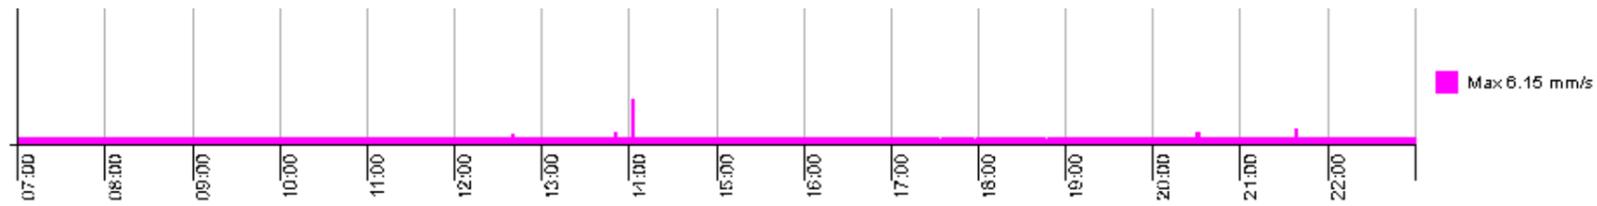
Exceedances on the 2nd, 3rd, 4th, 5th, 10th, 11th, 13th, 14th, 16th, 18th, 24th, 25th, 26th, 28th, 29th, 30th and 31st of October have been investigated and found to be caused by individual isolated events (graph above from the 02/10/2016). With the monitor being located in a public amenity area there is a likelihood that the exceedances seen above might have been caused by pedestrians using this area. However it is worth noting that during this period, there have been works ongoing at the Suds pond east of the south abutment, approximately 30m away. Due to this and the fact that there isn't any supporting evidence to state otherwise, these exceedances may have been caused by construction activities.

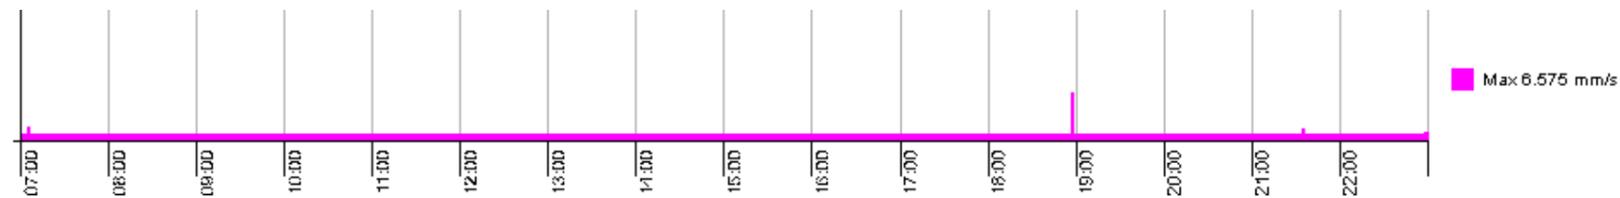
Exceedances on the 1st, 7th, 8th, 12th, 17th, 19th, 20th, 21st and 27th of October have been investigated and found to be caused out with construction working hours and therefore it is unlikely that construction related activity was the cause of these events (graph above from the 01/10/2016).

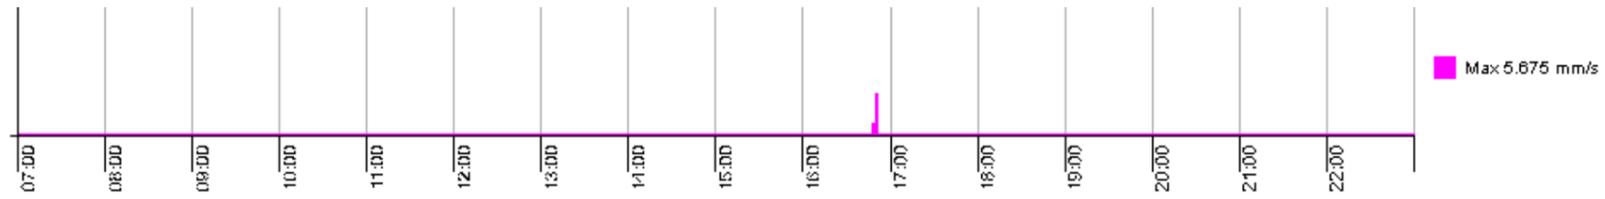
Exceedance on the 9th of October has been investigated and found to be caused out with construction working hours and therefore it is unlikely that construction related activity was the cause of these events.

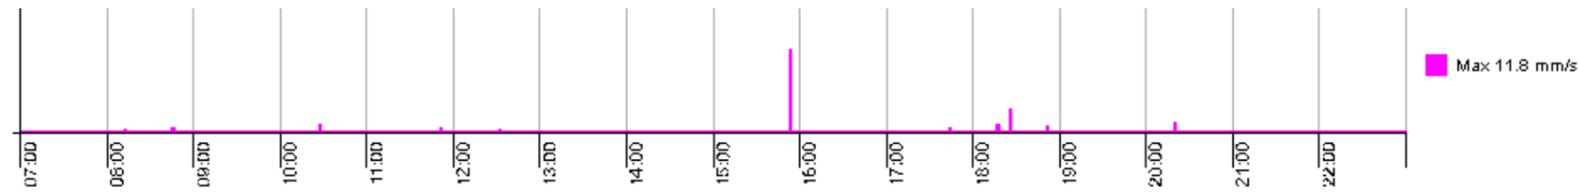
Exceedances on the 4th, 7th, 17th, 25th and 27th of October have been investigated and found to be caused by individual isolated events (graph above from the 07/10/2016). During this period, the resident at the property where the monitor is situated, had ongoing private construction works. It is likely that the exceedances shown in the graph above were caused by the private works at the property, rather than construction activities connected with the new bridge crossing and supporting infrastructure. However, it is worth noting during this period that there has been excavation works ongoing at the SUDS pond east of the south abutment, approximately 40m away. Due to the proximity of the excavation works, and the fact there isn't any supporting evidence to state otherwise, these exceedances may have been caused by construction activities.

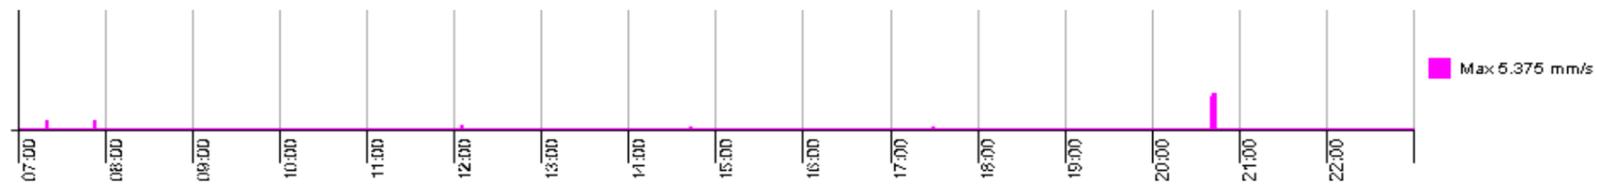
Exceedance on the 2nd of October has been investigated and found to have been caused out with construction working hours and therefore it is unlikely that construction related activity was the cause of these events (graph above from the 02/10/2016).

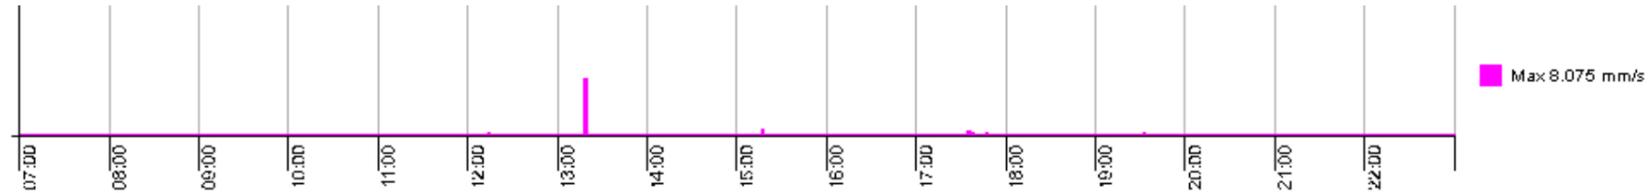
Exceedances on the 3rd, 4th, 8th, 10th, 13th, 16th, 17th, 18th, 19th, 22nd, 23rd, 24th, 25th, 26th, 28th, 29th and 30th of October have been investigated and found to have been caused by isolated events that are unlikely to have been construction related activities (graph above from the 08/10/2016). The monitor is situated in close proximity to the residents outdoor log store situated in the back garden. It is possible that these high readings were due to the residents fetching logs from this store area.

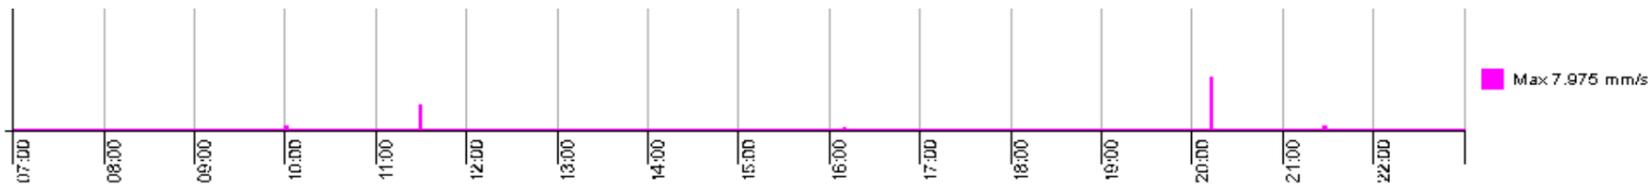
Exceedances on the 5th, 6th, 9th, 12th, 14th, 15th, 20th and 31st of October have been investigated and found to have been caused out with construction working hours and therefore it is unlikely that construction related activity was the cause of these events (graph above from the 31/10/2016).

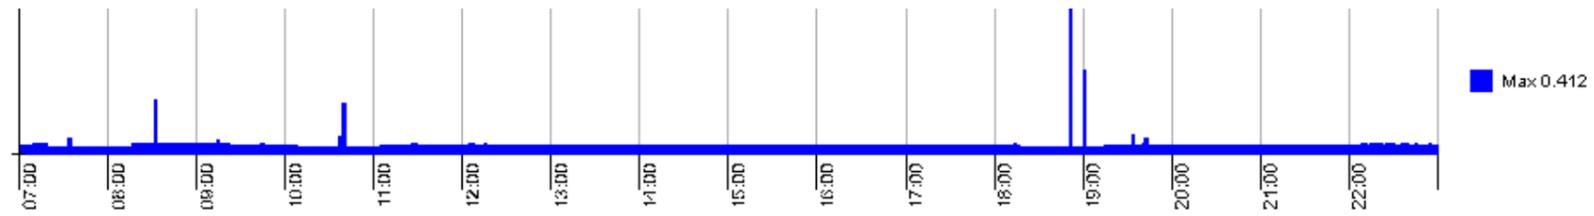
Exceedance on 15th of October has been investigated and found to have been caused by several isolated events that are unlikely to have been construction related activities.

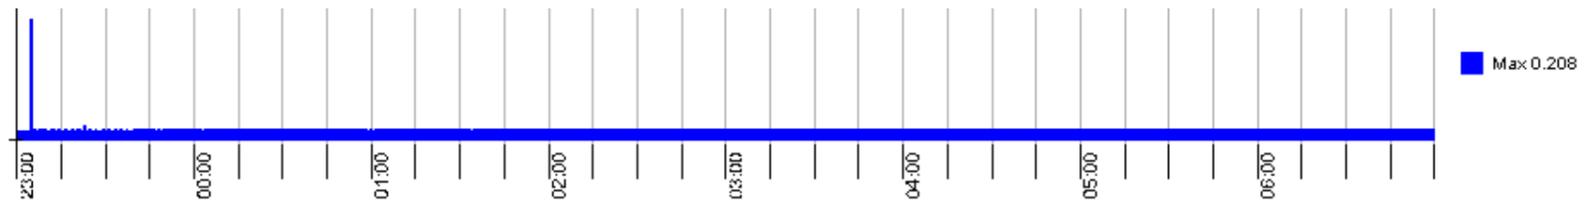
Exceedance on the 15th of October has been investigated and found to have been caused by an isolated event that is unlikely to have been a construction related activity.

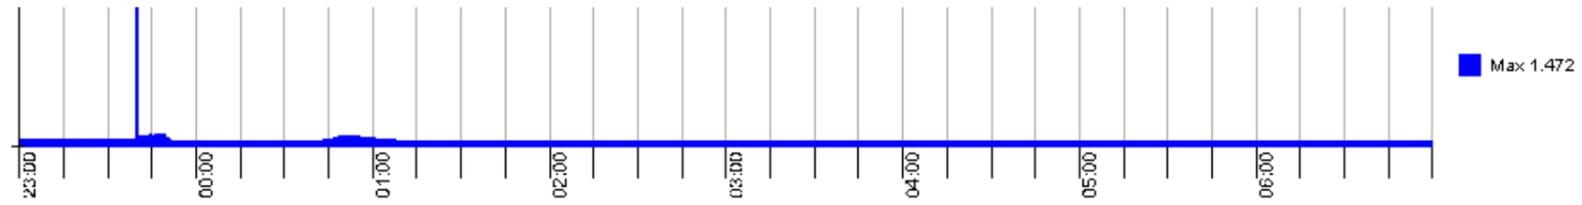
Exceedance on the 23rd of October has been investigated and found to be caused by an isolated event that is unlikely to have been a construction related activity.

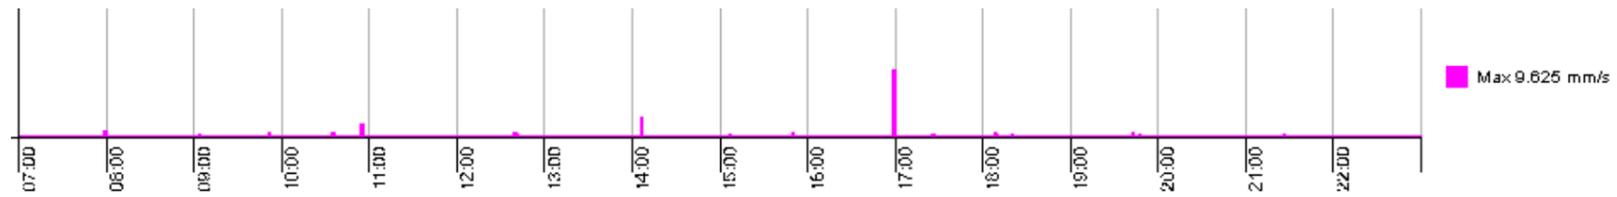
Exceedances on the 2nd, 3rd, 4th, 5th, 6th, 7th, 8th, 9th, 10th, 12th, 16th, 17th, 18th, 21st, 23rd, 24th, 25th, 27th, 28th, 30th and 31st of October have been investigated and found to be caused by individual isolated events that are unlikely to have been construction related activities (graph above from the 17/10/2016). The vibration monitor is located in the residents back garden, therefore resident's activity may have caused these exceedances.

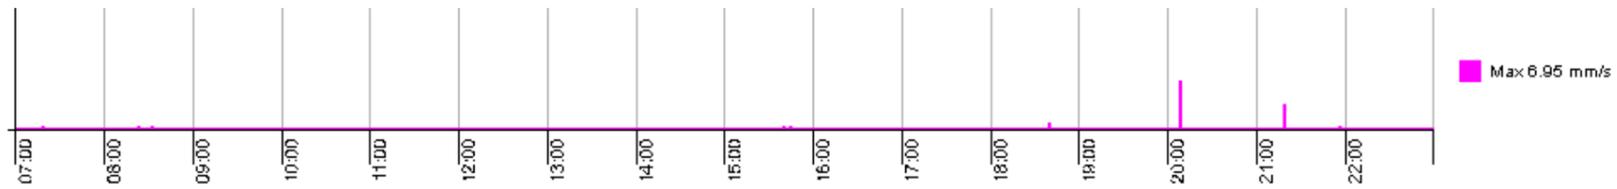
Exceedances on the 11th, 13th, 14th, 15th, 19th, 22nd, 26th and 29th of October have been investigated and found to have been caused out with construction working hours therefore it is unlikely that construction related activities were the cause of these events (graph above from the 17/10/2016).

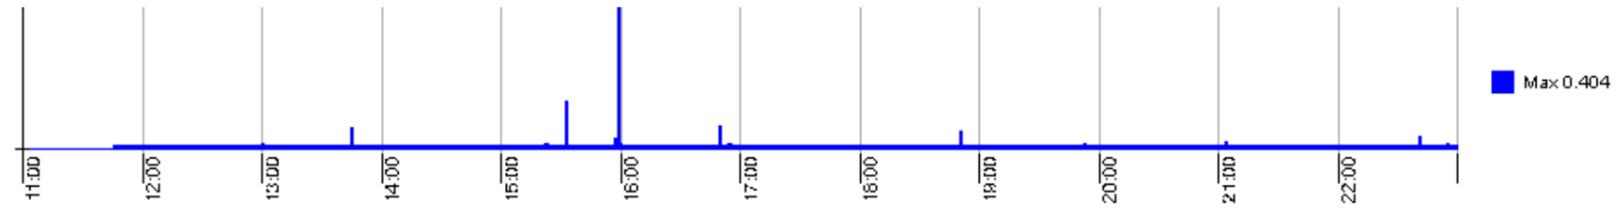
Exceedance on the 4th of October has been investigated and found to have been caused by an isolated event that is unlikely to have been due to a construction related activity.

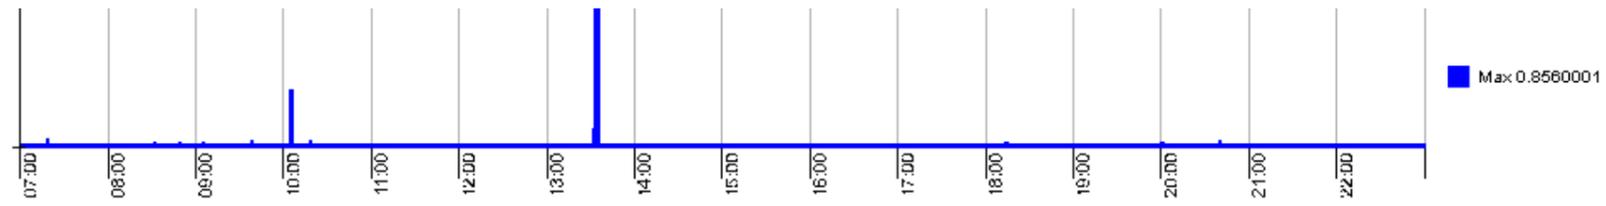
Exceedances on the 24th and 31st of October have been investigated and found to have been caused by isolated events which are unlikely to have been construction related activities (graph above from the 24/10/2016).

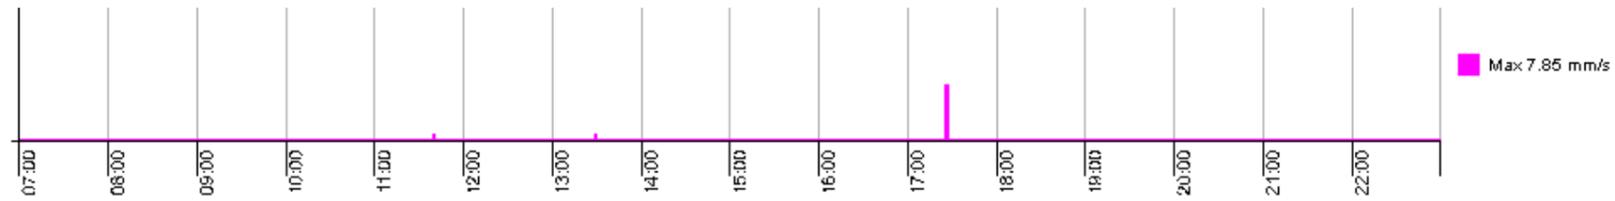
Exceedances on the 5th, 6th, 7th, 11th, 13th, 16th, 20th, 23rd and 31st of October have been investigated and found to have been caused by individual isolated events that are unlikely to have been construction related activities (graph above from the 13/10/2016).

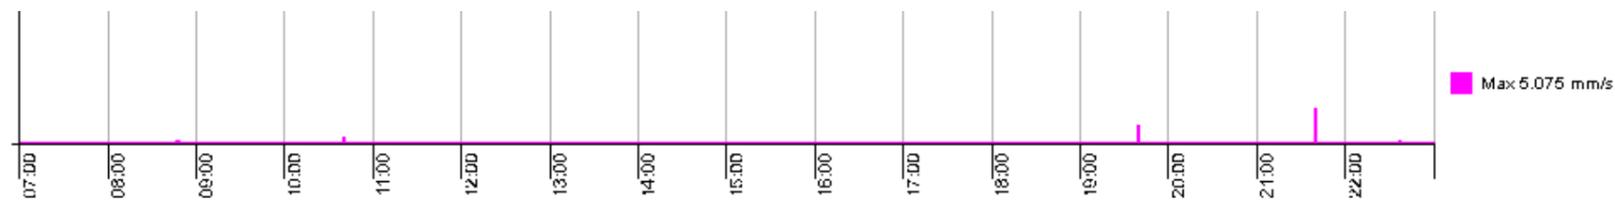
Exceedances on the 4th, 9th and 28th of October have been investigated and found to be caused out with construction working hours and therefore it is unlikely that construction related activities were the cause for these exceedances (graph above from the 28/10/2016).
