**Forth Crossing** Bridge Constructors

Project **FORTH REPLACEMENT CROSSING**

**VIBRATION MONITORING REPORT  
JUNE 2015**

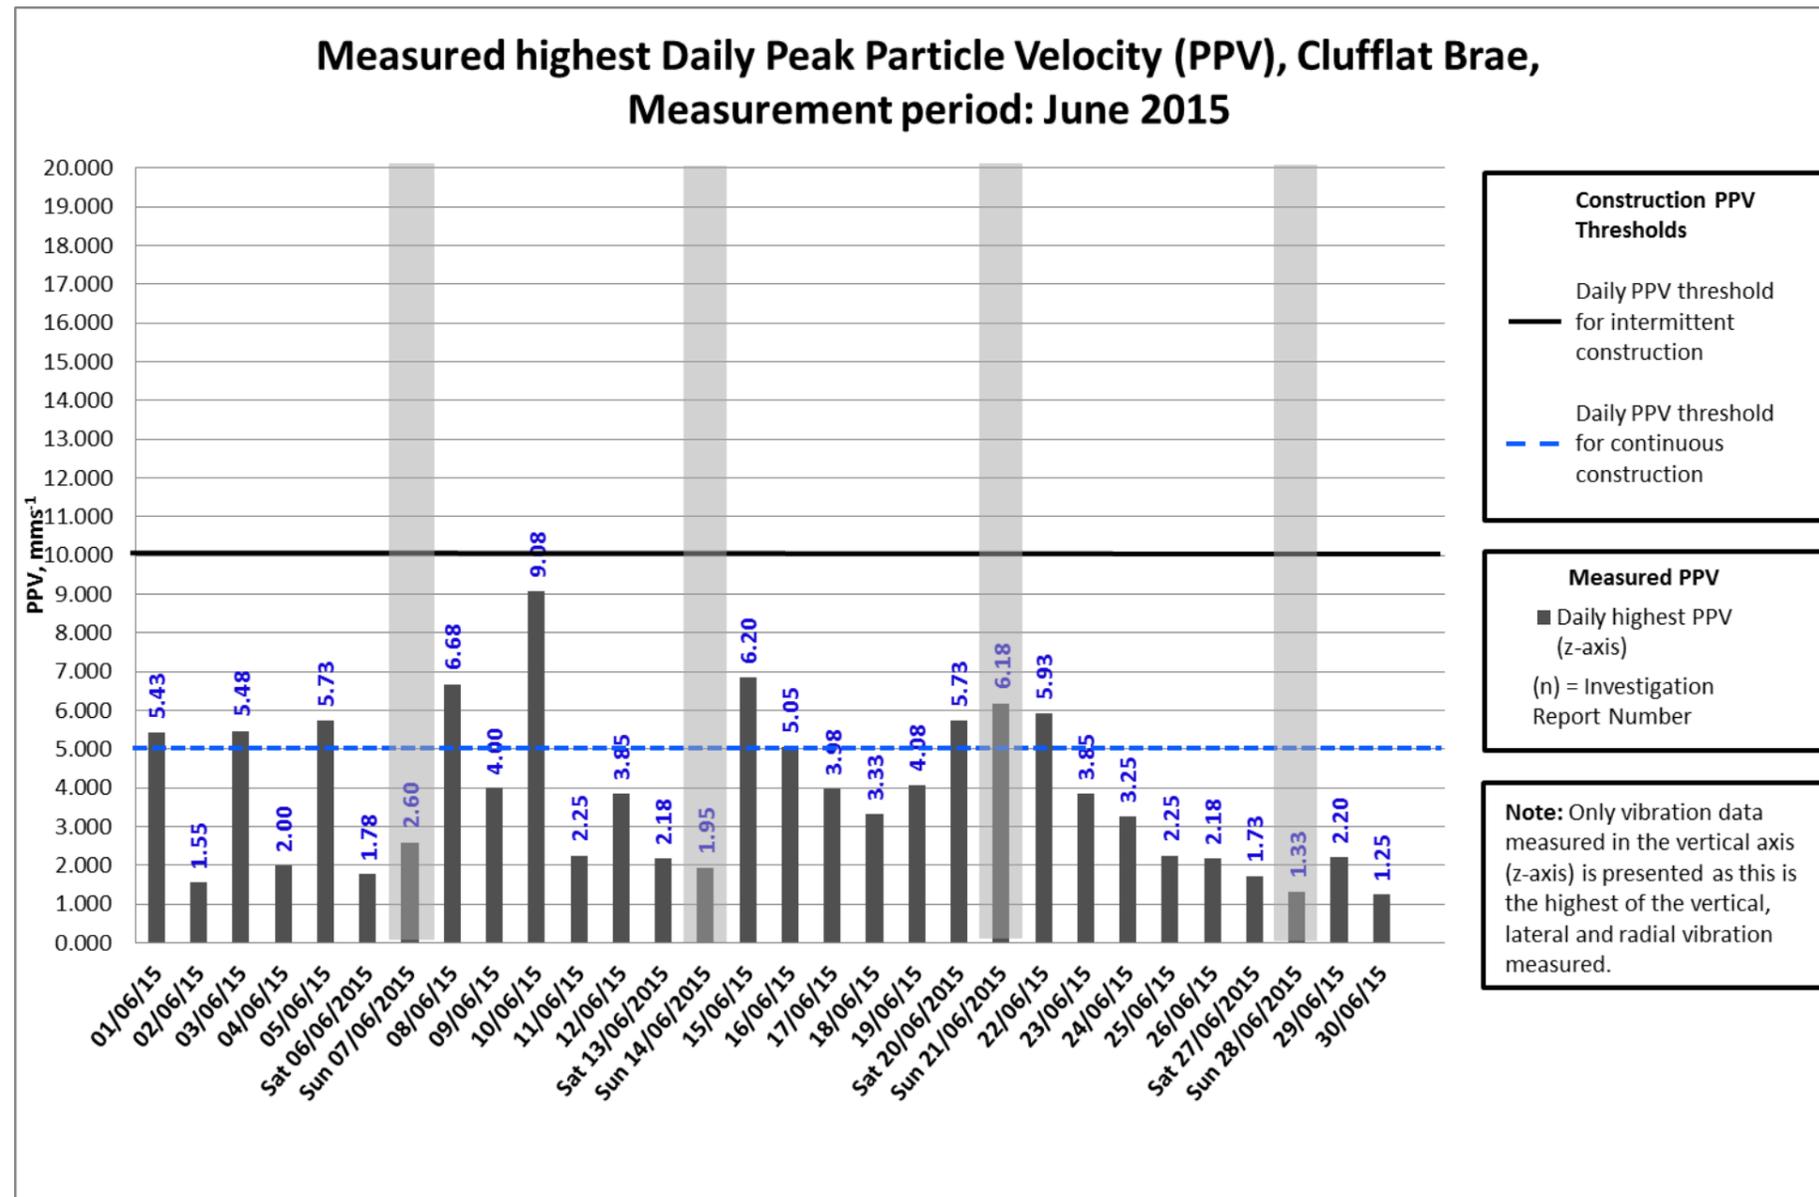
The graph above shows the events on the 10/06/2015, from investigation the nearest works from the monitor was 280m away and the vibration monitor from Linn Mill was only 200m away from the same works. After cross referencing the two graphs there was no similarity's apparent concluding that the vibrations caused on the 10<sup>th</sup> of June were not construction related. Other dates were investigated and found to be individual, isolated events due to external activity near/ directly above the transducers.

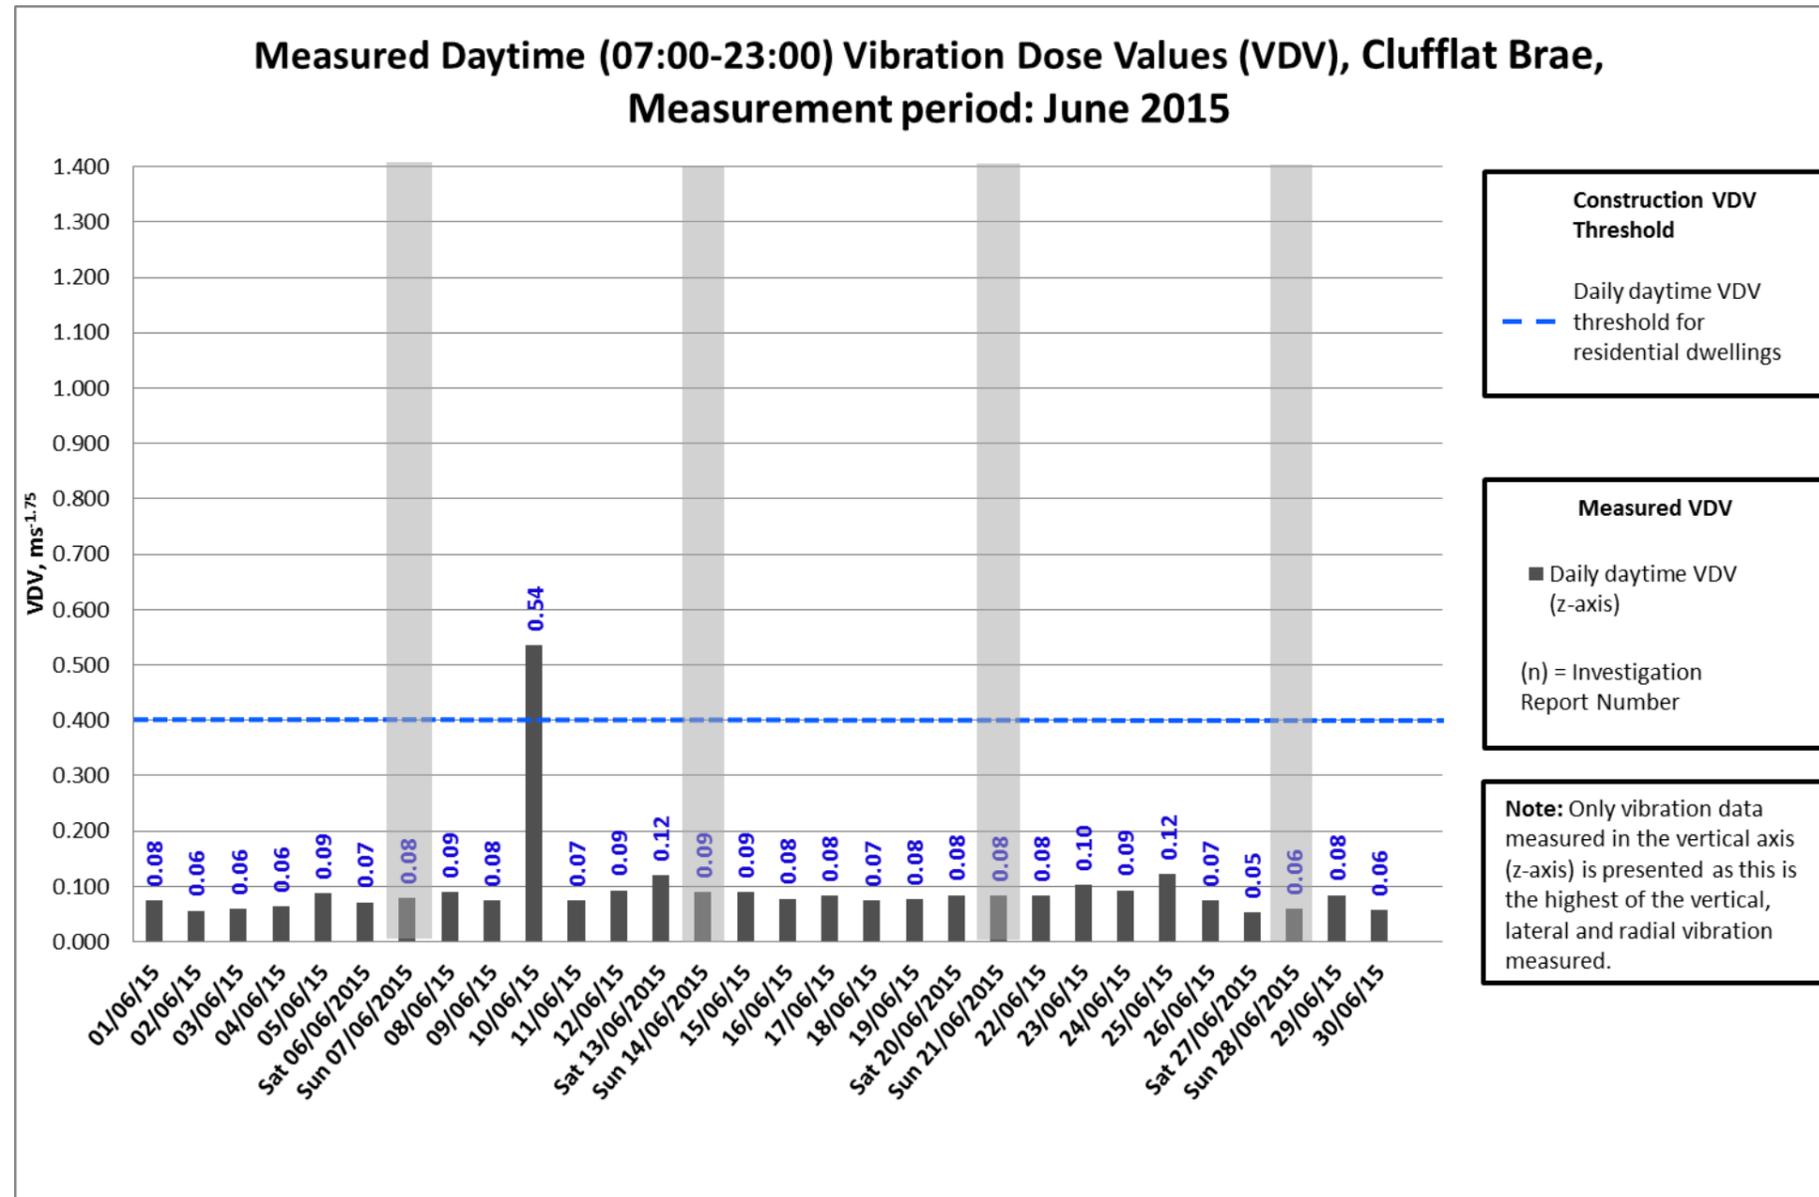
Note: The graph above shows the exceedances on the 10/06/2015. This was on the same day of the exceedance on the PPV Graph. It was investigated and found to be caused by non-Construction related activity.

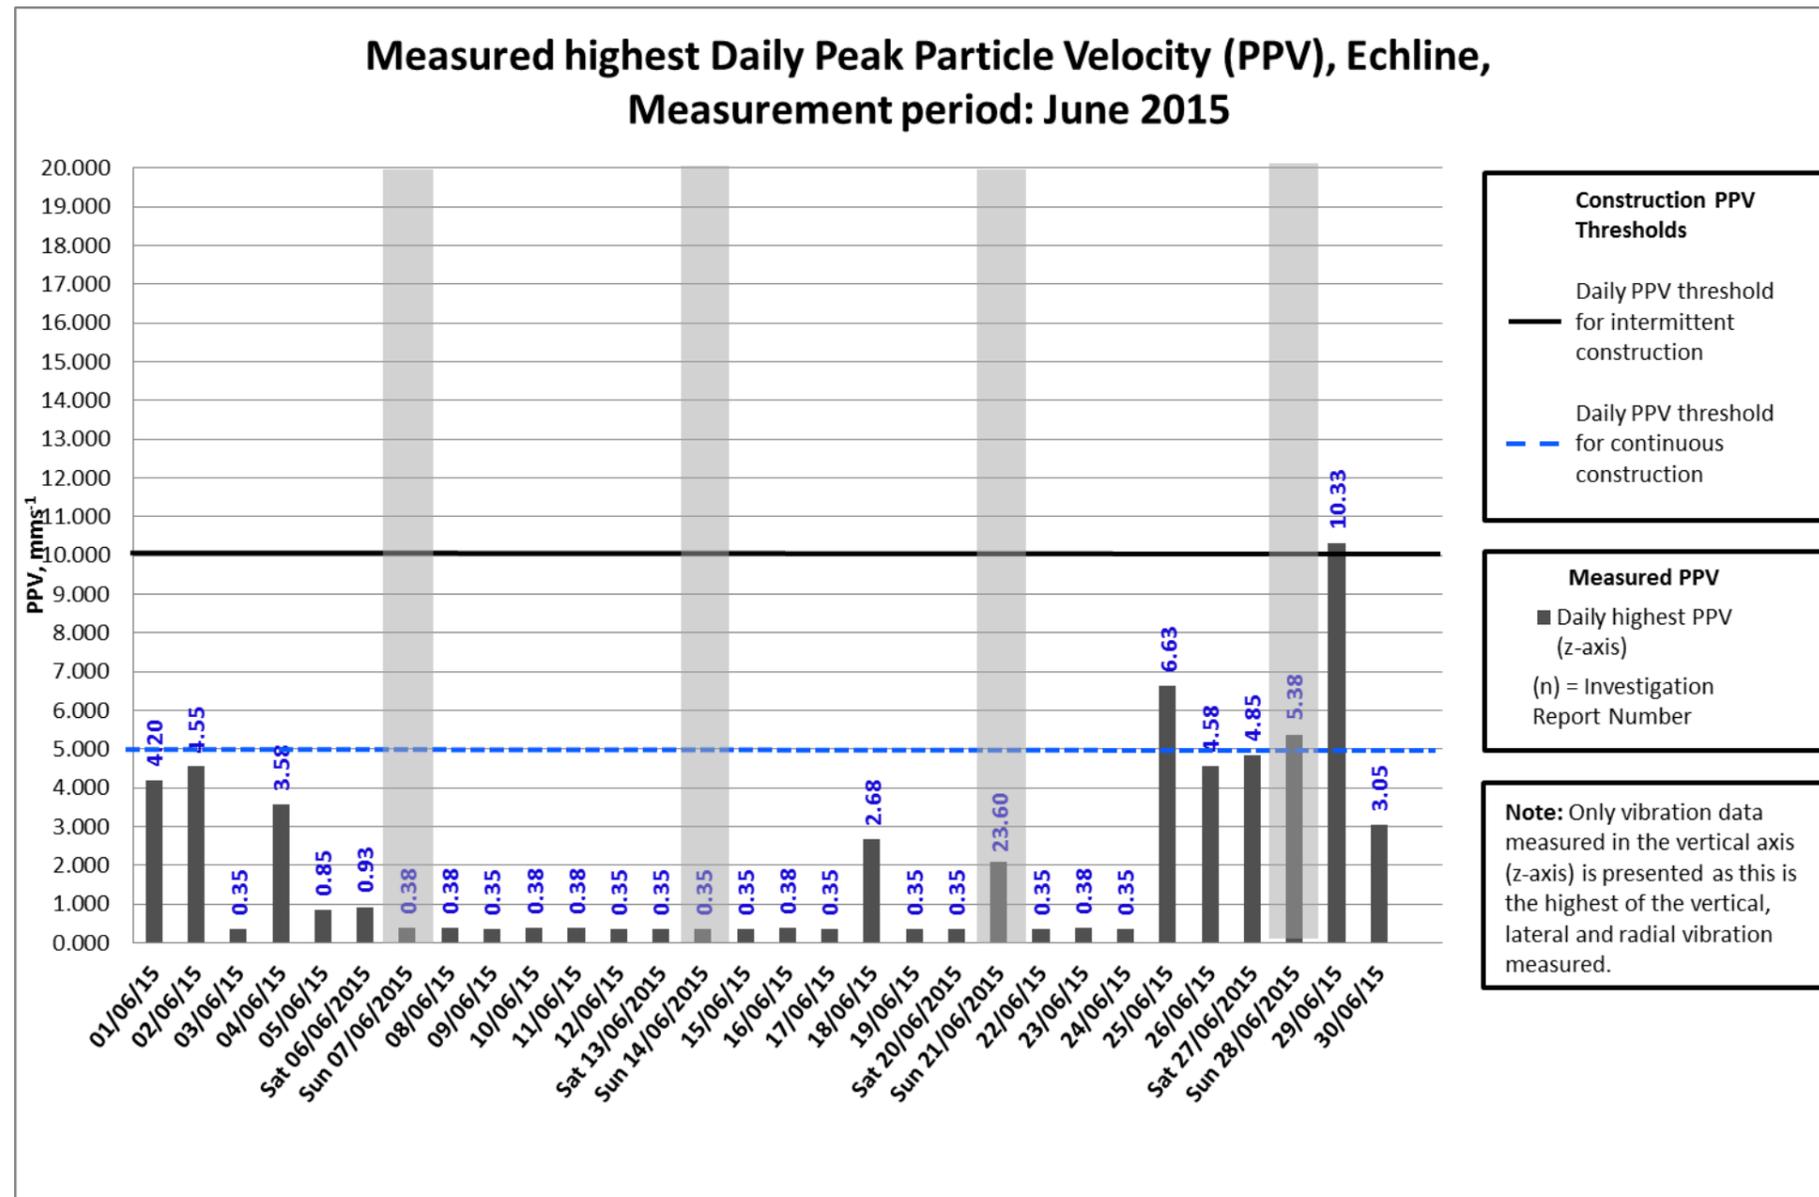
The graph above shows the events on the 25/06/2015, it has been investigated and has been seen to be individual, isolated event not related to construction. This figure is due to external activity near/ directly above the transducers. The exceedance on the 29<sup>th</sup> of June was investigated and found to be the same.

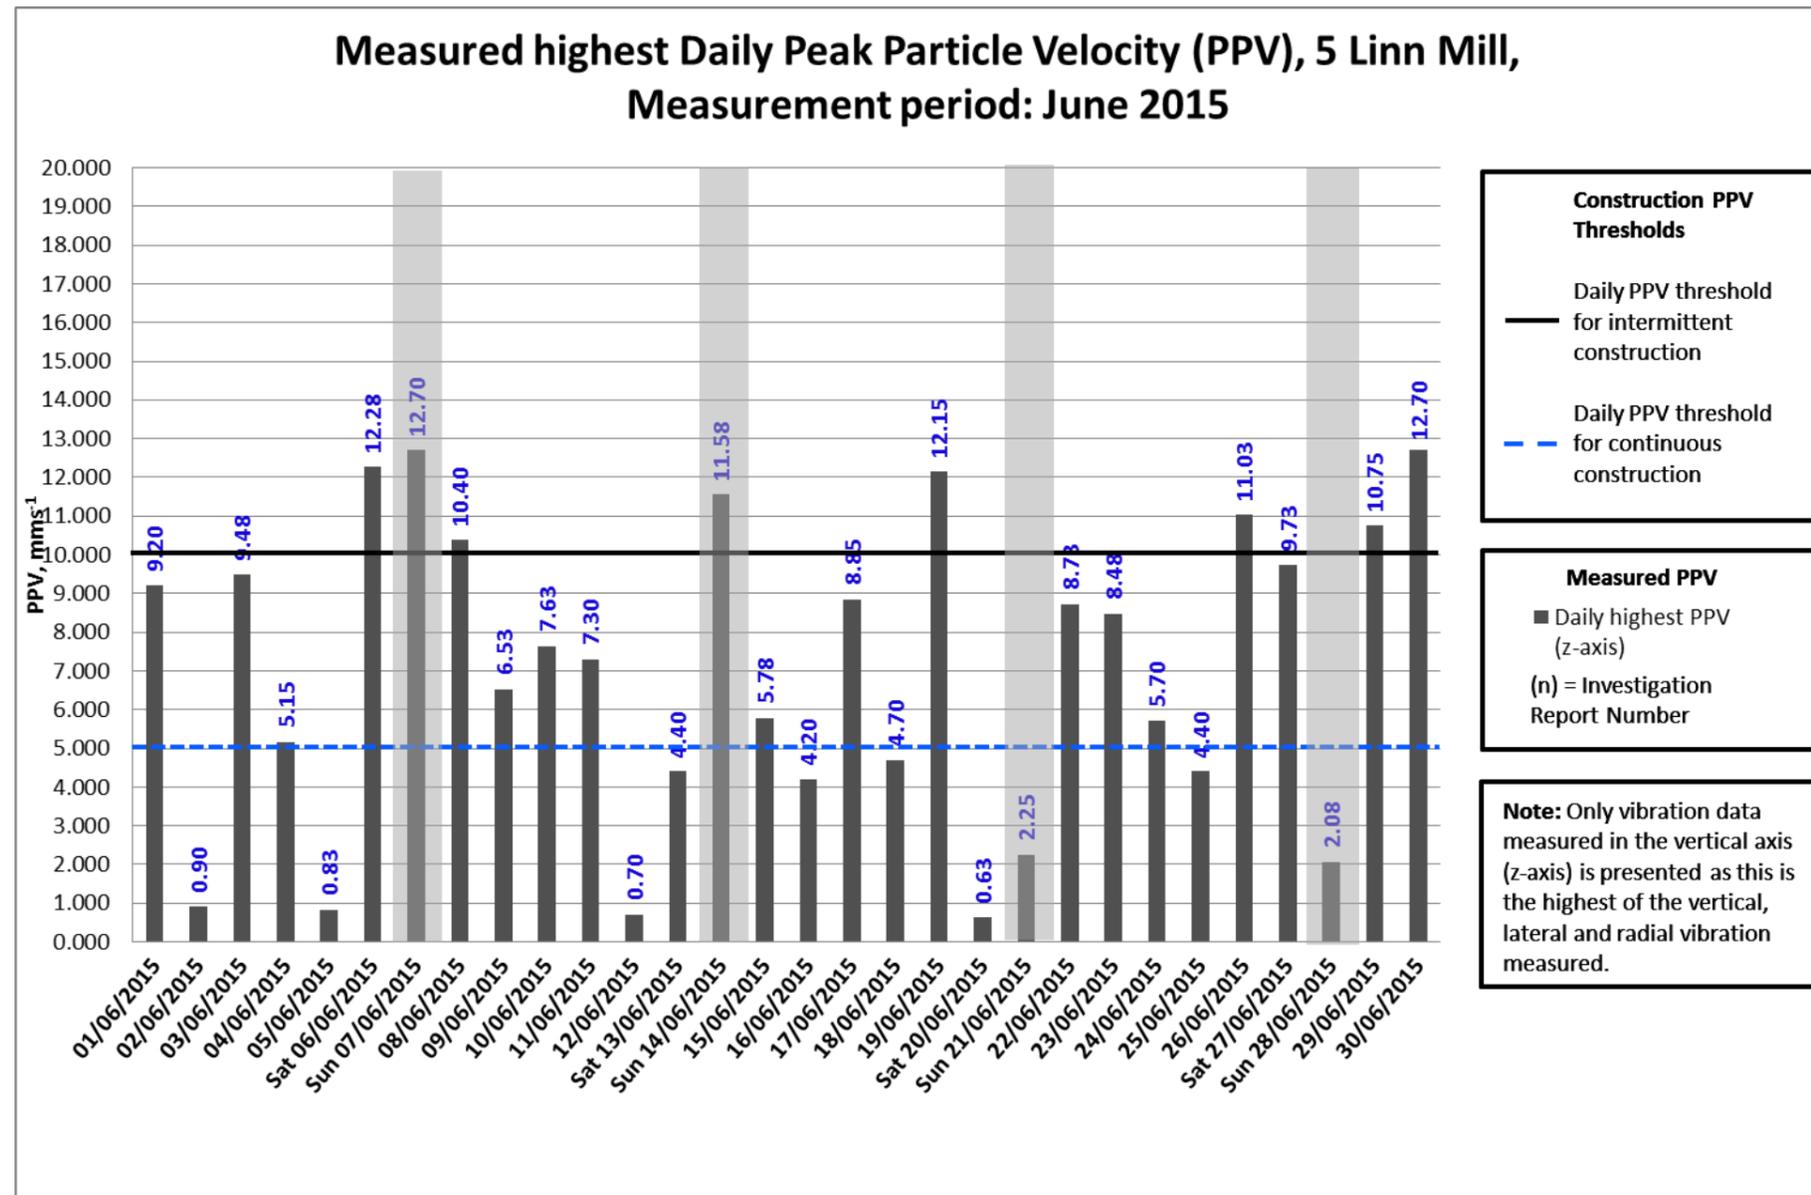
Note: Investigations have found the exceedances in the graph are due to the resident at 5 Linn mill having works done in close proximity of the vibration monitor. Referencing the graph above from the 8<sup>th</sup> of June you can see the exceedances are made at evening Out of construction working hours. This is typical for all exceedances at Linn Mill for the month of June. Furthermore Cross references with other vibration monitors in this location show no vibration similarities, concluding that the exceedances are local not related to construction.

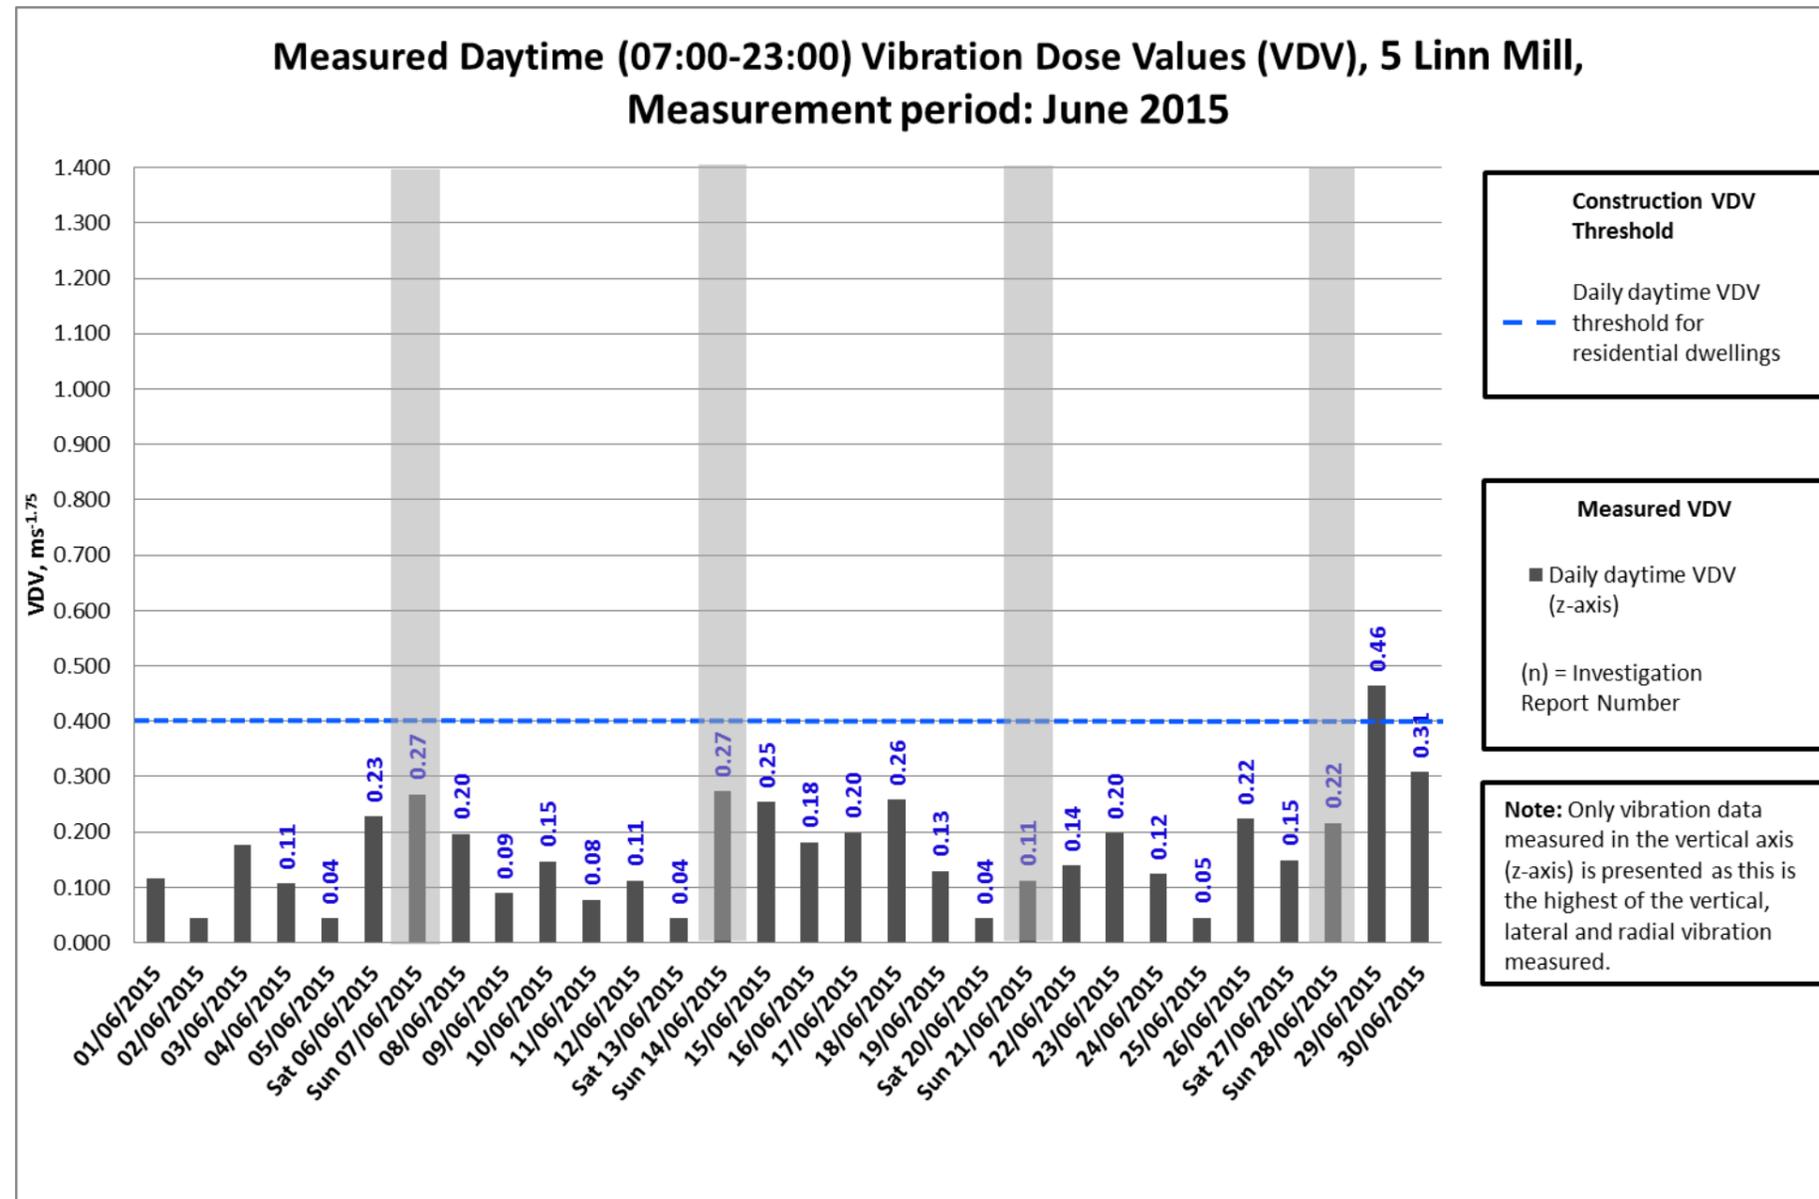
Note: Investigations have found the exceedances in the graph are due to the resident at 5 Linn mill having works done in close proximity of the vibration monitor.

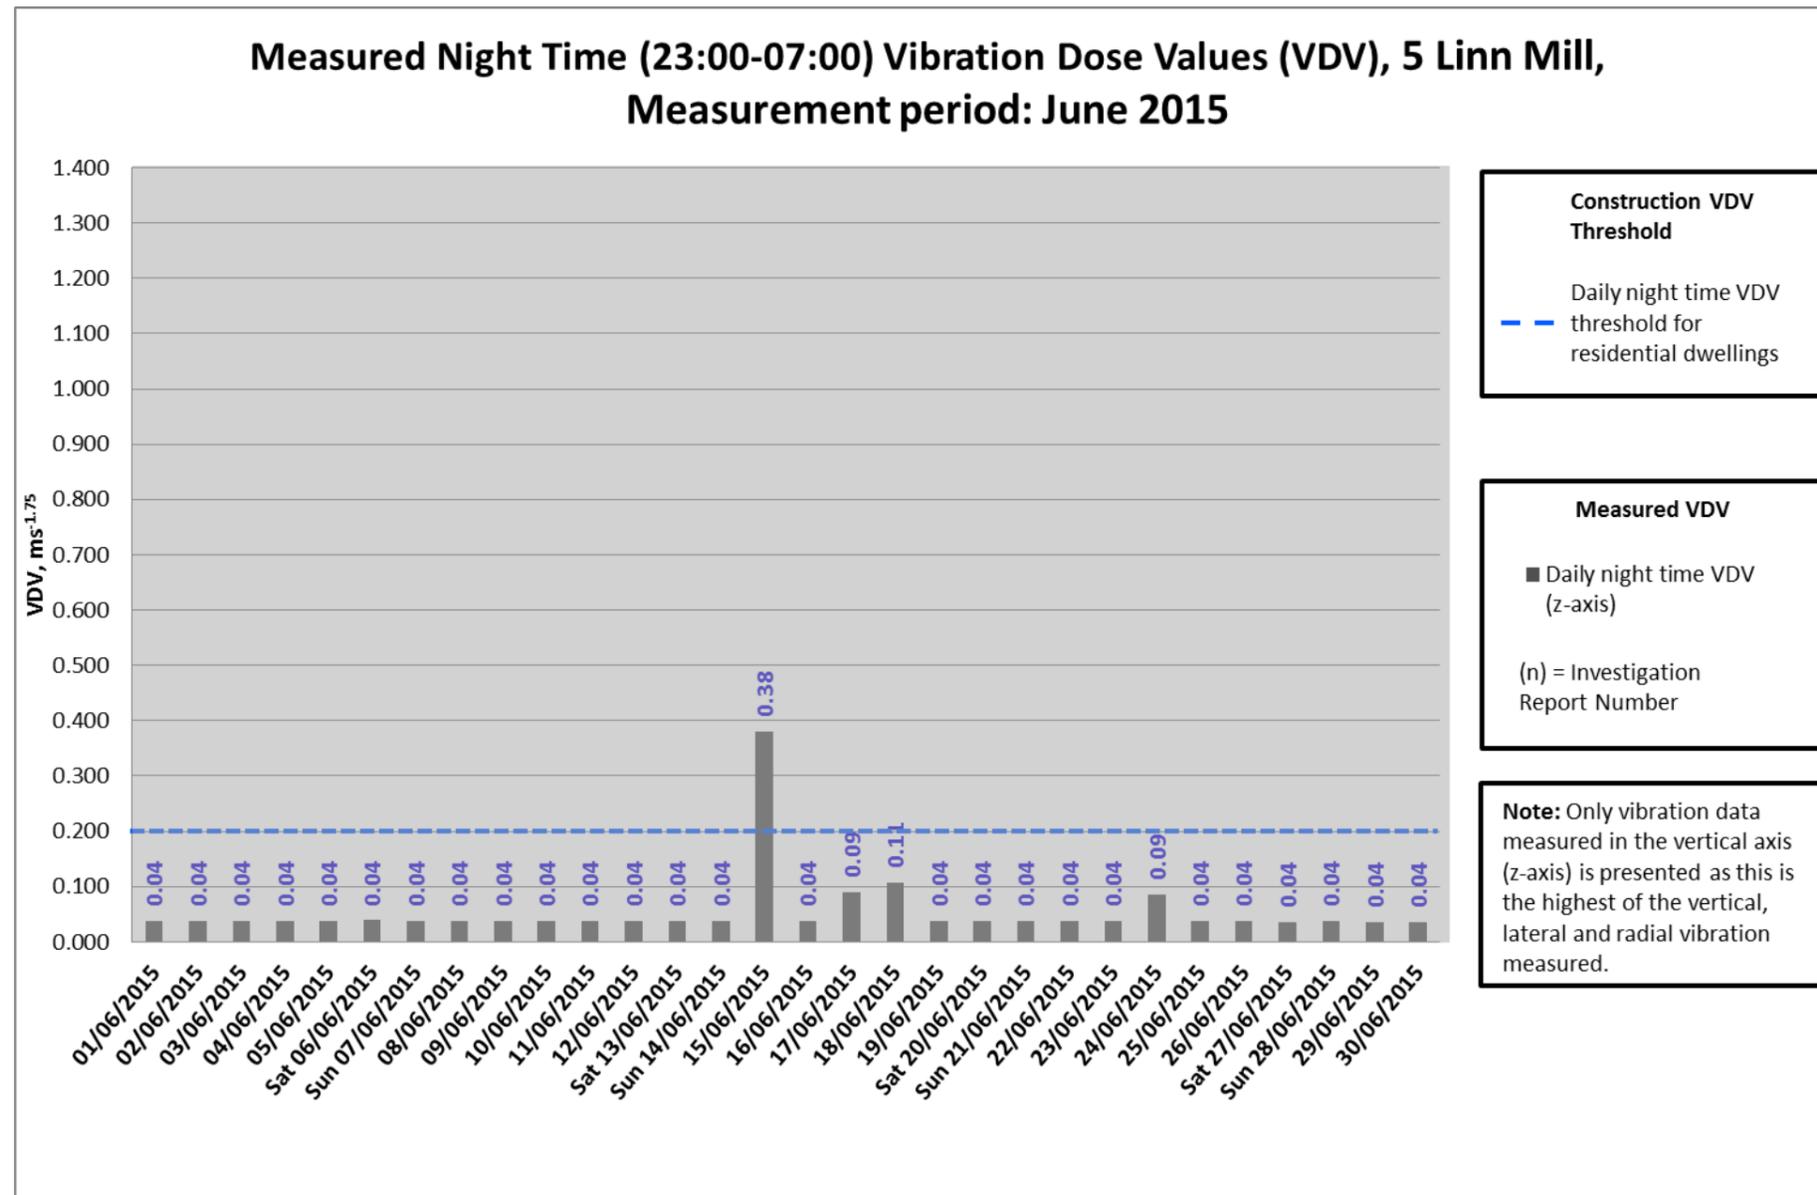
Note: Investigations have found the exceedances in the graph are due to the resident at 5 Linn mill having works done in close proximity of the vibration monitor

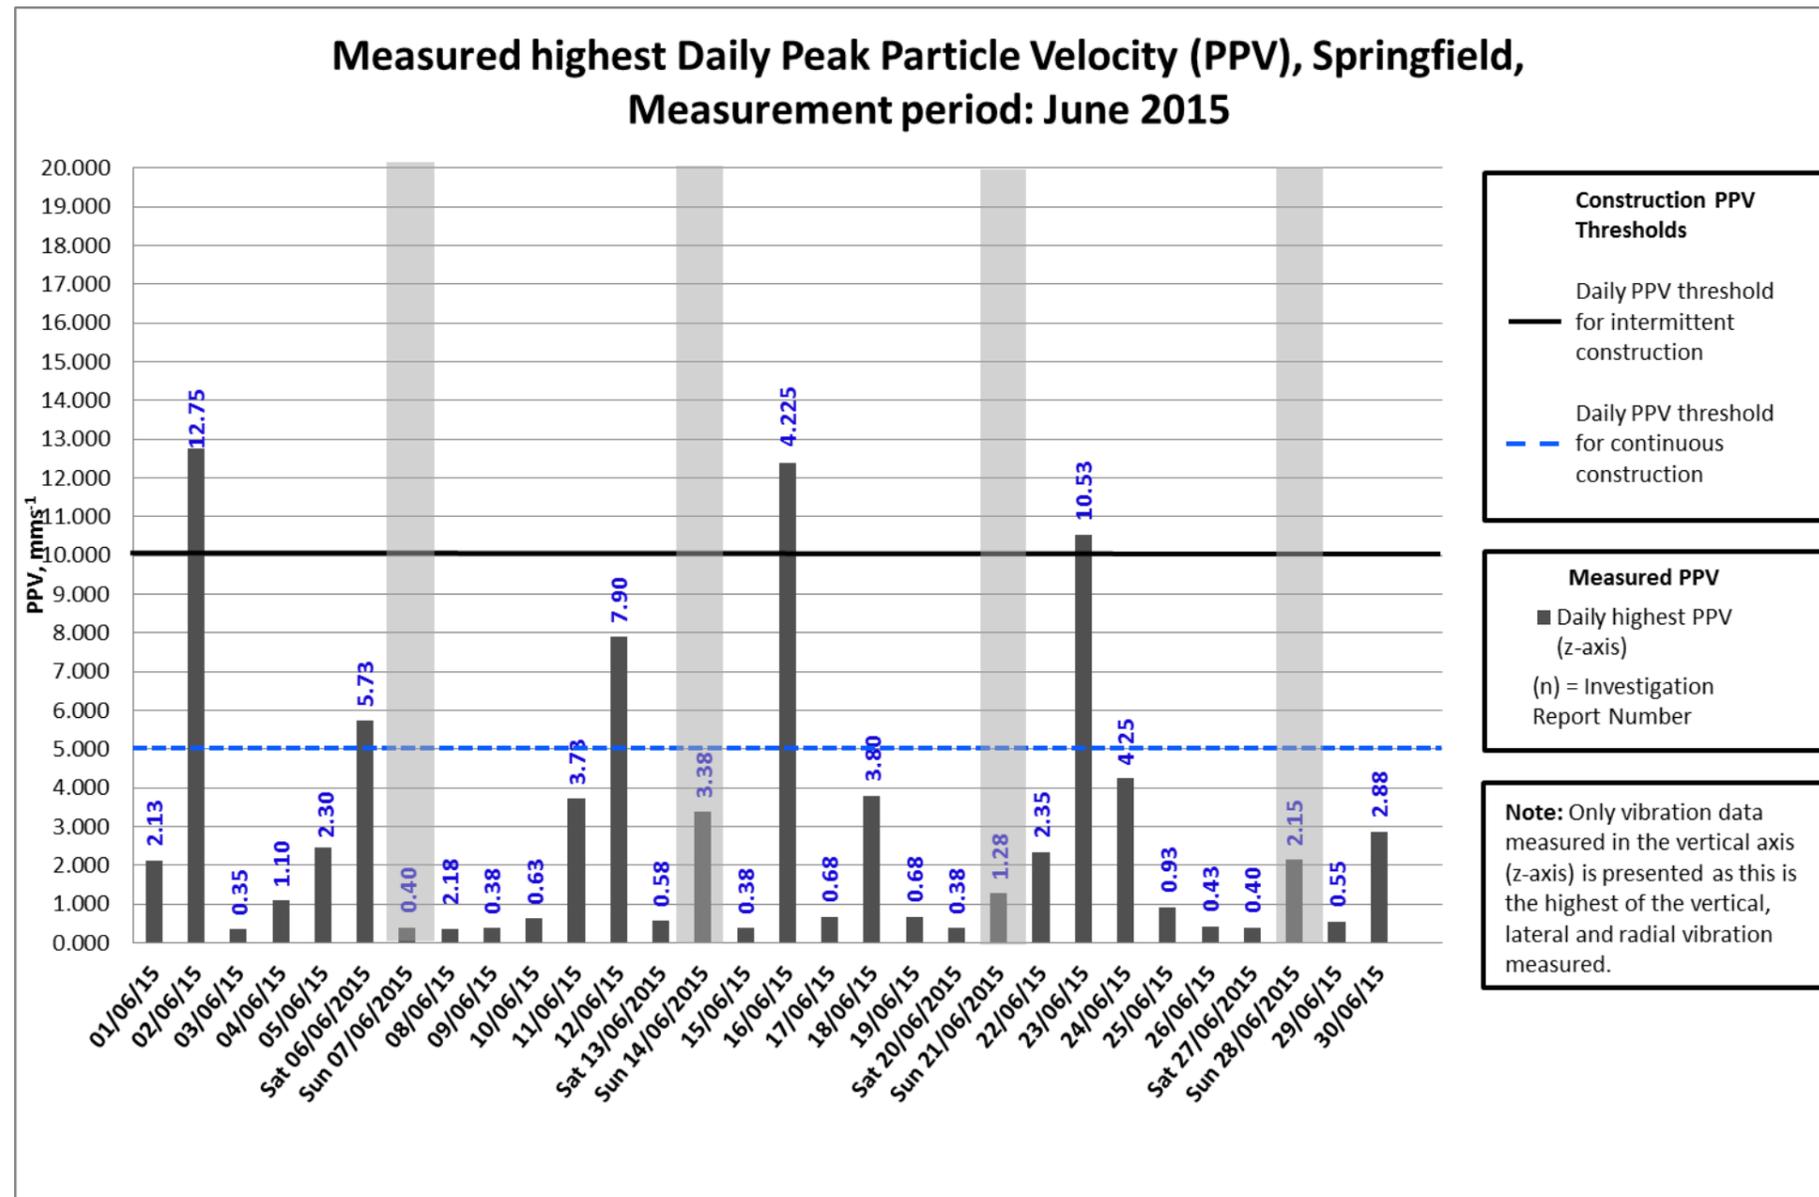
Note: The 02/06/2015 and the 23/06/2015 exceedances were due to monitor maintenance as seen above. Investigations for the 06/06/2015, 12/06/2015 and the 16/06/2015 have found the distance away from the nearest works was 280m away from the monitor. The vibration monitor at Linn mill is only 180m away. Comparing both graphs there was no similarity's found, concluding the vibration isn't related to construction and more than likely to be external activity near/ directly above the transducers.

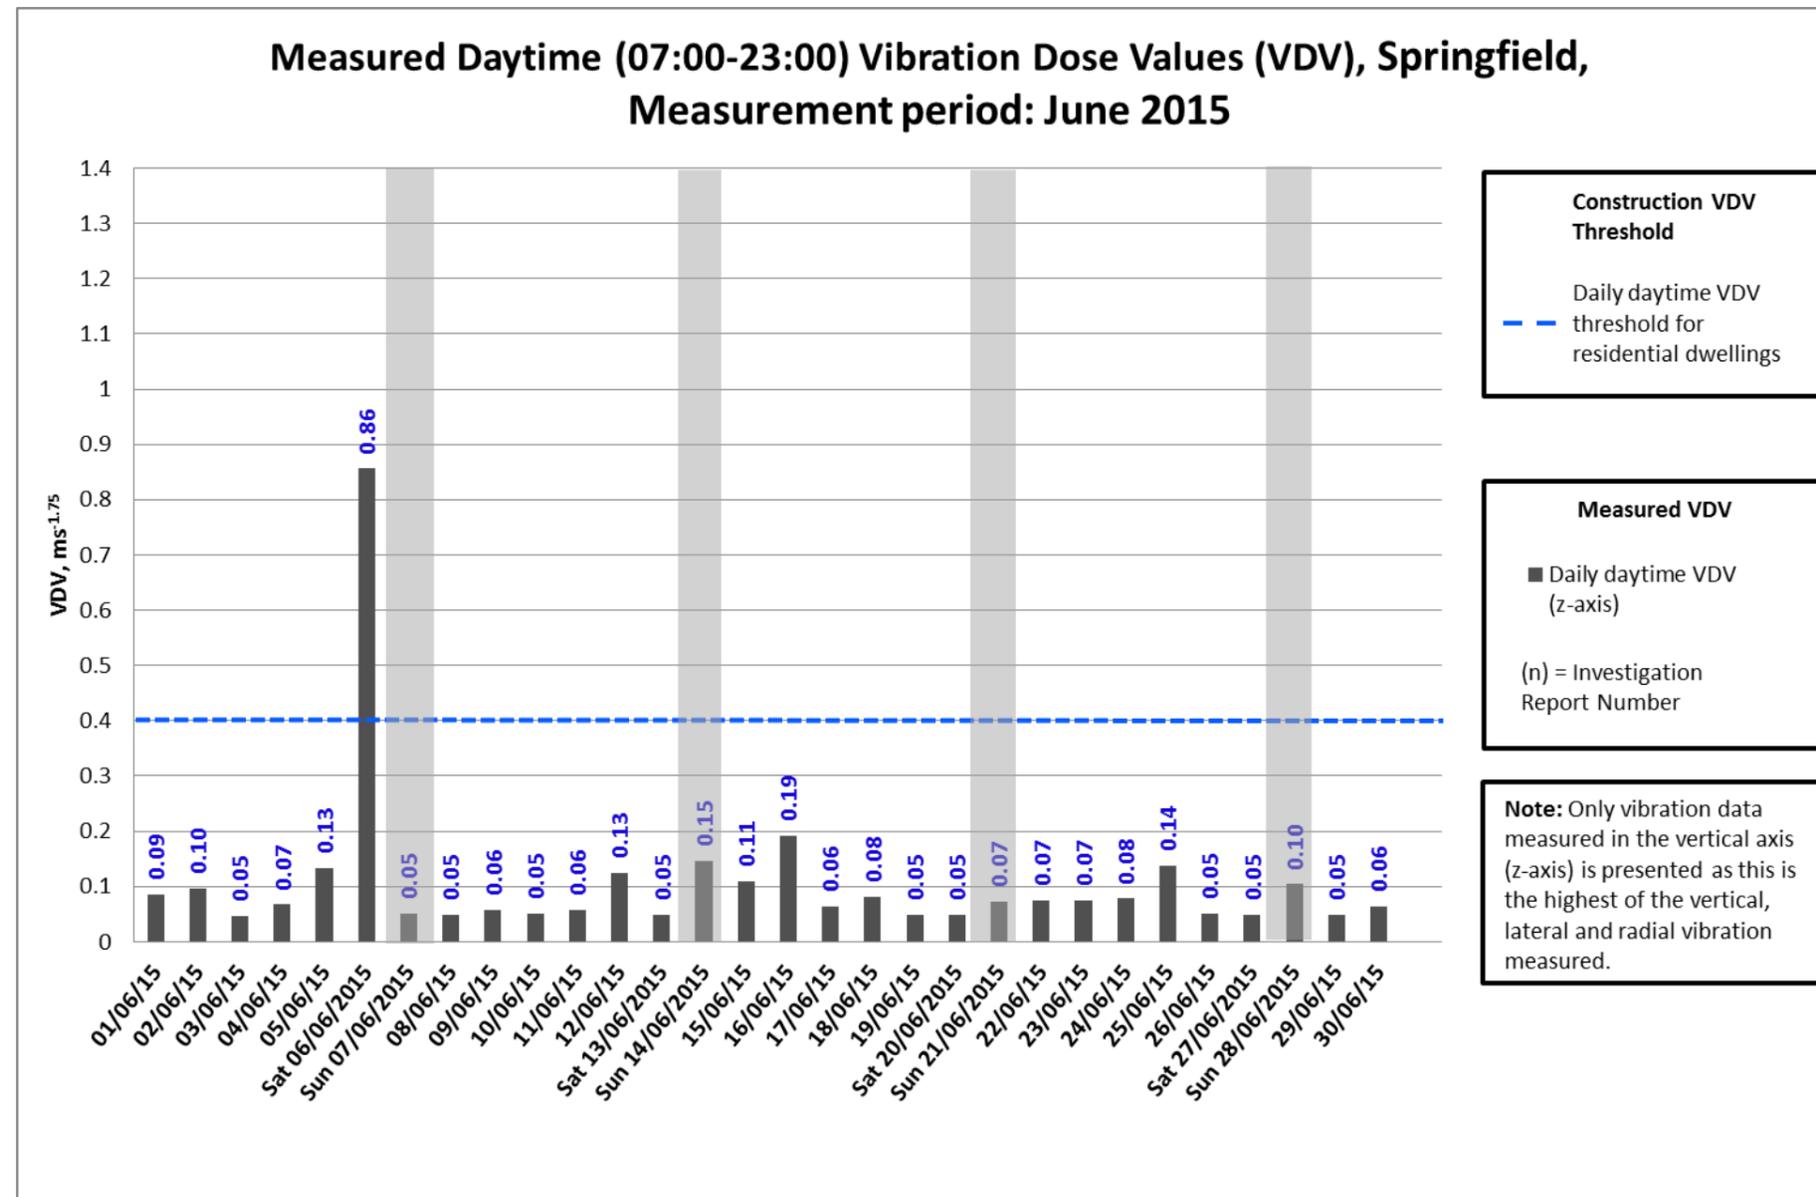
Investigation for the 06/06/2015 has found the distance away from the nearest works was 280m away from the monitor. The vibration monitor at Linn mill is only 180m away. Comparing both graphs there was no similarity's found, concluding the vibration isn't related to construction and more than likely to be external activity near/ directly above the transducers.

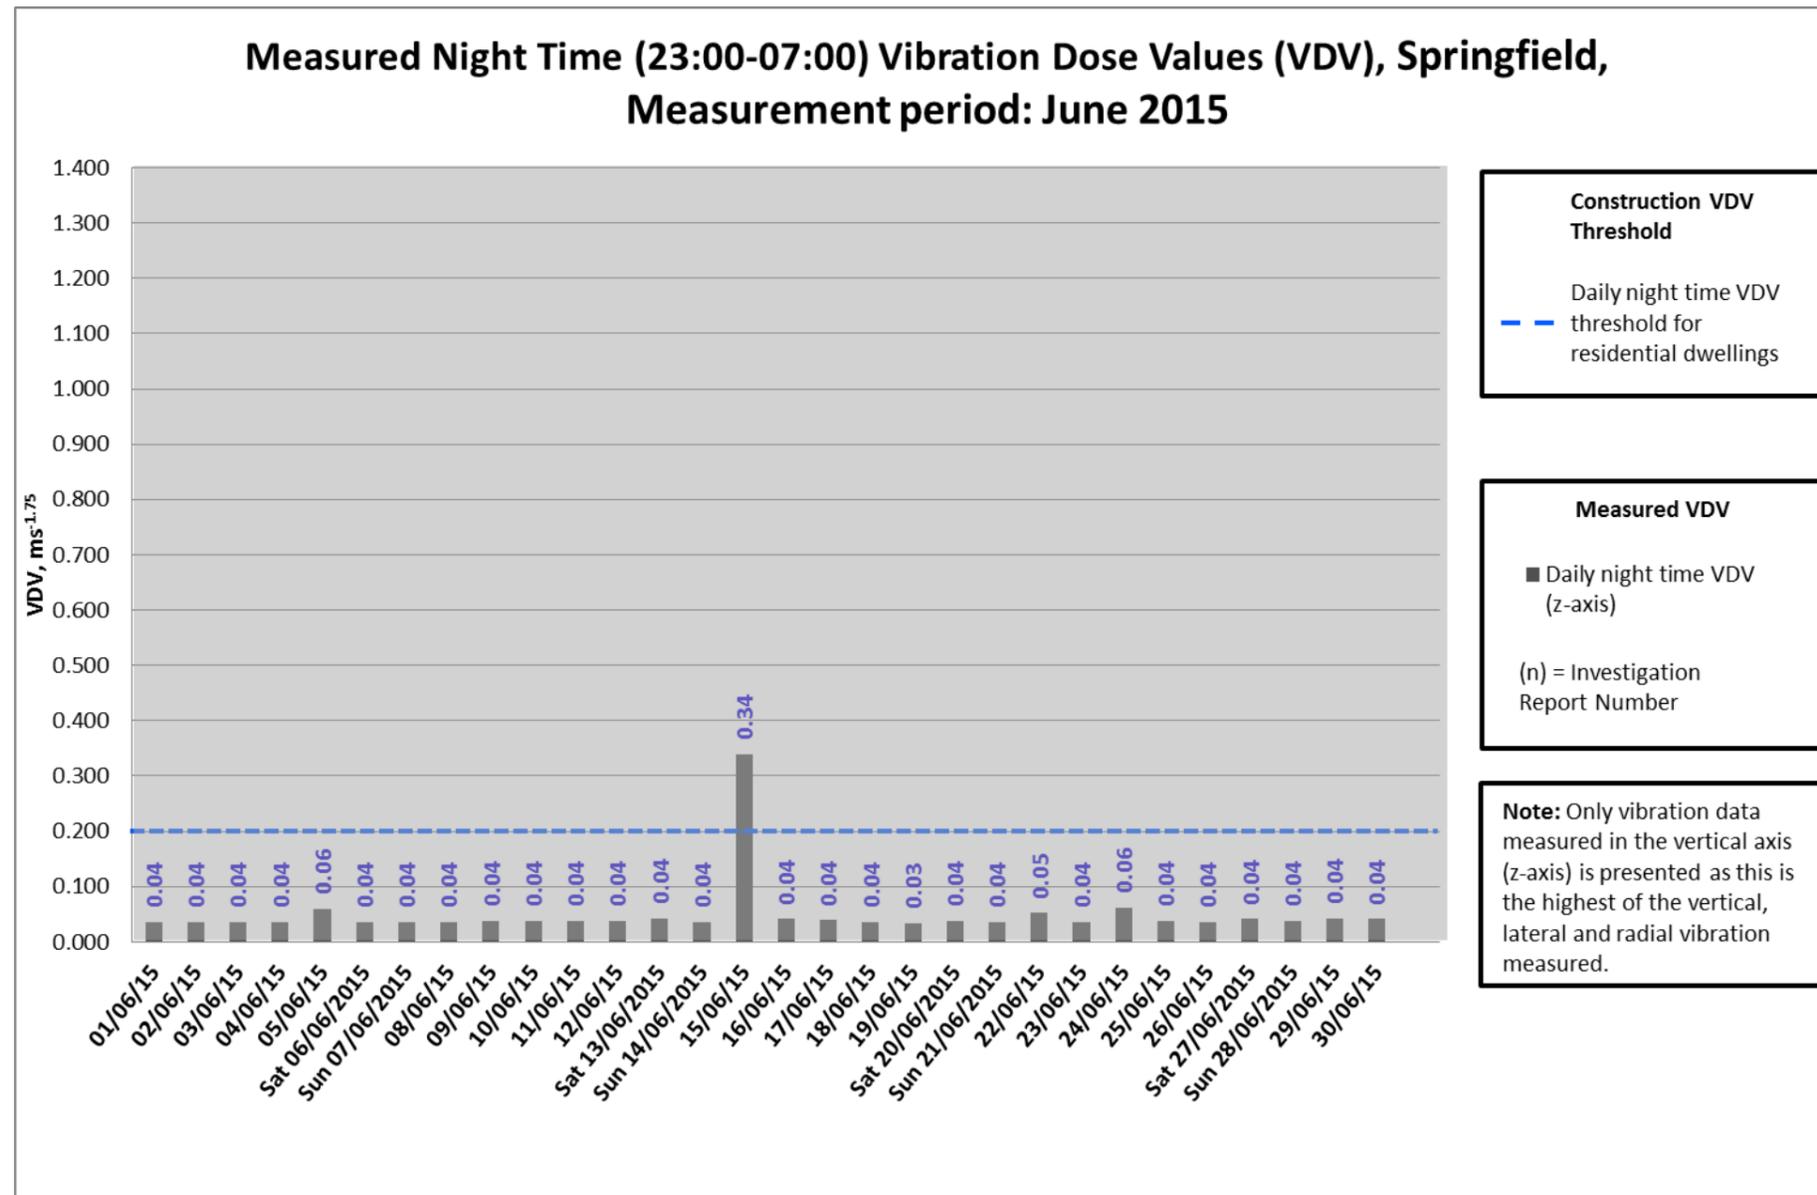
Note: The VDV values on 15/06/15 have been investigated and have seen to be an individual, isolated event within the period. This figure is due to external activity near/ directly above the transducers.

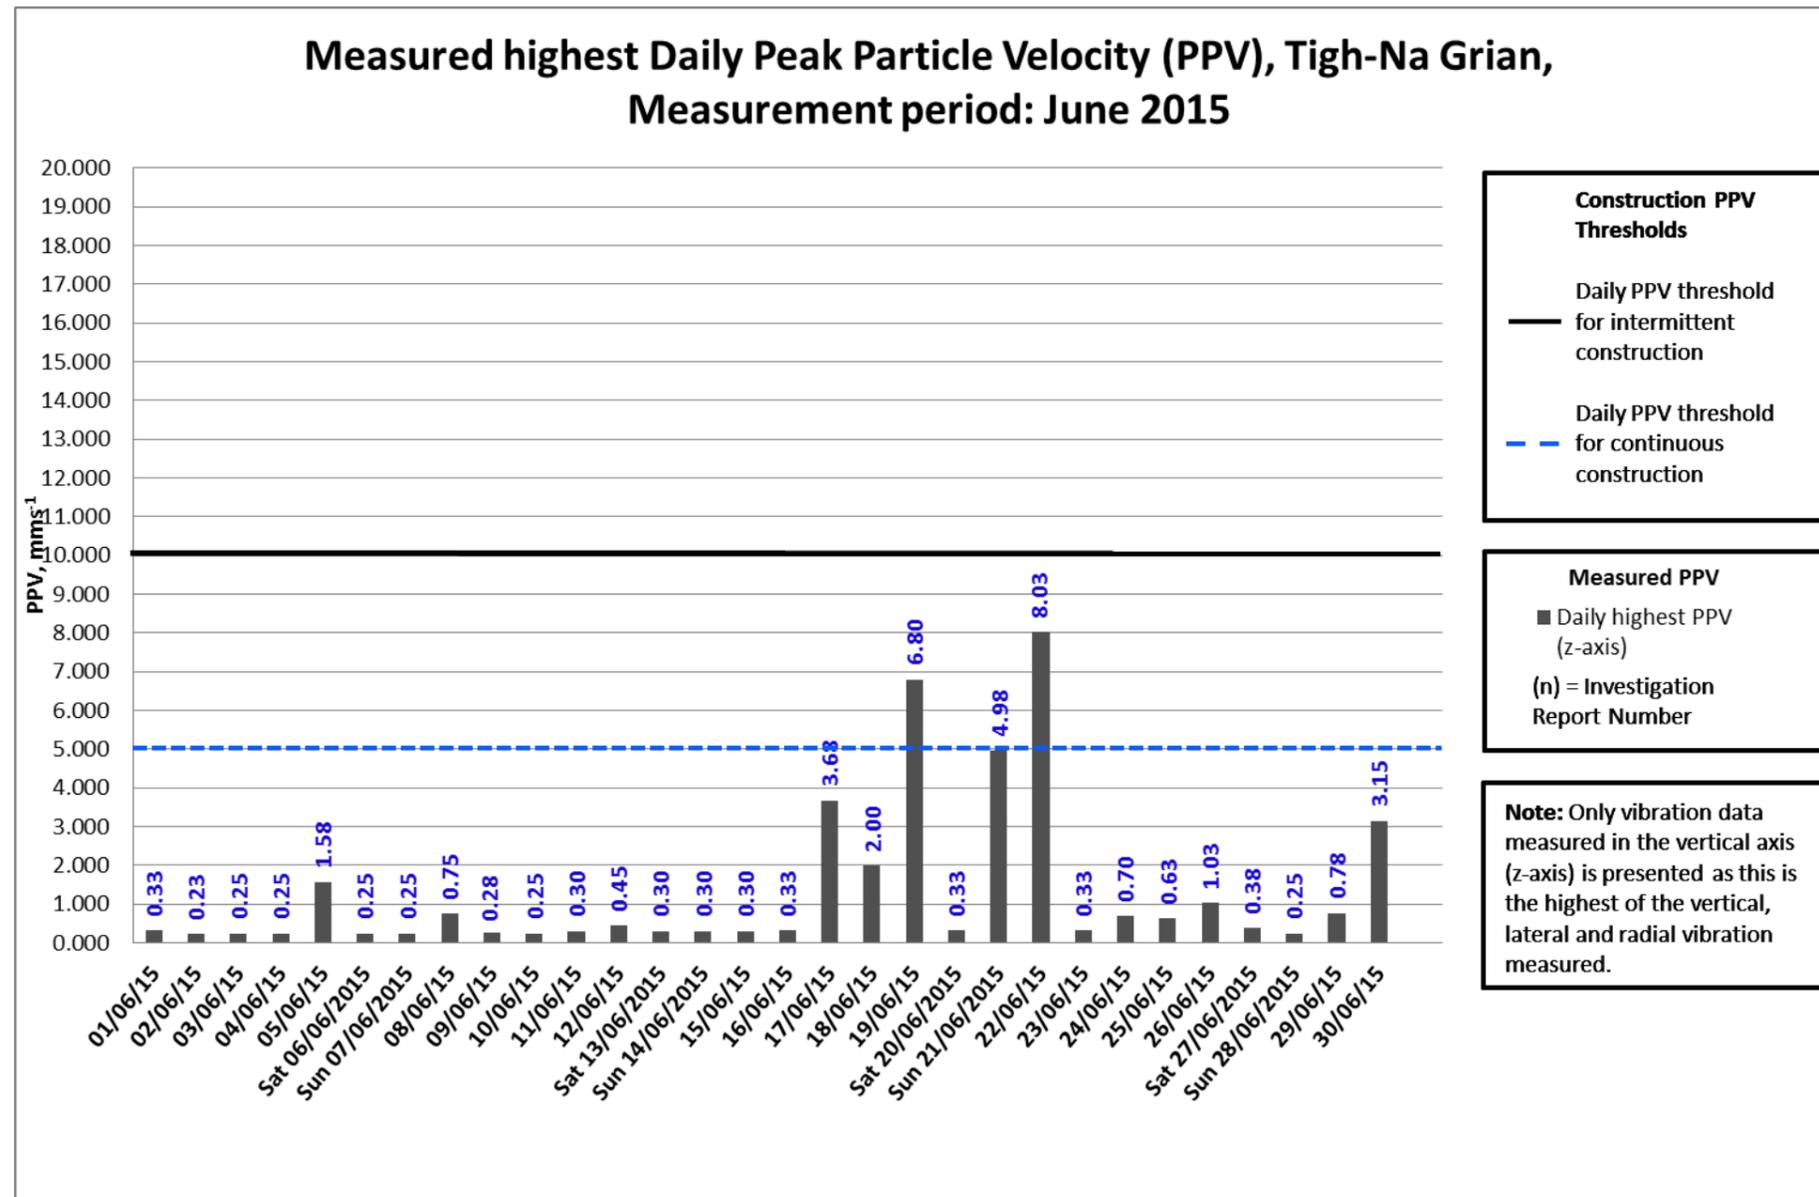
Note: The PPV values on 19/06/15 and 22/06/15 have all been investigated and have been seen to be individual, isolated events within the period. These values are due to monitor maintenance and most likely due to external activity near/ directly above the transducers.
