**Forth Crossing** Bridge Constructors

Project **FORTH REPLACEMENT CROSSING**

**VIBRATION MONITORING REPORT  
JUNE 2015**

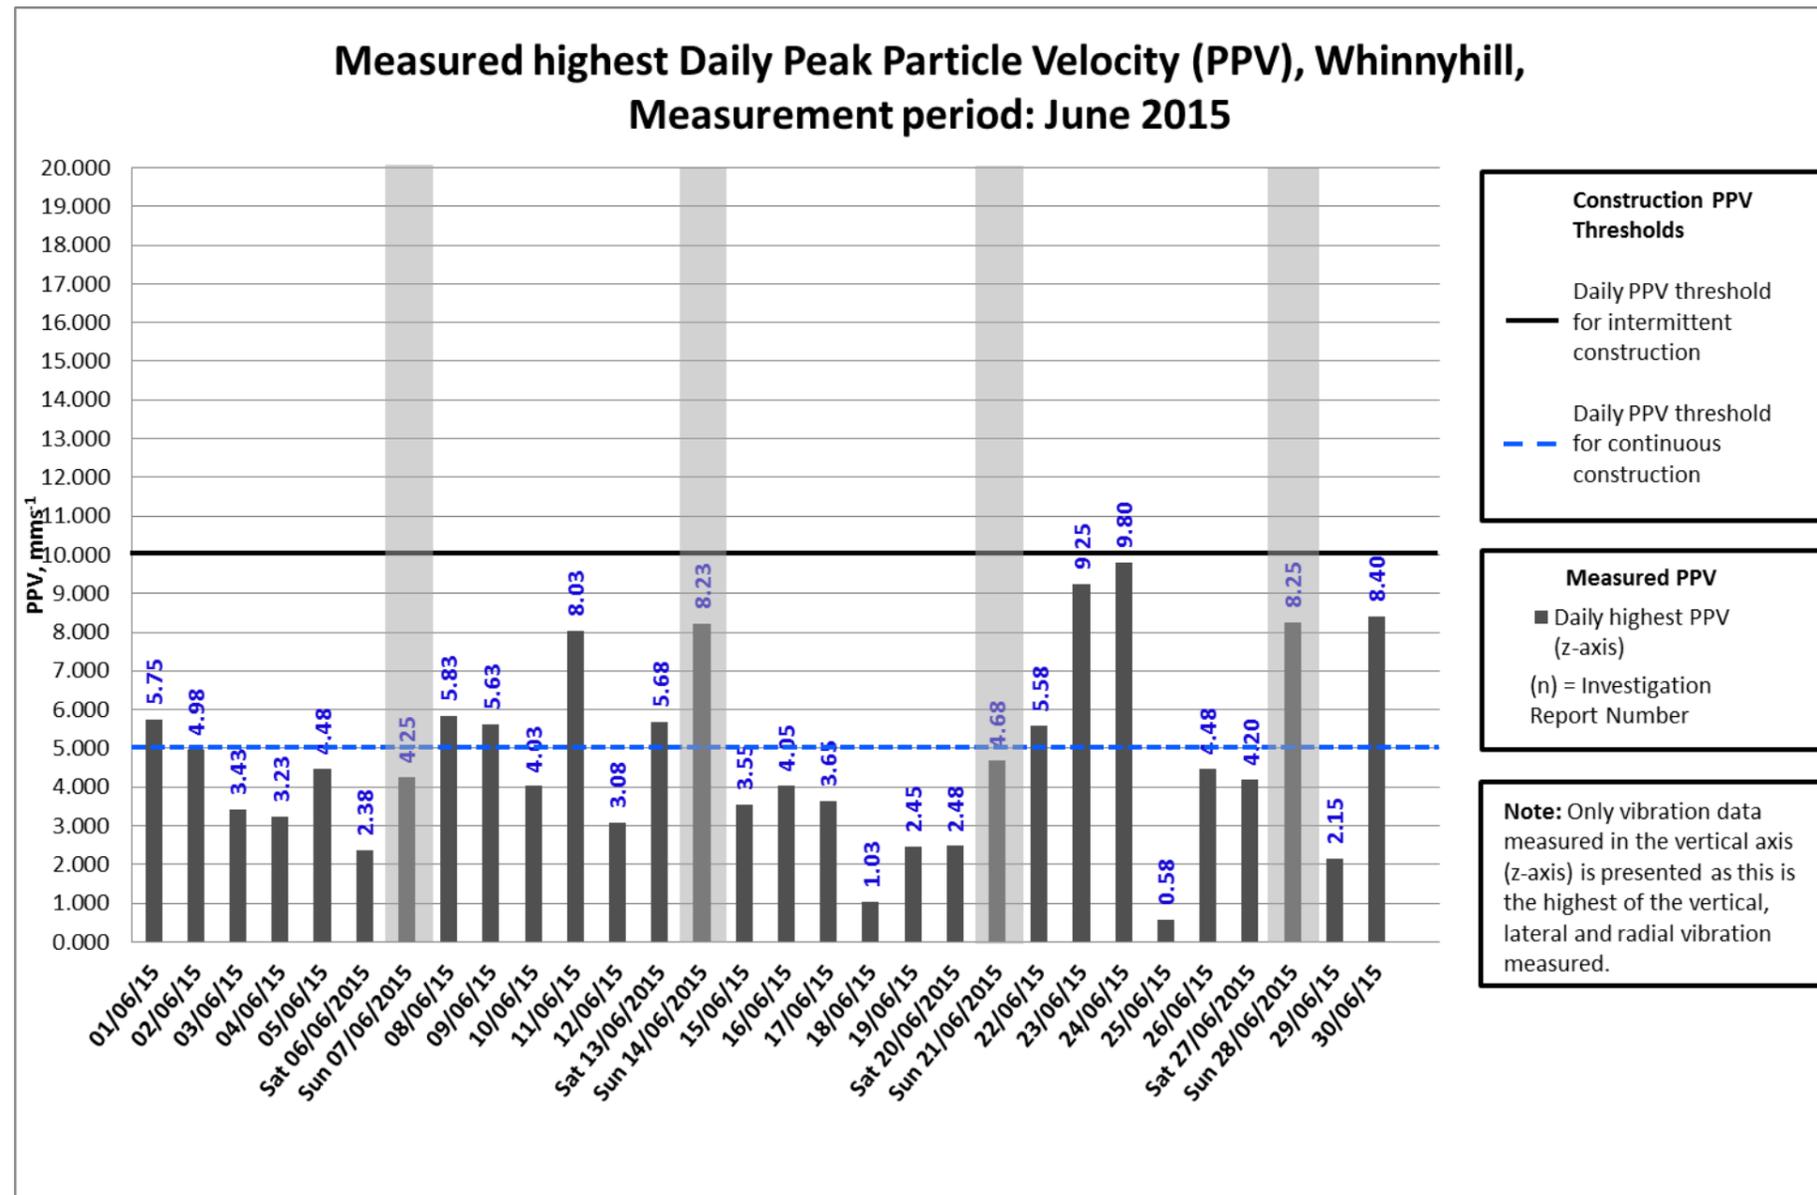
Note: The exceedances on the 08/06/2015, 09/06/2015, 11/06/2015, 13/06/2015, 14/06/2015, 22/06/2015, 23/06/2015, 24/06/2015 and 30/06/2015 have been investigated and have been found to be intermittent vibration that was an isolated incident (reference the graph above on the 11/06/2015 above).
