Appendix C – Debris Flow Photographs

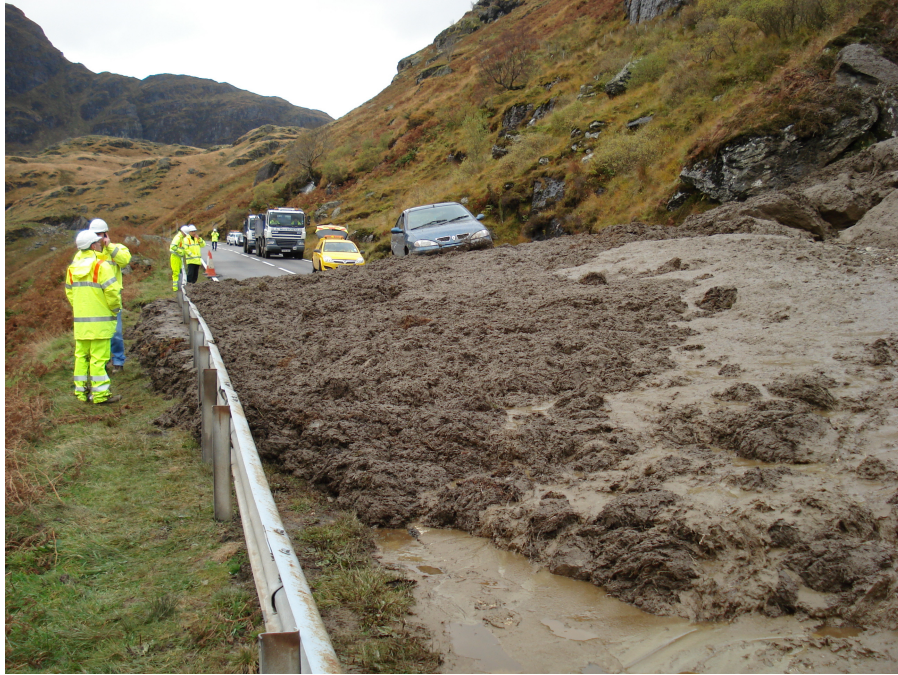
Photograph 1: Disruption to A83 by debris flow

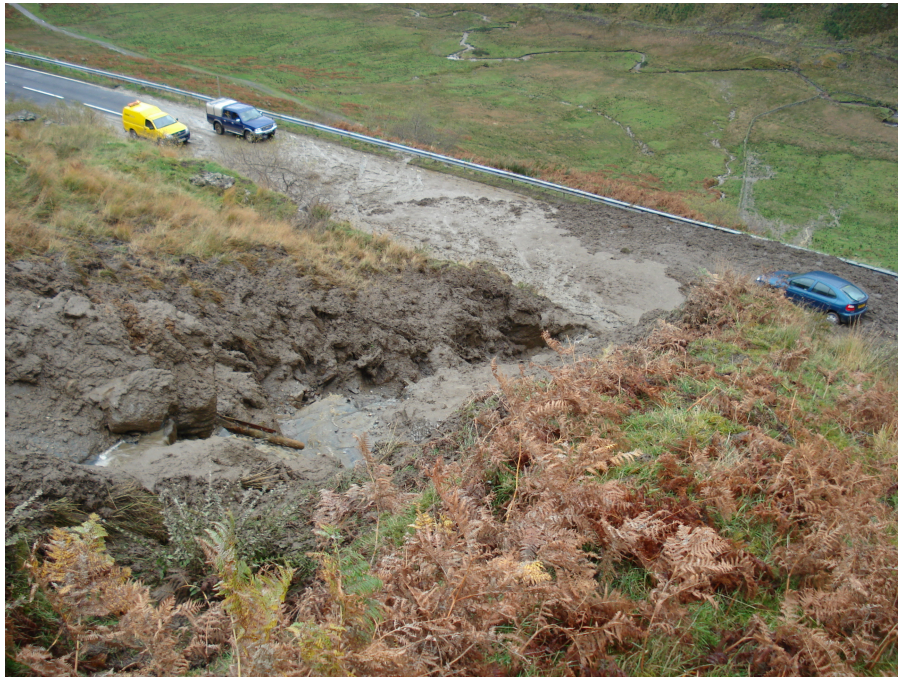
Photograph 2: Looking downhill onto the A83 at the lower section of run-out channel

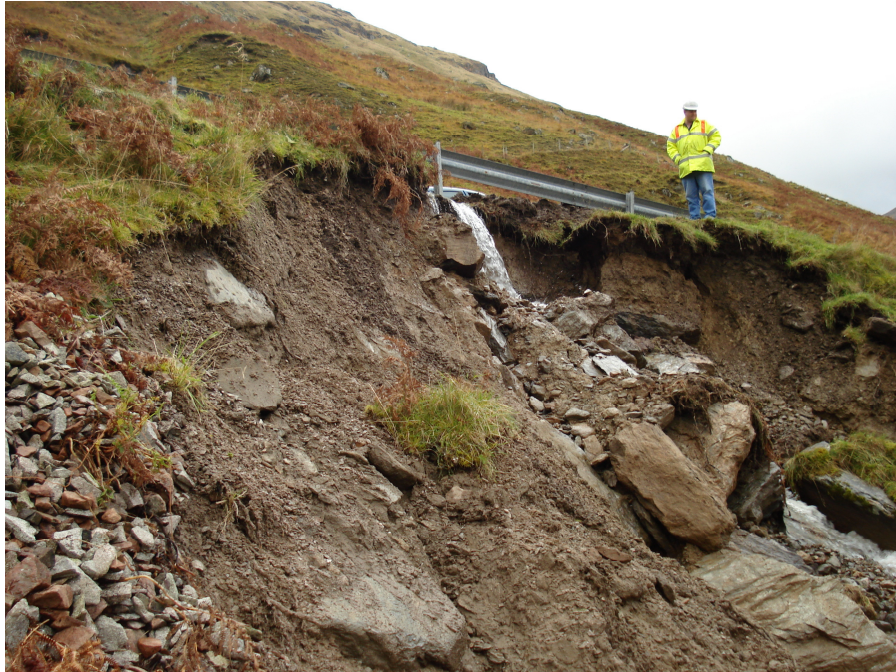
Photograph 3: Undercutting of A83 by debris flow and surface water erosion

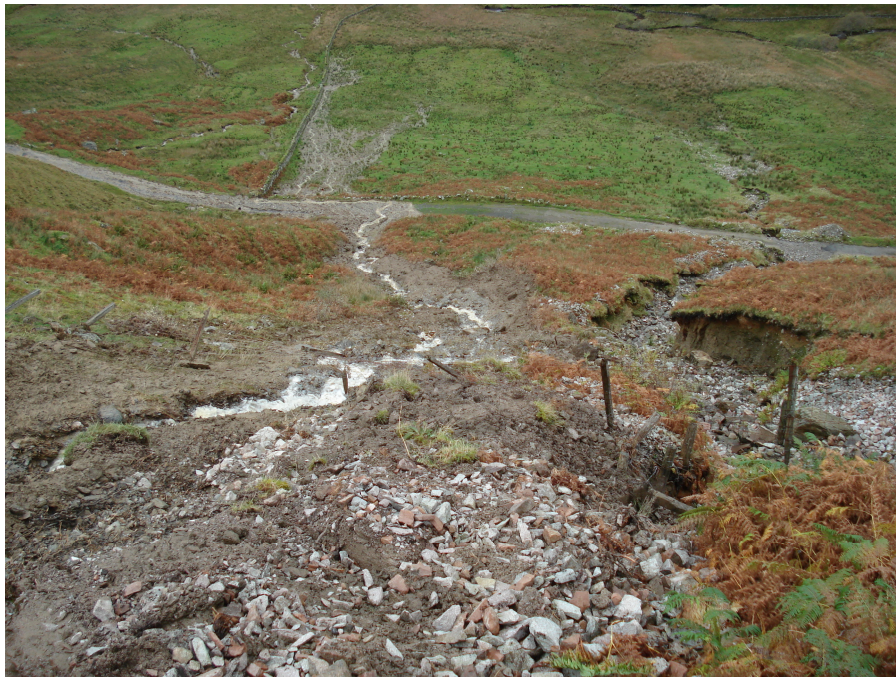
Photograph 4: Debris flow channel below A83. New channel formed by debris flow on left of picture. Previous erosion from culvert on right of picture.
