A83 Tarbet-Lochgilphead- Kennacraig Trunk Road

A83 Rest and Be Thankful

Debris Flow

Emergency Works

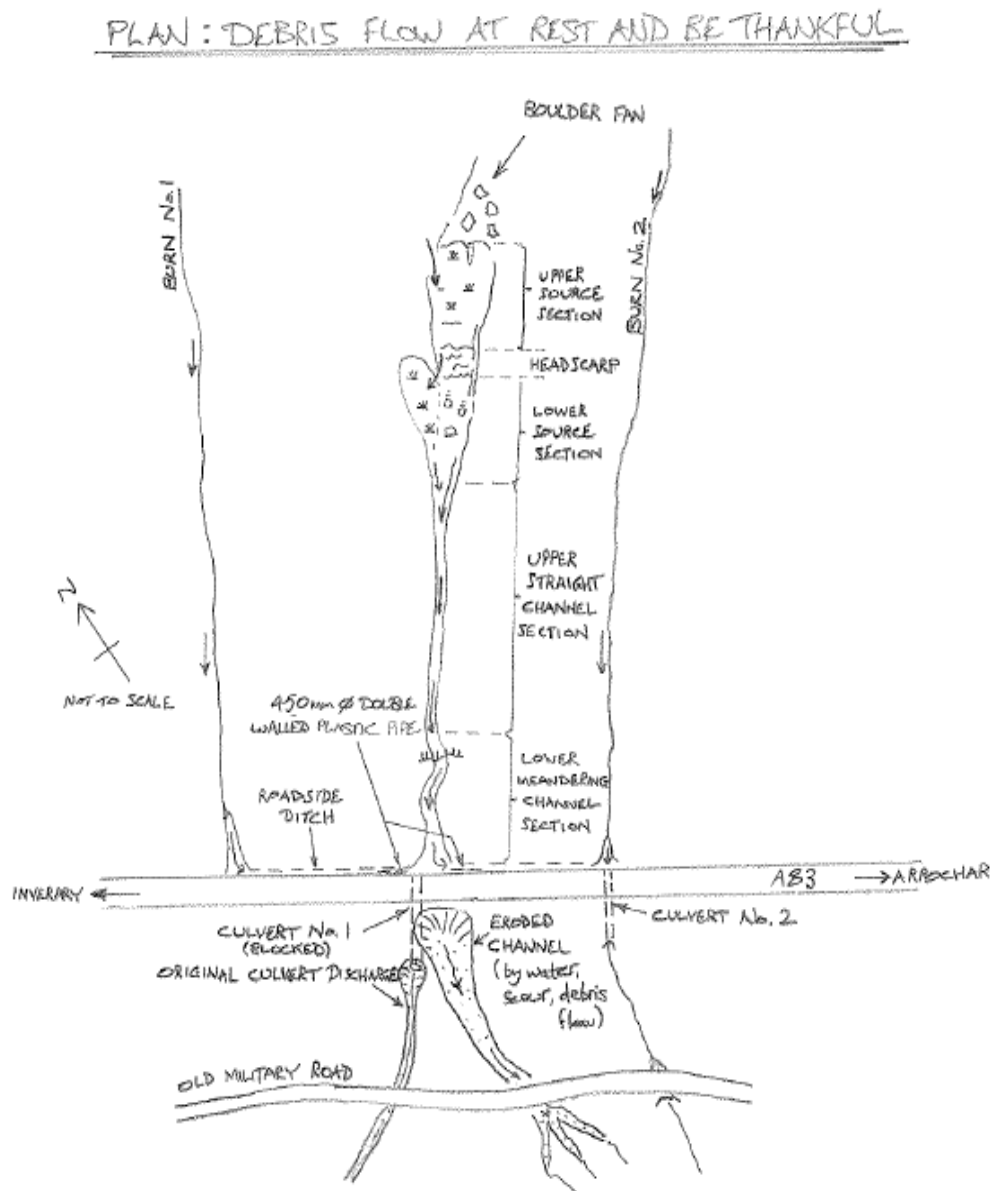
Figure 3 - Sketch Plan of Debris Flow Site

The debris flow channel and source area have been subdivided into four sections as shown on Figures 3 and 4. The path of the debris flow followed an existing shallow channel. This channel, which was deepened and scoured by the debris flow to expose rock in the bottom of channel sections, comprises a lower meandering section located below an upper “straight” section. Figure 5 presents a more detailed sketch plan of the upper and lower source sections shortly following the slope failure. The lower source section, approximately 20m wide by 50m long, which formed the source of the debris flow, has lost its vegetative cover exposing remnant disturbed materials ranging in size from fine-grained soils to abundant gravel, cobbles and frequent boulders (see Photograph 7). The upper subsoils to a depth of up to about 2.5m were removed in this section by the flow. A lobe of grassy, waterlogged material is located immediately west of the lower source area and separated from it by a “finger” of rock extending south towards the road (see Figure 5). Following the debris flow a surface water channel was observed to flow into this lobe.

The debris flow blocked Culvert No. 1 located beneath the road just west of the flow path which prior to the slope failure discharged water from Burn No. 1 (see Figure 3). Following the slope failure, water from Burn No. 1, which previously flowed along the roadside ditch located along the north side of the road was diverted by the debris flow onto the road and discharged onto the downslope embankment.

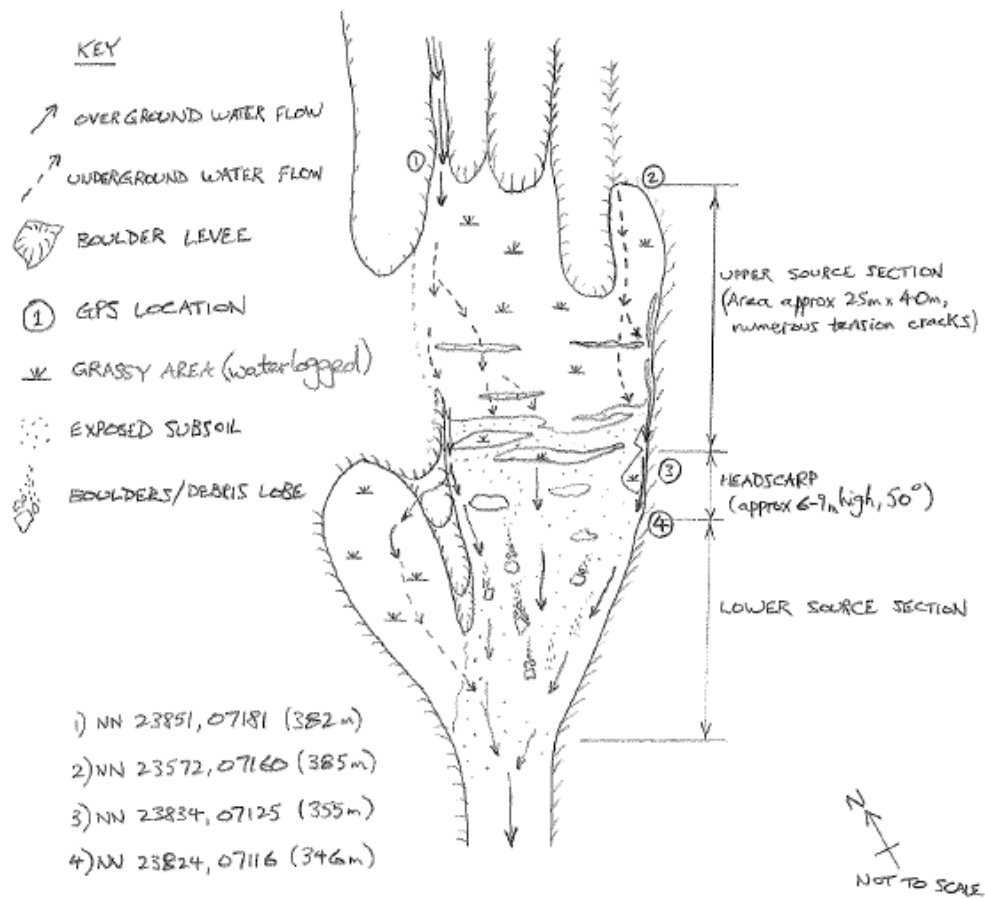
Figure 5 - Detailed Sketch Plan of Upper and Lower Source Sections

The debris flow head scarp is located immediately above the lower source section (see Photograph 8). Following the flow, the scarp varied between about 6 to 9m in height with sand/silt/clay mixtures containing frequent gravel and cobbles with scattered boulders observed in exposed sections of the scarp face. The upper source section located above the head scarp is about 25m by 40m in plan dimensions (see Photograph 9). Several tension cracks are located within this section which is bounded to the west and east by boulder “levees”, (see Figure 5).

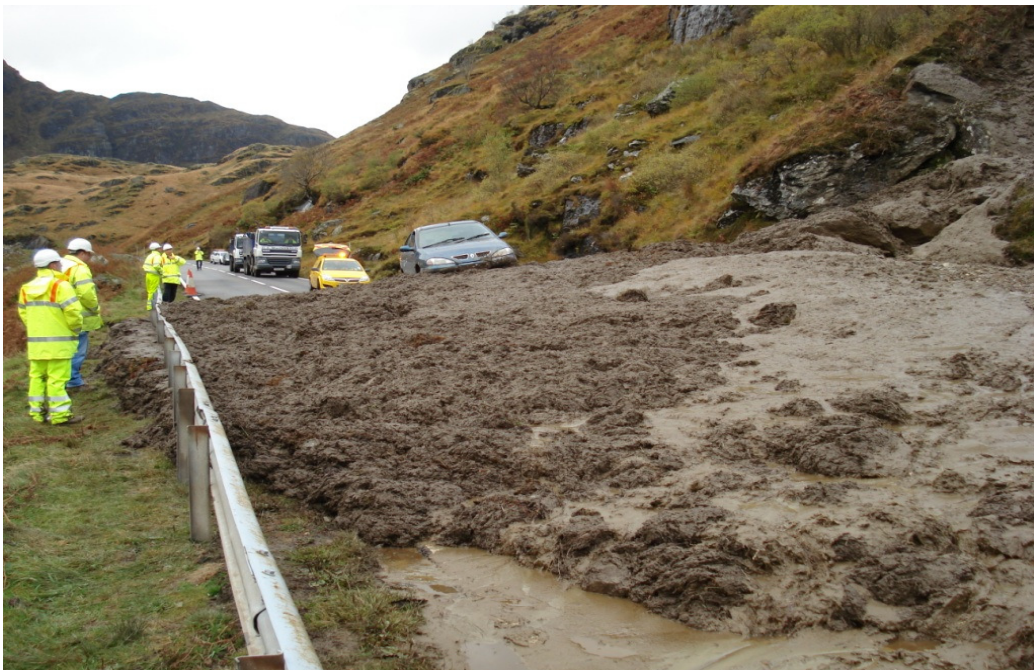
At approximately 03.00 hrs on 28th October 2007 a landslide occurred on the A83 trunk road near the Rest and Be Thankful summit (see Figure 1 and Photograph 1). Following the landslide, emergency services were provided at this location under Scheme No. 07/NW/0601/005 and OI No. 7301185. The landslide consisted of a debris flow which deposited saturated, boulder laden soils to a depth up to approximately 2.5m across the entire width of the road (see Photograph 2).

Photograph 2: Debris flow across the A83 (Note: driver attempted to drive across flow debris)

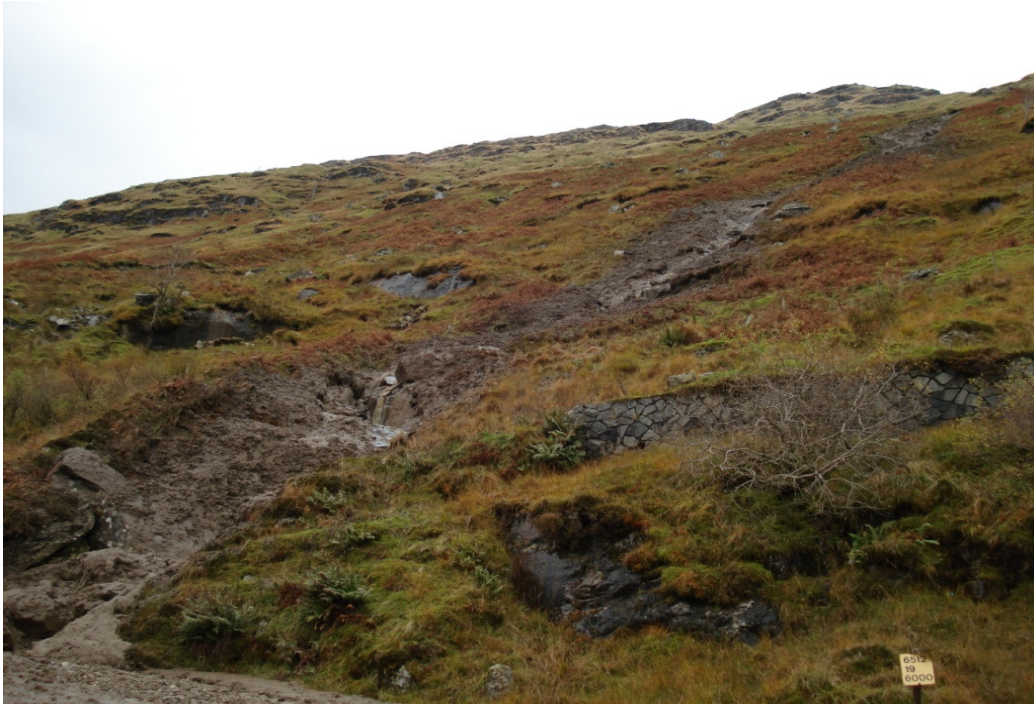
Above the road, a channel up to about 4m in depth, along which the flow occurred has been eroded. This channel extends approximately 200m up to the source area for the debris flow (see Photographs 3 and 4). Below the road, the embankment supporting the road was heavily eroded by scour from the flow debris and from surface water redirected onto the embankment (see Photograph 5). This erosion created a new channel, up to about 3m in depth, in the embankment removing materials which previously supported the verge and the safety barrier.

Photograph 3: Debris flow channel

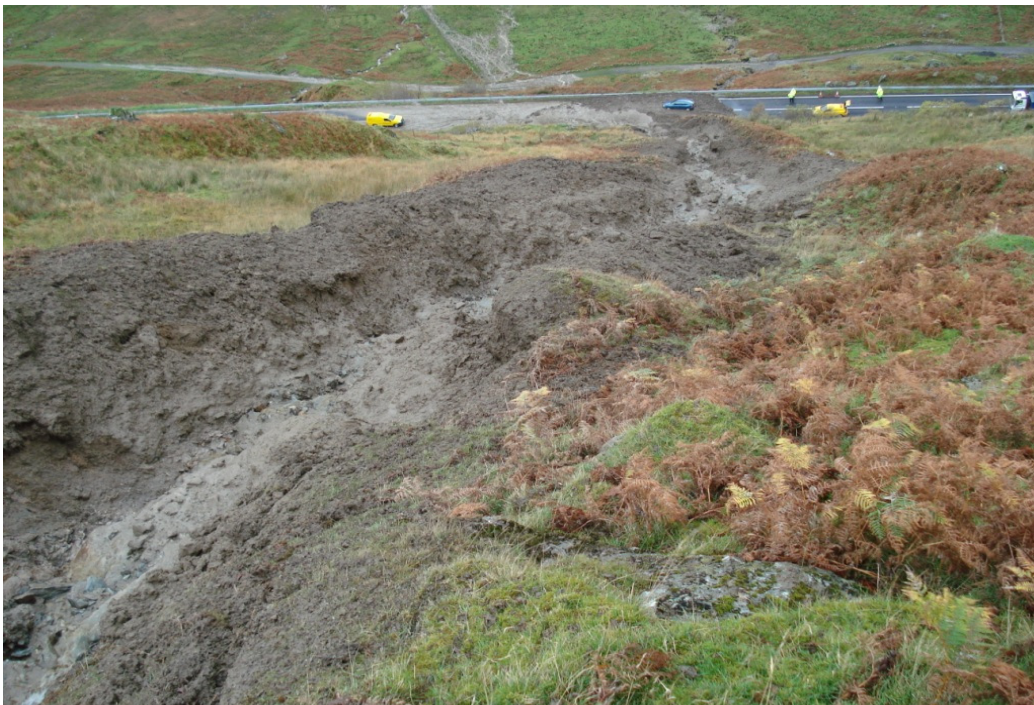
Photograph 4: Debris flow channel looking down slope

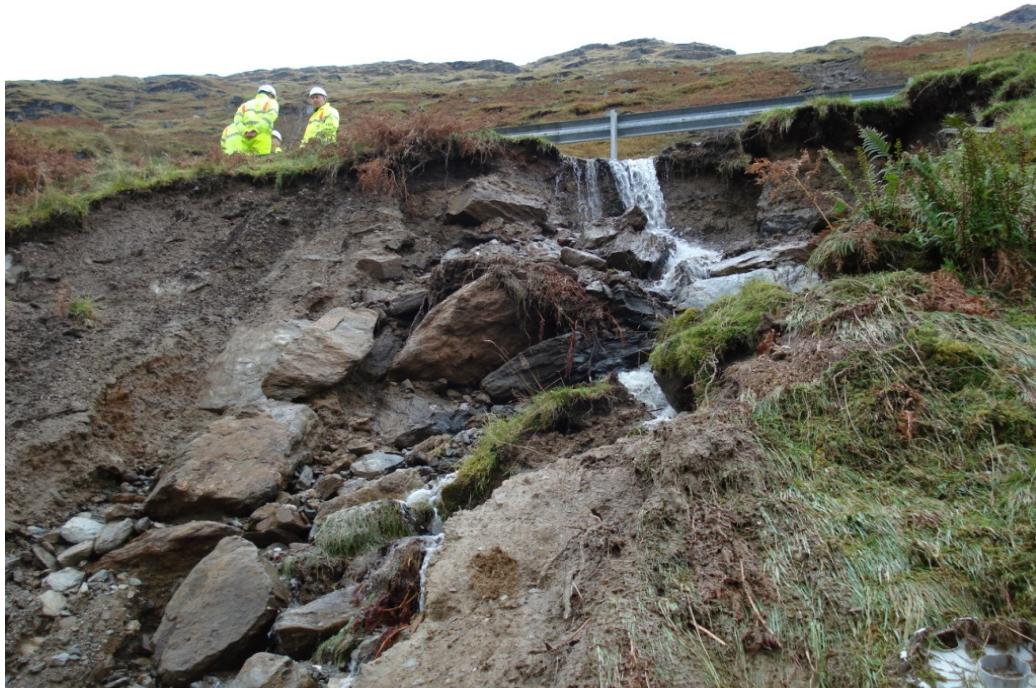
Surface water runoff and debris material had scoured out and incised a deep channel into the embankment below the road. The head scarp of this channel was slowly migrating upslope and undermining the road. As the road was being actively undermined there was a potential for partial road collapse if no remedial measures were taken. This potential was independent of the risk of road damage or destruction due to reactivation of unstable upslope material flowing down onto the road. If emergency protection of the downslope side of the road was not performed there was a risk that the road would become unusable due to the risk of collapse due to undermining.

Following the 28th October slope failure loosening of materials exposed in the headscarp of the erosion channel below the road and seepage of groundwater from the headscarp resulted in the active upslope migration of the erosion channel. This resulted in undermining of the grass verge and metal safety barrier adjacent to the carriageway. On 1st November the erosion channel had migrated upslope to within 0.7m of the carriageway.

Photograph 5: Erosion channel below the road

To help mitigate the potential for additional undermining of the verge and carriageway, a buttress rock fill was placed on 3rd November in the upper portion of the erosion channel to help support exposed sections of the road embankment (see Photograph 13). An excavator was used to place approximately 200 tonnes of 300mm gabion rock in the upper section of the erosion channel. The section adjacent to the road was capped using Type 1 granular fill (see Photograph 14). A sketch plan used for construction of the emergency buttress fill is shown as Figure 6 overleaf.

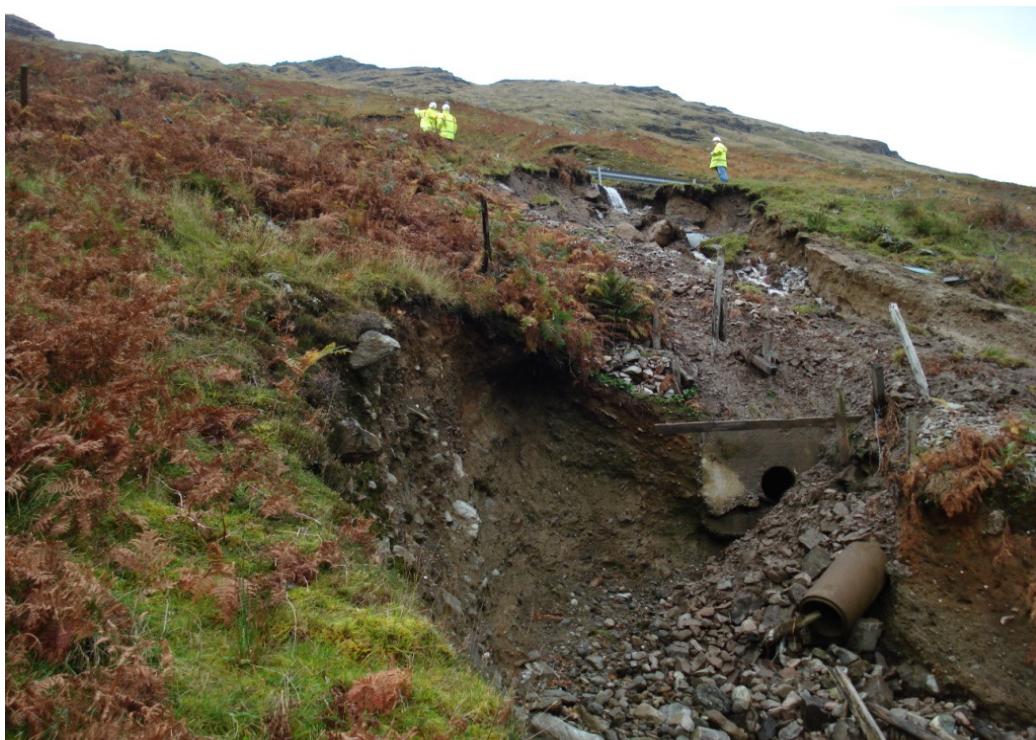
The slopes above and below the carriageway are vegetated with grasses, heather, reeds and occasional stunted small trees. Rock faces are exposed in the slope above the carriageway. The debris flow blocked a culvert located beneath the road just to the west of the site. The culvert discharge pipe is shown on Photograph 6. Emergency drainage measures are discussed in Section 3.1.

Photograph 6: Culvert discharge pipe

As Culvert No. 1 beneath the road was blocked, a 450mm diameter pipe was installed in the roadside ditch along the upslope side of the A83 to ensure the free flow of water from Burn No. 1 through the site to the adjacent intact downslope culvert (Culvert No. 2, see Figure 3). This culvert (Culvert No. 2) currently discharges surface water from Burn No. 1, Burn No. 2, and the debris flow channel

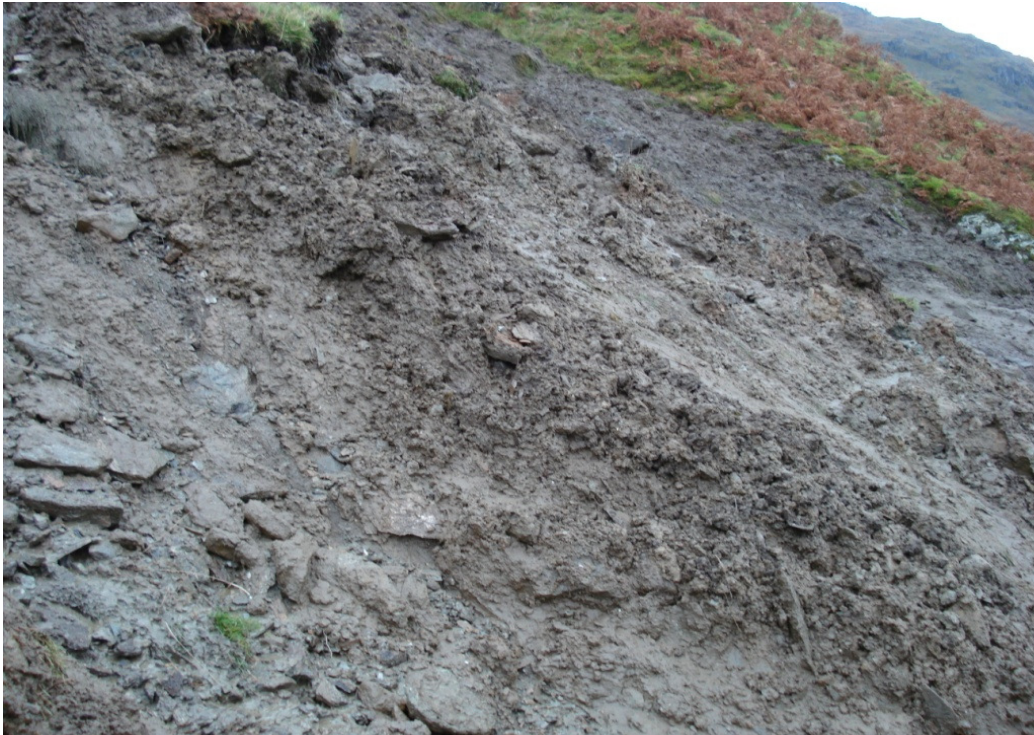
Following detailed assessment of the slope area by geotechnical and geomorphological specialists, unstable, deformed and deteriorating materials remaining in the source areas immediately above the head scarp area were identified as still posing a considerable risk to the travelling public on the A83 below.

Photograph 7: Debris flow lower source area

During the site walkovers potentially unstable materials were identified as remaining on the slope above the road. To help stabilise the slope above the road, water was introduced onto selected sections of the source areas to dislodge loose and potentially unstable materials and to flush these materials down the flow channel in a controlled manner. This work commenced on 5th November and continued until 14th November as detailed below.

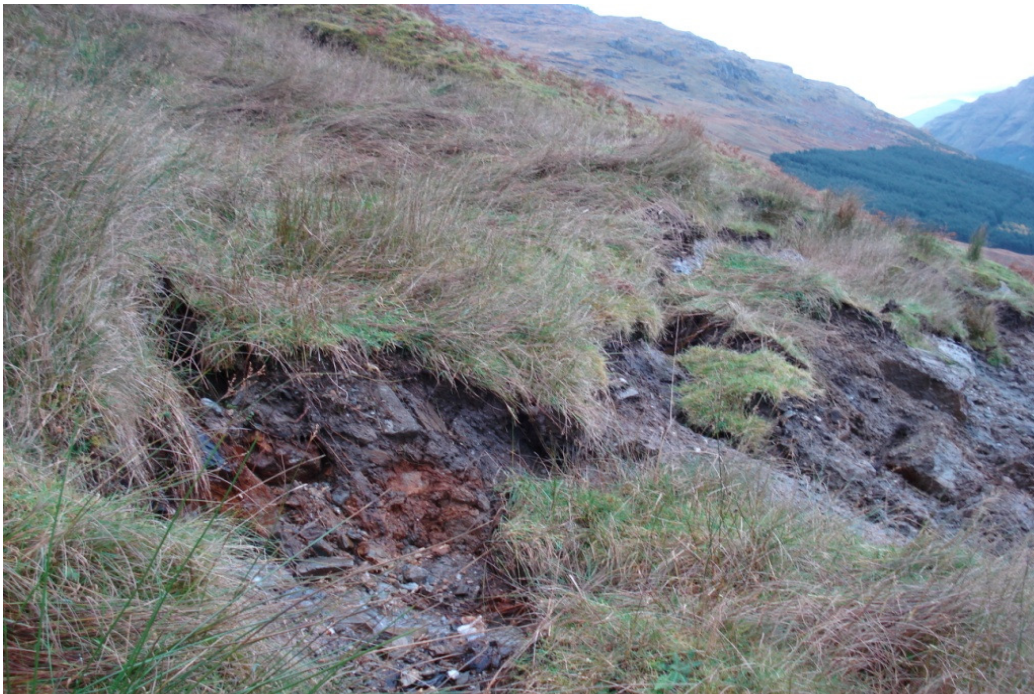
Photograph 8: Head scarp of debris flow

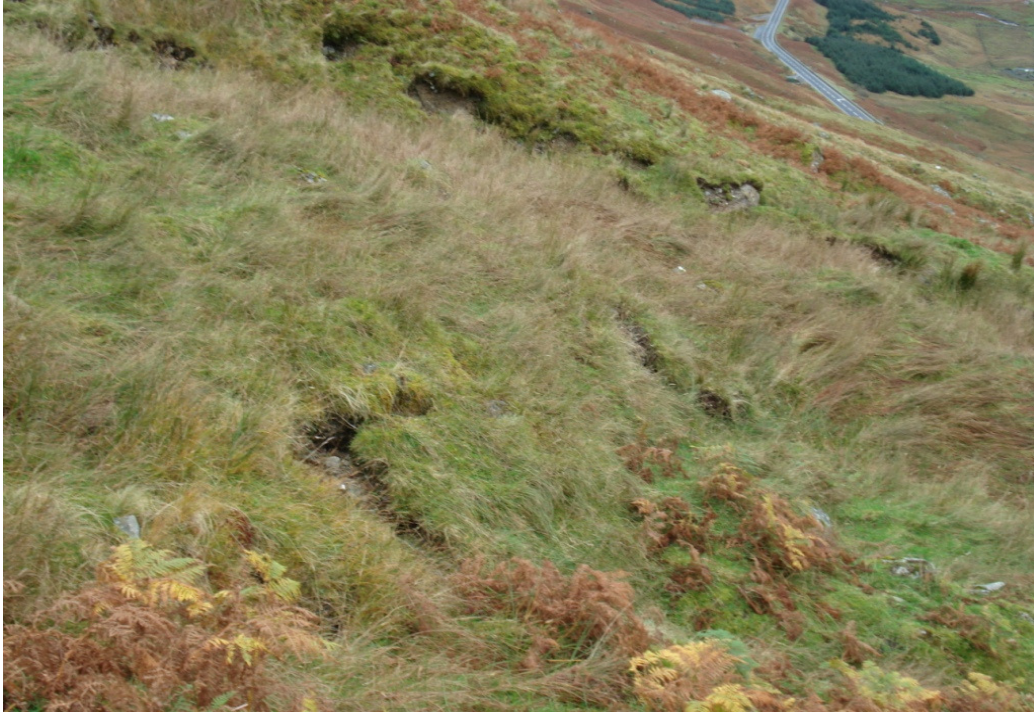
Photograph 9: Debris flow upper source area

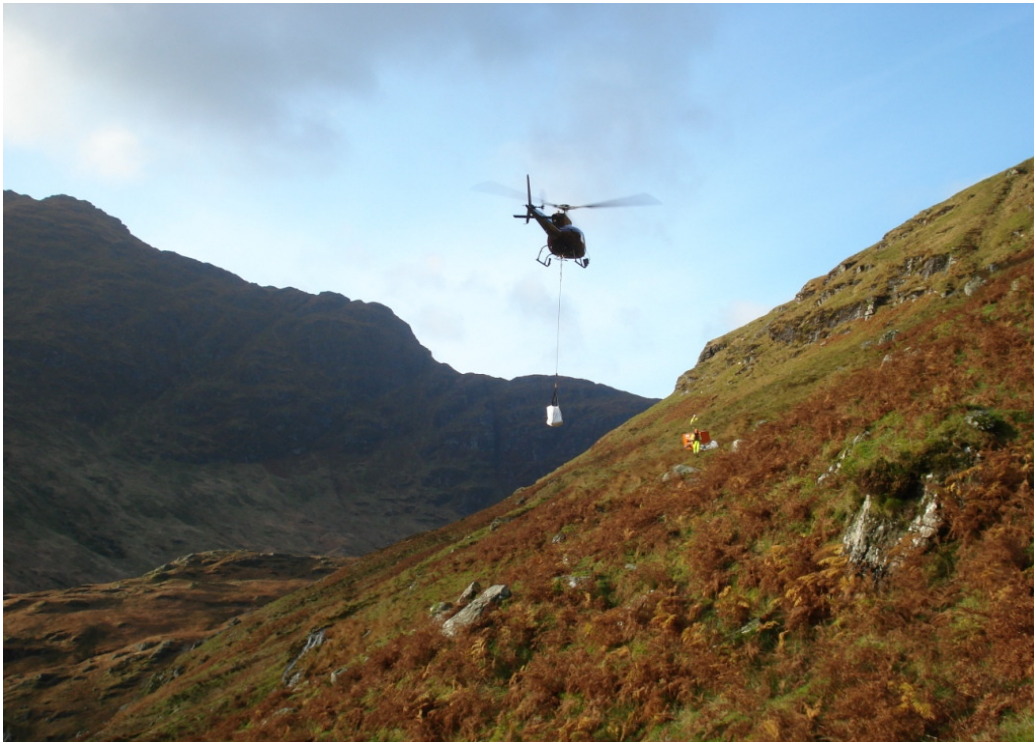
Photograph 10: Helicopter transport of equipment onto hillside

Initially, water was pumped onto sections of the source area using two 6-inch pumps secured adjacent to existing watercourses located immediately west and east of the slide area (Burn Nos. 1 and 2 respectively, see Figure 3). On 5th November a helicopter was used to transport the pumps, hose and associated equipment onto the slope (see Photograph 10). Hosing of water onto the source area commenced on 6th November and the hoses remained in place spraying water onto the source area overnight. On 7th November hosing continued combined with the manual removal of loose materials (see Photograph 11) from the source areas and the head scarp. The head scarp was reprofiled and overhanging soil rafts, debris and rock were removed. Water hoses were fixed in position with rebar on the 7th November but had stopped by the afternoon of 8th November. Adverse weather conditions (gales and heavy rain) precluded any personnel working on the hillside between 8th and 11th November. The pumps, hose and associated equipment were removed from the hillside by helicopter on 14th November.

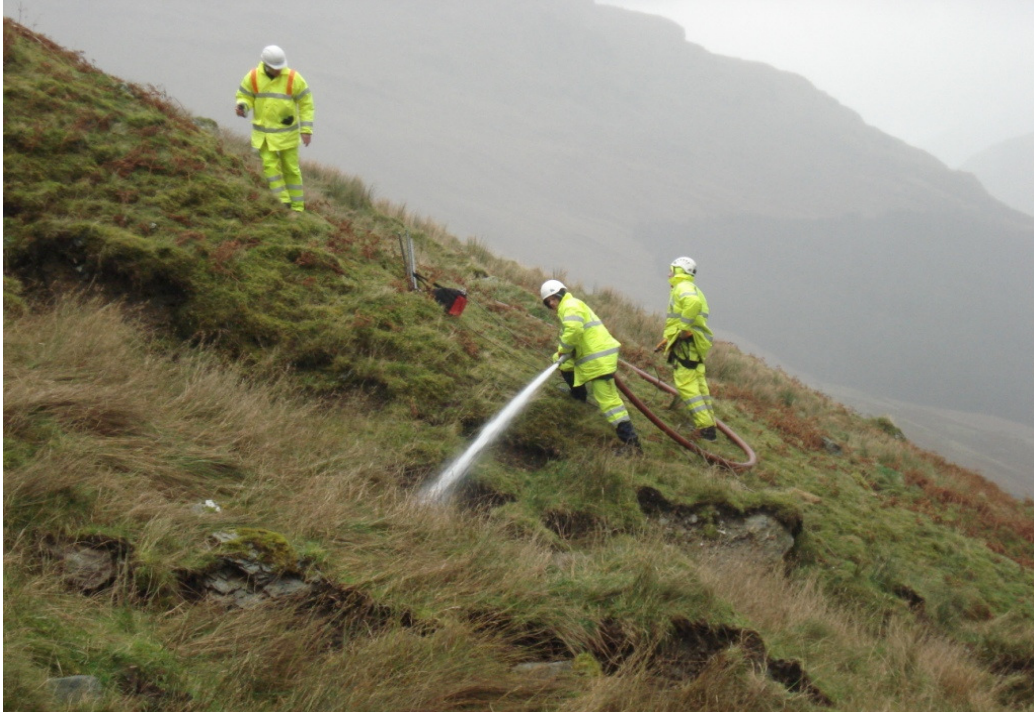
Photograph 11: Hosing water onto the source area

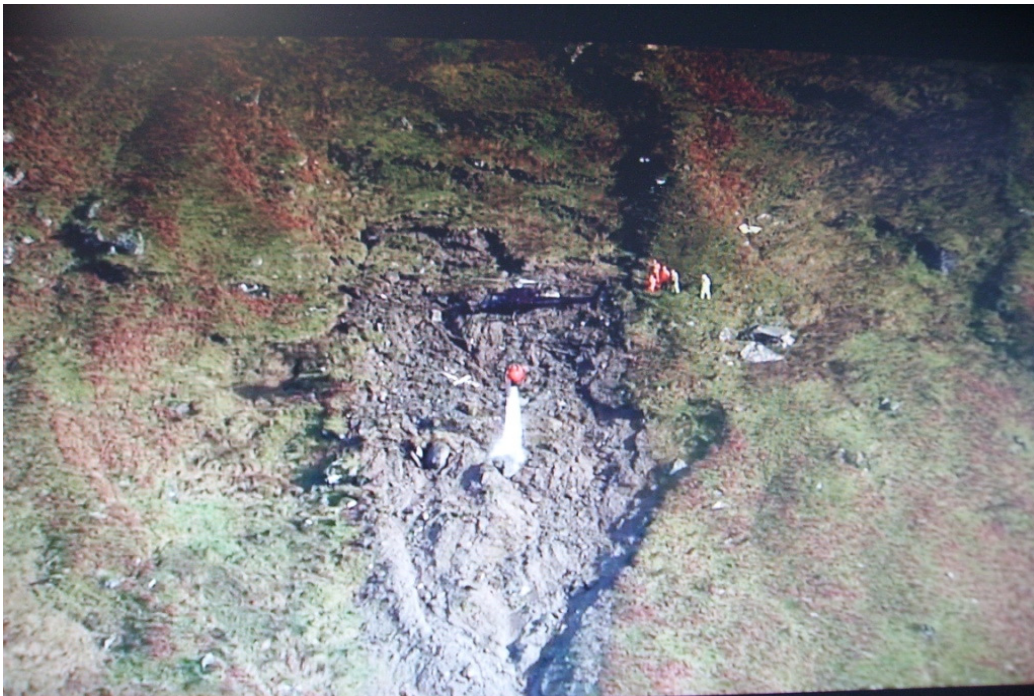
Photograph 12: Helicopter water drop onto the source area

Between the 8th and 12th November and following the water hosing operation, slope conditions were reassessed. Small areas of potentially unstable material were identified as remaining on the slope and the use of a helicopter to target selected areas with water drops was proposed. To deliver a greater volume of water over a shorter time period onto identified areas of potentially unstable soils, and to minimise personnel working on the slope due to safety considerations, a helicopter was used to drop water from variable heights onto the source areas using a 750-litre “Bambi” bucket (see Photograph 12). This technique was also used to help remove debris from vegetated areas of the side slopes of the flow channel. This work was carried out on 14th November. Approximately 15,000 litres in total were dropped onto the source area and the side slopes of the flow channel. Water was collected from Loch Restil located about 1km north of the site (see Figure 2).

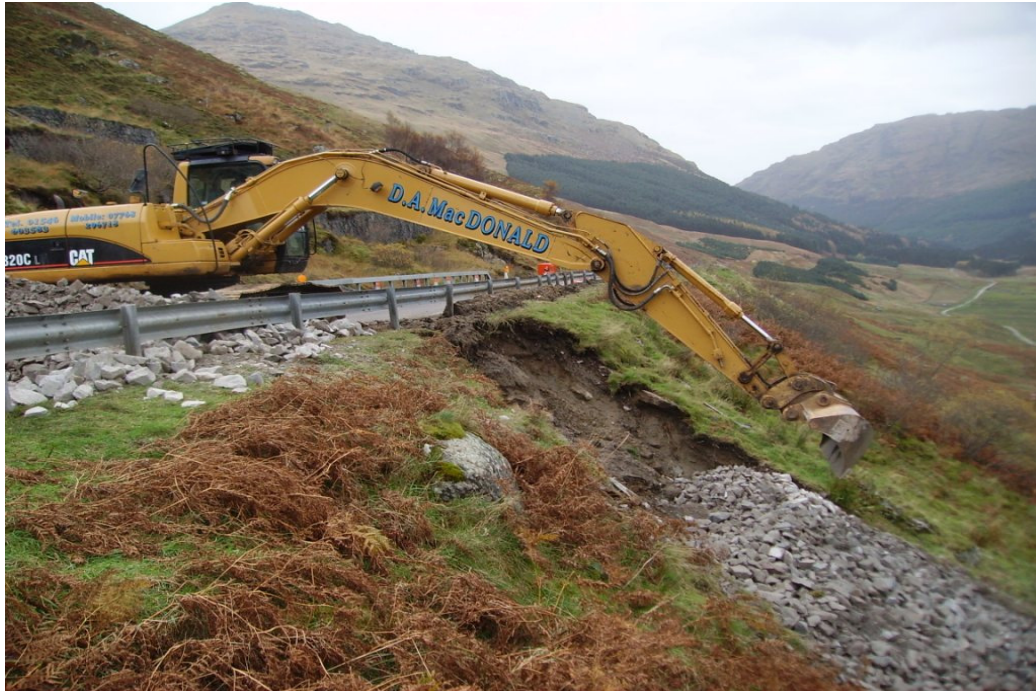
Photograph 13: Construction of buttress fill below the road

- Gabion rock fill (>300mm) used as buttress fill to support the road totalled about 200 tonnes. Approximately 20 tonnes Type 1 granular material was used as a capping material in the verge area.

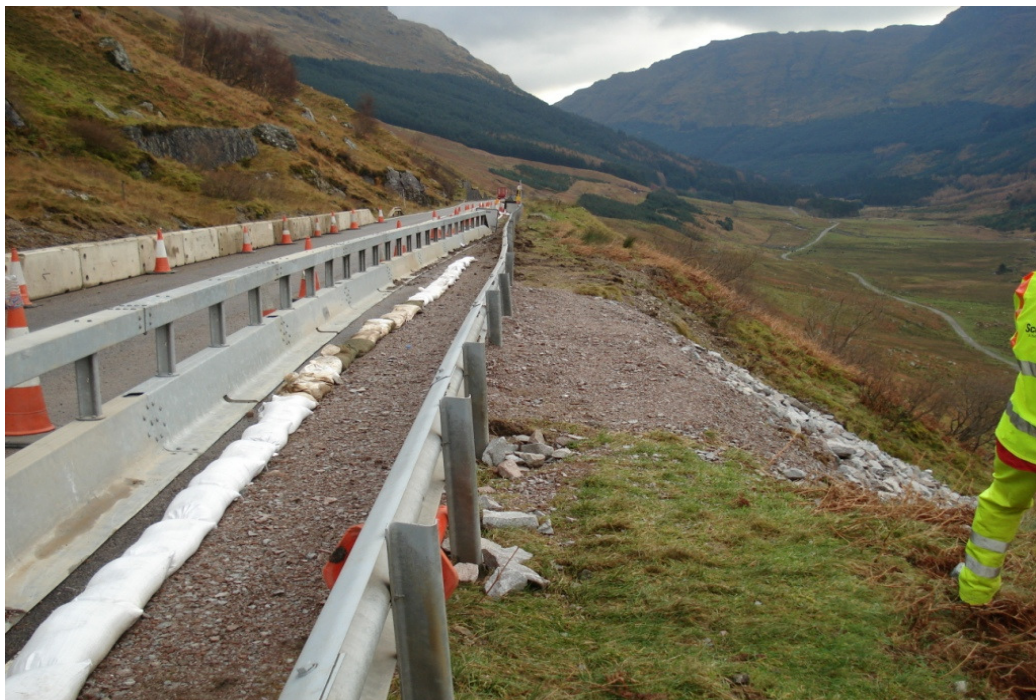
Photograph 14: Granular capping layer on buttress fill adjacent to carriageway
