SCRIM Site Secondary Investigation Form

Site Name	GLENFINNAN RLY BR TO RLY ACCESS GATE					
Road Name Details	A830 Fort William to Mallaig Trunk Road					
Location Details	Section Code	17208/35	Start Metre	60	End Metre	120
SCRIM Site Category Details	S2 - Bends radius <500m - single carriageway				Investigatory Level	0.50

Site Name: GLENFINNAN RLY BR TO RLY ACCESS GATE
Road Name: A830
Start Metre: 60

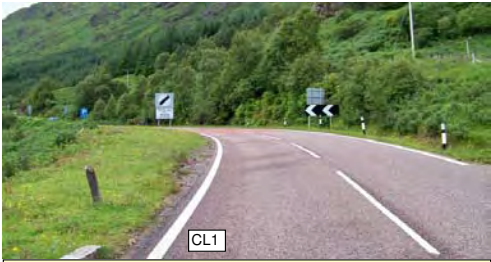
Photo 1: CL1 approach to bend and derestriction

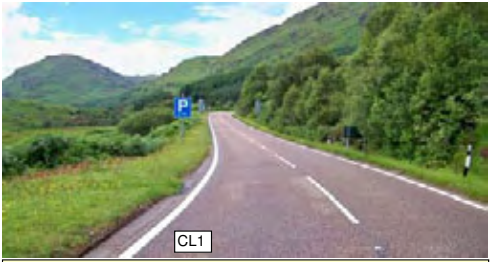
Photo 2: CL1 exit from bend

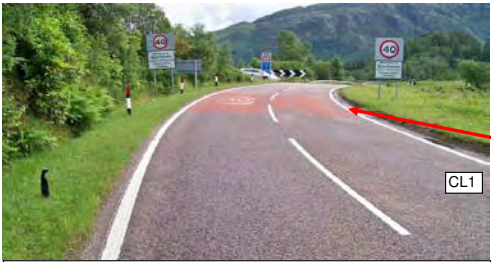
Photo 3: CR1 approach to bend and 40mph zone

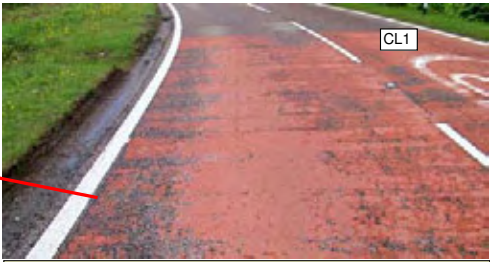
Visibility		Yes	No	Comments
20	Are traffic signals, signs, markings appropriate in all conditions?	<input checked="" type="radio"/>	<input type="radio"/>	21. Red slow banner at change to 40mph is worn.
21	Are traffic signals, signs, markings clearly visible to vehicles?	<input type="radio"/>	<input checked="" type="radio"/>	
21	Do approaches (Including side roads) have adequate site distances?	<input checked="" type="radio"/>	<input type="radio"/>

Photo 4: Worn 40mph banner on entry to restriction

Investigator's Recommendation	
Correct the site category and set appropriate IL for the site	<input type="checkbox"/>
Treatment to improve the skid resistance	<input type="checkbox"/>
Safety treatment other than improving the skid resistance eg markings, signs, etc	<input type="checkbox"/>
Routine maintenance	<input checked="" type="checkbox"/>
No further action, provide reasons	<input type="checkbox"/>
Description of Investigator's recommendation	
<p>Surface is in good condition, visibility and layout are adequate. No surface treatment is recommended at present. Slow banner on entry to 40mph is worn and should be considered for renewal.</p>

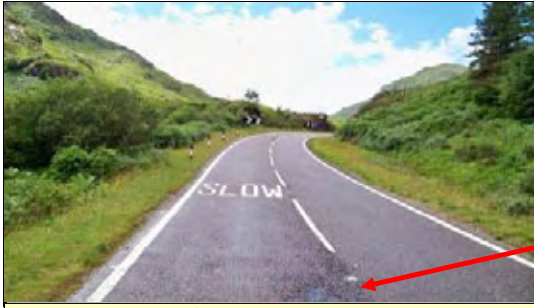
CL1 approach to bend

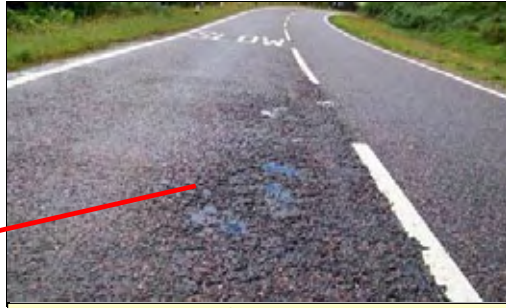
Roughness on CL1 at beginning of bend

Investigator's Recommendation	
Correct the site category and set appropriate IL for the site	<input type="checkbox"/>
Treatment to improve the skid resistance	<input type="checkbox"/>
Safety treatment other than improving the skid resistance eg markings, signs, etc	<input type="checkbox"/>
Routine maintenance	<input checked="" type="checkbox"/>
No further action, provide reasons	<input type="checkbox"/>
Description of Investigator's recommendation	
It is recommended that the area of sinking and the areas of roughness are patched.

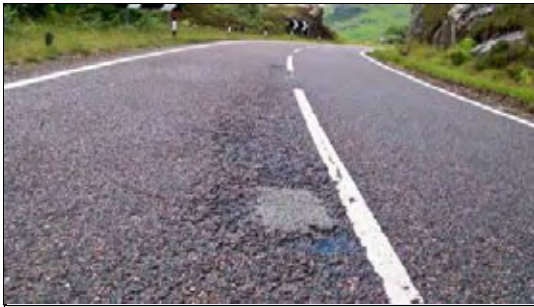
CL1 roughness

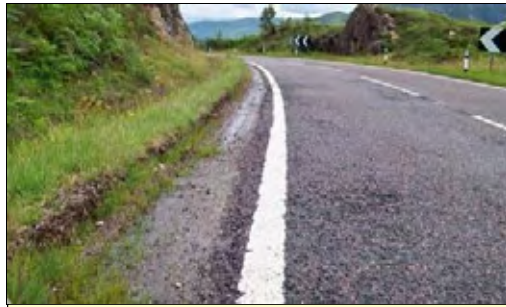
CR1 edge over run at approach to bend

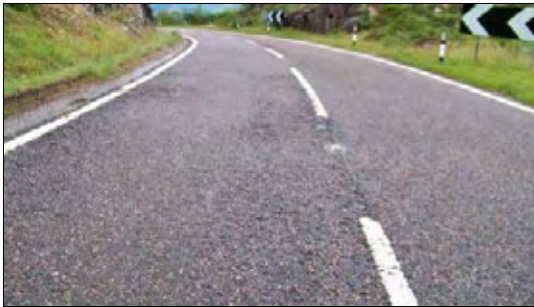
CR1 roughness

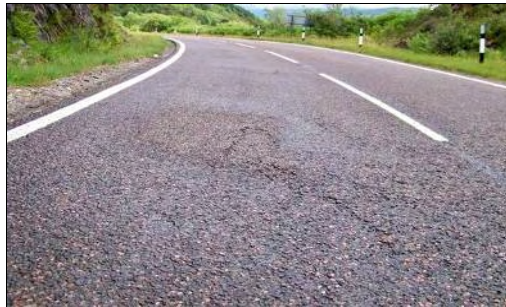
CR1 area of sinking in wheel track

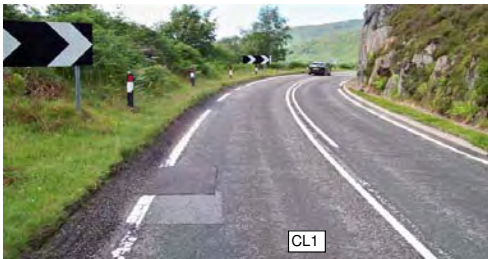
Photo 1: CL1 at eastern extent of site

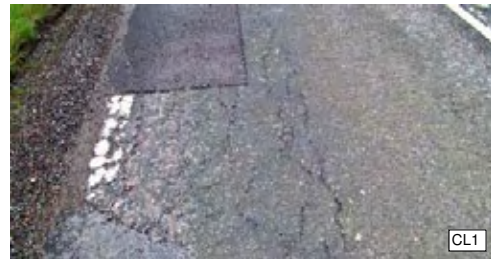
Photo 2: Cracking around patches at CL1 edge

Investigator's Recommendation	
Correct the site category and set appropriate IL for the site	<input type="checkbox"/>
Treatment to improve the skid resistance	<input checked="" type="checkbox"/>
Safety treatment other than improving the skid resistance eg markings, signs, etc	<input type="checkbox"/>
Routine maintenance	<input type="checkbox"/>
No further action, provide reasons	<input type="checkbox"/>
Description of Investigator's recommendation	
<p>It is recommended that a treatment to remedy defects and if possible provide a uniform surface through out the site is considered.</p>

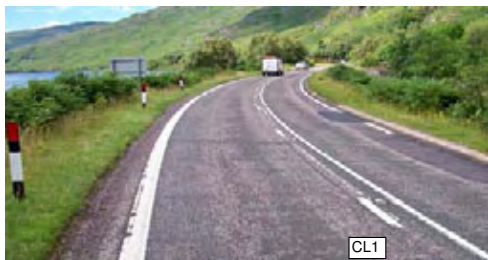
Photo 3: CL1 view through bend

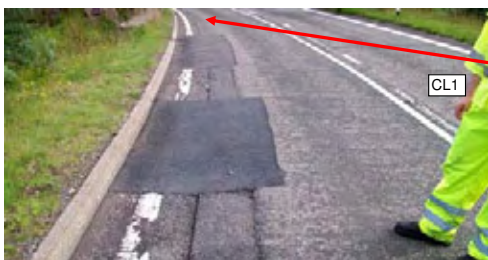
Photo 5: Various patches, some of which have deteriorated, providing an uneven surface of different materials

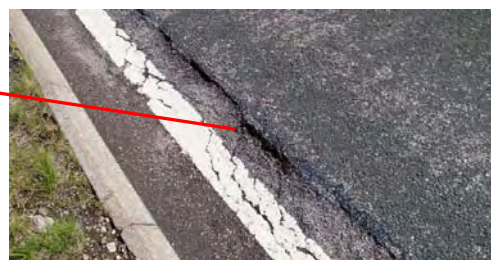
Photo 6: Deterioration of seam on previous repairs on CR1

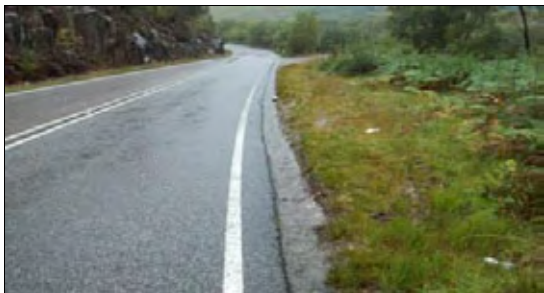
Photo 1 - View eastbound from CL1 up to site. Some edge overrun.

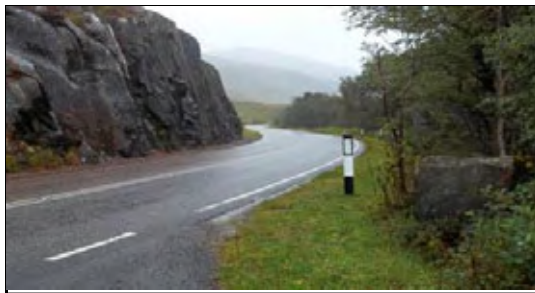
Photo 2 - View Eastbound on CL1 to bends prior to site

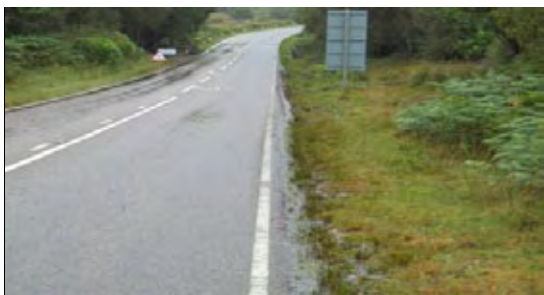
Photo 3 - CL1 - View of edge overrun further down site

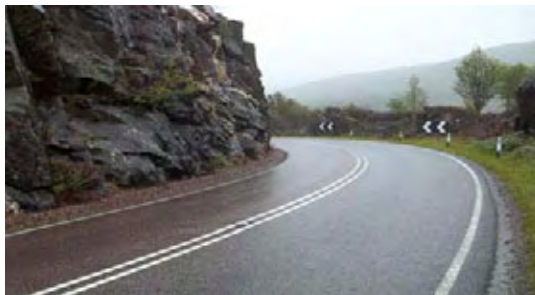
Visibility		Yes	No	Comments
20	Are traffic signals, signs, markings appropriate in all conditions?	<input type="radio"/>	<input type="radio"/>	21. Site would benefit from extra bend chevron (See attached)
21	Are traffic signals, signs, markings clearly visible to vehicles?	<input type="radio"/>	<input type="radio"/>	
21	Do approaches (Including side roads) have adequate sight distances?	<input type="radio"/>	<input type="radio"/>

Photo 4 - CR1 - Recommended location of extra chevron

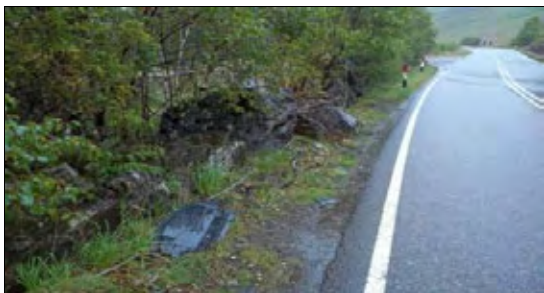
Photo 5 - CL1 Accident debris on edge of carriageway and water crossing both lanes

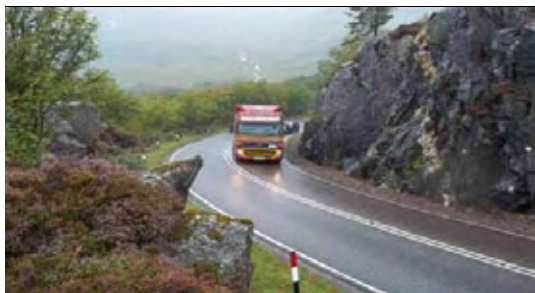
Photo 6 - Some HGV's seen to cross centreline and showing obtrusive rocks.

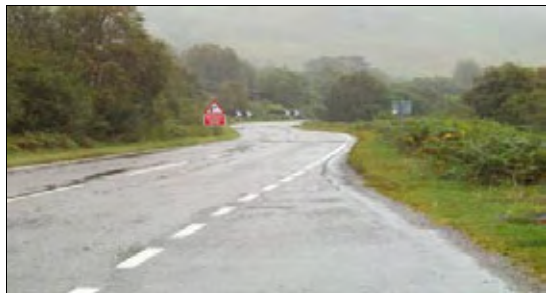
Photo 1 - View eastbound from CL1. Site well marked and bend indicated well

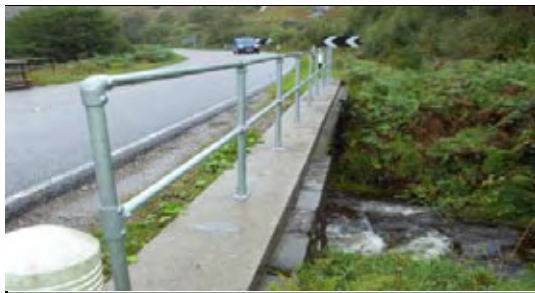
Photo 2 - Fence to edge of culvert

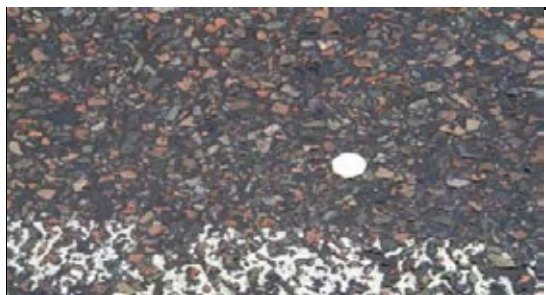
Photo 3 - Texture and Carrigeway in good condition

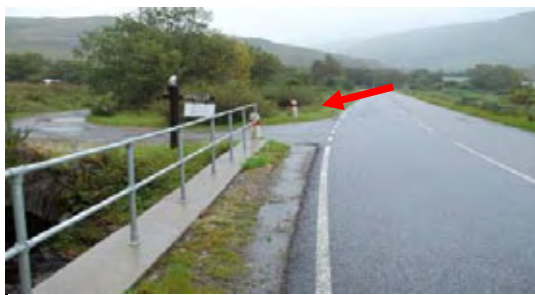
Photo 4 - CR1 - Site of recent vehicle leaving carrigeway and private access after bend

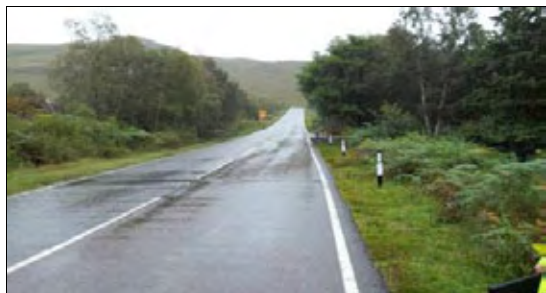
Pavement and Surface Condition Data		Yes	No	Comments
9	Does the SCRIM data appear to represent the site?	<input checked="" type="radio"/>	<input type="radio"/>	9 - Different aggregate on either side of the carriageway
10	Is the macrotexture adequate for the site?	<input checked="" type="radio"/>	<input type="radio"/>

Photo 5 - Looking Eastbound towards site 1. Showing two different materials in each lane

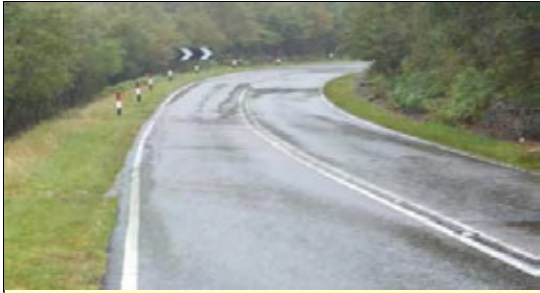
Photo 1 - View Westbound from CL1. Bend indicated well

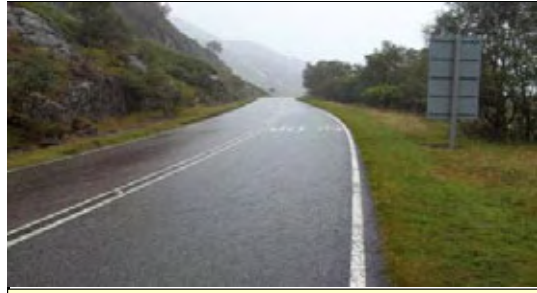
Photo 2 - View Eastbound on approach to bend

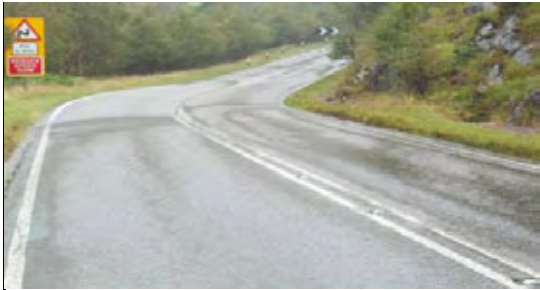
Photo 3 - Bend well marked and indicated. Large amounts of surface water crossing carriageway

Investigator's Recommendation	
Correct the site category and set appropriate IL for the site	<input type="checkbox"/>
Treatment to improve the skid resistance	<input type="checkbox"/>
Safety treatment other than improving the skid resistance eg markings, signs, etc	<input checked="" type="checkbox"/>
Routine maintenance	<input checked="" type="checkbox"/>
No further action, provide reasons	<input type="checkbox"/>
Description of Investigator's recommendation	
<p>Site would benefit from removal of overhanging vegetation It is understood that the survey was carried out in extremely adverse conditions, however, the site would still benefit from maintenance to the existing drainage grips and some additional ones also.</p>

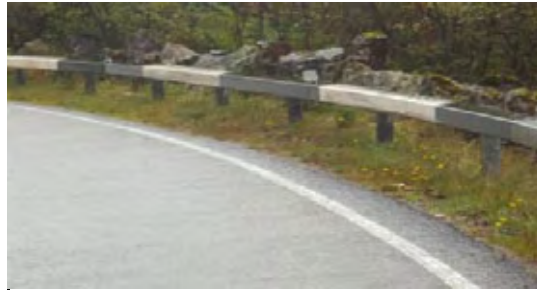
Photo 4 - Evidence of barrier strikes on bend

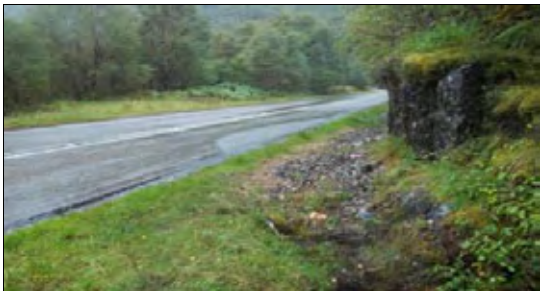
Photo 5 - Large amounts of surface water on carriageway
