A83 Tarbet – Lochgilphead – Kennacraig Trunk Road
Study into Potential Emergency Diversion Routes at the
Rest and Be Thankful

Transport Scotland

Report Title Study into Potential Emergency Diversion Routes at the Rest
and Be Thankful

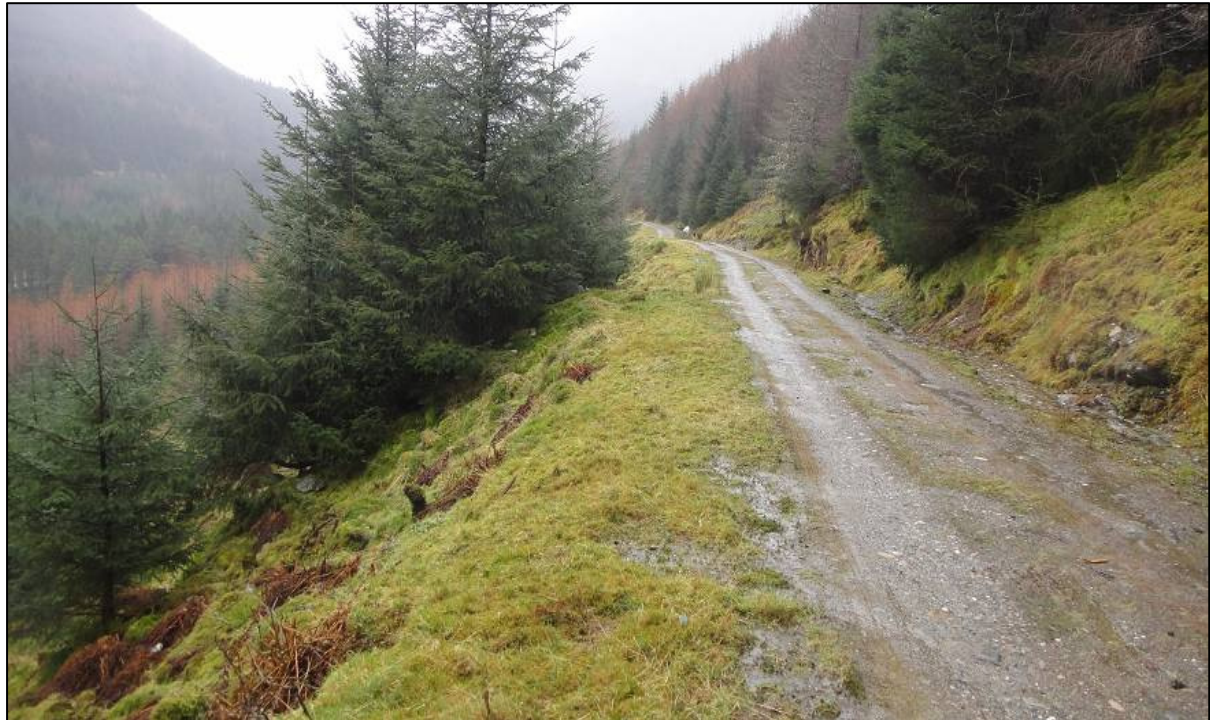
Figure 3: Image of forestry track and adjacent lower steep slope

The forestry track is on sidelong ground with a steep lower slope below which presents a significant hazard along its full length. See Figure 3 below.

The steep slope is separated from the forestry track by an existing soft verge. The width of the verge is changeable, ranging from 0.2 metres at its narrowest to 6.6 metres at its widest, but it generally measures 1.2 metres.

There is a very little scope to widen the track to negate any errant vehicle reaching the lower slope hazard and to improve the swept path of larger vehicles. Nevertheless, risks could be reduced by limiting emergency use to within daylight hours only and restricting access to cars and light goods vehicles only whilst being managed by a convoy system at 10mph. Post and wire fencing could be used to delineate the narrow soft verge but would not contain vehicles. Ribbed road markings would also aid informing and deterring drivers away from both the lower slope and the open drainage ditch.

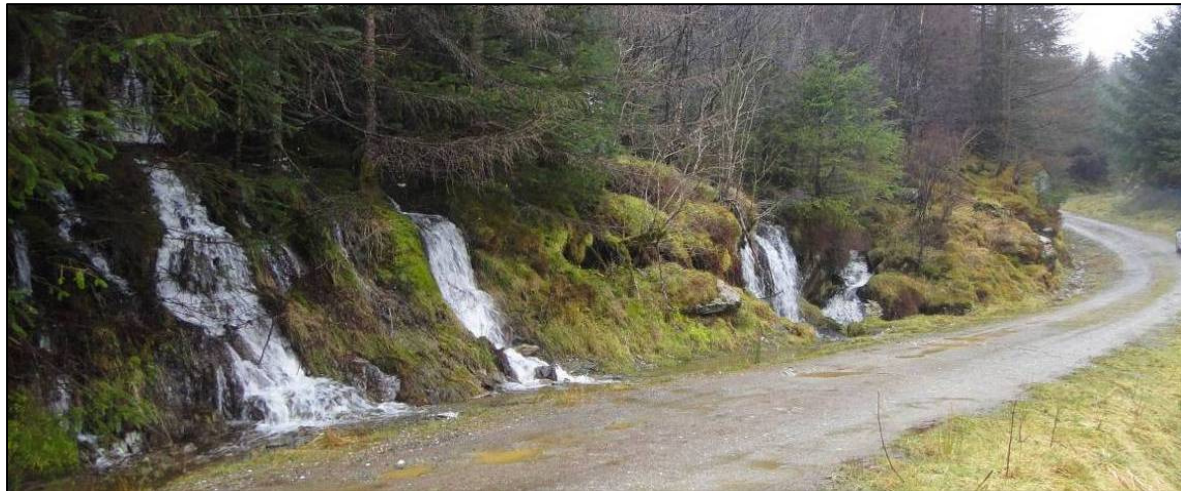
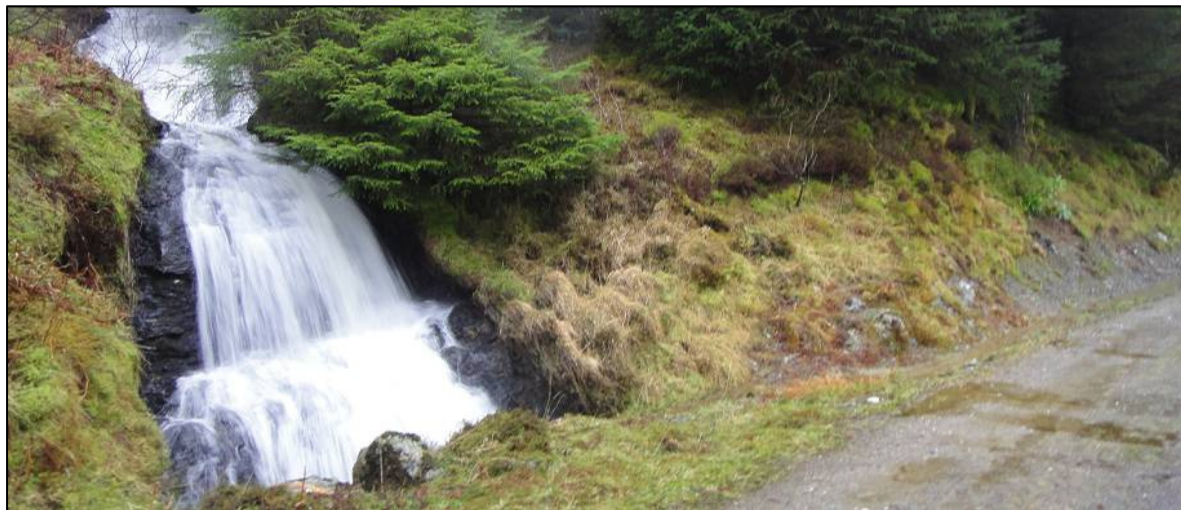
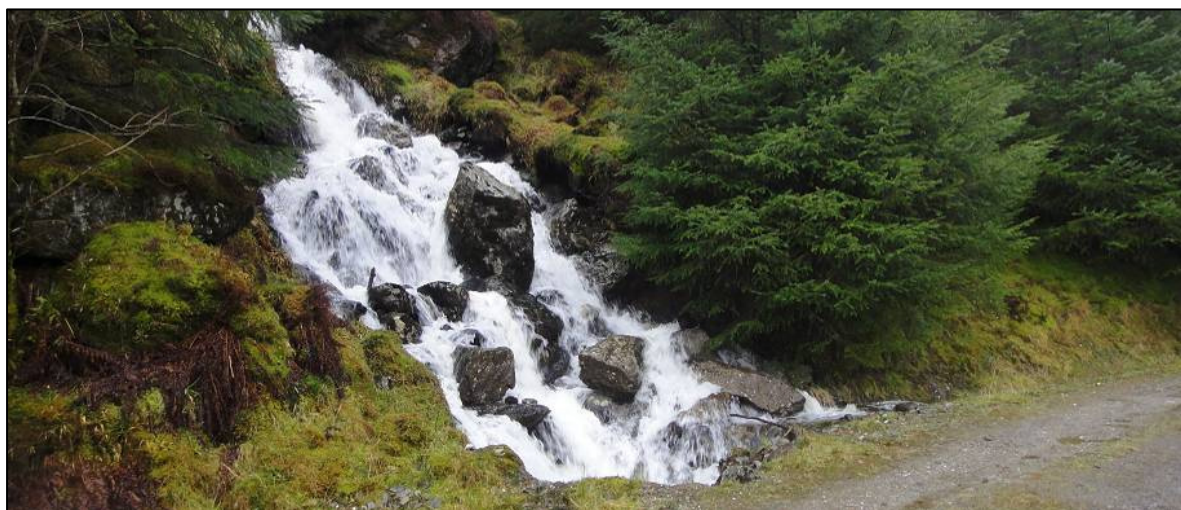
Figure 4: Images of streams in spate after heavy rainfall

Numerous streams flow down the slope above the track which channel, in prolonged periods of rainfall, high volumes of water. Images of the streams in spate have been provided in Figure 4. Water from these streams is managed by a very effective open ditch system which runs most of the length of the western side of the track. The main benefit of an open ditch system is that it ensures that any new streams are fully captured and piped beneath the track, thus removing any potential risk of water reaching the track and saturating the unbound pavement. The existing culverts vary in size from 300mm up to 750mm. The majority appear to be of concrete construction although there are also upvc, stone and steel types. Some of the culverts are showing signs of damage or collapse at the inlet side and

several were completely buried or blocked. There is no evidence of headwalls at either the inlet or outlet sides of any of the culverts.

Numerous emergent stream beds have also been observed, suggesting that the hydrology of the upper slope is evolving and forming new channels, reinforcing the need for a drainage ditch along the length of the track.

As the track will only be operational for a short duration there is no benefit in radically improving the condition of all the existing culverts and therefore they could be left in their current condition. However, inspections should be carried out daily whilst the track is in use.

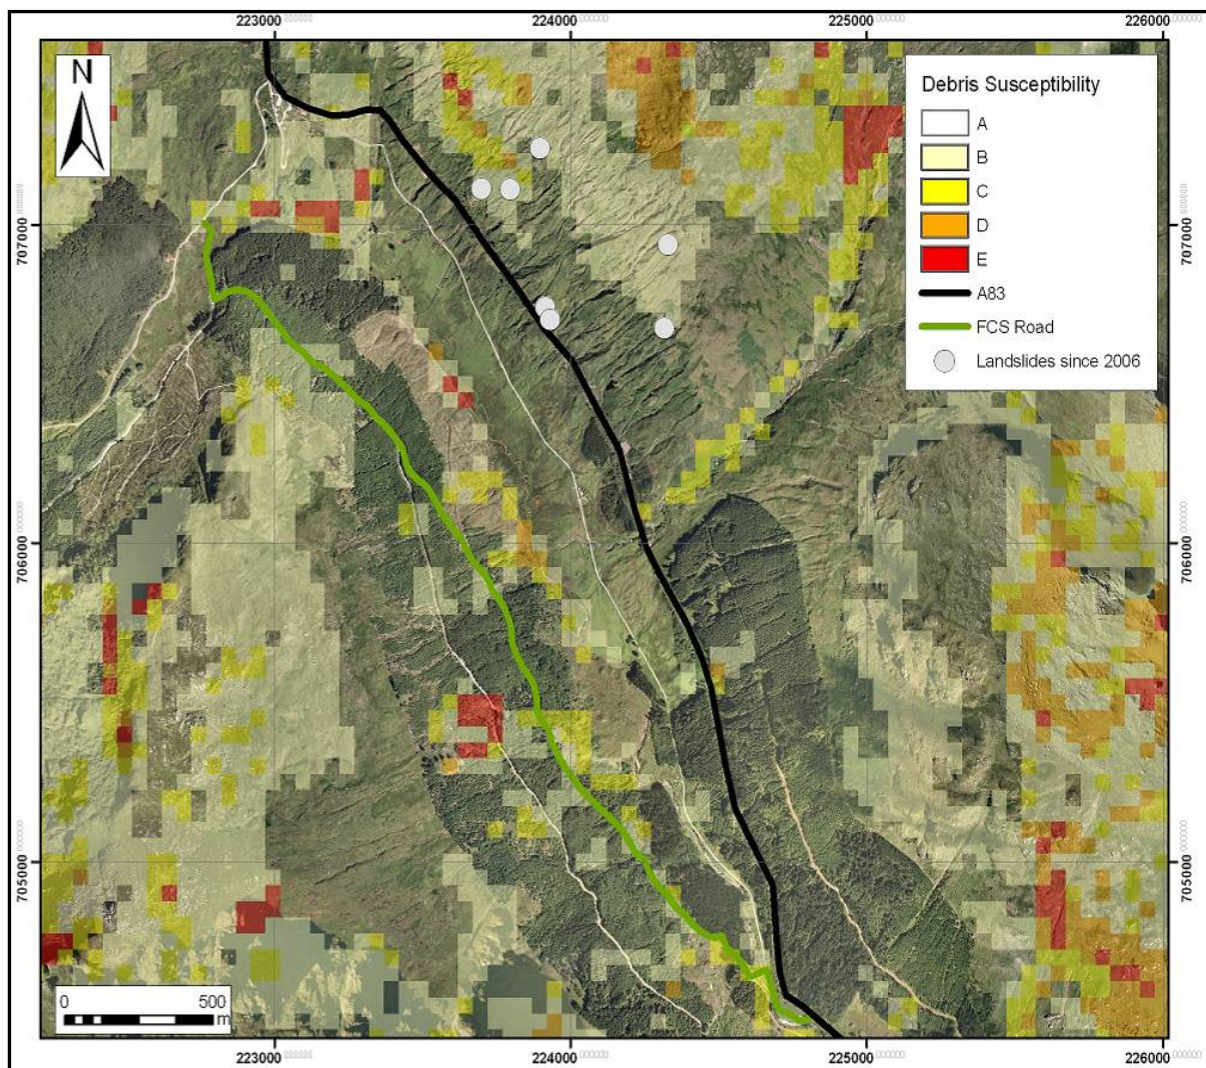
Figure 5: Debris susceptibility Map

The A83 between Ardgartan and the Rest and Be Thankful, Glen Croe has a long history of landslide events. Transport Scotland's "Scottish Road Network Landslide Study" categorised the area a priority one status in terms of high perceived hazard. To illustrate the potential debris susceptibility of this area Transport Scotland GIS susceptibility layer has been overlaid on an aerial photograph to produce a debris susceptibility map. See Figure 5 below.

The map shows, in red, a number of areas of debris flow susceptibility within the forestry track. The western slope of Glen Croe, on which the forestry track is formed, shares a lot of similarity with the neighbouring eastern slope, where the A83 is constructed, in terms of hydrology and geology. As a result they also share the same potential risk of landslide

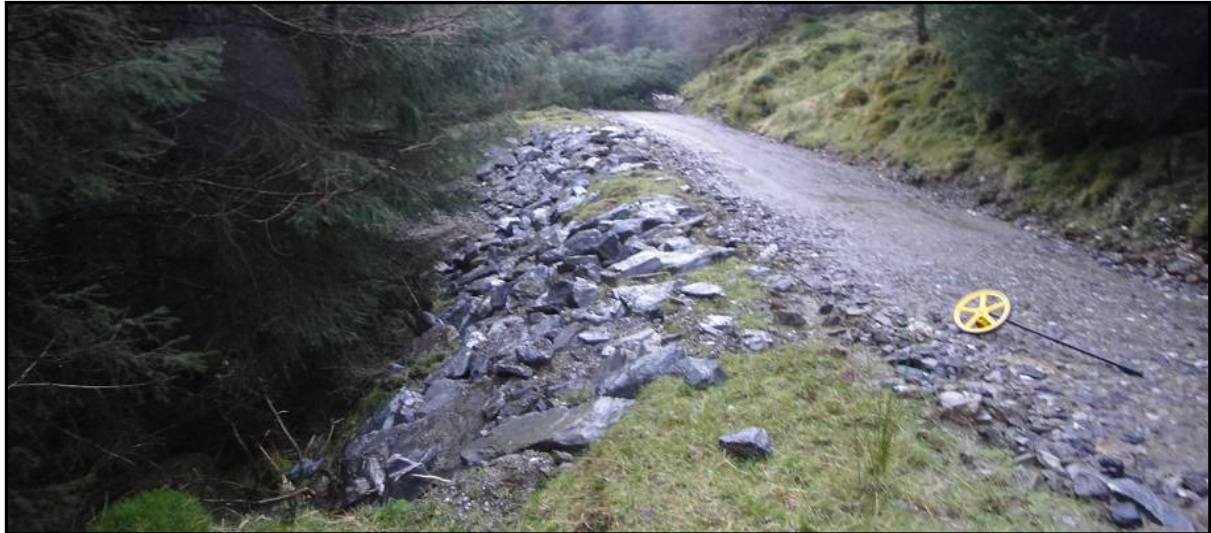
Figure 6: Image of the slope remedial measures carried out. Note also fallen tree in background

failure. Indeed, during the debris event in December 2011, when the A83 was closed, there was a lower slope failure on the forestry track at the same time. This required the Forestry Commission to carry out slope remediation measures, using rock infill to stabilize the failure and so protect the integrity of the forestry track. An image of the subsequent measures taken by the forestry commission to stabilize the failure is shown in Figure 6 below.

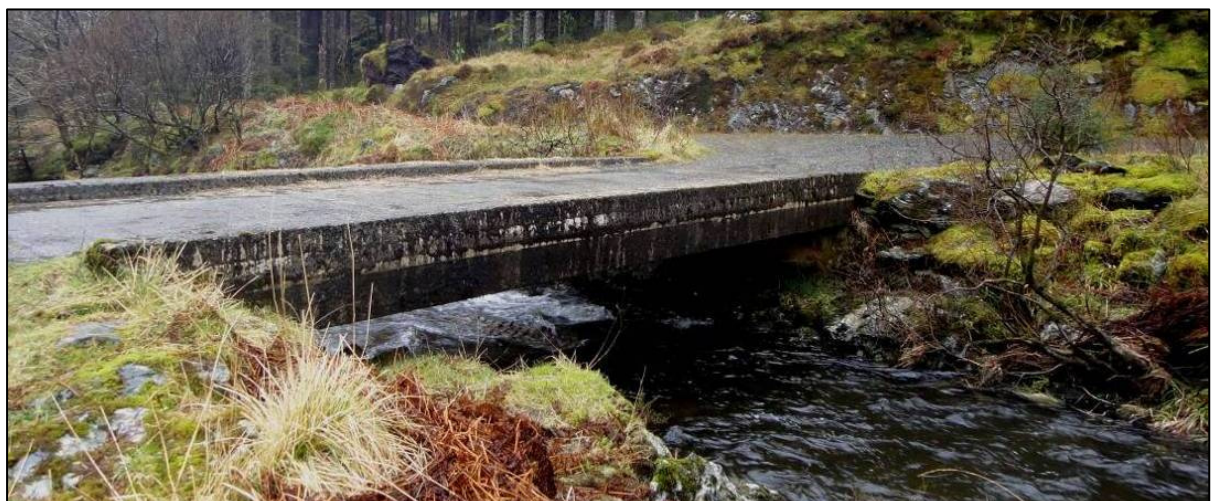
Figure 7: Images of the existing bridge over the River Croe.

There is one structure which crosses the Croe Water, at the eastern section of the forestry track. The structure is a narrow single lane 8m span bridge which is constructed from pre-stressed concrete beams with an insitu cast concrete deck, as shown in Figure 7 below. The operating limit of the bridge is 44 tonnes, which is suitable for trunk road traffic.

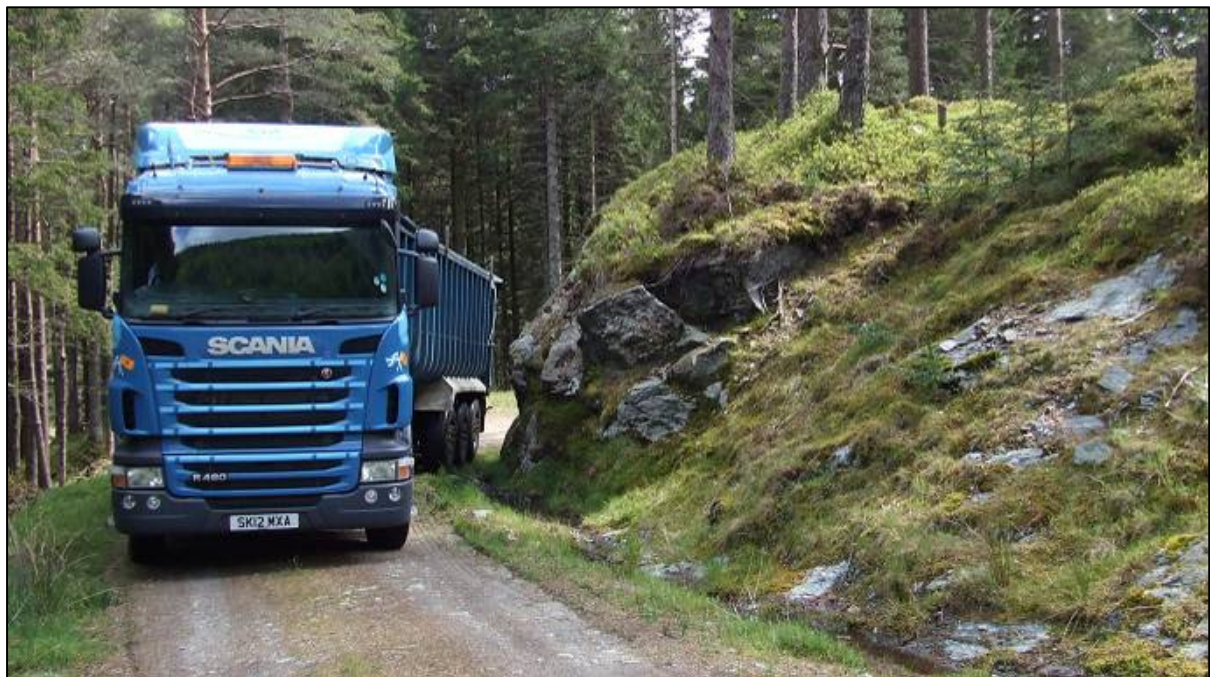
Figure 8: Image of the 13.5m HGV negotiating a rock outcrop near the start of the east access

The trial involved using an unloaded 13.5 metre long articulated vehicle. Although not the longest articulated vehicle or the most onerous vehicle in terms of swept path, it was deemed sufficient to carry out this type of exercise. Refer to Figure 8 below.

The outcome of the trial demonstrated that it is possible for heavy goods vehicles to negotiate the ascent and descent of the forestry track. However, there were times when the wheels of the vehicle swept uncomfortably close to the steep-sided lower slope raising concerns for driver safety. The alignment of the approaches to the existing bridge over the Croe Water on either side was also problematic because of sharp 90° bend at each side of

Furthermore, whilst carrying out the descent the vehicle undertook significant braking to control speed. Both of these observations led to an overriding conclusion that, although feasible to manoeuvre a larger vehicle along the track, the likelihood of larger vehicles losing traction or mounting sections of narrow soft verge was high. This probability would increase further during periods of poor weather conditions, something to be anticipated regularly given the location and elevation of the site.

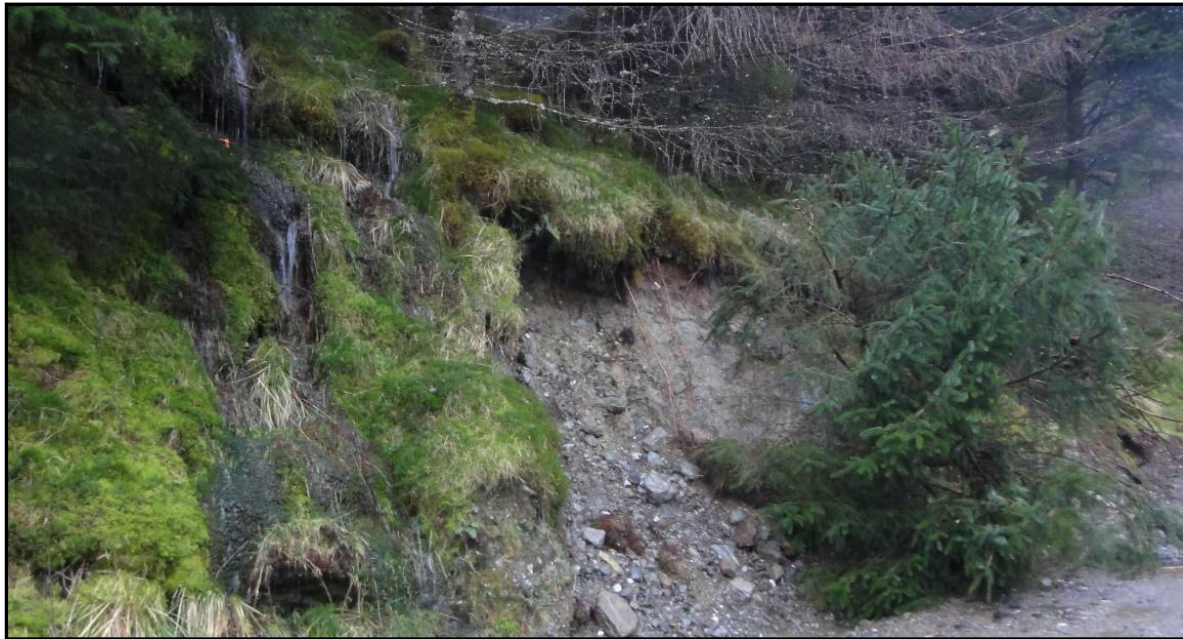
Figure 10: Image of tree and small slope failure noted during walkover surveys.

It was noted during our geotechnical walkover that the stability of the upper and lower slopes is questionable, with moderate to high risk for slope failure. One of key features that aids in minimising existing slope failure is the trees which grow on the upper and lower slopes. Their root system acts as a natural reinforcement to the slopes soils and therefore any removal of these trees will increase the probability of slope failure. To mitigate any risk of slope failure earth retaining measures, such as soil nailing or geotextiles would be required over the full

length of cutting. This type of slope stabilising engineering would require extensive time to plan detailed ground investigations to define which areas required treatment. Without conducting a full ground investigation over the full length of the track, this type of solution is difficult to define. But considering the track is approximately 3.5km in length and would require work on both slopes, investment of both time and cost would be significant. As a result of all of these factors, conducting any form of improvement to track width is considered to be unfeasible under the terms of this study.

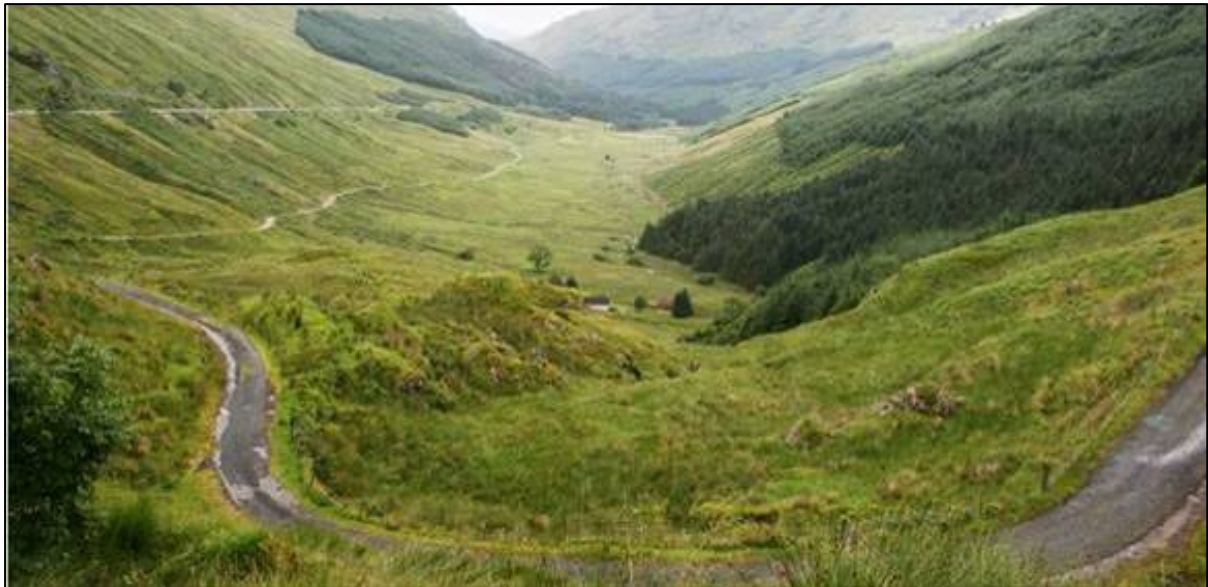
Figure 11: Image taken from the Rest and Be Thankful car park overlooking the hill climb of the old military road

The total length of the bituminous bound old military road is slightly shorter than the forestry track at 4.0km. Road width generally ranges between 3.0m to 3.5m apart from where it widens to 6-8 metres towards the hill climb at the far west of the route. See Figure 11.

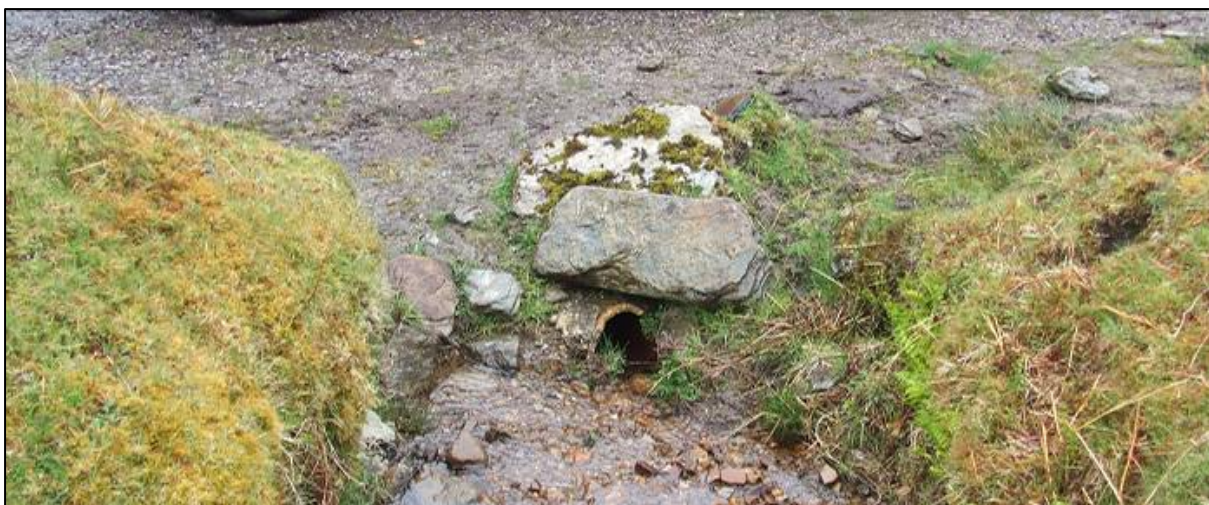
Figure 14: Image taken of a typical piped inlet.

One clear advantage of the old military road is that it does not contain any existing hazards of notable concern in comparison to the ever-present steep lower slope that runs adjacent to the forestry track. However, as with the forestry road, water flowing off the hillside is an issue. Generally, where streams are formed, there are various bridges, pipe culverts and old stone built systems which allow water to pass under the military road. All of these would need repairs or to be replaced. Additionally, there are sections where new streams have been formed and discharged over the existing paved surface which, ideally, need to be managed with new cut ditches and piped culverts.

Carry out improvements to existing drainage and form new ditches and piped culverts where required.

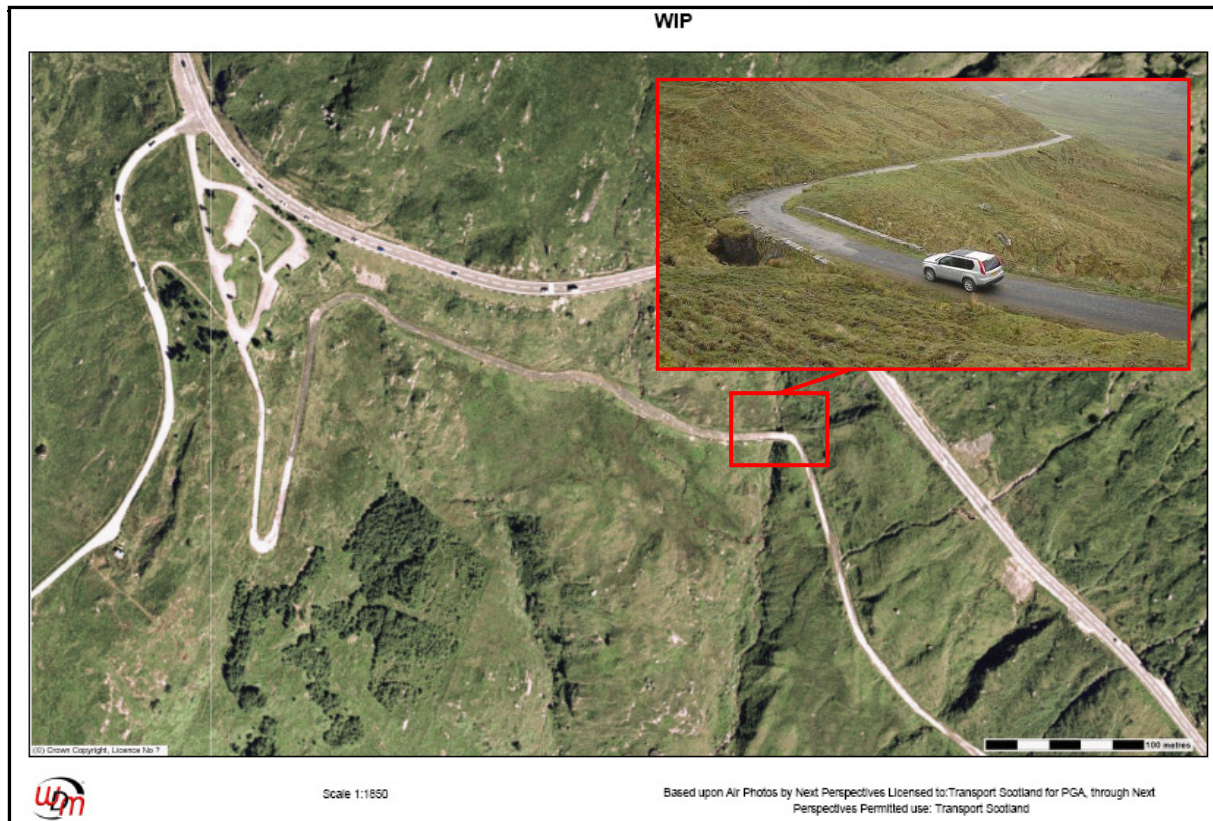
Figure 17: Image of area of concern requiring potential slope stabilisation

There is one particular corner however which will need a new cutting to be formed within an existing steep embankment. The corner is located at the largest of the masonry structures and roughly within the initial third of the hill climb section. See Figure 17.

It is envisaged that a cutting up to 2 metres in width into the upper slope would be required to form sufficient room to accommodate the largest vehicle swept path. The formation of this cut will result in an overly steep slope and it will therefore require suitable sympathetically constructed reinforcement to ensure its stability.
