Project FORTH REPLACEMENT CROSSING

REP-00255

AIR QUALITY MONITORING REPORT OCTOBER 2015

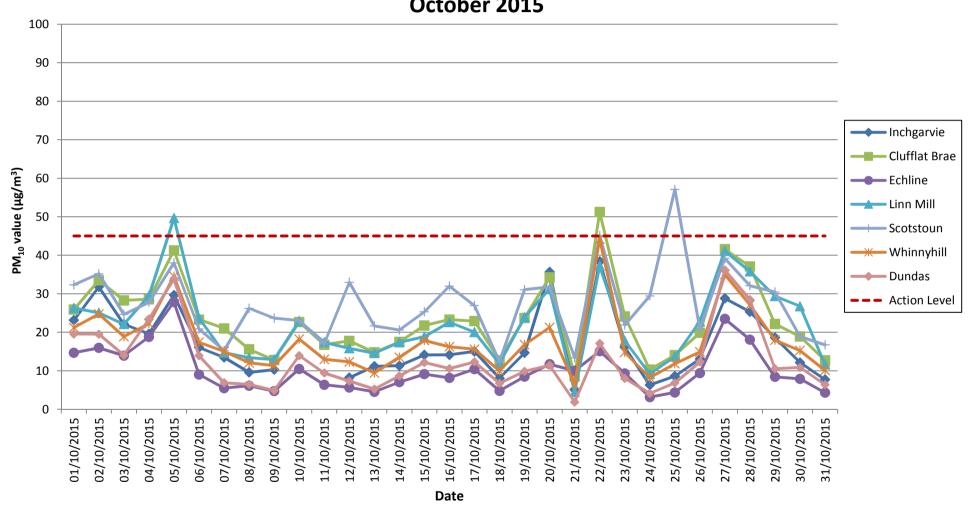
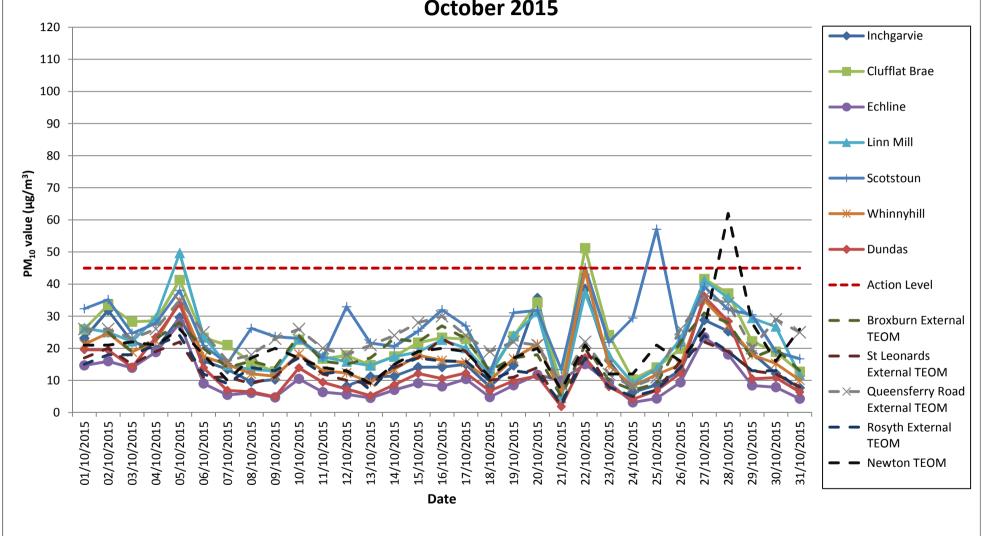
APPENDIX A: LIGHT SCATTER METER RESULTS

3.1.1. Light scatter results for October 2015 have been presented in a monthly chart; this can be found in Appendix A. Results show that the PM₁₀ levels were mostly below threshold levels throughout the month with the exception of four exceedances. One exceedance occurred on the 5th October at Linn Mill. Two exceedances occurred at Scotstoun and Clufflat on the 22nd October. Another exceedance occurred on the 25th October at Scotstoun. With regards to the exceedance on the 5th at Linn Mill, as this corresponds to wet ground conditions and all monitors showed an increase on this day it is concluded that the exceedance was caused by regional changes in air quality rather than being driven

by construction related activities. The exceedances on the 22nd at Clufflat and Scotstoun correspond with dry weather. However, as all monitors show an increase on this day it is concluded that these exceedances also were caused by air quality in the region rather than construction work. The exceedance at Scotstoun on the 25th October corresponds to dry weather conditions and is likely to have been caused by the B800 bridge demolition work that took place on this day (see 3.1.3).

- 3.1.2. The PM₁₀ results have also been compared to the daily mean results obtained from the TEOM air quality monitoring stations located in Newton, Rosyth, and Broxburn, and from the TEOM FDMS station located at Queensferry Road and St Leonards, Edinburgh (an urban background site). The TEOM at Newton was installed by West Lothian Council, facilitated by FCBC, during October 2012. The comparison between the light scatter and TEOM results demonstrates that both sets of results generally follow the same pattern, indicating that the pattern observed throughout October was largely driven by regional changes in air quality, with the exception of the exceedance for Scotstoun on the 25th October as noted in 3.1.1.

- 3.1.3. During October, site operations continued around the B800 north of the bridge over the A90. These works currently extend up to the fence line where the Scotstoun PM₁₀ monitor is located. These works include landscaping, surfacing and earthworks in the vicinity of the monitor. The demolition of the B800 bridge was also a major activity with the first section being demolished over the weekend of 24th/25th October. This means that the monitor is essentially on-site and that operations are now closer to some receptors. However, with the exception of the exceedances noted in 3.1.1, the Scotstoun PM₁₀ results throughout the month of October are under the threshold. It is noted that on the 8th and 12th October, the PM₁₀ levels were elevated compared to the other monitors. FCBC will continue to monitor this area closely over the next

few months as works in this area progress, and provide mitigation as necessary.

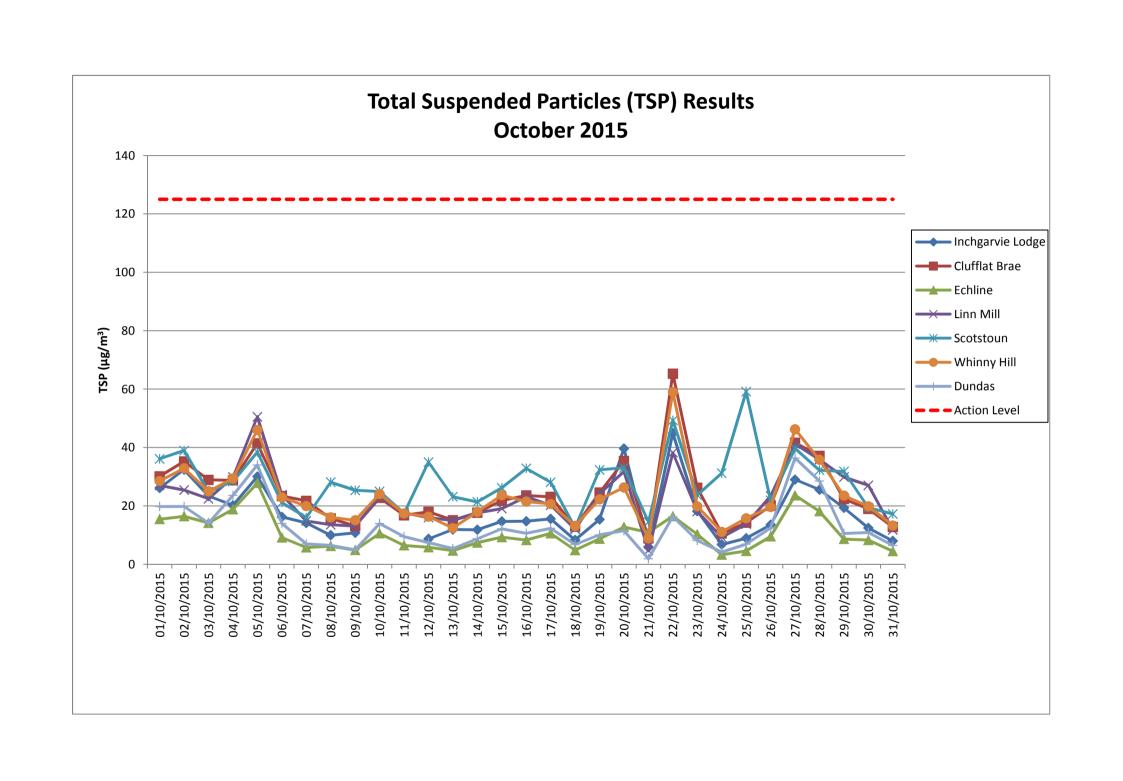
APPENDIX B: TOTAL SUSPENDED PARTICLES

3.2.1. The TSP results for October 2015 have been presented in a monthly chart; this can be found in Appendix B. The TSP levels at monitoring locations during October were found to be generally low and all within the threshold. All locations across the site were mostly found to follow a similar pattern (similar to that observed for PM₁₀ levels). As with PM₁₀ it is considered that, in general, the TSP levels across site were influenced by regional changes in TSP levels, with the exception of the increases corresponding to the higher PM₁₀ levels noted at Scotstoun on the 8th, 12th and 25th October.

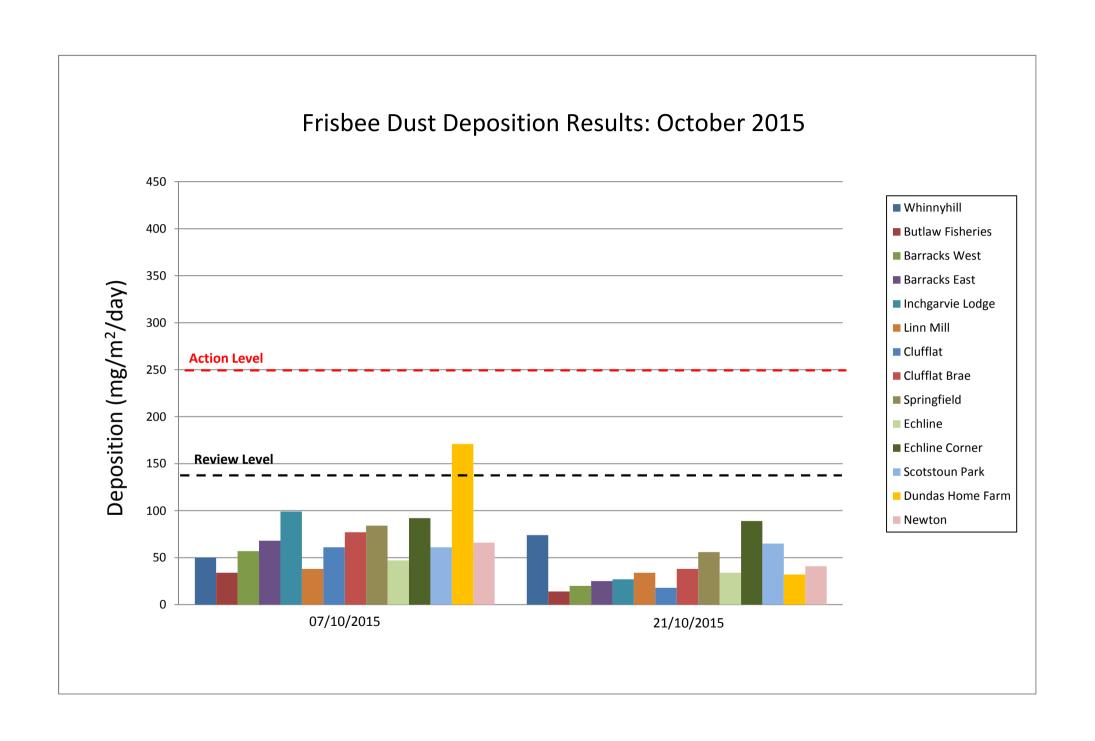
APPENDIX C: FRISBEE GAUGE RESULTS

3.3.3. During October there was one exceedance of the review level at Dundas for the fortnight concluding 7th October. The Dundas light scatter meter registered levels well below the action levels for both TSP and PM₁₀ during the period. The main carriageway works being undertaken during this period potentially gave rise to dust although dusty conditions were not observed during site visits or reported. The ground conditions for the period were mostly dry. Therefore, it is possible that construction activities contributed to the dust deposition result. FCBC will continue to monitor this area and provide mitigation as necessary.
