Project FORTH REPLACEMENT CROSSING

# AIR QUALITY MONITORING REPORT OCTOBER 2013

Document number REP-00144-00

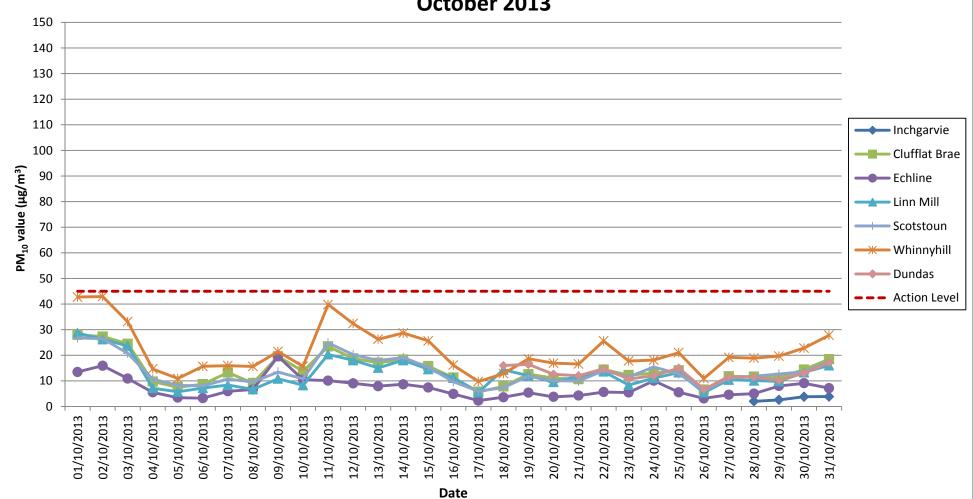
**Note:** Please refer to section 3 of the Air Quality Monitoring Report: October 2013. Data is missing from Inchgarvie for the period 01/10/13 to 27/10/13 as the device had to be returned to the supplier for servicing due to an error with the device. Data is also missing for Dundas for the period 01/10/13 to 17/10/13 due to loss of power caused by a third party.

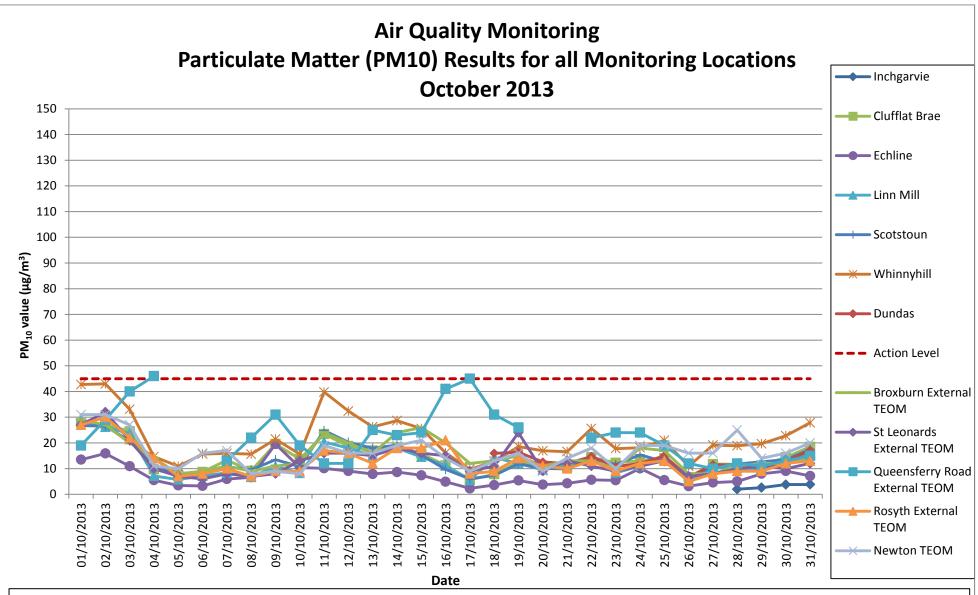
**Note:** Please refer to section 3 of the Air Quality Monitoring Report: October 2013. Data is missing from Inchgarvie for the period 01/10/13 to 27/10/13 as the device had to be returned to the supplier for servicing due to an error with the device. Data is also missing for Dundas for the period 01/10/13 to 17/10/13 due to loss of power caused by a third party.

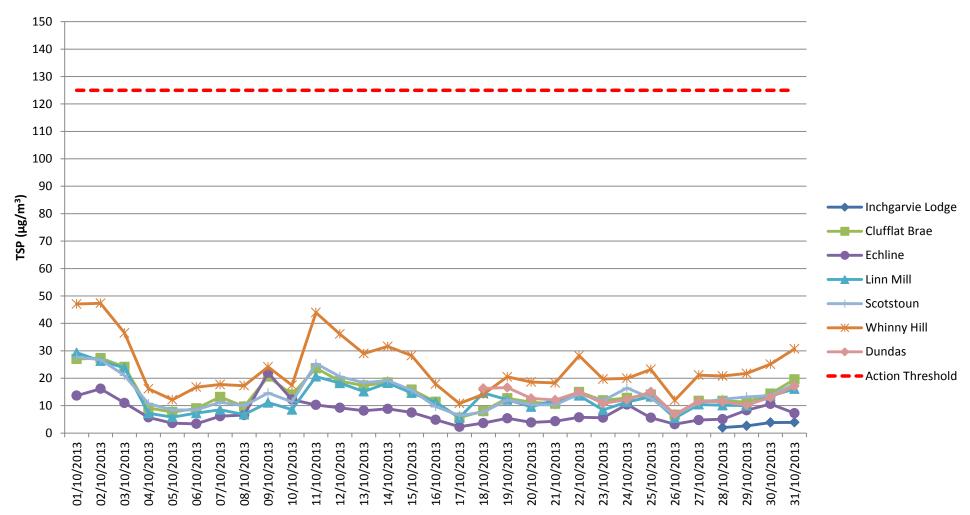
**Note:** Data is missing from Inchgarvie for the period 01/10/13 to 27/10/13 as the device had to be returned to the supplier for servicing due to an error with the device. Data is also missing for Dundas for the period 01/10/13 to 17/10/13 due to loss of power caused by a third party.
