FORTH REPLACEMENT CROSSING

AIR QUALITY MONITORING REPORT MAY 2014

REP-00178-01

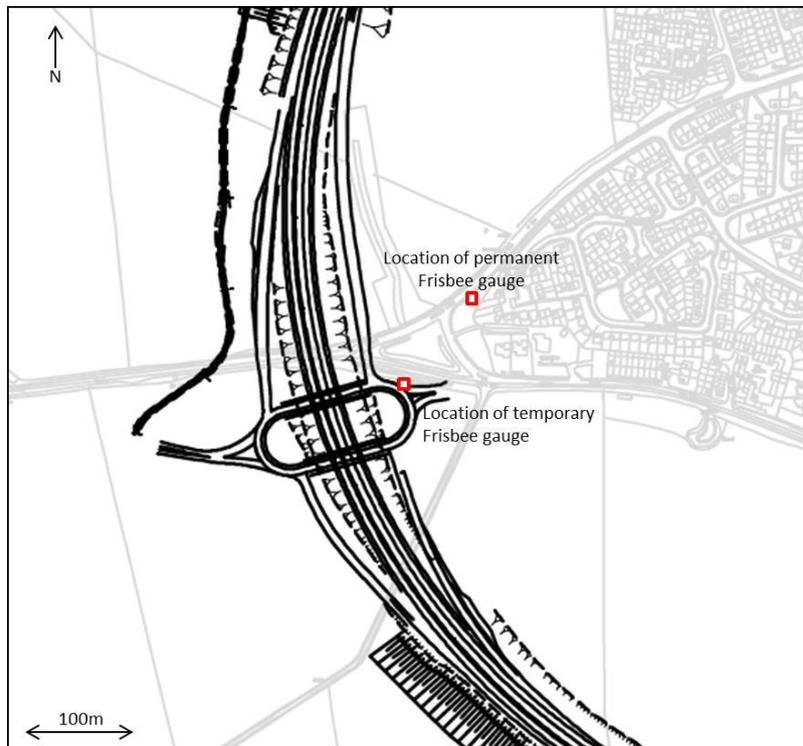
Figure 3: Location of additional temporary Frisbee gauge (Echline Corner)

3.3.10. During the fortnight ending 28th May the Echline Corner Frisbee registered levels above the action level. This is an additional temporary Frisbee that was put in place after the dust incident during April. It has been positioned within the construction site and provides information regarding dust levels generated on-site. As mentioned in 3.3.9 a thorough review was conducted into the results observed in this area during May. The result obtained for the Echline Corner Frisbee during the period ending the 28th May was exceptionally high. Following review and analysis it is concluded that construction activity was responsible for the high levels. However, the location is also directly adjacent to the A904 and so can also be affected by dust from the public road (Figure 3). It should be noted that this monitor can provide an indication of levels of dust at source and the levels recorded do not necessarily represent levels of dust migrating off-site. The exceedance at Echline during the first two weeks of May is not supported by a high dust result at the site, as the result at Echline Corner during this time was relatively low.

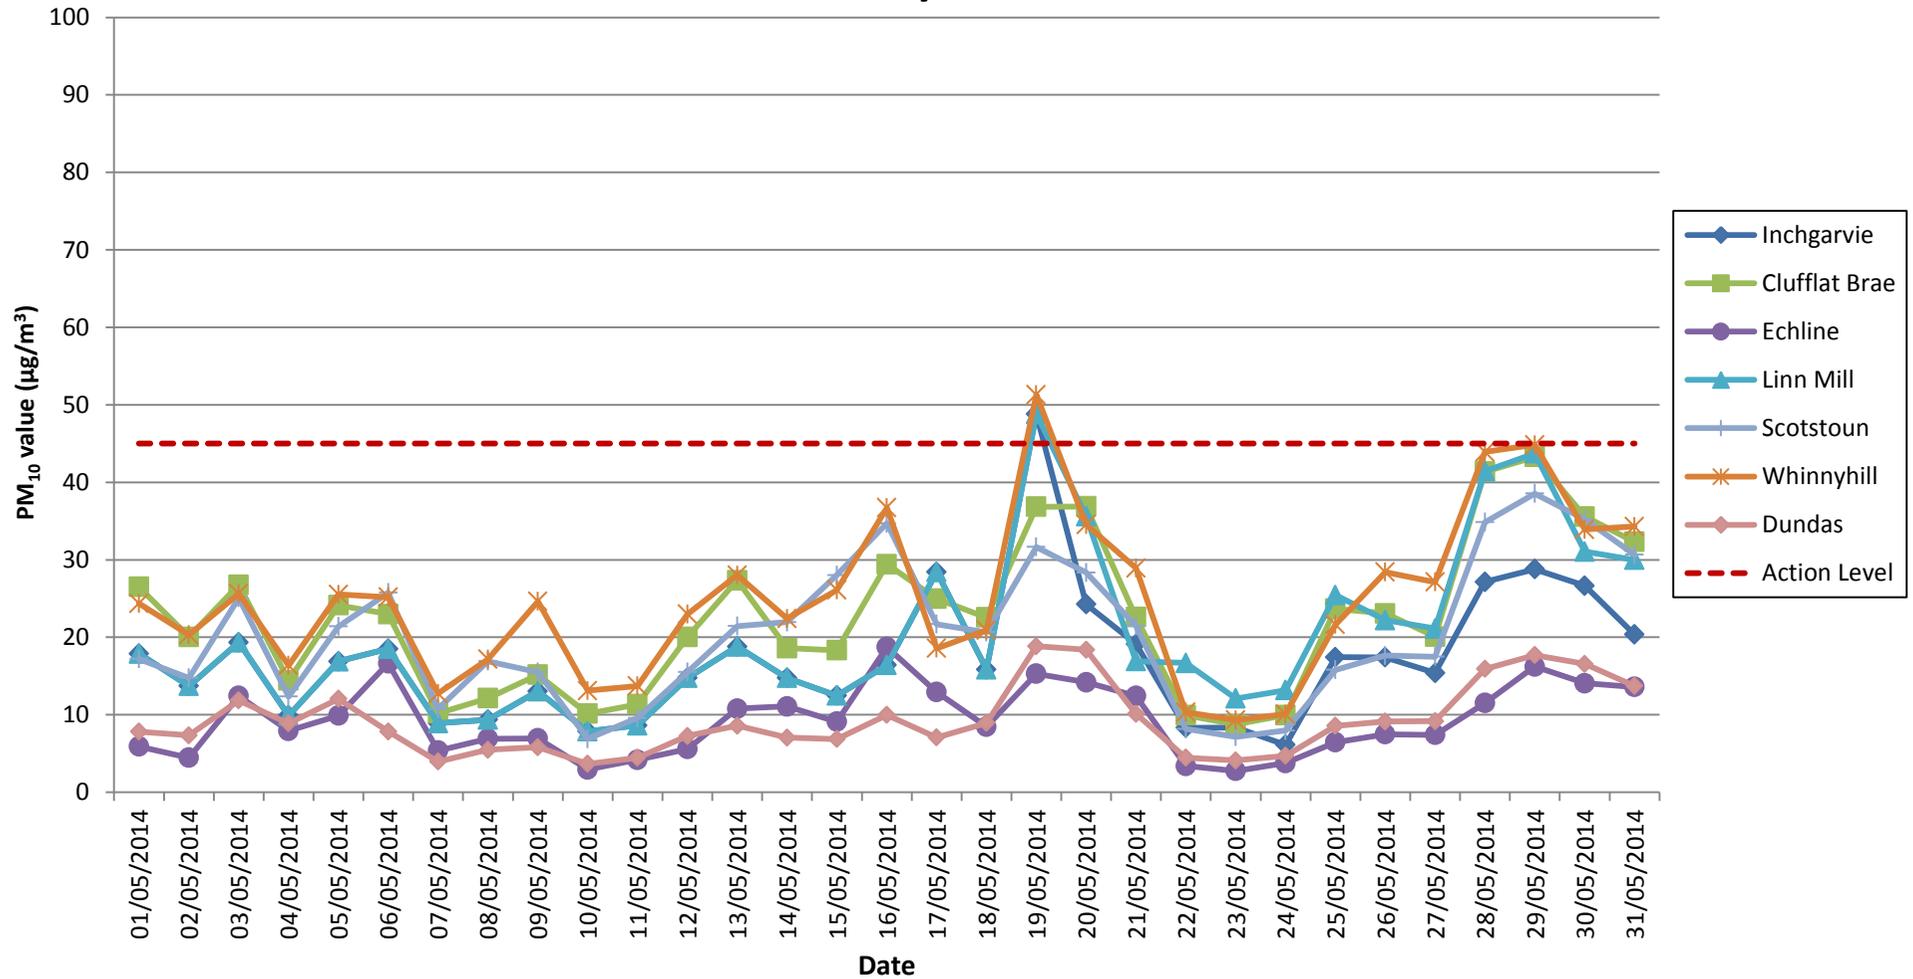
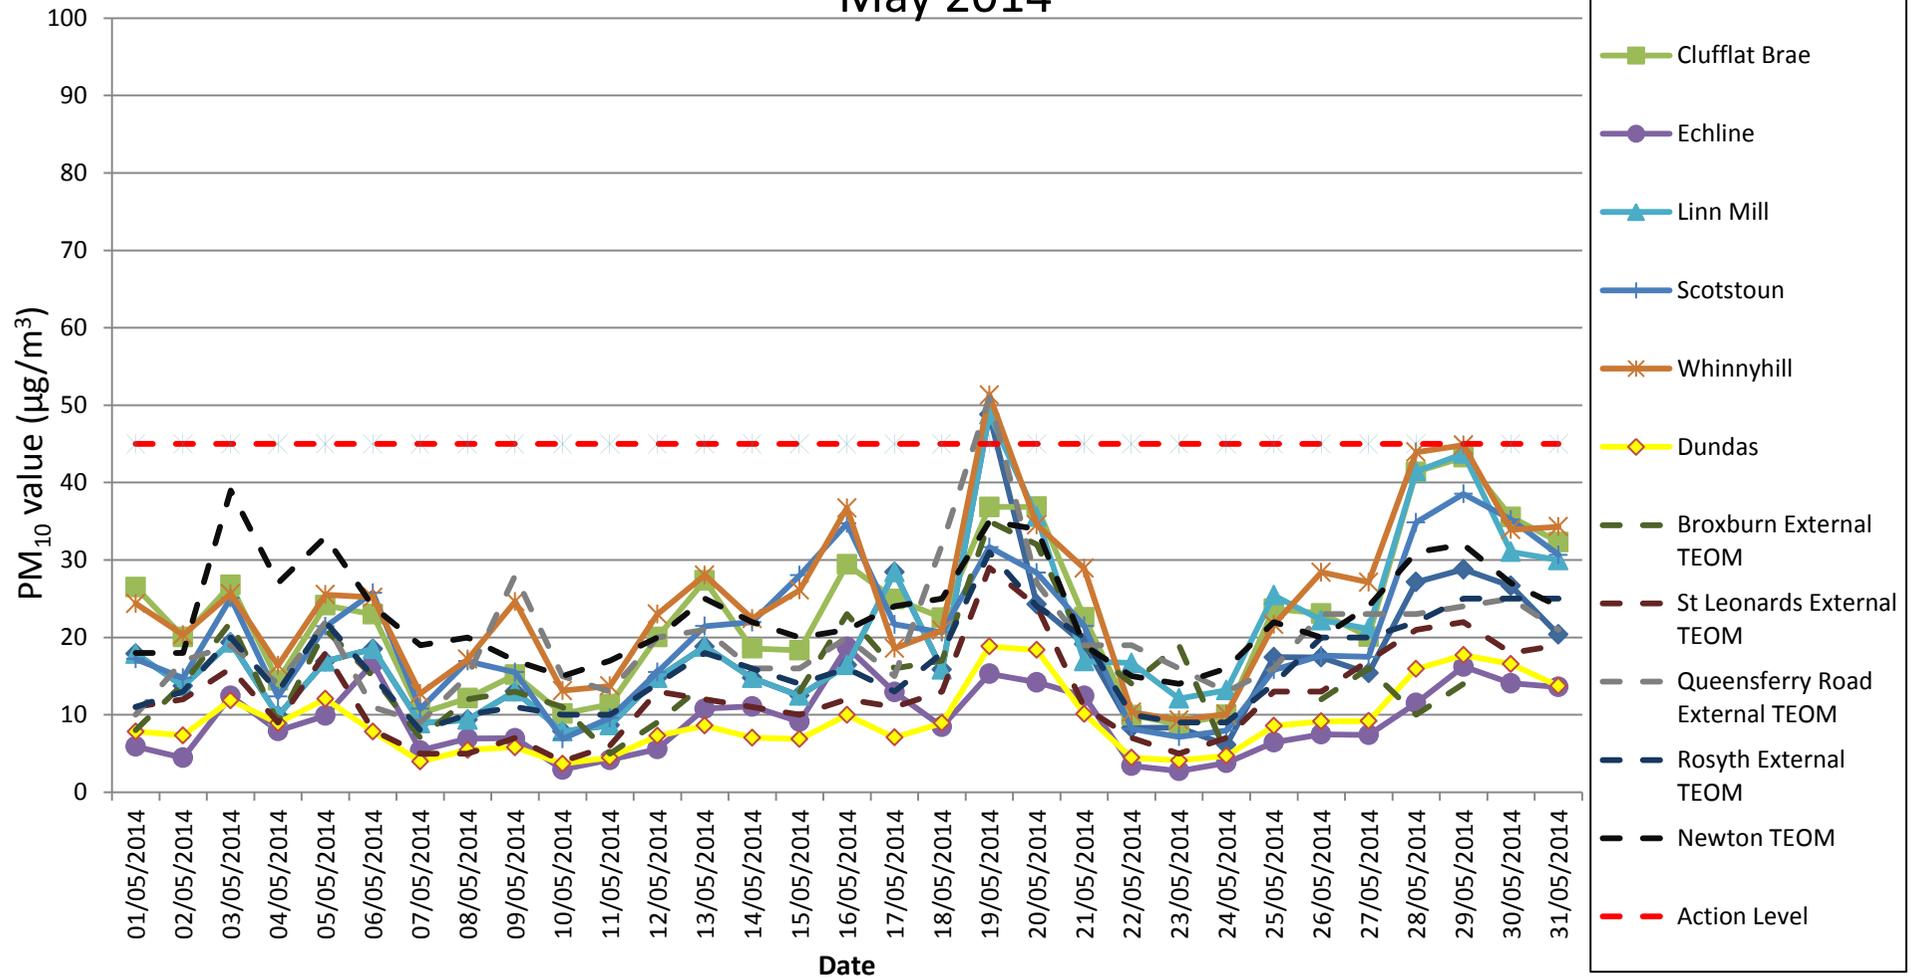
3.1.1. Light scatter results for May 2014 have been presented in a monthly chart; this can be found in Appendix A. Results show that the PM₁₀ levels were below threshold levels throughout the month with the exception of one day. Linn Mill, Whinny Hill and Inchgarvie monitors all exceed the review level on the 19th May.

3.1.2. It was noted that fog occurred during 19th and 20th May which can affect the meter readings (see section 2.2). Ground conditions during these periods were damp or wet throughout. The fact that all 7 monitors showed increased levels during this period would suggest that a regional event affected the levels across the whole area rather than the increases being related to works activities in one specific area affecting only a few monitors. The PM₁₀ results have also been compared to the daily mean results obtained from the TEOM air quality monitoring stations located in Newton, Rosyth, and Broxburn, and from the TEOM FDMS stations located at Queensferry Road, Edinburgh. The same increases in levels during this period can be seen in this TEOM data, confirming that the increases were likely to be caused by a regional event rather than localised works activities.

Note: The Clufflat monitor defaulted to a value of 99998 for a five minute period on the 31/05/2014. This erroneous value was removed for calculations for the above figure.

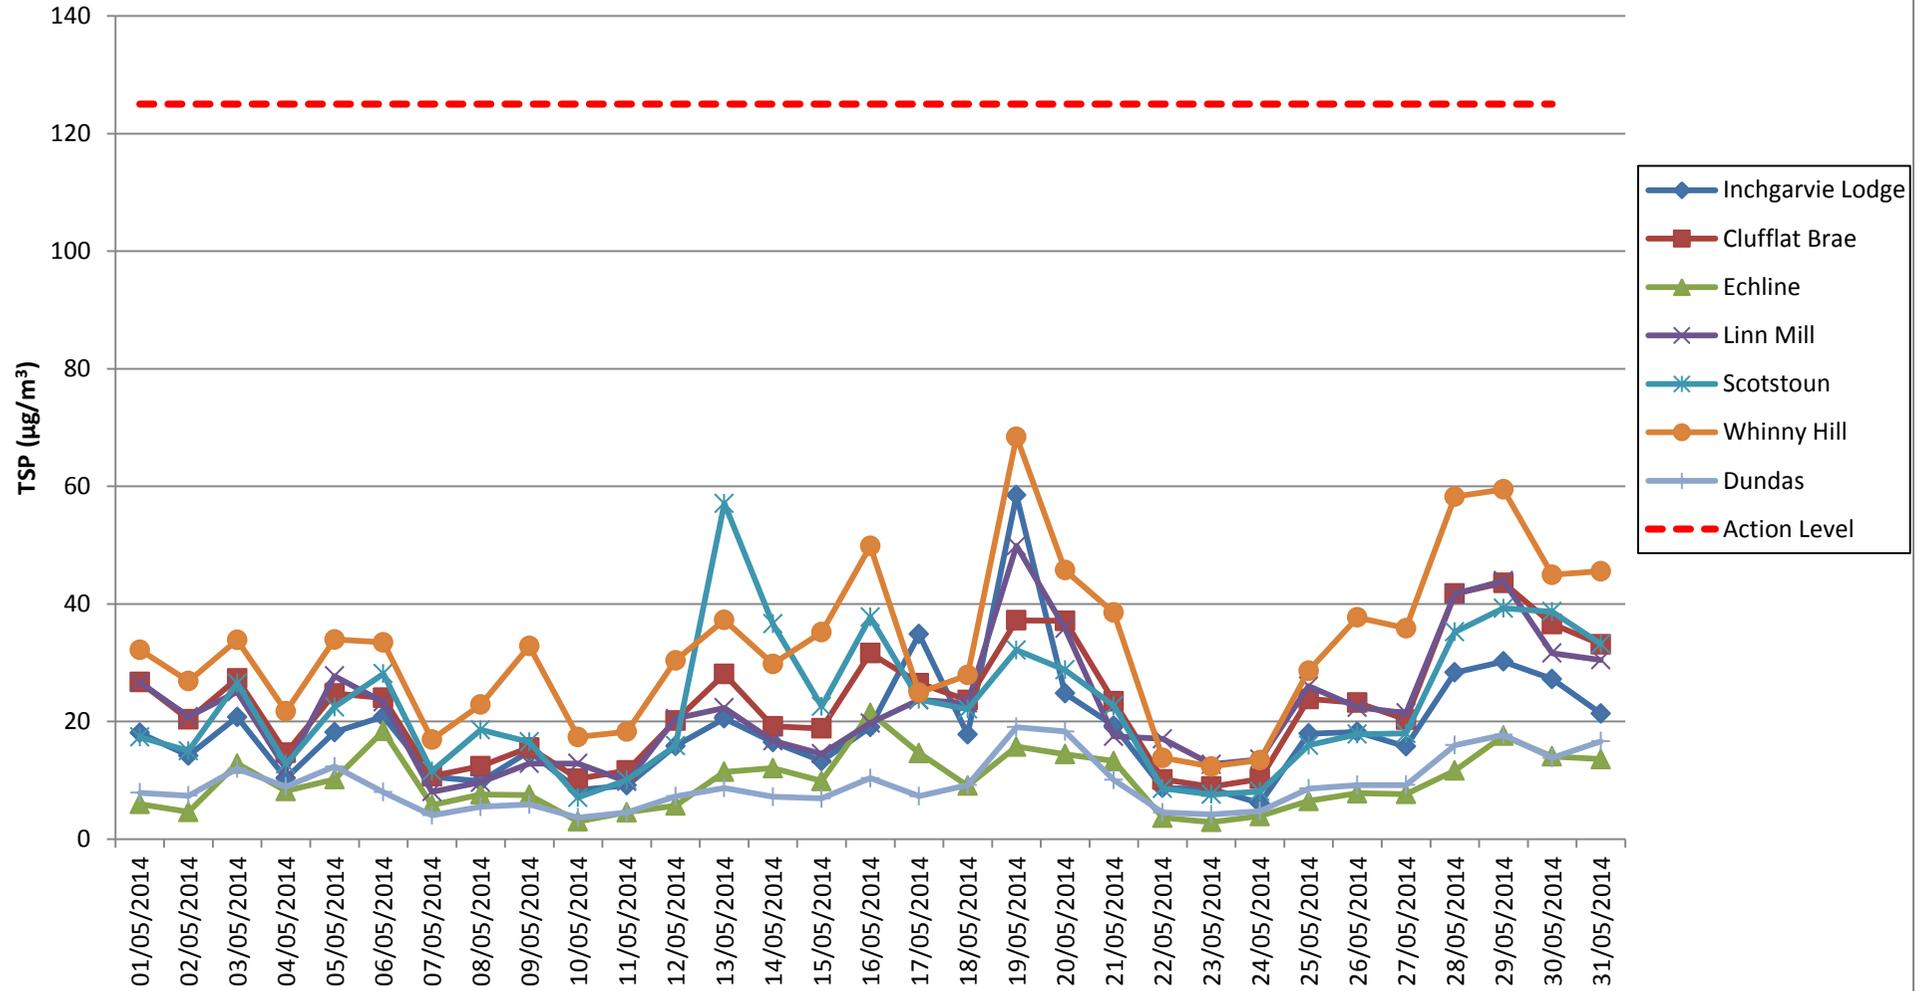
Total Suspended Particles (TSP) Results May 2014

3.2.1. The TSP results for May 2014 have been presented in a monthly chart; this can be found in Appendix B. The TSP levels at monitoring locations during May were found to be low and all within the threshold level. All locations were mostly found to follow a similar pattern across the site, demonstrating that, in general, the levels were influenced by regional changes in TSP levels, rather than construction works.

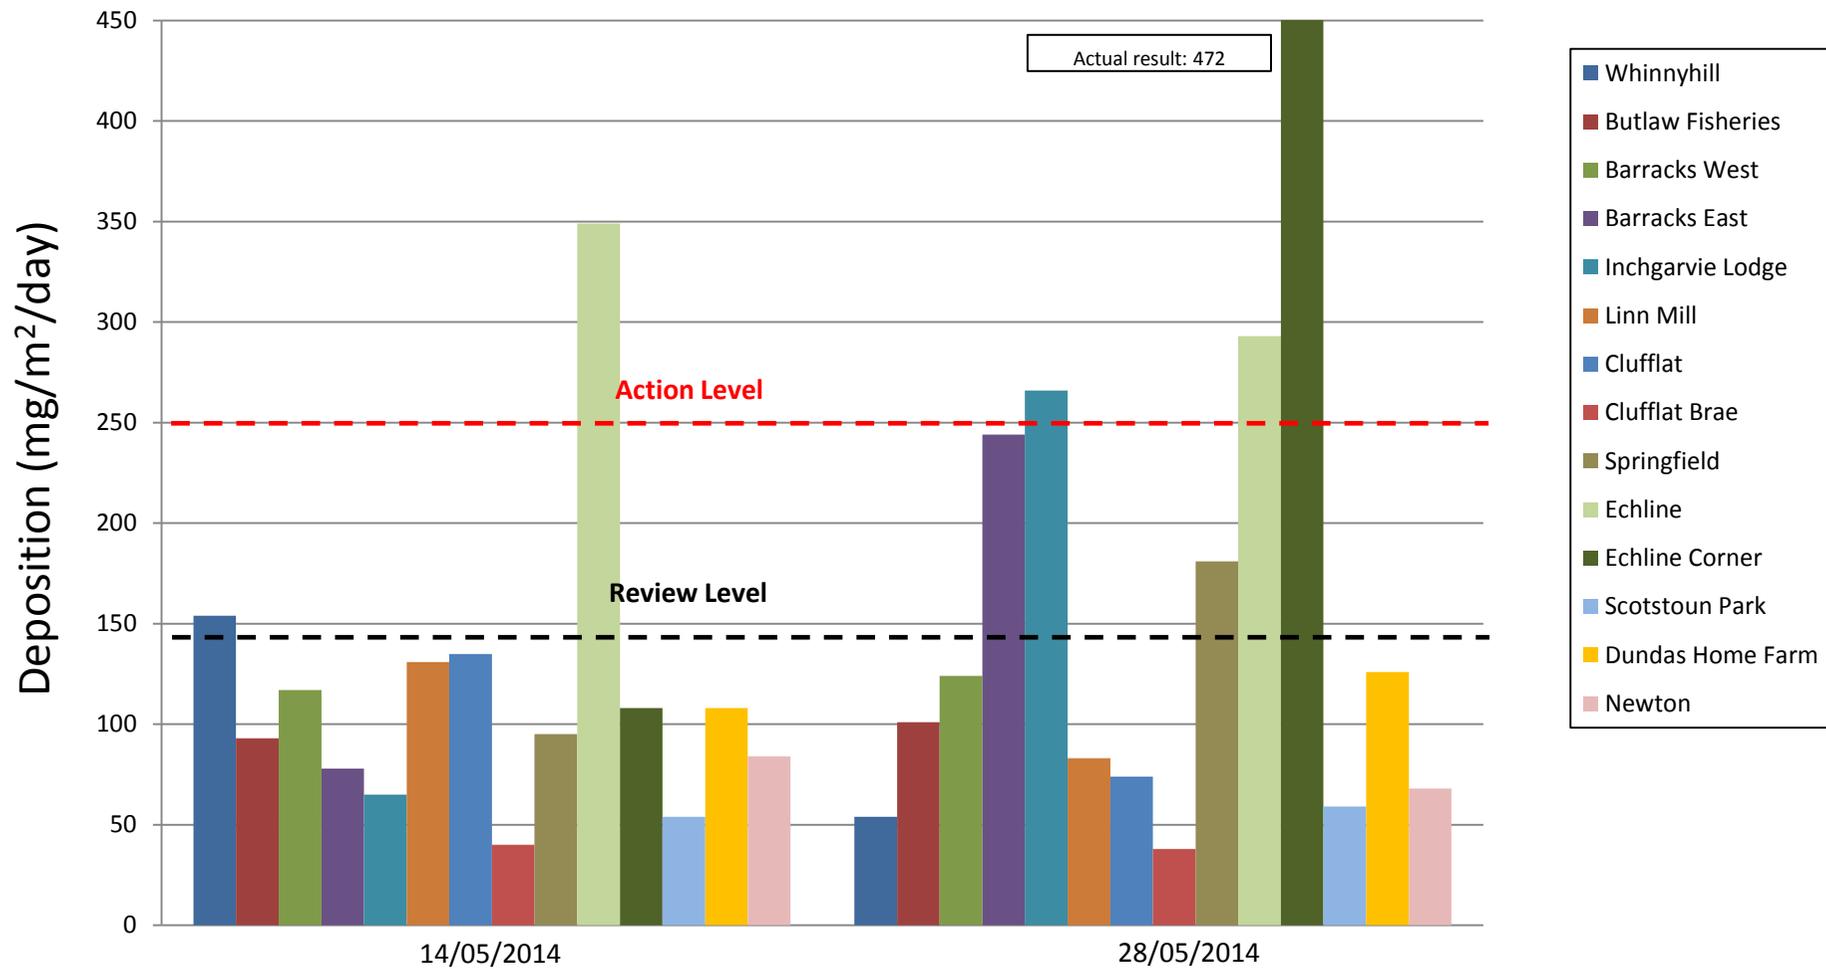
Frisbee Dust Deposition Results: May 2014

3.3.3. During May there were three exceedances of the site review level (see Table 4) and four exceedances of the action level. With the exception of the locations where exceedances occurred, Frisbee results from monitoring locations across site were generally low, although showing higher levels than previously observed during 2014 at some locations.

- 3.3.5.** During the fortnight ending 28th May the Inchgarvie Frisbee registered levels above the action level. For this collection, the Frisbee collection bottle was found away from the Frisbee and on its side, likely leading to contamination of the sample and erroneous results. A review of works was undertaken and it was found that no FCBC construction activities took place in the area that were likely to create dust. A light scatter dust monitor is also located at this location. This monitor indicates low particulate matter levels for both PM₁₀ and TSP during the period in question with the exception of one day when fog occurred (section 3.1.2). After a thorough review it was concluded that the high results at Inchgarvie cannot be explained by FCBC construction activities undertaken during this period and are likely to be due to sample disturbance and contamination. This bottle has subsequently been replaced and checked to ensure it is not an ongoing issue.

- 3.3.6.** During the fortnight ending 28th May the Springfield Frisbee registered levels above the review level. For this collection the Frisbee collection bottle was found in place but empty. All other collection bottles that were found in place were approximately one third full. This suggests that at some point the bottle was overturned and the sample lost with possible contamination of the sample bottle occurring. A review of works was undertaken and it was found that no FCBC construction activities took place in the area that were likely to create dust. A light scatter dust monitor is located approximately 150 metres from this location (Clufflat). This monitor indicates low particulate matter levels for both PM₁₀ and TSP during the period in question with the exception of one day when fog occurred (section 3.1.2). After a thorough review it was concluded that the high results at Springfield cannot be explained by FCBC construction activities undertaken during this period and are likely due to the Frisbee collection bottle being found empty and contaminated.

- 3.3.7.** With regard to the exceedance of the review level at Whinnyhill for the period ending 14th May, whilst construction activities cannot be excluded from considerations, a review of the works at this location, the PM₁₀ data and the weather conditions during this period demonstrate that the impact of construction activities on the dust levels at these receptors is likely to have been minimal. Increased inspections have been implemented in the area to ensure any dust generating construction activities are being adequately mitigated.

- 3.3.8.** The exceedance of the review level at Barracks East for the period ending 28th May also initiated a further review into works undertaken in the vicinity. However, during the period in question no construction activities that would be likely to give rise to dust took place in the area, indicating that the exceedance at this location was not related to construction works. The area adjacent to the Frisbee has been closed for access to vehicles in June. Proximity to turning cars has been identified previously as a potential cause for high levels. The results for June and July will help to identify if this has been affecting levels.

- 3.3.9.** During both two week periods the Echline Frisbee registered levels above the action level. A review of the works was undertaken and it was found that although construction activities that could give rise to dust took place in the area during this period, mitigation was in place to prevent dust migrating off-site. Due to the dust incident in April, increased inspections have taken place in the area during May. These inspections not only included identifying dust emissions but also checked the procedures in place to suppress any dust. Inspections were carried out specifically on days where dust was more likely to be an issue (no/low rainfall and dry ground conditions). Live PM₁₀ and TSP levels were also monitored very closely during these days. PM₁₀ and TSP data has been retrospectively interrogated closely for these periods due to the elevated Frisbee results. The automatic light scatter dust monitor for Echline is positioned adjacent to the Frisbee (<1m away). TSP and PM₁₀ levels throughout these periods are low. The automatic light scatter dust monitors were recently calibrated (9th & 10th April 2014) and registered the dust incident that occurred during the 16th & 17th April 2014 indicating that the monitor is

functioning correctly. It is possible that the position of the gauge near to mature trees has resulted in some small vegetation particles affecting the results. Elevated Frisbee levels were also noted at this location during May 2013 with similarly low TSP and PM₁₀. There has been a focus on completion of the works in closest proximity to this monitoring location in order to limit the potential for dust emissions in the area. After a thorough review it was concluded that FCBC construction activities are likely to have contributed to the exceedances. However, in taking account of weather and ground conditions throughout May, in addition to the TSP and PM₁₀ levels recorded, it is considered other factors may also have contributed to the exceedance. Due to the nature of the work and sensitivity of the area, the extra precautions put in place to mitigate dust, including inspections, are continuing until work in the area has been completed.

Note: 28/05/2014 results for Inchgarvie and Springfield represent erroneous values as sample bottle found empty and/or away from gauge.
