Project FORTH REPLACEMENT CROSSING

AIR QUALITY MONITORING REPORT JUNE 2014

Document Number REP-00185

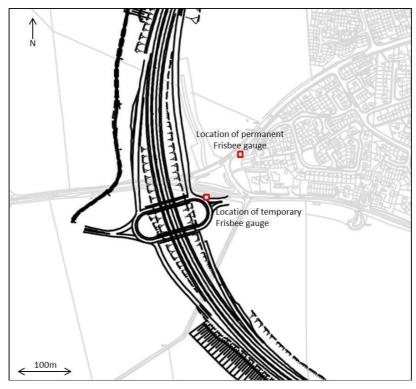
Figure 3: Location of additional temporary Frisbee gauge (Echline Corner)

3.3.6. During the periods ending 11th and 25th June the Echline Corner Frisbee registered levels above the action and review levels respectively. This is an additional temporary Frisbee that was put in place after the dust incident during April. It has been positioned within the construction site and provides information regarding dust levels generated on-site. After being cleaned during the collection on the 11th June, this Frisbee became covered in a fine oily deposition which was noted at the next collection on the 25th June. This deposition did not appear related to construction activity in the vicinity. It was considered more likely that this deposition was due to the close proximity to the A904. It should be noted that the Frisbee at Echline (located 80m to the north), see (figure 3) registered low levels throughout June. Due to these findings and a change in road layout for the A904 at the start of July, the Echline Corner Frisbee was relocated to the other side of the works in that area on 25th June. Although the monitor remains in close proximity to the works it is no longer directly adjacent to the A904. FCBC will continue to conduct increased inspections in the vicinity to ensure any dust generating construction activities are adequately mitigated.

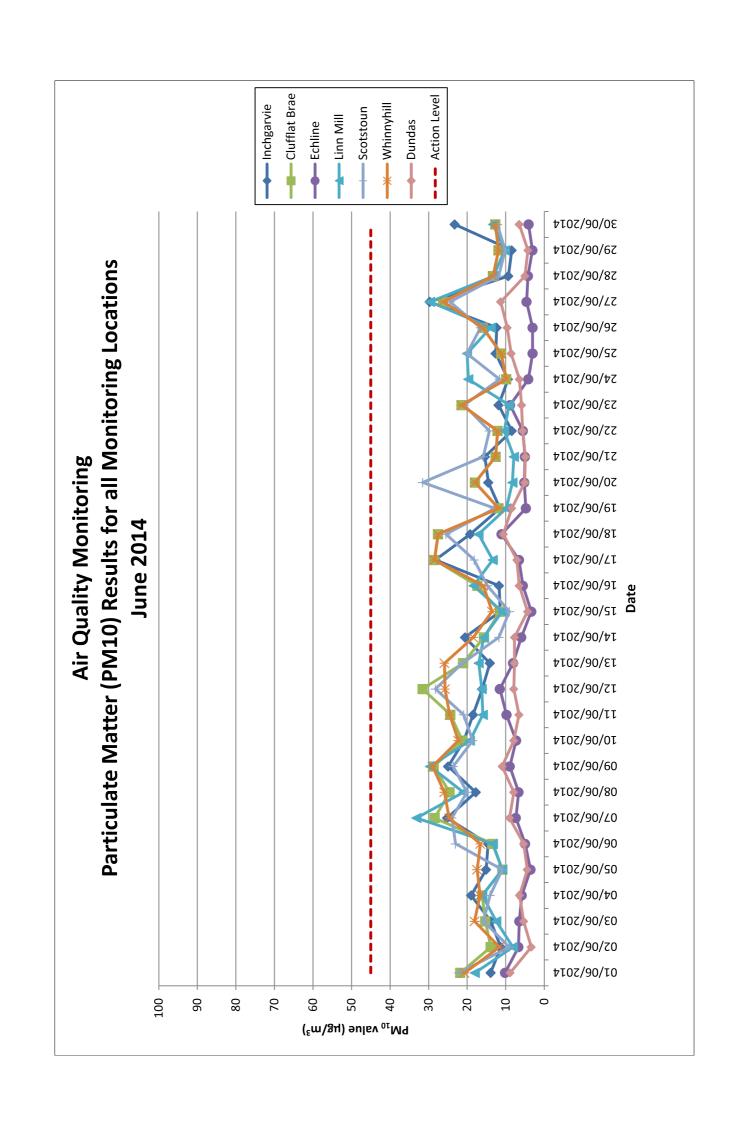
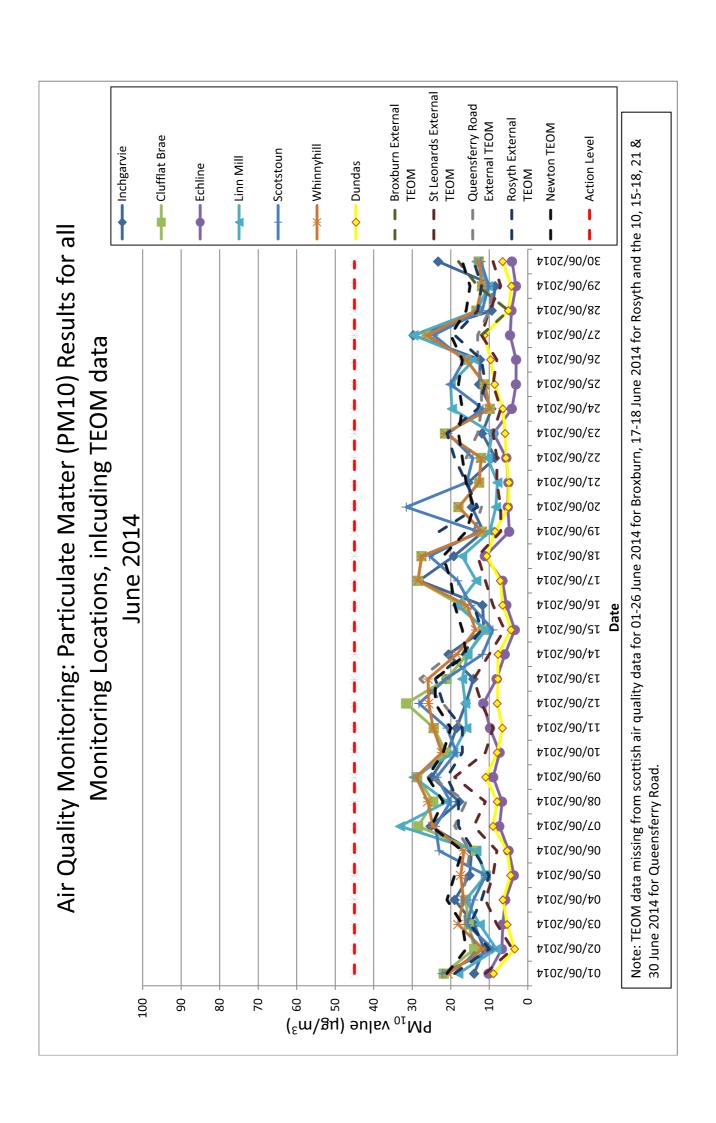
APPENDIX A: LIGHT SCATTER METER RESULTS

- **3.1.1.** Light scatter results for June 2014 have been presented in a monthly chart; this can be found in Appendix A. Results show that the PM₁₀ levels were below threshold levels throughout June and generally followed the same pattern across the site.

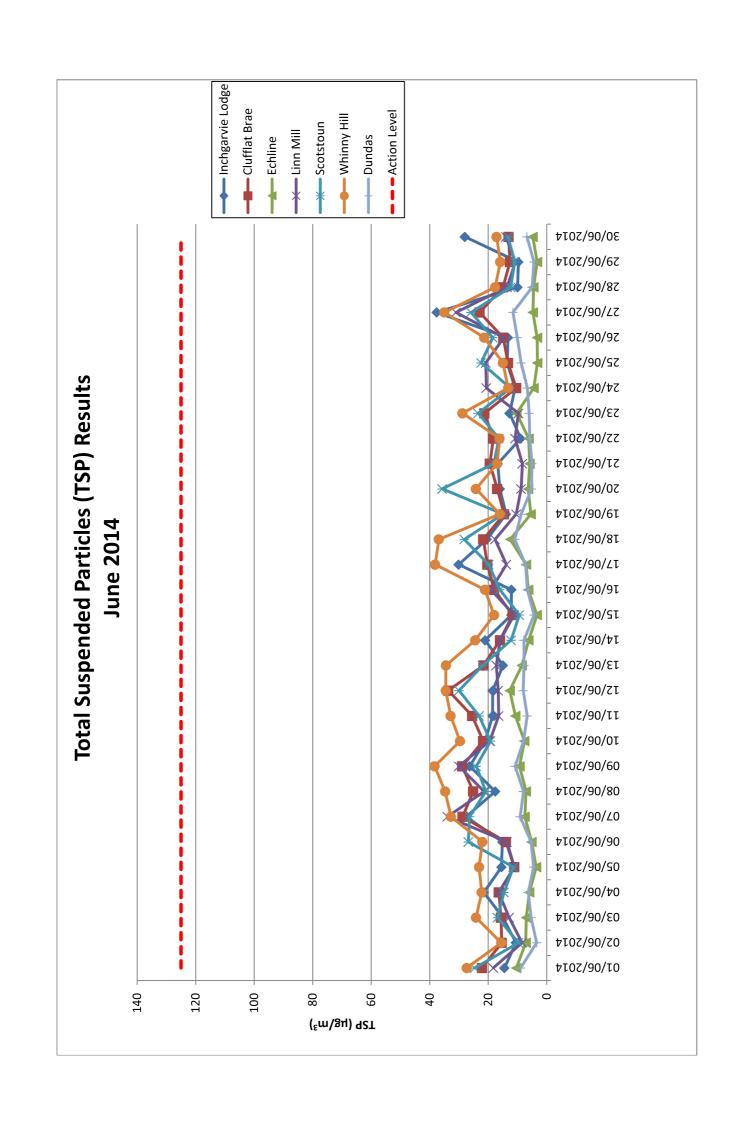
APPENDIX B: TOTAL SUSPENDED PARTICLES

3.2.1. The TSP results for June 2014 have been presented in a monthly chart; this can be found in Appendix B. The TSP levels at monitoring locations during June were found to be low and all within the threshold level. All locations were mostly found to follow a similar pattern across the site, demonstrating that, in general, the levels were influenced by regional changes in TSP levels, rather than construction works.

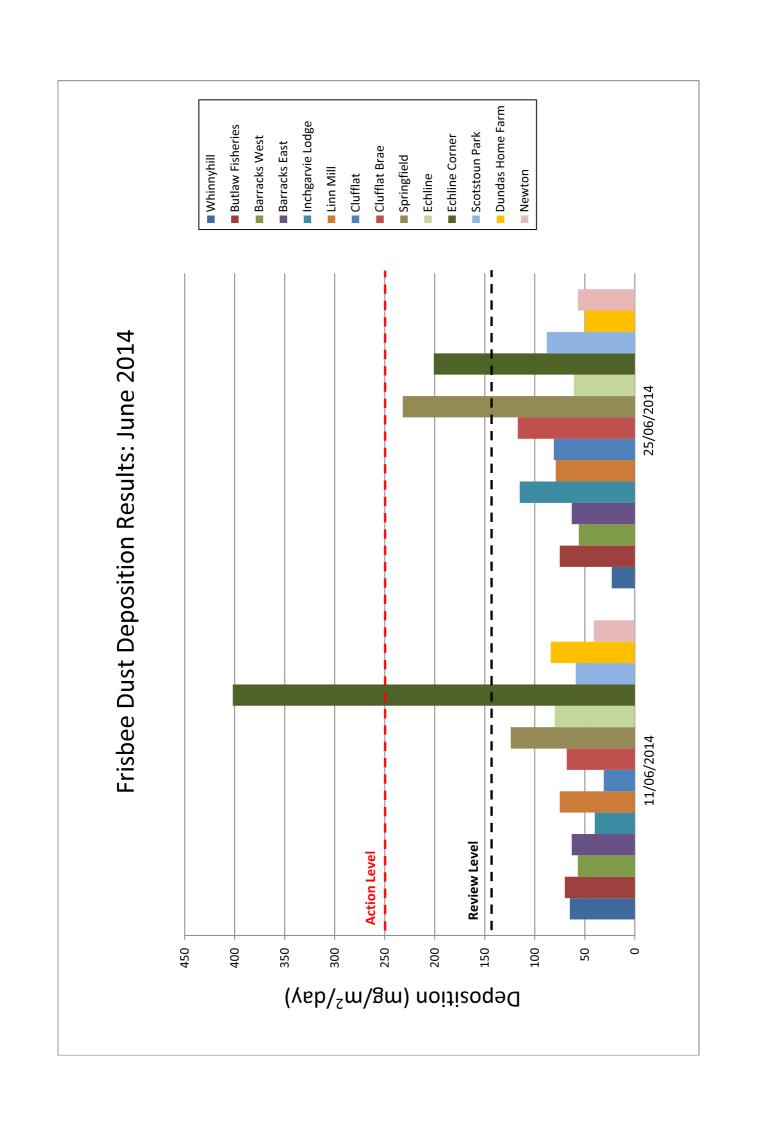
APPENDIX C: FRISBEE GAUGE RESULTS

- **3.3.1.** The Frisbee dust deposition results for June 2014 have been presented in a chart and can be found in Appendix C. Frisbee dust deposition results were collected fortnightly, and the results averaged over this fortnight period to give a daily dust deposition rate. Two collections were made in June, on the 11th and 25th. The next collection will take place on the 9th July 2014.

- **3.3.3.** During June there were two exceedances of the site review level (see Table 2) and one exceedance of the action level. With the exception of the locations where exceedances occurred, Frisbee results from monitoring locations across site were generally low.
