FORTH REPLACEMENT CROSSING

AIR QUALITY MONITORING REPORT JULY 2016

REP-00289

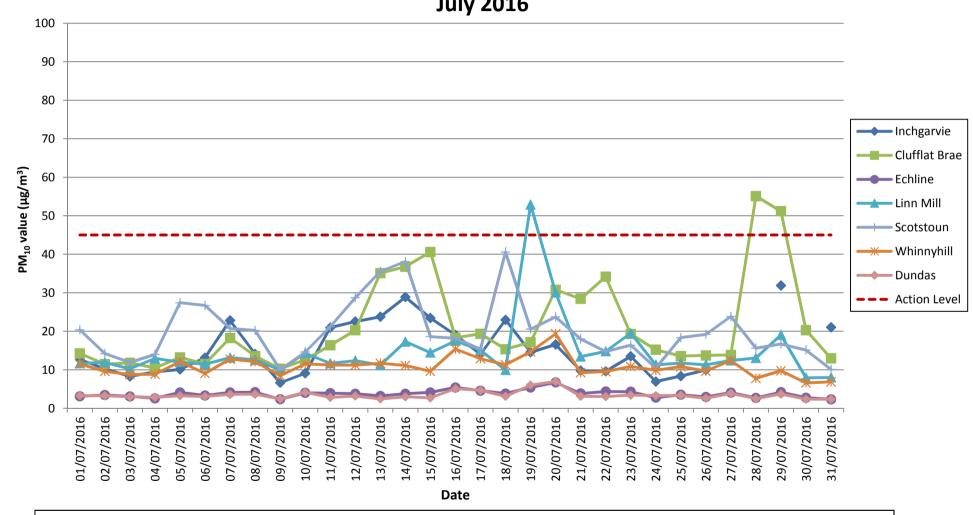
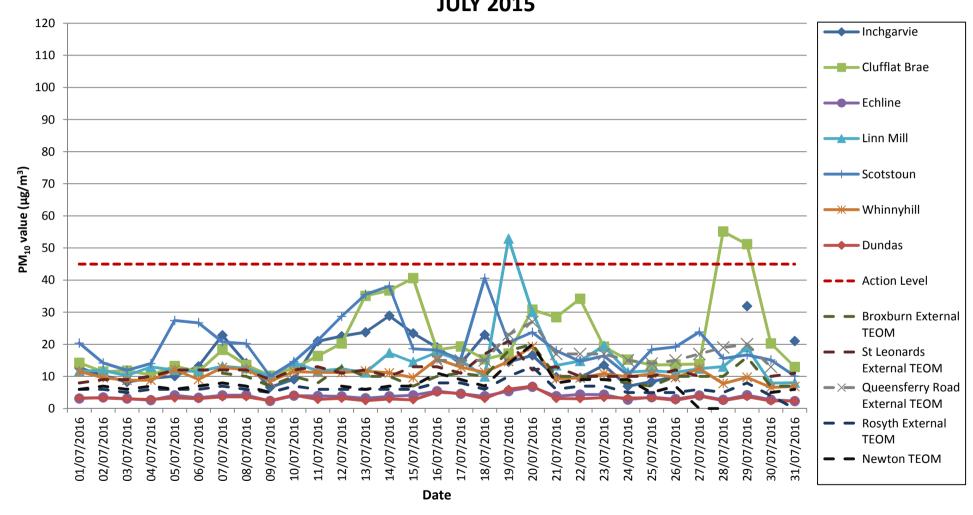
APPENDIX A: LIGHT SCATTER METER RESULTS

3.1.1. Light scatter results for July 2016 have been presented in a monthly chart; this can be found in Appendix A. Results show that the PM₁₀ levels were below threshold levels throughout July with the exception of Linn Mill on the 19th July and Clufflat Brae on the 28th and 29th July. All monitors generally follow the same pattern throughout the month, with the exception of the exceedances noted above, in addition to Scotstoun on 5th, 6th and 18th July and Clufflat Brae on 15th and 22nd July (although below the threshold level on these dates). With the exceedance on the 19th July at Linn Mill, the weather on this day was hot and dry so it is possible that this exceedance was caused by dust from the access track on site. The access track has since been resurfaced which has

reduced any dust emissions in this area. With regards to the exceedance at Clufflat Brae on 28th and 29th July, the light scatter meters registered 15 minute exceedances for PM₁₀. The FCBC Environmental Coordinator investigated the area and confirmed that although dry, the site conditions were not dusty and that sufficient mitigation was in place. The closest works to the monitors was surfacing works on the main line (approx. 200m away). It was considered unlikely that this work would cause the exceedances registered on the meter due to the distance and absence of any visible evidence of dust. FCBC will continue to monitor construction works closely in this area and provide mitigation when necessary.

- 3.1.2. On 27th, 28th and 30th July the light scatter meter at Inchgarvie registered a number of extremely high results (eg. 1604μg/m³). These results occurred in the afternoon / early evening. The FCBC Environmental Coordinator attended the site on 28th July to investigate the incident on that day. There was no visible signs of dust in the vicinity of the meter and no construction works being undertaken which were a likely source of the high levels. Furthermore, on Saturday 30th July the only construction works being undertaken in the afternoon at the time of the high results were deck works on the viaduct section of the bridge. These works would not have provided a source of PM₁₀. The results for Inchgarvie have therefore been excluded from the charts in Appendix A and B as erroneous results on these days.

Note: Data missing from Inchgarvie on 27th, 28th and 30th due to erroneous results (see 3.1.2 of report)

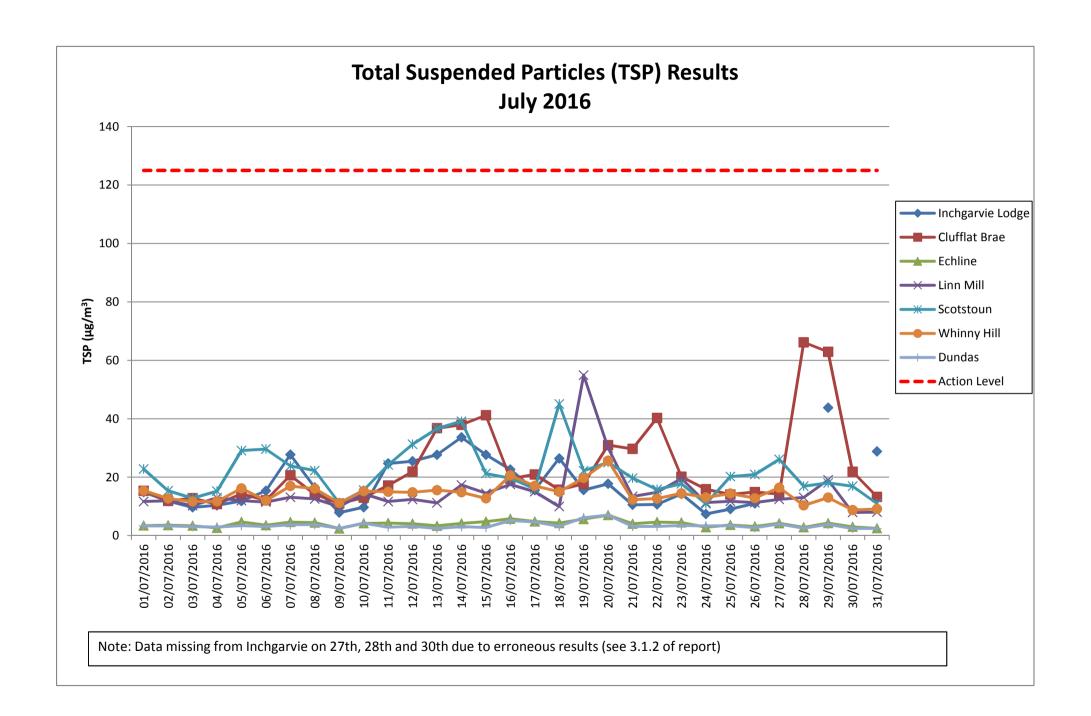
APPENDIX B: TOTAL SUSPENDED PARTICLES

- **3.2.1.** The TSP results for July 2016 have been presented in a monthly chart; this can be found in Appendix B. The TSP levels at monitoring locations during July were all within the threshold. The TSP pattern at locations across the site was similar to that observed for PM₁₀ levels. As with PM₁₀ it is considered that the TSP levels across site were generally influenced by regional changes in TSP levels, with the exception of results corresponding with the higher peaks noted in 3.1.1 and 3.1.3 above.
- **3.2.2.** The results for Inchgarvie have been excluded from the chart in Appendix B as erroneous results on these days (see 3.1.1).

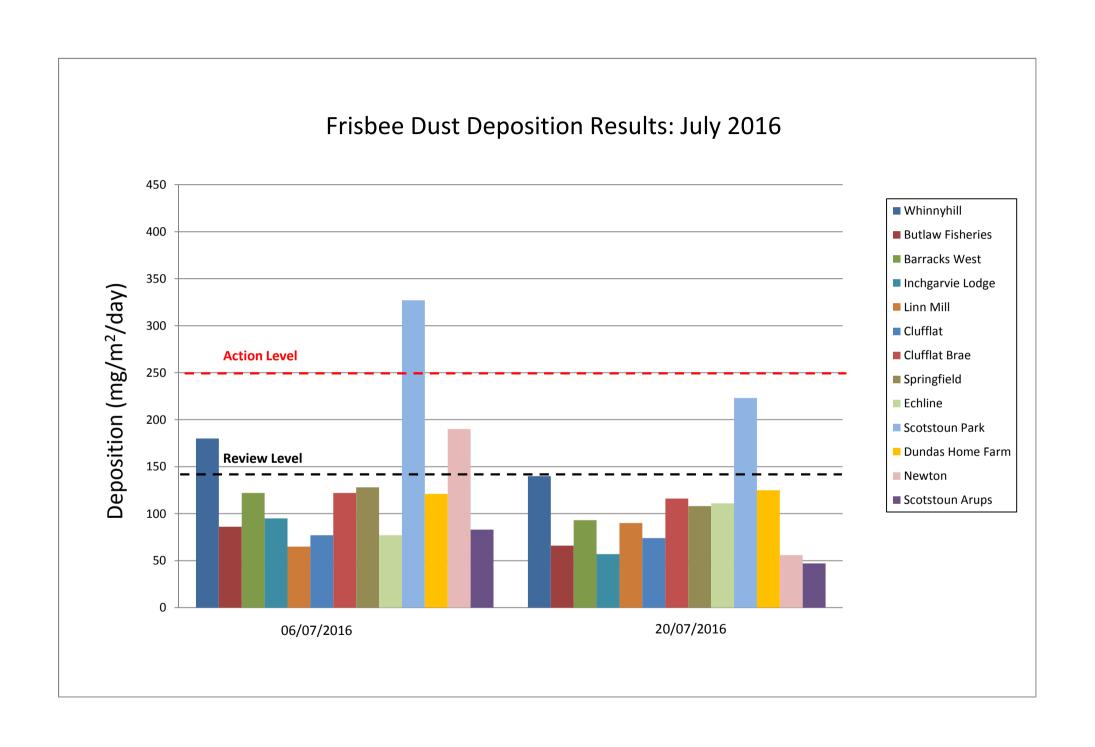
APPENDIX C: FRISBEE GAUGE RESULTS

- **3.3.3.** During July there was one exceedance of the action level at Scotstoun Park for the fortnight concluding 6 July. There were three exceedances of the review level, at Whinnyhill and Newton for the fortnight concluding 6th July and at Scotstoun Park for the fortnight concluding 20th July. With regards to the review level at Whinnyhill, the closest works being undertaken were approx. 90 metres away. However, due to the elevated height of the residential area it is considered unlikely that the construction works caused the exceedance. The light scatter meter at this location indicated mostly low levels of PM₁₀ and TSP during this fortnight. FCBC will continue to monitor the area as works on the carriageway progress at this location. The exceedance at Newton was caused by the Frisbee container being found away from the Frisbee during collection, leading to likely contamination of the sample. The closest FCBC work is approx. 1.75 kilometres away. With regards to the exceedance at Scotstoun Park, the light scatter meter at this location indicated a number of peaks in levels of PM₁₀ and TSP during this fortnight. The temporary Frisbee at Scotstoun Arups, which is located closer to the FCBC works, indicates a significantly lower result than for the permanent Frisbee during this period. This suggests that the higher results obtained recently at the permanent monitoring location are not entirely due to FCBC activities. As noted in previous reports, other construction work (not project related) is ongoing in the Scotstoun area. However, FCBC will continue to monitor Forth Replacement Crossing construction closely as works progress and provide mitigation as necessary.
