Project FORTH REPLACEMENT CROSSING

AIR QUALITY MONITORING REPORT DECEMBER 2013

Document number REP-00152-00

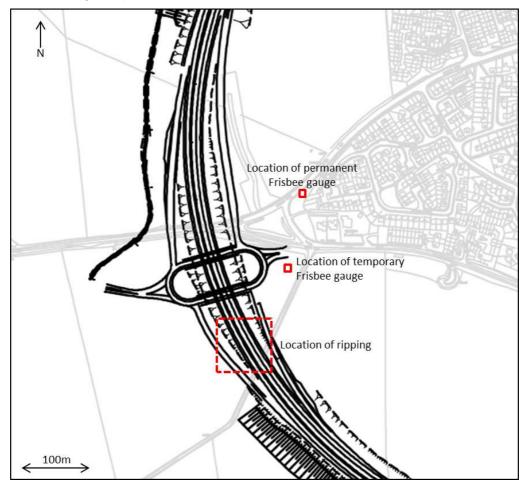
Figure 3: Location of temporary Frisbee, ripping works and permanent Frisbee

3.3.7. The exceedance of the review level at Echline initiated a further review into dust levels at this location, with factors such as the location of the gauge, any works undertaken and the weather conditions taken into account. Whilst this gauge is located close to an area where ripping work was on-going (a distance of around 250 metres), an additional Frisbee was located closer to these works (a distance of around 100 metres) between 05/12/13 and 12/12/13 (Figure 3). This additional gauge was positioned to the south of the A904 with the intention of monitoring dust from operations more closely. The results from this additional Frisbee showed no exceedance of the threshold during the monitoring period (results were 97 mg/m²/day). No other works with the potential to give rise to dust were on-going in this area during the period and it should also be noted that no exceedances of particulate matter were noted during this period.

3.3.8. It is possible, therefore, that adverse weather conditions during this period impacted the results at Echline; strong winds may have mobilised particles from surrounding vegetation and roads, increasing the Frisbee gauge deposition results. It should also be noted that ground conditions on site were wet or damp throughout the period in which the exceedance of the review level threshold occurred.

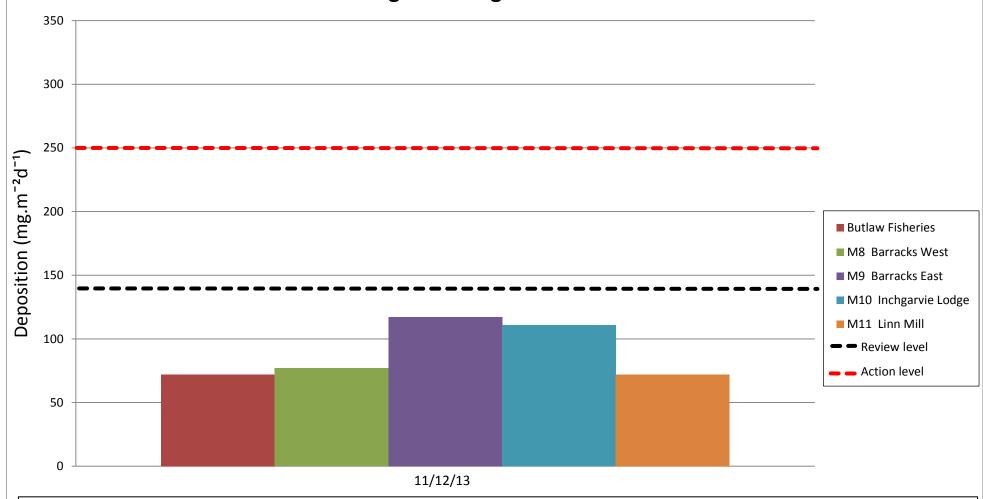
Note: When collected, the gauges located at the Barracks were found to have blown over in strong winds.
