Appendix 9

Fish Habitat Assessment Survey

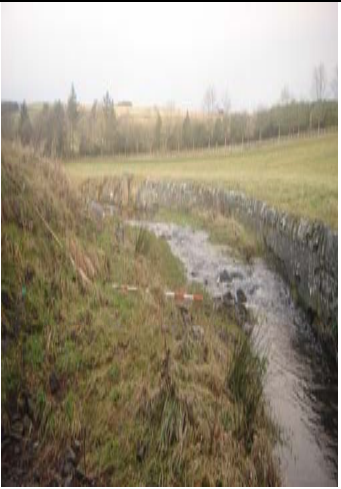
| Section | NGR | Mean Stream | | | Substratum Composition (%) | | | | | | | Observation | Photograph |
|---|---|---|---|---|---|---|---|---|---|---|---|---|---|
| 15 | NT49388 54580 | 1.8 | 0.3 | Riffle/Run | | 10 | 30 | 30 | 30 | | | 6-9 m of this stretch is likely to be lost due to bridge extension. Clear fast flowing channel with the flow type in the vicinity of the bridge predominately a run, with a riffle approximately 8m upstream of the bridge. The left bank is reinforced and the land at the top of the reinforcement forms the bridge embankment. The right hand bank has a 4.5m margin of cobbles and pebble deposits possibly derived from past channel clearance or bank slumping, and had established a vegetation structure of soft rush and grasses. The bridge and embankment provides a moderate degree of shading to the channel. The riffle ca. 8m upstream of the bridge provides suitable spawning habitat for salmonids and lamprey. | |

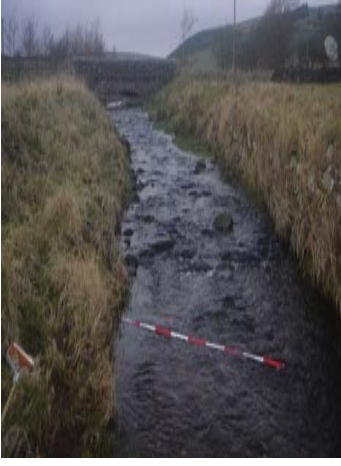
| Section | NGR | Mean Stream | | | Substratum Composition (%) | | | | | | | Observation | Photograph |
|---|---|---|---|---|---|---|---|---|---|---|---|---|---|
| 16 | NT49363 54609 | 3.0 | 0.15 | Riffle | | 10 | 20 | 35 | 35 | | | Bridge crossing the D45715. Clear fast flowing channel with small 4m ² sidebars composed of silts and sand downstream of the bridge. Both banks show sign of past reinforcement and were well vegetated with grasses. Livestock poaching of the left hand bank was evident in places. Occasional evidence of filamentous algae and mosses on cobble substrate. Further evidence of salmon remains noted. Suitable spawning habitat for salmonids and lamprey. Directly upstream of the B45715 bridge an area of seasonally wet channel comprising abundant vegetation over predominately silts and sands. Under suitable flow conditions, this area may provide suitable nursery habitat for lamprey ammocoetes. | |
