# Appendix 11.4

## Hydromorphology Assessment Part 3

**Annex 11.4.3 - Hydromorphological Catchment Assessment - 12**

| REV | SUIT | DATE | DESCRIPTION | BY | APP |
|---|---|---|---|---|---|
| <b>PROJECT 7 GLEN GARRY TO DALWHINNIE EIA</b><br><b>Drawing 11.4.3.1 Catchment 12 Catchment Overview</b> | | | | | |

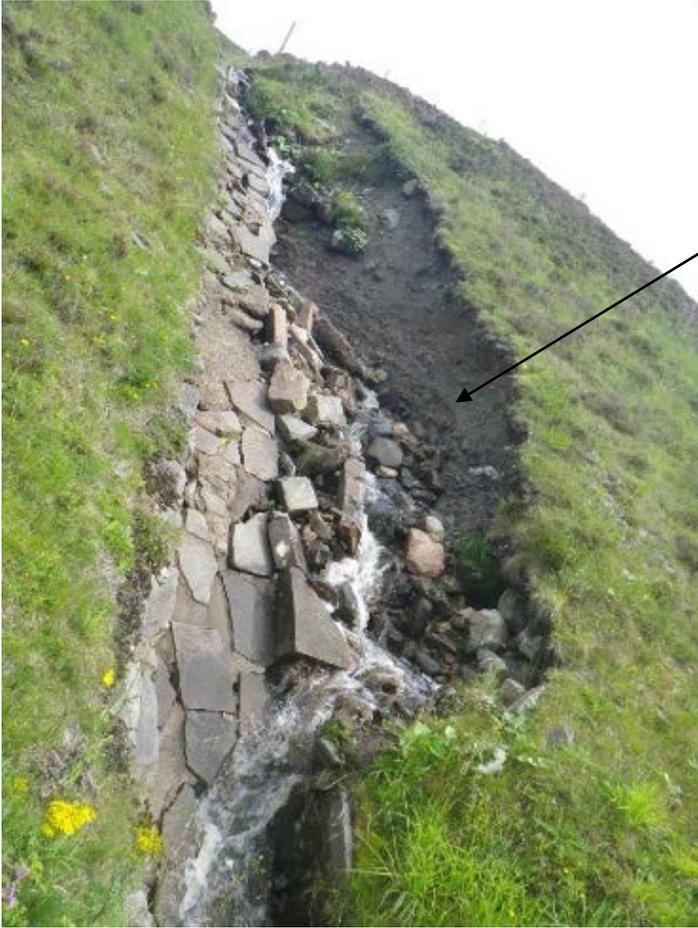
Photograph 11.4.3.38-Upstream of crossing

Lateral channel change  
leading to change in  
flow path

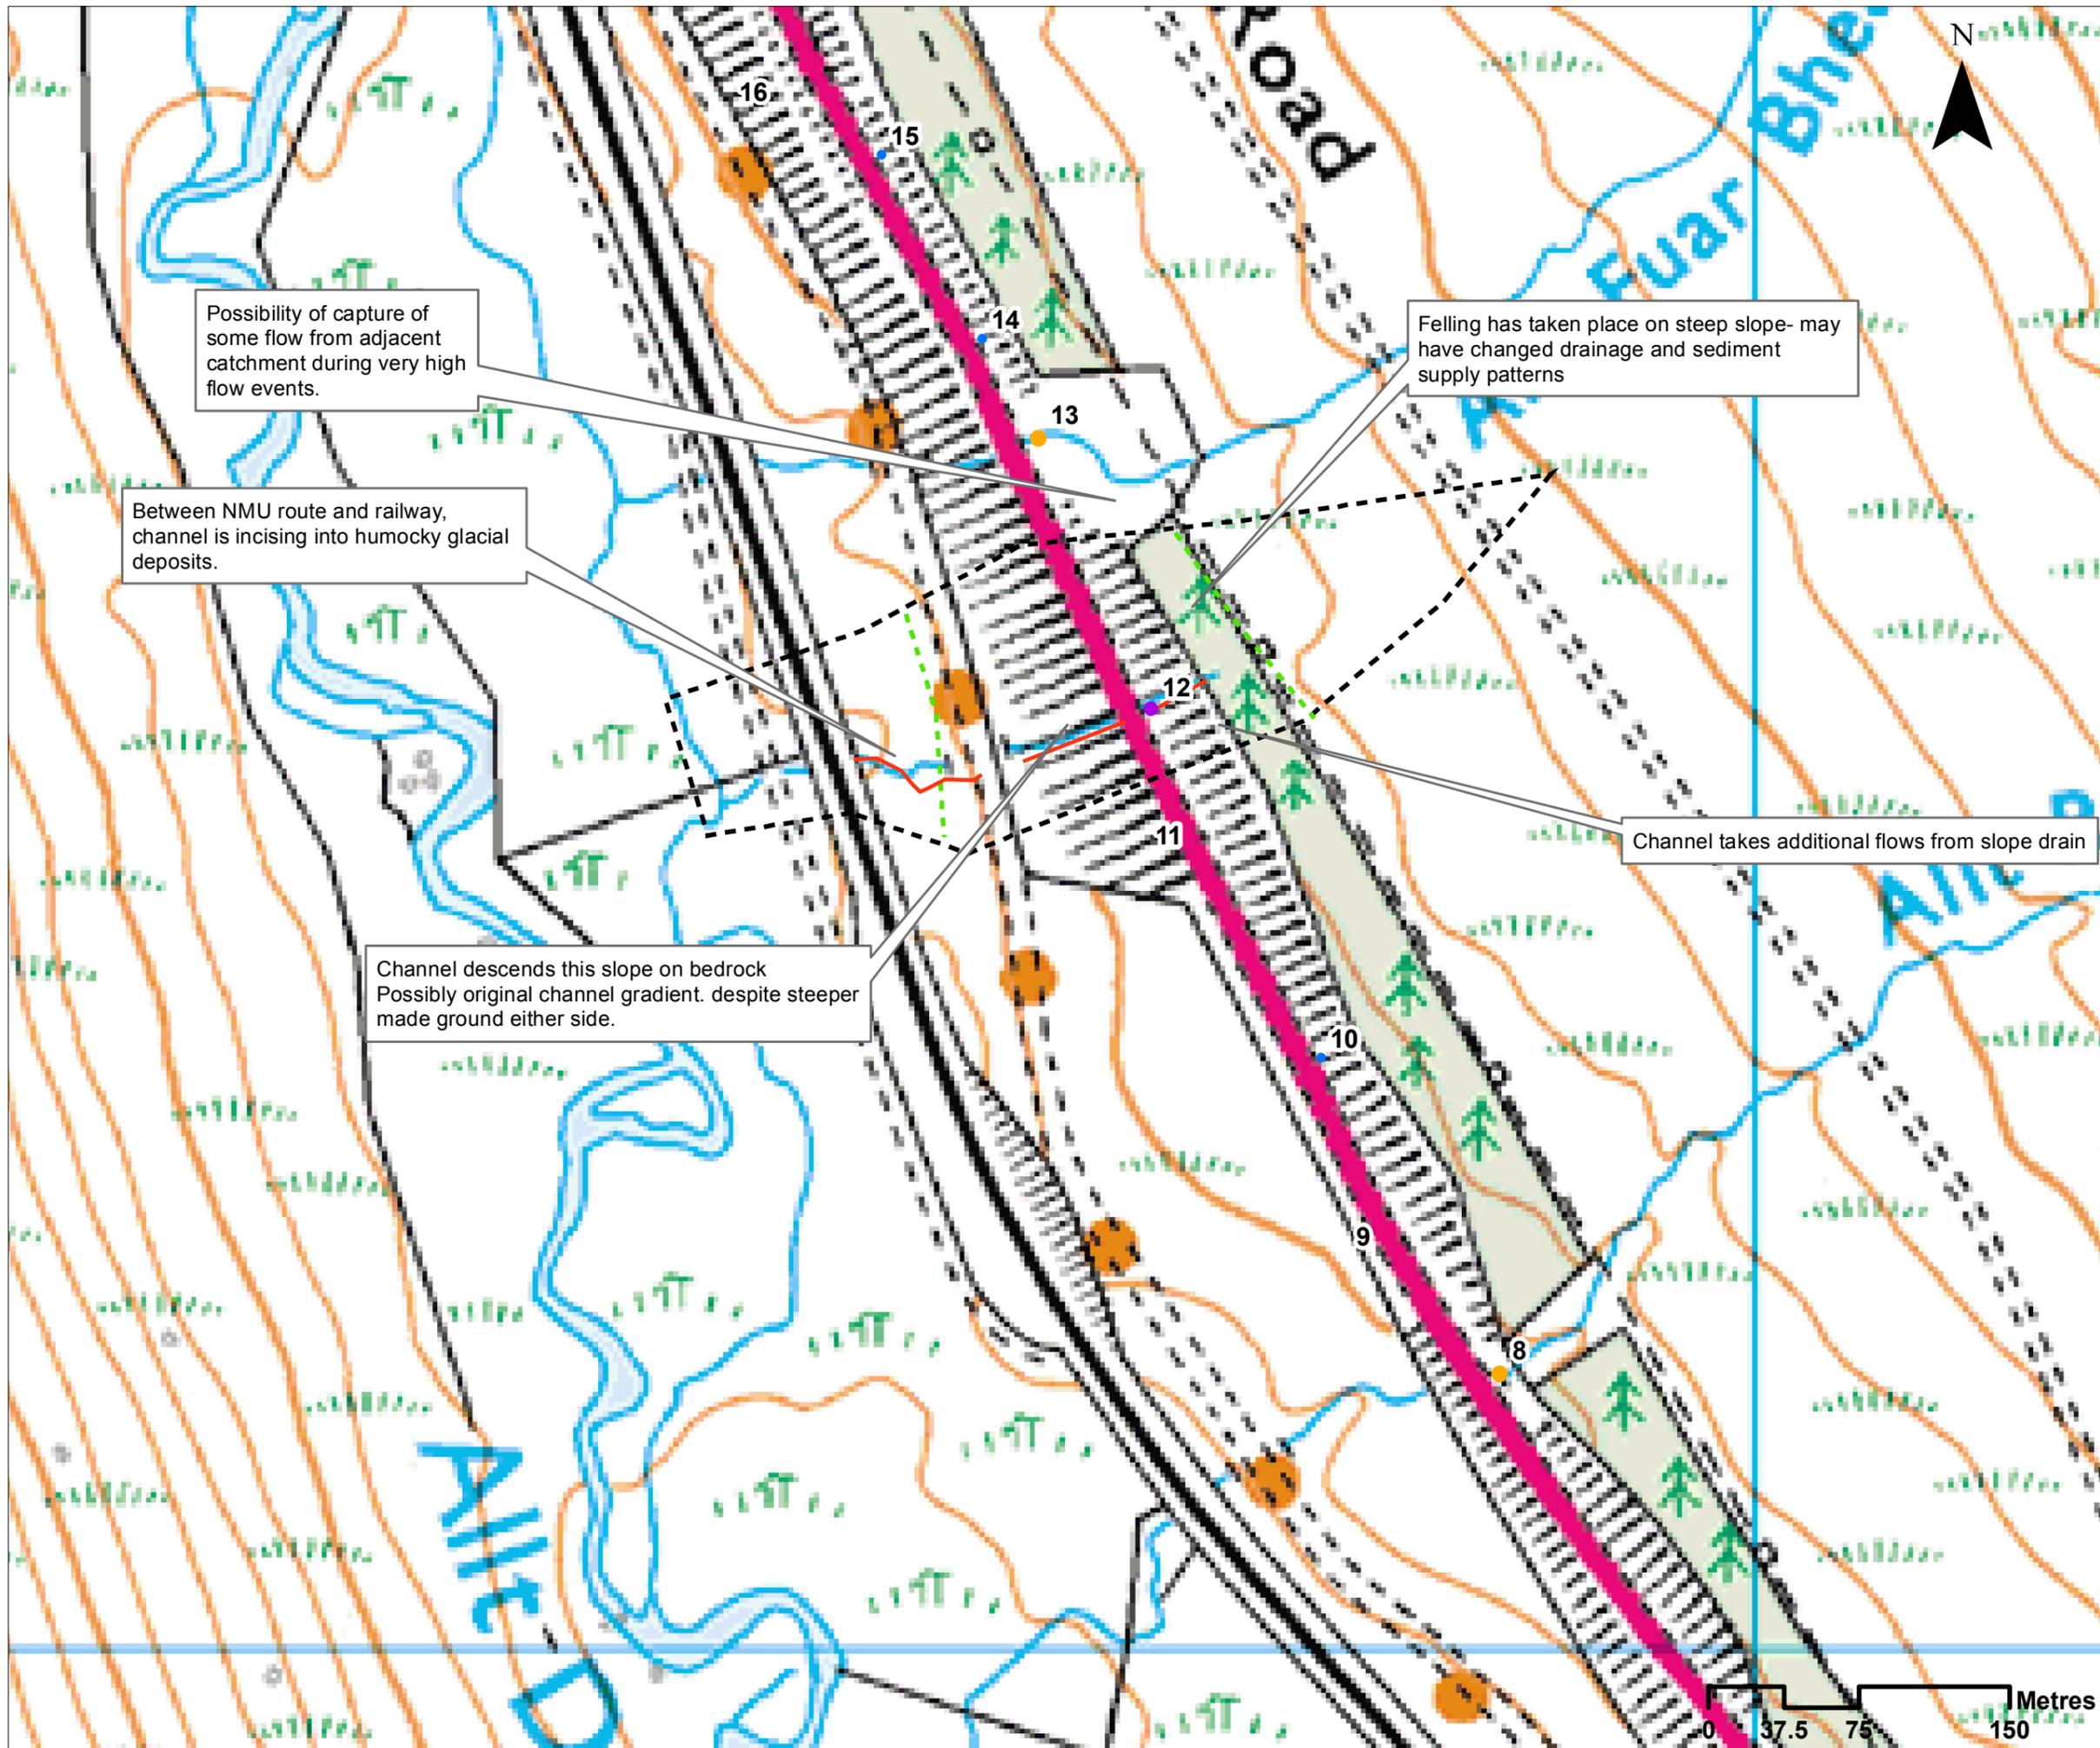
**PROJECT 7 GLEN GARRY TO DALWHINNIE EIA**  
**DRAWING 11.4.3.2. Catchment 12 Baseline Assessment**

Possibility of capture of some flow from adjacent catchment during very high flow events.

Between NMU route and railway, channel is incising into hummocky glacial deposits.

Channel descends this slope on bedrock  
Possibly original channel gradient, despite steeper made ground either side.

Felling has taken place on steep slope- may have changed drainage and sediment supply patterns

Channel takes additional flows from slope drain

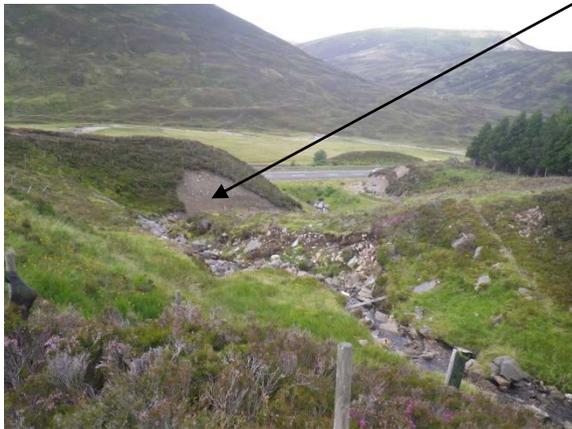
Photograph 11.4.3.41-Downstream, channel  
incising

Valley side erosion due  
to channel incision

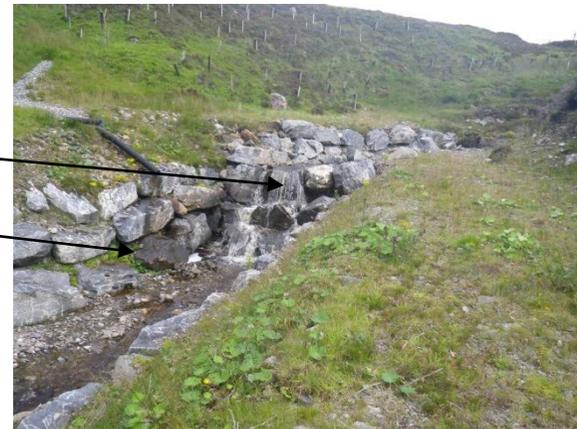
Stone weir  
Recent bank protection

Photograph 11.4.3.42-Upstream to stone weir,  
fixing bed level, to reduce upstream channel  
incision

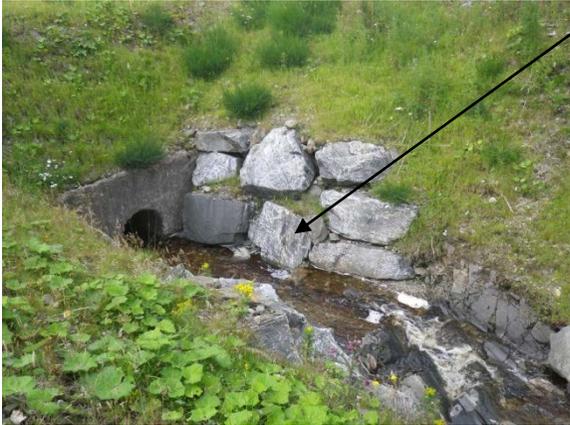
Photograph 11.4.3.43-Entrance to culvert

Recent bank protection

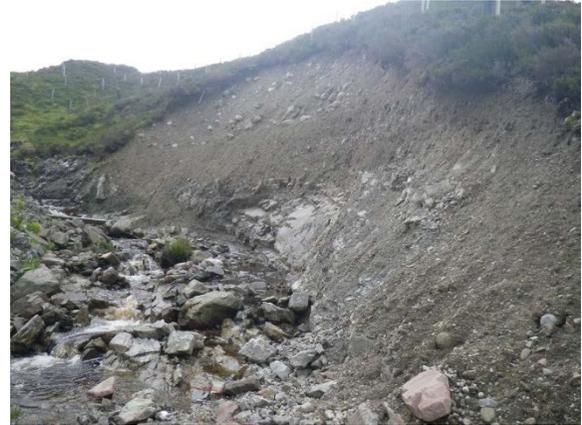
Photograph 11.4.3.44-erosion of valley side

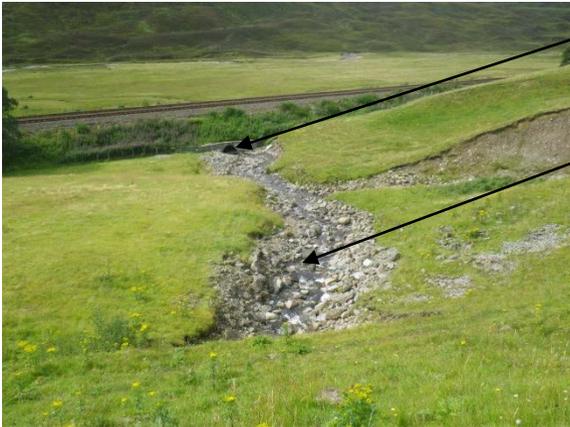
Photograph 11.4.3.45-Downstream of small road crossing

Small railway crossing

Channel incision

Channel incision  
downstream of crossing  
14/15

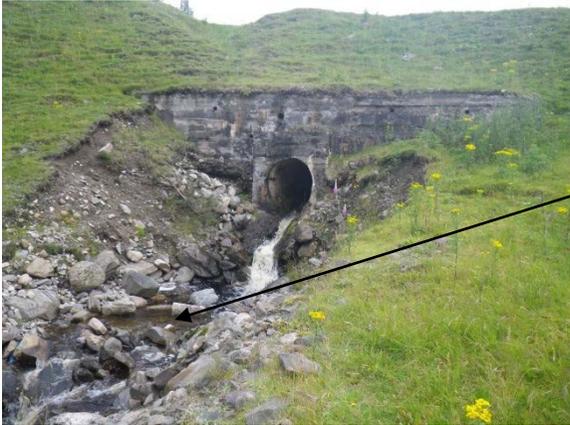
Photograph 11.4.3.47-Upstream to small road crossing

Incision of the bed

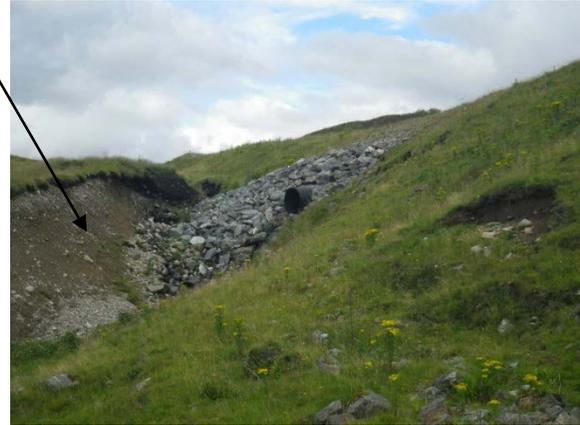
Photograph 11.4.3.48-Additional outfall- crossing 14 downstream of NMU

Scour

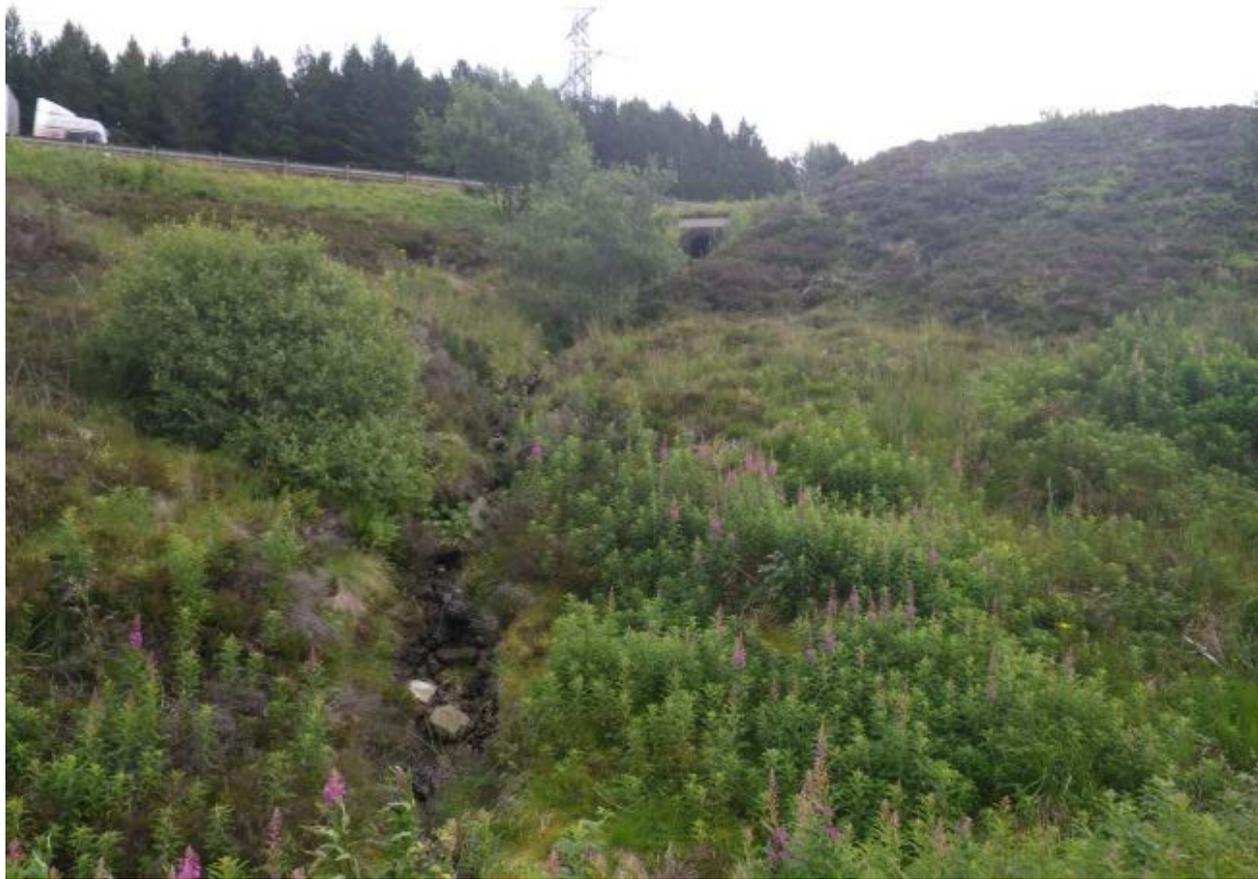
Photograph 11.4.3.50- Some erosion to concrete/boulder cascade on exit of crossing

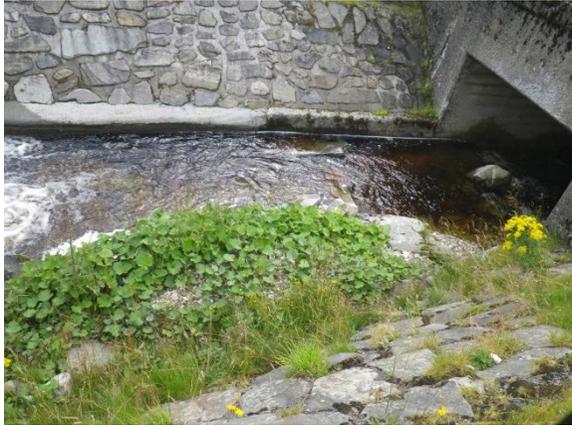
Photograph 11.4.3.51-Some gravel deposition at old road crossing

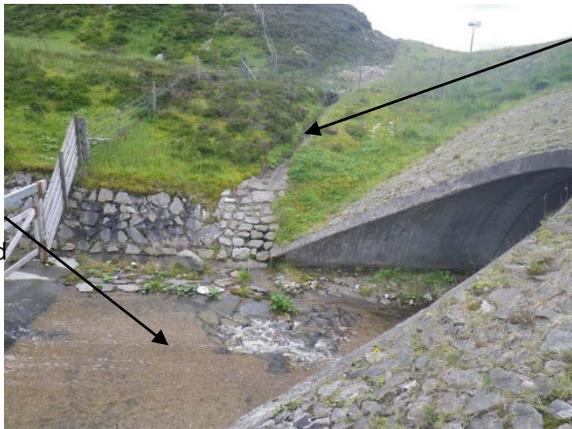
Photograph 11.4.3.53-Crossing inflow

Over wide channel with concrete bed

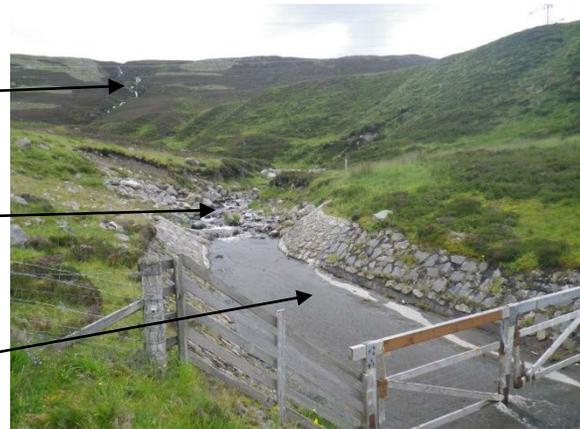
Photograph 11.4.3.54-Upstream of crossing

Incision and bank erosion upstream of concrete section

Concrete bed and pitched banks

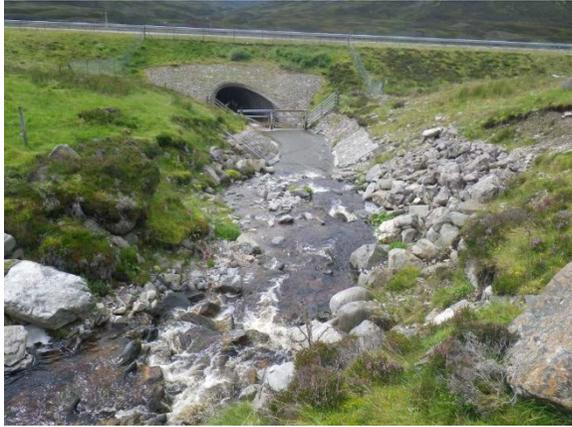
Photograph 11.4.3.55-Downstream to culvert entrance

Small pockets of gravel deposition at channel margins

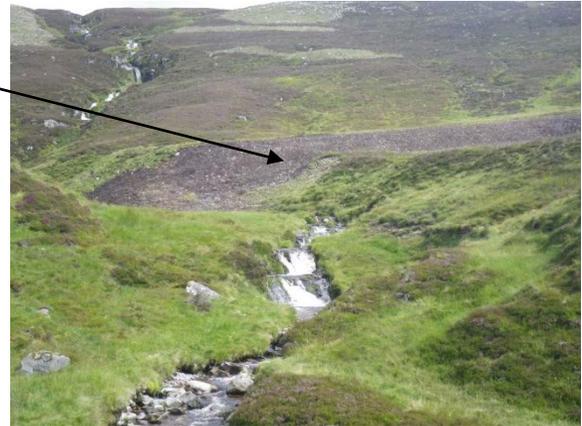
Photograph 11.4.3.58- Cascade morphology in confined channel

Exposed unvegetated material left after pylon installation

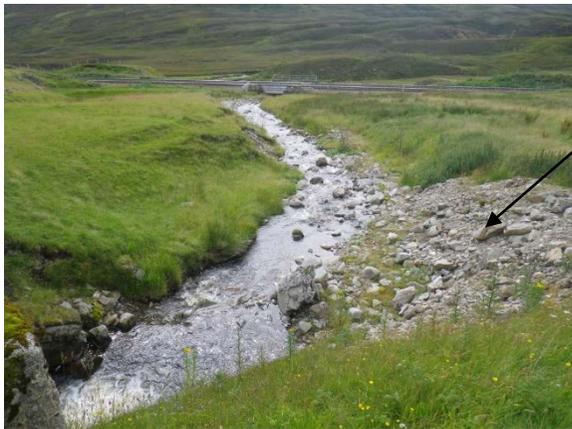
Photograph 11.4.3.61-Downstream to railway crossing

Local erosion

Crossing fixing bed level

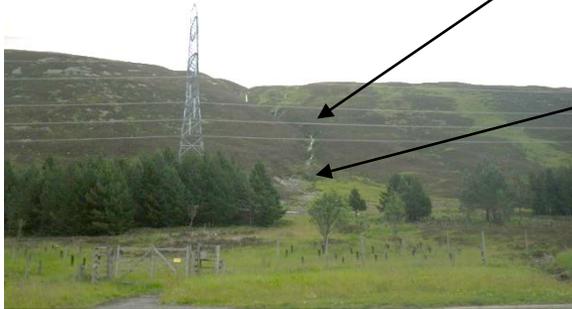
Photograph 11.4.3.63-Upstream to catchment

Very steep channel

Deposition as slope reduces

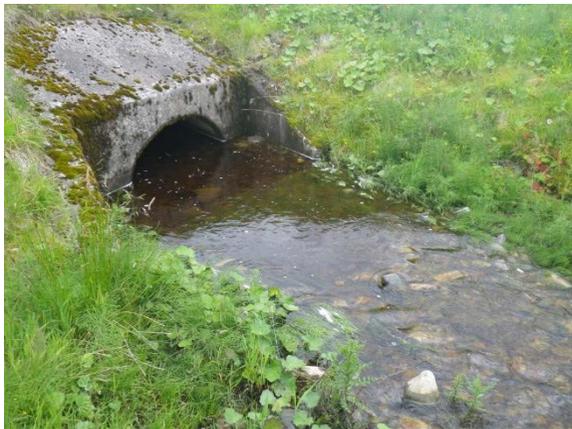
Photograph 11.4.3.65-Culvert exit

Some scour

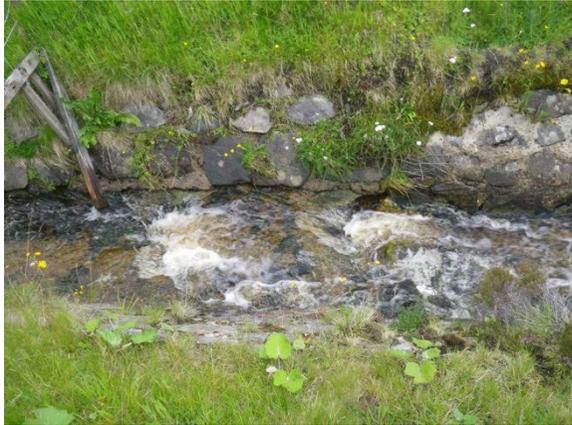
Photograph 11.4.3.67-Damaged concrete bed on entrance to the culvert

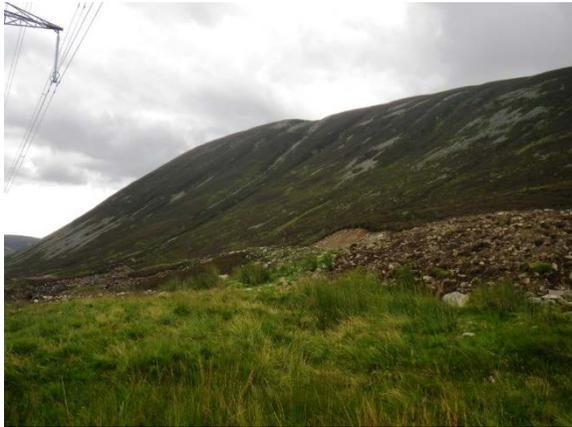
Photograph 11.4.3.71-Debris flow tracks

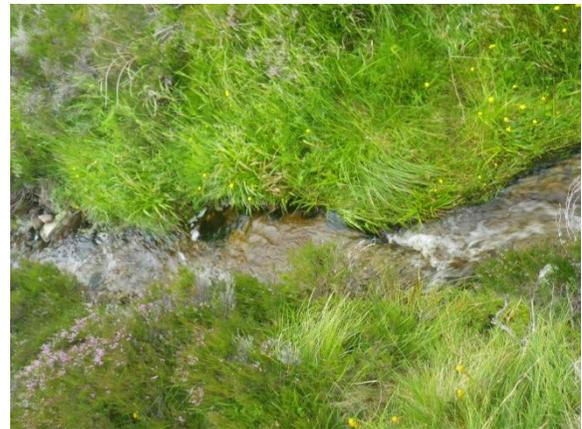
Photograph 11.4.3.74-Some scour to concrete bed

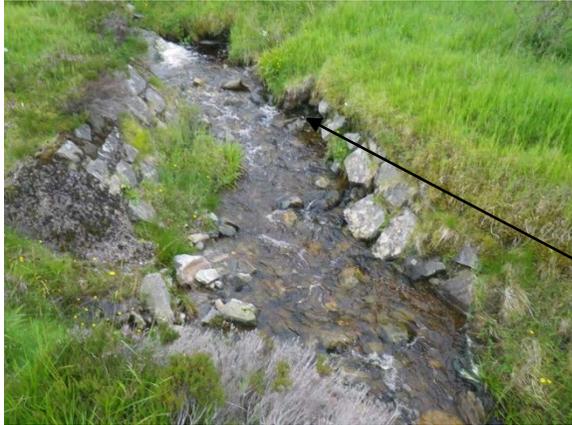
Photograph 11.4.3.75-Upsteam

Incision damaging concrete bed and starting to destabilise banks

Incision undercutting engineered banks
