# Appendix 12.6

## Protected Vertebrate Update Survey

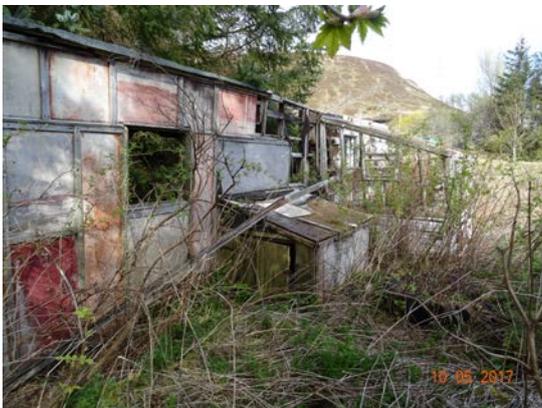
Photograph 3-1: Building 2 looking east

- 3.3.3 Building 2 is also constructed using a simple timber-frame with the external wall comprising wood panelling. It has fallen into disrepair and a neighbouring windblown tree has collapsed over the felt-roof. A brick-built rendered chimney is present on the south-facing gable-end. Flooring within the building has partially collapsed and broken glass was scattered below windows and doors. On this basis, a full internal inspection was not carried out on health and safety grounds; however, the building was visually assessed as far as reasonably practicable from windows, doors and surrounding high ground.

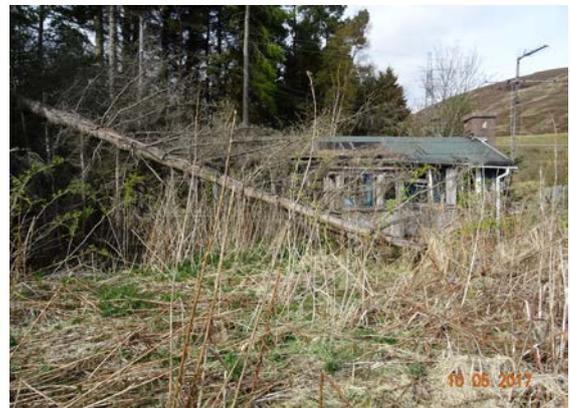
- 3.3.1 Building 1 is constructed using a simple timber-frame with the external wall comprising wood panelling. It has fallen into disrepair as the felt-roof has partially collapsed to expose the internal structure where dense vegetation has become established, presumably through natural regeneration. On this basis, a full internal inspection was not carried out on health and safety grounds; however, the building was visually assessed as far as reasonably practicable from windows, doors and surrounding high ground.

- 3.3.2 During the survey, no bat roost potential (BRP) features were noted on any external aspects to the building. Given that the roof has partially collapsed, it is considered that the roof space will be frequently exposed to the elements (e.g. wind and rain). In addition, it is considered that vegetation growing inside the property will likely obstruct access to internal parts of the building. Therefore, building 1 has negligible potential to support summer or winter roosting bats.

Photograph 3-2: Building 1 looking south

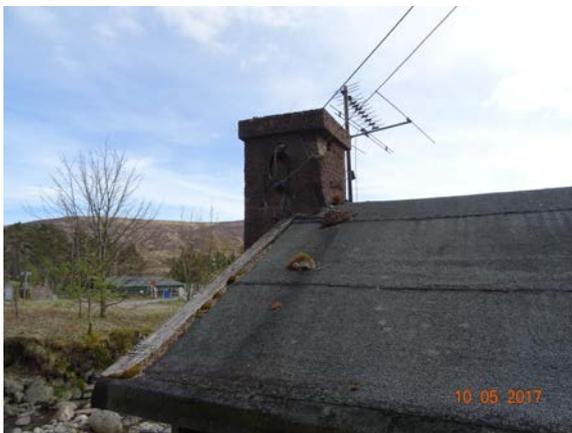
- 3.3.4 During the survey, a single BRP feature was noted on the chimney where the pebble-dash rendering has come away from the brickwork above the apex of the roof. The feature did not appear to lead to any internal cavity and on a precautionary basis was characterised as providing low summer roosting potential.

Photograph 3-3: Chimney with BRP feature

- 3.3.5 An emergence survey was carried out at dusk to detect any bats emerging from the BRP feature. No bats were seen emerging from this feature or any other parts of the building. During the survey, bat activity in the locality was found to be low with individual bat passes, assumed to be coming from buildings and woodland towards Keepers Cottage. At the end of the survey, the BRP feature was assessed using high-power torch where it could be determined that the feature did not lead to any internal cavity, nor could it support more than a single bat. On this basis, the BRP feature was considered to be unsuitable for roosting bats and no further surveys were carried out.

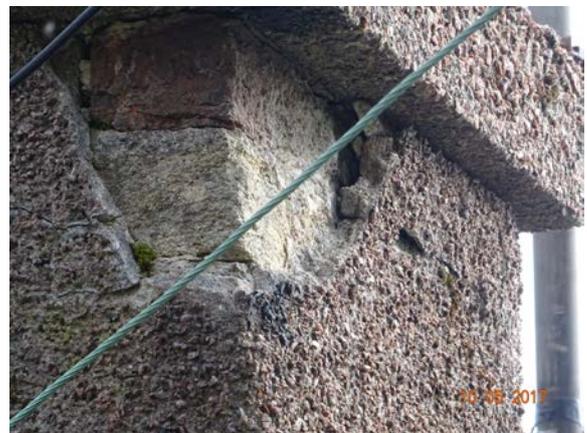
Photograph 3-4: Close-up of BRP feature

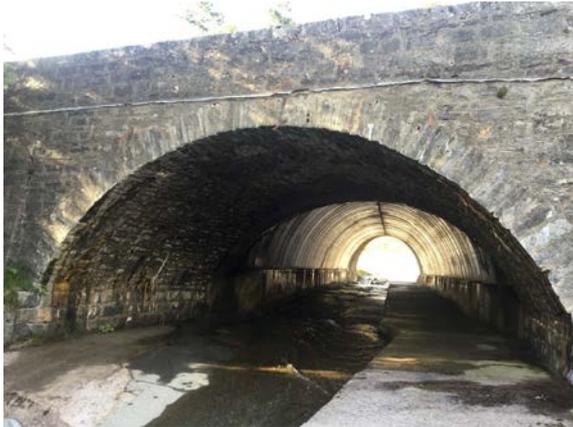
- 3.3.6 The Dalnaspidal culvert is constructed with large sectioned concrete structures, connected with expansion joints. The Dalnaspidal culvert connects to a traditional stone built structure that supports traffic to Dalnaspidal and the NCN7.
- 3.3.7 The traditional stone bridge connected to the Dalnaspidal culvert is well sealed and does not support any features suitable for any hibernating bats (see **Photograph 3-5**).
- 3.3.8 The concrete culvert structures have expansion gaps that could support roosting crevice dwelling bats (See **Photograph 3-6**). No bats or signs of bats were found within any part of the structure during this visit undertaken in the winter period.

Photograph 3-5: Dalnaspidal Culvert

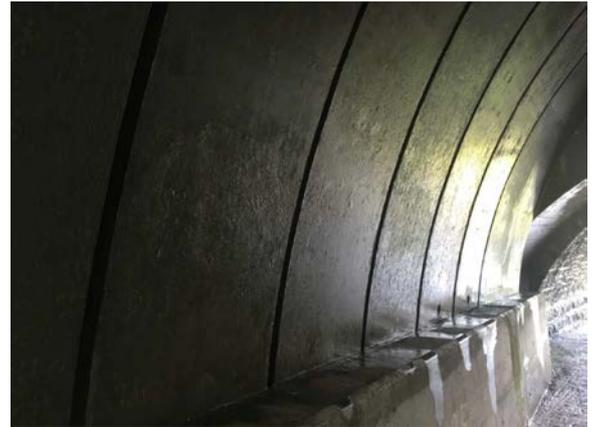
Photograph 3-6: Dalnaspidal Culvert Internals

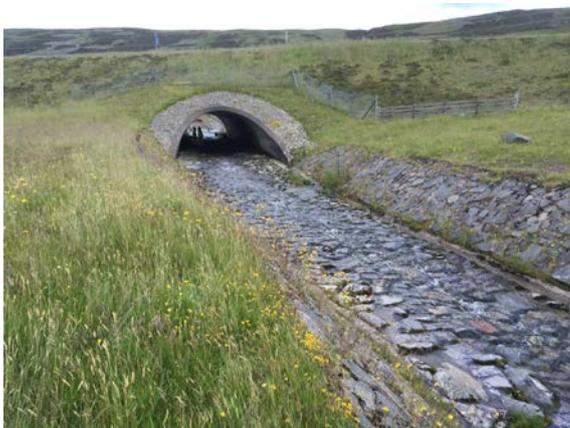
- 3.3.9 The Allt a' Chaorainn culvert is of a similar specification to the Dalnaspidal culvert, with large sectioned concrete structures connected by expansion joints.
- 3.3.10 Expansion joints can provide BRP for crevice dwelling bats; as rubber seals can crack over time and may lead to larger internal cavities behind the expansion joint (See **Photograph 3-7**). No bats or signs of bats were found in any part of the structure during this survey undertaken during the winter period. The absence of any indication of hibernation are consistent with the very low value given in **Appendix 12.5**.

Photograph 3-7: Allt a' Chaorainn culvert

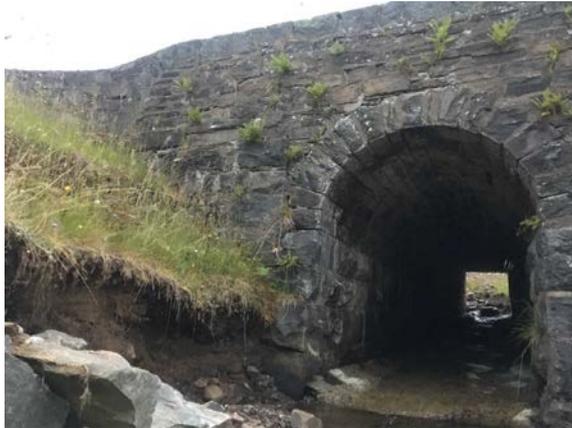
- 3.3.11 Within the Allt nan Sigolieren NCN7 culvert, the majority of the structure is well sealed. However, at the western extent of the culvert there are gaps in the mortar between stonework that leads to cavities in the structure that could support roosting bats (see **Photograph 3-8** and **Photograph 3-9**).
- 3.3.12 No bats or signs of bats were found in any part of the structure during this inspection undertaken during the winter period, despite good access being possible within this low structure to the cavities which were present.

Photograph 3-8: Allt nan Sg oilearan NCN7 culvert

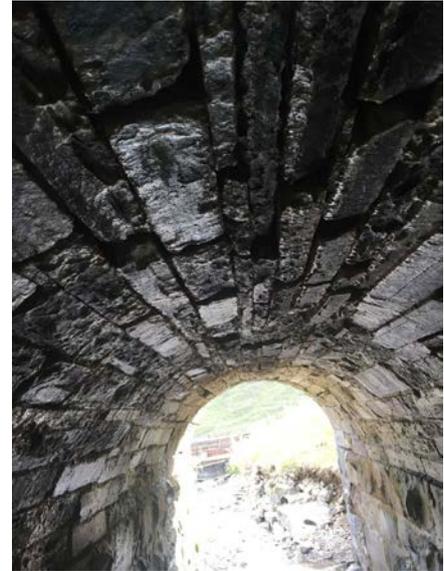
- 2.6.5 Due to the height of the Dalnaspidal culvert and the Allt a' Chaorainn culverts, where some crevices are present at joints throughout the arch of the structures, as well as the traditional stone structures of the Allt Ruidh nan Sgoliearan NCN7 culvert (see **Photograph 3-9**) where deep cavities in mortar are present, not all areas could be searched for hibernating bats. However, searches for signs of the species around the entrances to these areas as well as searches in areas that are accessible meant that an assessment of the value of the culverts could be made for hibernating bats.

Photograph 3-9: Gaps between mortar in stonework
