Appendix 11.4

Hydromorphology Assessment Part 2

Hydromorphology Catchment Baselines

Spey Catchment Overview

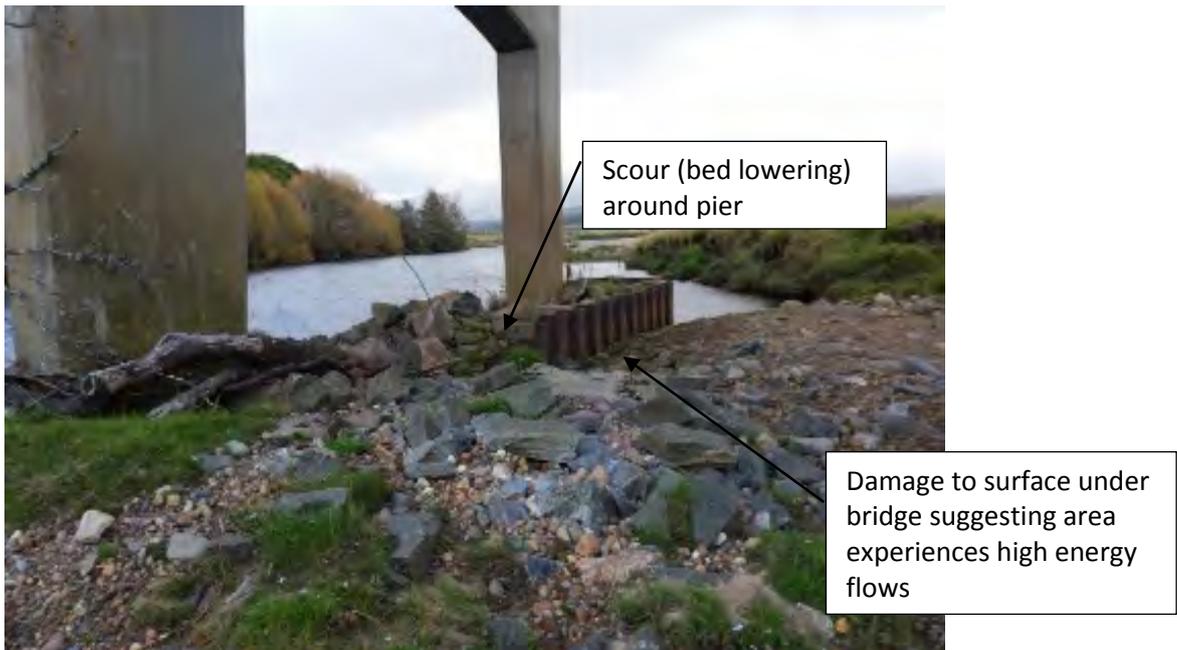
- 11.4.4.32 From the initial desk study and walkover it appears that the bridge abutments and A9 embankment (which runs across the floodplain) constrict downstream high flows, which increases erosive energy under the bridge, causing scour to the bed and erosion of the right bank, where the channel is not fixed and able to adjust.
- 11.4.4.33 The current A9 Spey bridge is restricting natural geomorphological processes and will continue to do so as it alters flows and fixes the bank positions, and it therefore forms a morphological pressure within the Spey catchment.
- 11.4.4.34 If the rate of channel change in the area were to continue (as it is expected to do so) then over time it would be expected that future A9 maintenance would need to consider an intervention to protect the existing bridge embankment from erosion.

Photograph 1: Scour to bridge pier

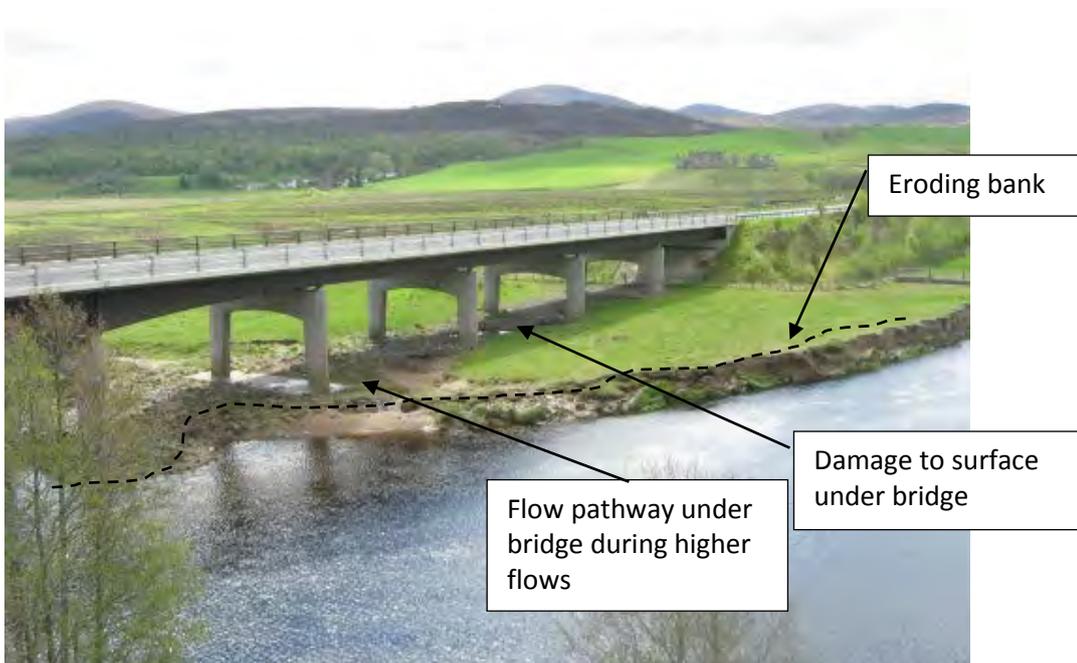
Photograph 2: Erosion of the right bank

The rate of erosion of the right bank upstream of the bridge may also have been increased by the construction of the A9, as the velocity increases a small amount here, suggesting that the channel has more energy to erode material from its bed and banks.

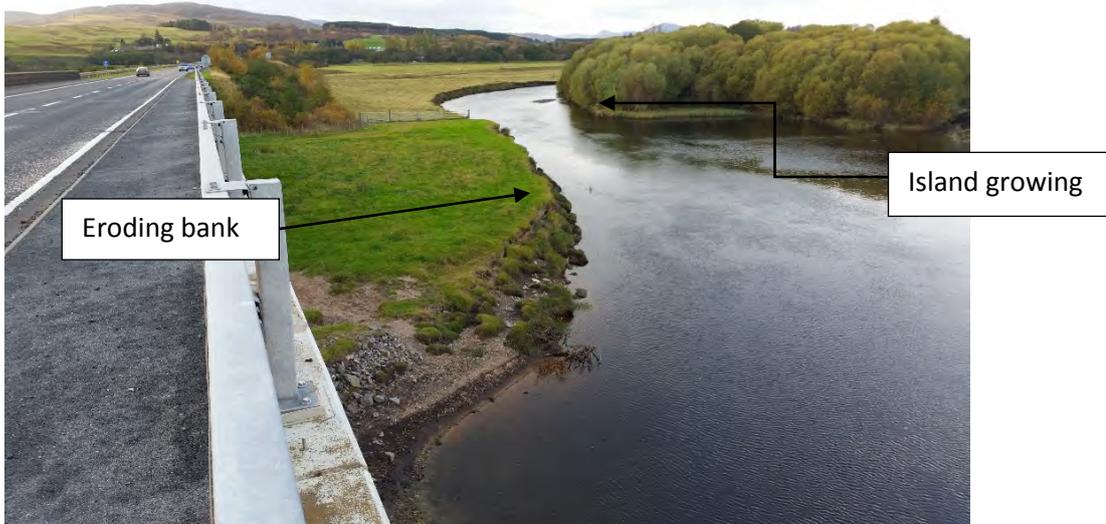
Photograph 3: Erosion of the right bank (looking upstream)

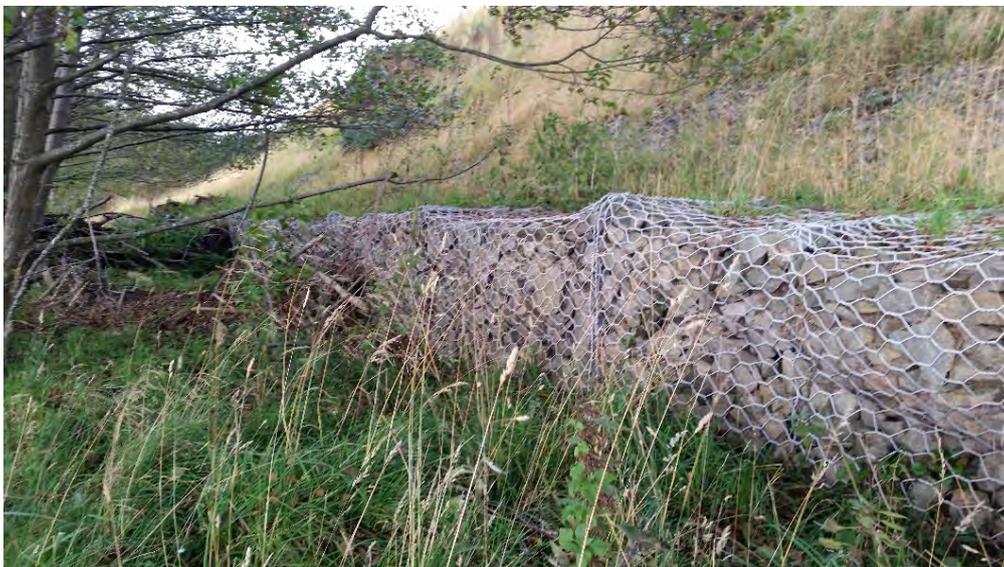
form the valley side, and this has been protected with gabion baskets (**Photograph 4**), fixing the bank position on this side. It is also recorded that in the 1980's rock was placed in the channel to protect the piers along this side from scour.

Photograph 4: Gabion basket bank protection along left bank

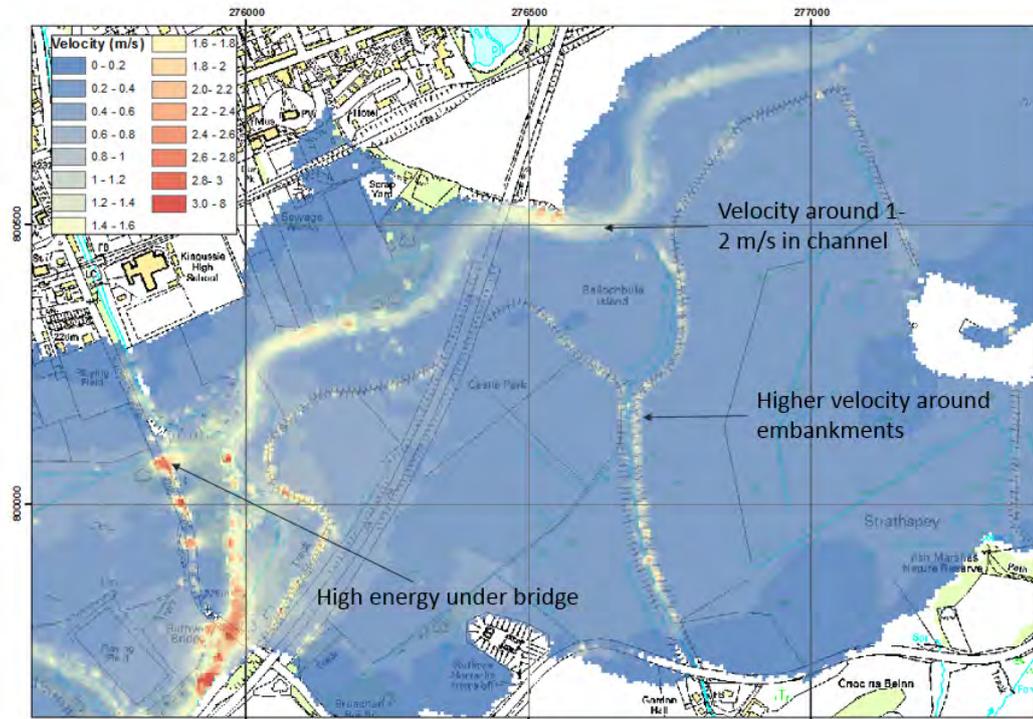
Figure 5: 1:200 year velocity modelling under 'natural' floodplain conditions prior to A9 construction

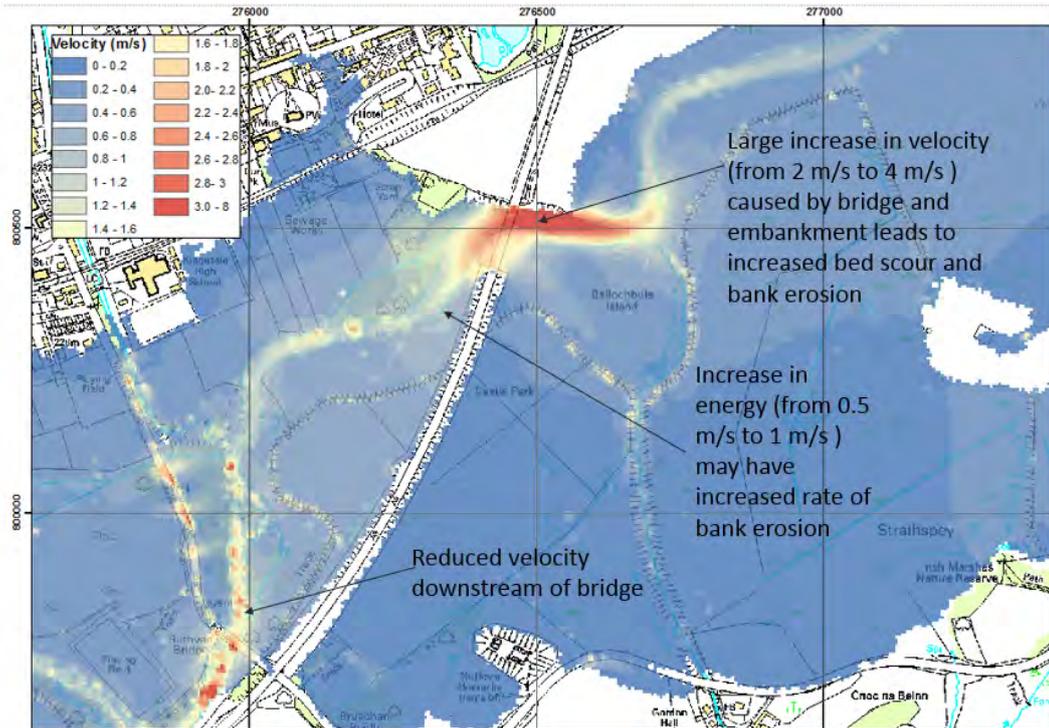
- 11.4.4.37 The results show that there is a large increase in velocity in the vicinity of the bridge with the current embankment in place compared to the pre A9 conditions. This substantiates the field observations that the bridge and embankment create high velocity flow under the bridge and downstream, which increases the rate of bed scour and bank erosion. The left bank and bed

along the left side are fixed by previous engineering works and so are relatively stable, but the right side is subject to scour, leaving the pier that was on the right bank (when constructed) now close to becoming an island in the channel as the channel moves.

Figure 6: 1:200 year velocity modelling under current conditions, with embankment and bridge abutments in place

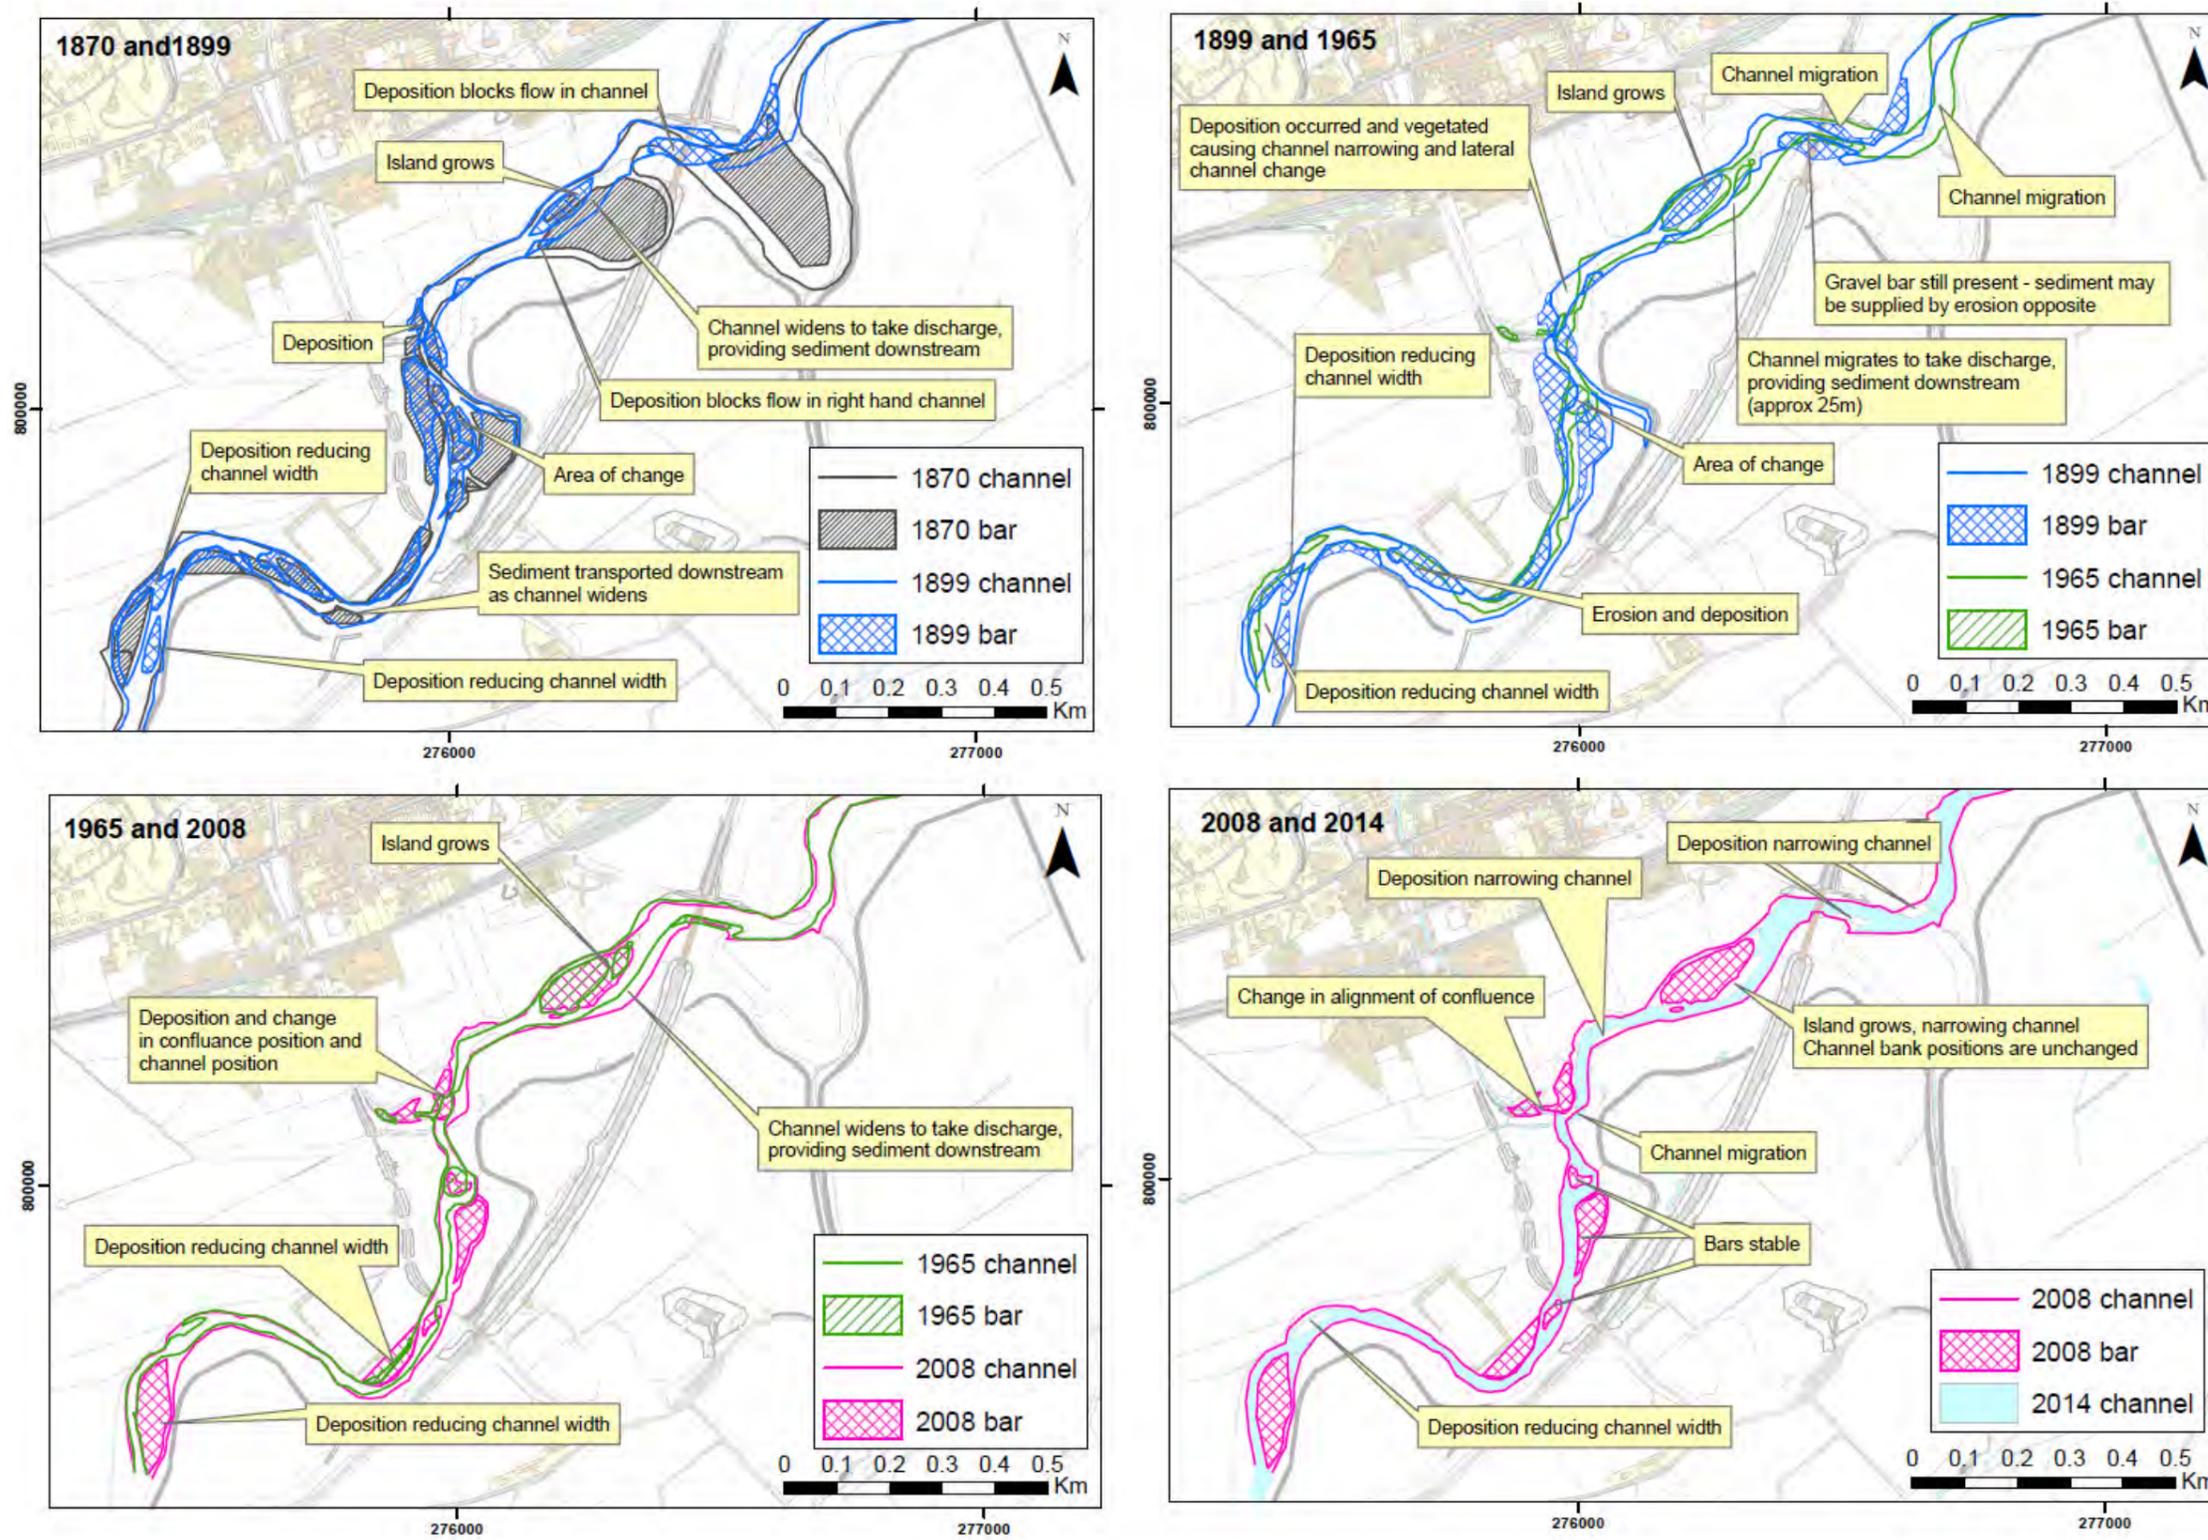
- 11.4.4.40 The assessment shows that there has been a historical trend of channel narrowing, since 1870. It also shows that channel movement upstream of the Spey crossing location has had a net trend direction since 1899, with the channel moving towards the south east. This area of lateral channel movement is a concern as it has the potential to increase scour around the piers, as the bed of the channel moves across and these piers end up in the channel, as well as undercutting and eroding into the existing A9 embankment. This channel movement will also impact any future A9 crossing and embankment.

Figure 7: Historical channel positions

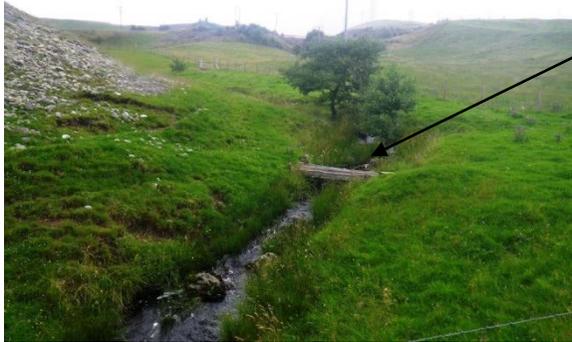
Photograph 11.4.4.12- Upstream

Incised channel
in open valley

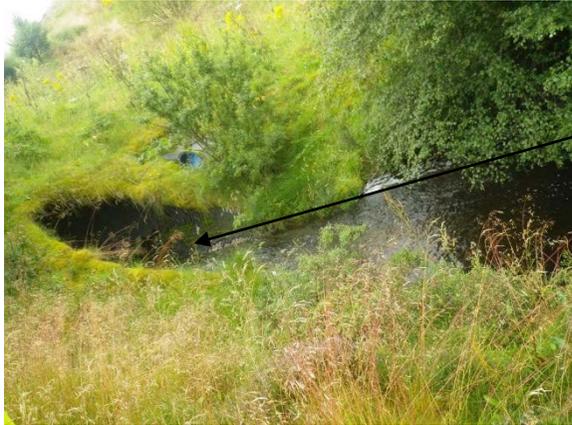
Photograph 11.4.4.16- Downstream of crossing

Culvert exit

Step-pool morphology

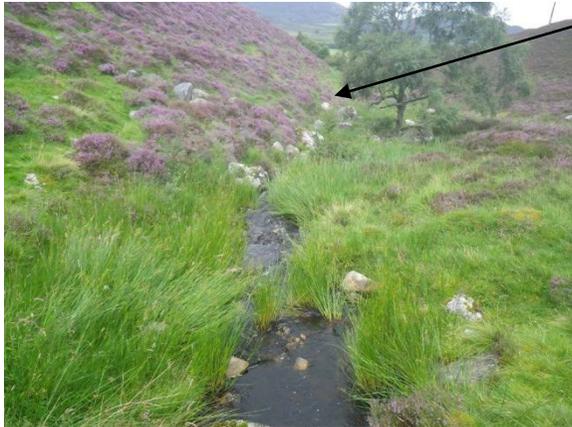
Photograph 11.4.4.18- Downstream

Channel confined by valley sides

Step-pool morphology

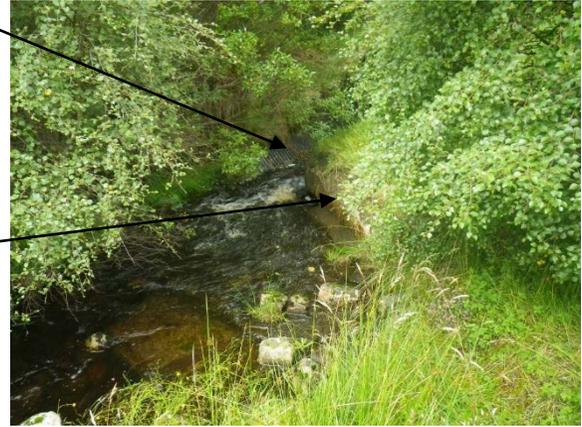
Photograph 11.4.4.21- Looking downstream to crossing

Localised erosion at entrance
